Table E-1
2014 Erosion Monitoring and Maintenance

ESCA RP 2014 Annual Natural Resource Report - Appendix E

Appendix E - Erosion Monitoring and Maintenance Photo-documentation

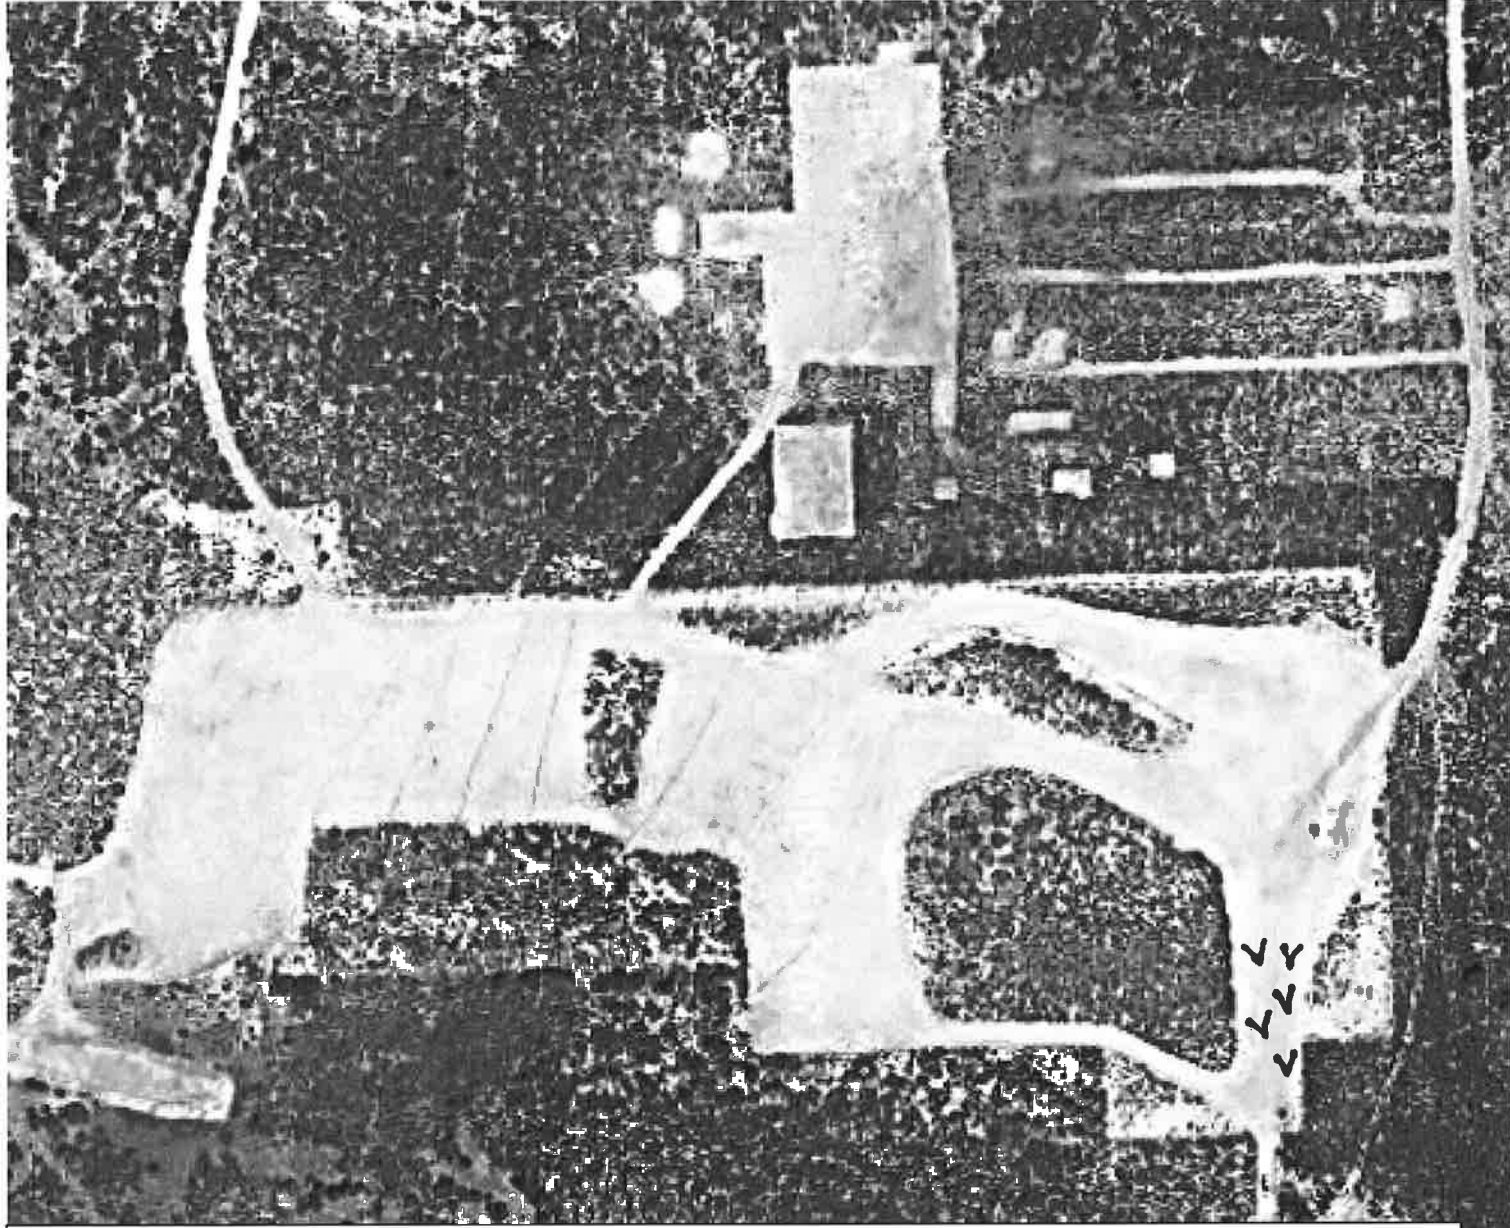
IAR-Devel. Parcel/NR44 Erosion Monitoring

< = Sand bag chevron installed to slow water flow and increase sediment deposition.

Sand bags were filled and placed in the
south IAR development parcel to control
erosion in rills turning to gullies.

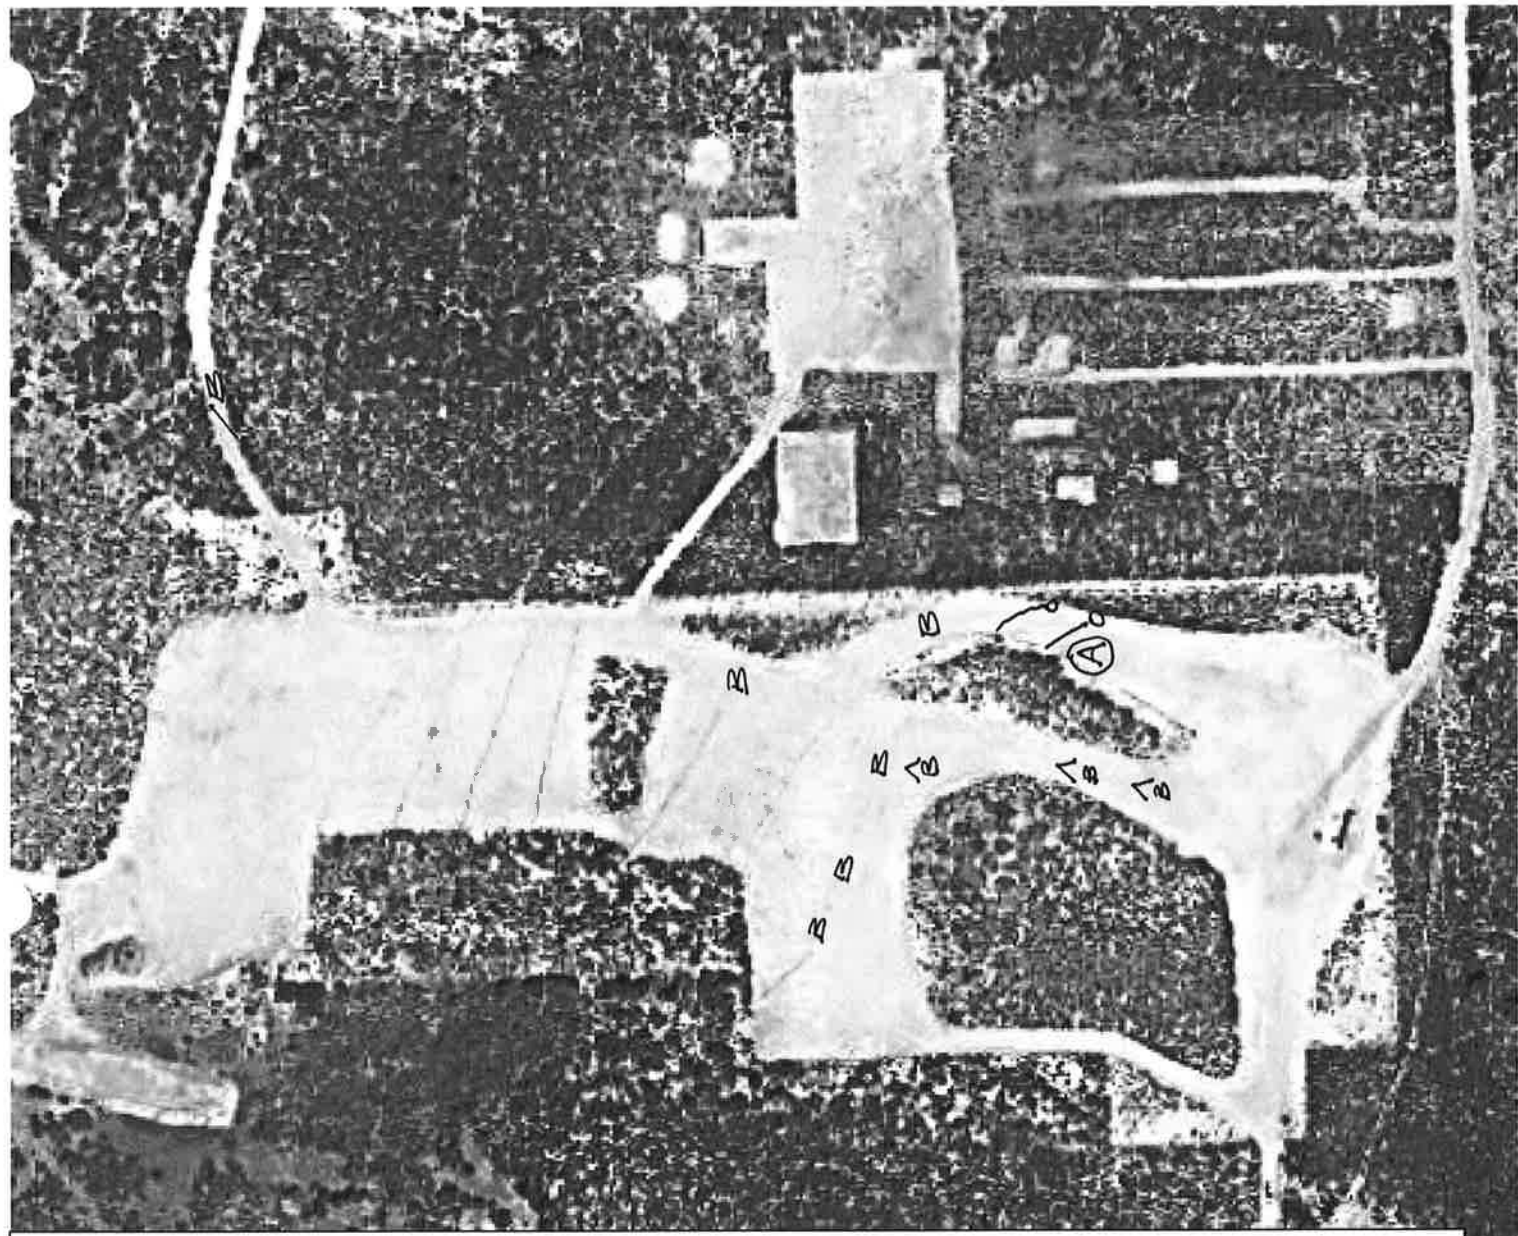
① Wattles need to be weighted down with additional sand bags

② Additional sand bags needed

Type	Functioning Properly? (Evidence of overtopping, undermining or flow around?)	Need repair or correction?	Comments/Notes
Wattles	N	Y	Need more sand bags to weight down wattles - see map
Blanket	N/A		
Silt Fence	N/A		
Sand Bags	N	Y	Need to add bags of sand as per map.

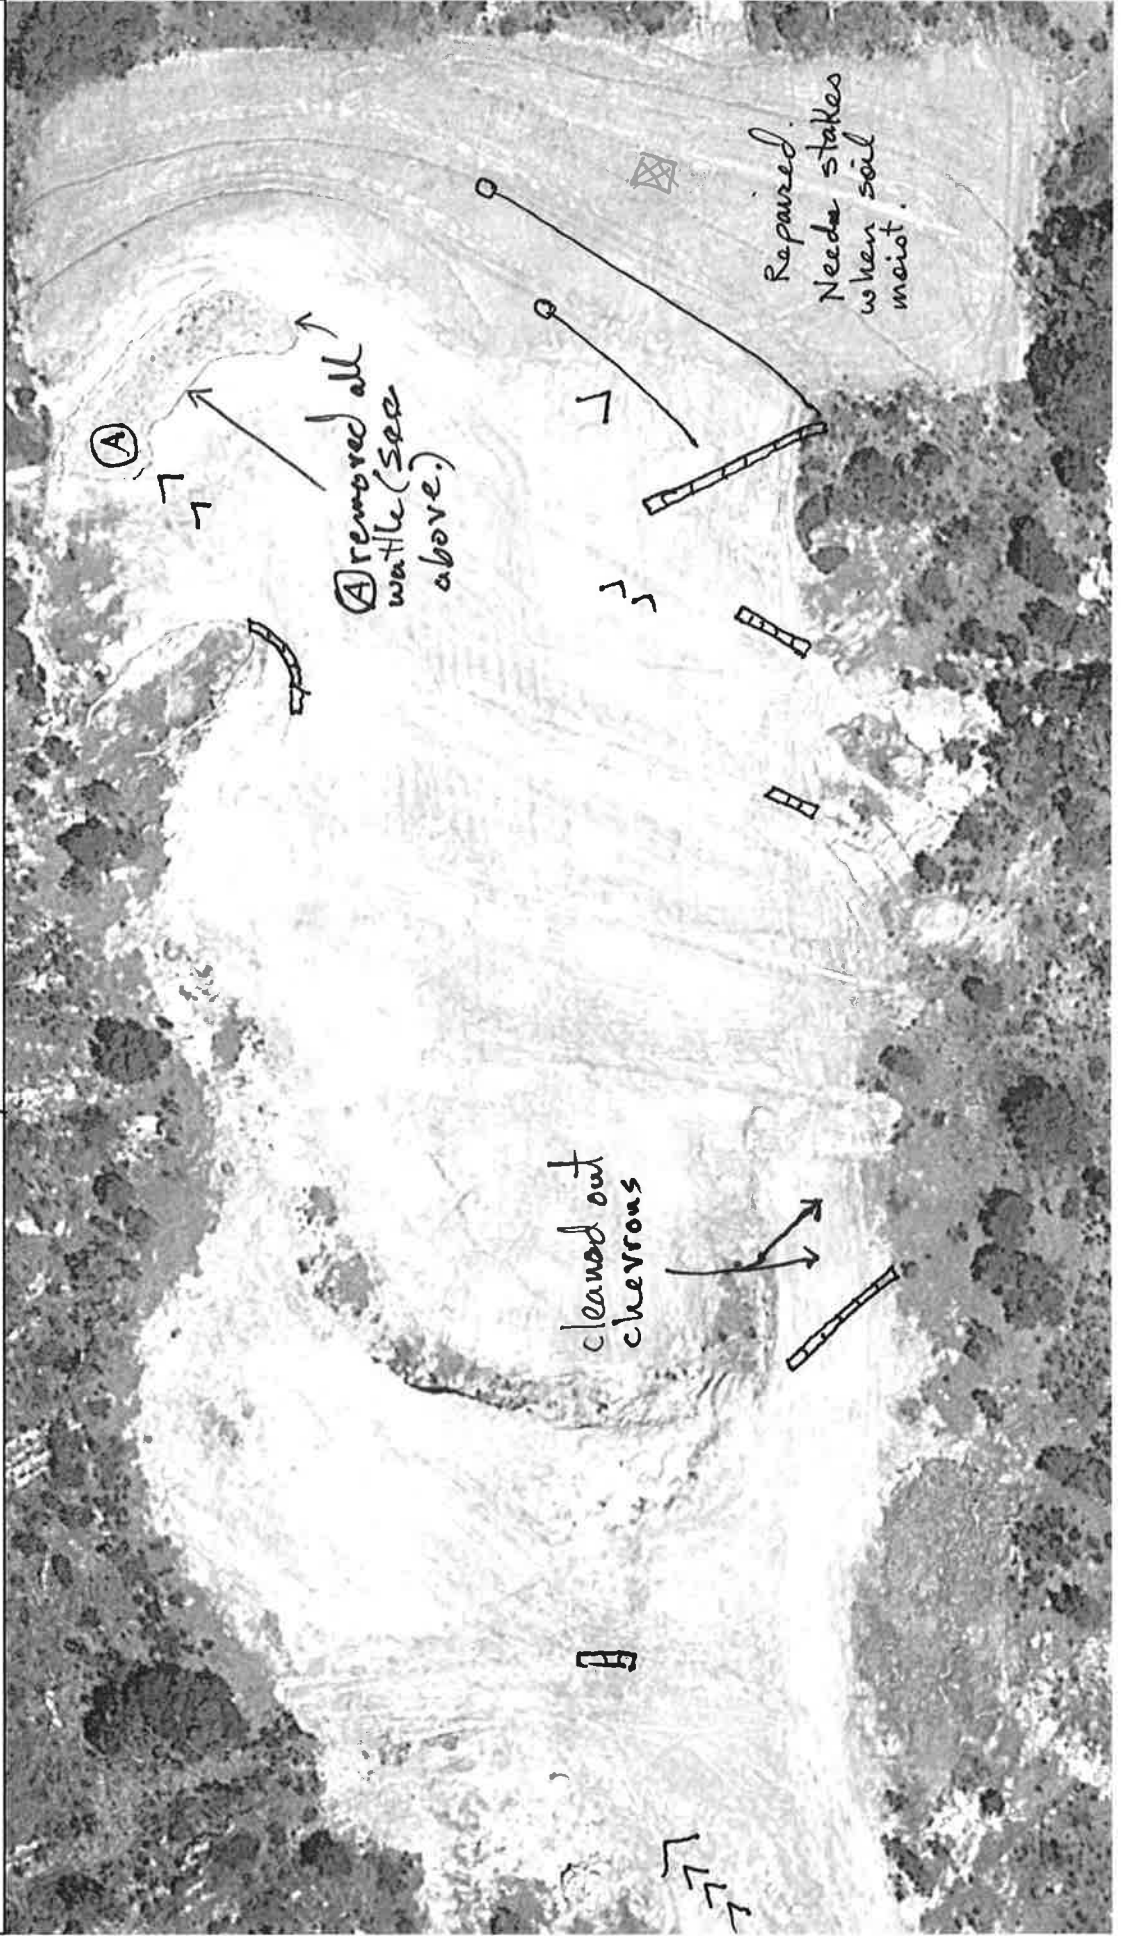
— = straw wattle installed or replaced

⊠ = erosion blanket installed or replaced

Type	Functioning Properly? (Evidence of overtopping, undermining or flow around?)	Need repair or correction?	Comments/Notes
Wattles	New wattles installed as per map. Existing wattles functioning well.	Removed old wattles.	
Blanket	Repaired blanket where undercutting occurring by stubbing rolled blanket in gully. Soil too hard for adequate staking. Add stakes when soil moist.		
Silt Fence	None		
Sand Bags	New bags installed as per map. Plastic bags replaced w/ burlap.

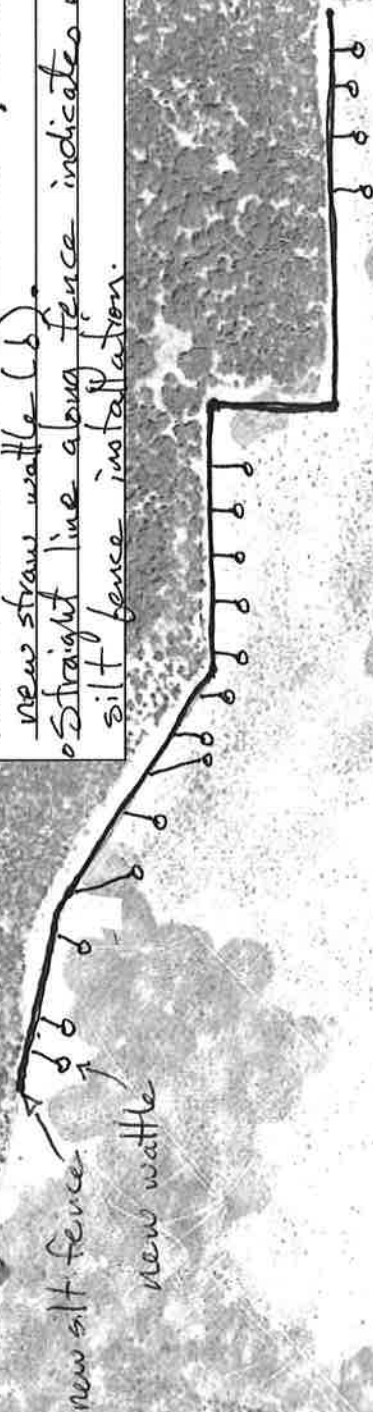
new wattle

new straw wattles (b)
o straight line along fence indicates new
silt fence installation.

Type	Functioning Properly? (Evidence of overtopping, undermining or flow around?)	Need repair or correction?	Comments/Notes
Wattles	New wattles installed along N side of R47 as per map.		
Blanket			
Silt Fence	Additional (2nd) silt fence installed upslope of existing fence on N side of R47 as per map. New silt fence installed on east side of site as per map.		
Sand Bags

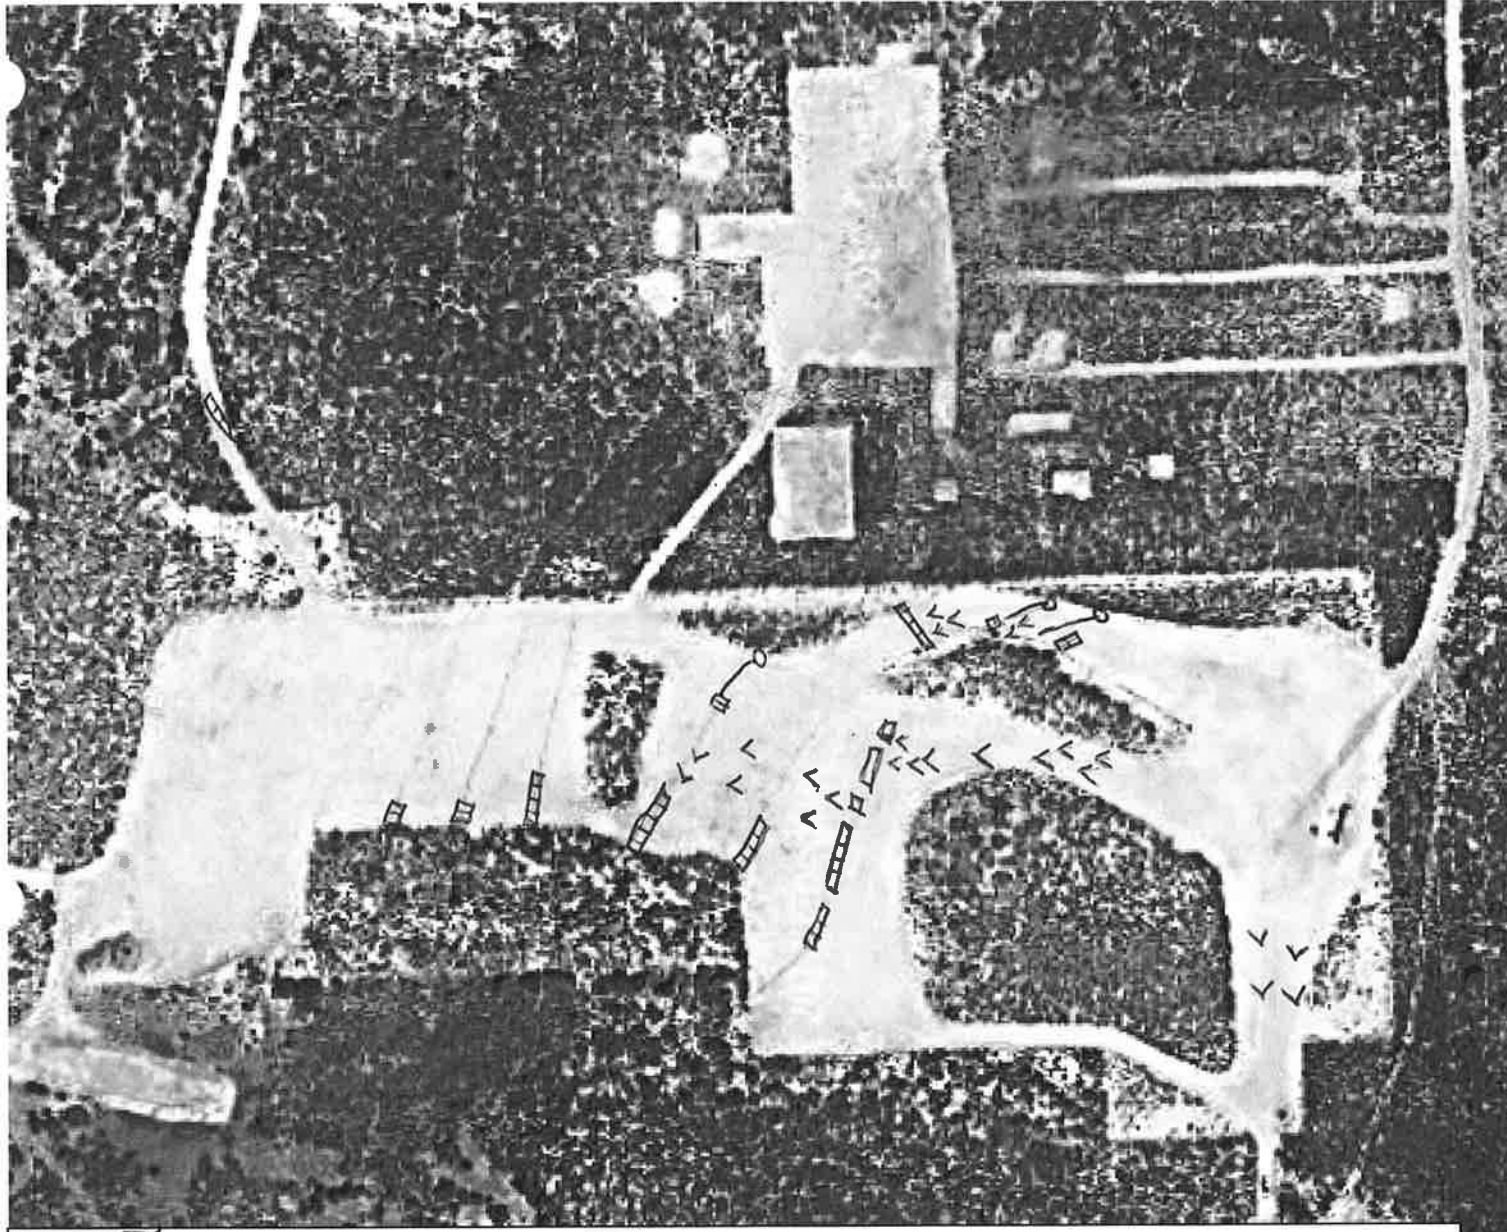
— = straw wattle installed

⊠ = erosion blanket
or riprap

Type	Functioning Properly? (Evidence of overtopping, undermining or flow around?)	Need repair or correction?	Comments/Notes
Wattles	New wattles installed as per map.		
Blanket	None		
Silt Fence	None		
Sand Bags	New sand bags installed as per map.

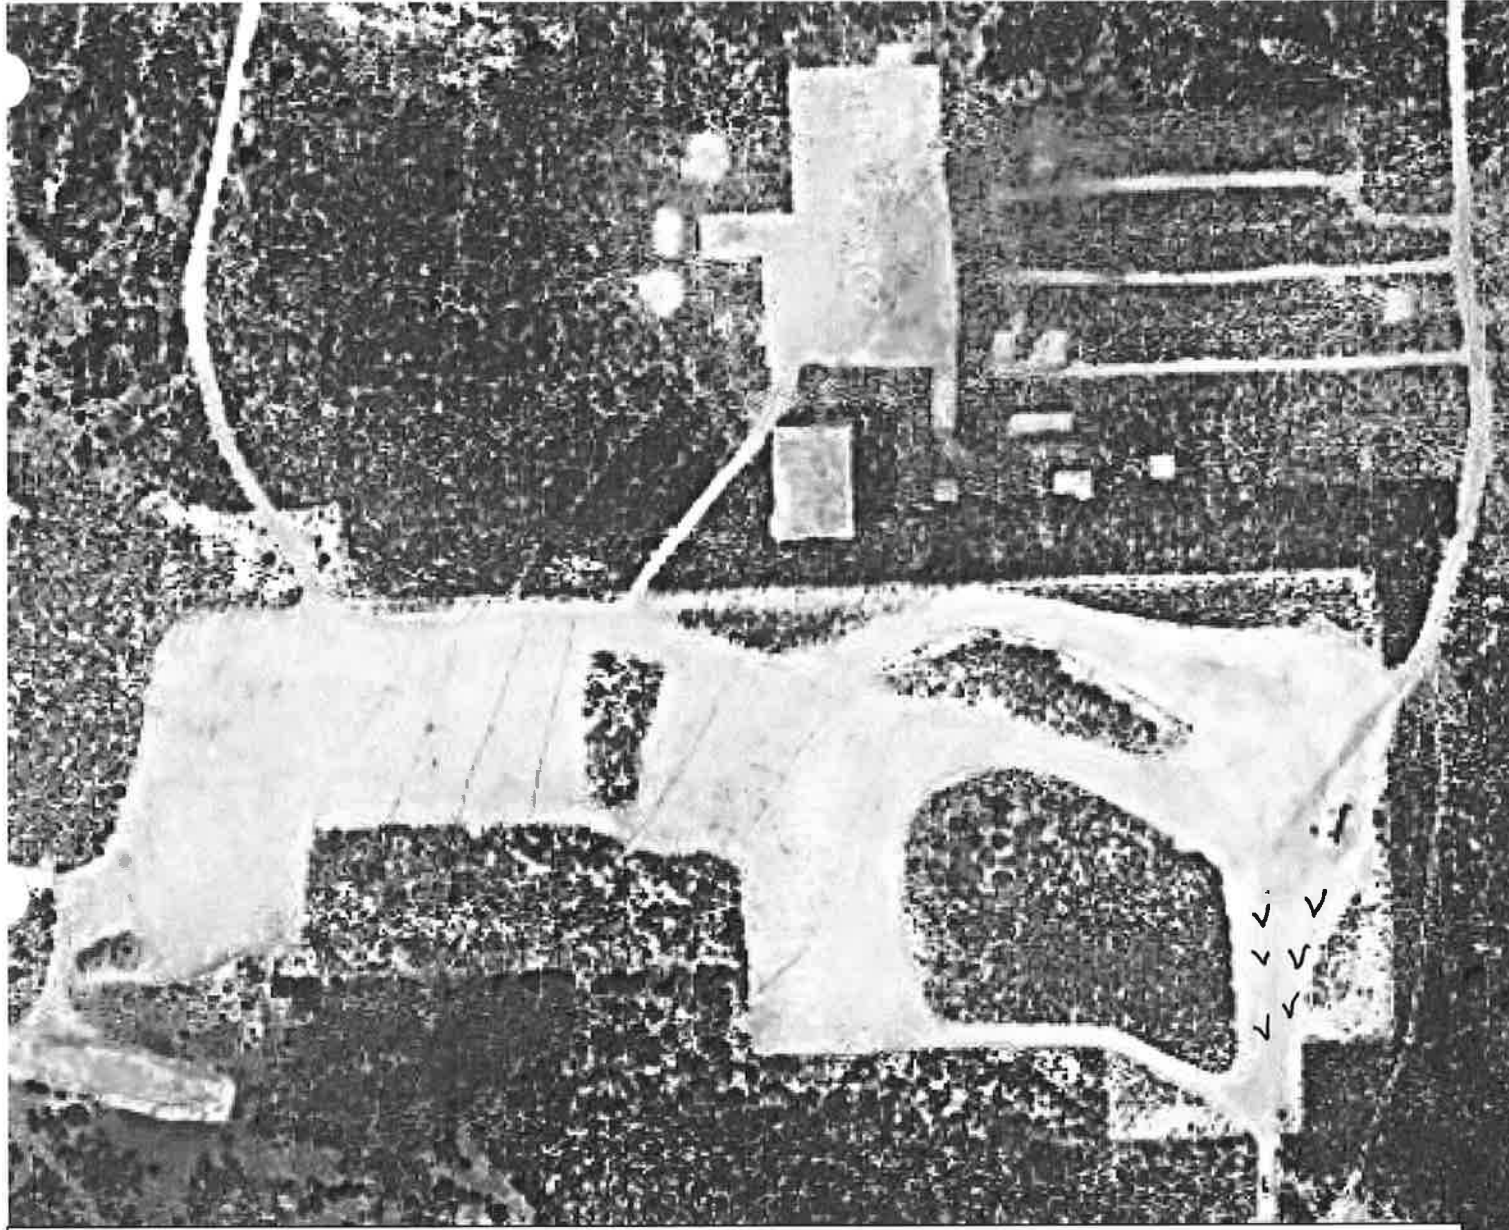
Date: 10/27/2014

"<" indicates location
of acquired sand
by chevron.

Type	Functioning Properly? (Evidence of overtopping, undermining or flow around?)	Need repair or correction?	Comments/Notes
Wattles	<u>Not inspected</u>		
Blanket	<u>Not present</u>		
Silt Fence	<u>Not present</u>		
Sand Bags	<u>N</u>	<u>Y</u>	<u>Recent 1/4" rain event on 10/25/14 caused sand to build up behind sand bag chevrons and in some cases to run around them. Sand was removed from behind chevrons and more bags were added.</u>

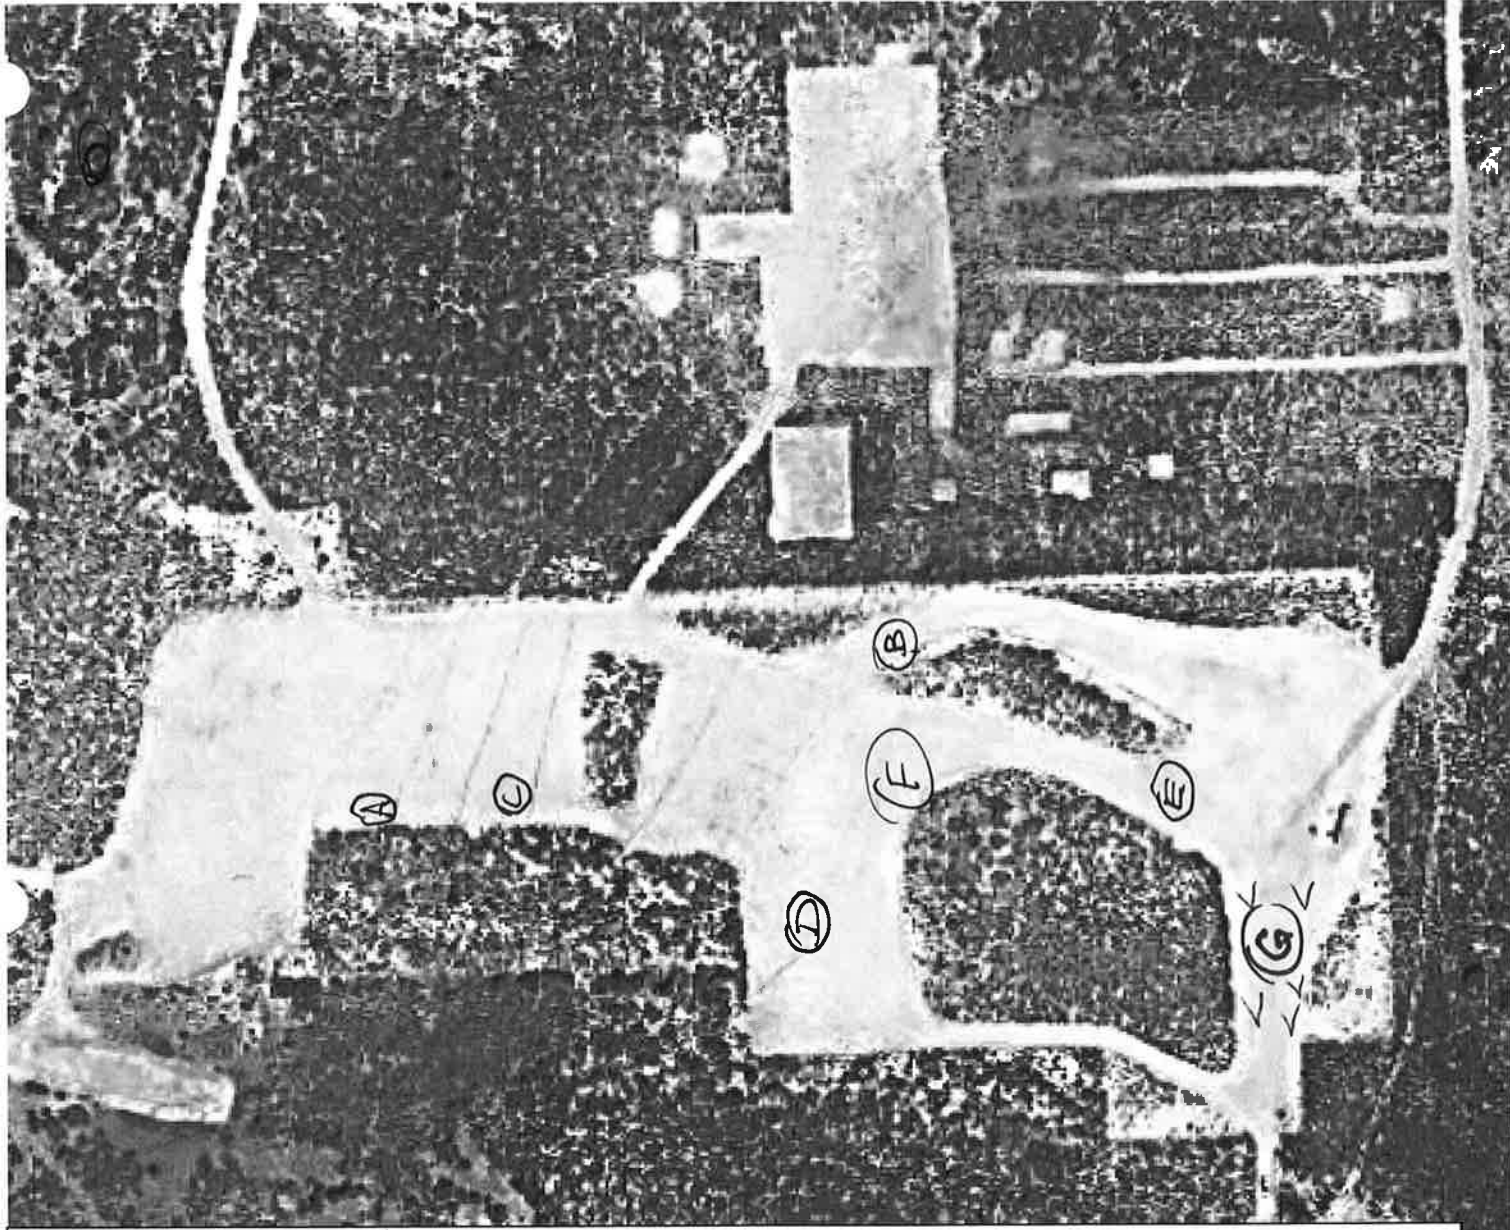
F: Significant sand deposition in alluvial fans.

G: Many sandbags needed to fix chevrons, water bearing under and around.

Type	Functioning Properly? (Evidence of overtopping, undermining or flow around?)	Need repair or correction?	Comments/Notes
Wattles	<u>Y</u>	<u>N</u>	
Blanket	<u>N/A</u>		
Silt Fence	<u>N/A</u>		
Sand Bags	<u>N</u>	<u>Y</u>	<u>Most sand bags working well. Many sand bags were moved to function better. More bags needed @ A on way.</u>

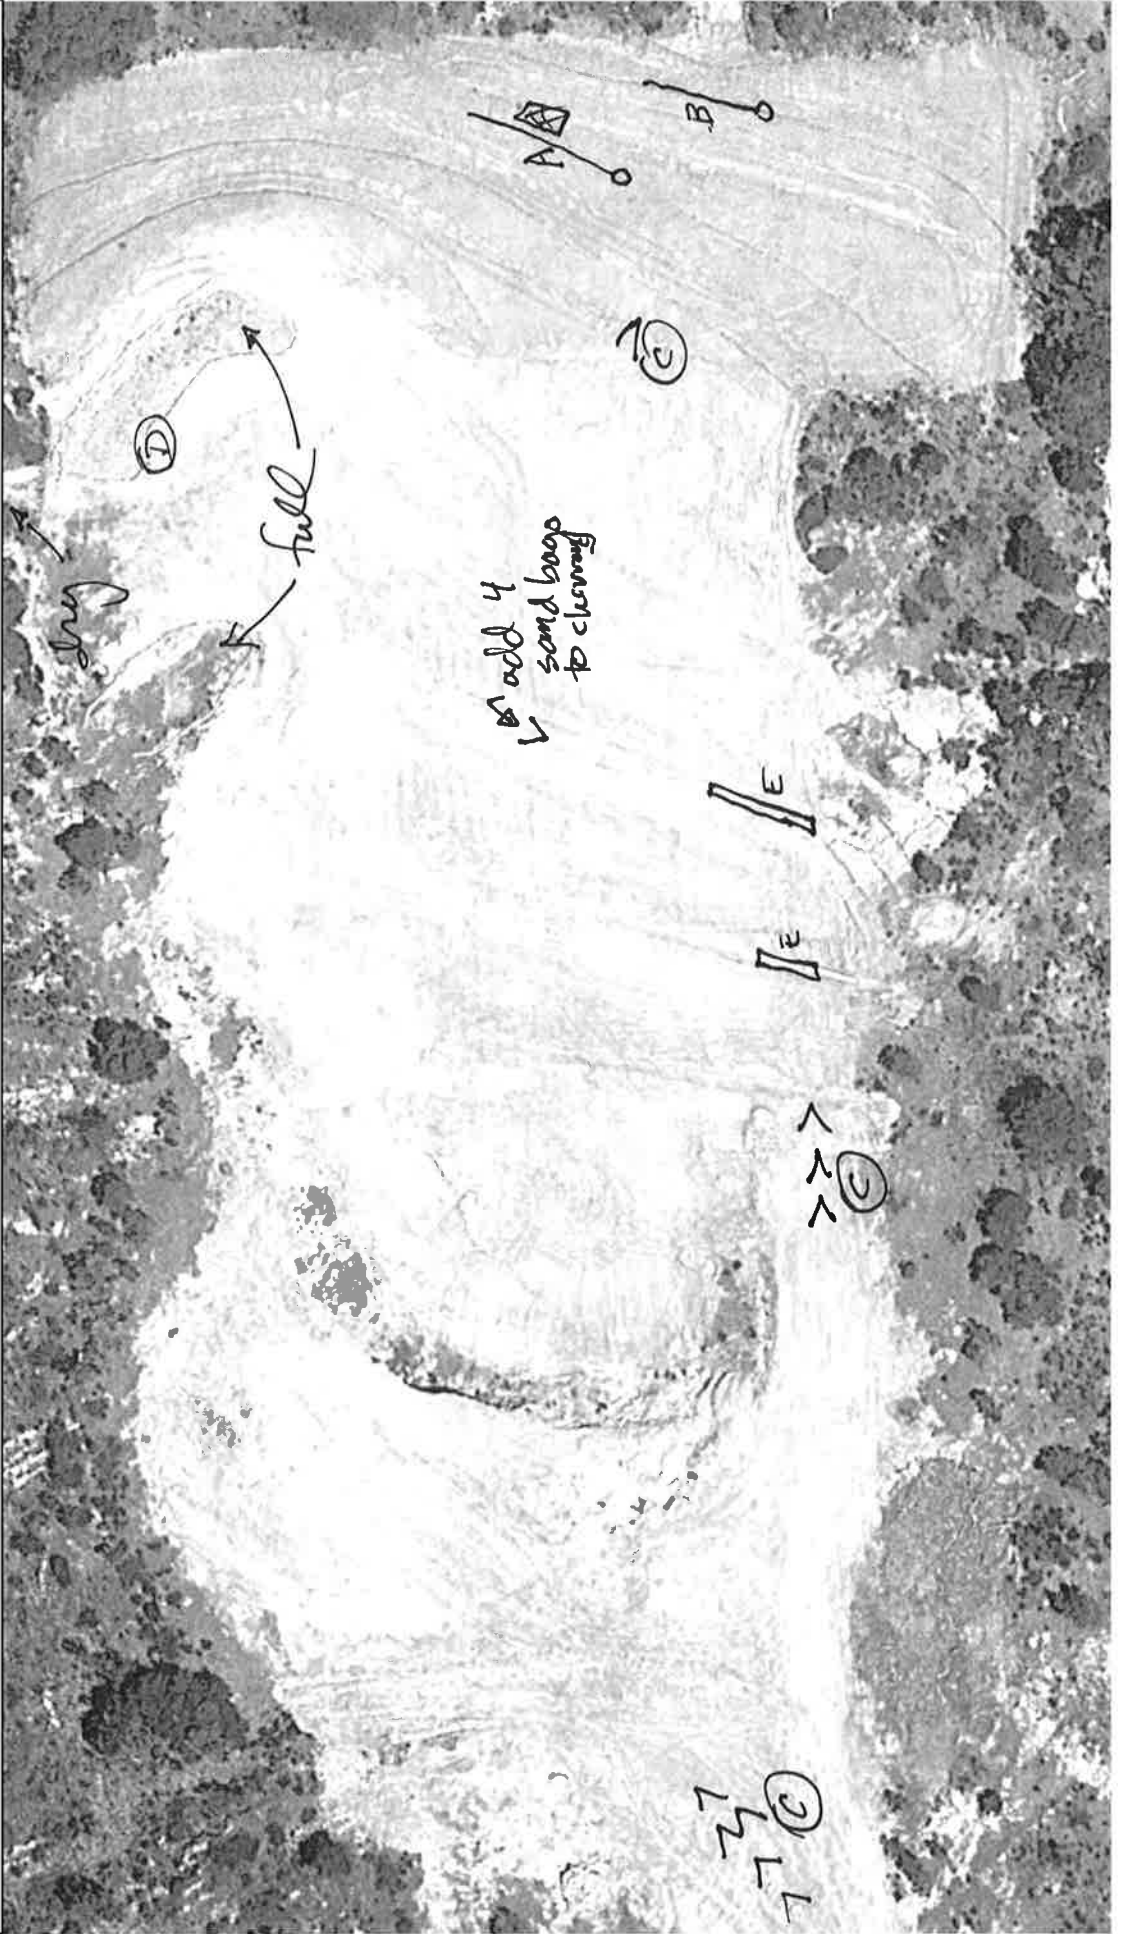
A: New wattles needed, erosion blanket repaired

D: Small alluvial fan near aquatic feature

E: Sand removed and placed on water bar

Type	Functioning Properly? (Evidence of overtopping, undermining or flow around?)	Need repair or correction?	Comments/Notes
Wattles	<u>No</u>	<u>Y</u>	<u>On some old wattles water is overtopping. On some newer ones it's running.</u>
Blanket	<u>No</u>	<u>Y</u>	<u>Did staking to secure underneath blanket. More stakes needed.</u>
Silt Fence	<u>N/A</u>		
Sand Bags	<u>No</u>	<u>Y</u>	<u>most sand bags working well. Some needed shoring up behind chevron. This was done. 4 bags need still as per map.</u>

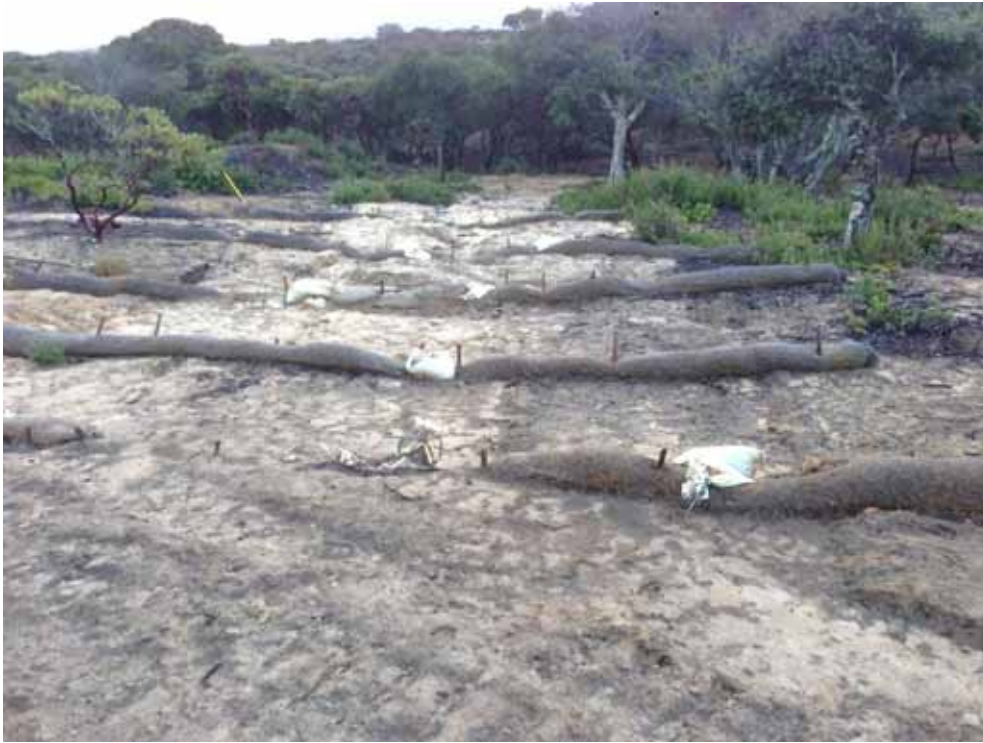
Photograph 1

Wattles installed in 2013 continue to function well in this location. Most flow has since been diverted away using water bars.

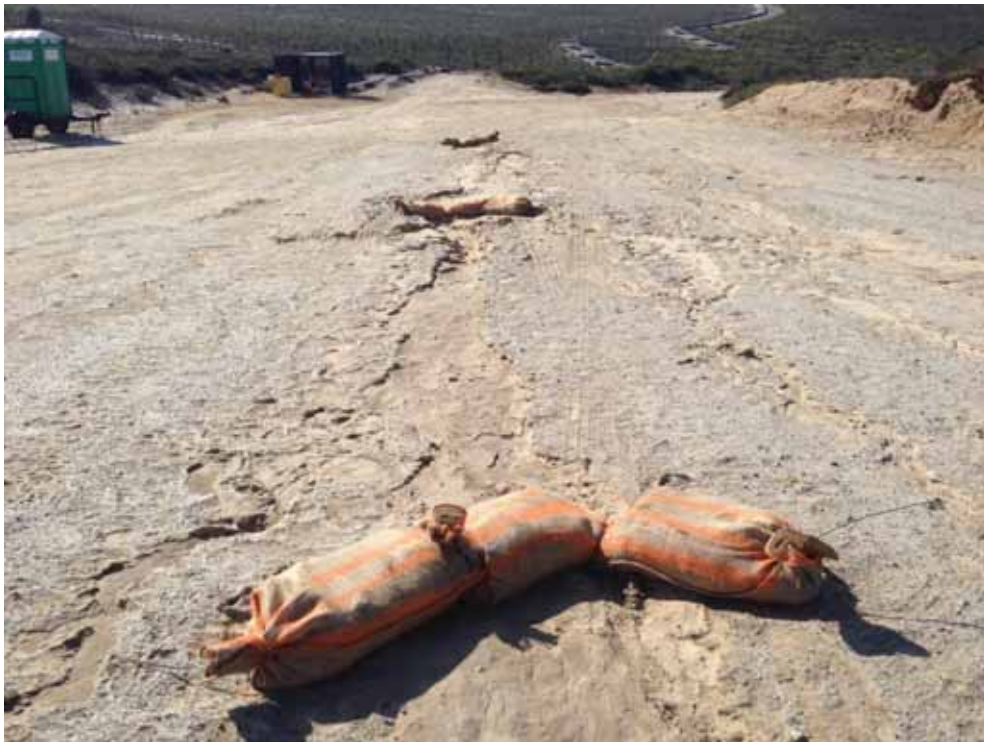
Photograph 3

New sand bag chevrons installed to slow water and prevent gully formation.

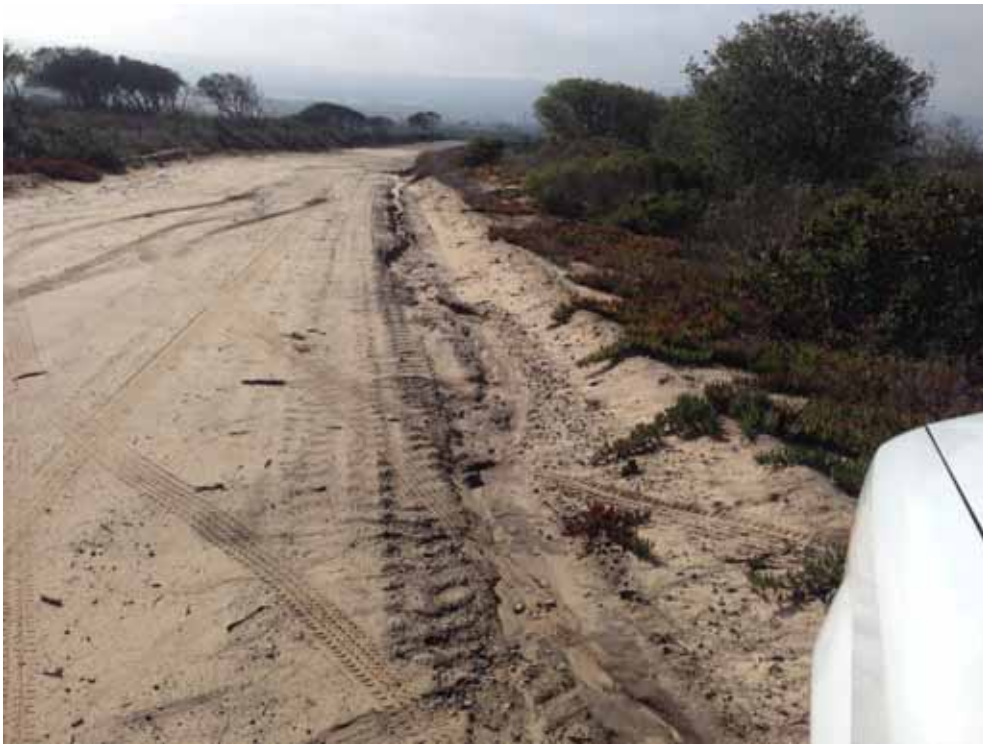
Photograph 5

Early signs of gulling at north end of Seaside MRA.

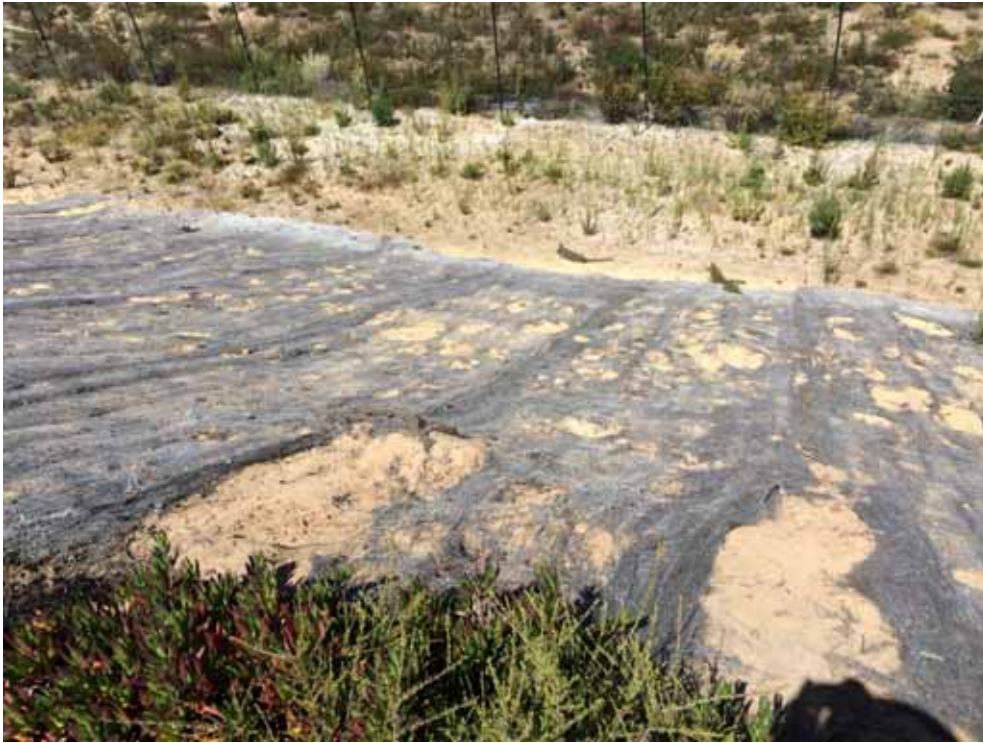
Photograph 7

Erosion blanket
natural
degradation on
escarpment, 1.5
years after
installation.

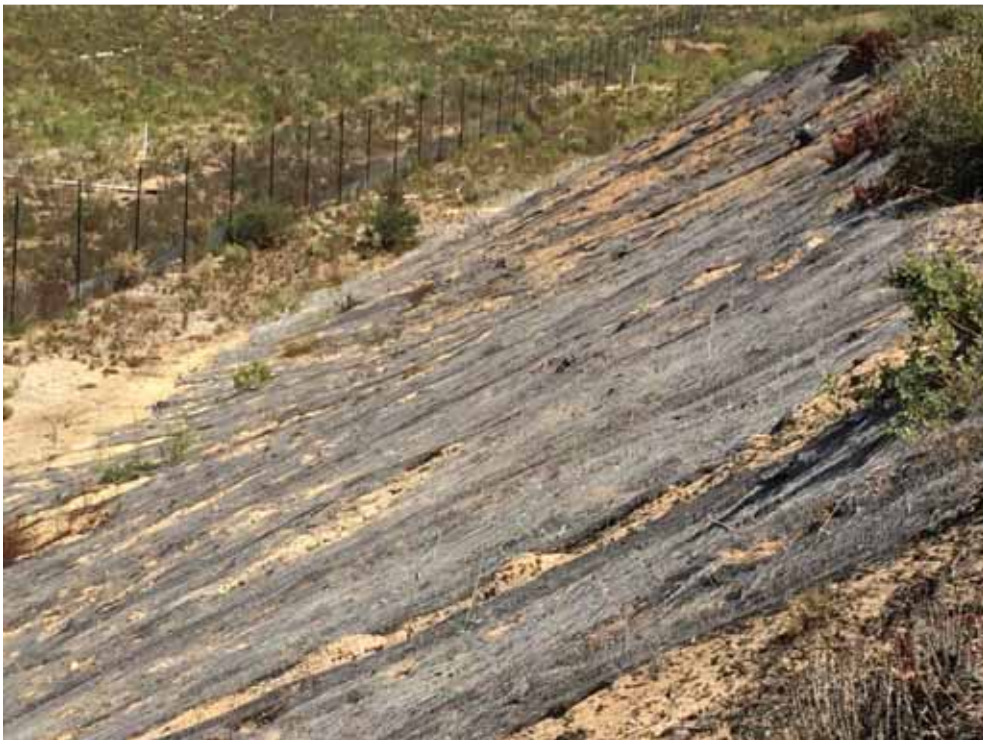
Photograph 8

Erosion blanket
natural degradation
on escarpment, 1.5
years after
installation.

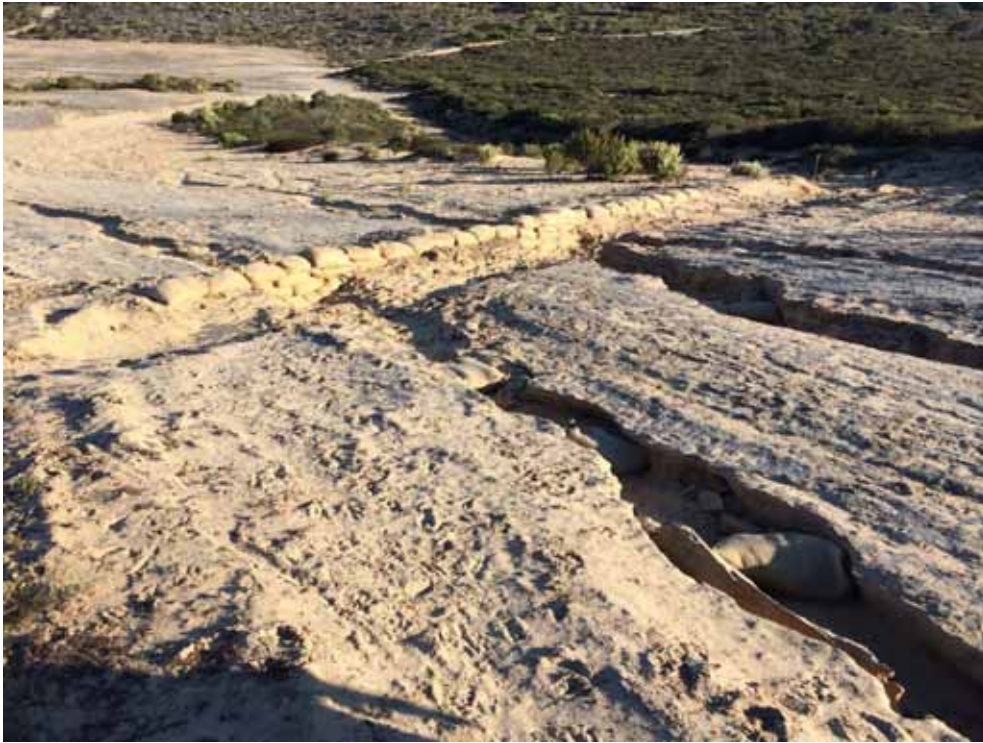
Photograph 9

New sand bags
installed to form a
water bar to
redirect flow.

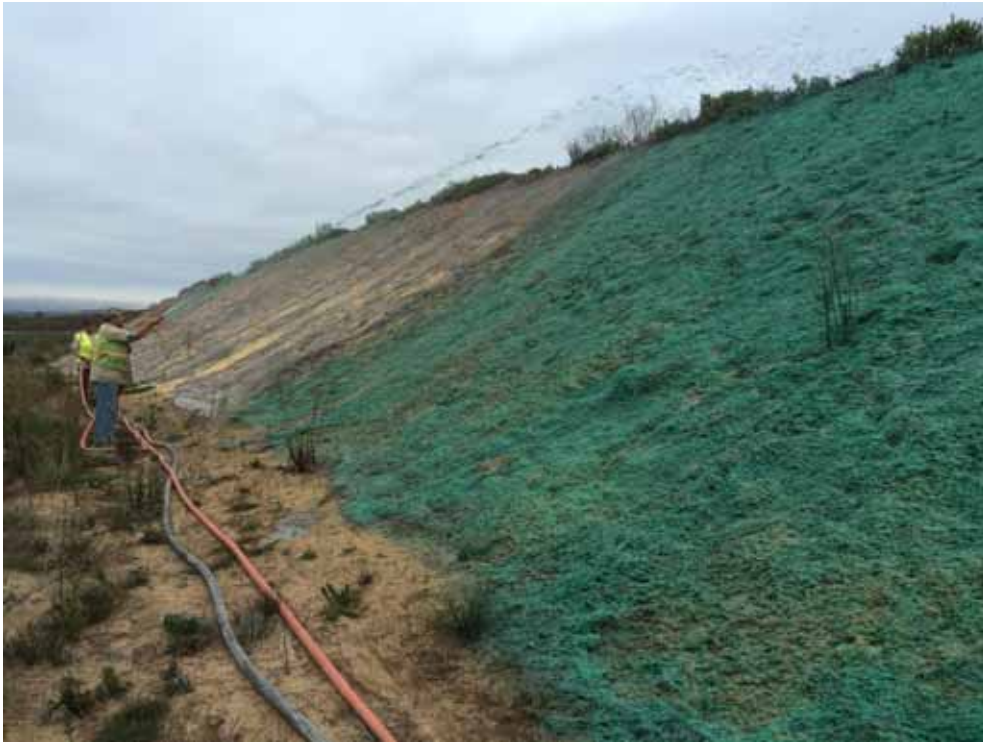
Photograph 11

Whole escarpment hydroseeded with wood fiber mulch, mycorrhizal inoculant, fertilizer, and native local seed to reinforce erosion control blanket.

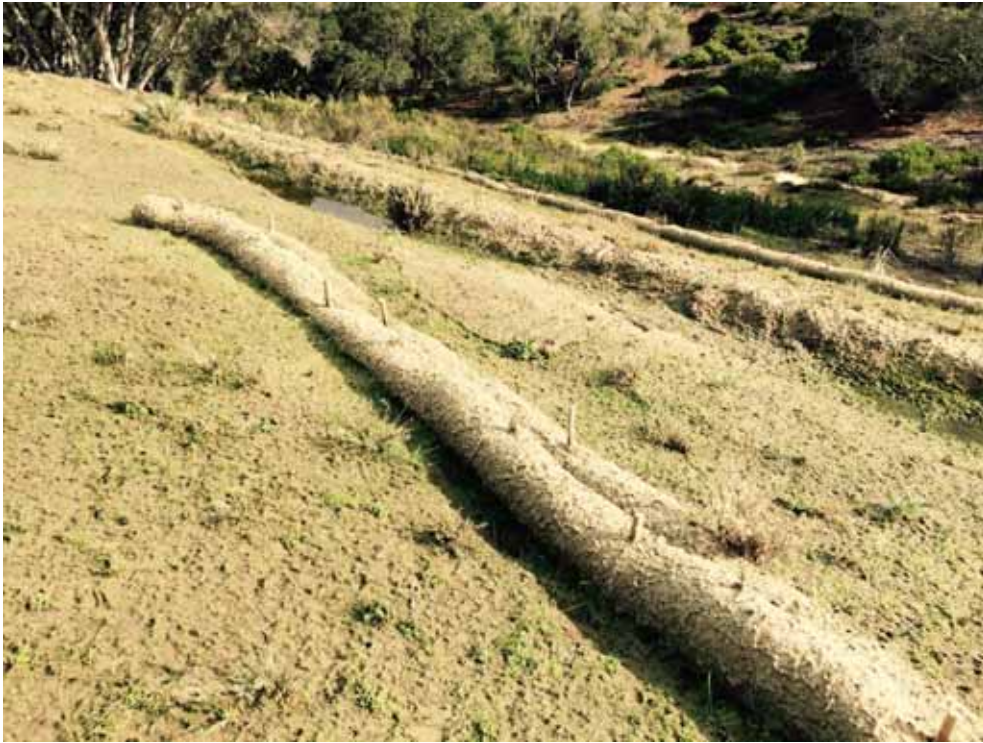
Photograph 13

Hydroseed
beginning to
sprout on east
facing slope.
