ESCA RP Erosion Monitoring Form

Table E-1
2016 Erosion Monitoring and Maintenance

ESCA RP 2016 Annual Natural Resource Report - Appendix E

Appendix E - Erosion Monitoring and Maintenance Photo-documentation

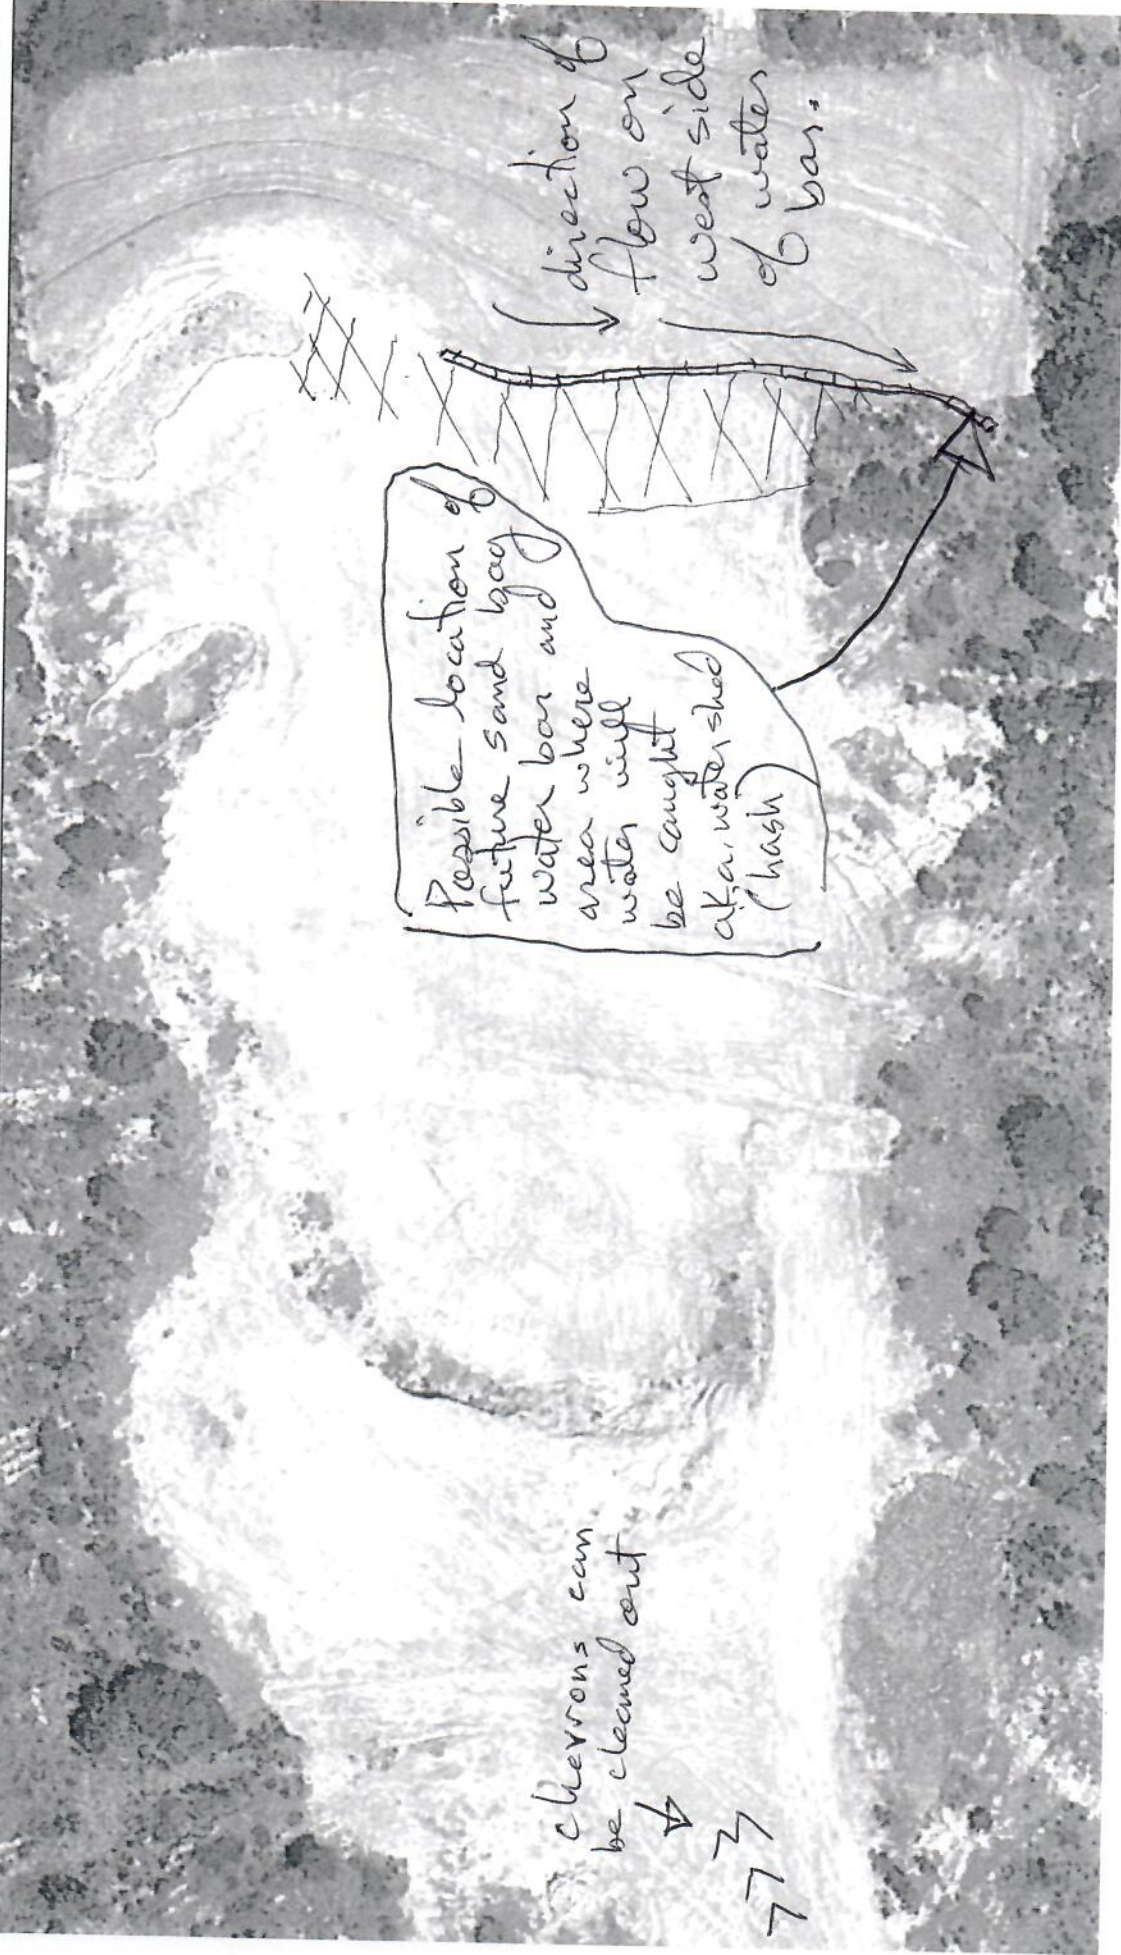
East facing slope is stable and small and large plants cover it. However, the same area is starting to get waterlogged and eroding. A new sand bagged water bed was visualized in case conditions get worse and it needs to be installed.

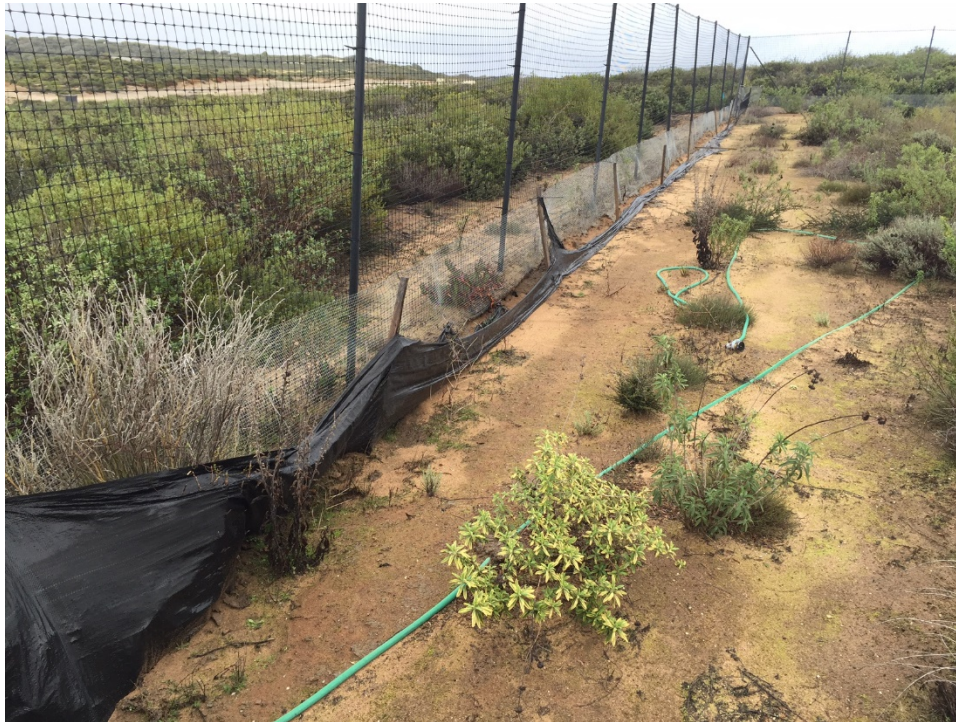
Photograph 1

Type	Functioning Properly? (Evidence of overtopping, undermining or flow around?)	Need repair or correction?	Comments/Notes
Wattles			
Blanket			
Silt Fence	A 100 ft stretch of silt fence on east end of R47 has degraded and needs replacing.		
Sand Bags			
Hydro-mulch + seeding	Escarpment has no new signs of erosion

Description:
100-foot length of silt fence in need of repair on east end of Range 47 in the Interim Action Ranges MRA. This silt fence was later replaced.

Replaced 100 ft
silt fence

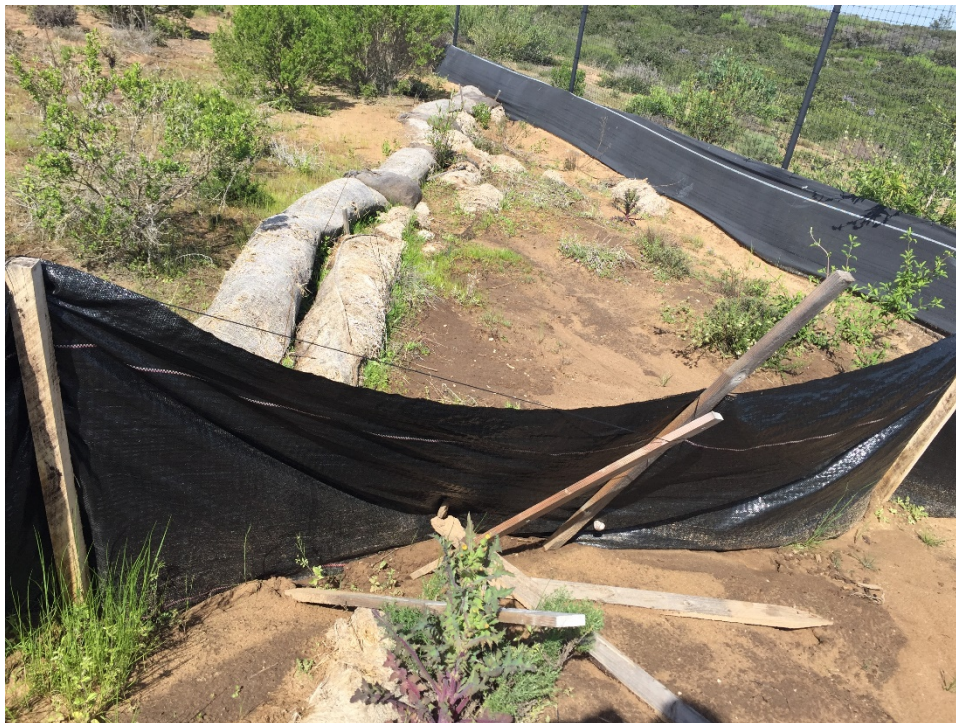
Photograph 2

1. Existing Erosion/Sediment Control Measures Present? <u>Y</u> or N. If N skip to 2.			
Type	Functioning Properly? (Evidence of overtopping, undermining or flow around?)	Need repair or correction?	Comments/Notes
Wattles	<u>-</u>		
Blanket	<u>-</u>		
Silt Fence		<u>Y</u>	<u>On north side of R47 the silt fence needs minor maintenance.</u>
Sand Bags	<u>-</u>

Description:
Silt fence in need of maintenance on north side of Interim Action Ranges MRA. This silt fence was later repaired.

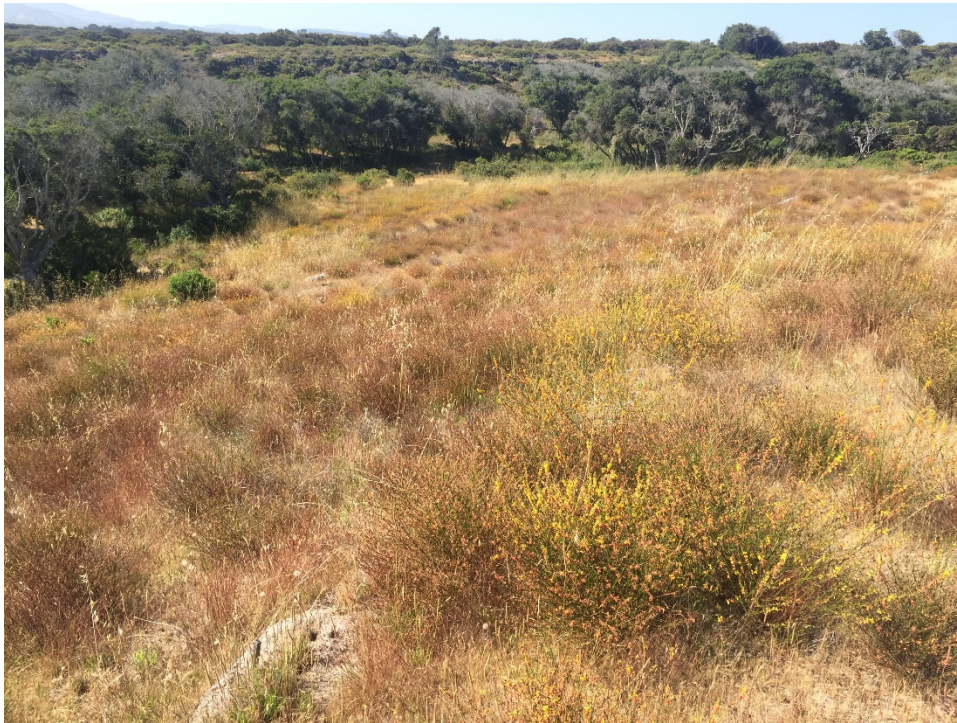
Photograph: 3

East facing slope in
Future East
Garrison MRA
grenade range is
well vegetated and
stable

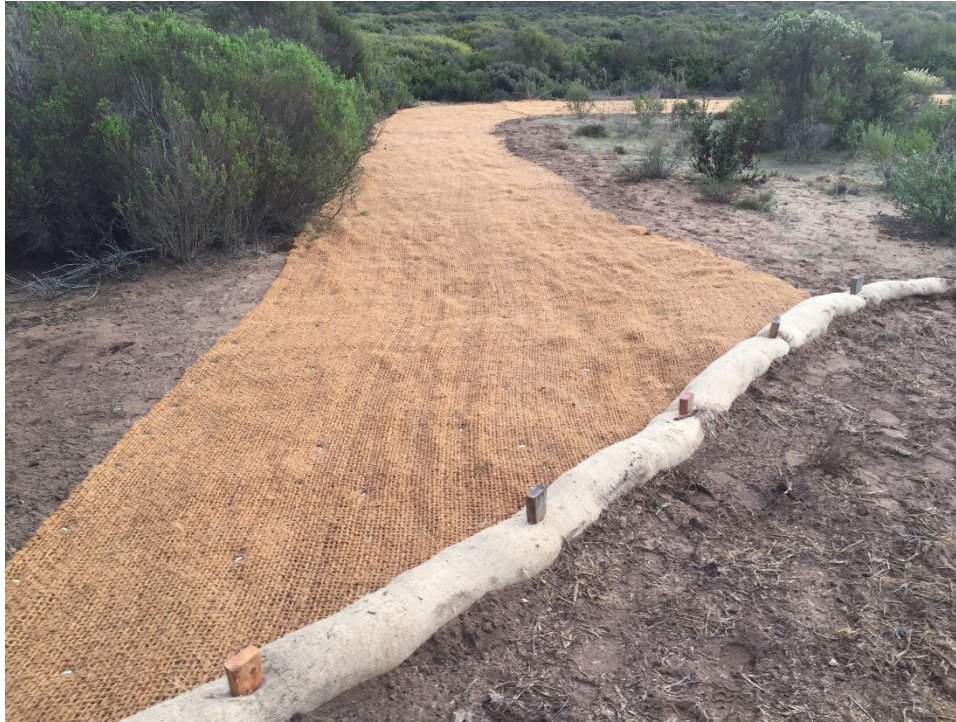
Photograph 5

Description:
New erosion control
BMPs installed at
north end of Range
47 after removal of
fence and gopher
wire.
