Report
Investigation of Munitions and
Explosives of Concern (MEC) Incident
Discarded Military Munitions (DMM)
Grenade, Hand, Smoke, White
Phosphorous, M15

November 9, 2009

Report
Investigation of Munitions and Explosives of Concern (MEC) Incident
Discarded Military Munitions (DMM) Grenade, Hand, Smoke, White Phosphorous, M15
August 29, 2009

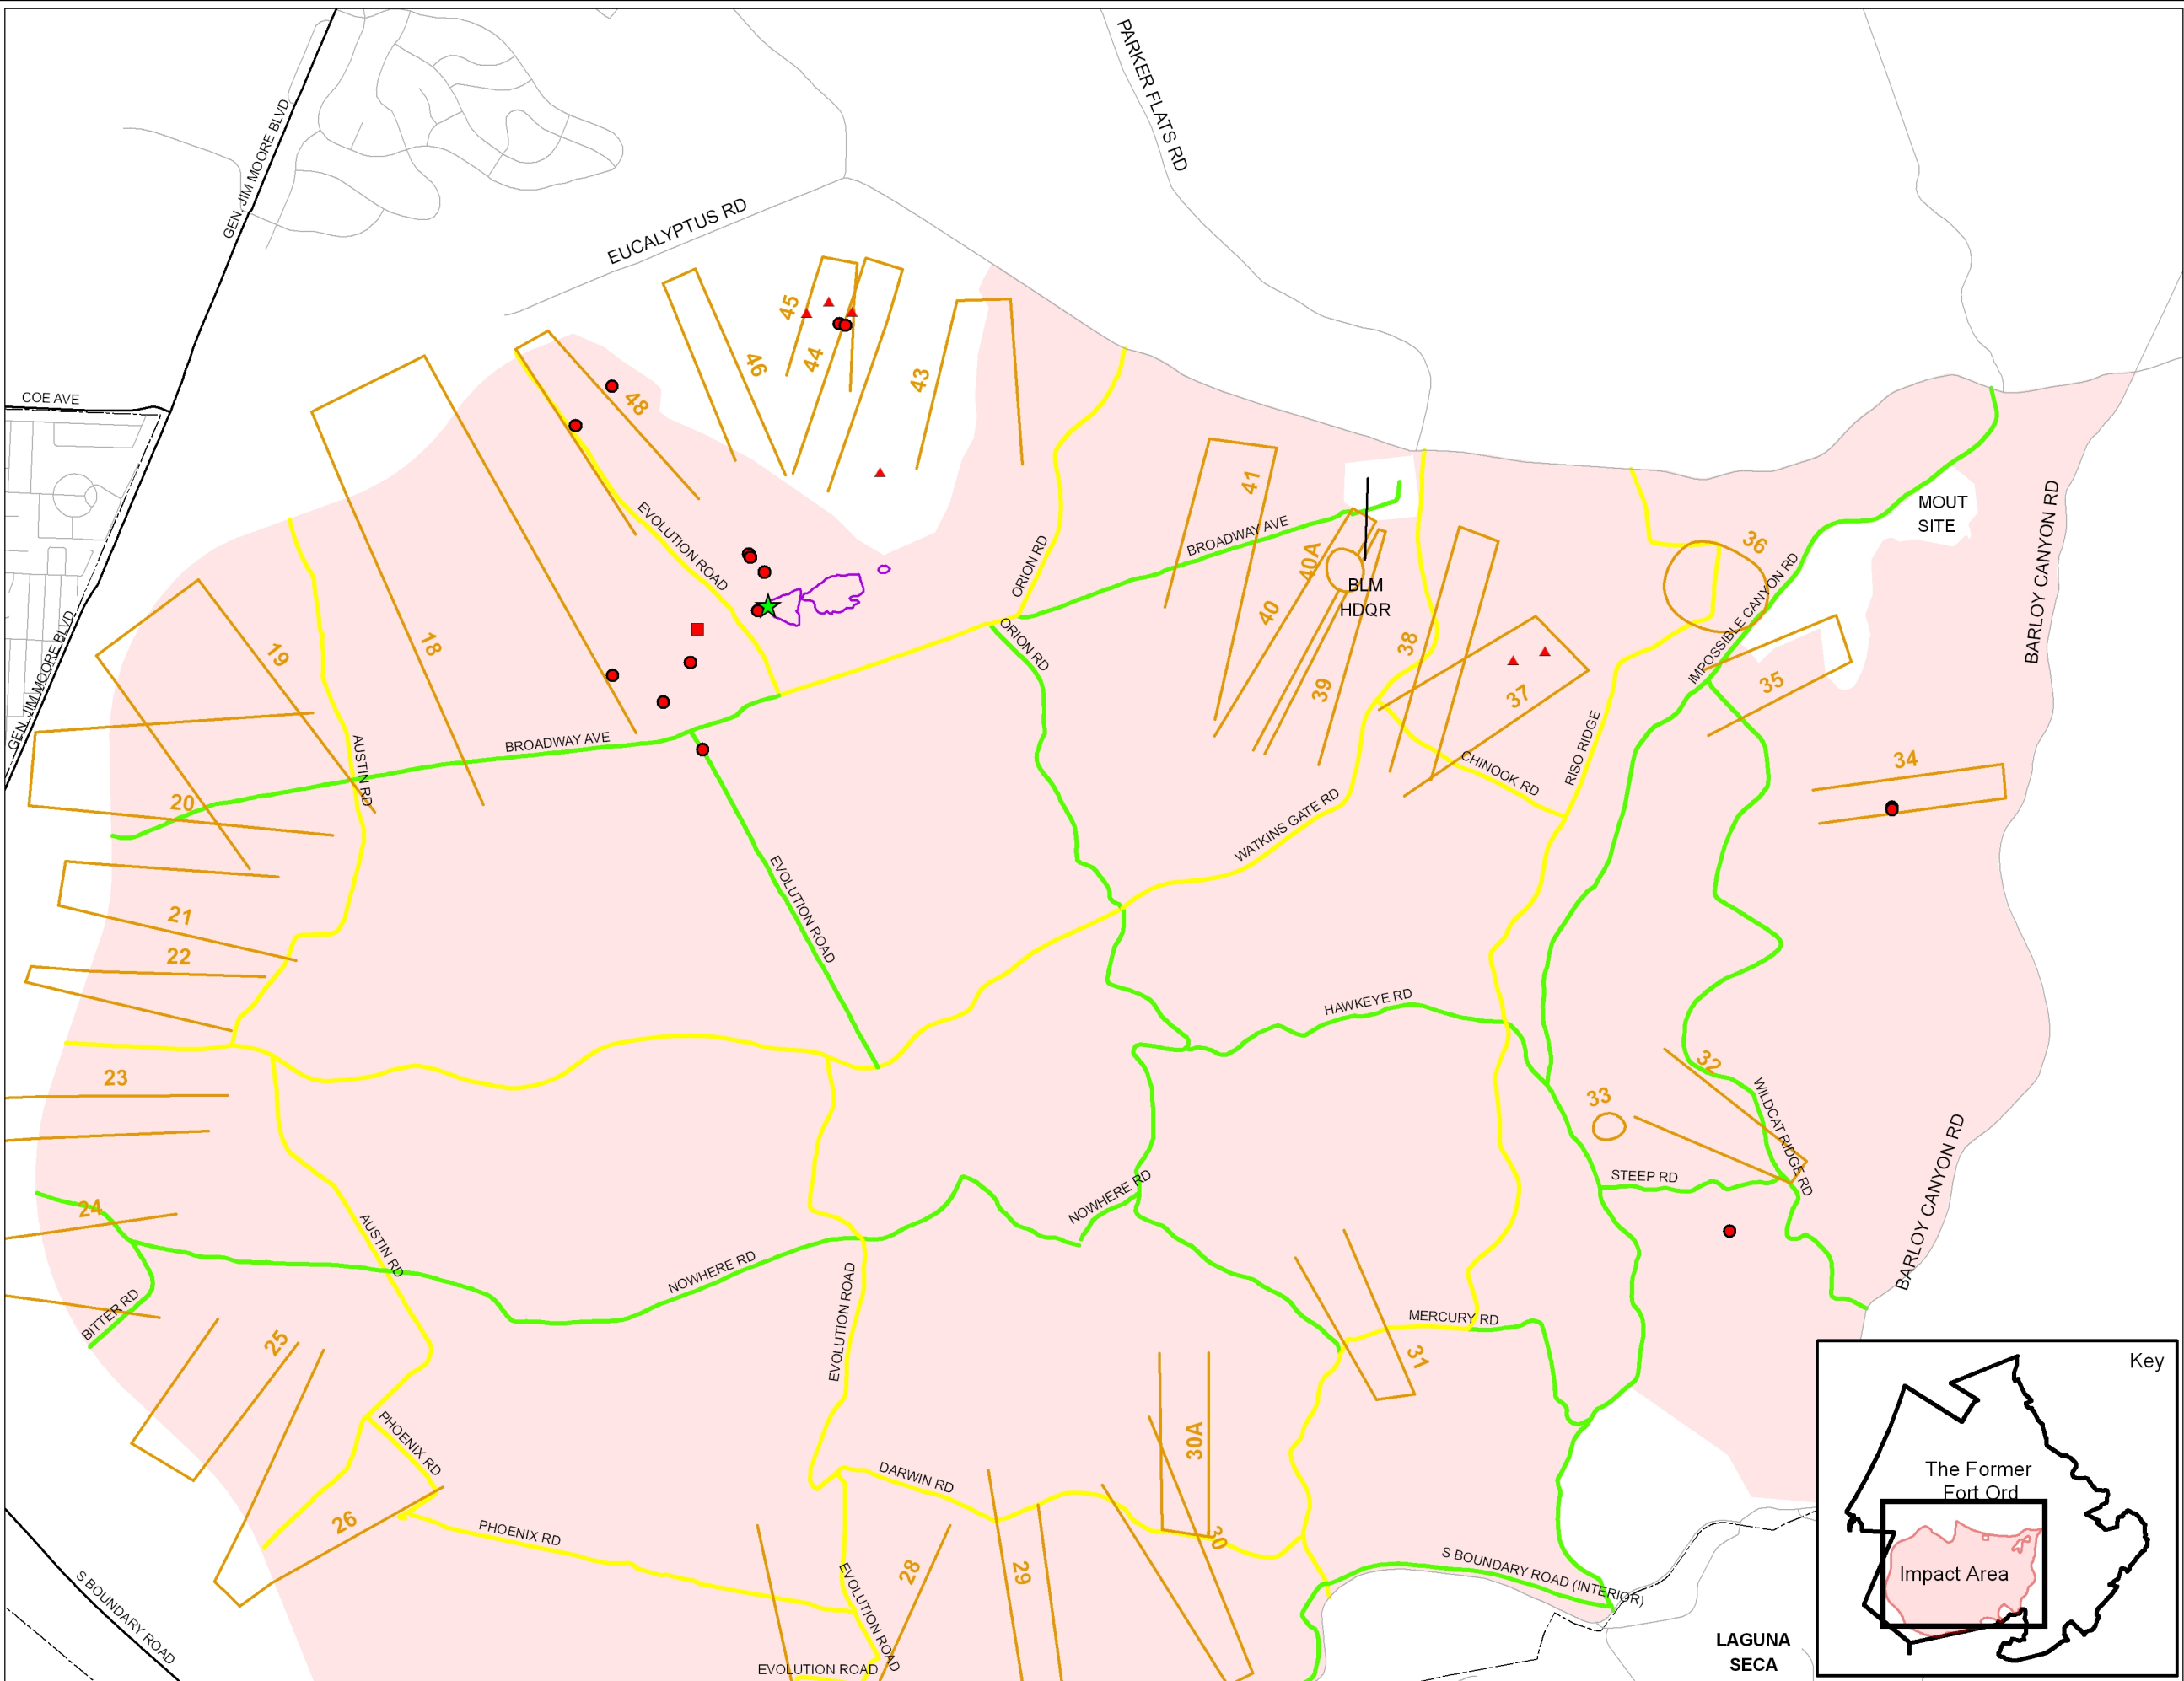
Report - Fort Ord MEC
Incident 29 August 2009
Attachment 2

The location of UXO WP grenades found during the 2003 surface remedial action in proximity of the incident location indicates that this item was possibly associated with one or more training/simulation or demonstration events involving the employment of several of such grenades. The condition of the previously found grenades described by the project OE safety specialist indicates that the bodies of such grenades are subject to oxidation during prolonged exposure to environmental moisture. It is possible that oxidation of the DMM grenade, perhaps accelerated by exposure to fire (2003), resulted in an exposure of the WP filler sufficient to result in self-ignition and subsequently functioning of the bursting charge. Experience and after action reports from remedial actions sites on the former Fort Ord indicate that analog and digital geophysical mapping detection equipment can detect WP grenades and similar objects.

- MEC White Phosphorous Found (2003)
in Proximity of Incident Item Location
- Model Description - MM Type
- Grenade, hand, smoke, white phosphorous, M15 - ISD
 - Grenade, hand, smoke, white phosphorous, M15 - UXO
 - Grenade, hand, smoke, white phosphorous, M34 - UXO
 - Grenade, rifle, smoke, white phosphorous, M19A1 - ISD
 - Grenade, rifle, smoke, white phosphorous, M19A1 - UXO
- ★ Incident Item
- ⬭ Burn Area (7 Acres)
- Impact Area
- Range Fans
- Major Roads
- Secondary Roads
- Fort Ord Boundary
- Fuel Breaks Status
- 30' Surface/15' Sub, Total 45', Maint for vehicles
 - 45' Subsurface Clearance, Maintained for Vehicles

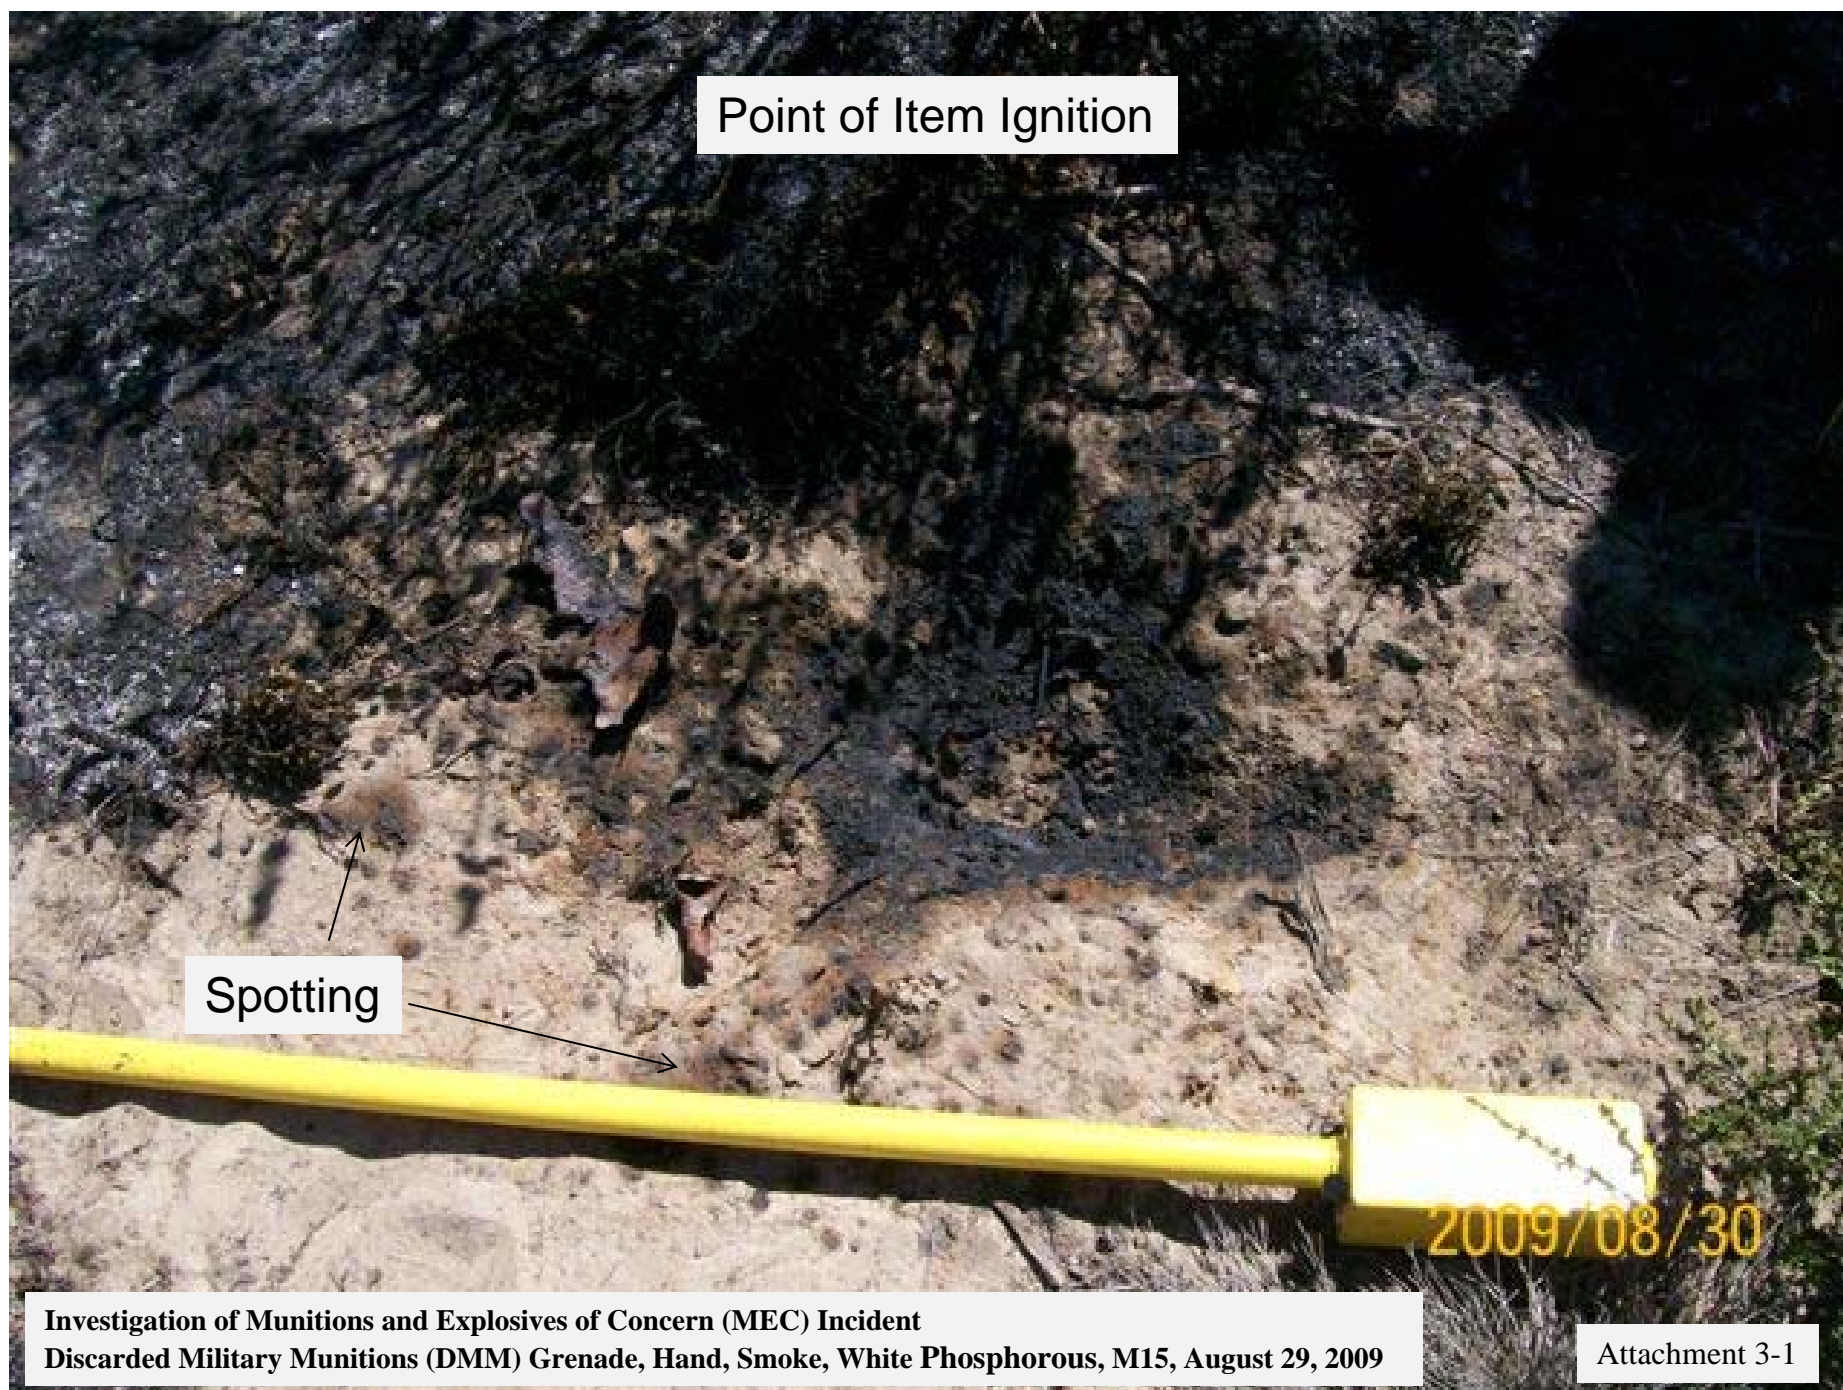
Findings: The proximity and functional characteristics of the item and conditions at the point of ignition indicate that the grenade was the likely cause of the reported wildfire. Spotting (scorched areas), considered the result of the burning of fragments of WP, was identified in the area surrounding the item remnants indicating that the bursting charge functioned (Attachment 3 photos 1&2). The safety pin and a portion of the safety lever were found intact, this fact, and field technical experience with the item fuze type indicates that the grenade's bursting charge was initiated by other than the mechanical function of the fuze system (attachment 4 photo 3). The chemical composition and location of the bursting charge makes it susceptible to the heat resulting from the burning of surround WP. Limited spotting from the identified point of the fire ignition (approx. 1m) and the heavily rusted condition of the grenade remnants indicates that the body may have been corroded and degrading the efficiency of the burst and allowing air to contact the WP filler prior to the functioning of the bursting charge. It is possible that the bursting charge was initiated by heat resulting from the burning of the WP filler.

Photo Ground Surface 1m North East of Item Ignition Point

Spotting

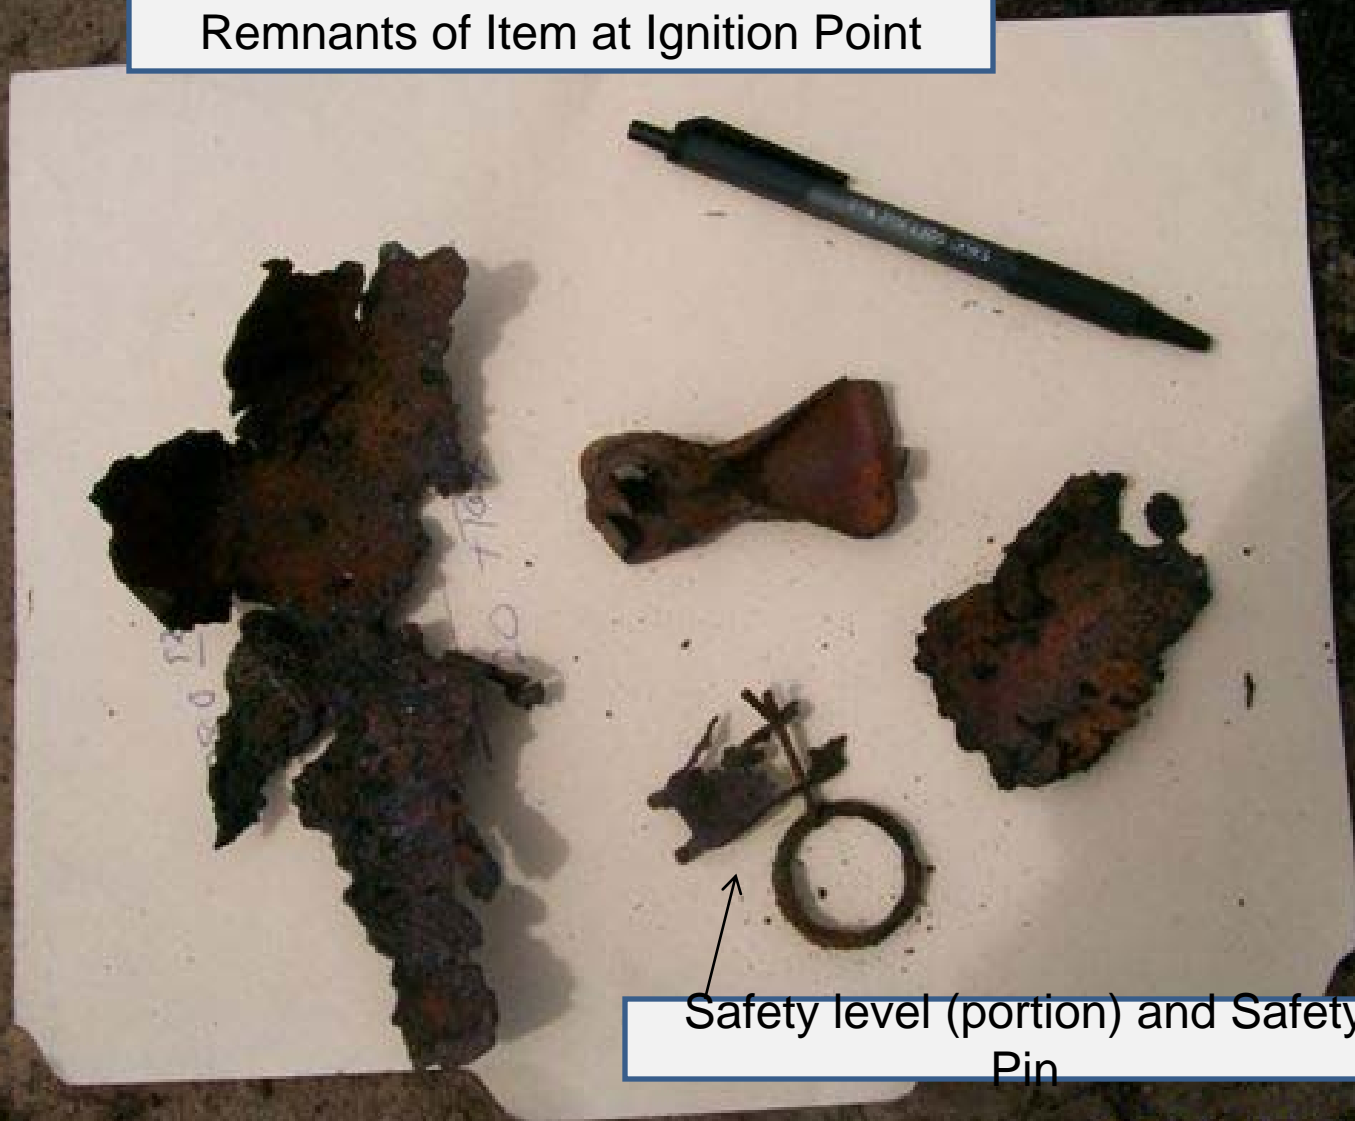
Attachment 3-2

A contract Senior Unexploded Ordnance (UXO) safety officer conducted an initial inspection of the area identified by POM FD as the likely origin of the fire on August 30 and identified the remnants of an expended Grenade, Hand, Smoke, White Phosphorous, M15 at that location. The remnants included spalled steel (grenade body), a safety pin, and a portion of a safety lever intact. The UXO safety officer detected the odor of phosphorous in vicinity of the remnants and concluded that a WP item had likely recently functioned at that location.

Remnants of Item at Ignition Point

Safety level (portion) and Safety Pin
