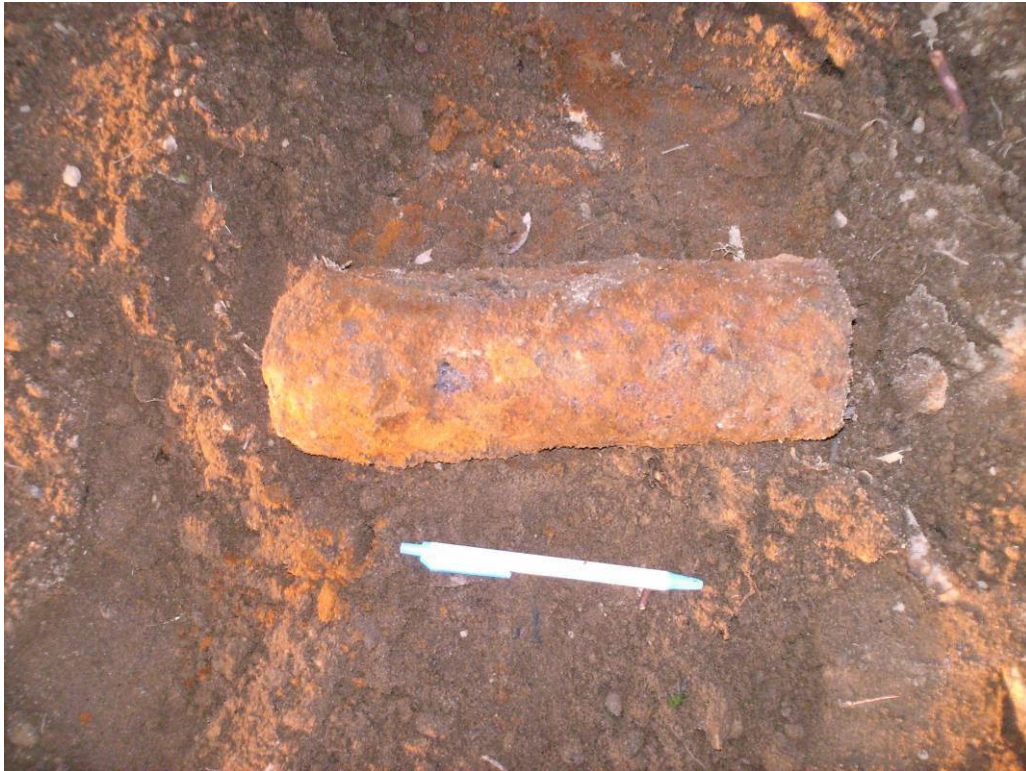
Photograph 1: January 16, 2008. Projectile, 75mm, shrapnel, MK I (unfuzed). Recovered during roadway alignment clearing and grubbing activities north of MRS-15SEA.4.

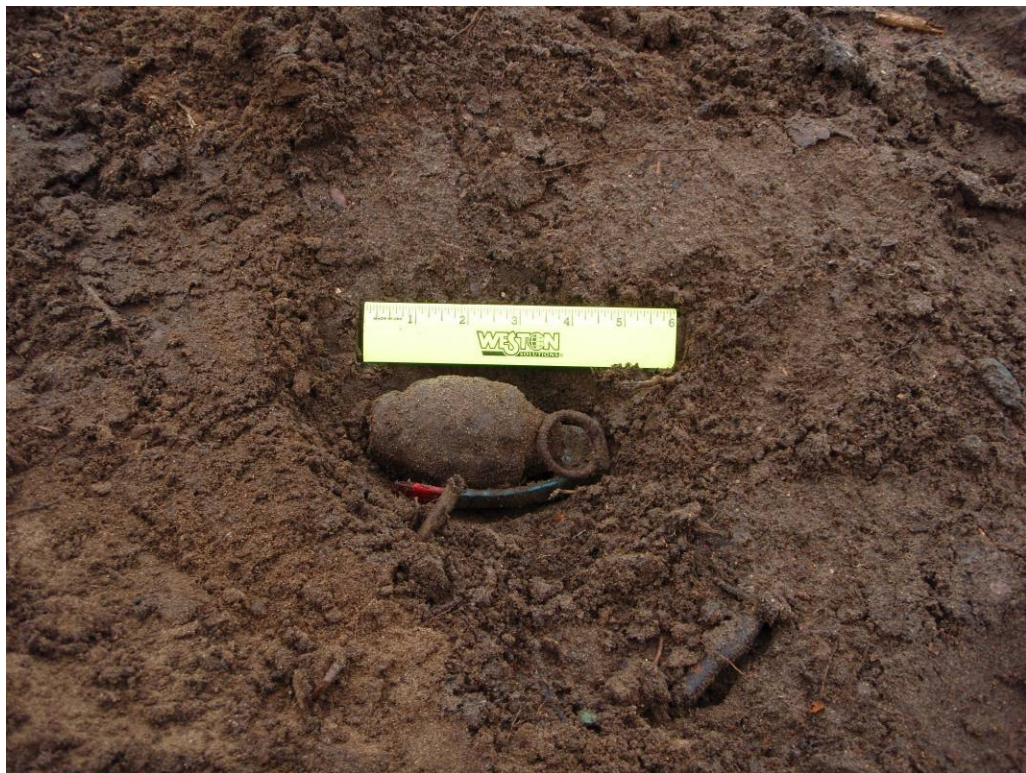
Photograph 2: January 25, 2008. Grenade, hand, practice, MK II. Recovered during roadway alignment clearing and grubbing activities on MRS-15SEA.1.

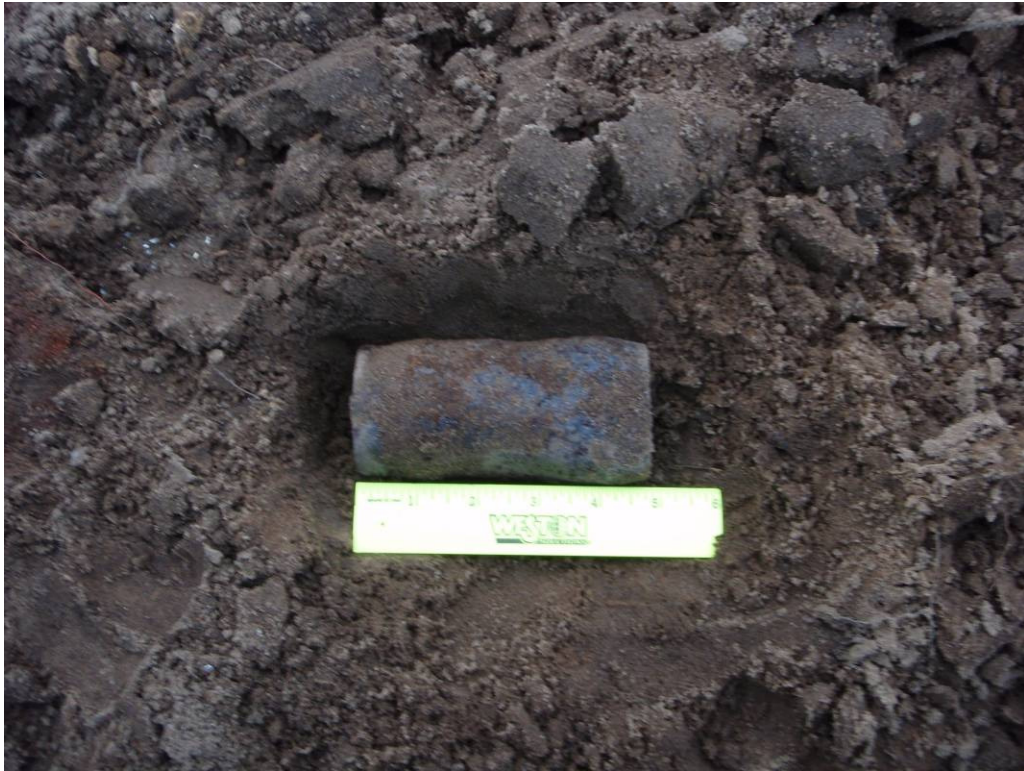
Photograph 3: January 29, 2008. Projectile, 57mm, HE M306 (unfuzed). Recovered during roadway alignment clearing and grubbing activities north of MRS-15SEA.4.

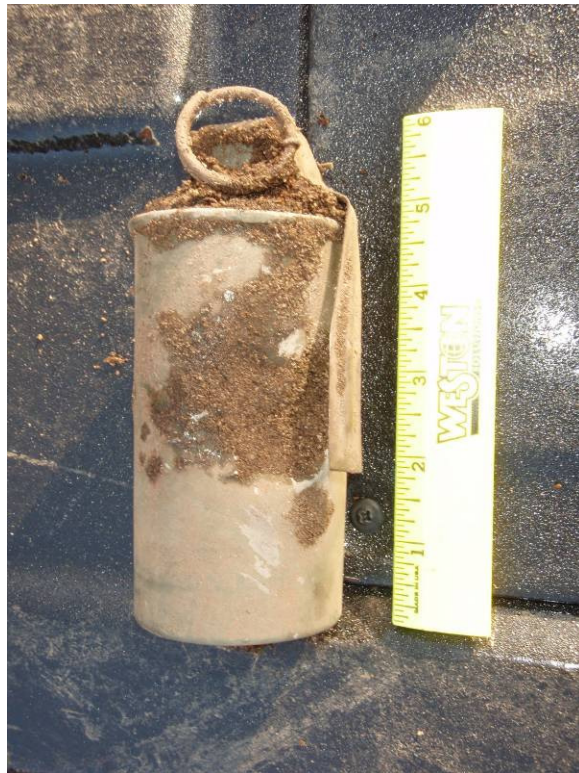
Photograph 4: January 30, 2008. Grenade, hand, smoke, M18 (green). Recovered during roadway alignment clearing and grubbing activities north of MRS-15SEA.3.

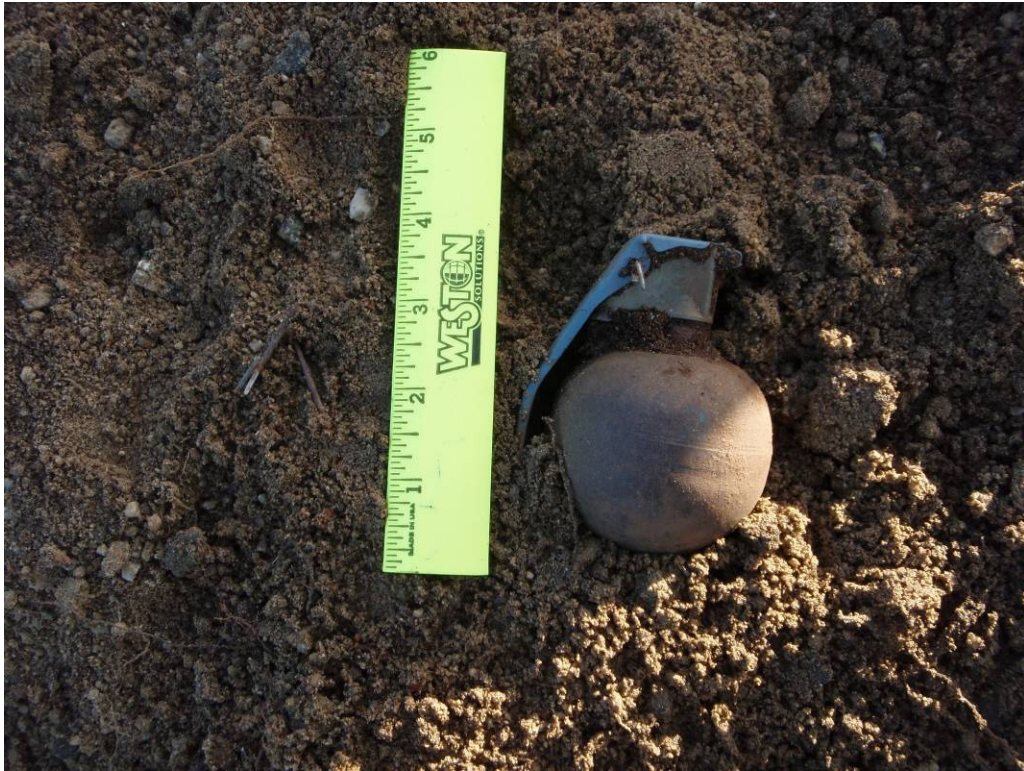
Photograph 5: January 30, 2008. Grenade, M69, practice. Recovered during roadway alignment clearing and grubbing activities north of MRS-SEA15.3.

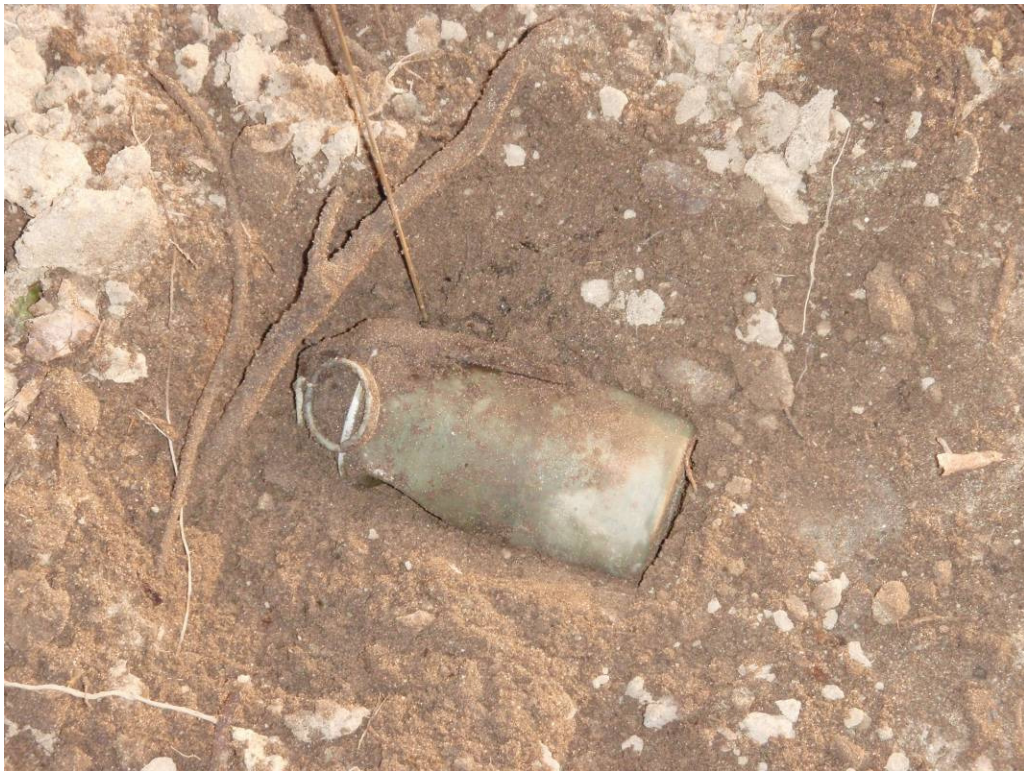
Photograph 6: February 6, 2008. Grenade, hand, smoke, M18 (purple). Recovered during roadway alignment clearing and grubbing activities north of MRS-15SEA.4.

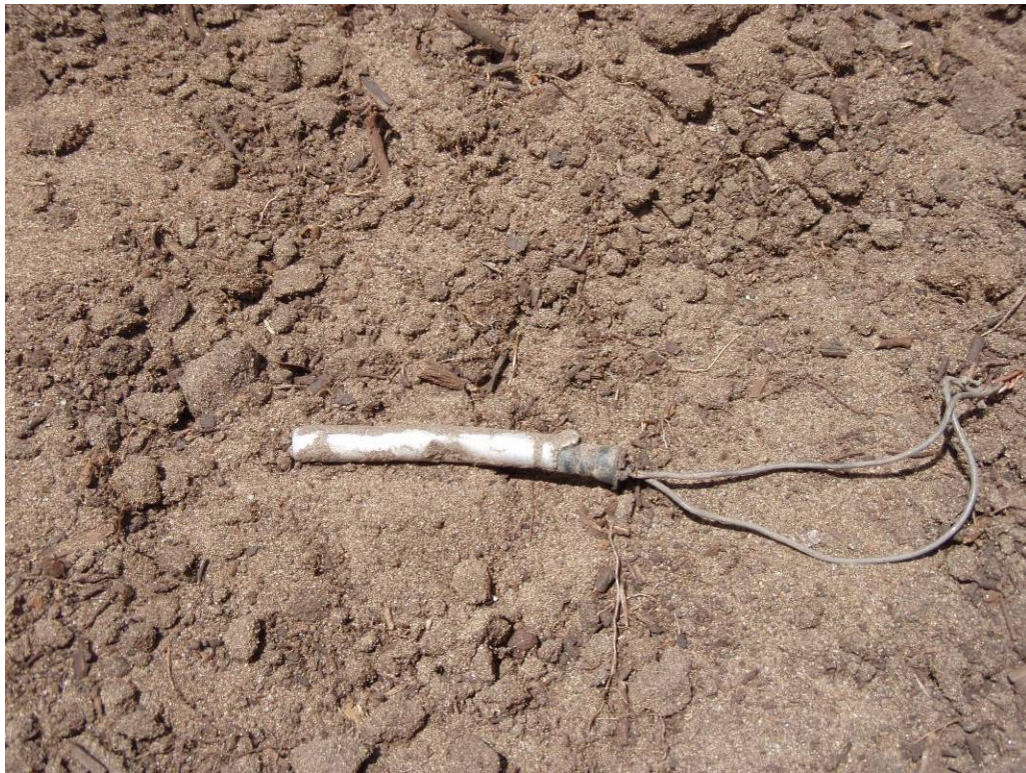
Photograph 7: May 28, 2008. Cap, blasting, electrical, M6. Recovered during soil sifting activities for soil from MRS-15SEA.1.

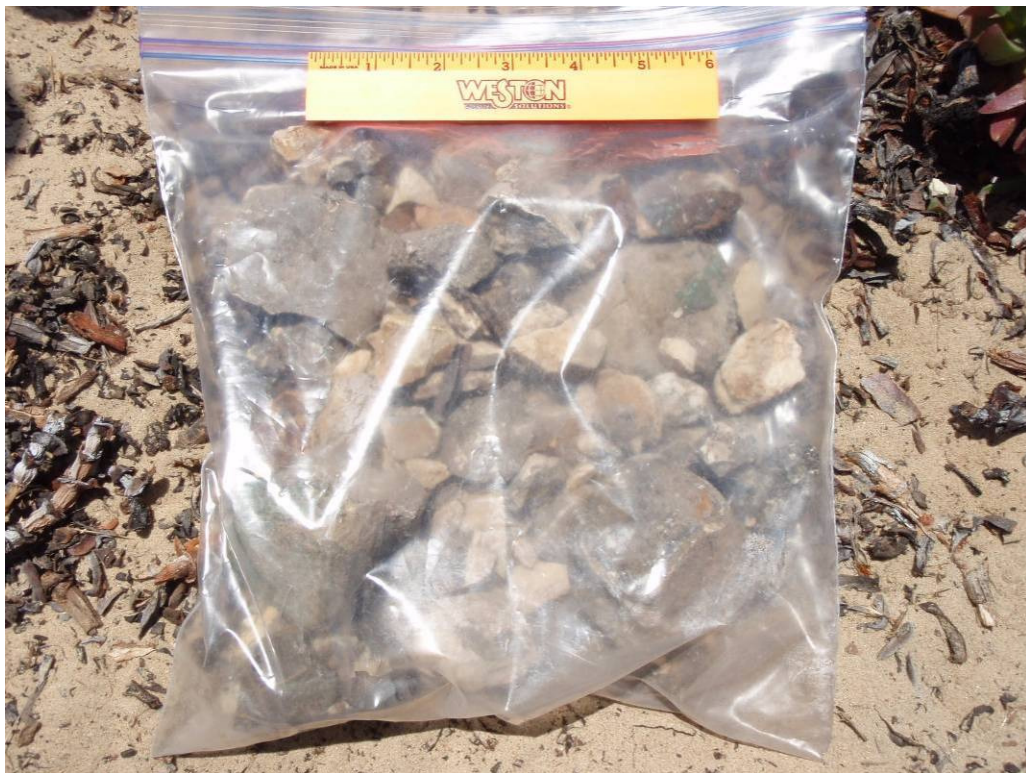
Photograph 8: May 30, 2008. Charge, 2.5 lbs, demolition, TNT. Recovered during DGM anomaly investigation in hillside west of GJMB.

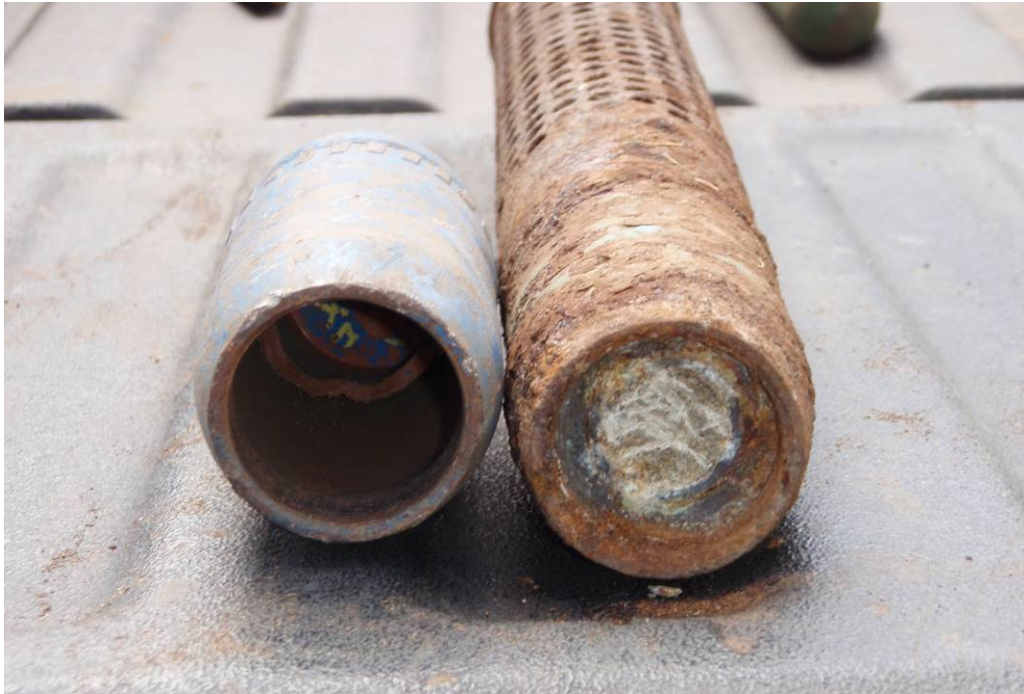
Photograph 9: June 4, 2008. Cartridge, 57mm, TP M306A1 (includes projectile, unfuzed). Recovered during soil sifting activities for soil from MRS-15SEA.4.

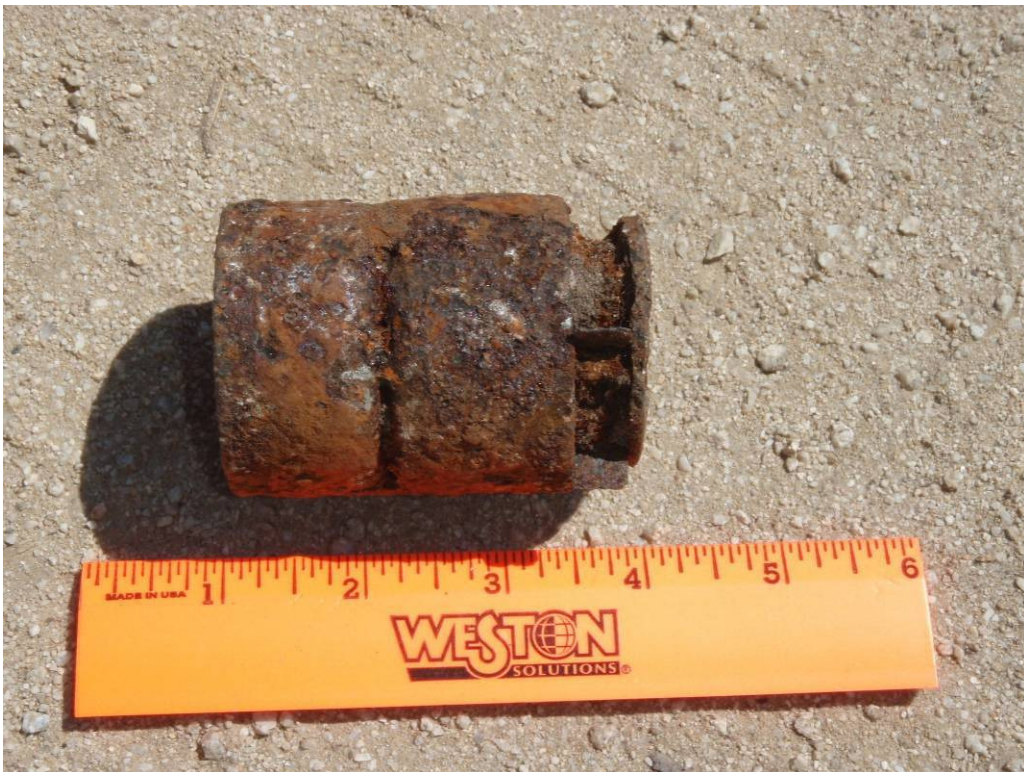
Photograph 10: June 10, 2008. Fuze, mine, antitank, practice, M1A1 (safety clip in place). Recovered during soil sifting activities for soil from MRS-15SEA.4.

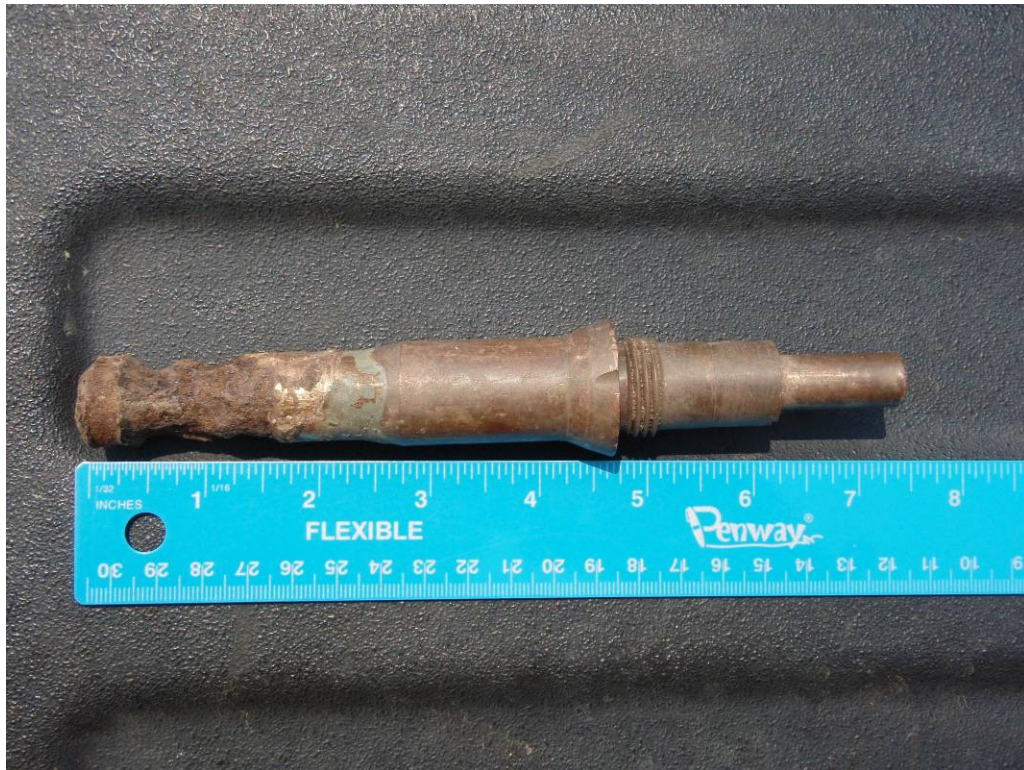
Photograph 11: June 12, 2008. Fuze, PD, French No. 5. Recovered during soil sifting activities for soil from MRS-15SEA.4.

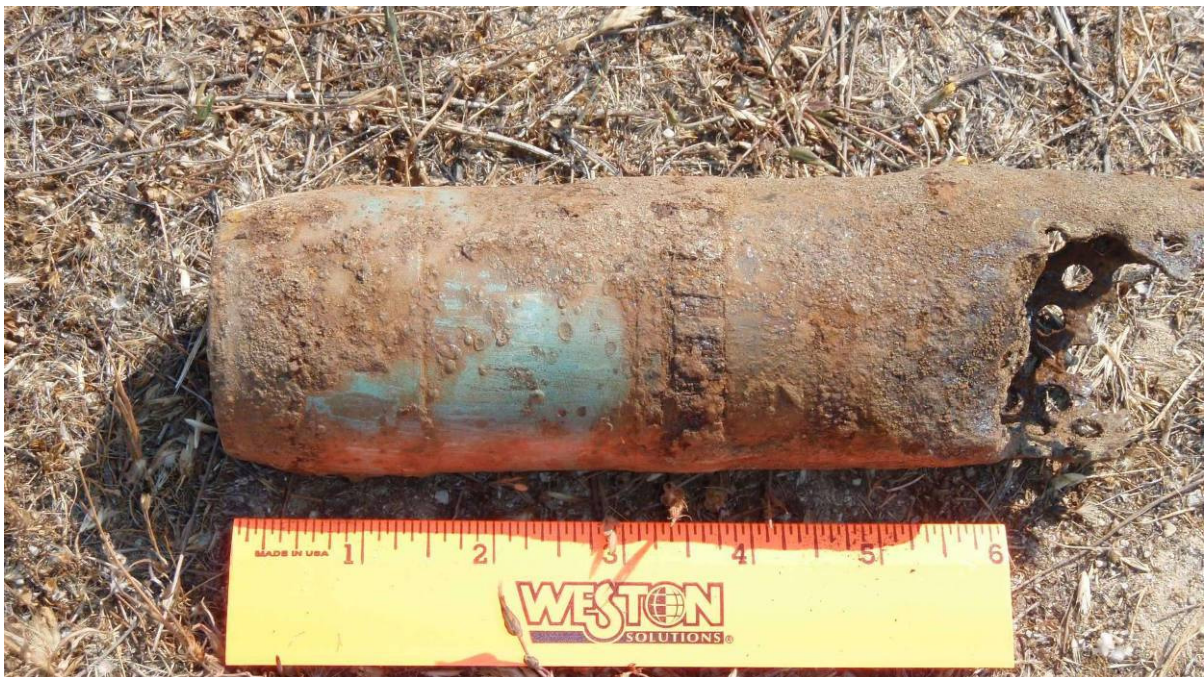
Photograph 12: June 12, 2008. Projectile, 57mm, TP M306 (unfuzed, unfired with possible spotting charge). Recovered during soil sifting activities for soil from MRS-15SEA.4.

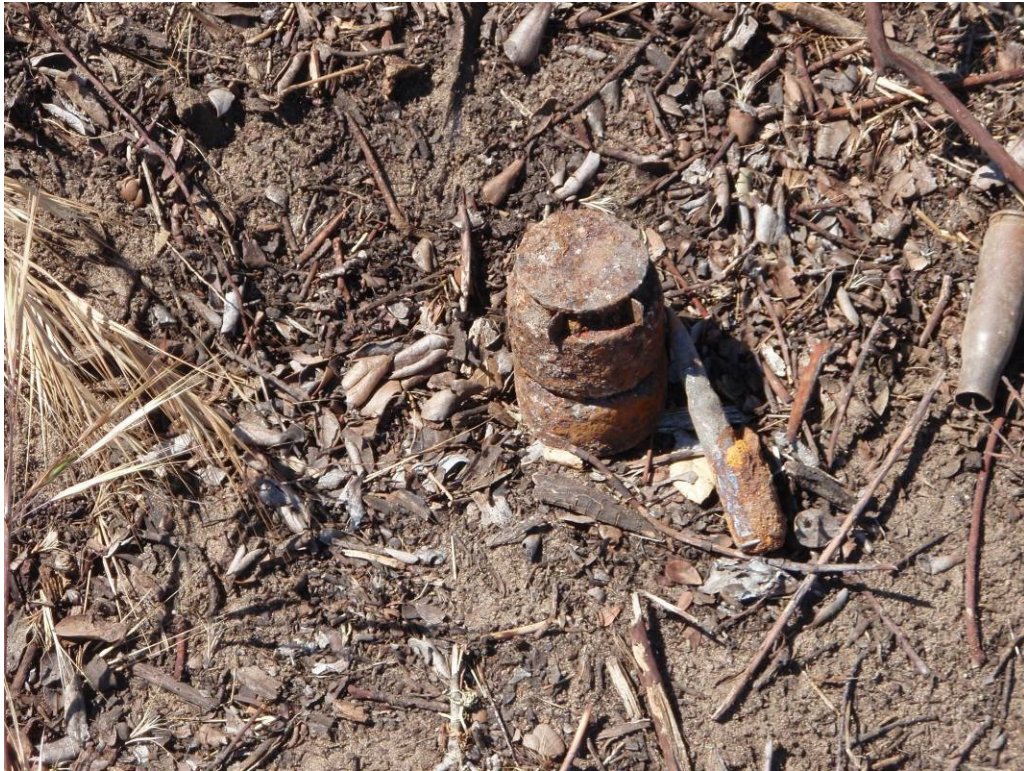
Photograph 13: June 13, 2008. Fuze, mine, antitank, practice, M1A1 (safety clip in place). Recovered during soil sifting activities for soil from MRS-15SEA.4.

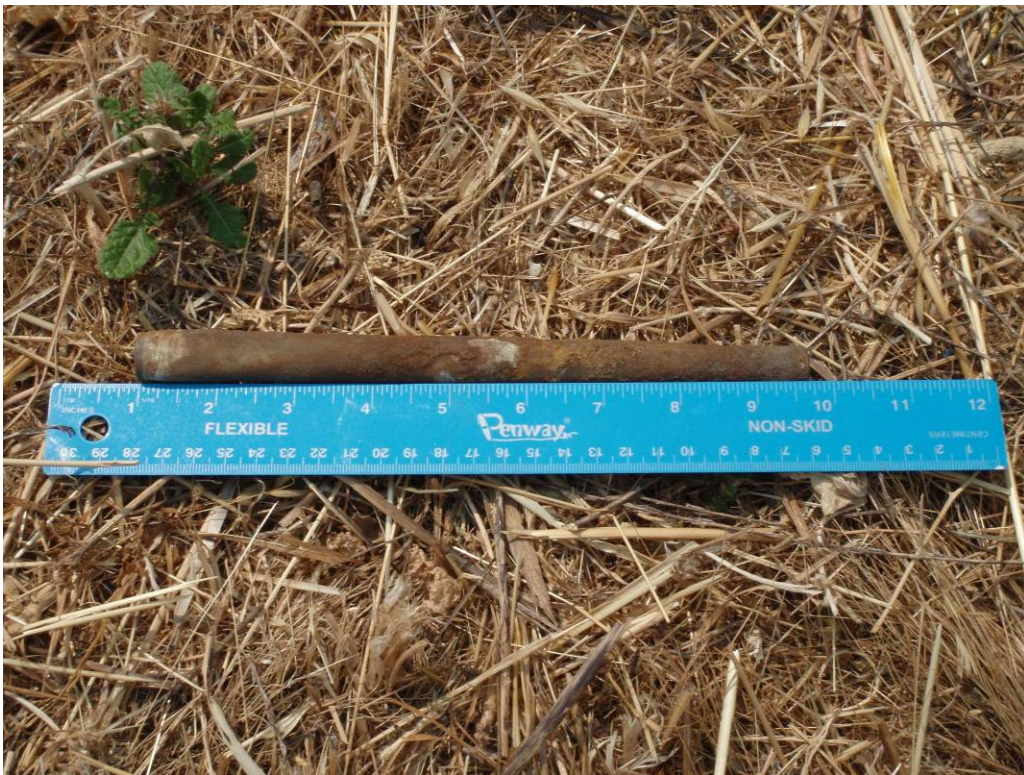
Photograph 14: June 13, 2008. Burster tube. Recovered during DGM anomaly investigation in SCA_W048 on MRS-15SEA.1.

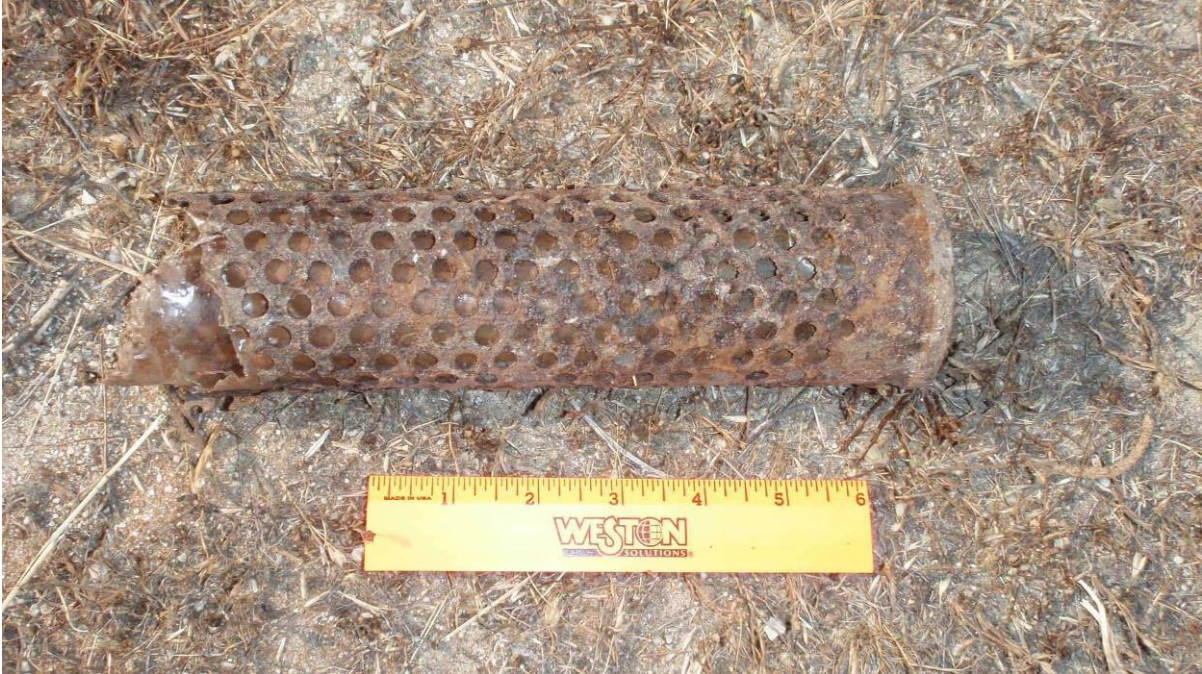
Photograph 15: June 17, 2008. Cartridge, 57mm, M60A1 (no projectile, primer live). Recovered during soil sifting activities for soil from MRS-15SEA.4.

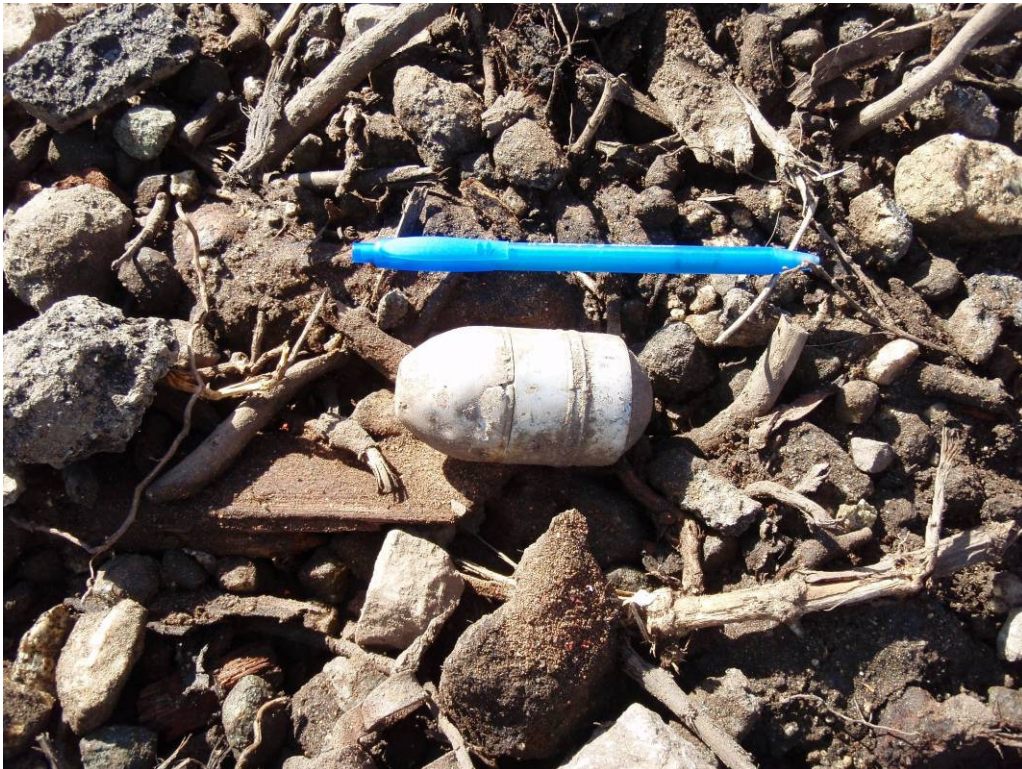
Photograph 16: June 18, 2008. M407A1, 40mm, practice. Recovered during soil sifting activities for soil from MRS-15SEA.4.

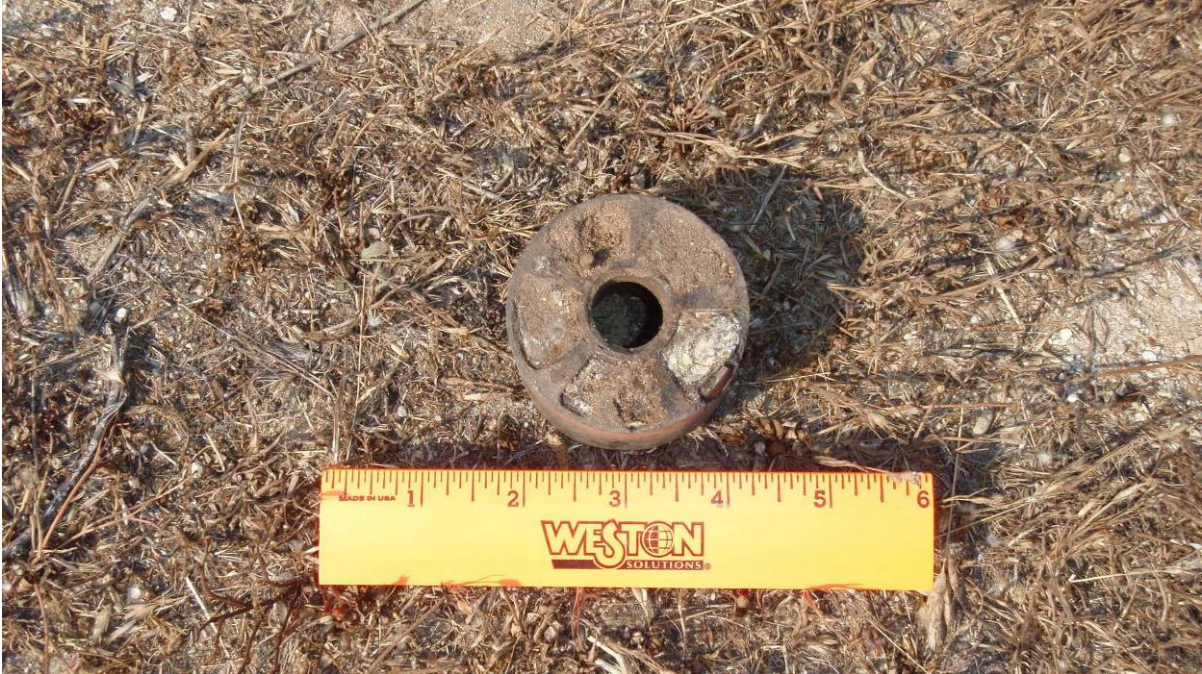
Photograph 17: June 24, 2008. One of two Igniter, flame throwers. Recovered during soil sifting activities for soil from MRS-15SEA.4.

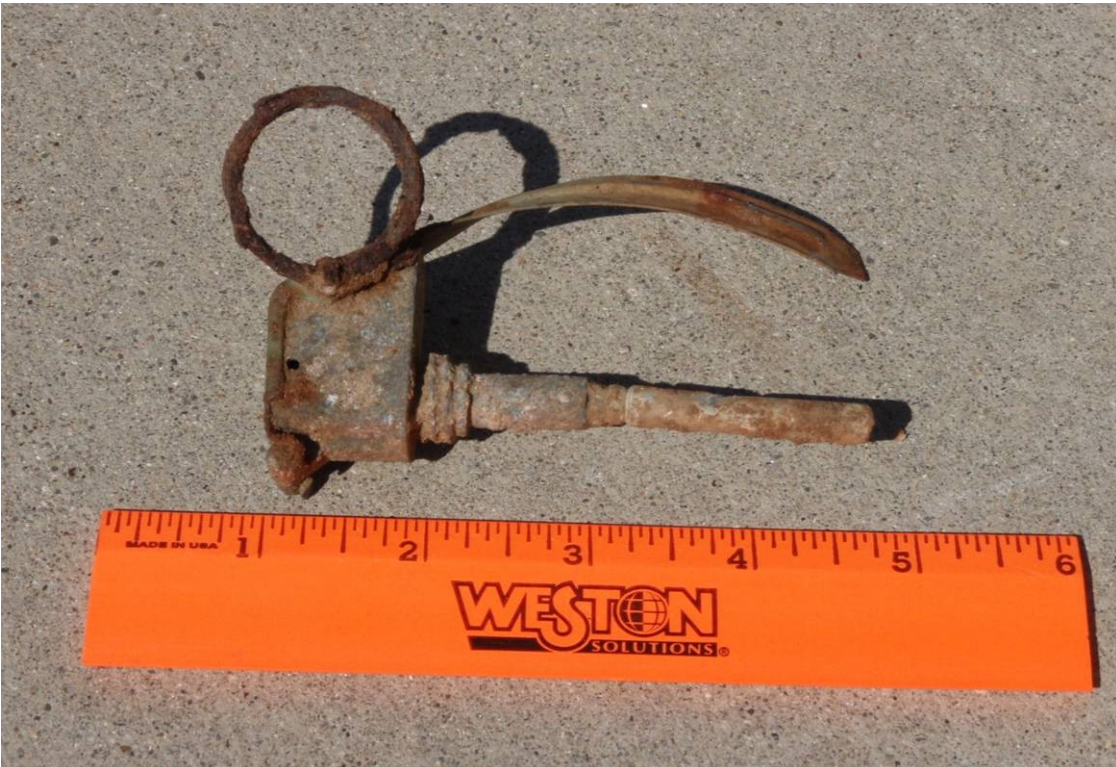
Photograph 18: June 26, 2008. Hand grenade fuze. Recovered during DGM anomaly investigation in hillside west of GJMB.

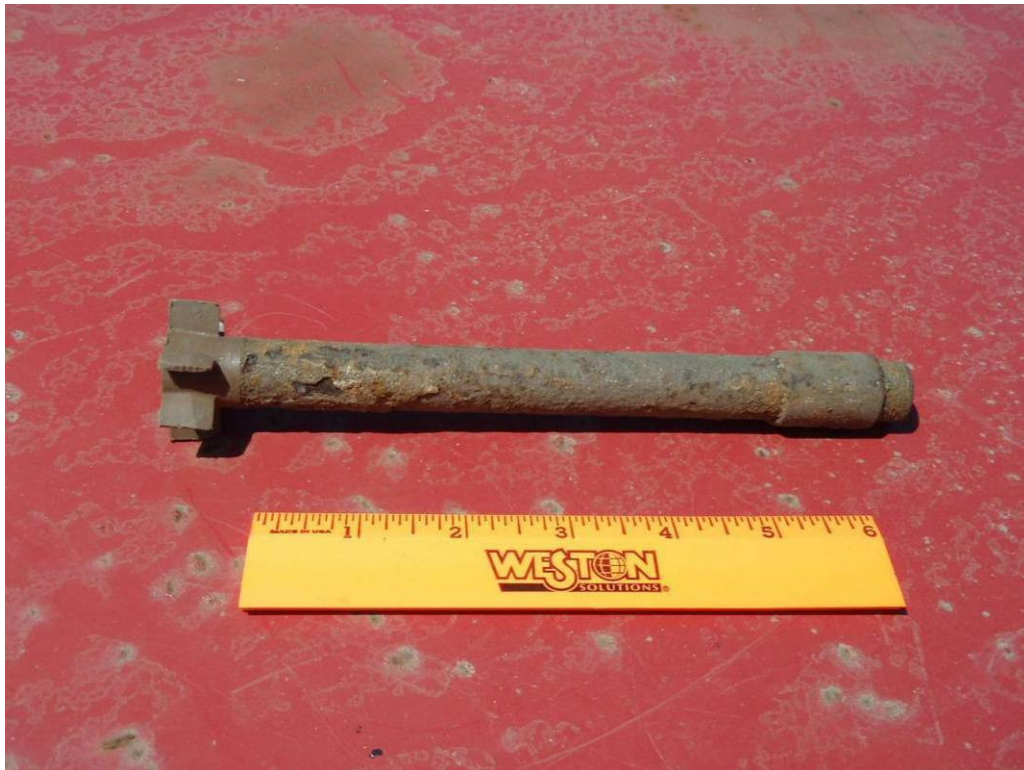
Photograph 19: July 15, 2008. Rocket, 35mm, subcaliber, practice, M73. Recovered during soil sifting activities for soil from MRS-15SEA.4.

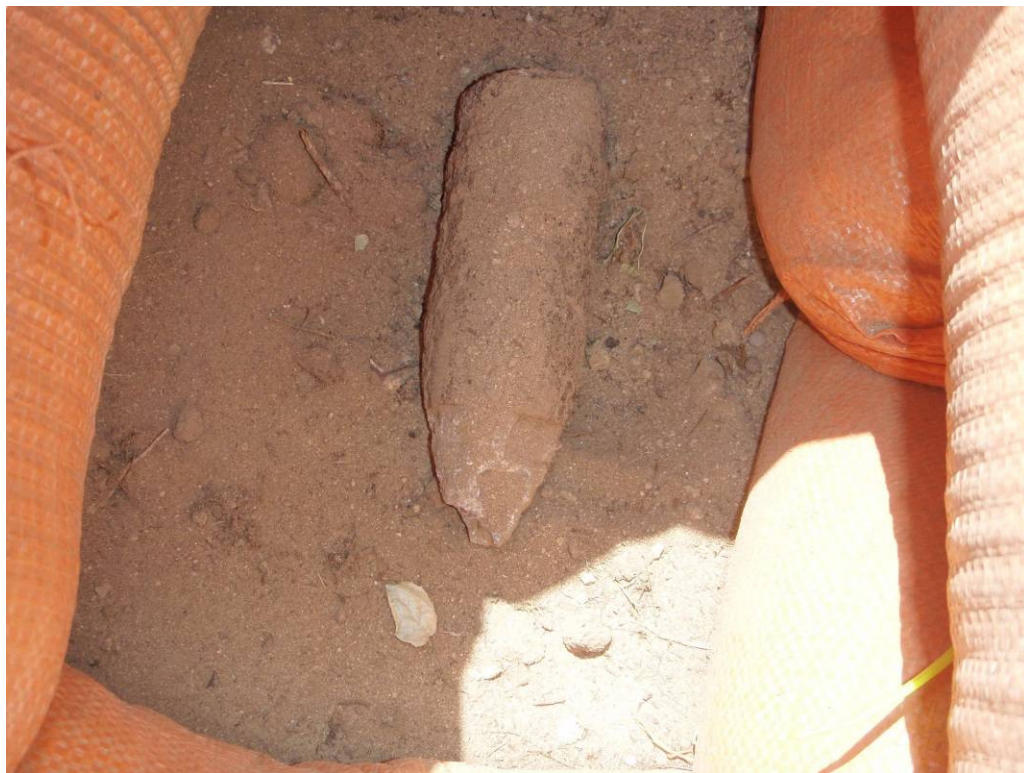
Photograph 20: July 22, 2008. Projectile, 57mm, HE M306. Recovered during DGM anomaly investigation in SCA_W140 on MRS-15SEA.4.

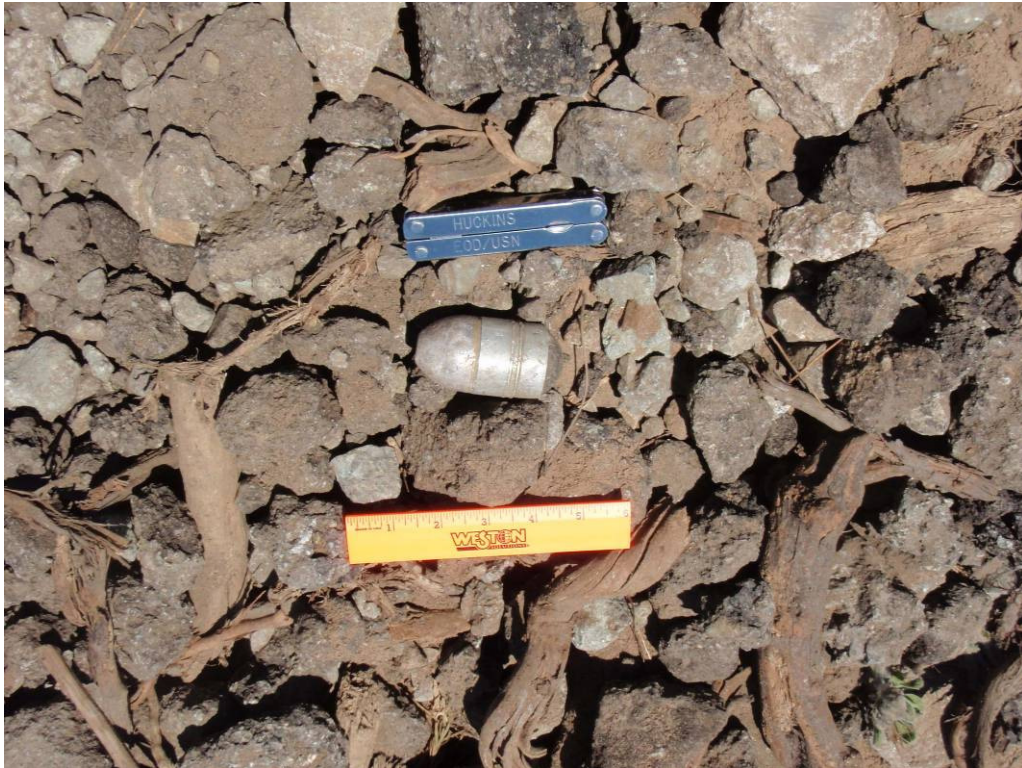
Photograph 21: August 11, 2008. M407A1, 40mm, practice. Recovered during placement of oversize material in roadway repair work by Army.
