Subject: **Future East Garrison Munitions Response Area (Grenade Range) - Erosion Inspection on December 3, 2012**

FORA ESCA Remediation Program Team

Subject: **Future East Garrison Munitions Response Area (Grenade Range) - Erosion Inspection on December 27, 2012**

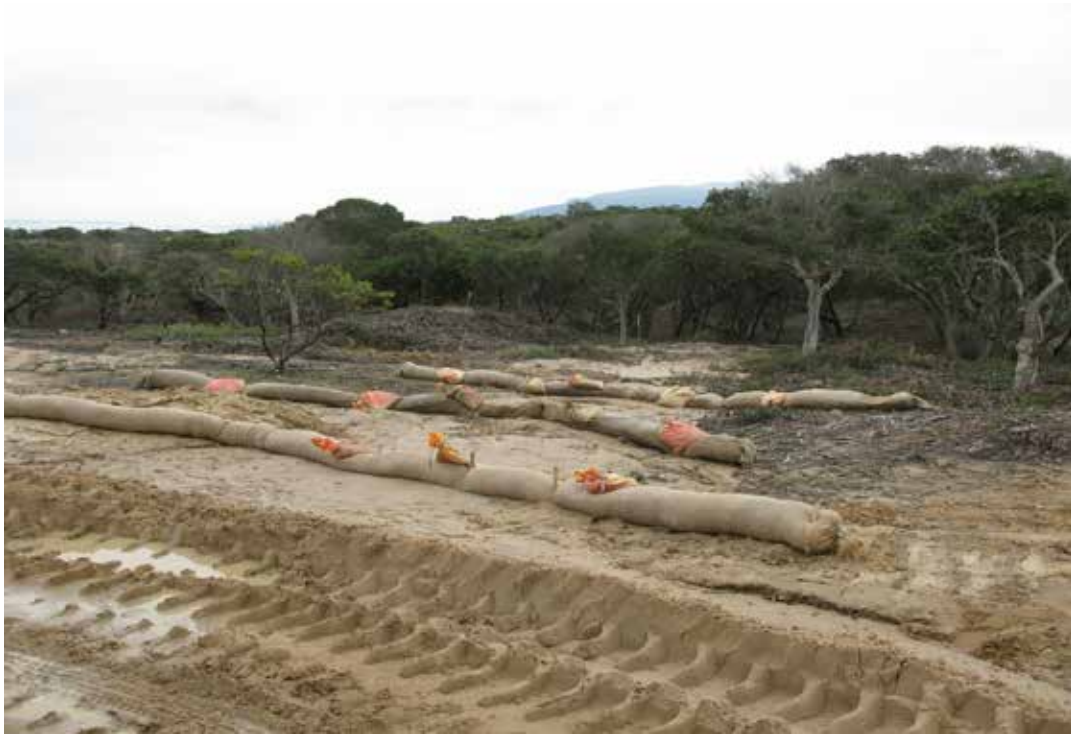
Photo #3

In the ‘grenade range’ in FEG, sediment laden water left the work area in two locations over the top of installed BMPs (See Map A DYM 2012 12 03). Sediment laden water went over two straw wattles installed on the south end of the work area. The sediment traveled approximately 50 feet into vegetation (Photo 1 and 2). The sediment was observed to be up to 4 inches in depth in vegetated areas. The wattles were pulled out of the sediment and placed on top of the sediment. In addition grading was completed so that less run-off would be directed to this location. One additional straw wattle was also installed at this location (Photos# 3).

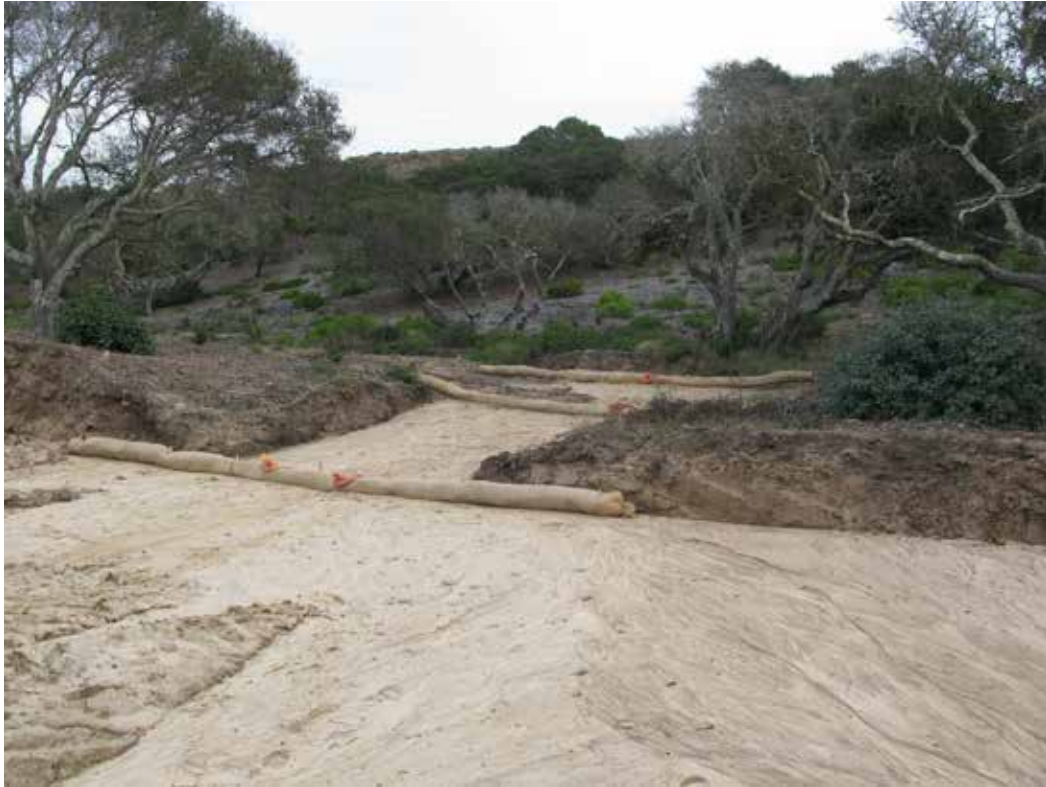
Photo #7

The top soil and subsoil have been removed in the eastern end of in the site during remediation work. The soil has been stockpiled in the west side of the grenade range. By removing the soil layers a temporary “catch basin” was created in the eastern end of the site. However, due to the large amount of rain fall received, sediment laden water flowed over the top of this area at the lowest point (Photo 4). Sediment laden water travelled several hundred feet down a dirt road to the east north east of the grenade range (Photo # 5-6). Weston Solutions employees installed four straw wattles with stakes and sand bags at this location on December 4, 2012 to try to resolve this issue (Photo #7).

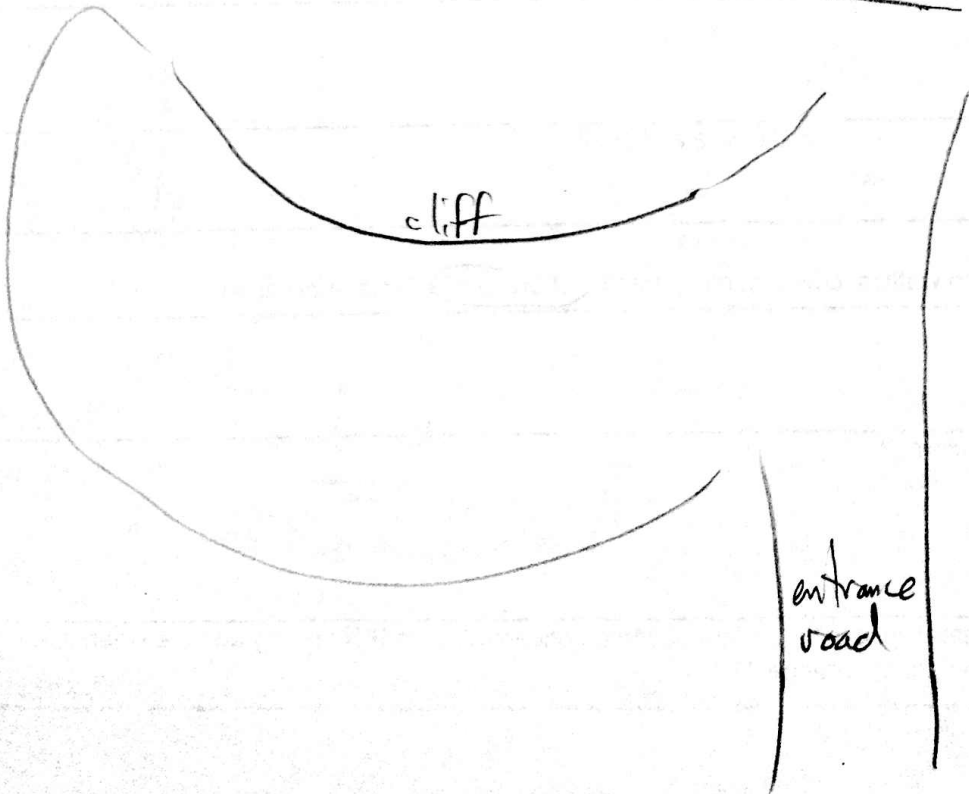
Wattles have been  
overtopped and have  
minimal function.

water bar is too  
low and allows  
water to cut  
through water  
bar @ X

Type	Functioning Properly? (Evidence of overtopping, undermining or flow around?)	Need repair or correction?	Comments/Notes
Wattles	old wattles partly over- topped New wattles are fine	Y	old wattles on south side in disrepair - See map on reverse
Blanket	N/A	-	
Silt Fence	N/A	-	
Sand Bags	Y	N	only used to hold wattles in place.
Hydromulch	Y	N	clumping on upper road where steep. Over-all it looks great
water bar	N	Y	one water bar poorly designed, should be repaired. See map on reverse

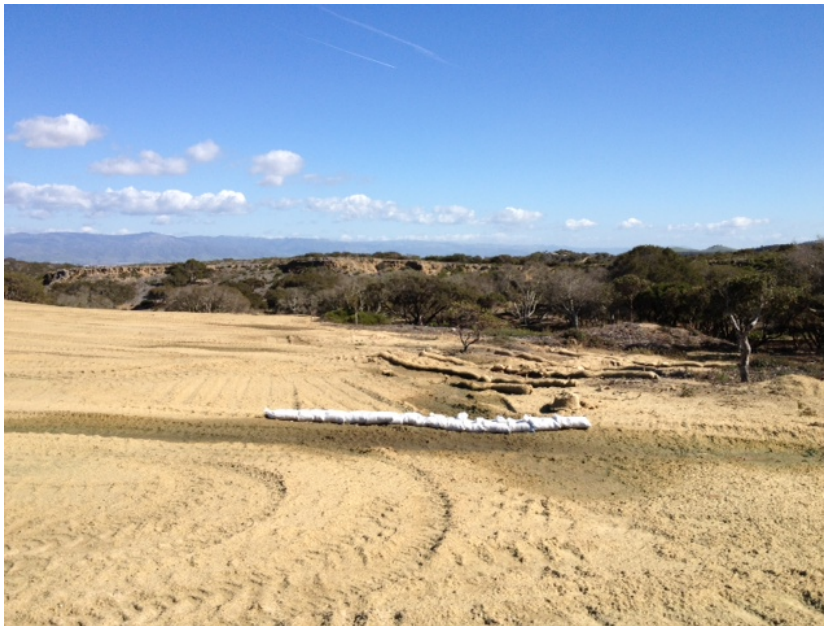
Photograph #1 – Sand bag repair for water bar

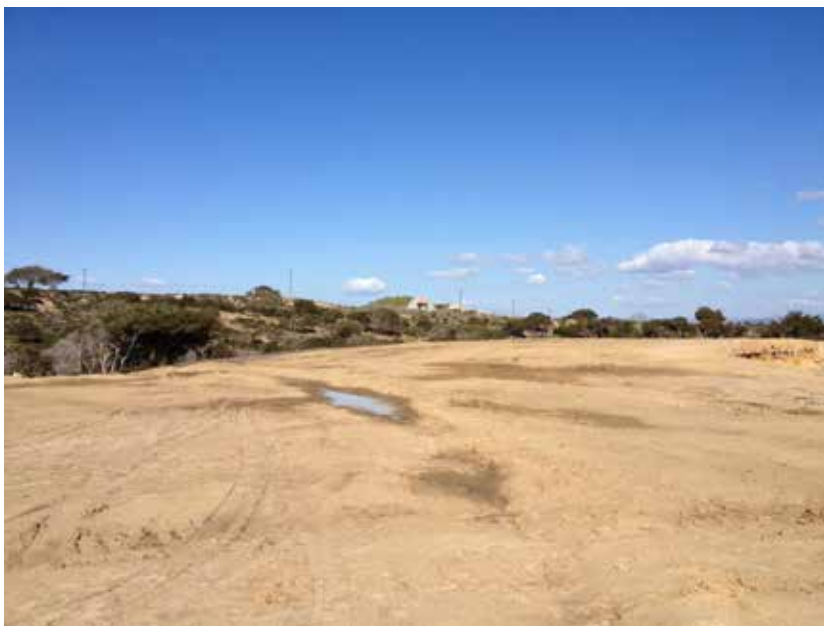
Photograph #2 - Ponding down gradient of water bar

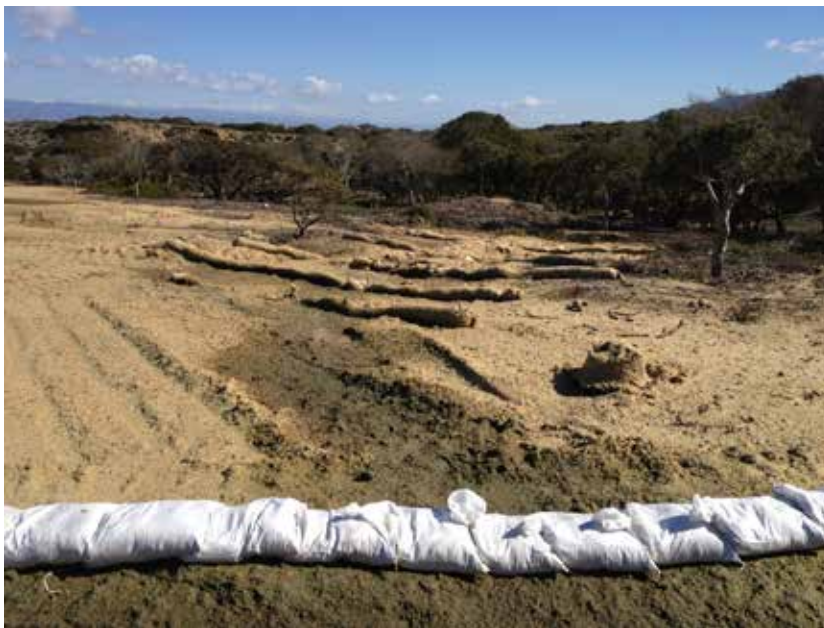
Photograph #3- Potential need for wattle replacement, but no new sediment observed

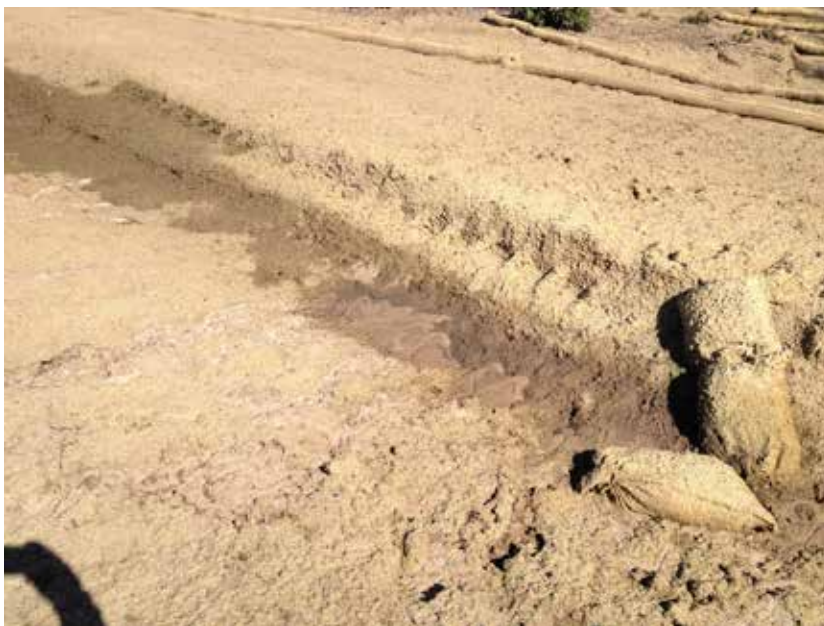
Photograph #4 – Check dams mid-gradient stopped sediment

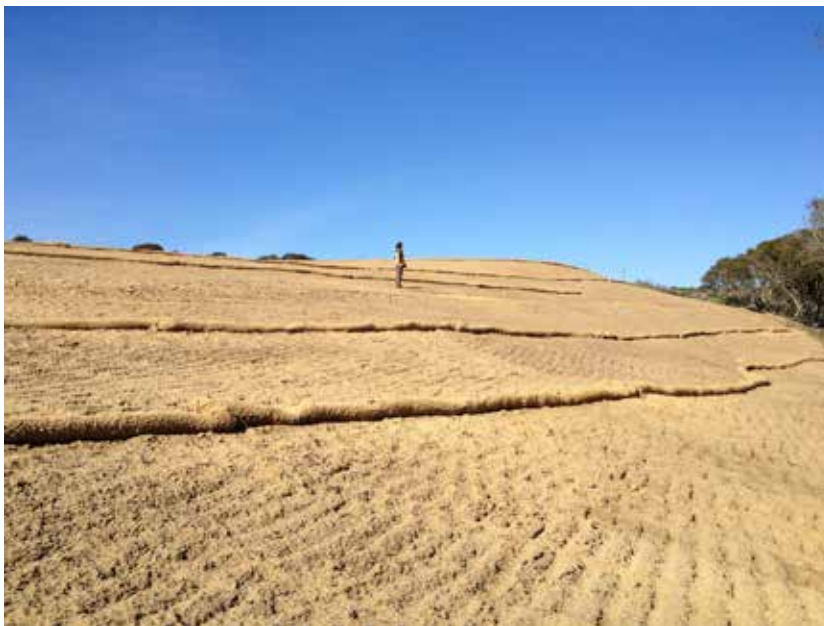
Photograph #5 Hydromulch and wattles in good repair

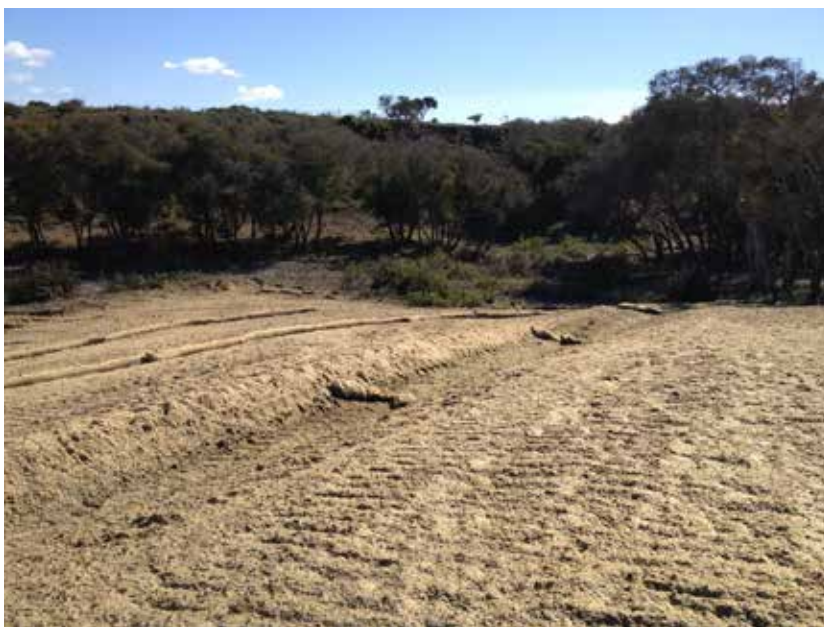
Photograph #6 Water bar and check dams in good repair

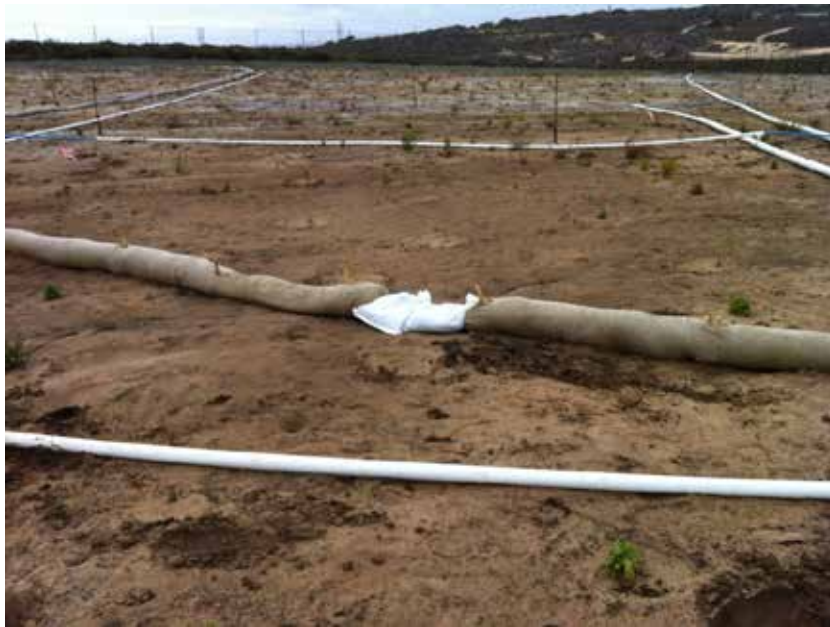
Photograph #1 – Straw wattles, - gap between run, fixed with sand bags

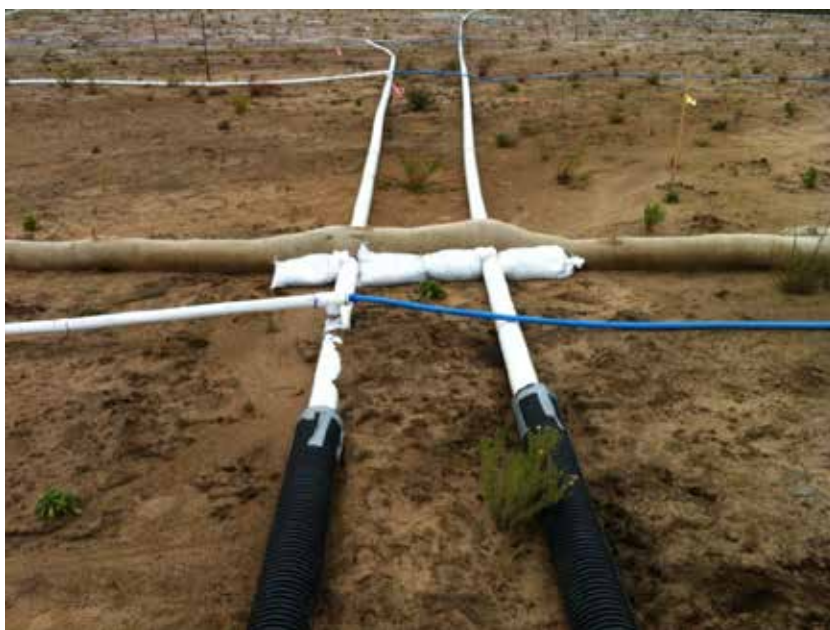
Photograph #2 - Straw wattles – gaps between irrigation lines, fixed with sandbags

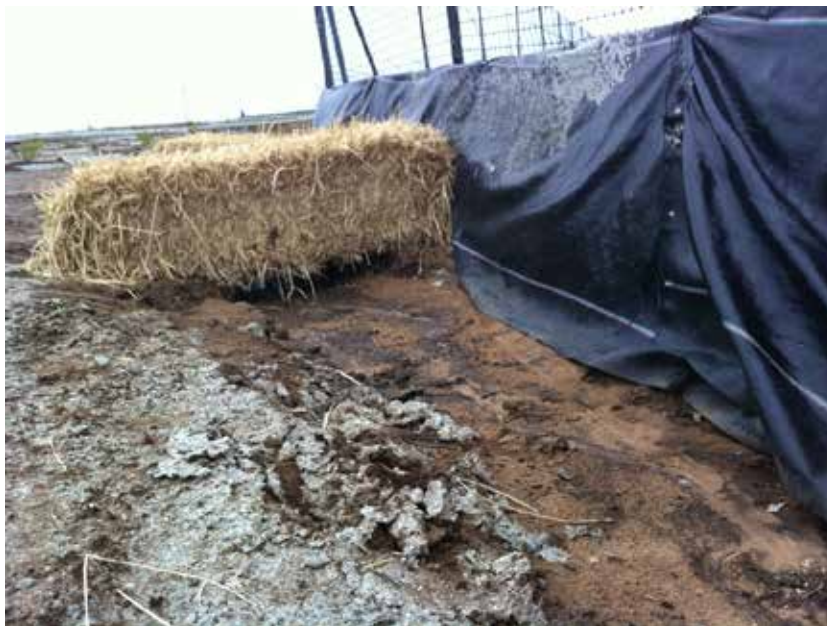
Photograph #3 – Silt fence – Section not properly buried

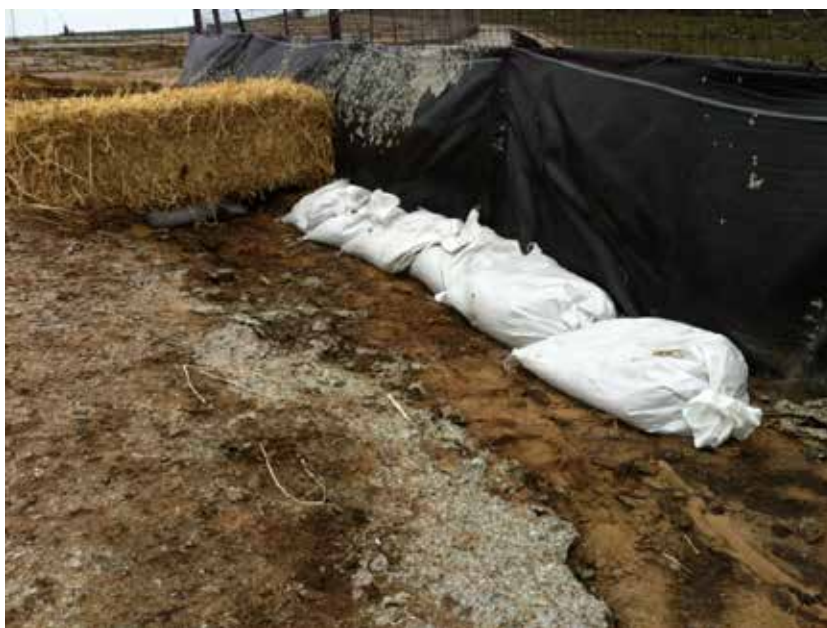
Photograph #4 – Silt fence – Section not properly buried, covered with sandbags

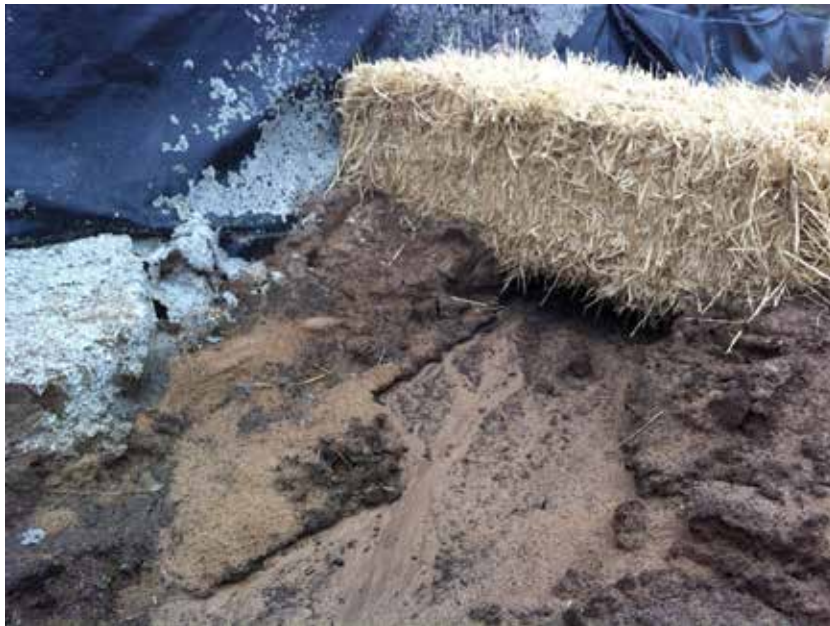
Photograph #5 – Straw Bales – Gaps under bales

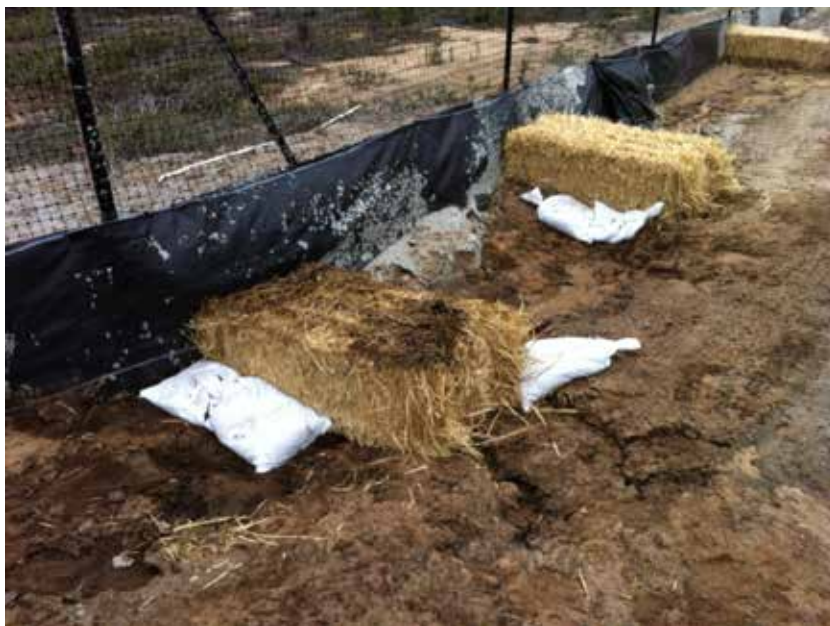
Photograph #6 – Straw Bales – Gaps under bales filled with sandbags

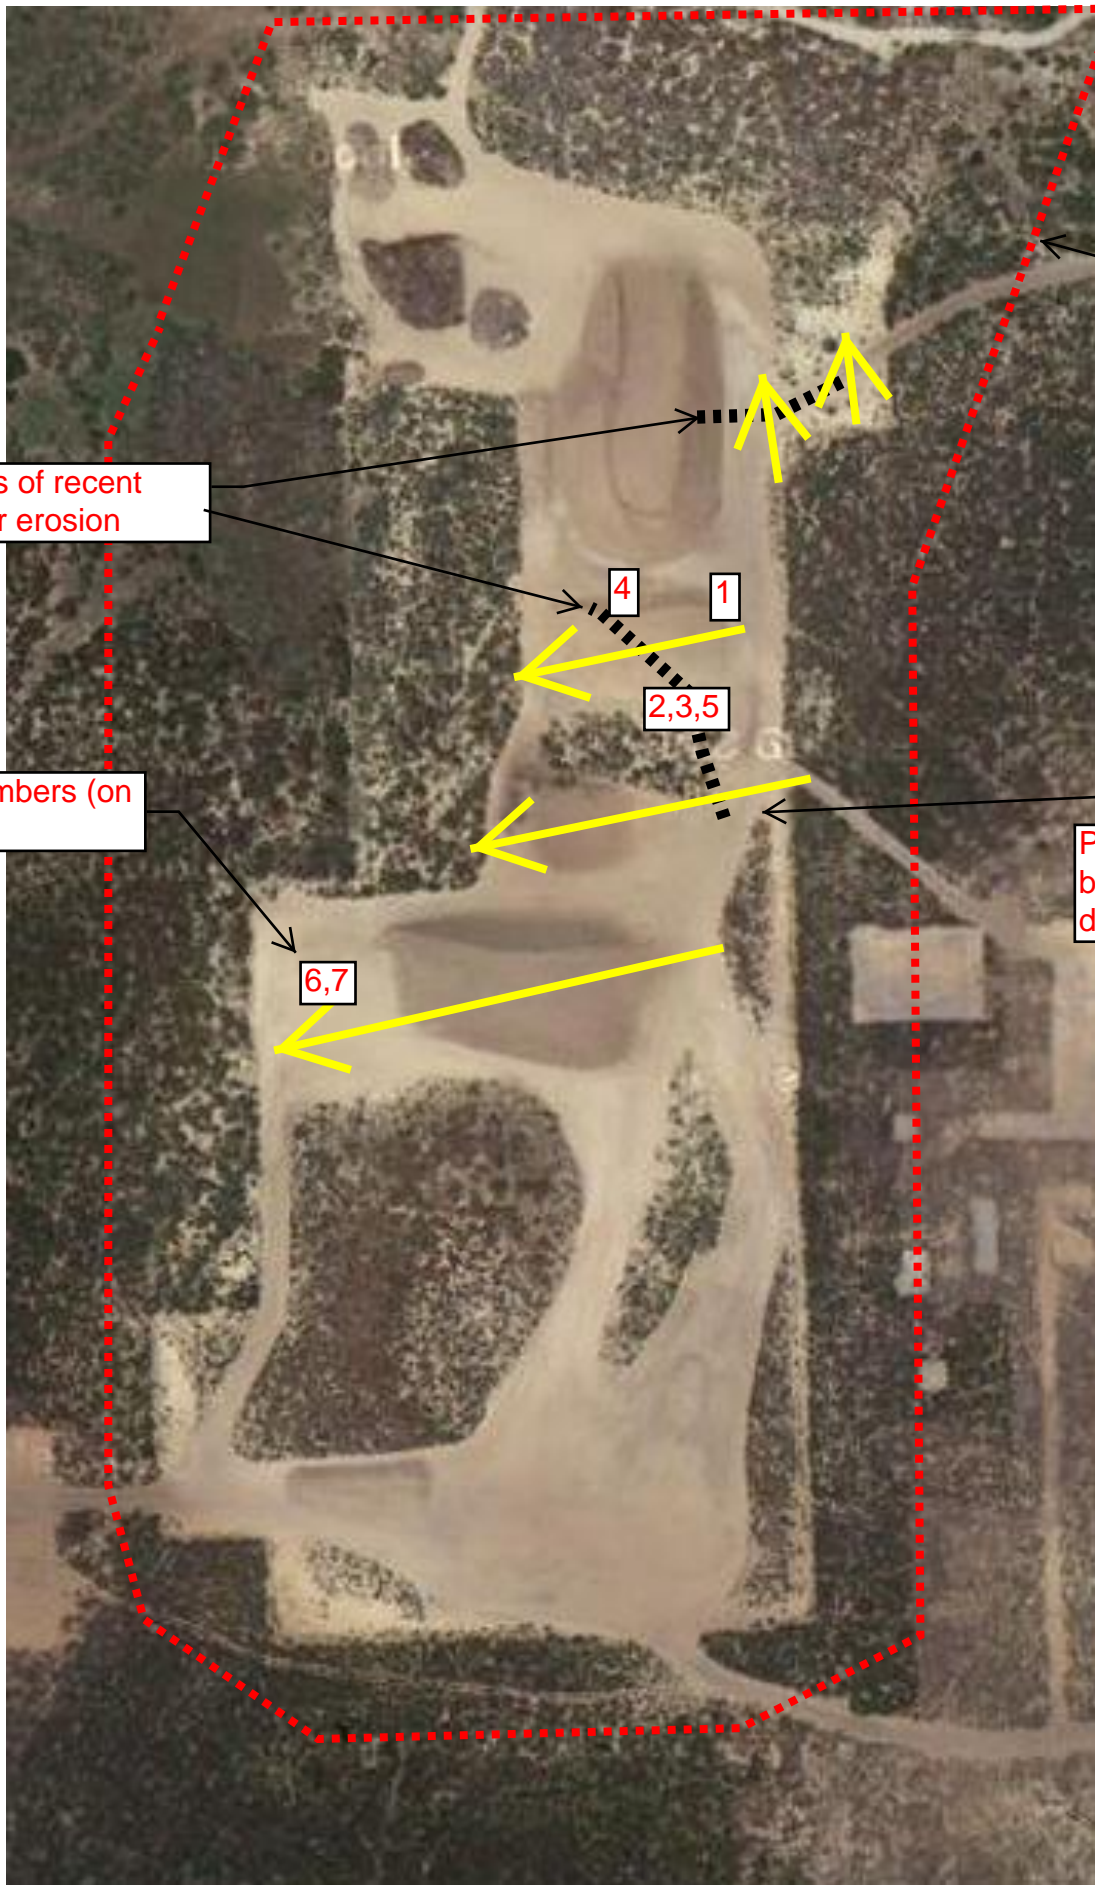
IAR Development Parcel Potential Erosion Control Plan. 2/21/2013

Comments: Limited rilling as seen on attached map and photos

Signs of recent water erosion

Proposed water bars. Arrow show direction of flow

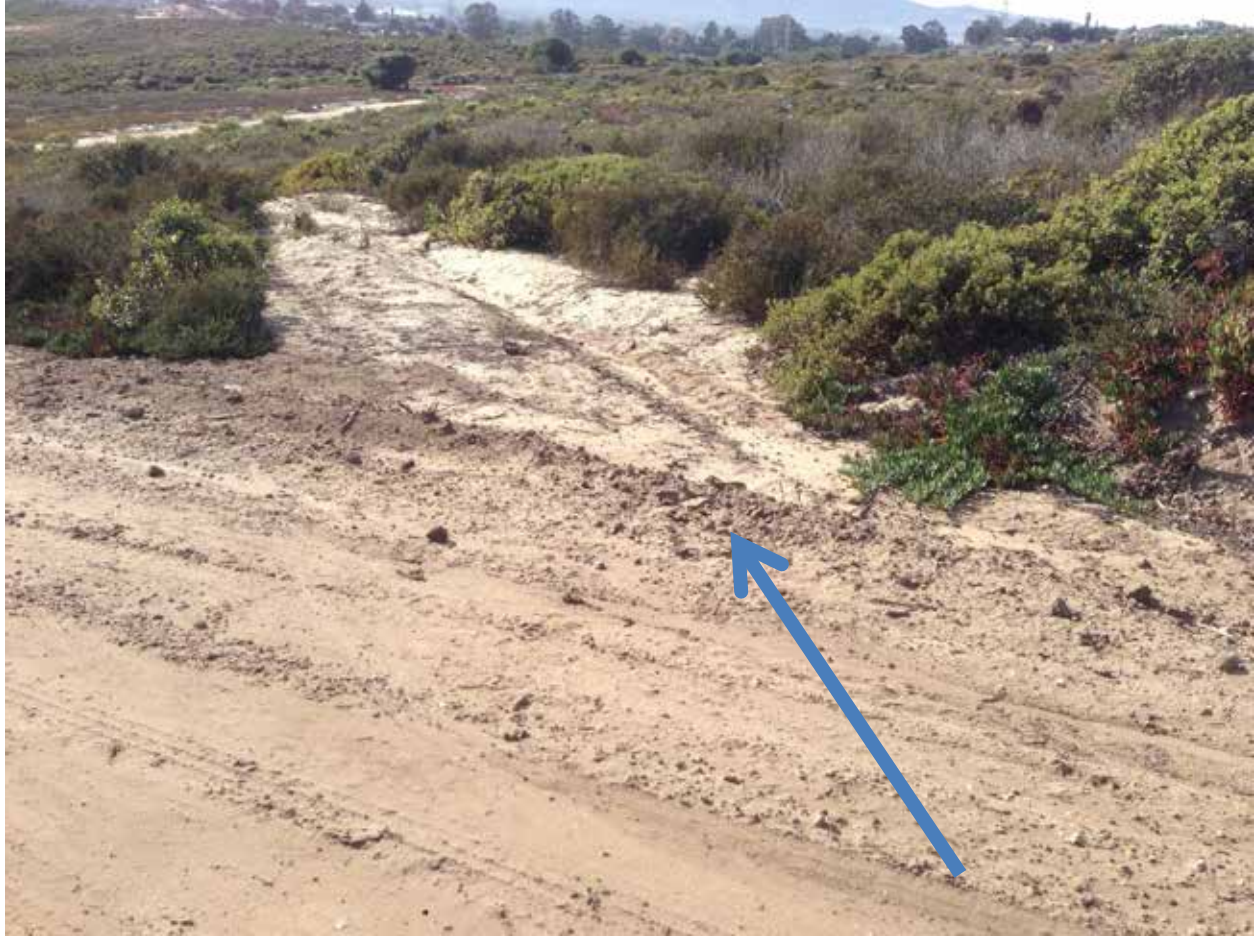
Photo 1. November 6, 2013 in southern Seaside MRA near Watkins Gate Rd. The road has developed a shoulder berm that prevents water from flowing in the direction of the arrow into the cross drain. The recommended erosion control practice is to remove the berm and create a rolling dip. Rolling dips should be cut deep enough to effectively divert water off the road, be backed up by a mound down slope, and be cut wide enough to easily pass traffic (50-100 feet). Department of Transportation specifications are discussed at [http://ntl.bts.gov/lib/24000/24600/24650/Chapters/l\\_Ch7\\_Drainage\\_of\\_Low\\_Volume\\_Roads.pdf](http://ntl.bts.gov/lib/24000/24600/24650/Chapters/l_Ch7_Drainage_of_Low_Volume_Roads.pdf).

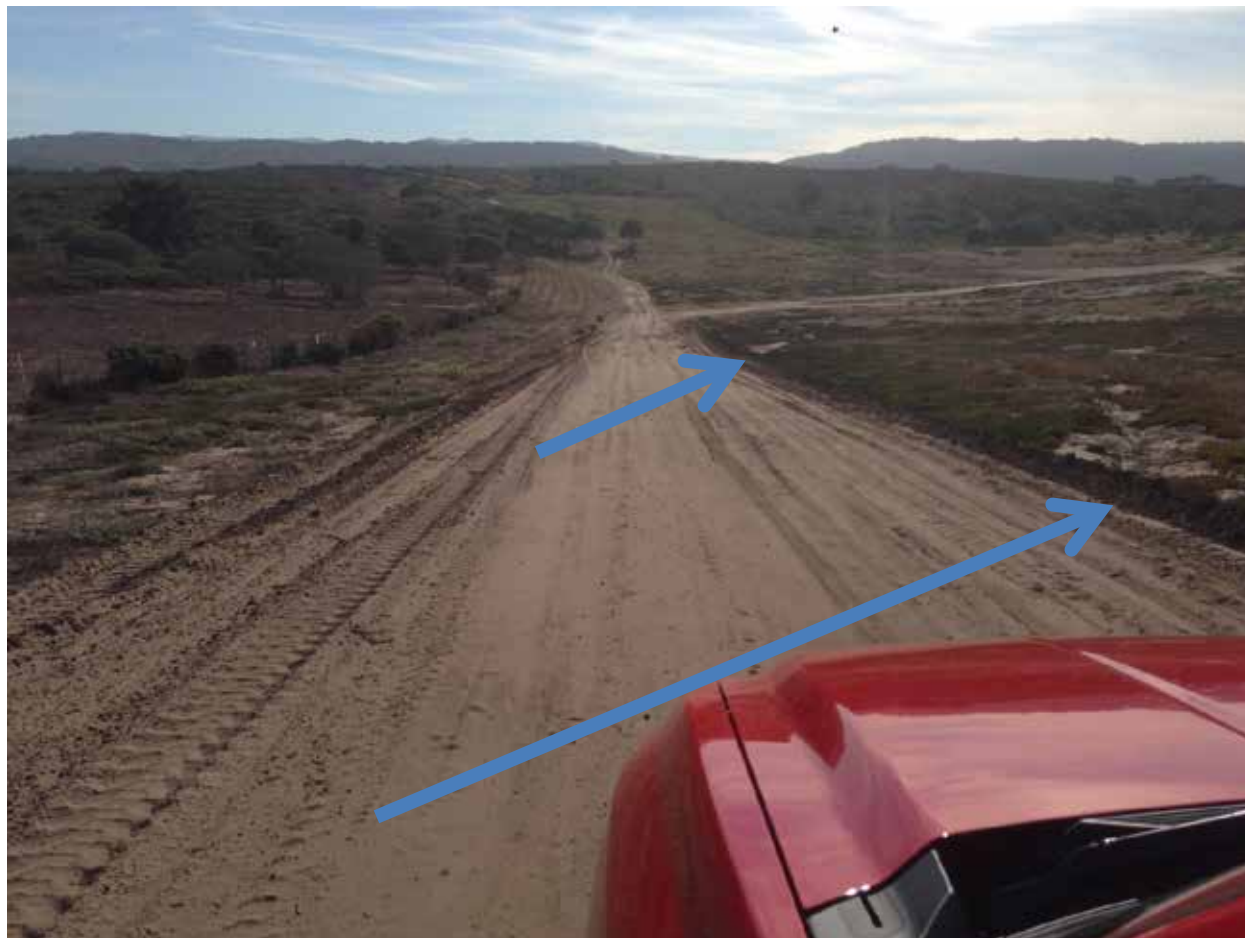
Photo 2. November 6, 2013 in southern Seaside MRA near Watkins Gate Rd. Arrows show two cross drains that are currently blocked by mounded soil on right side of road. Arrows show approximate placement of recommended rolling dips to direct flow off the road.

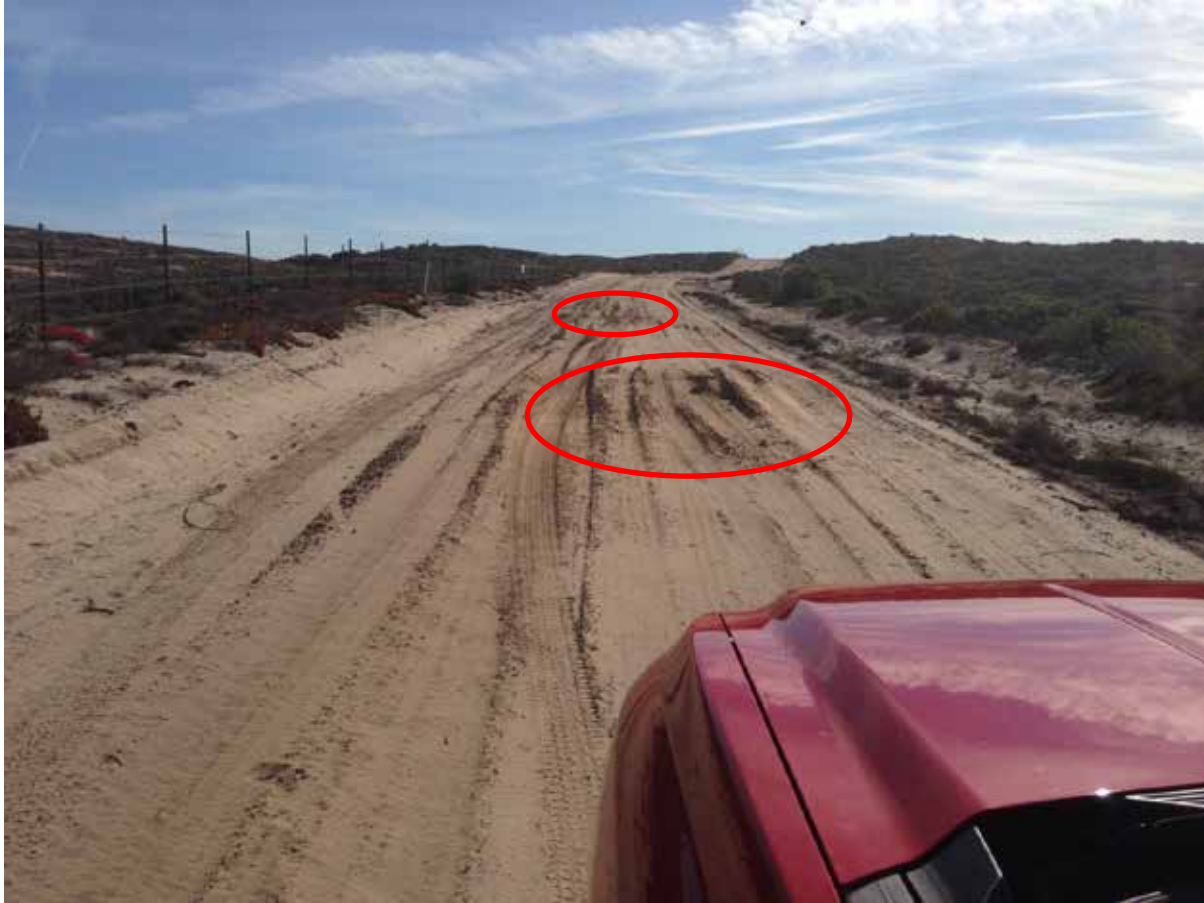
Photo 3. November 6, 2013 in Seaside MRA near Broadway West Gate. The road does not have sufficient crown to provide drainage to the sides. Generally recommended side-slope or crown slope is 4% to protect the road surface from erosion. Two circles show sunken areas with soft sand. During wet season these are at risk of erosion or of softening to the point of inhibiting vehicle passage.
