**Independent Third-Party Quality Assurance Work
Summary Report for
Munitions and Explosives of Concern Activities at
Interim Action Ranges Munitions Response Area
Former Fort Ord Facility, Monterey, California**

August 2014

ERRG implemented quality assurance (QA) efforts in support of the design study for the Interim Action Range (IAR) Munitions Response Area (MRA) Range 44 and 47 Special Case Areas (SCA) and Central Area Non-Complete Areas (NCA) in compliance with the QASP to satisfy regulatory agency concerns. It is recognized that a MEC removal action may not successfully acquire and recover all MEC therefore the regulatory agencies have expressed concern regarding the residual risk that remains after MEC removals have taken place, particularly in areas that are slated as planned for community development with borderland that will interface habitat reserve (with administrative controls). This report is intended to document ERRG's efforts in providing the ESCA MEC Remediation Program with Third-Party Quality Assurance oversight, as required by the regulatory agencies, in addition to the Quality Control provided by Weston during their field work.

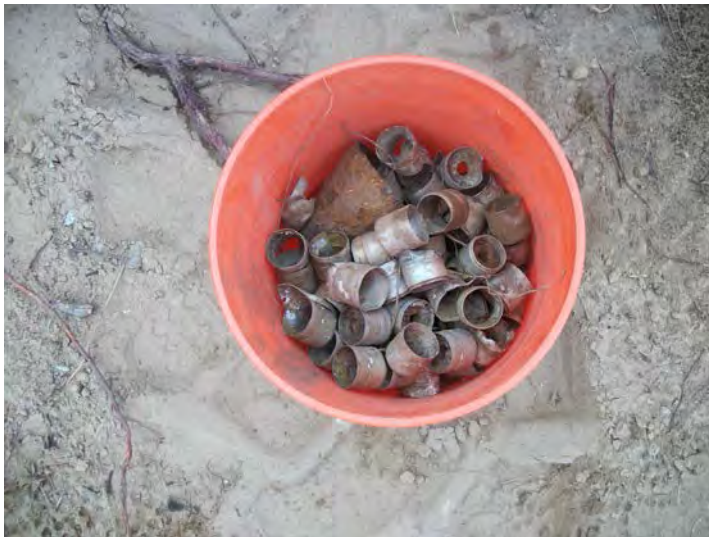
Pictures 1&2: Sifting Operations in the Interim Action Range

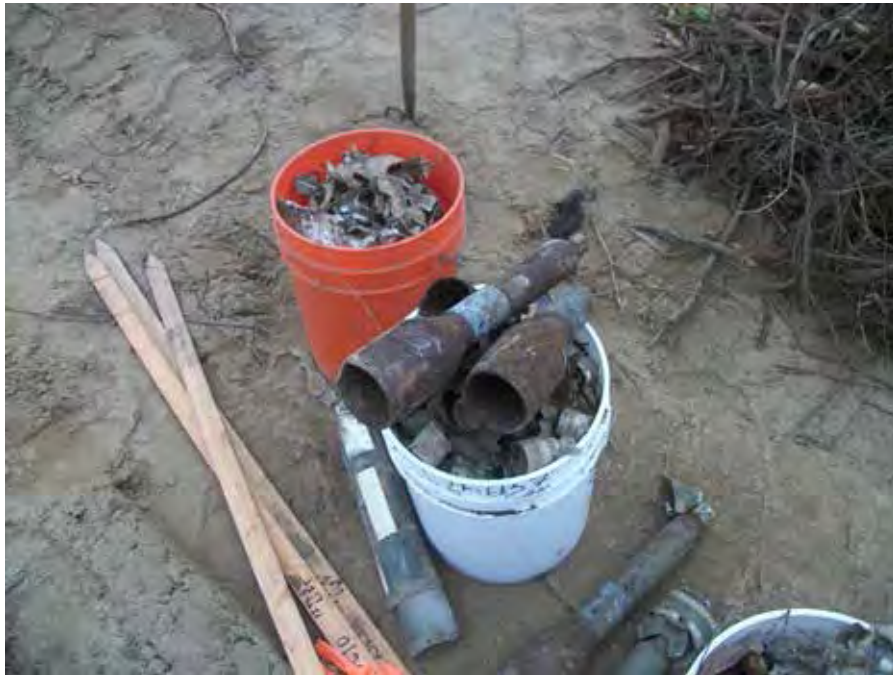
Picture 2: 40 MM, M407A1 found during Sifting Operations

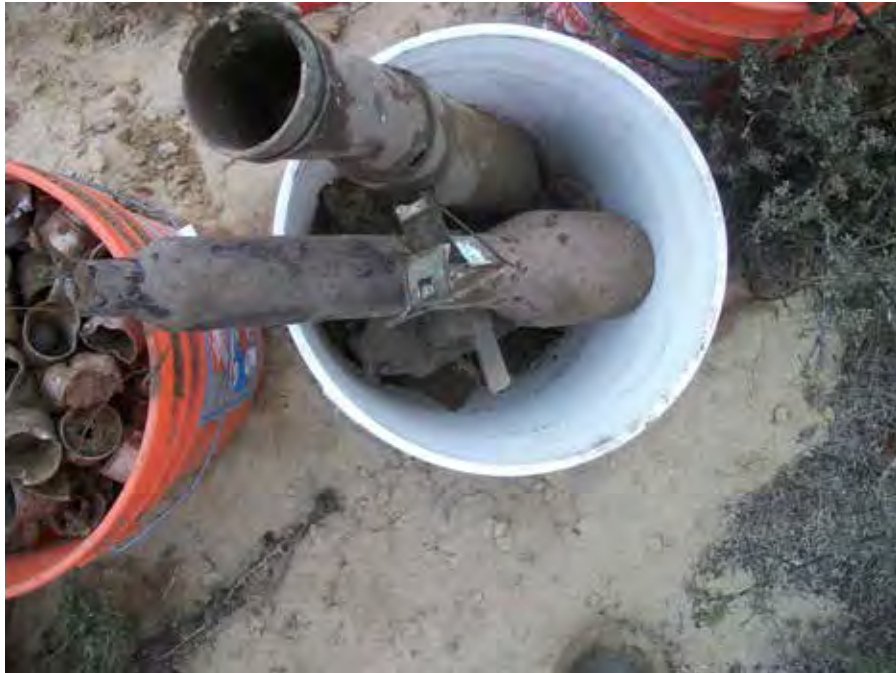
Picture 3: MEC items found during R47 SCA Berm sifting operations

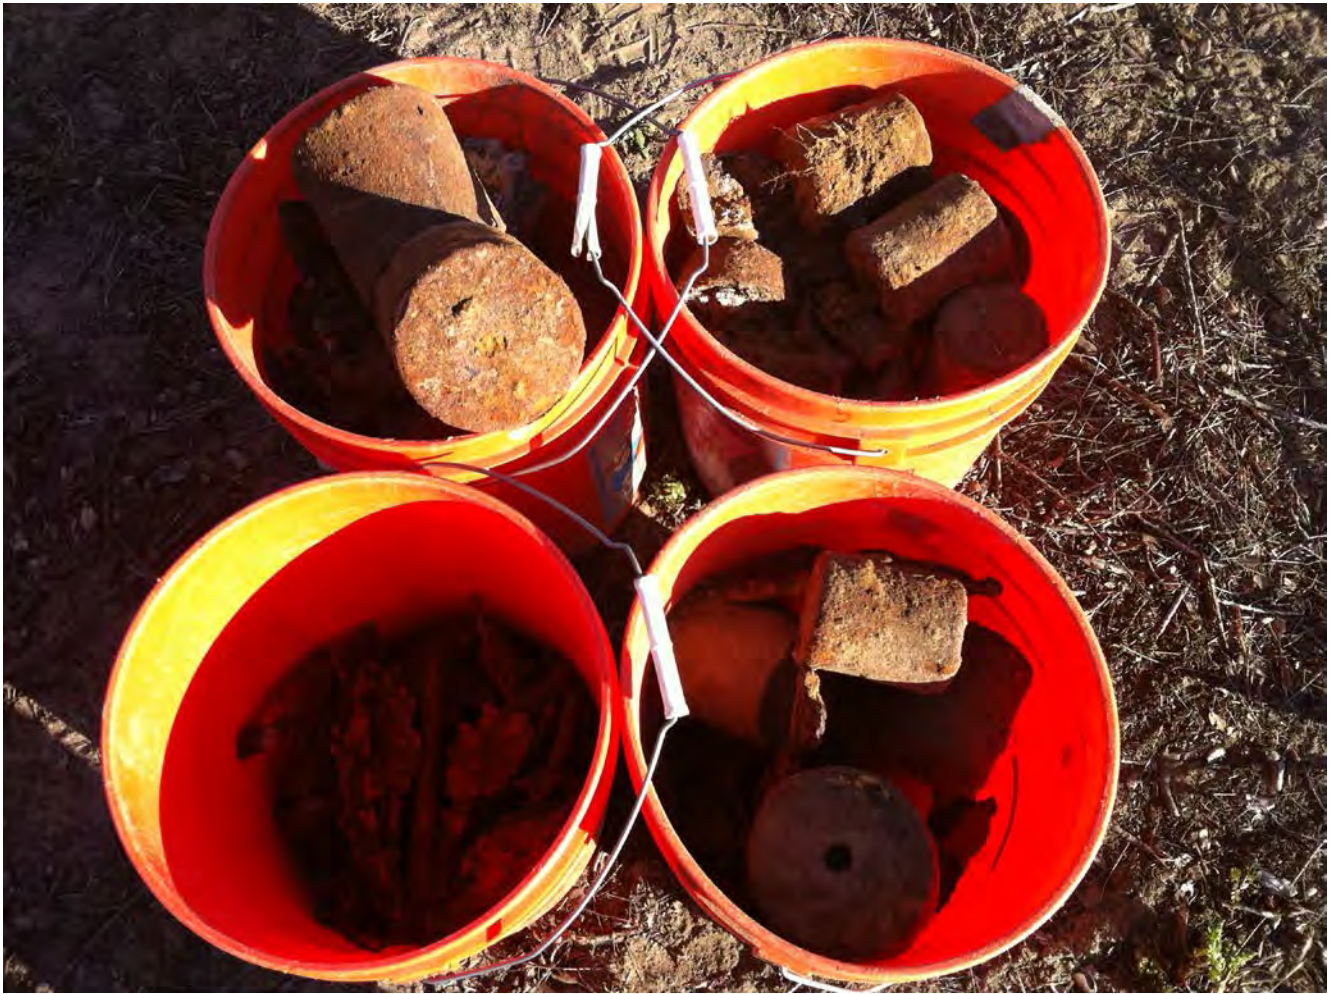
Picture 4: Expended smoke canisters and other munitions scrap

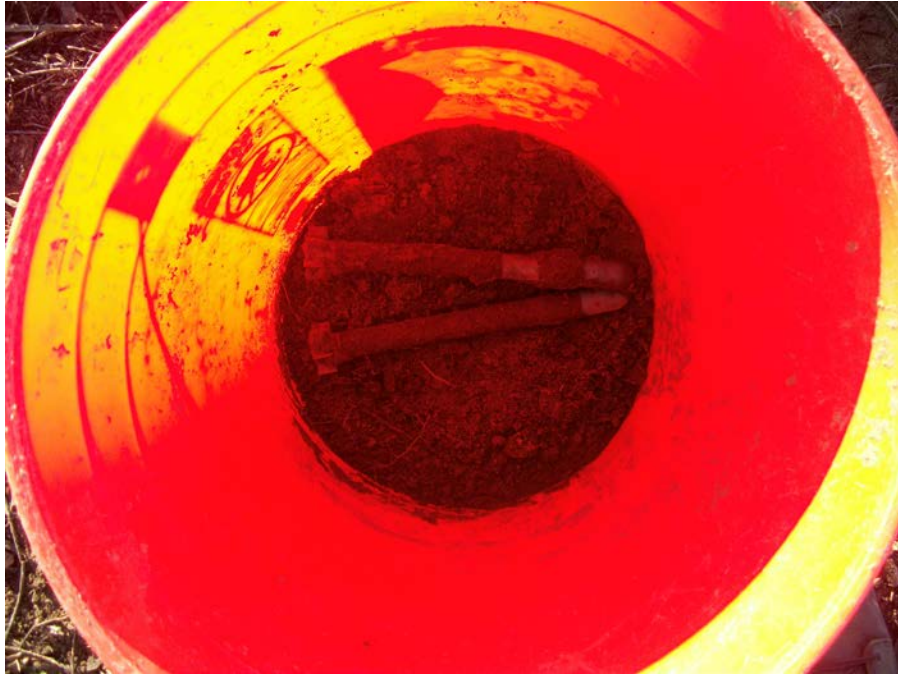
Picture 4: M73 35-MM Sub-Caliber rockets

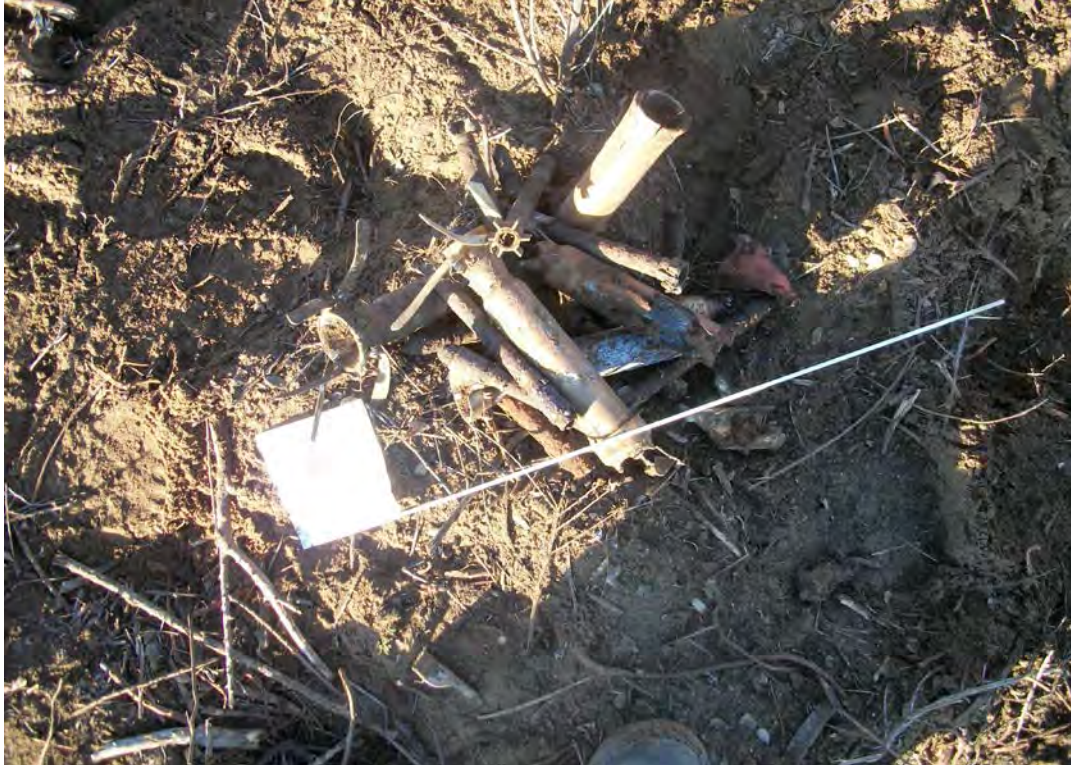
Picture 5: Expended M72 LAW rockets

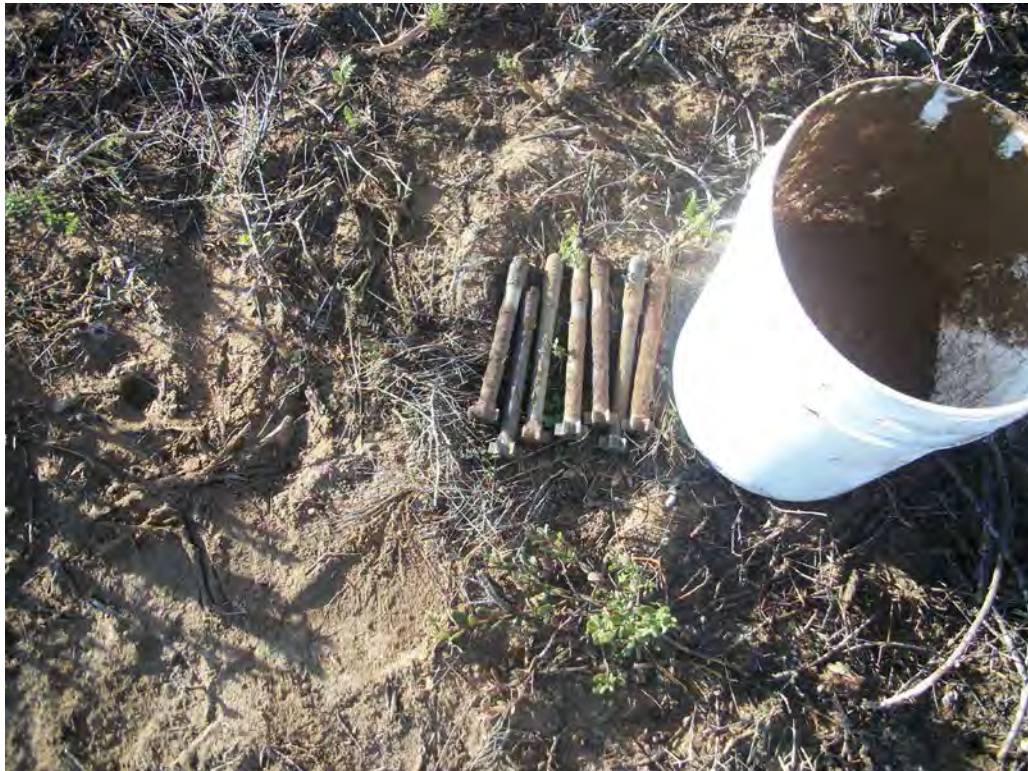
Picture 5: Recovered M73 sub-caliber rockets

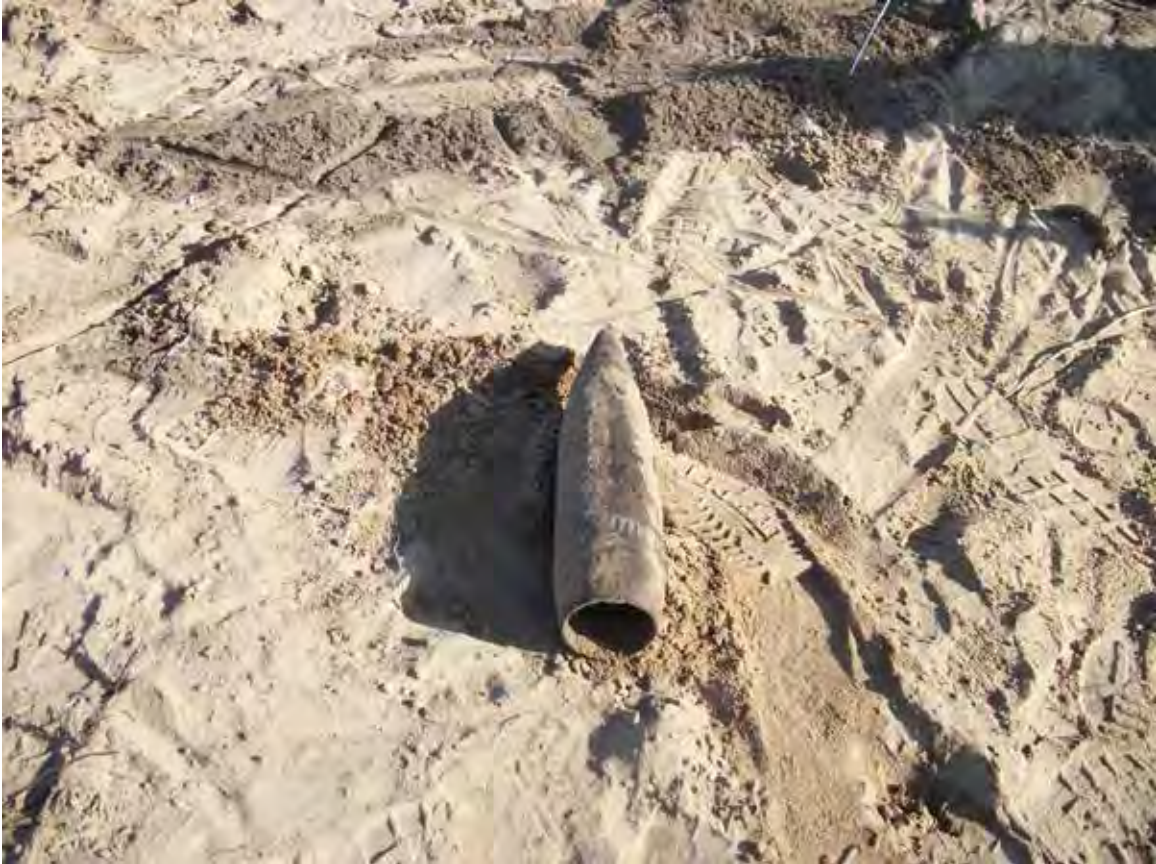
Picture 3: Expended 105MM, M314 projectile
