ESCA RP Erosion Monitoring Form

Appendix C – 2015 Aquatic Feature Monitoring Photo-documentation
Future East Garrison MRA – Grenade Range

FORA ESCA Remediation Program

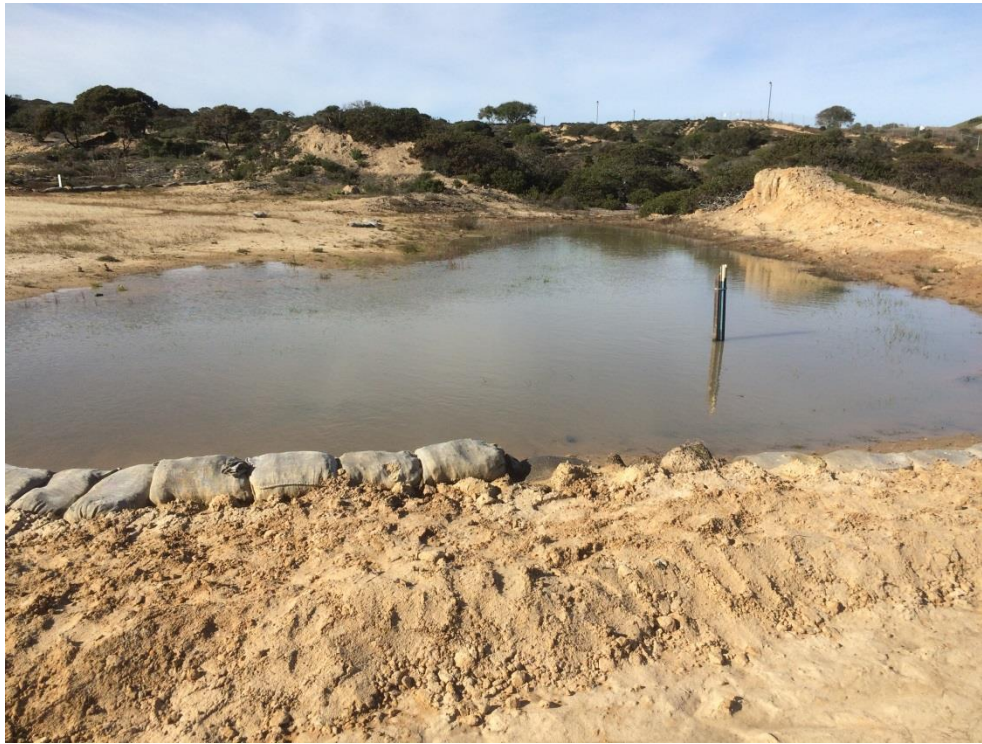
Photograph 1

Restored aquatic
feature AF09-1A

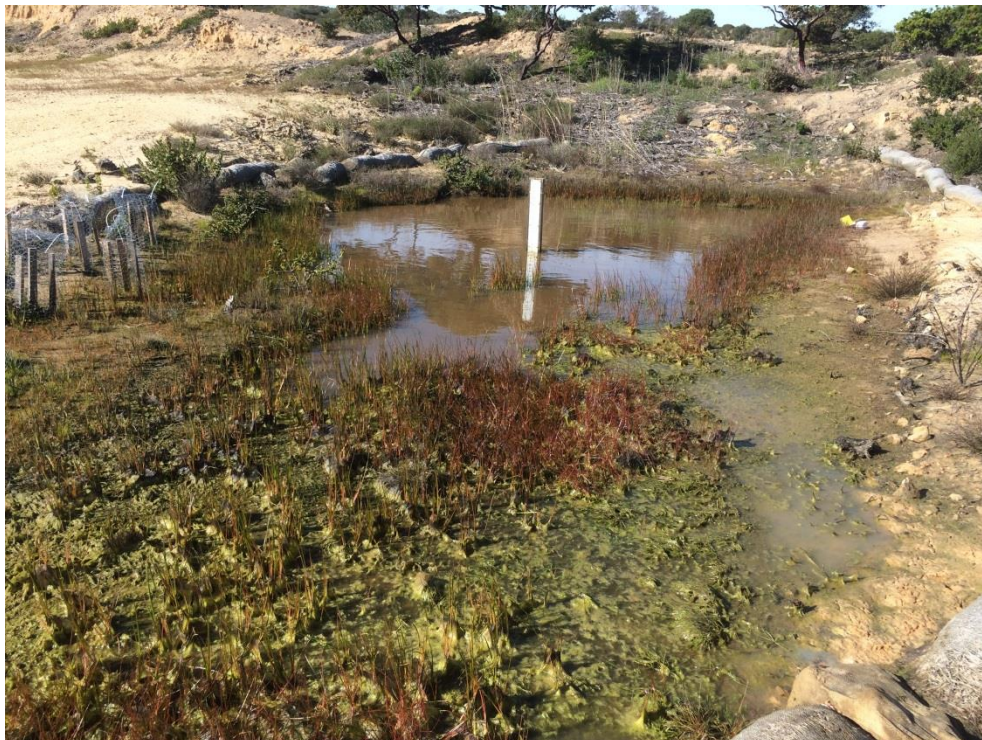
Photograph 2

Reference aquatic
feature AF09-2

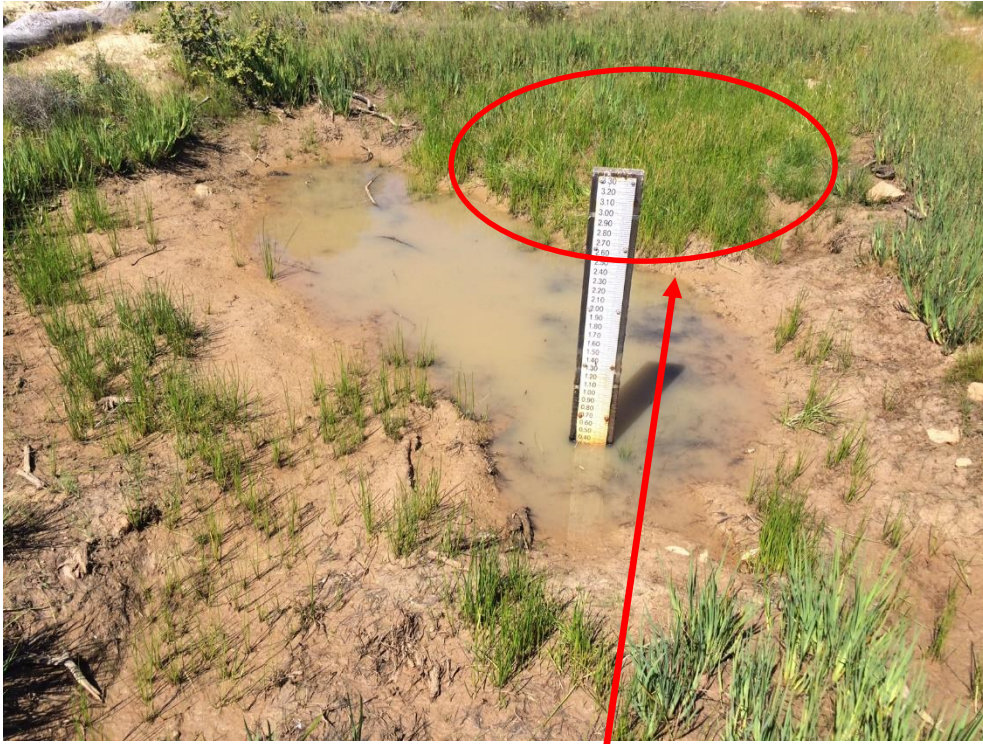
Photograph 4

Flowering common
spikerush
(*Eleocharis
macrostachya*) from
reference aquatic
feature AF09-2

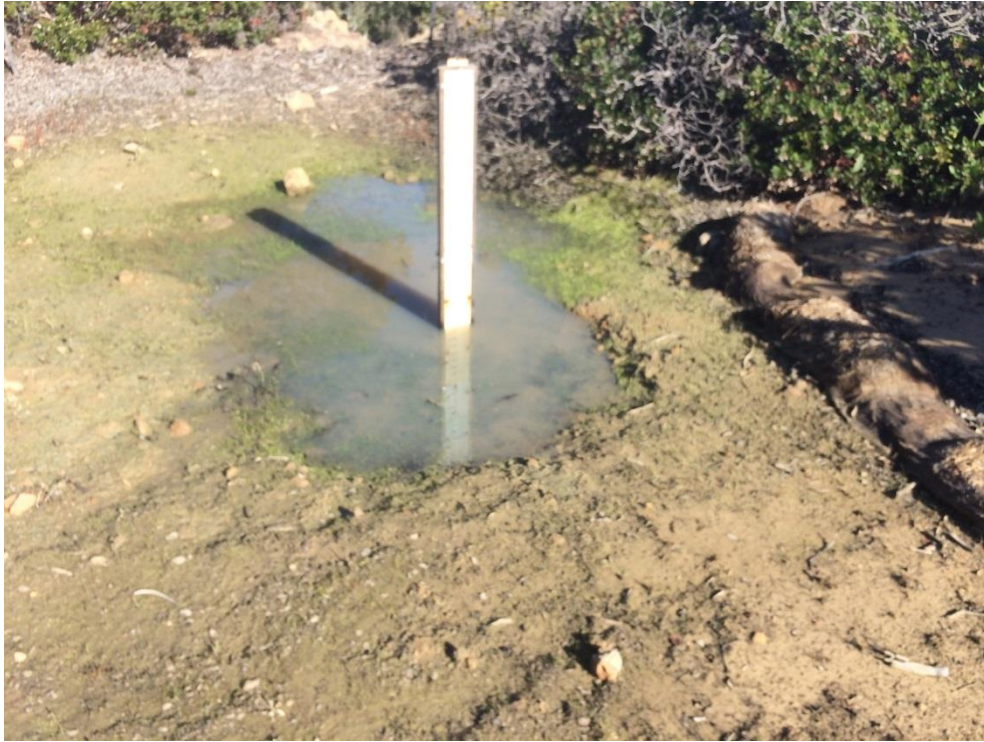
Photograph 5
Reference aquatic feature AF09-1B
26 March 2015

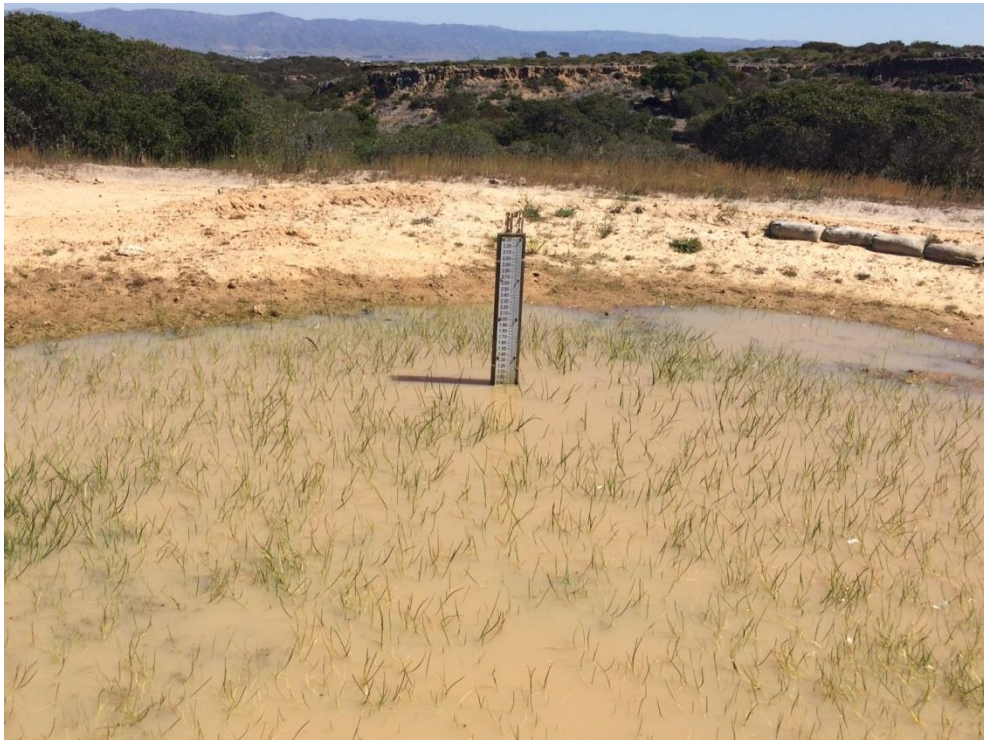
Photograph 6
Restored aquatic feature AF09-1A
26 March 2015

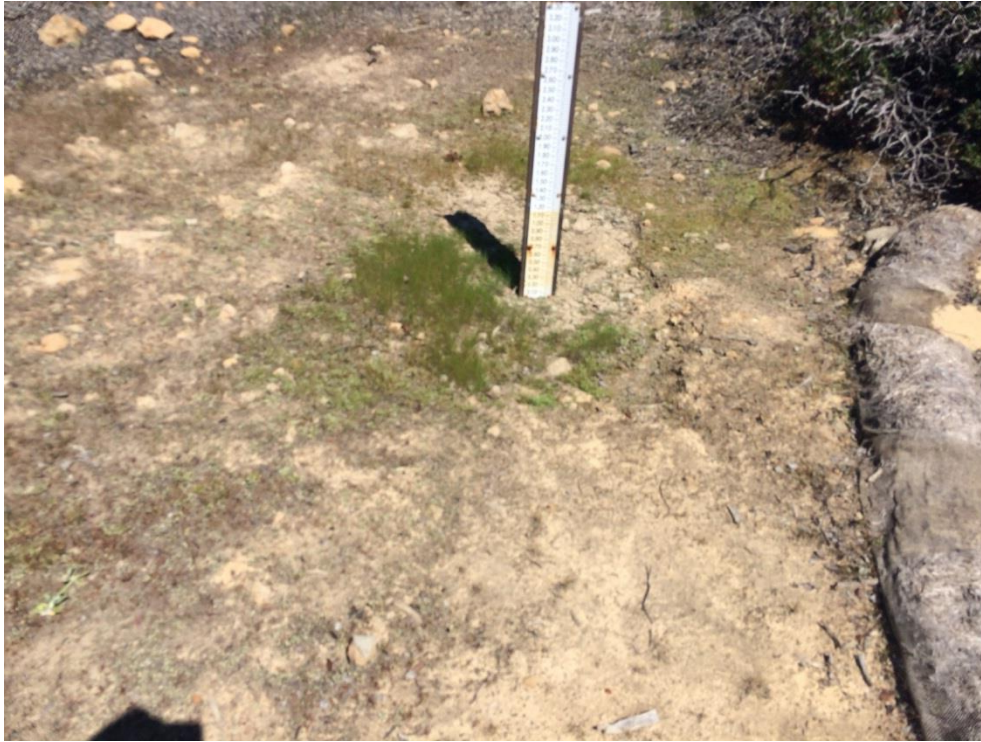
Photograph 7

Reference aquatic feature AF09-1B

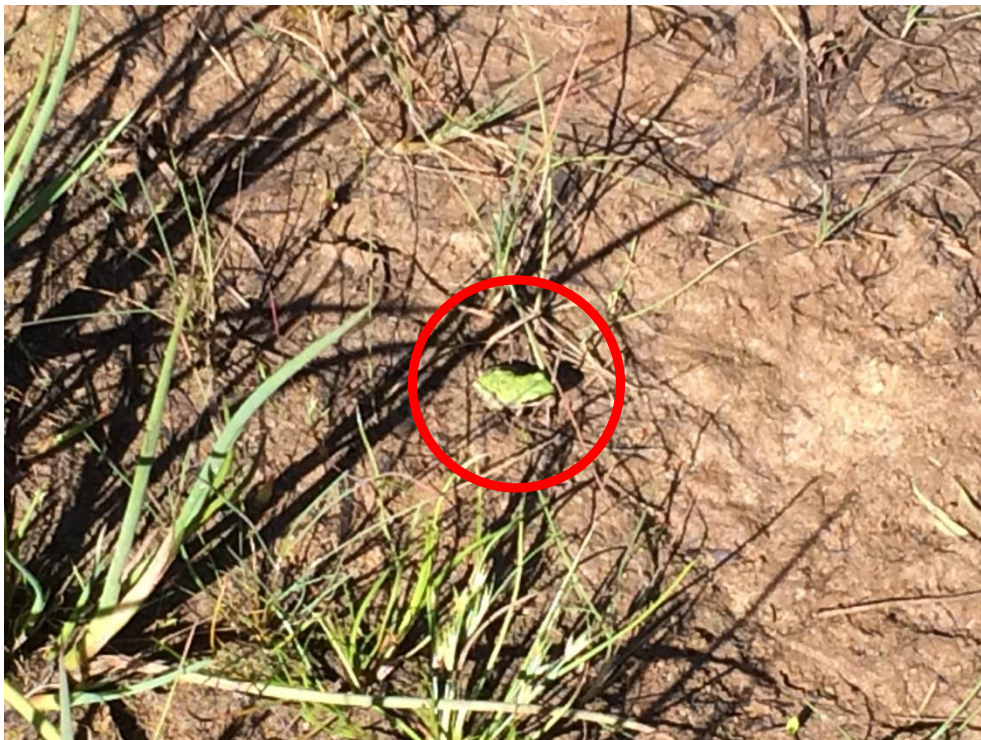
Photograph 8

Reference aquatic feature AF09-2

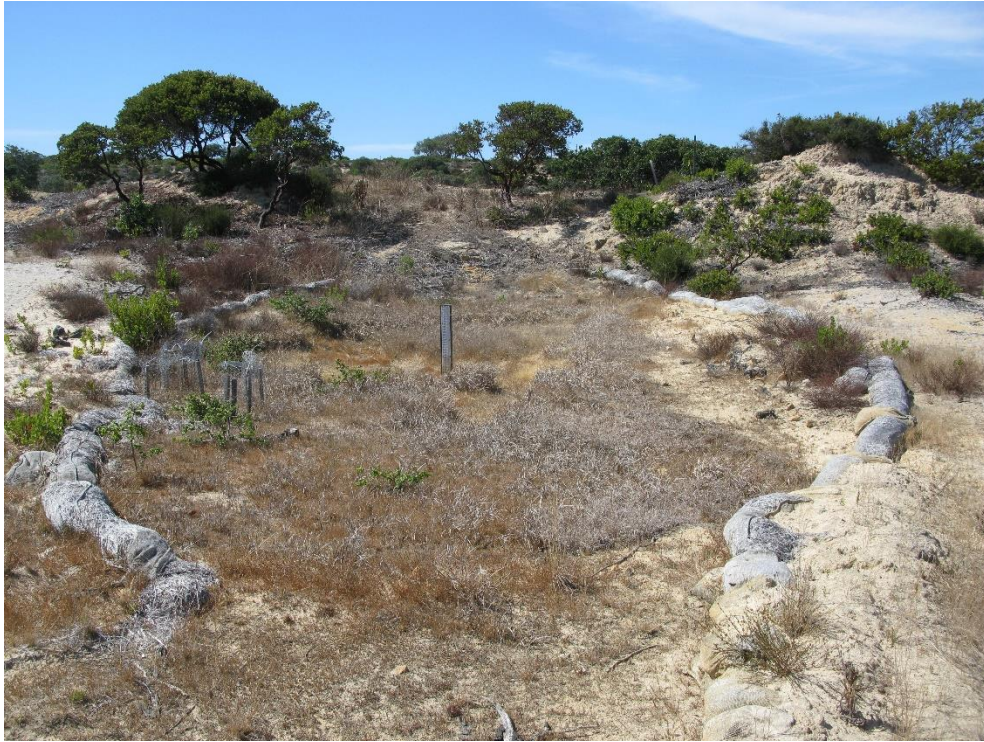
Photograph 9

Reference aquatic feature AF09-2

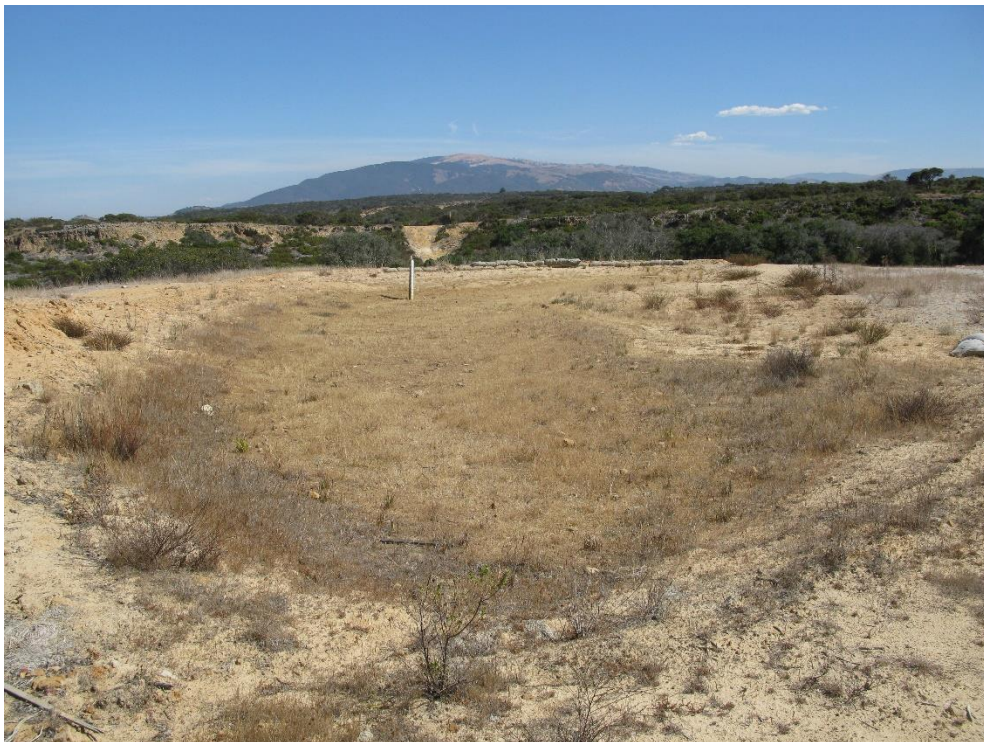
Photograph 10

Restored aquatic feature AF09-1A

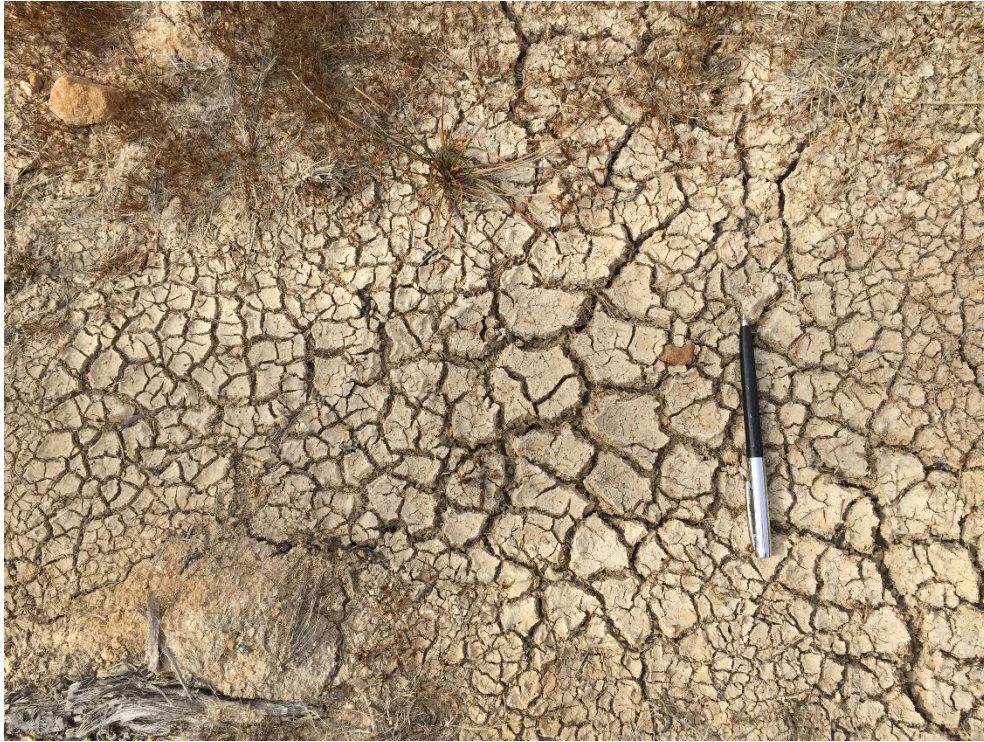
Photograph 11

Reference aquatic
feature AF09-2

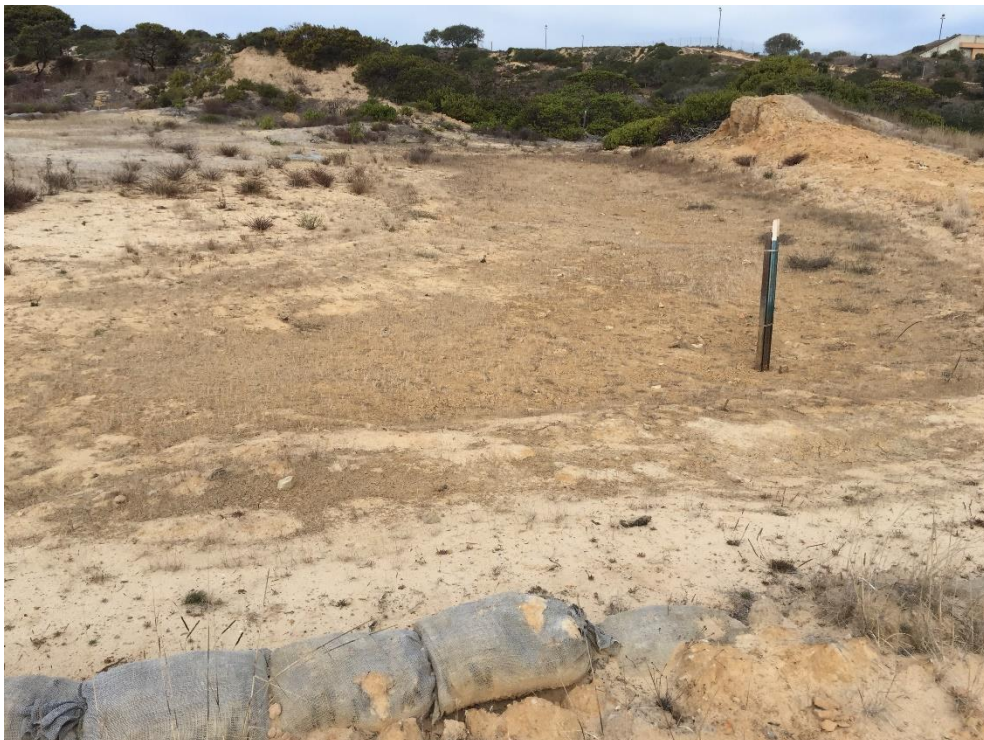
Photograph 12

Restored aquatic
feature AF09-1A

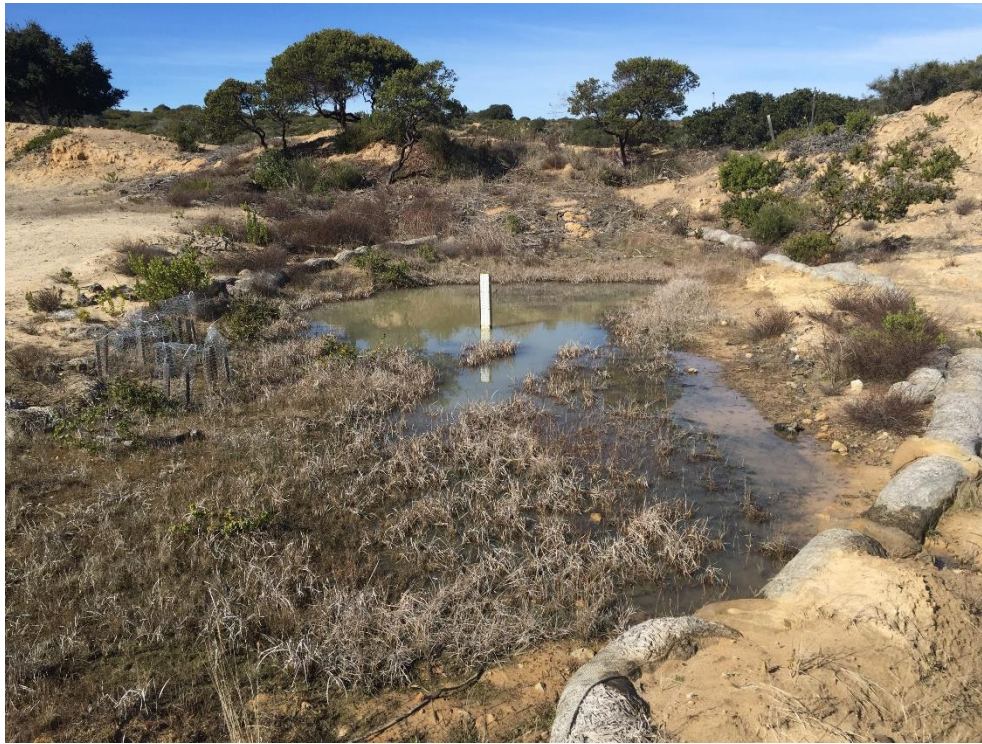
Photograph 13
Reference aquatic feature AF09-2
17 November 2015

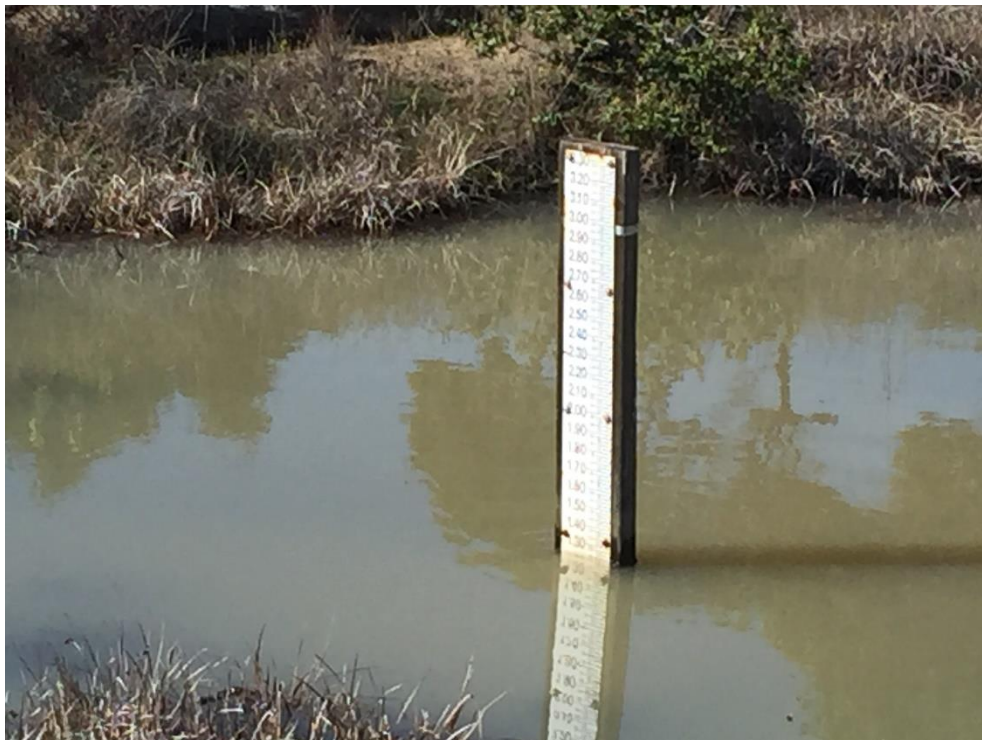
Photograph 14
Reference aquatic feature AF09-2
17 November 2015

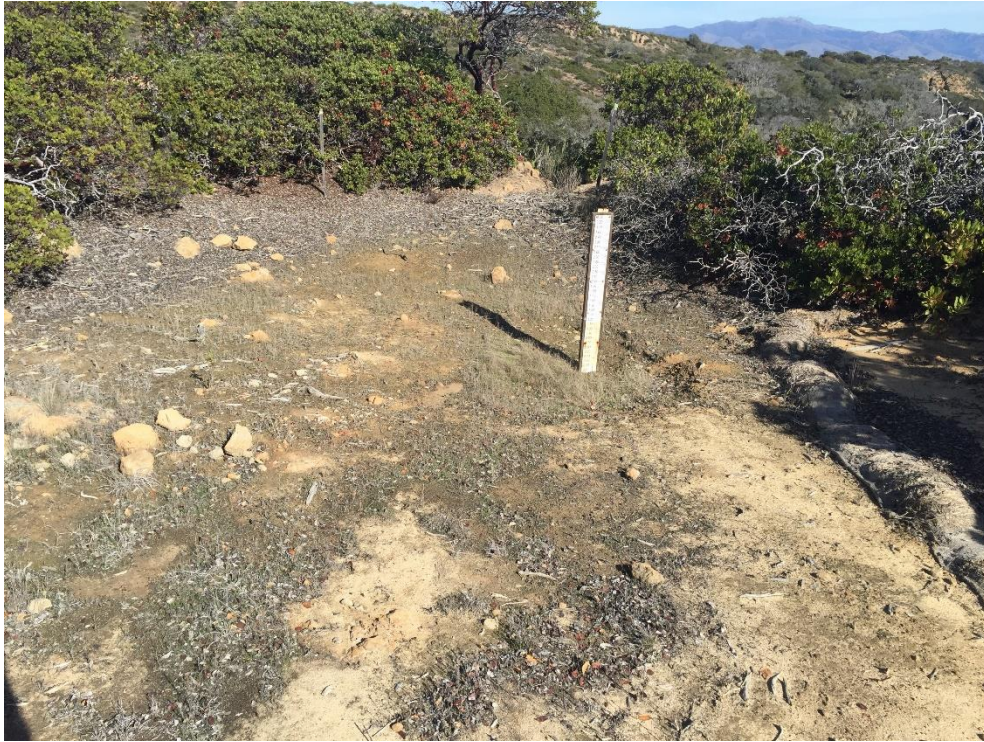
Photograph 15

Reference aquatic feature AF09-1B

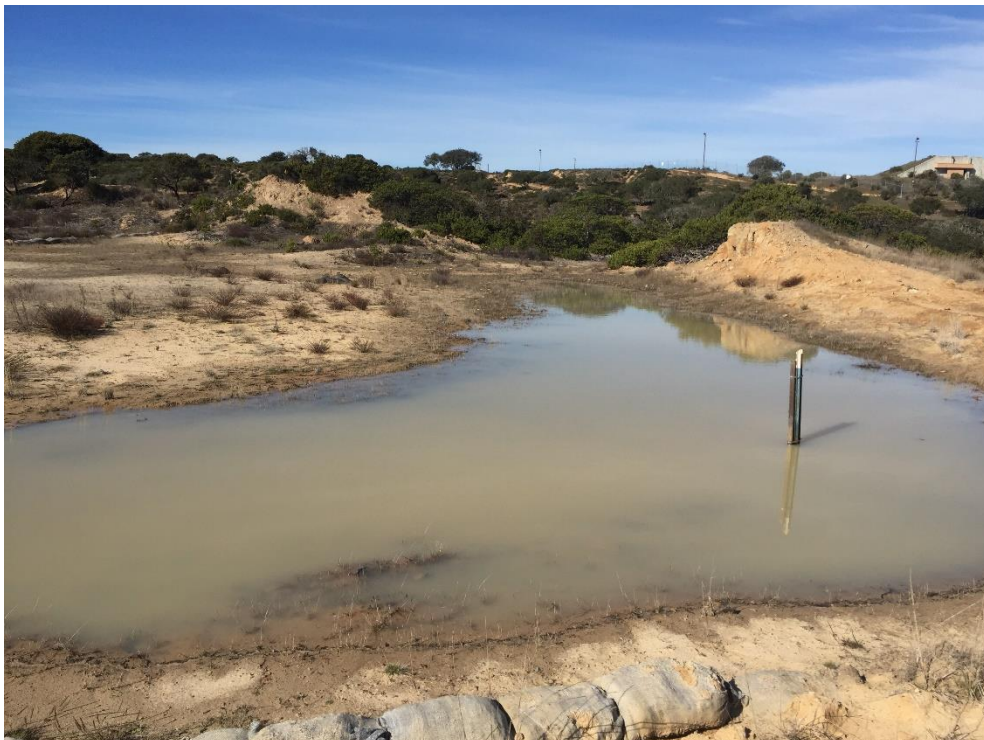
Photograph 16

Restored aquatic feature AF09-1A

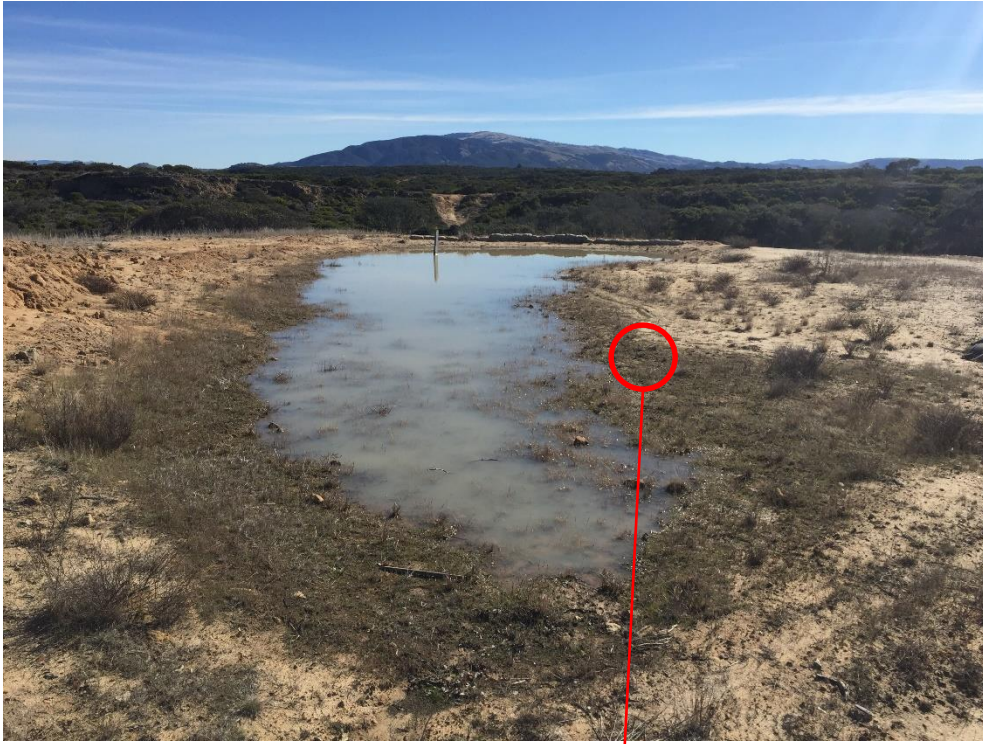
Photograph 18

Restored aquatic
feature AF09-1A
