Attachment A

FONR OU-1 Environmental Monitoring Report Site Pictures

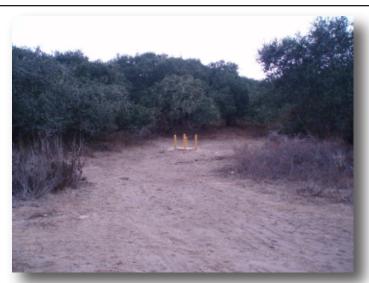
Photo 36. Finished well location MW-A (MW-OU1-88-A).

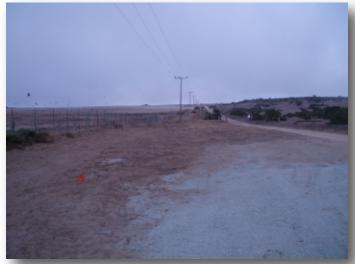
Photo 38. FONR staging area looking east after de-mobilization

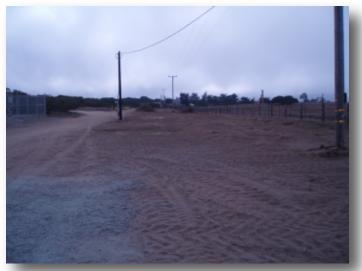
Photo 37. FONR staging area looking west after de-mobilization.

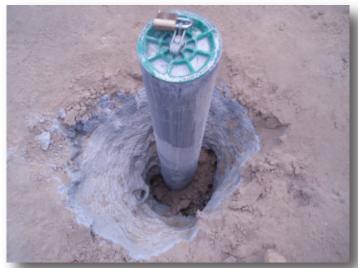
Photo 39. EW-OU1-71-A representative of wells surrounded by a depression after settling of concrete. All depressions were subsequently filled by HGL field staff.
