## **BRA and Lead Evaluation Status**

### **Fort Ord HTW BCT**

**14 March 2019**

#### **Building Demolition Project**

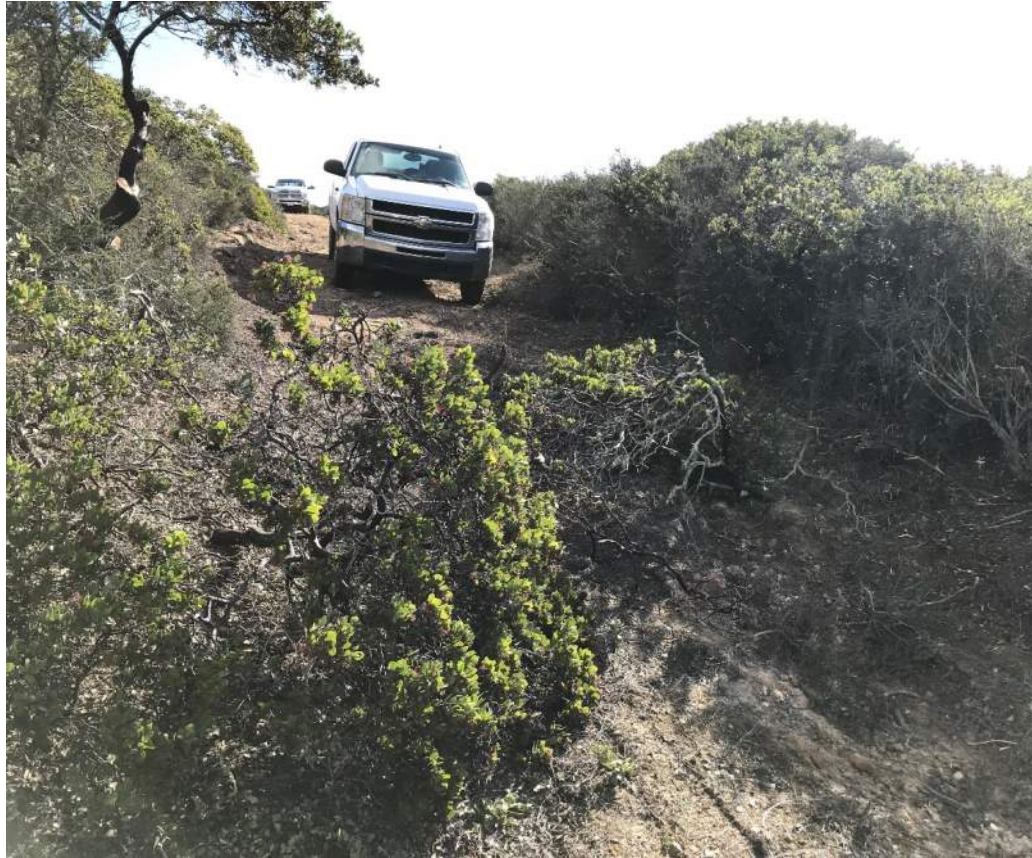
A) Workers spent several days gaining entrance to the structures in Unit 13 by clearing the old access road.

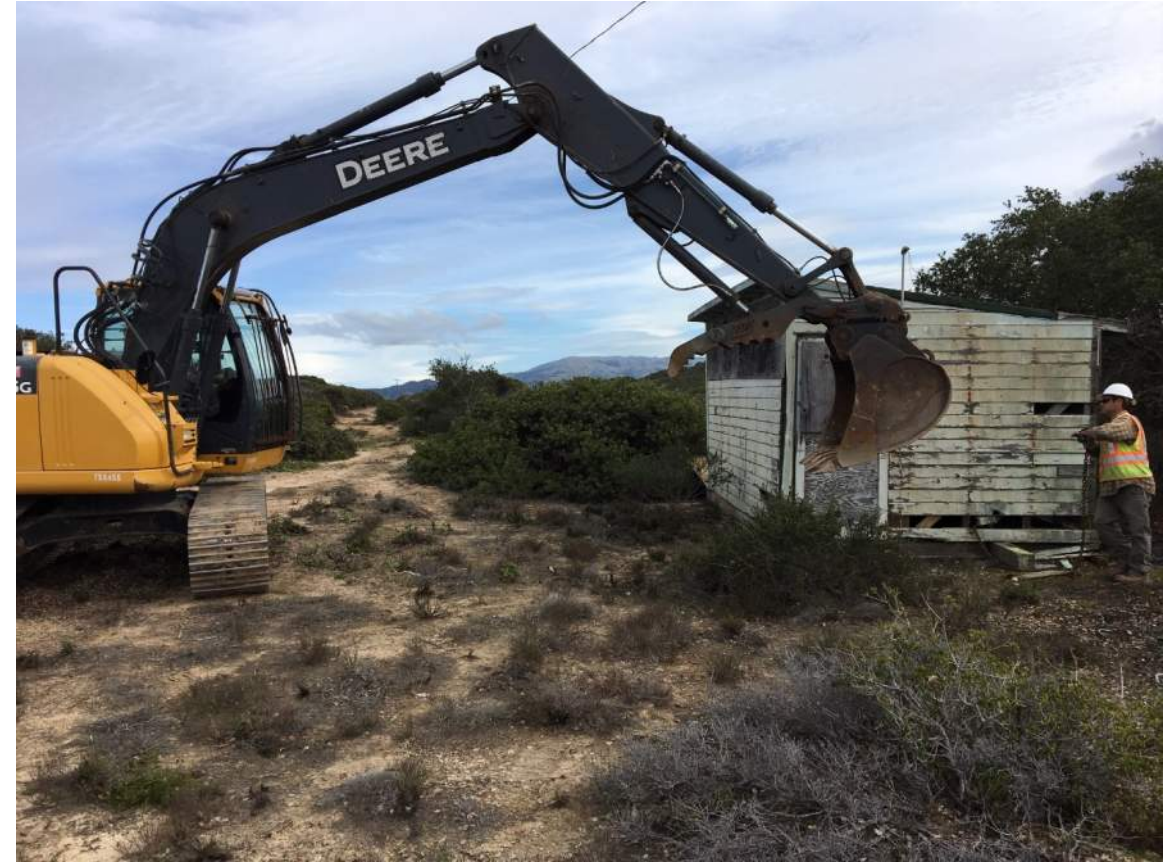
B) Construction workers slid the latrine to a location where it was easier to demo.
