**ESCA RP Weed Monitoring Report**

**MRA/Parcel and Specific Locations Monitored:** Future East Garrison Munitions Response Area (MRA), Interim Action Ranges MRA, and Seaside MRA

## ESCA RP Weed Abatement Report

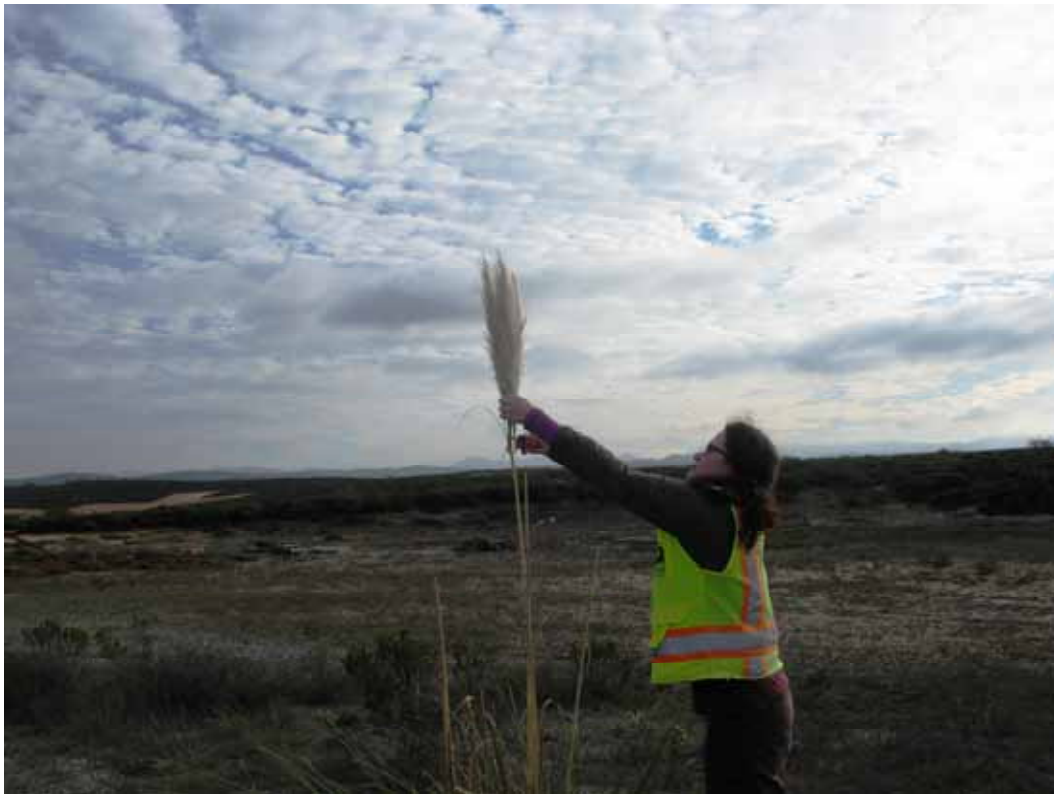
Photo 1: Pampas grass seed head removal in Seaside MRA

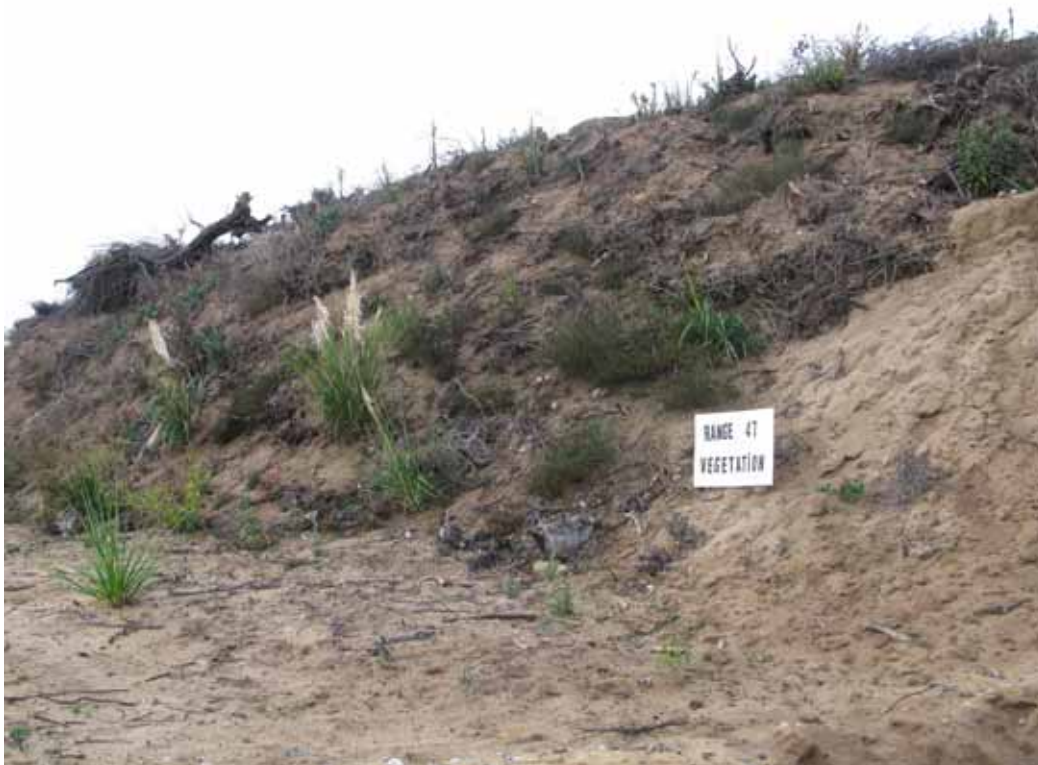
Photo 2: Pampas grass seed head removal in Interim Action Ranges MRA vegetation pile

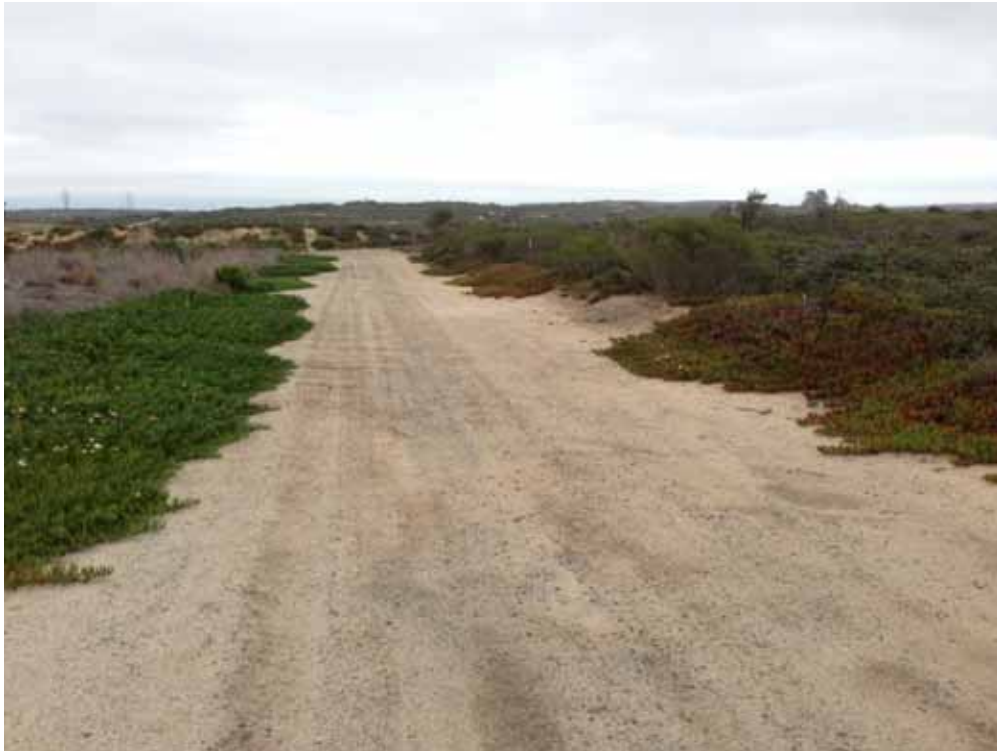
Ice plant was observed commonly in all of the Seaside MRA along the Blue Line Road and on either side of the fence line (Photo 1). In some locations it was observed that ice plant has been abated with herbicide application on the east side of the blue line road (Photo 2).

**Photo 1: Ice plant observed on either side of the Blue Line Road**

Ice plant is abundant in the Seaside MRA and was pre-existing prior to ESCA RP activities. However, it is recommended that ESCA RP remove or spray ice plant with herbicides along the west side of the Inland Impact Ranges fence line in locations where it has been recently treated on the east side of the fence line. This would ensure that the ice plant was not recruiting back across the borderland boundary/blue line into the habitat parcel, where it has been abated.

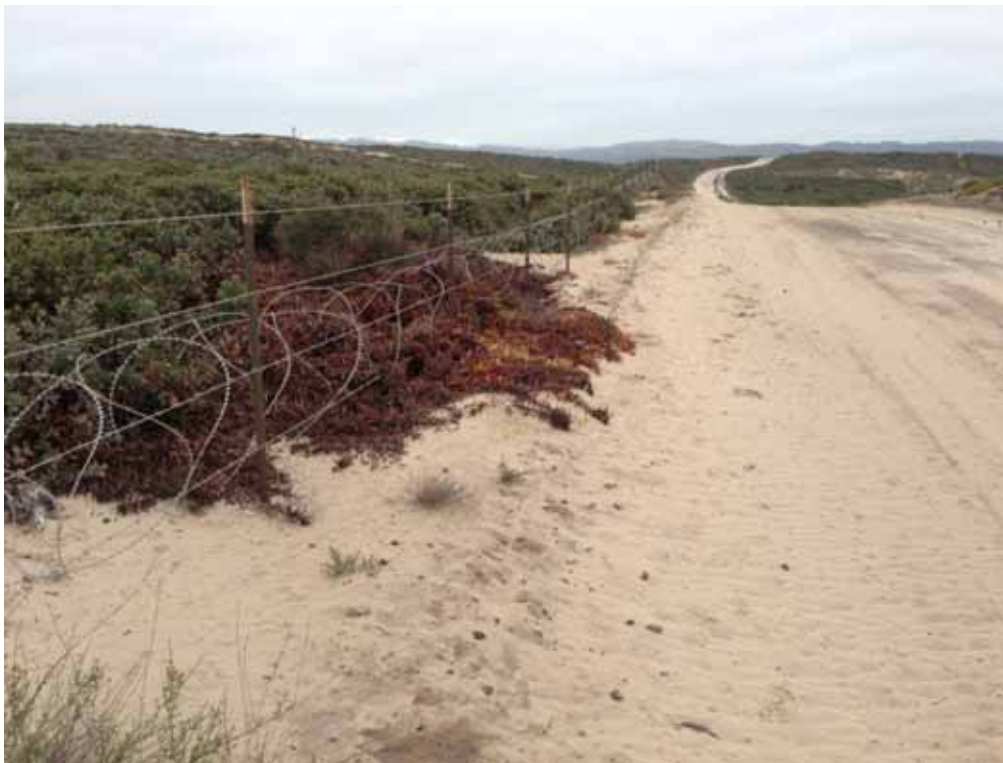
**Photo 2: Ice plant abated with herbicide on the east side of the Blue Line Road**

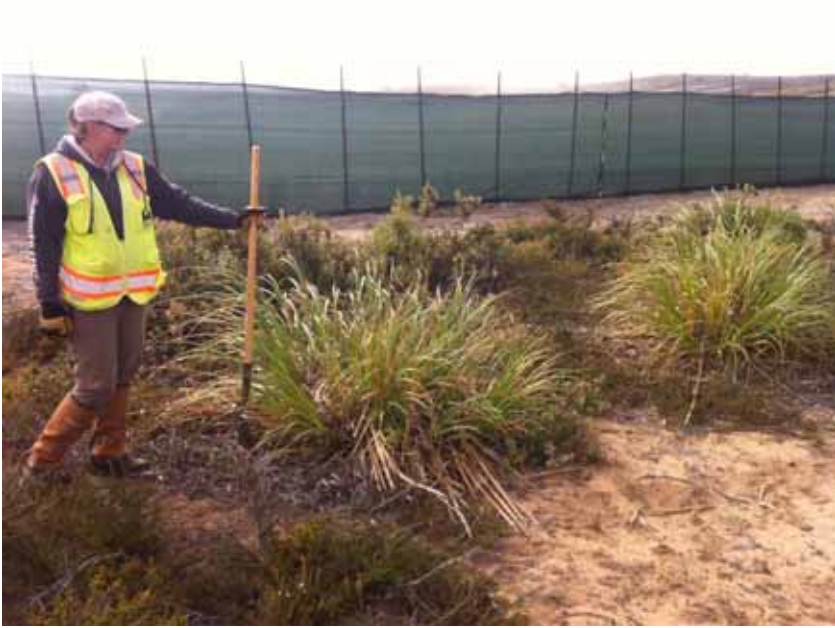
Photo 1: Pampas grass plants abated using shovels.

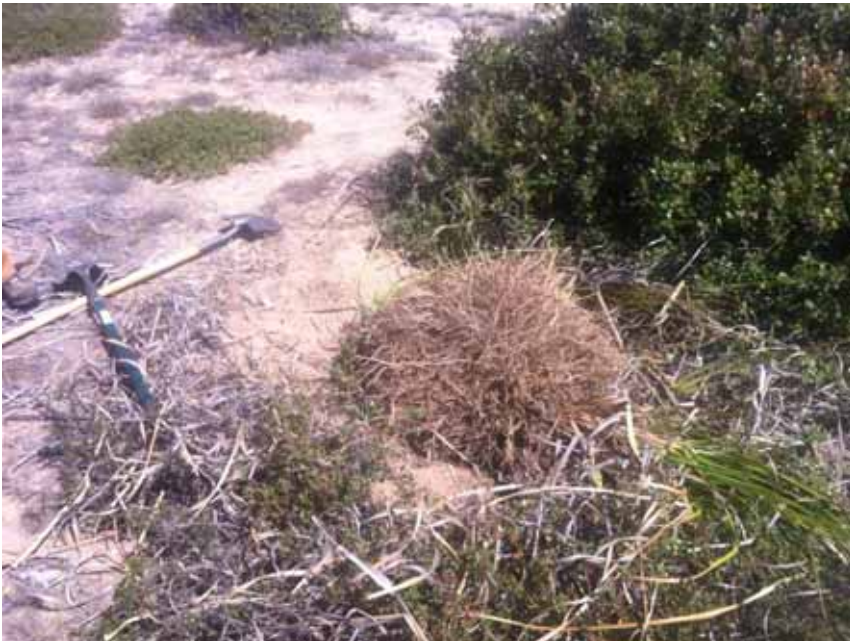
Photo 2: Pampas grass plant turned over once removed.

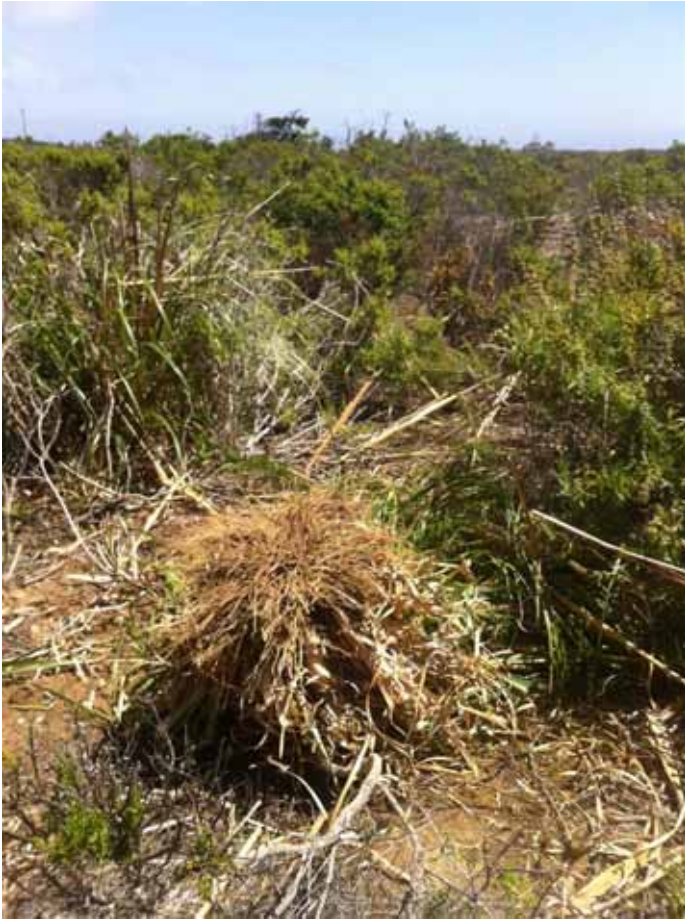
Photo 3: Pampas grass plants abated with shovels.

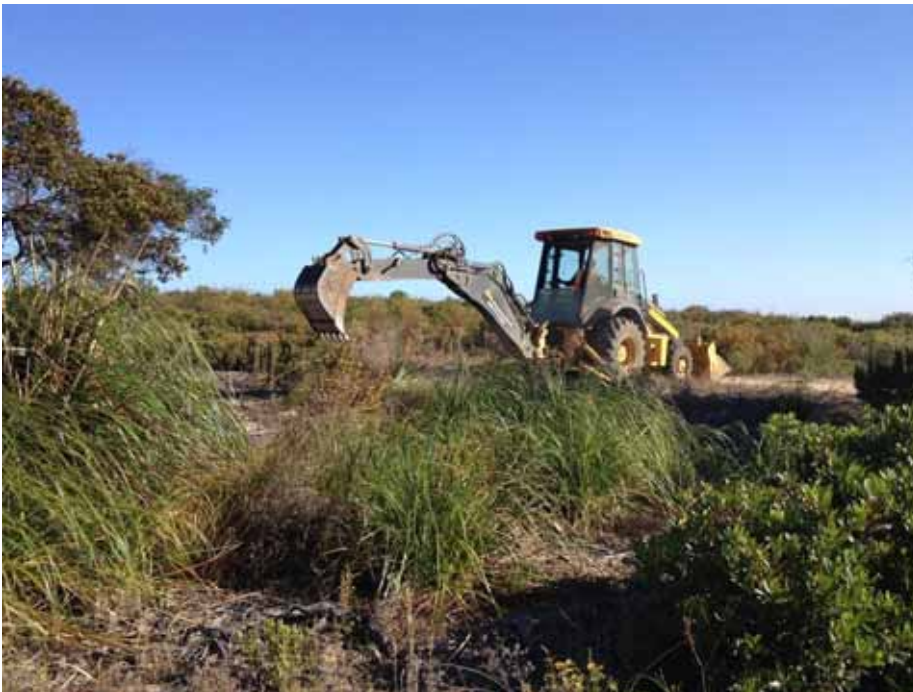
Photo 4: Pampas grass abated with backhoe.

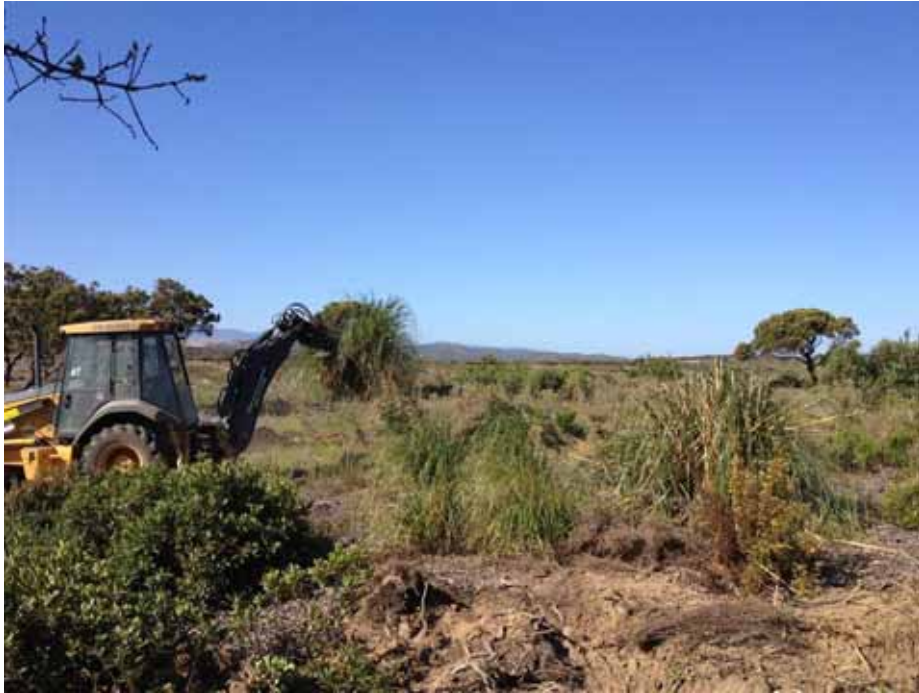
Photo 5: Pampas grass abated with backhoe.

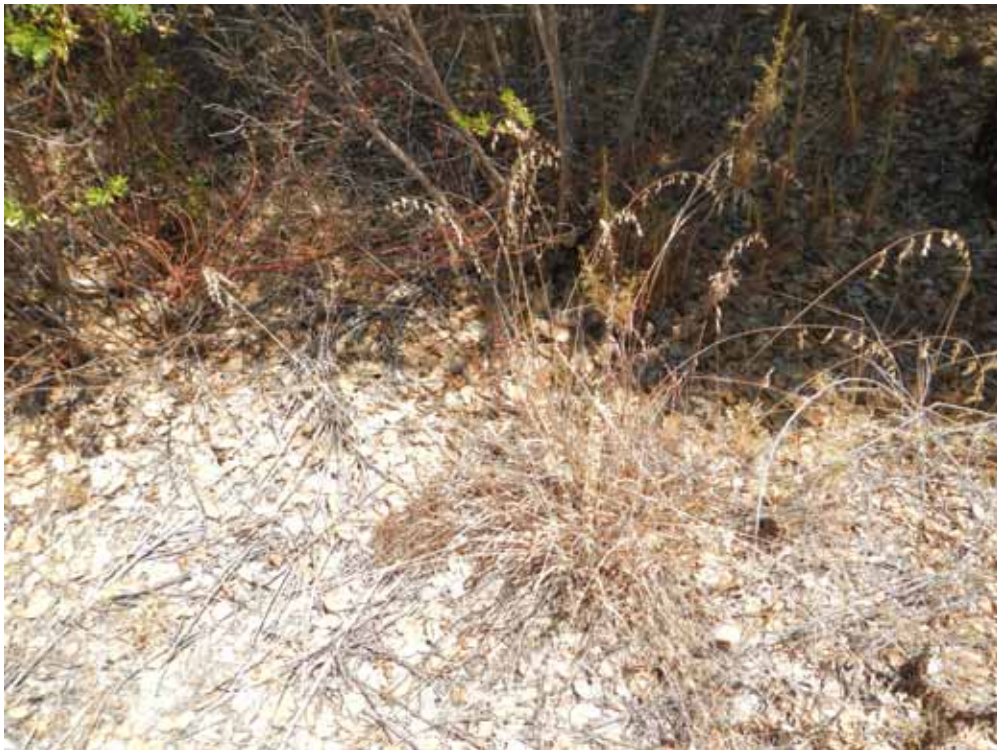
Abatement: Existing veldt grass plants were not abated and are currently growing in cracked asphalt just outside the FEG MRA.

Photograph 1: Veldt grass individual growing in asphalt at side of road just outside FEG MRA.

Recommendations: While manual removal is possible for perennial veldt grass, it is recommended to that the plants be treated with an appropriate herbicide because the plants are growing in asphalt on the edge of the road where complete manual removal would be difficult. Subsequent visual surveys should be conducted in northeast FEG MRA each spring when the flowering structures of the plants are readily visible and before seed has set. Abatement should be implemented immediately if additional plants are observed.

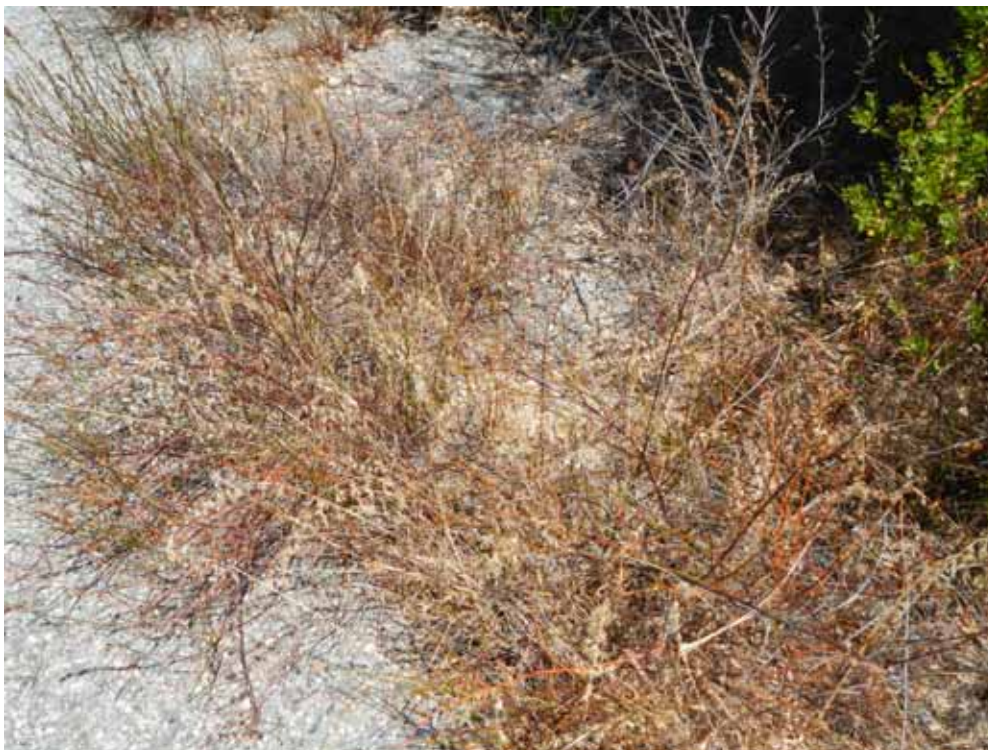
Photograph 2: Several isolated clumps of veldt grass grow up and through deerweed and other plants within 20 feet of each other in this location.
