SUMMARY MEMORANDUM FOR THE FORT ORD NATURE RESERVE OU-1 ENVIRONMENTAL MONITORING IN SUPPORT OF SUMMER 2007 WELL CONSTRUCTION

MEMORANDUM

RE: **Summary Memorandum for the Fort Ord Nature Reserve OU-1
Environmental Monitoring in Support of Summer 2007 Construction
Activities**

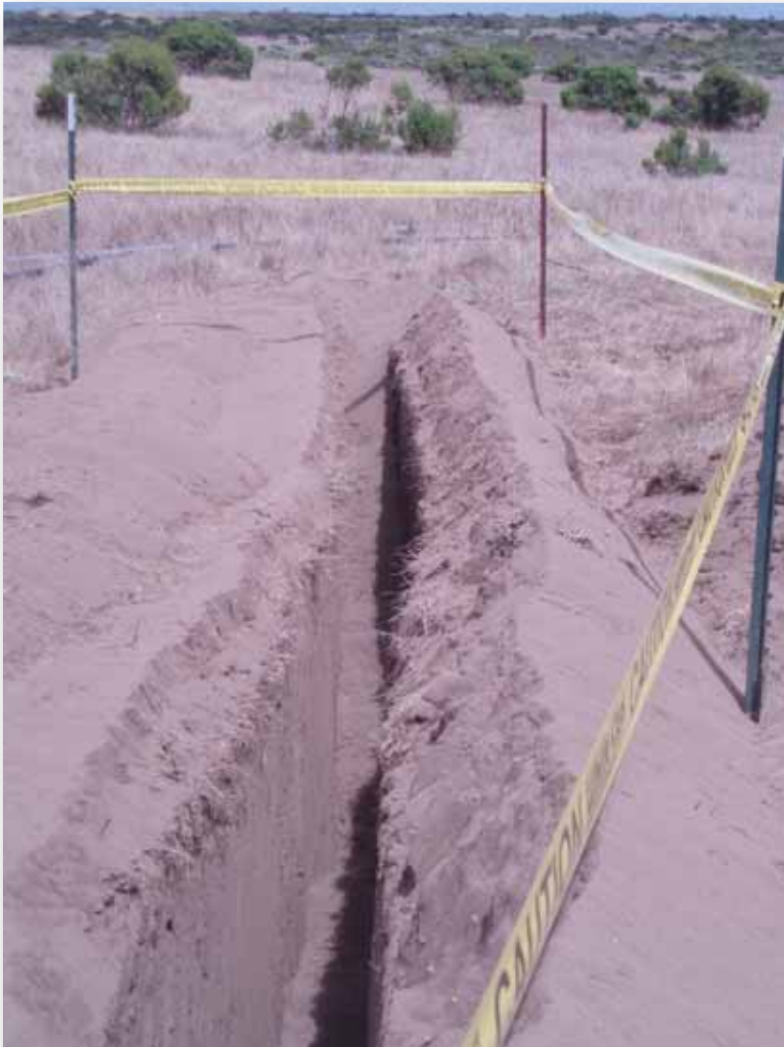
- Along the main road, trenches were excavated and DD&A environmental monitors examined the trenches for soil ramps at either end so that special-status species would not become trapped (Attachment A, Photos 1 & 2).

Photo 1. Trench with dirt ramp (looking East).

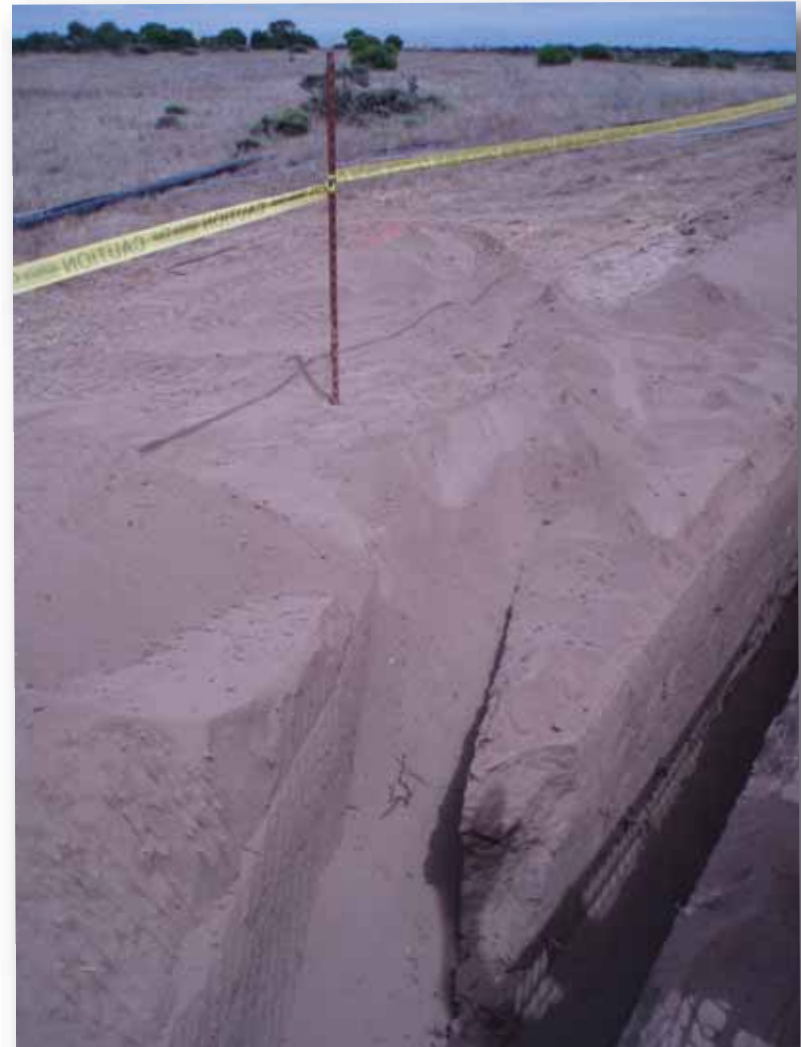
Photo 2. Close up of a dirt ramp (looking Southeast).

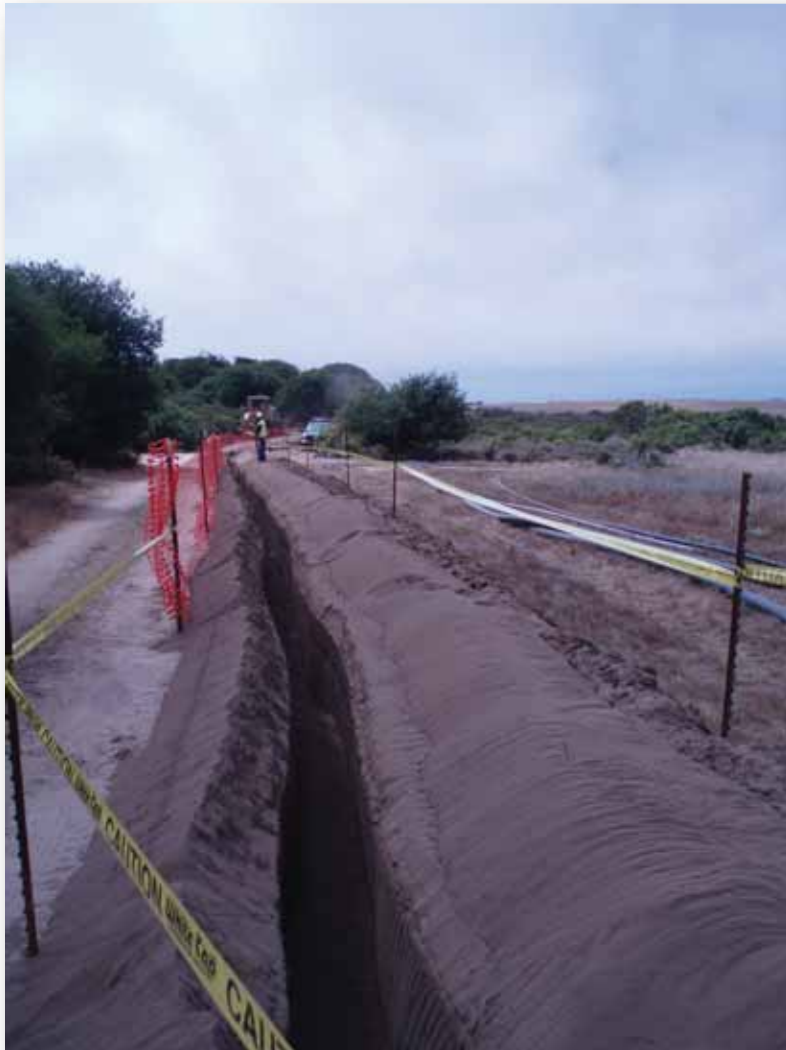
- DD&A environmental monitors documented that fences and caution tape were placed around the open trenches (Attachment A, Photo 3).
- During the site visit on July 26, 2007, DD&A environmental monitors observed construction activities along site 3, including placement of piping in the trenches constructed along the dirt road associated with site 3 (Attachment A, Photo 4).

Photo 3. Trenches buffered with caution tape and fence (looking Northwest).

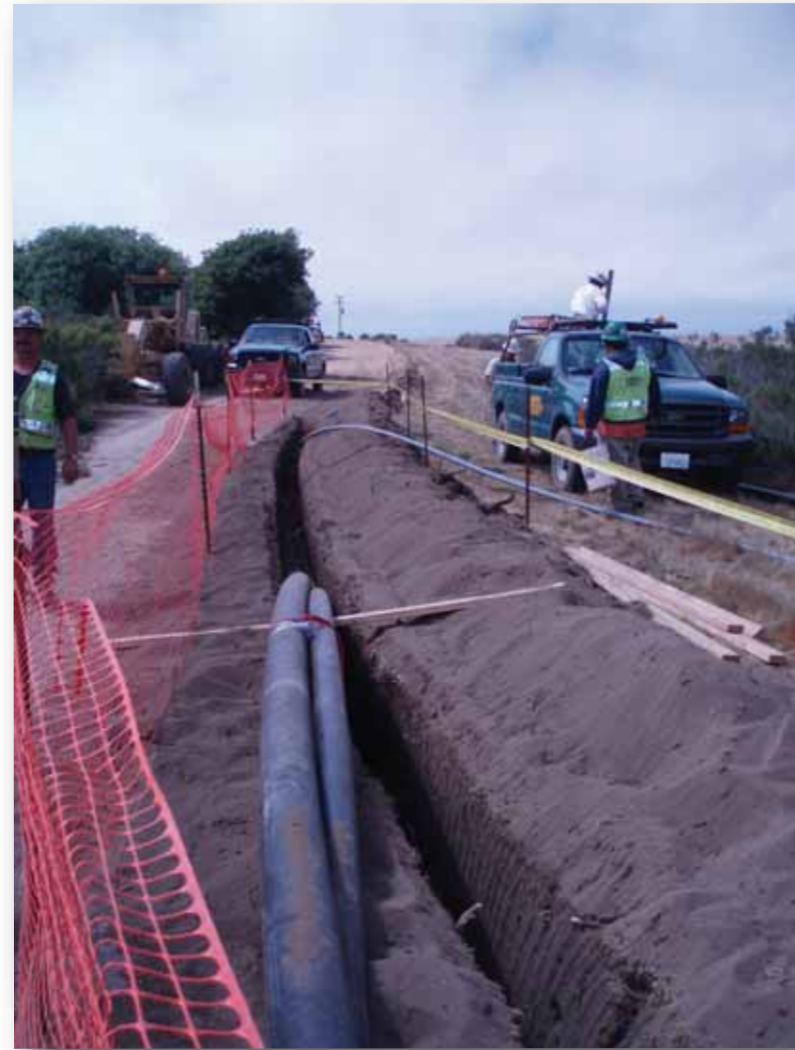
Photo 4. Pipe installation (looking Northwest).

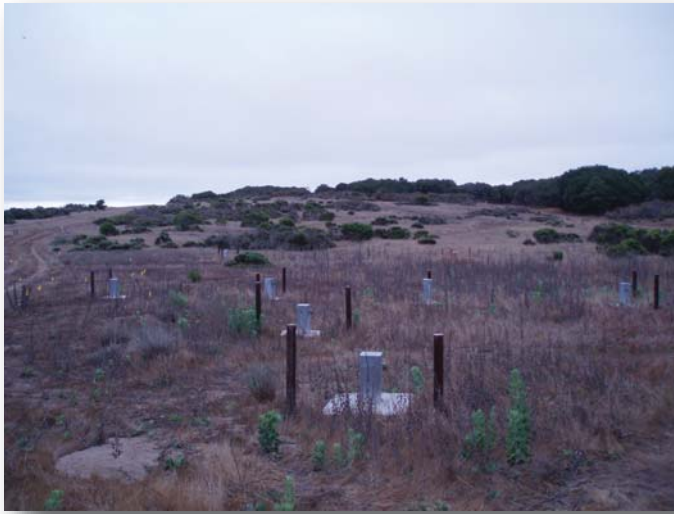
- DD&A environmental monitors were called to the project site on July 27, 2007, to confirm the presence and identification of a possible California tiger salamander (*Ambystoma californiense*, CTS) discovered within the construction zone. In accordance with the environmental guidance governing activities within the FONR, the HGL field supervisor also informed Mr. William Collins (Biologist, Fort Ord Base Realignment and Closure team; permitted for CTS relocation) of the CTS sighting. Before DD&A environmental monitors arrived on site, Mr. Collins had identified and relocated the CTS. DD&A environmental monitors documented with photos and GPS positional data the location that the CTS was captured (Attachment A, Photo 5) and the location the CTS was released (Attachment A, Photo 6). DD&A also photographed the CTS (Attachment A, Photos 7 & 8).

Photo 5. Location where possible CTS was found (looking East).

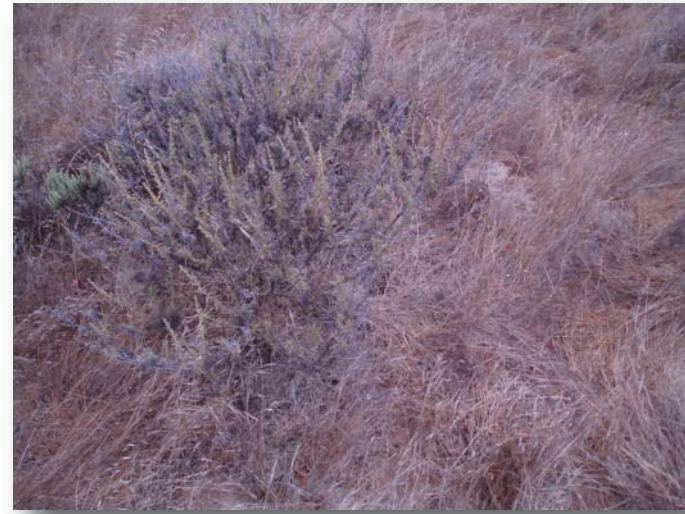
Photo 6. Location where possible CTS was relocated.

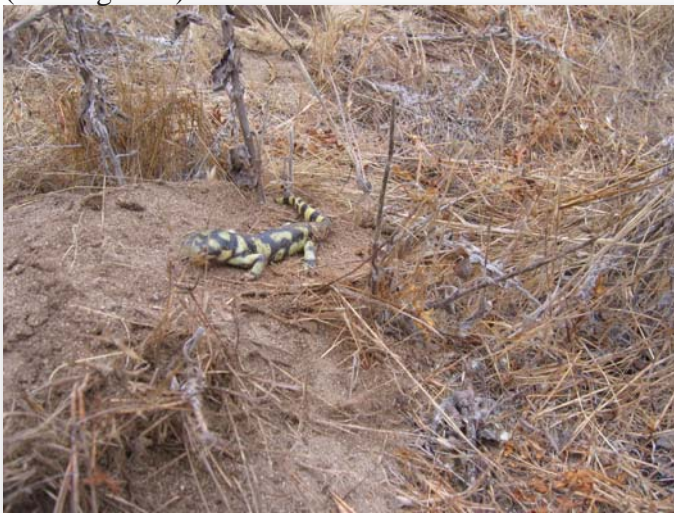
Photo 7. Possible CTS that was found.

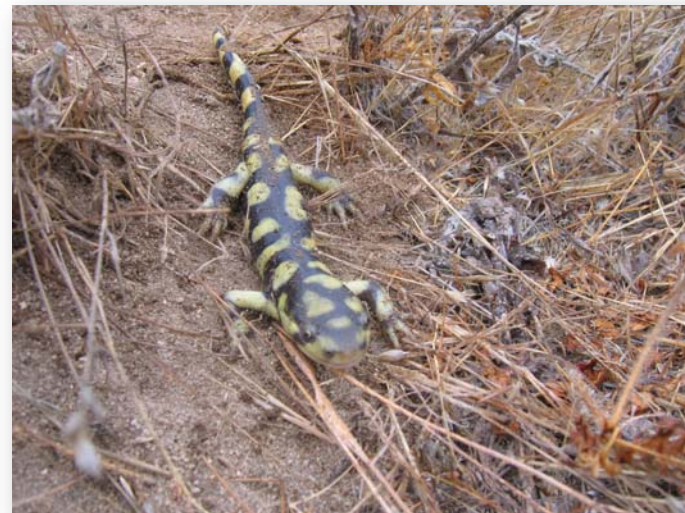
Photo 8. Close up of possible CTS.

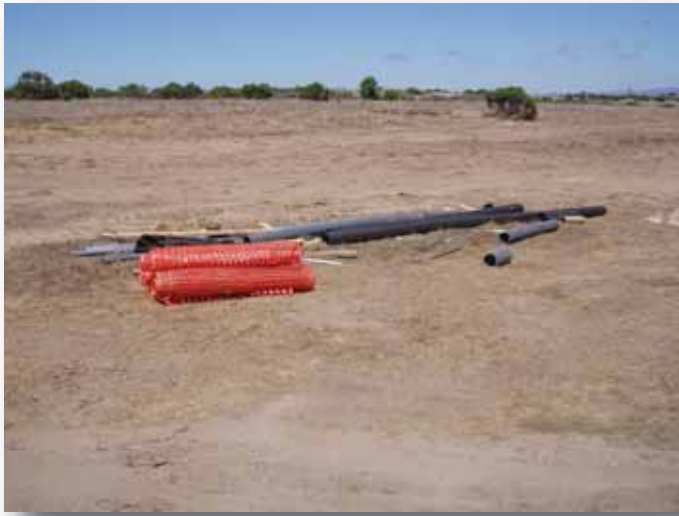
Photo 9. Piping at site 3 uncapped (looking Northeast).

- FONR site 6: Plastic piping was lying on the ground without caps on the ends (Attachment A, Photo 9). DD&A environmental monitors advised the HGL field supervisor that all piping associated with construction activities should be capped during storage. During subsequent visits DD&A environmental monitors observed all piping stored and capped according to the guidelines set out in the initial environmental worker education training seminar.

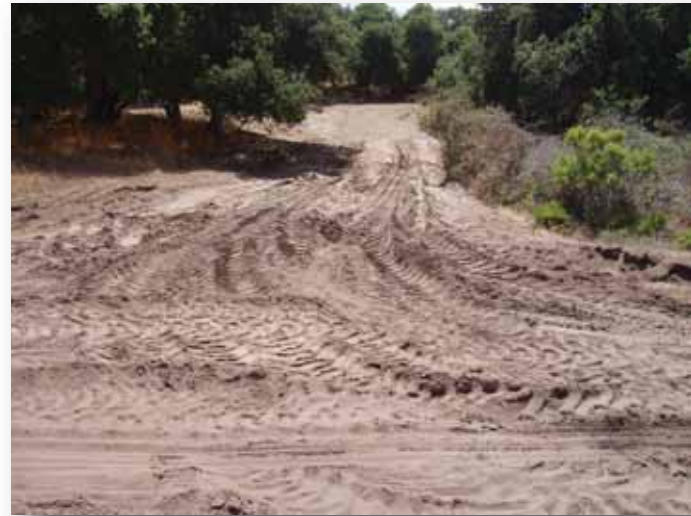
- FONR Site 6, well location EW-OU1-71-A: Activities associated with construction had created ruts approximately 4-6 inches deep along the road associated with this well (Attachment A, Photo 10). DD&A environmental monitors communicated that the road must be graded to pre-construction conditions at the completion of construction activities to the HGL Field Supervisor. The re-grading was later performed as documented in Attachment A, Photo 27.

- FONR Site 3: Traffic from concrete trucks and tractors continued to create large ruts along main road between wells MW-OU1-71-A and MW-OU1-85-A (Attachment A, Photo 10). DD&A environmental monitors re-iterated that the road must be graded to pre-construction conditions at the completion of construction activities to the HGL Field Supervisor.

Photo 10. Ruts at junction of main access road (Site 3) and well access road (Site 6) (looking Southwest).

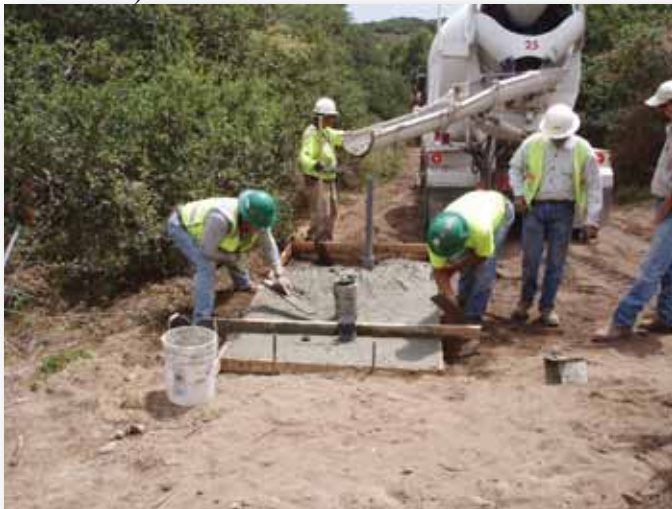
- FONR Site 7, well location MW-OU1-85-A: Concrete was poured at well location MW-OU1-85-A (Attachment A, Photo 11 & 12). Concrete was poured in a

contained area; excess concrete exceeded the contained area. DD&A environmental monitors communicated to the HGL Field Supervisor that any excess concrete must be contained and disposed of properly from the FONR project site. The excess concrete was later removed as documented in Attachment A Photo 24.

Photo 11. Pouring concrete at well location MW-OU1-85-A.

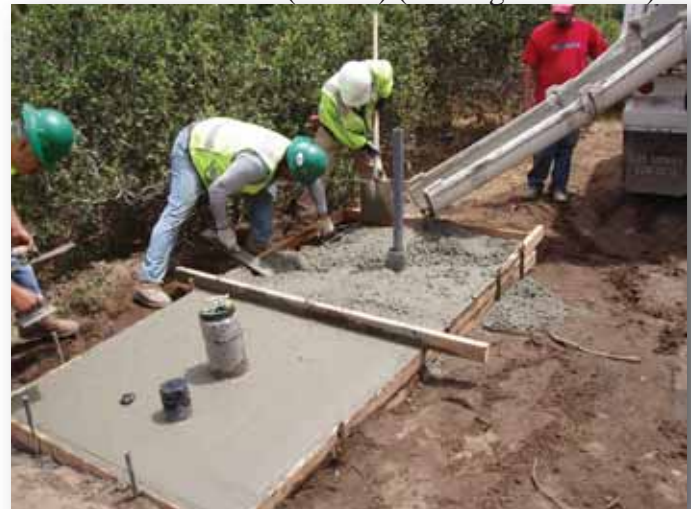
Photo 12. Pouring concrete at well location MW-OU1-85-A.

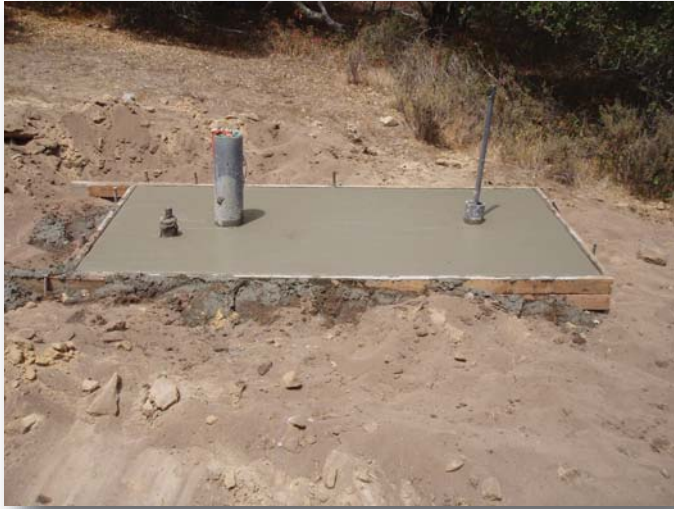
- DD&A environmental monitors visited all the well locations to assess progress. DD&A environmental monitors observed that concrete had been poured at each of the wells (Attachment A, Photo 13 shows a typical well pad).

Photo 13. Concrete poured at well location EW-OU1-71-A.

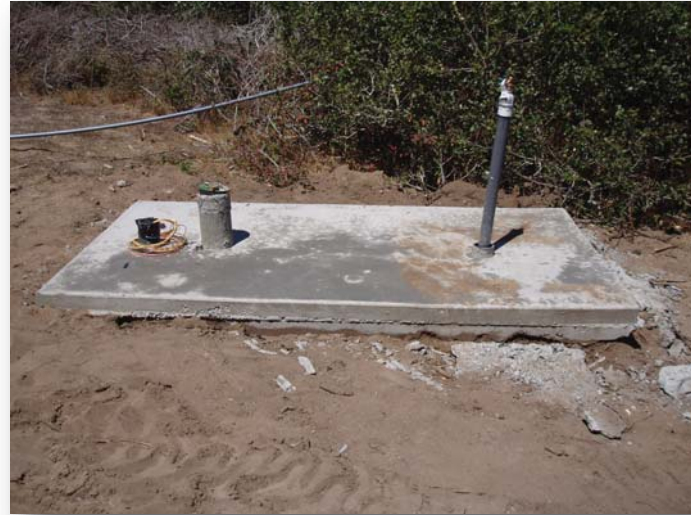
- DD&A environmental monitors also observed that electrical work had taken place at some of the well locations (Attachment A, Photo 14).
 - FONR Site 6, well location EW-OU1-71-A: DD&A environmental monitors observed a possible barn owl (*Tyto alba*) roosting location in an oak tree near well EW-OU1-71-A. Barn owl feathers, scat, and white wash were observed on the ground beneath the roosting tree (Attachment A, Photo 15 & 16). The roosting tree was approximately 50 feet from well EW-OU1-71-A (Attachment A, Photo 17). DD&A environmental monitors communicated the presence of a possible barn owl roosting site near well EW-OU1-71-A to the HGL Field Supervisor.

Photo 14. Electrical work at well location MW-OU1-85-A.

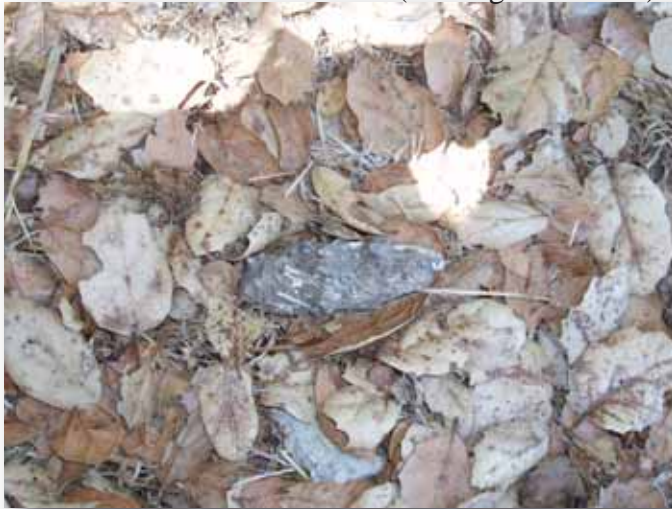
- During the site visit on August 17, 2007, DD&A environmental monitors observed a second barn owl roosting location at site 6. Barn owl feathers, scat, and white wash were observed on the ground beneath the second roosting tree (Attachment A, Photo 19). The second roosting tree was located approximately 85 feet from well EW-OU1-71-A

Photo 19. Barn owl scat under roosting location near EW-OU1-71-A.

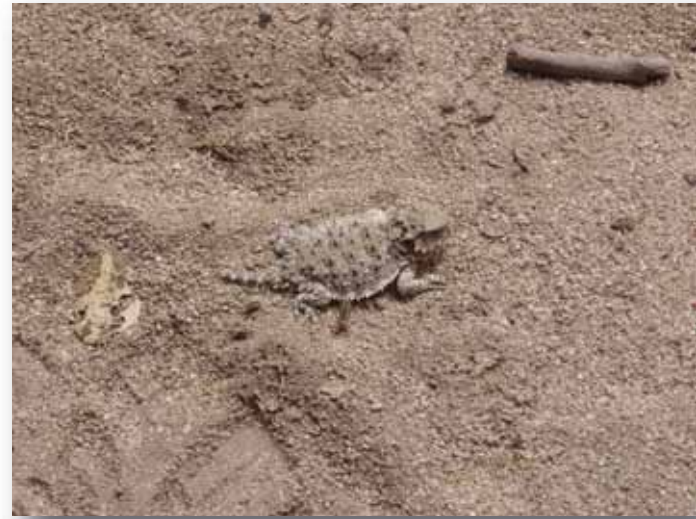
- FONR Site 3, well location EW-OU1-87-A: A coast horned lizard (*Phrynosoma coronatum*) was observed along the main road (Attachment A, Photo 18). The coast horned lizard was approximately 75 feet from well location 87-A. DD&A environmental monitors communicated the observation of the coast horned lizard near well 87-A to the HGL Field Supervisor. The coast horned lizard was relocated along the main road approximately 300 feet beyond the construction area by DD&A environmental monitors.

Photo 18. Coast horned lizard near well MW-OU1-87-A.

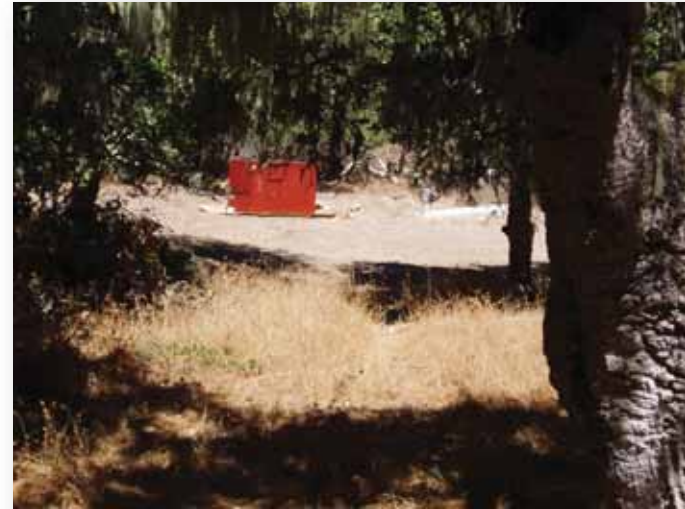
- (Attachment A, Photo 20). DD&A environmental monitors communicated presence of a second barn owl roosting site to the HGL Field Supervisor.
- During the site visit on August 20, 2007, DD&A environmental monitors observed construction activities at site 6. Two adult and two sub-adult barn owls were observed by DD&A environmental monitors (Attachment A, Photo 21).

Photo 20. Barn owl second roosting tree approximately 85 feet from well EW-OU1-71-A (looking Northwest).

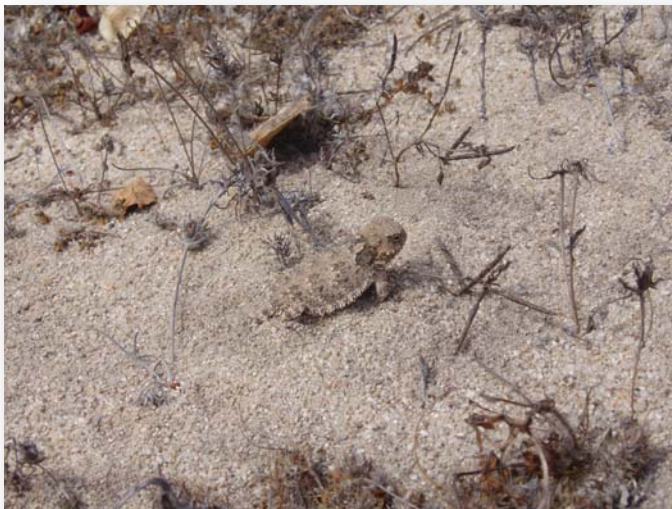
- FONR Site 3, well location MW-OU1-87-A: a coast horned lizard was observed along the main road in between wells MW-OU1-87-A and EW-OU1-71-A (Attachment A, Photo 23). The coast horned lizard was approximately 65 feet from well MW-OU1-87-A. DD&A environmental monitors communicated the observation of the coast horned lizard near well 87-A to the HGL Field Supervisor. The coast horned lizard was relocated along the main road approximately 300 feet beyond the construction area by DD&A environmental monitors.

Photo 23. Juvenile coast horned lizard near well MW-OU1-87-A.

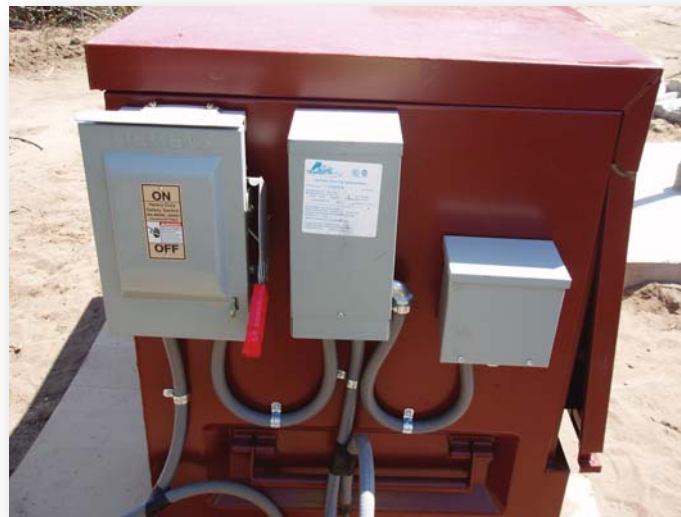
- FONR Site 8, well location MW-OU1-46-AD: Telemetrix staff were observed mounting and installing transformers at well location MW-OU1-46-AD (Attachment A, Photo 22).

Photo 22. Transformers mounted on metal well cover at well MW-OU1-46-AD.

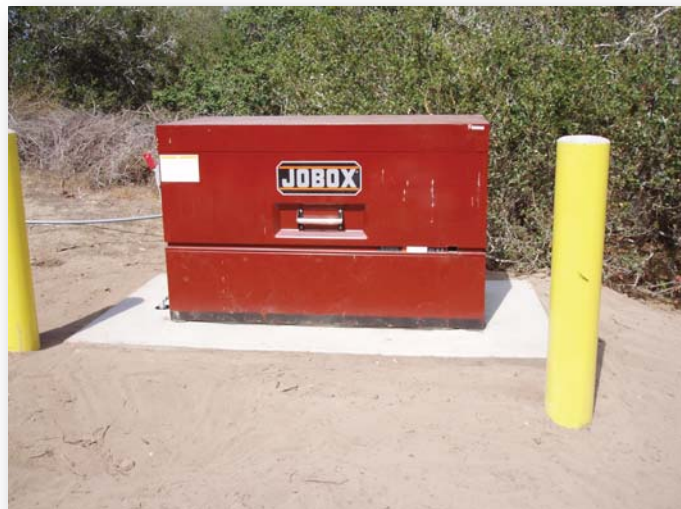
- DD&A environmental monitors observed that excess concrete mentioned during the August 3rd site visit had been collected and disposed of properly by HGL and Granite staff (Attachment A, Photo 24).

Photo 24. Spilled concrete cleaned up at well MW-OU1-85-A.

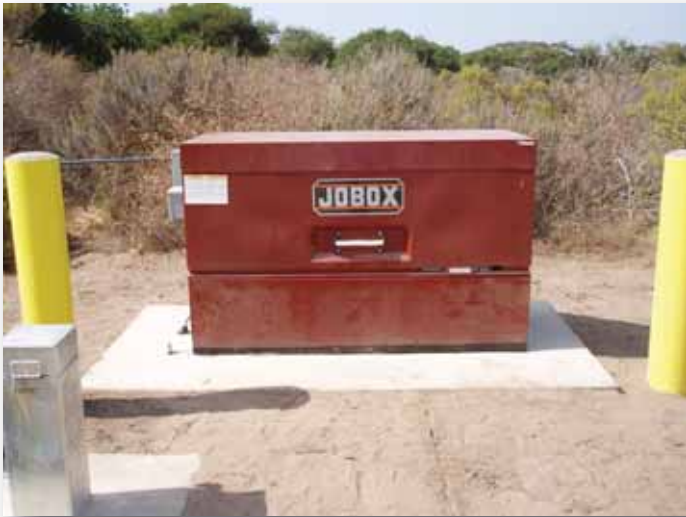
- DD&A environmental monitors observed that pumps and the electrical boxes had been installed at all well locations (Attachment A, Photos 25 and 26 show typical installations).

Photo 25. Metal box mounted on well MW-OU1-46-AD.

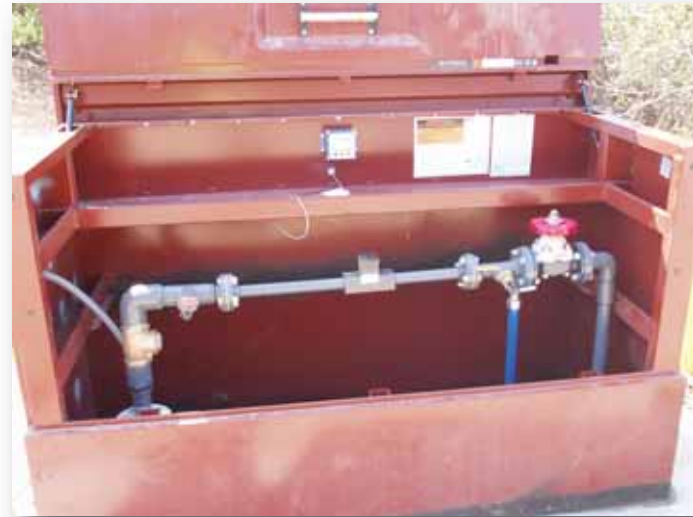
Photo 26. Well pump inside of metal box at well MW-OU1-87-A.

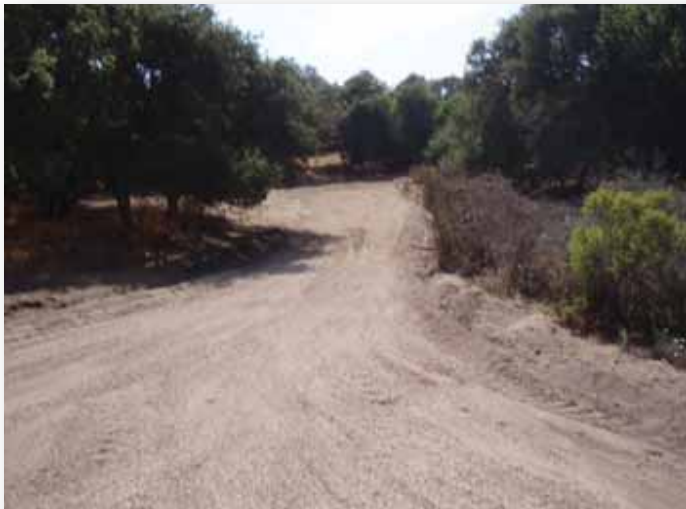
- DD&A environmental monitors observed that impacts to the roads throughout the site mentioned during the August 2nd site visit had been graded to pre-construction conditions by HGL and Granite staff (Attachment A, Photo 27).

Photo 27. Regraded road along site three (looking Southwest).

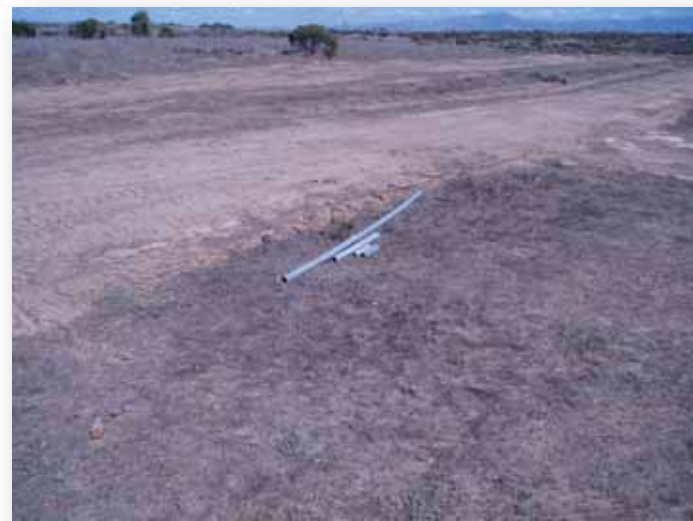
Photo 28. Piping left in staging area. Caps missing on pipe ends (looking Northeast).

- Several items were left throughout the construction site including: a portable toilet, caution tape and staking, and piping (without capped ends). All unnecessary or temporary equipment and debris should be removed and disposed of properly at the completion of construction activities (Attachment A, Photos 28-30).

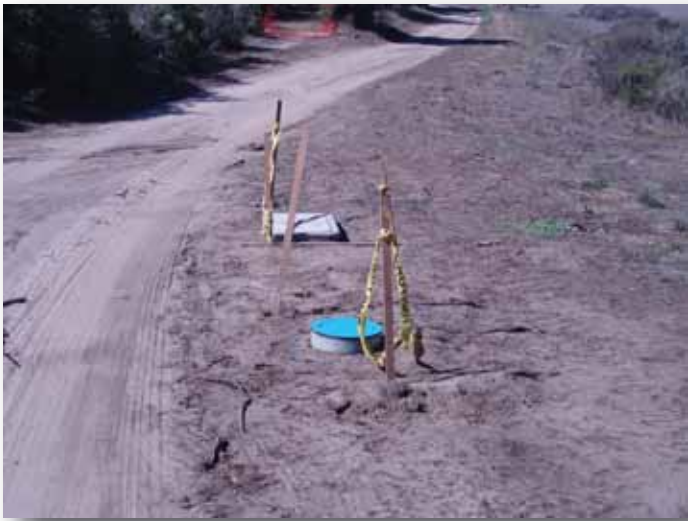
Photo 29. Caution tape and staking left along Site 3 after the completion of construction activities (looking Northwest).

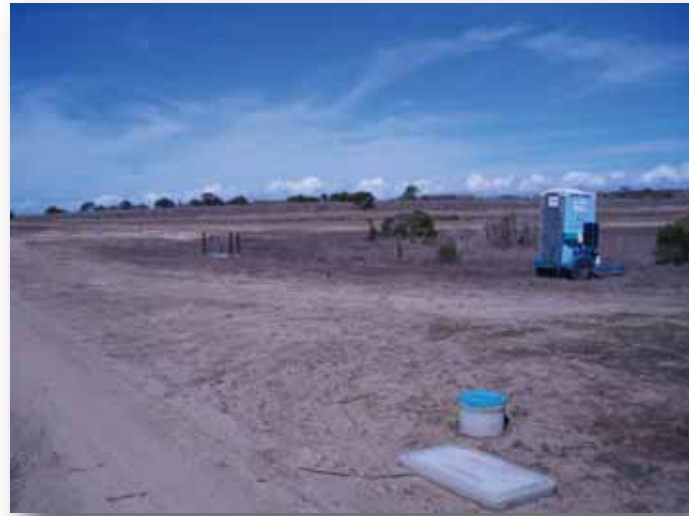
Photo 30. Portable toilet left near staging area after the completion of construction activities (looking North).

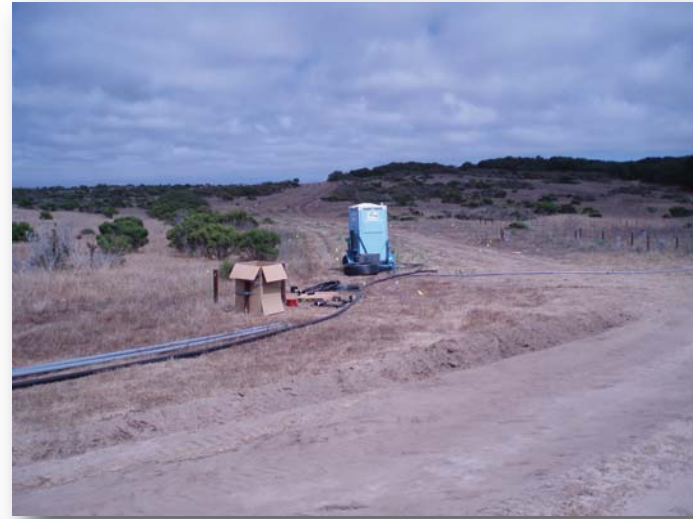
- During the initial site visit mammal burrow openings located within the staging area next to site 5 were flagged by DD&A environmental monitors. (Attachment A, Photo 38) Construction and HGL personnel were instructed to avoid these flags during construction activities. DD&A environmental monitors also documented a staging area located near site 1 (Attachment A, Photo39).

Photo 38. Staging Area near site 5 with flagged mammal burrows (looking Northeast).
