**Final
Annual Report
Former Fort Ord Site 39
Habitat Restoration
2014
Contract Nos.
W91238-10-D-0002 & W91238-14-D-0010**

**FORMER FORT ORD
Monterey County, California**

April 2015

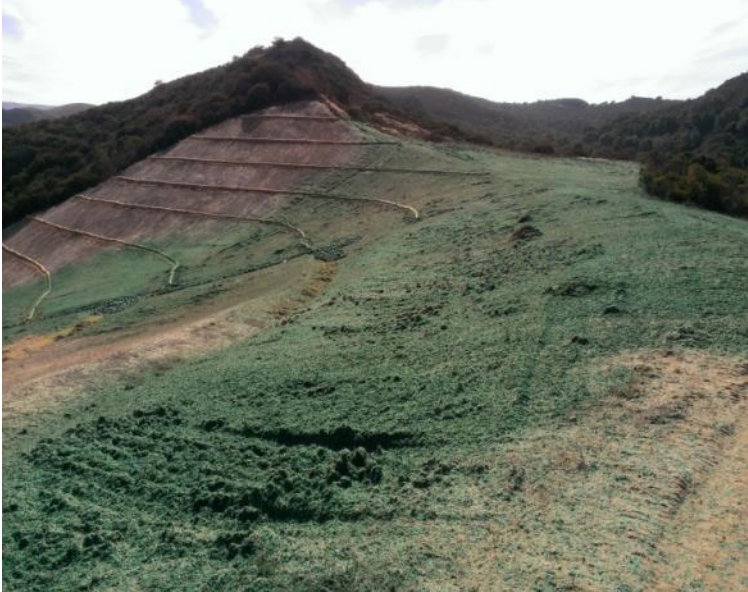
Photo Description	Photo
<p>Restoration Activities</p> <p>View of upper portion of HA 34 following hydro-seeding activities. Burleson supplied the hydro-seeder with native seed used in the application at HA 34. Native seed should speed up the restoration process.</p> <p style="text-align: center;">C-3</p>

In January 2014, Burleson provided approximately 86.1 pounds of surplus seed to ITSI/Gilbane to support erosion control hydroseeding activities at HA 34. The seed was added to the hydroseed slurry and applied on site. Burleson provided oversight during the hydroseeding activities. The surplus seed added to the site does not count to target quantities because it was used for erosion control.

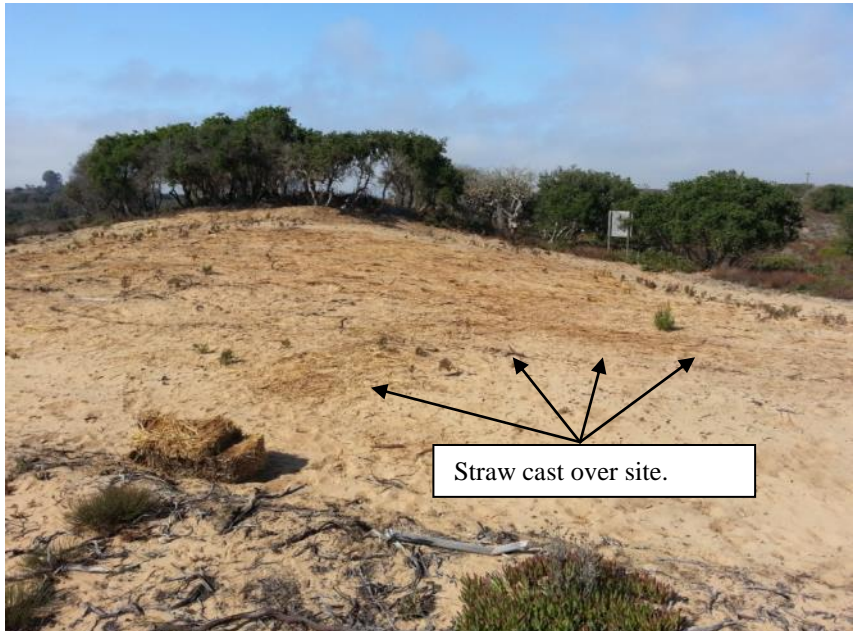
<p>Restoration Activities</p> <p>HA 38 has several passive restoration areas. Here is one of these areas that has been casted with native seed and covered with straw.</p> <p style="text-align: center;">C-6</p>

At HA 38, only 0.2 acres of the total 1.0 acres received seed during the initial broadcast in March 2014 on the portions of the site requiring passive restoration. The site was revisited in December 2014 to complete passive restoration on the remaining 0.8 acres in the active restoration area. Table A-4, Appendix A, shows the total pounds of seed broadcast per species. HA 38 has received 100% of the passive restoration and is now in a monitoring phase.

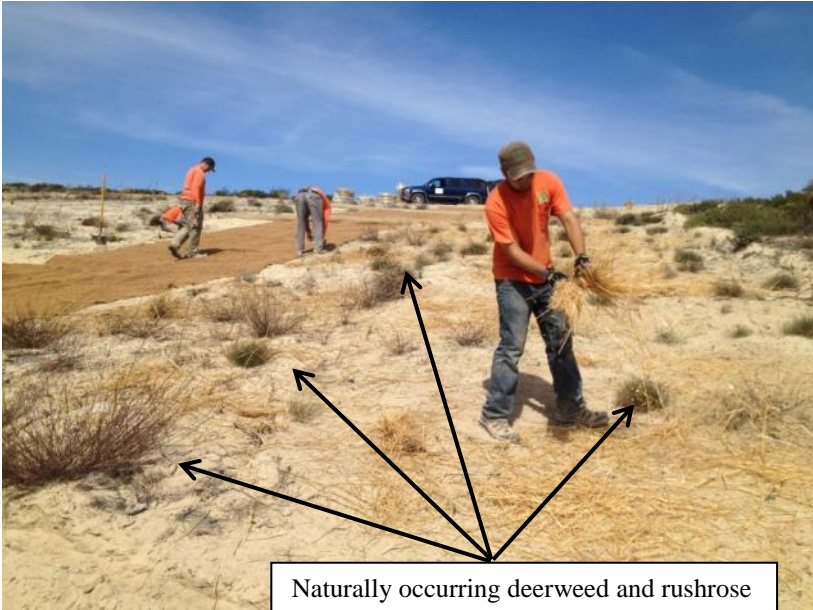
Photo Description	Photo
<p>Erosion Control Activities</p> <p>Burleson Horticultural Technicians broadcast straw mulch after erosion control activities were completed. Naturally recruited plant species can be seen in foreground.</p> <p style="text-align: center;">D-3</p>

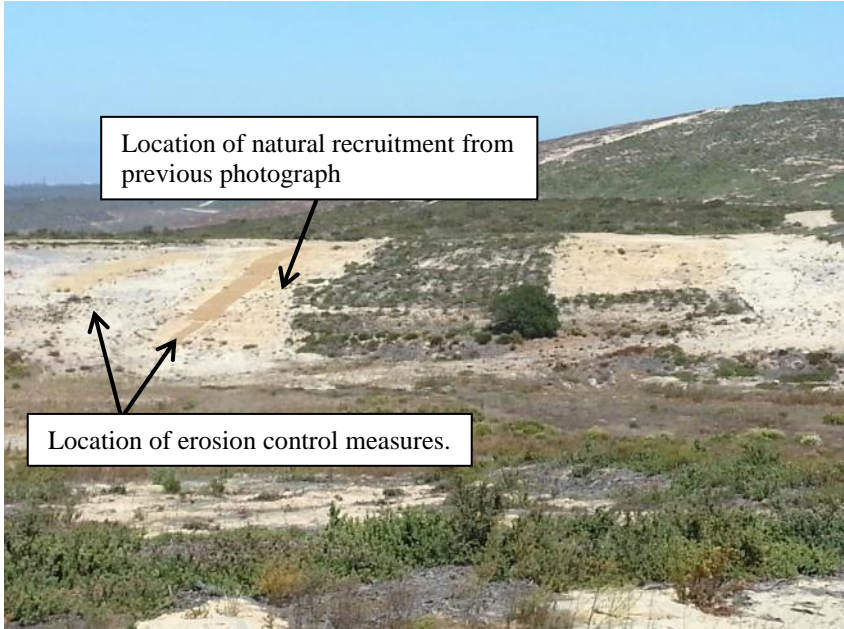
<p style="text-align: center;">Naturally occurring deerweed and rushrose</p>
<p>Erosion Control Activities</p> <p>Overall view of HA 28 following erosion control activities.</p> <p style="text-align: center;">D-4</p>

<p style="text-align: center;">Location of natural recruitment from previous photograph</p> <p style="text-align: center;">Location of erosion control measures.</p>

Burleson installed erosion control Best Management Practices (BMPs) for minor storm water-related damage at HAs 34 and 37. Activities included repairing rill erosion, installing 2,000 linear feet of straw fiber rolls, and installing 3,000 square feet of coir fabric.
