Attachment

A

FONR OU-1 Environmental Monitoring Report Site Pictures

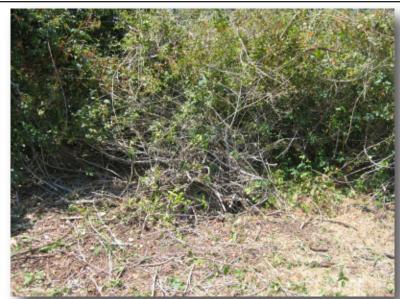
Photo 11. Woodrat nest left intact on northern border of well location MW-E (MW-OU1-84-A).

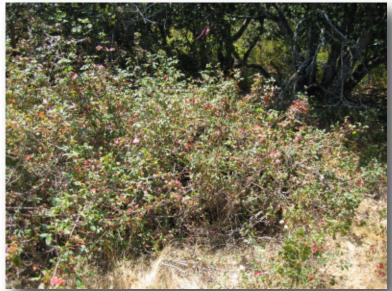
Photo 12. Woodrat nest before dismantling on well location IW-OU1-73-A. See photo 16 for post-dismantling view.
