**2011 FONR IMPACT ASSESSMENT AND HABITAT
AND RARE PLANT SPECIES SURVEY RESULTS
OPERABLE UNIT 1
FORMER FORT ORD, CALIFORNIA**

HydroGeoLogic, Inc.
14142 Denver West Parkway, Suite 225
Lakewood, Colorado 80401-3127

February 2012

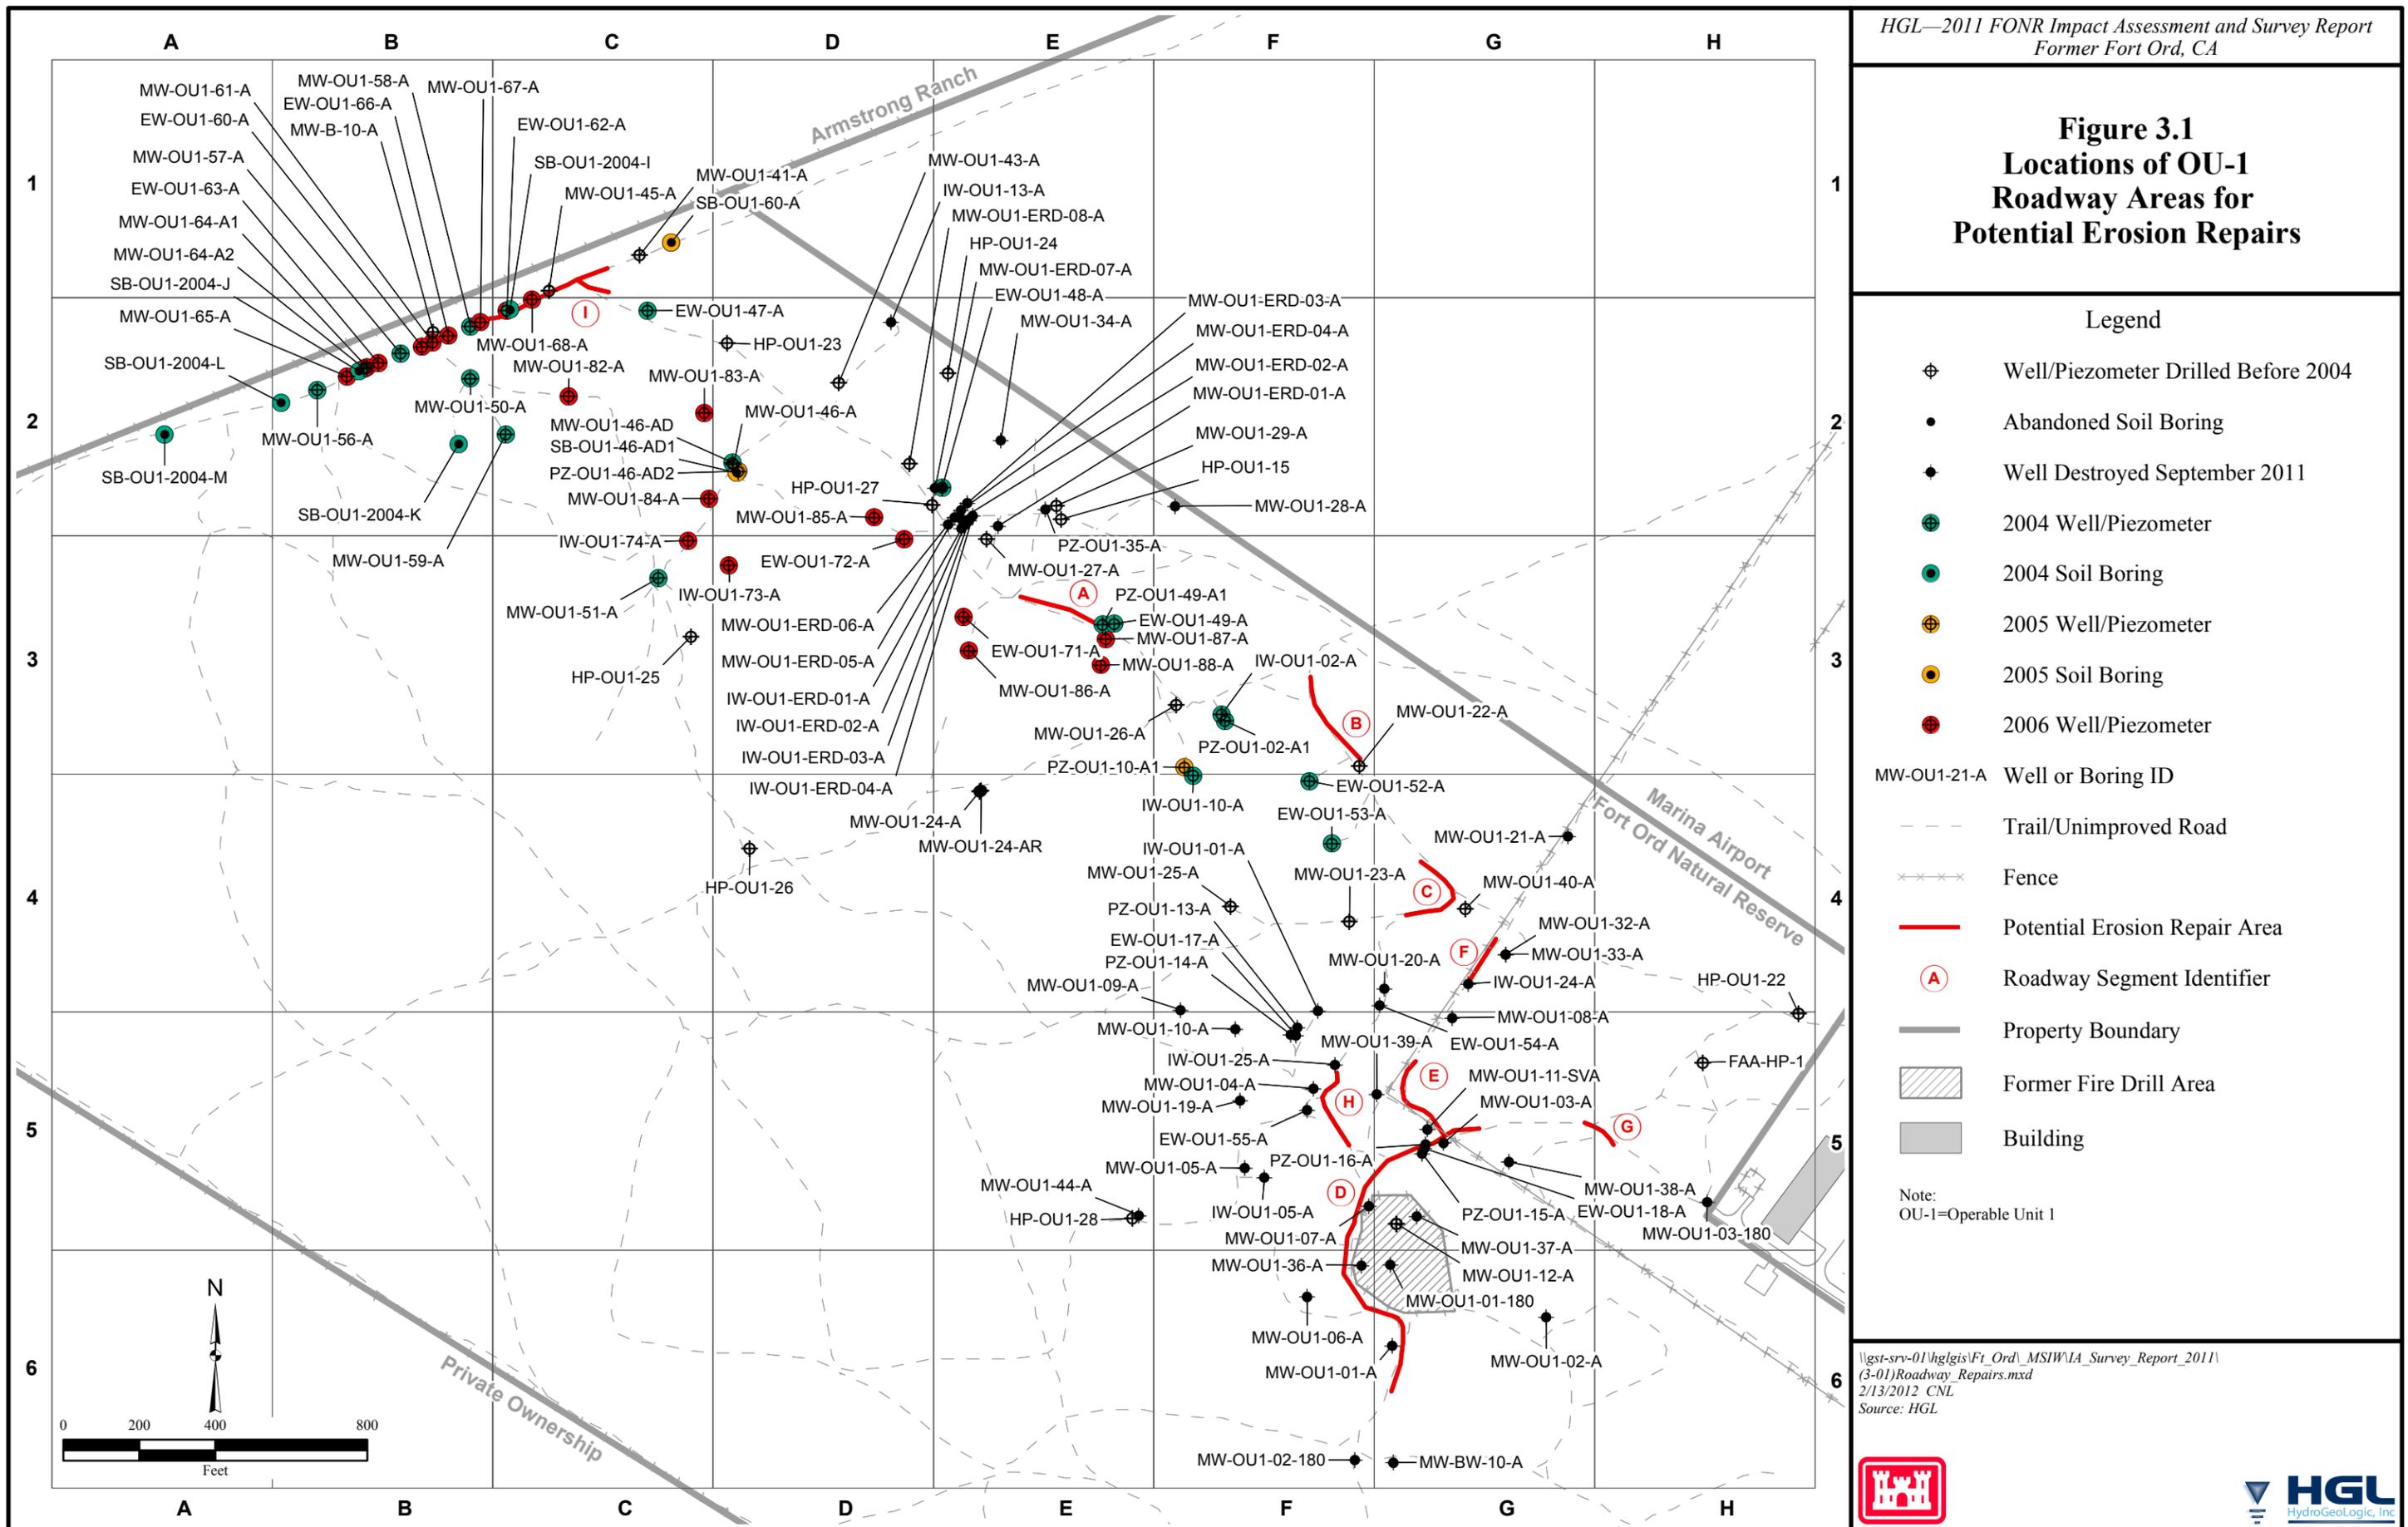
Figure 3.1
Locations of OU-1
Roadway Areas for
Potential Erosion Repairs

HGL staff conducted visual reconnaissance surveys to detect erosion resulting from construction activity along the roadways used to access the construction areas and the monitoring well network. These erosion surveys are conducted routinely during the quarterly groundwater monitoring events and on occasion during routine system maintenance. Erosion was observed on the FONR roadways during 2011 (see Figure 3.1) in some of the areas where construction occurred in 2010 and where the drill rig and support vehicles traveled during the 2011 well destruction effort. The affected roadways will be repaired in 2012 after discussions with UCSC to determine scheduling and when weather conditions are appropriate.

- Repair roadways where erosion has become a current or potential problem (see Figure 3.1).
- Coordinate with UCSC staff regarding potential remediation activities around well MW-OU1-61-A.

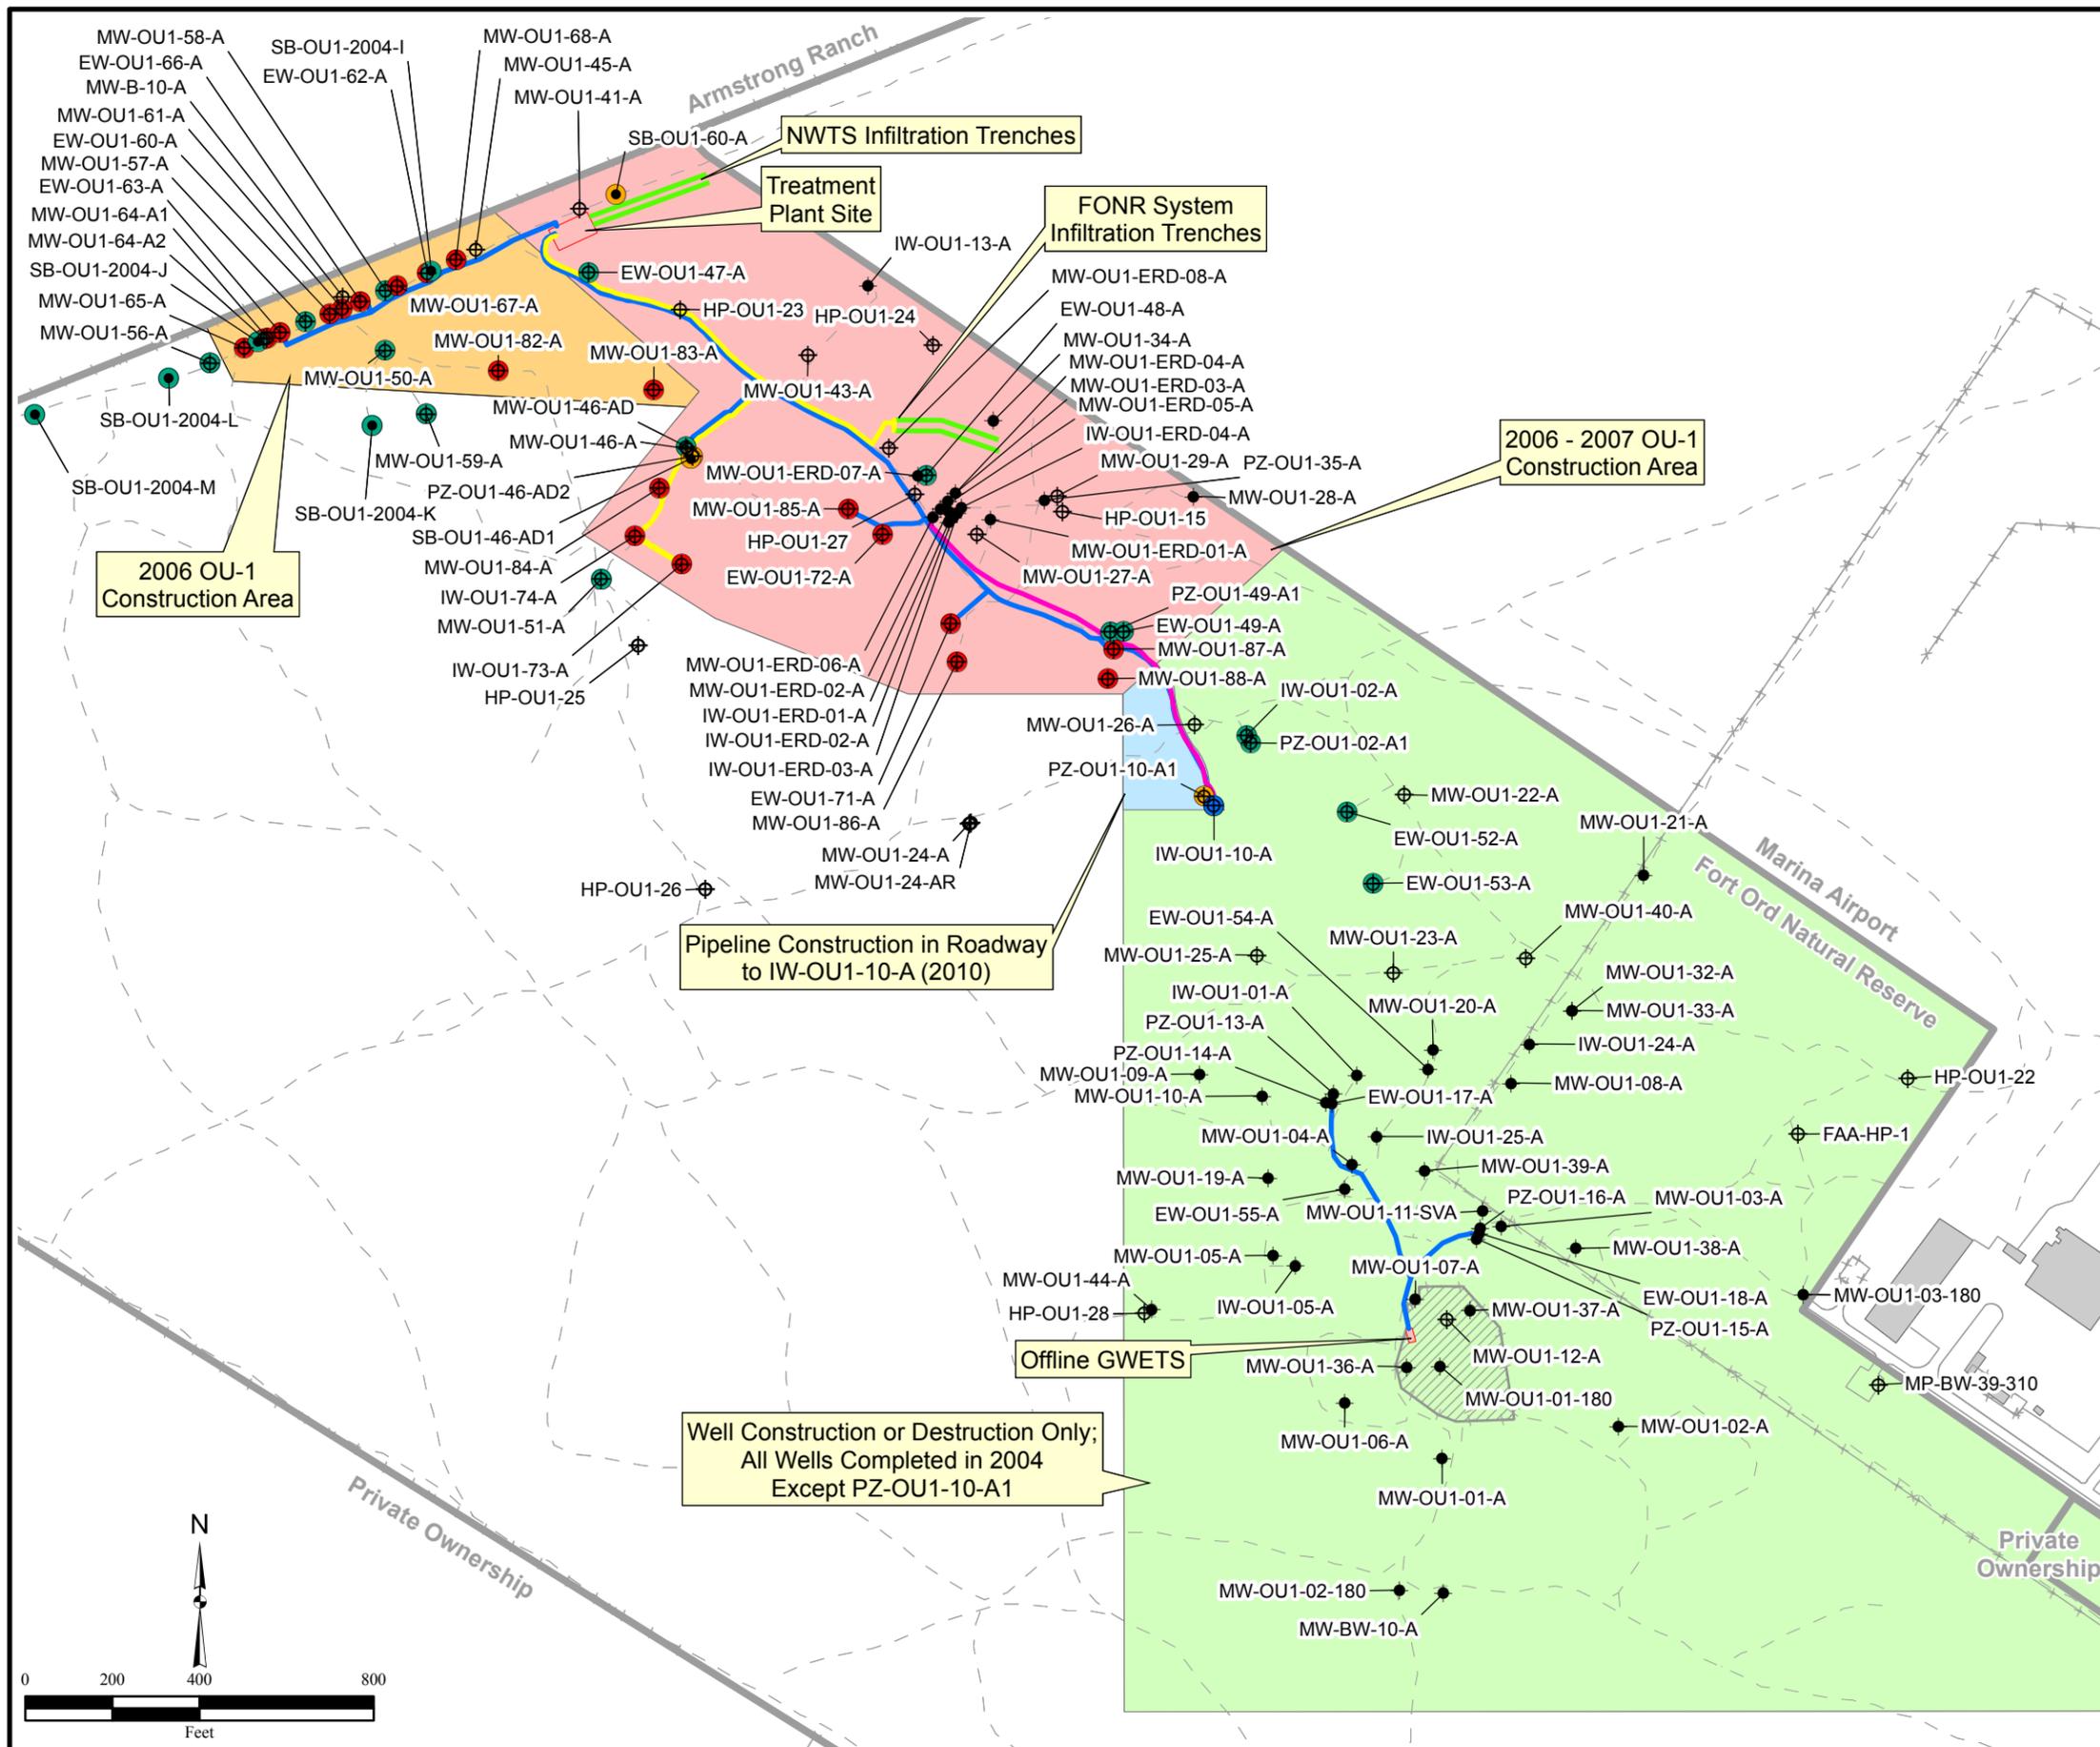
Figure 4.1
OU-1 Construction Activities
2004-2011

- Drilling soil borings;
- Constructing extraction, injection, and monitoring wells;
- Installing water conveyance pipelines;
- Installing infiltration trenches;
- Constructing a groundwater treatment facility;
- Converting IW-OU1-10-A from a monitoring well to an extraction well; and
- Destroying 54 wells within the FONR.

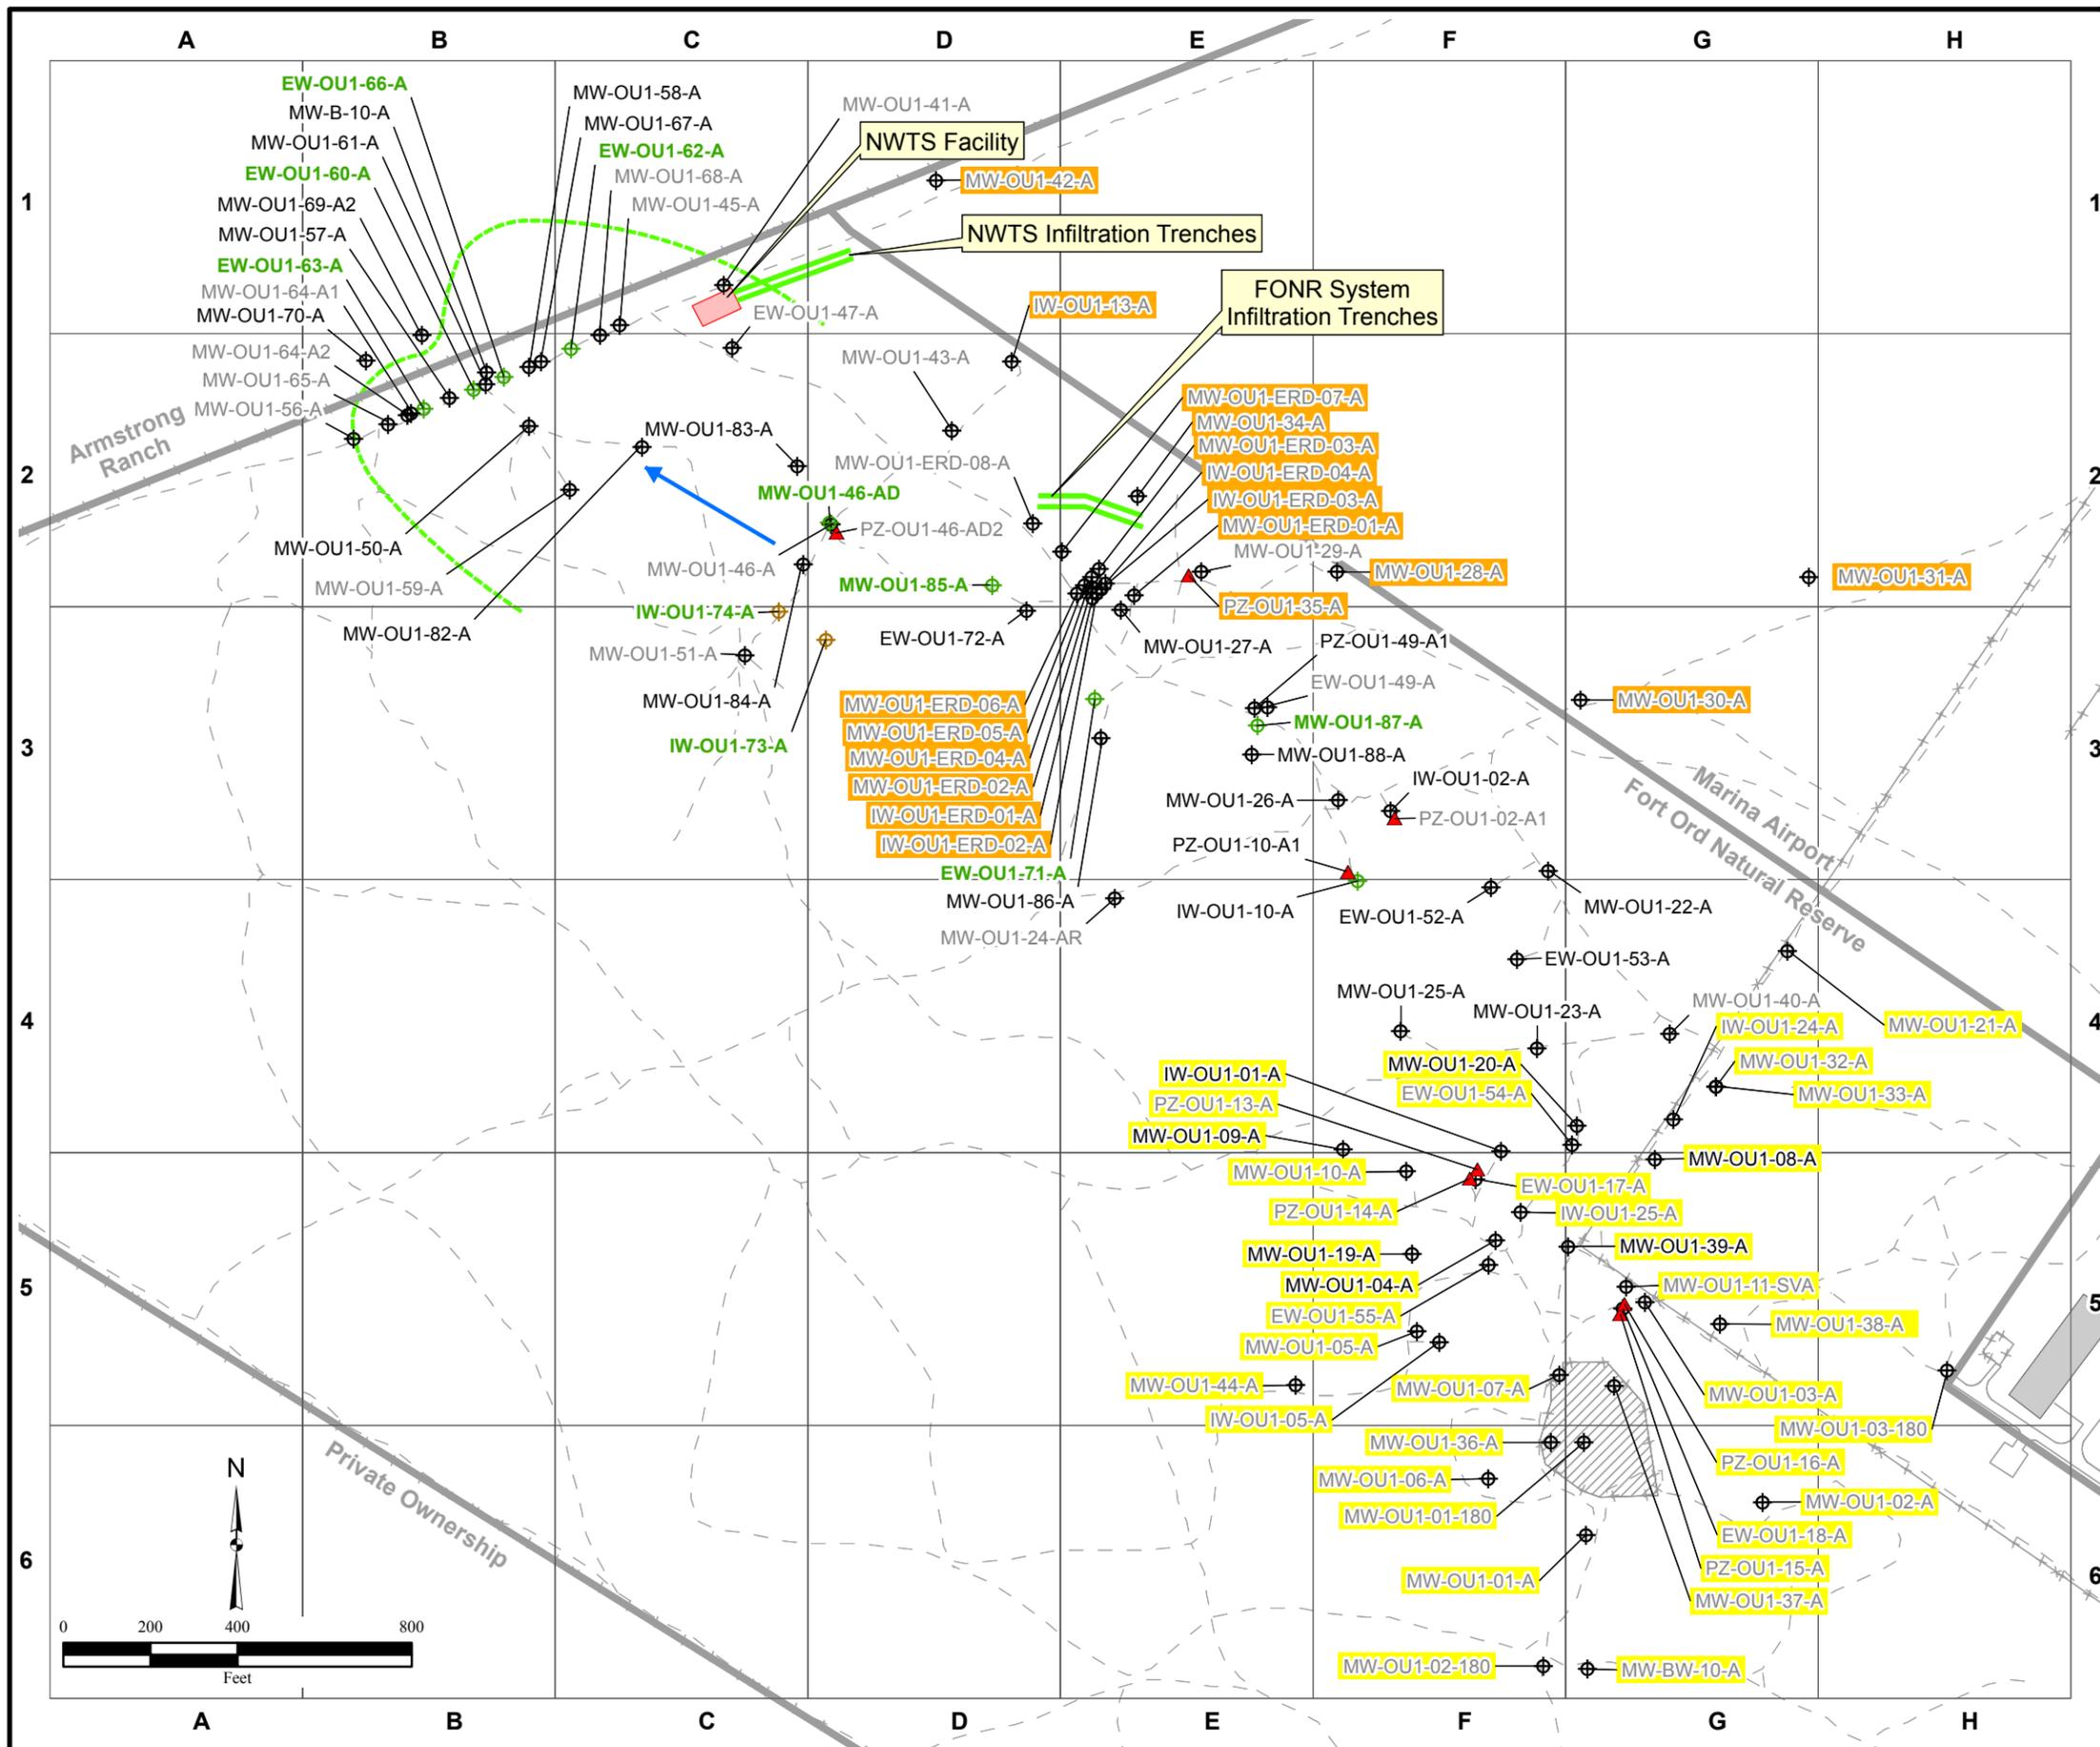
Figure 4.2
Former Fort Ord OU-1
Wells Destroyed in 2011

During September of 2011, HGL destroyed 54 wells within the FONR; this effort is described in the *Draft Well Destruction Report* (HGL, 2011c). DD&A provided environmental field support for the destruction activity. All well destruction activities were conducted with an emphasis on minimizing impact to the existing habitat. Recommendations and requirements from DD&A and UCSC staff provided a baseline for well destruction activities at FONR OU-1 and were followed by all personnel. The well destruction methods and field procedures employed to minimize habitat impact are described in the *Recommended Well Destruction Technical Memorandum* (HGL, 2011d).

As noted in Section 4.1.2, each well slated for destruction in September 2011 was surveyed in 2011 (see Table 4.2 for detailed results). The overall results were:

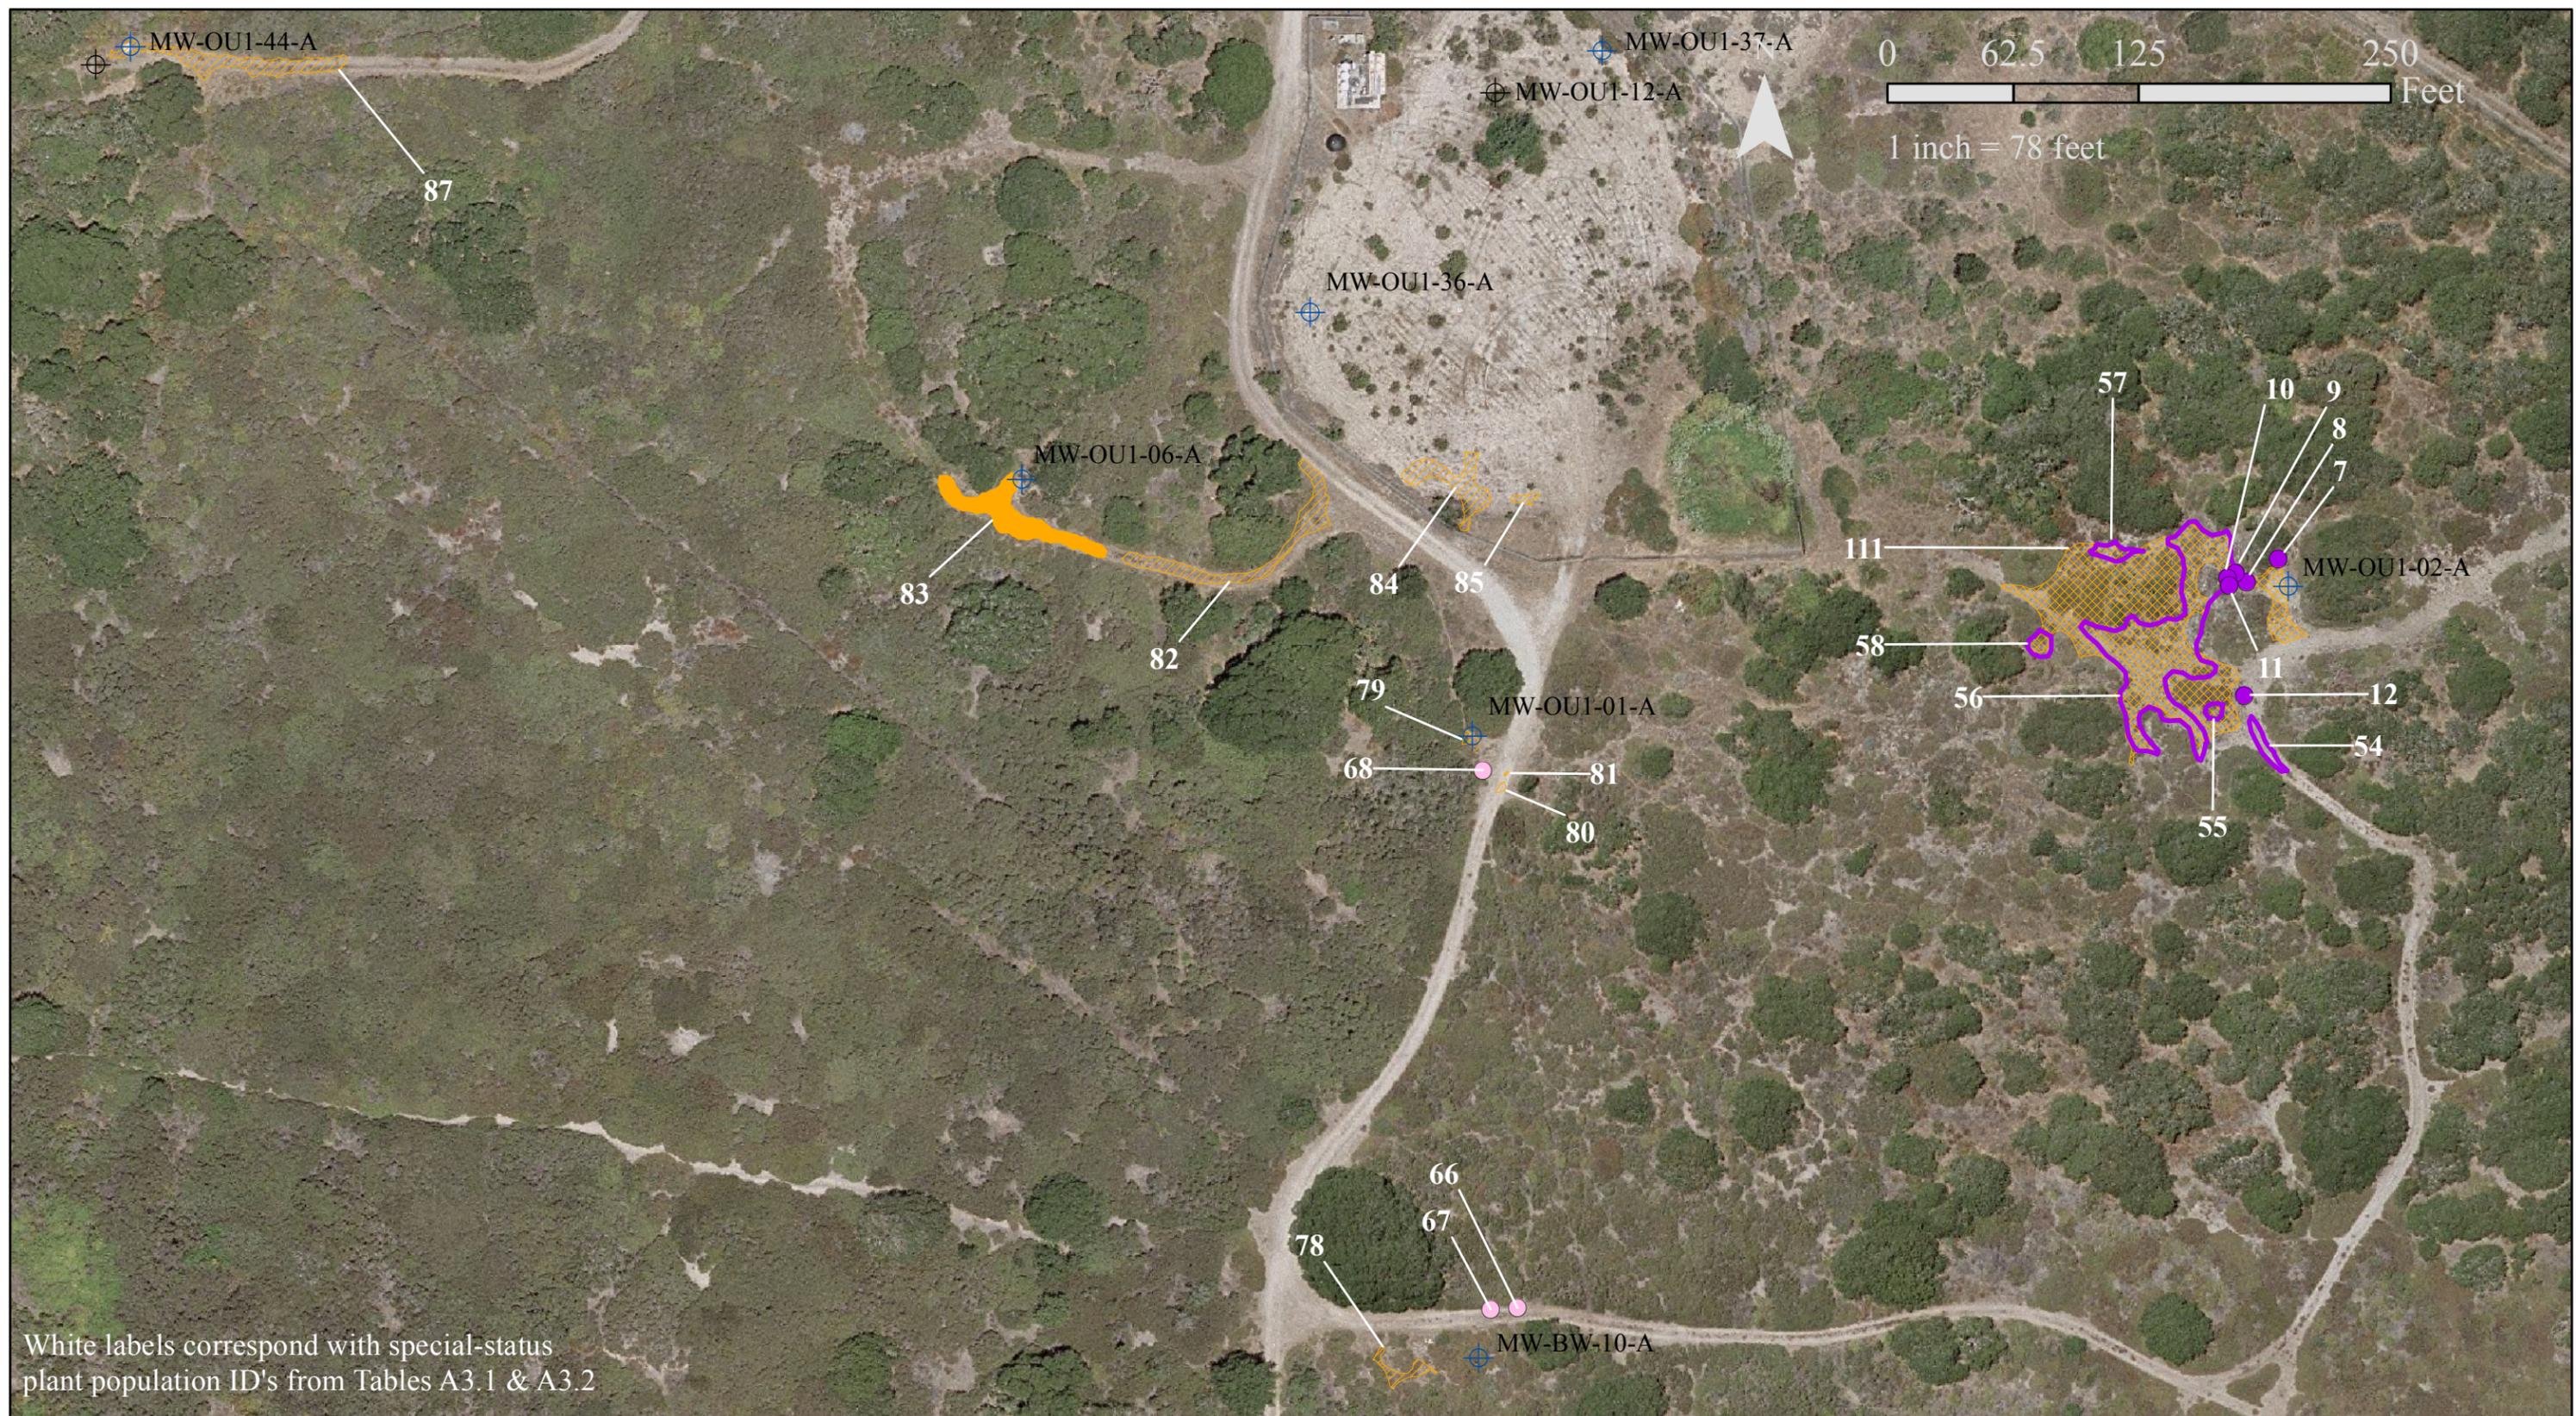
Figure A3.3

2011 Rare Plant Survey Results
South FONR-OU1

Sand gilia was observed and mapped at the DD&A reference site and at 11 of the 35 well sites. A total of 65 populations (52 points and 13 polygons) of sand gilia were mapped within the 2011 survey area (see Appendix A Table A3.1 and Figures A3.1, A3.2, and A3.3). A total of 1,580 individual plants were mapped at the 65 populations.

A total of 46 populations (12 points and 34 polygons) of Monterey spineflower were mapped at the DD&A reference site (Table A3.2 and Figures A3.1-A3.3). Because population size estimates are not as easily quantified as the sand gilia populations, individual Monterey spineflower plants were not counted within the GIS polygons. As mentioned in the methods section of this document, populations of Monterey spineflower were given a percentage of cover using visual estimation. Of the 34 populations of
