2012 ANNUAL BIOLOGICAL MONITORING REPORT FORMER FORT ORD, CALIFORNIA

**WORLDWIDE ENVIRONMENTAL REMEDIATION SERVICES
CONTRACT NO. W912DY-10-D-0024**

February 2013

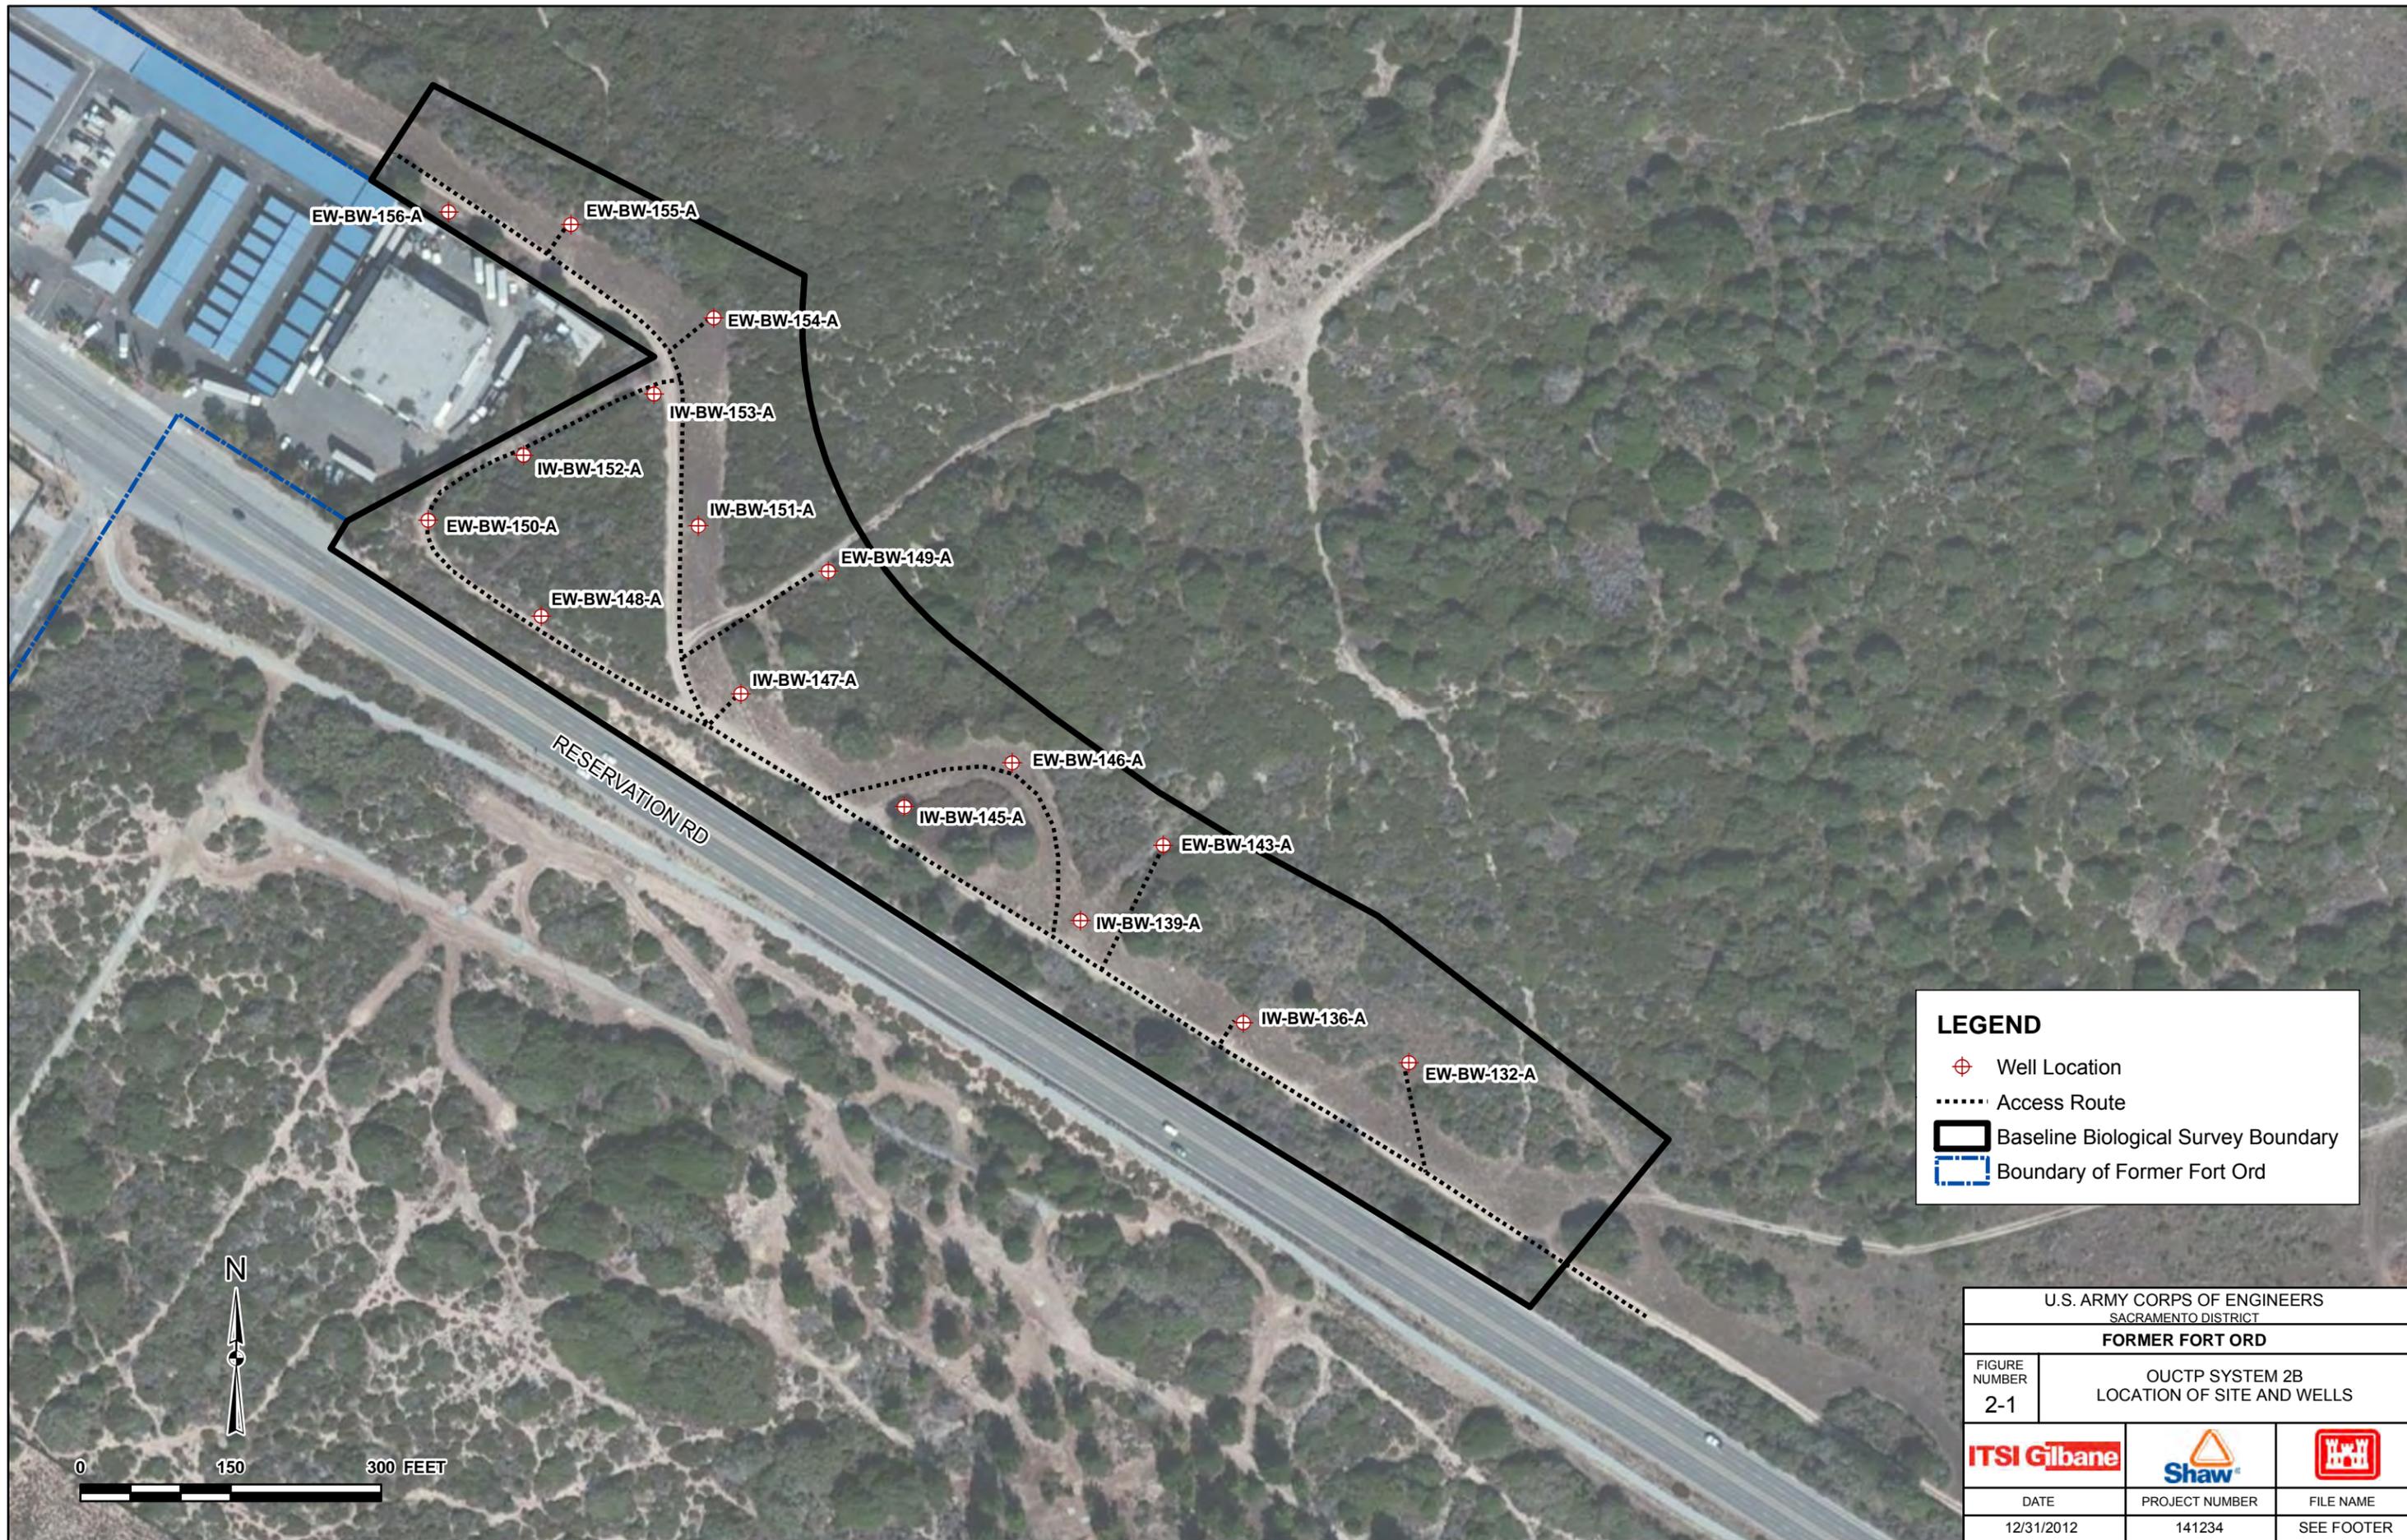
Vegetation monitoring was conducted within the FONR where 16 wells were installed between January and March 2010 (Figure 2-1). The wells were installed as part of the ongoing groundwater remediation of the Carbon Tetrachloride Plume (CTP) within the Lower 180-foot Aquifer (System 2B). In June and July 2011, an aboveground pipeline system connecting wells to the sampling trailer was installed. Groundwater recirculation continued until March 22, 2012, and the pipeline system and trailer were removed on July 25, 2012. Groundwater monitoring is ongoing. The description of the project is in the *Final Operable Unit Carbon Tetrachloride Plume Remedial Action Work Plan, Former Fort Ord, California* (USACE, 2009b).

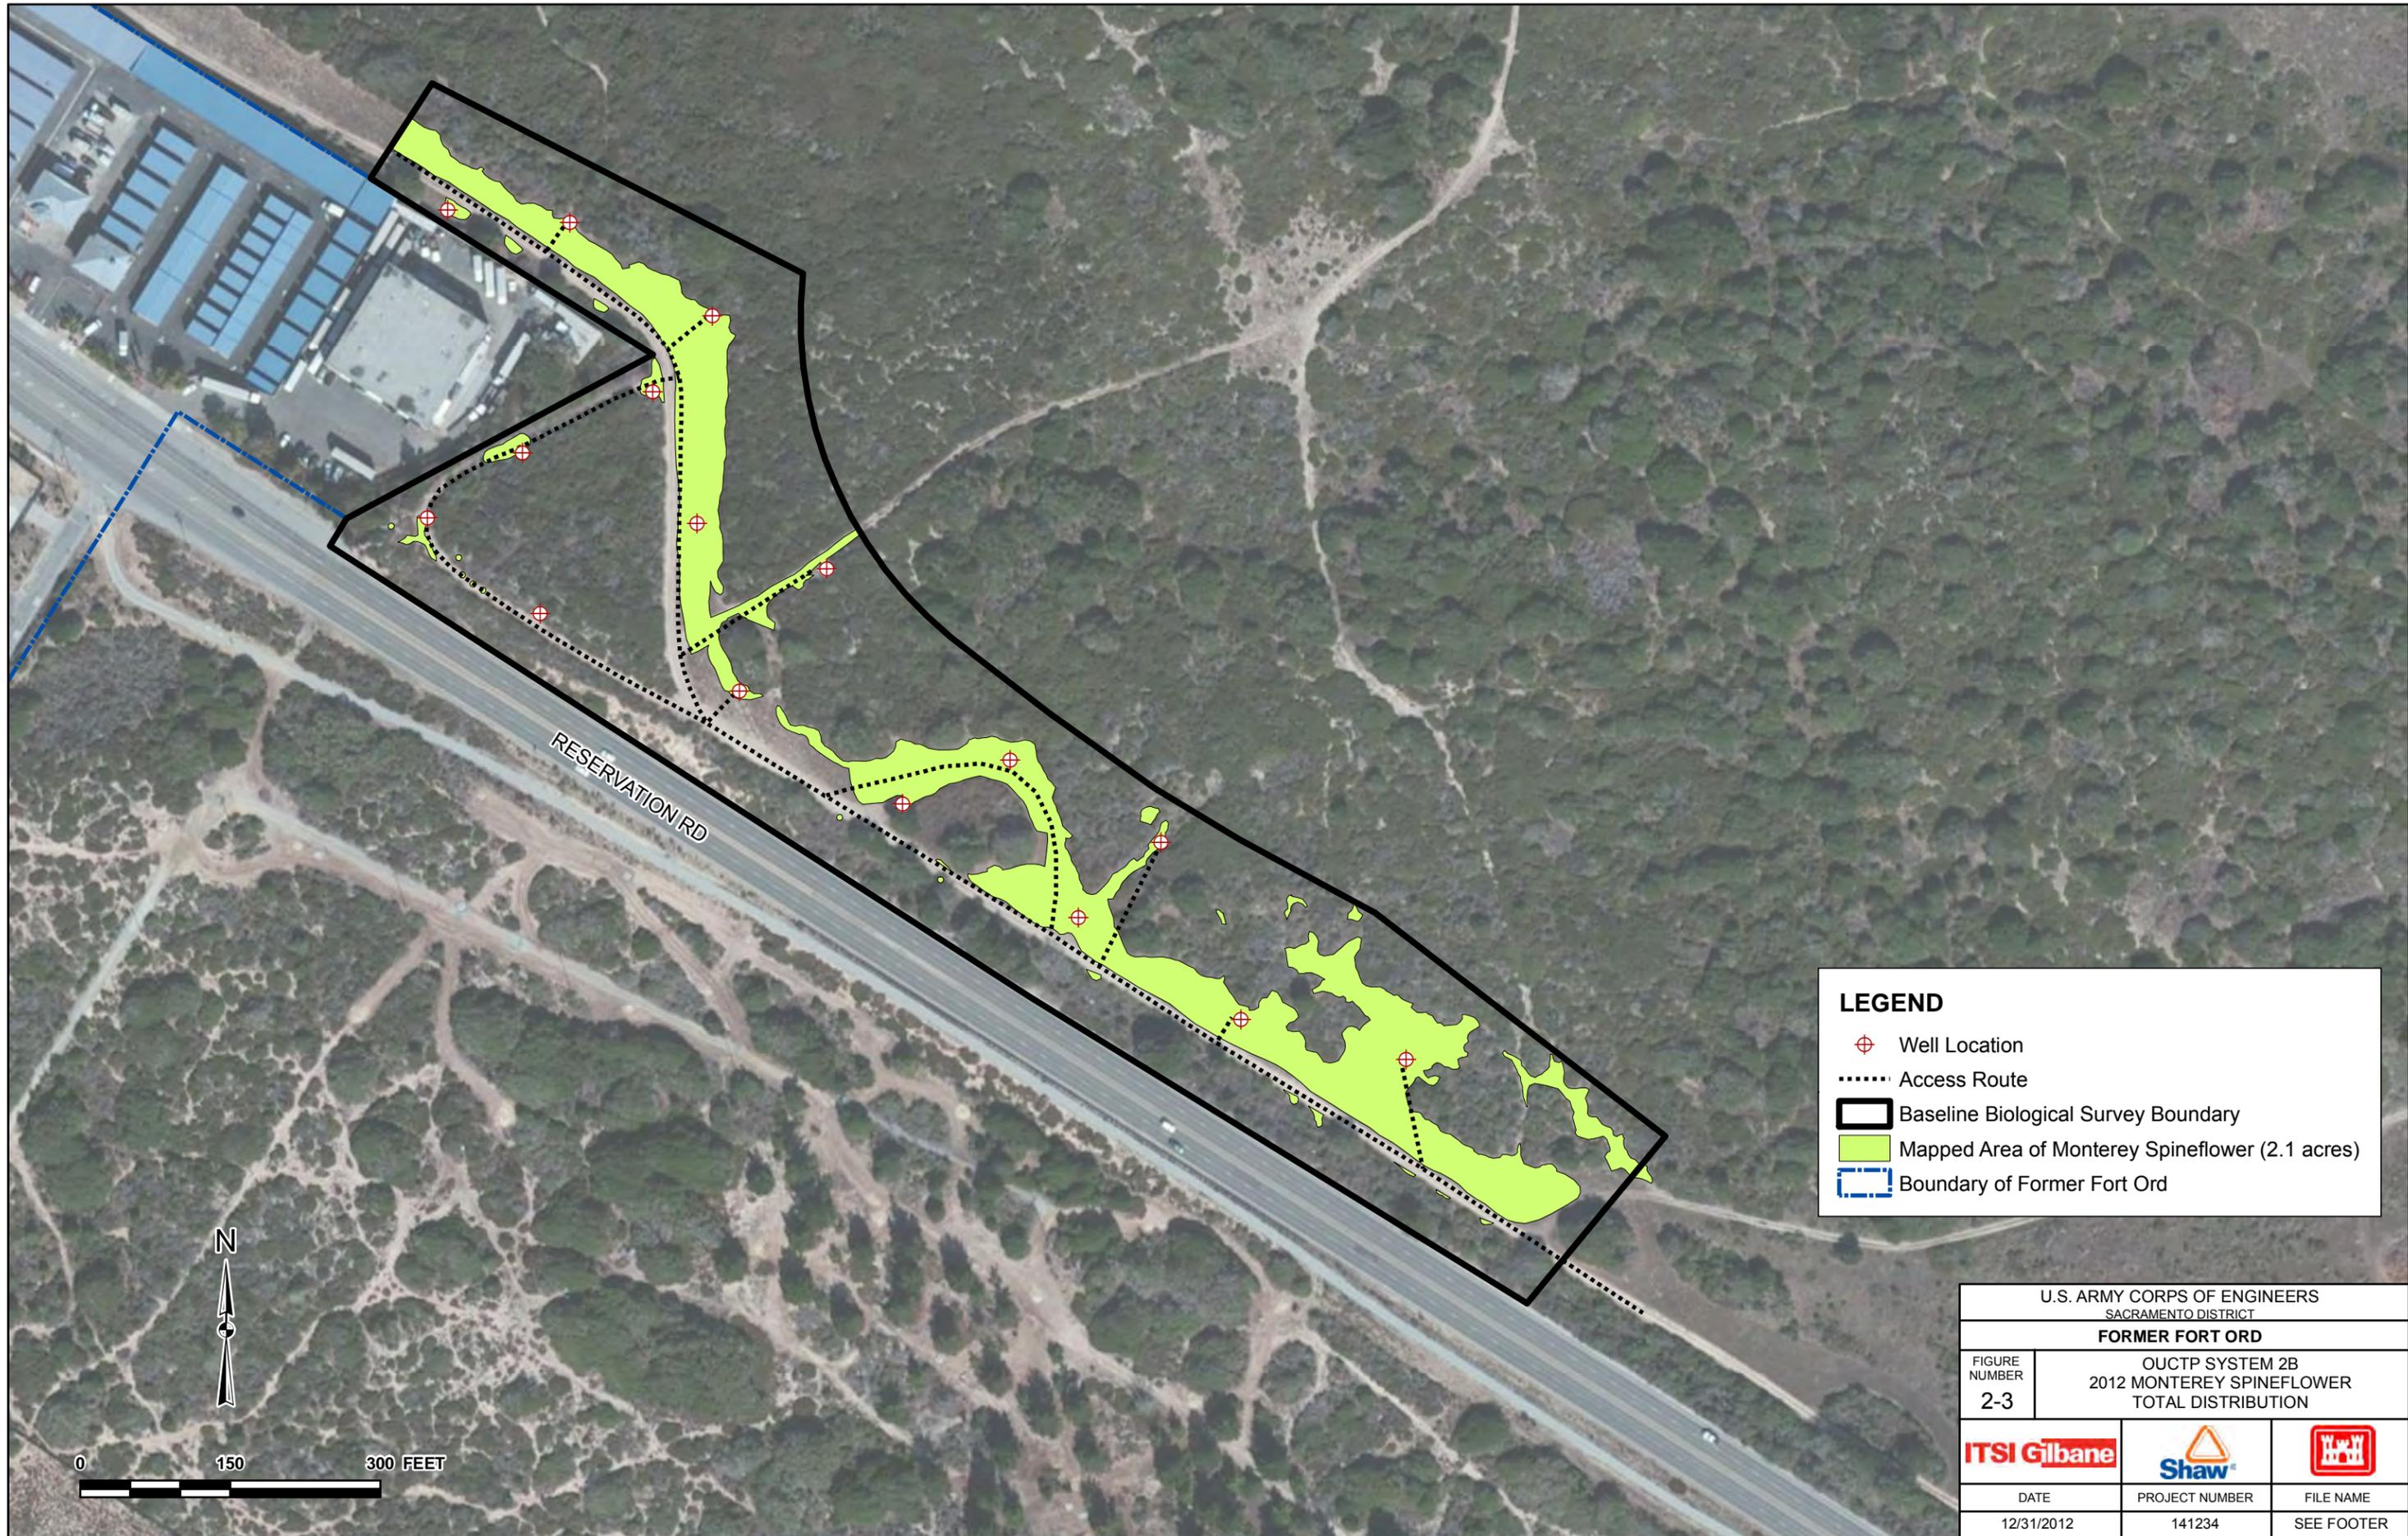
The results of the 2012 monitoring for Monterey spineflower are shown below in Table 2-2 with a comparison to the results of monitoring from 2009 to 2011. The total area of Monterey spineflower observed within the OUCTP System 2B area was 2.1 acres, as shown in Figure 2-3. Approximately 57% of occupied spineflower habitat was in the very sparse cover category. The remaining 43% of the mapped area consisted of patches of sparse and medium-low density Monterey spineflower. Areas with cover greater than very sparse (i.e. >3% cover) are shown in Figure 2-4.

- Well Location
- Access Route
- Baseline Biological Survey Boundary
- Mapped Area of Monterey Spineflower (2.1 acres)
- Boundary of Former Fort Ord

The total area of Monterey spineflower within the OUCTP System 2B area has decreased very slightly since 2011, but has increased from the 2009 baseline. The majority of the area inhabited remains within the very sparse cover class; however, there was a measureable increase in the area of medium-low density cover class in 2012. Distribution of the highest cover classes of Monterey spineflower was concentrated within two to five feet of shrub edges where non-native grass cover tended to be low, similar to previous years. However, unlike previous years, very sparse densities of Monterey spineflower were present throughout most of the mowed fuel breaks greater than four to six feet from the shrub edges. This data suggests that the Monterey spineflower population is recovering well from the disturbance, the success criteria have been met, and future monitoring for this species within the OUCTP System 2B area is not necessary.

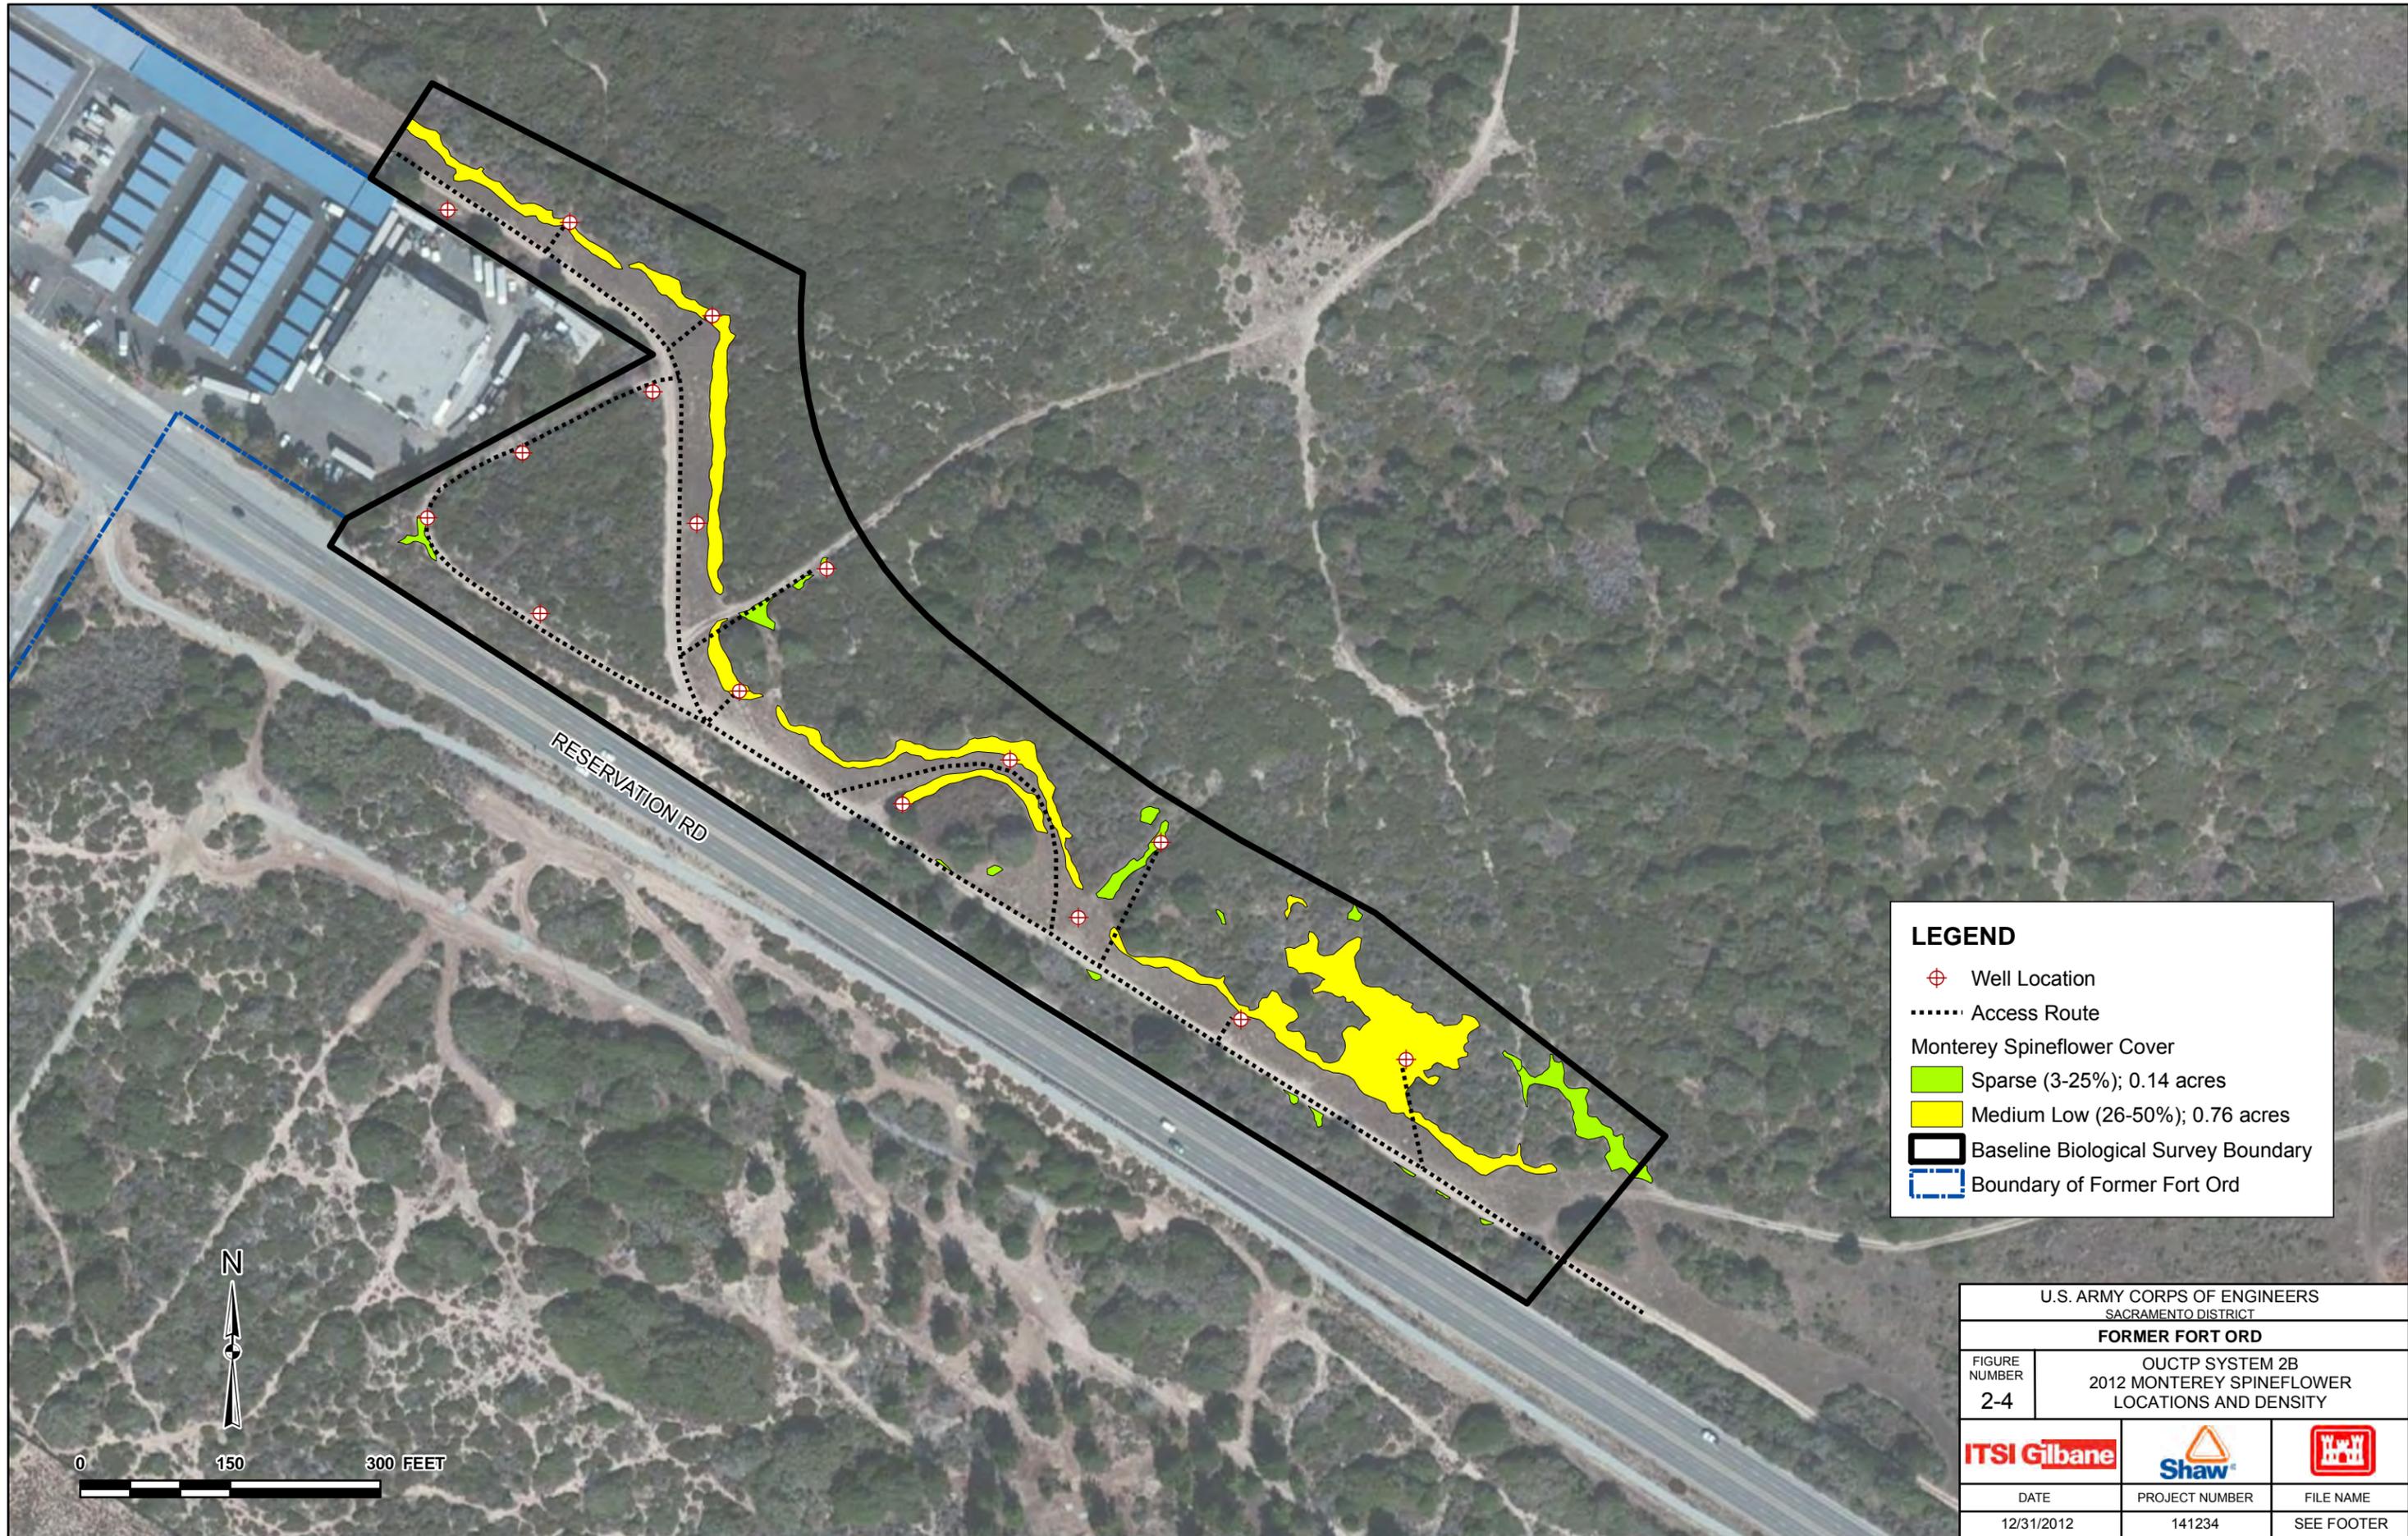
- Well Location
- Access Route
- Monterey Spineflower Cover
 - Sparse (3-25%); 0.14 acres
 - Medium Low (26-50%); 0.76 acres
- Baseline Biological Survey Boundary
- Boundary of Former Fort Ord

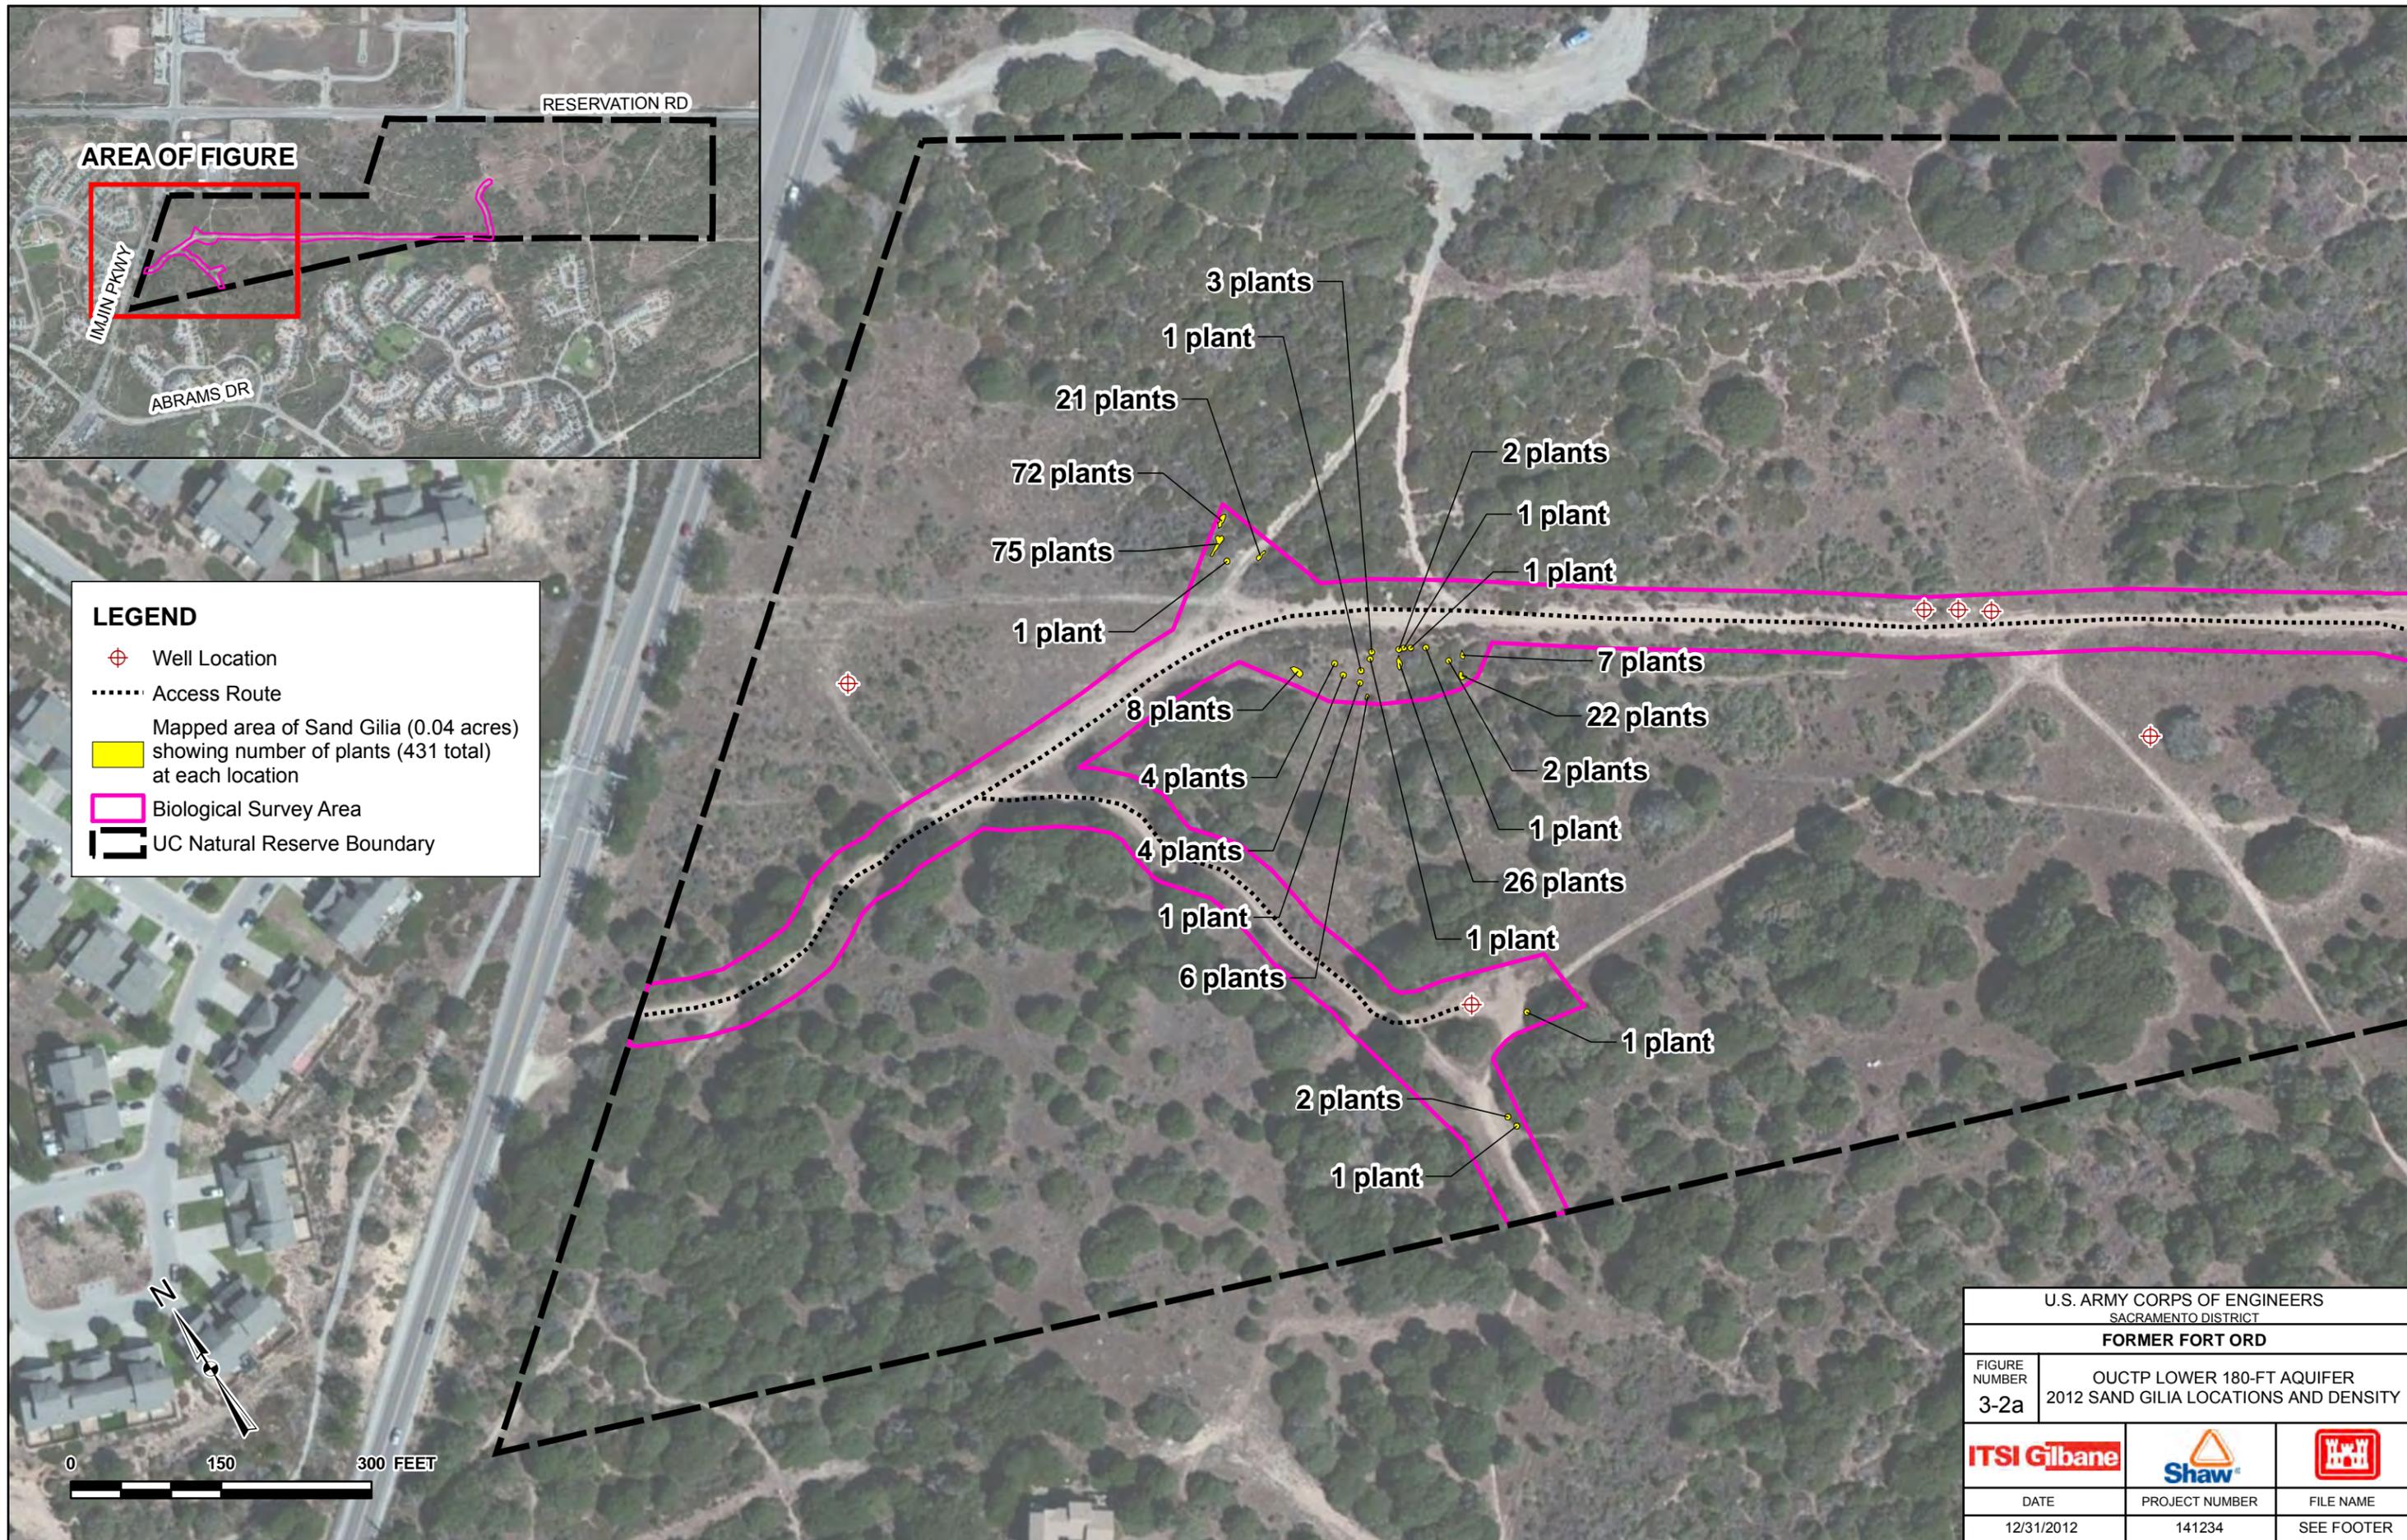
| FIGURE NUMBER 3-2a | OUCTP LOWER 180-FT AQUIFER 2012 SAND GILIA LOCATIONS AND DENSITY | |

The number of individual plants decreased by approximately 27% from that observed in 2011 and approximately 77% from the 2010 baseline. The overall area only decreased slightly from that observed in 2011, but has decreased by approximately 66% from the 2010 baseline. However, because most of the sand gilia areas were outside the actual work zones, the overall trends in abundance of sand gilia are probably most influenced by the variation and the timing in rainfall and temperature patterns over the monitoring period. During the 2011-2012 rainy period, there was a low amount of precipitation in the area early in the season, which may have contributed to a low sand gilia germination rate. This trend is consistent with other sand gilia counts in the reference populations and other survey areas of the former Fort Ord where population decreases were also observed (please refer to survey results in Sections 2.3.1 and 4.2). Further, there have not been increases in the density of annual grass in the areas that support sand gilia within the OUCTP U/L 180-ft Aquifer, so it is unlikely that any observed decrease in the sand gilia population is due to an increased density of non-native annual grasses. One additional year of monitoring is scheduled to document any project-related impacts in the sand gilia population.

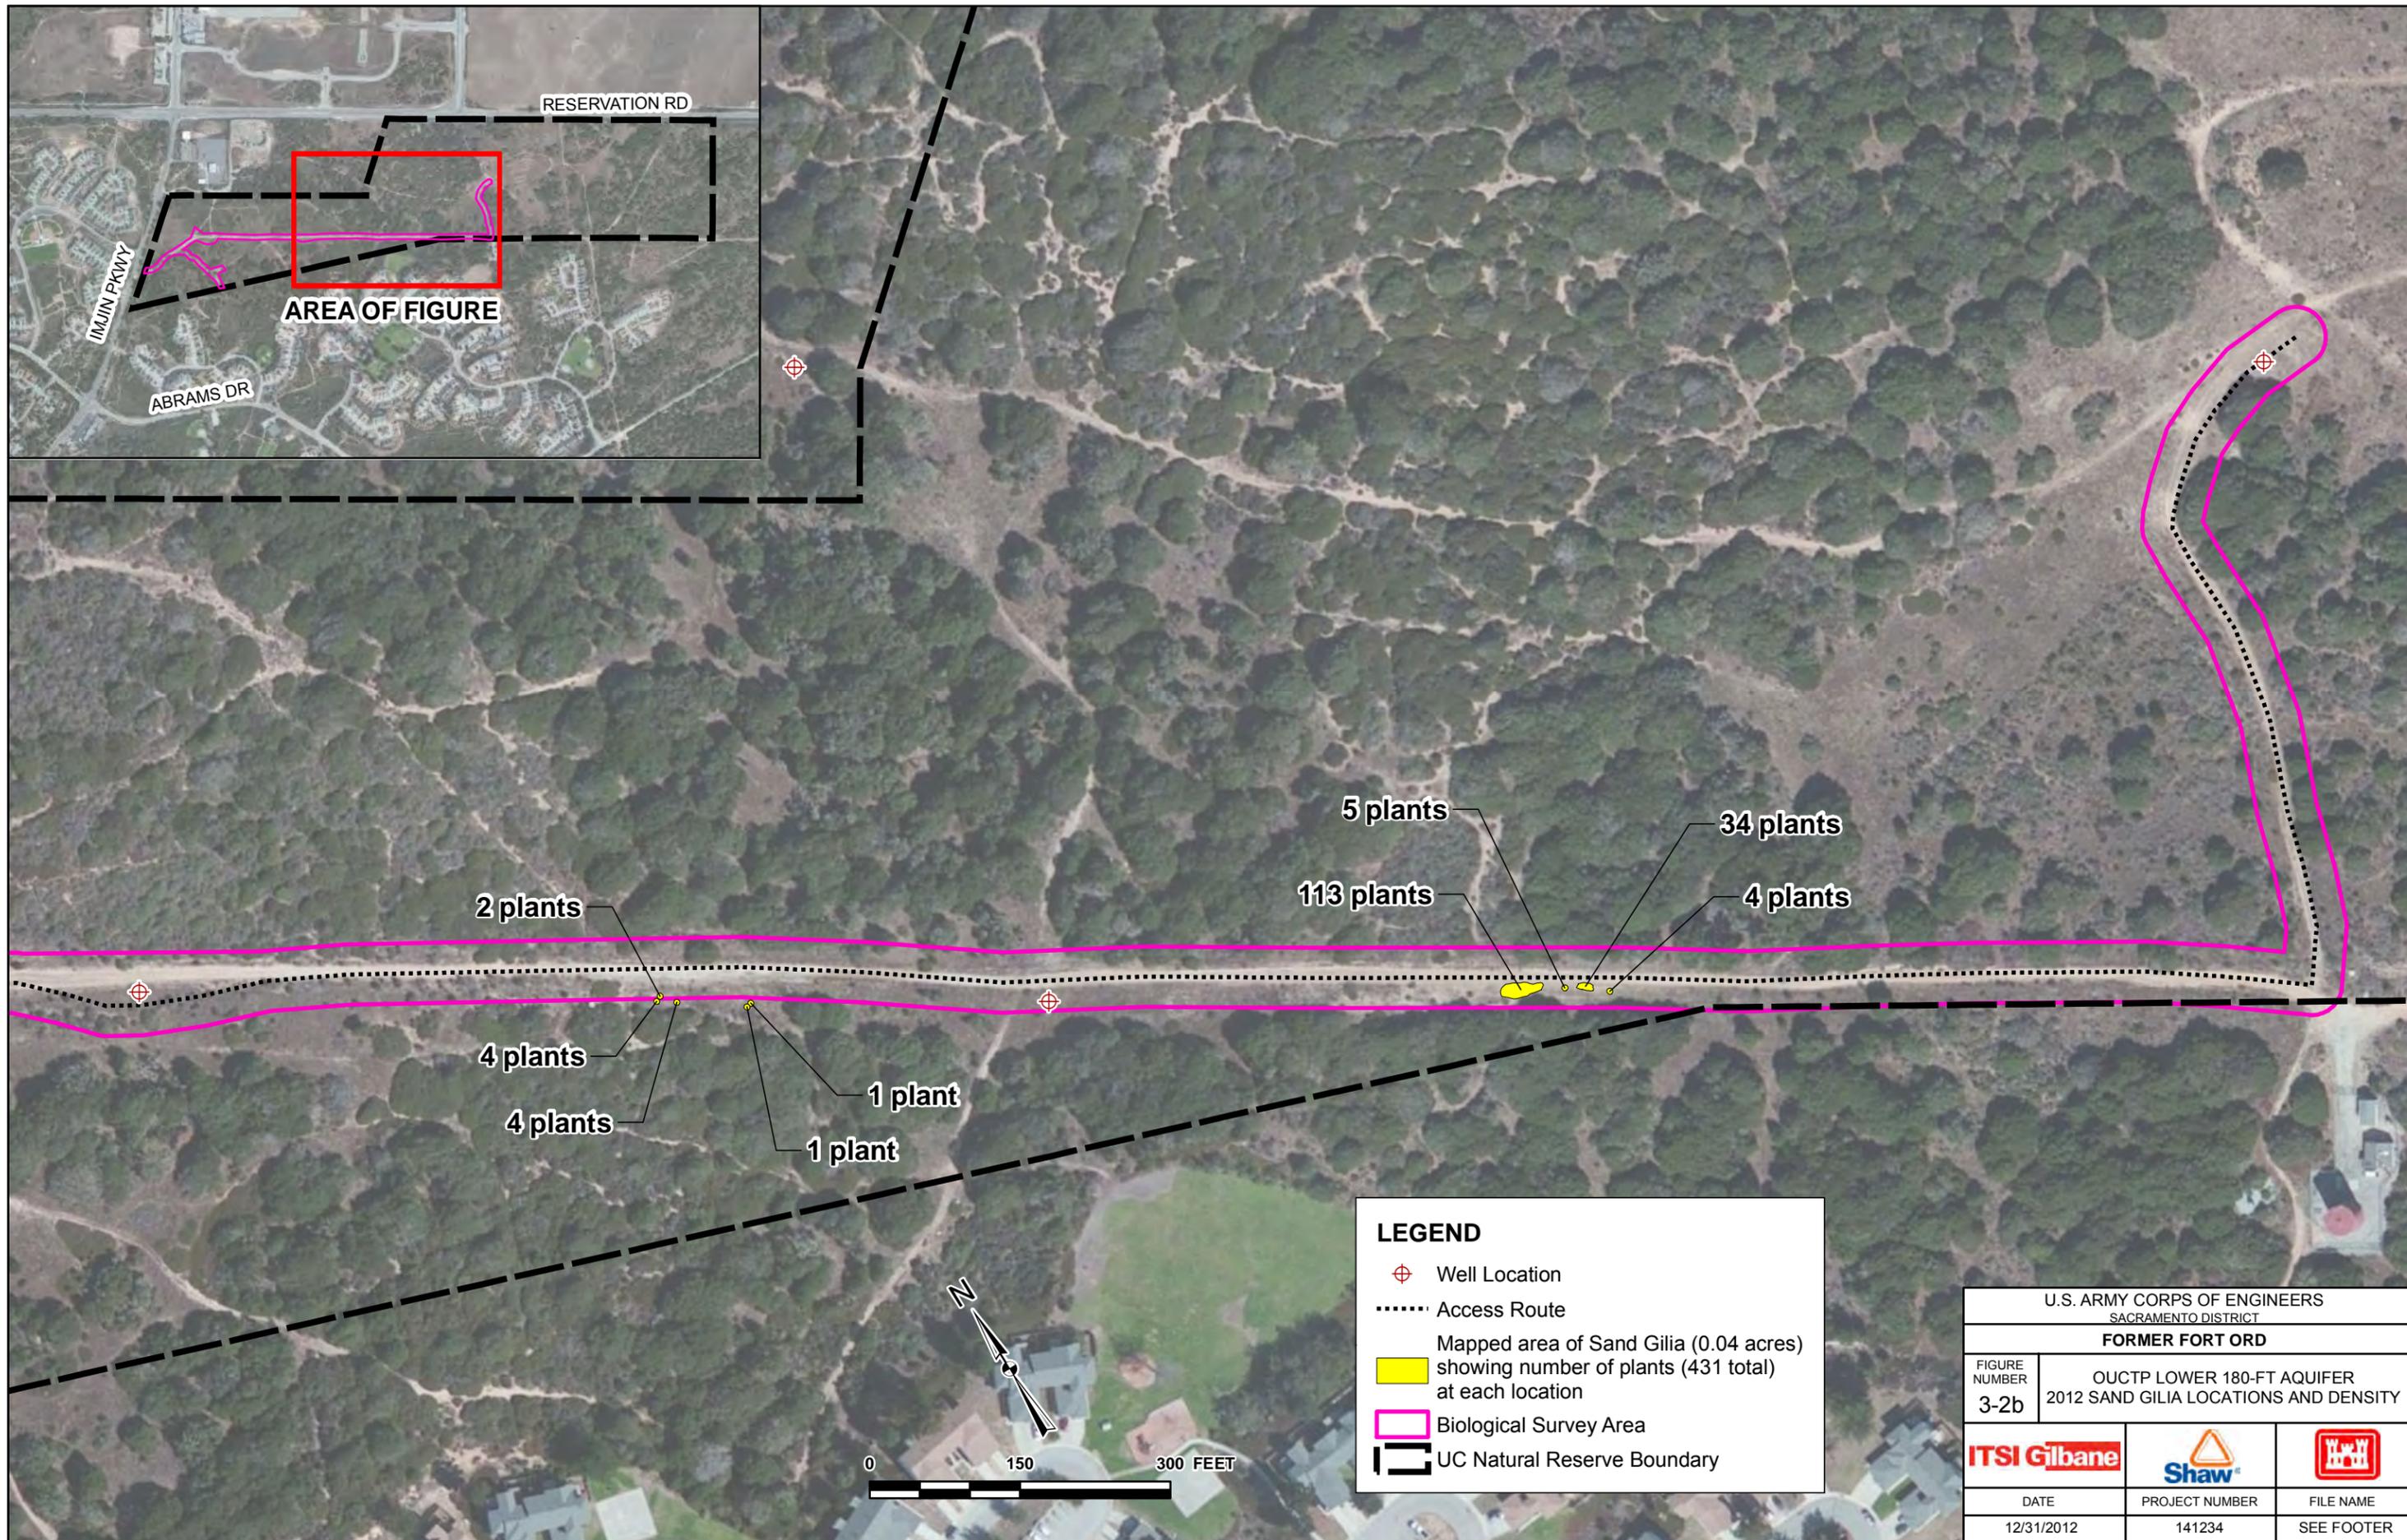
| FIGURE NUMBER 3-2b | OUCTP LOWER 180-FT AQUIFER 2012 SAND GILIA LOCATIONS AND DENSITY | |

- Well Location
- Access Route
- Mapped area of Sand Gilia (0.04 acres) showing number of plants (431 total) at each location
- Biological Survey Area
- UC Natural Reserve Boundary
