2012 ANNUAL BIOLOGICAL MONITORING REPORT FORMER FORT ORD, CALIFORNIA

**WORLDWIDE ENVIRONMENTAL REMEDIATION SERVICES
CONTRACT NO. W912DY-10-D-0024**

February 2013

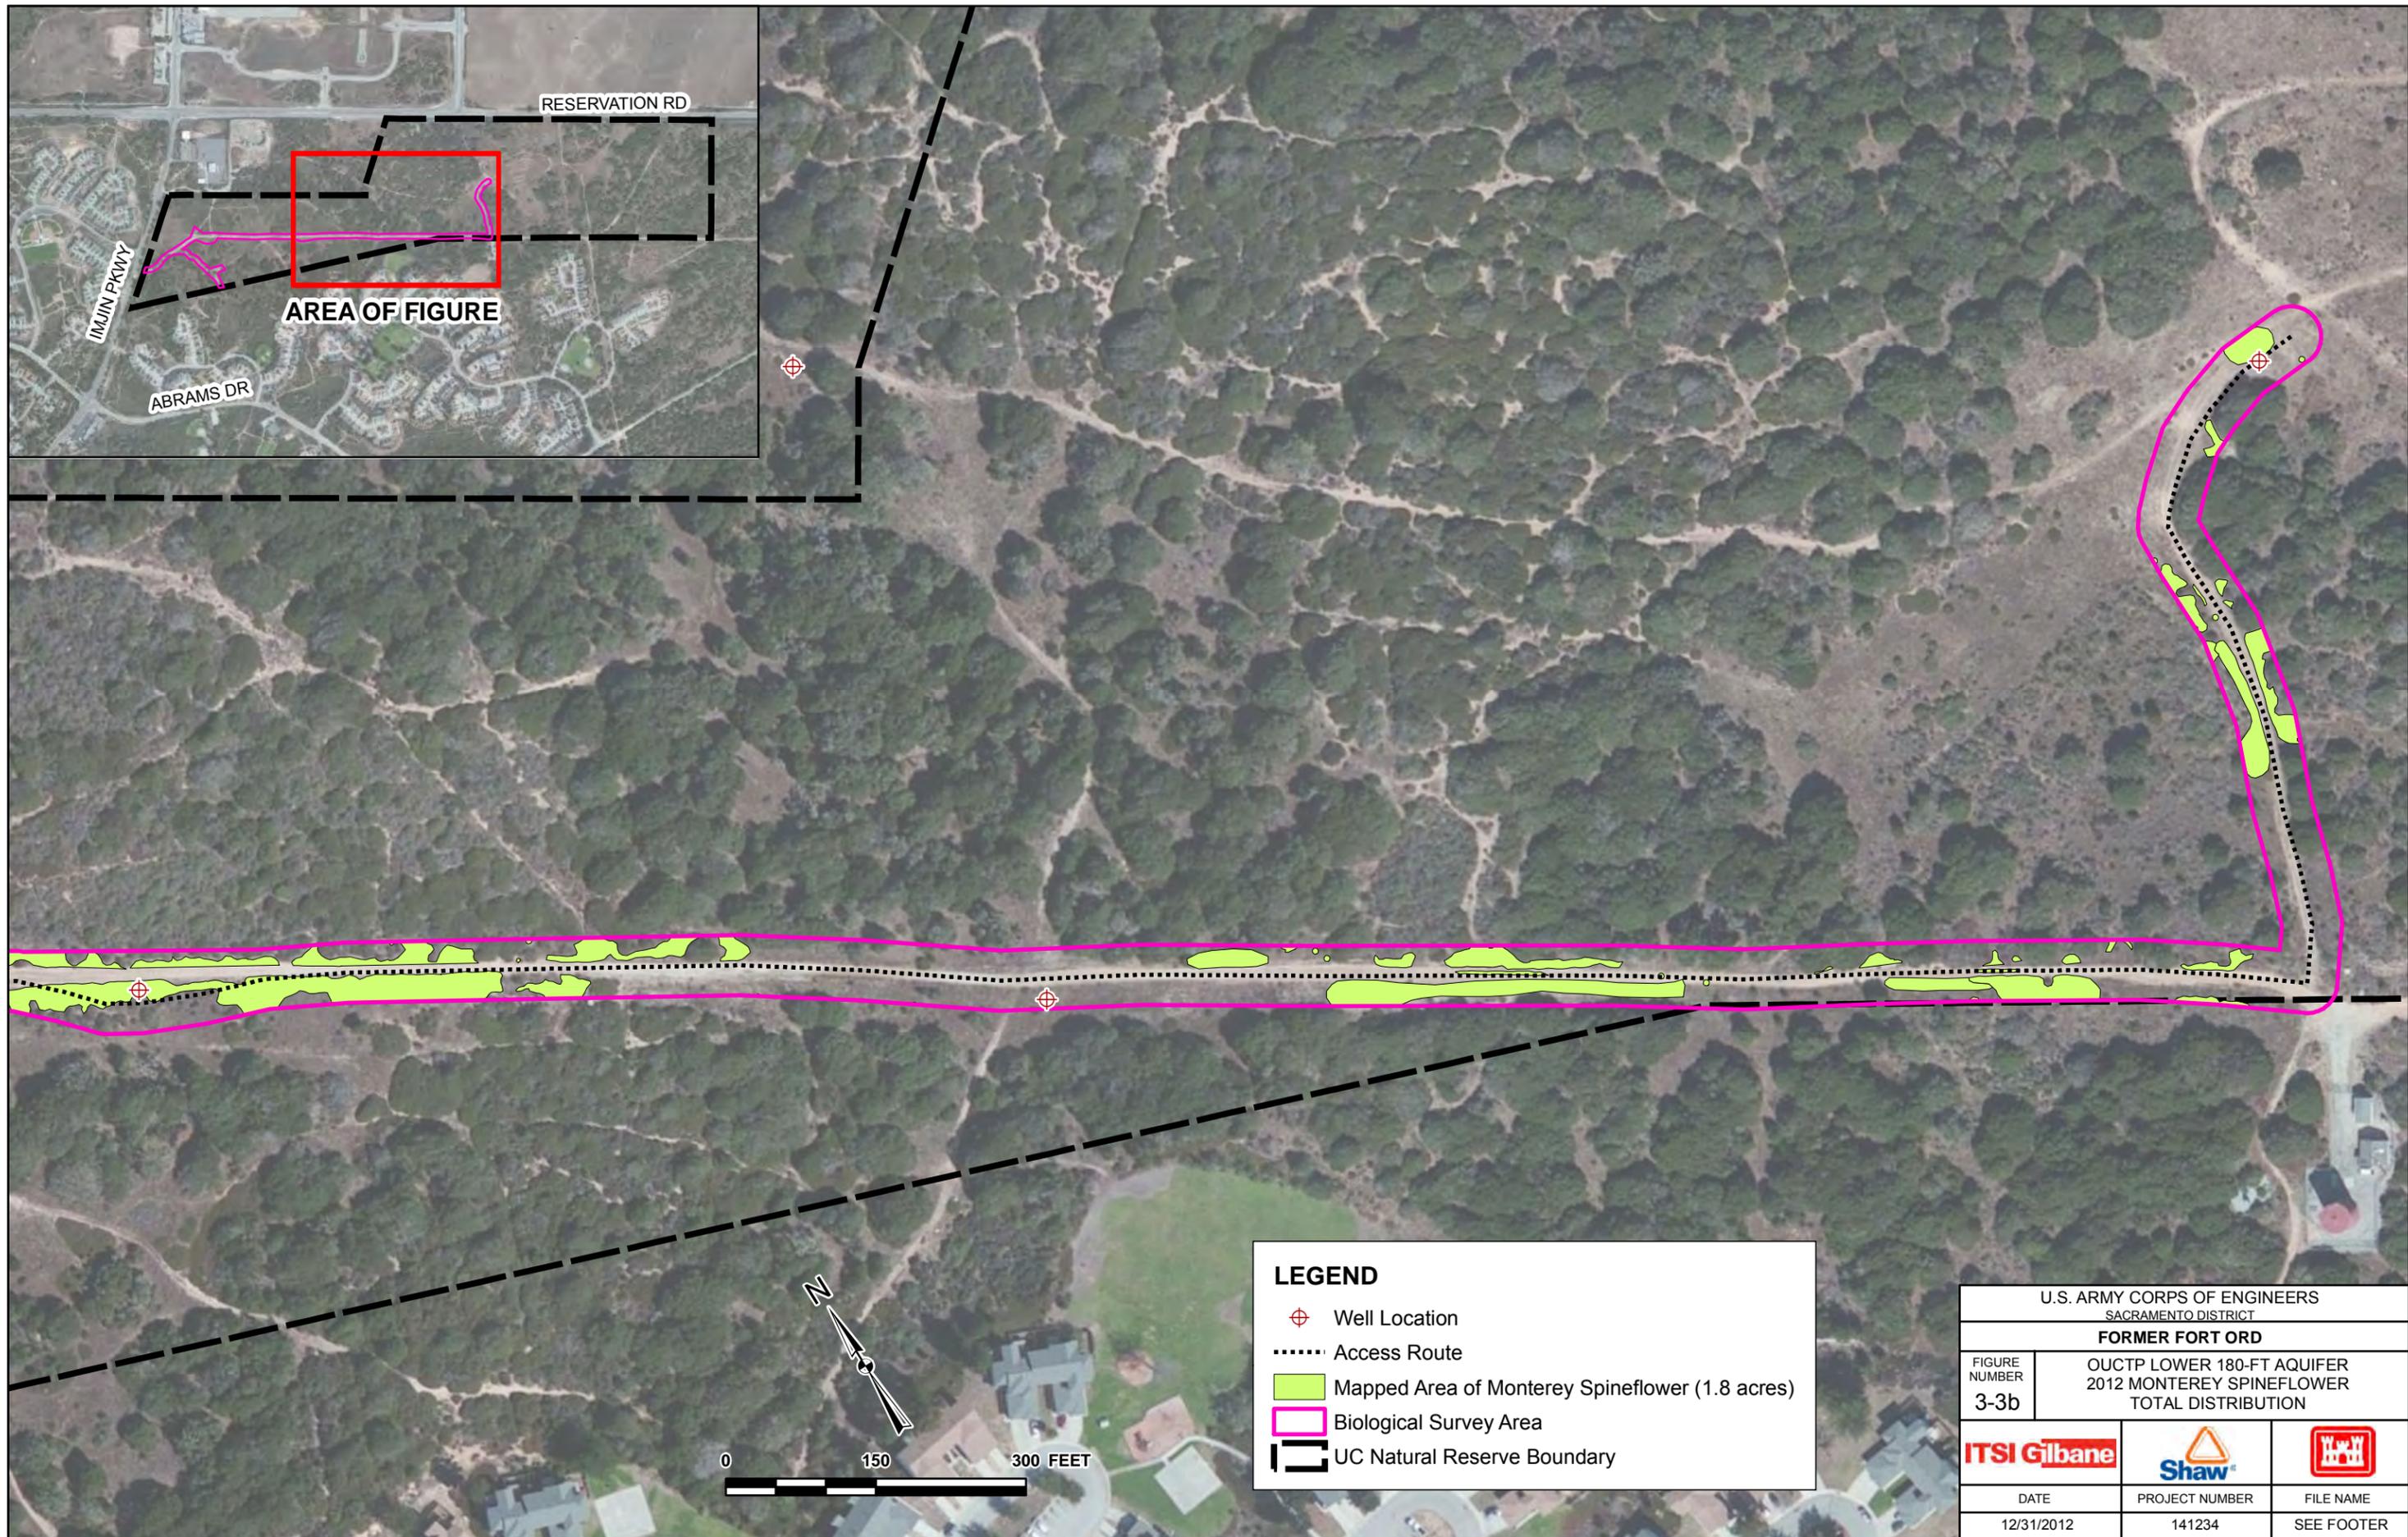
| FIGURE NUMBER 3-3b | OUCTP LOWER 180-FT AQUIFER 2012 MONTEREY SPINEFLOWER TOTAL DISTRIBUTION | |

The total area of Monterey spineflower within the OUCTP U/L 180-ft Aquifer area decreased by approximately 16% from that observed in 2011, and by approximately 33% from the 2010

baseline. The area of the very sparse cover class decreased significantly from that observed in 2010 and 2011; however, the area of sparse and medium-low cover classes was four times greater in 2012 than in 2011. This increase in the higher cover classes shows a positive trend in the Monterey spineflower population within the OUCTP U/L 180-ft Aquifer area, despite the decrease in overall area. There have not been increases in the density of annual grass in the areas that support Monterey spineflower within the OUCTP U/L 180-ft Aquifer, so it is unlikely that any observed decrease in the area of Monterey spineflower is due to an increased density of non-native annual grasses. Further, because most of the Monterey spineflower areas were outside the actual work zones, the overall trends in abundance of Monterey spineflower are probably most influenced by the variation and the timing in rainfall and temperature patterns over the monitoring period. During the 2011-2012 rainy period, there was a low amount of precipitation in the area early in the season, which may have contributed to a somewhat lower Monterey spineflower germination rate. The Monterey spineflower population appears to be recovering well from the disturbance; however, one additional year of monitoring is scheduled to document any project-related changes in the population.

- Well Location
- Access Route
- Mapped Area of Monterey Spineflower (1.8 acres)
- Biological Survey Area
- UC Natural Reserve Boundary

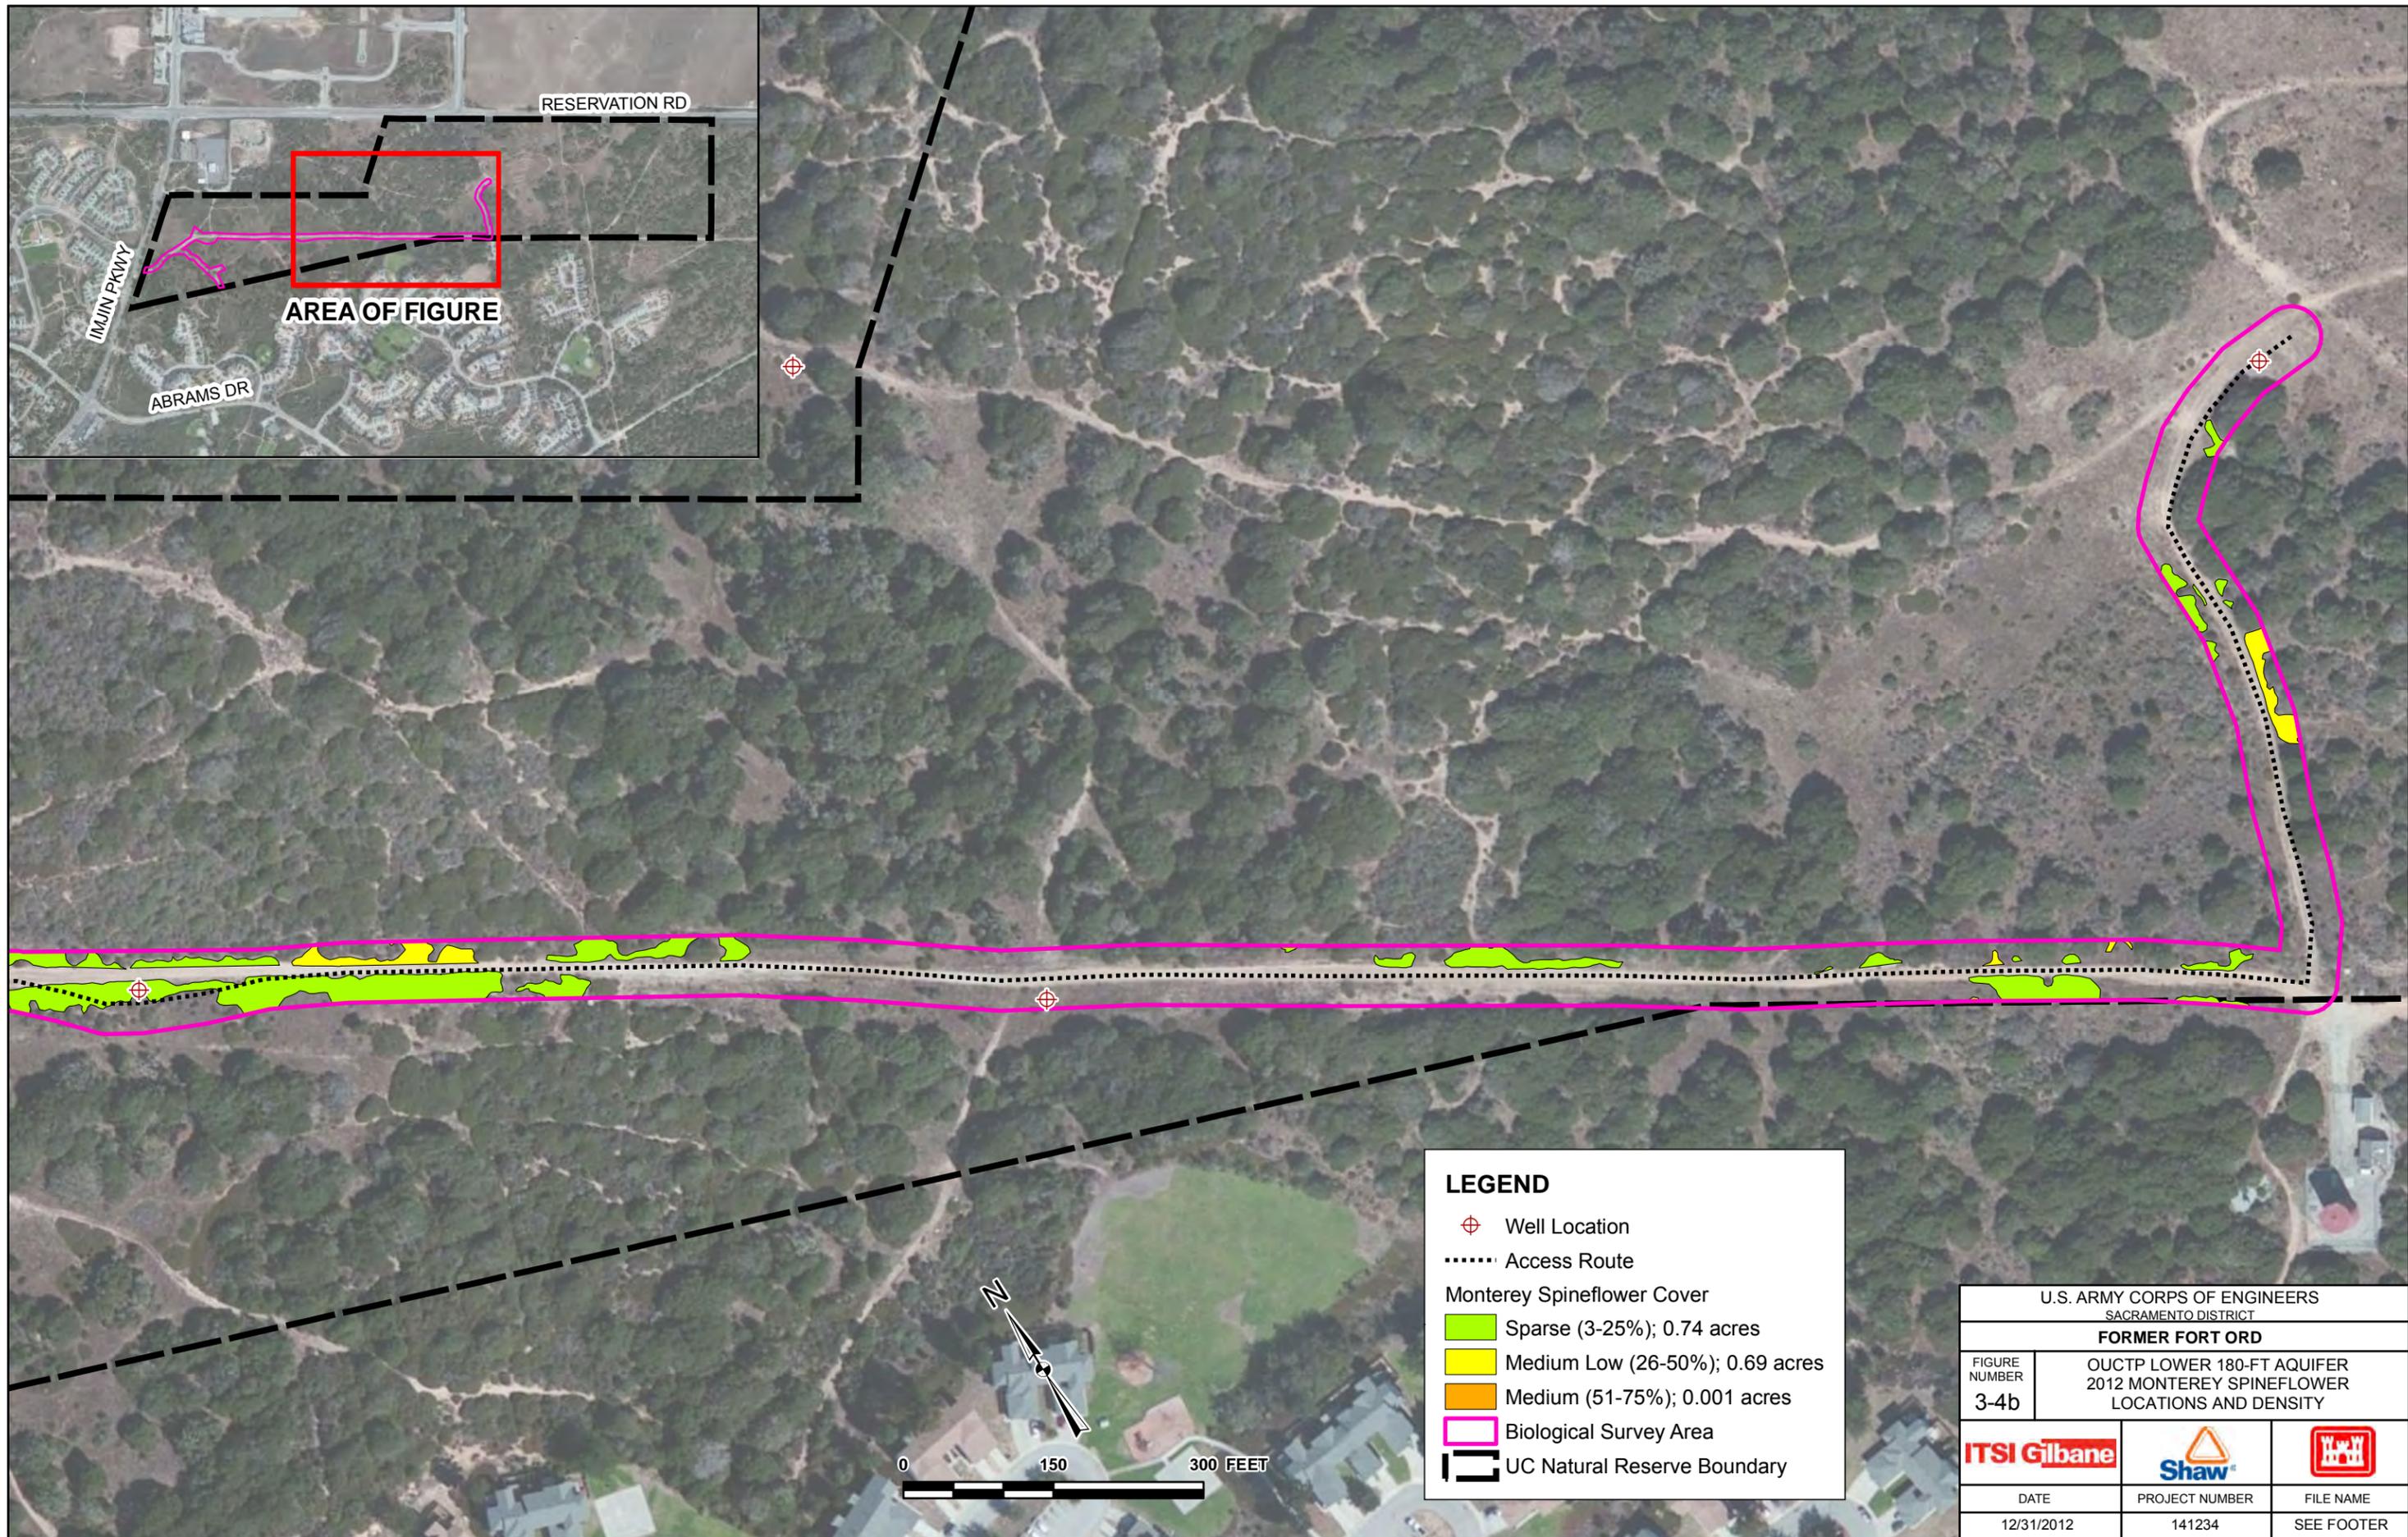
- ⊕ Well Location
- Access Route
- Monterey Spineflower Cover
 - Sparse (3-25%); 0.74 acres
 - Medium Low (26-50%); 0.69 acres
 - Medium (51-75%); 0.001 acres
- ▭ Biological Survey Area
- ▭ UC Natural Reserve Boundary

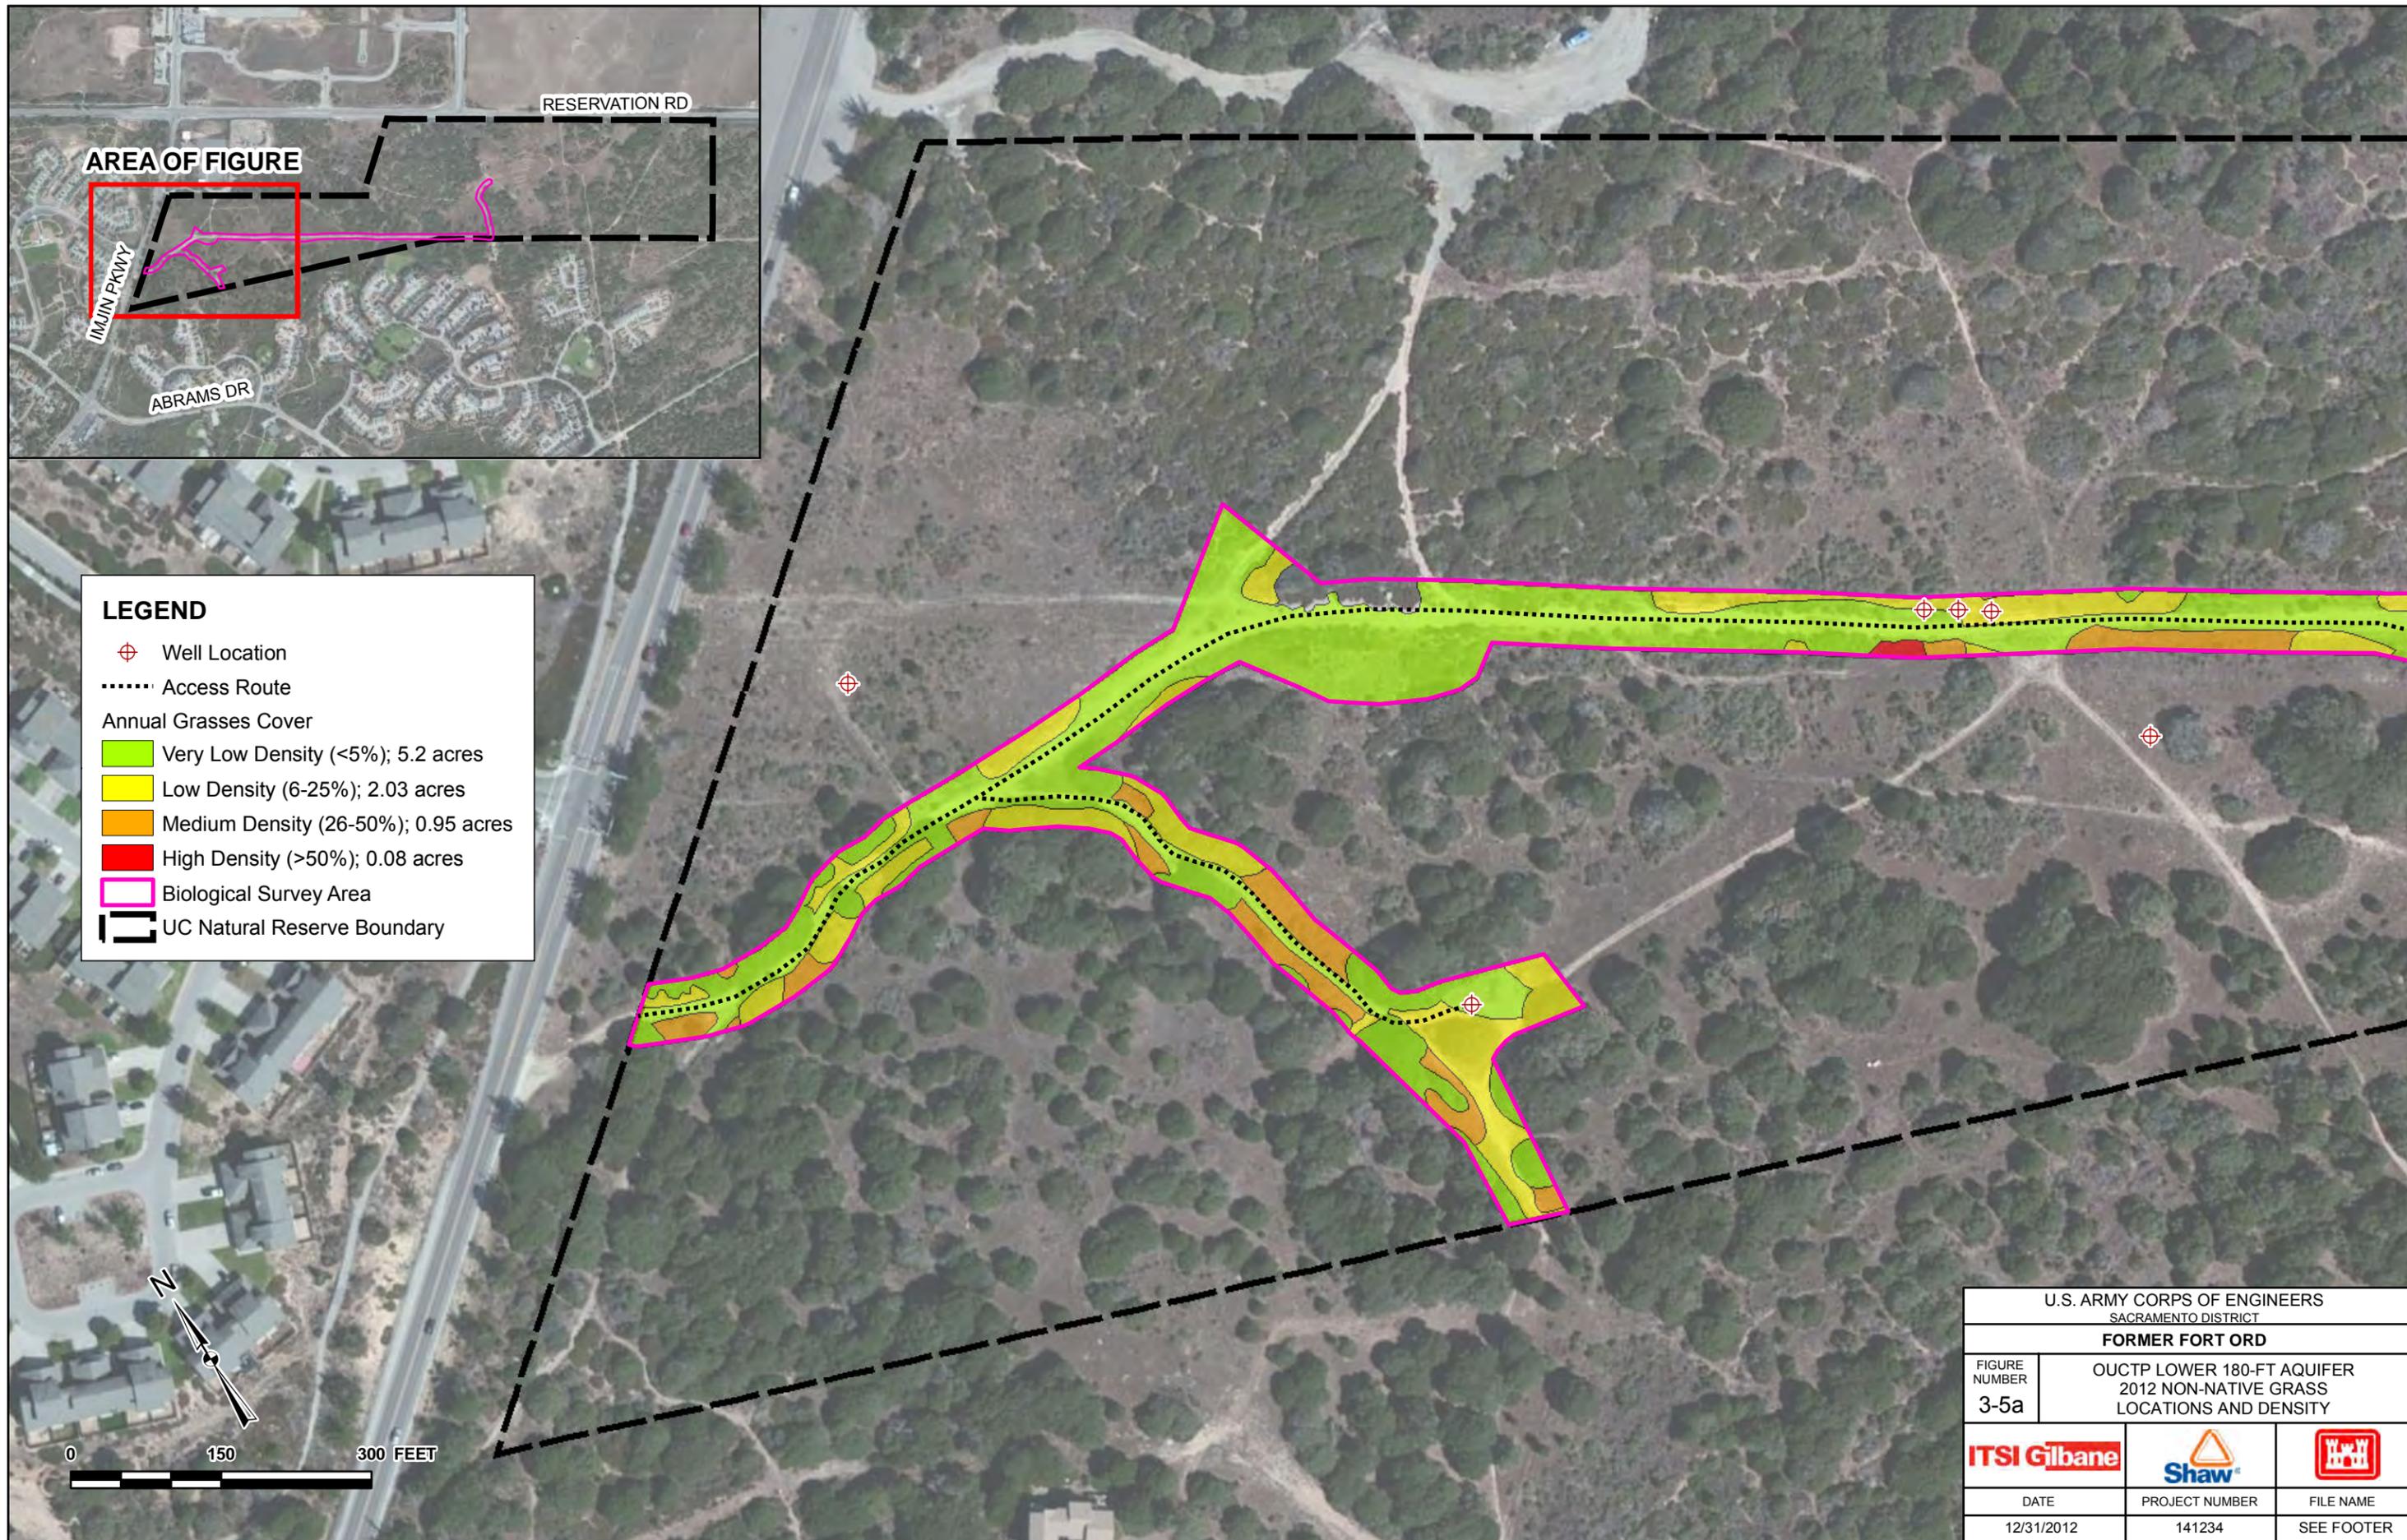
| FIGURE NUMBER 3-5a | OUCTP LOWER 180-FT AQUIFER 2012 NON-NATIVE GRASS LOCATIONS AND DENSITY | |

- ⊕ Well Location
- Access Route
- Annual Grasses Cover
- Very Low Density (<5%); 5.2 acres
- Low Density (6-25%); 2.03 acres
- Medium Density (26-50%); 0.95 acres
- High Density (>50%); 0.08 acres
- Biological Survey Area
- UC Natural Reserve Boundary

Annual grass encroachment, if persistent, can obscure available habitat for these sensitive HMP annual species. Annual Fusilade® treatment or seasonally-timed mechanical vegetation clearance are possible methods that will be considered for the well location and access routes, if a significant increase in grass densities in low cover areas is observed during future monitoring that results in a reduction of HMP species abundance.

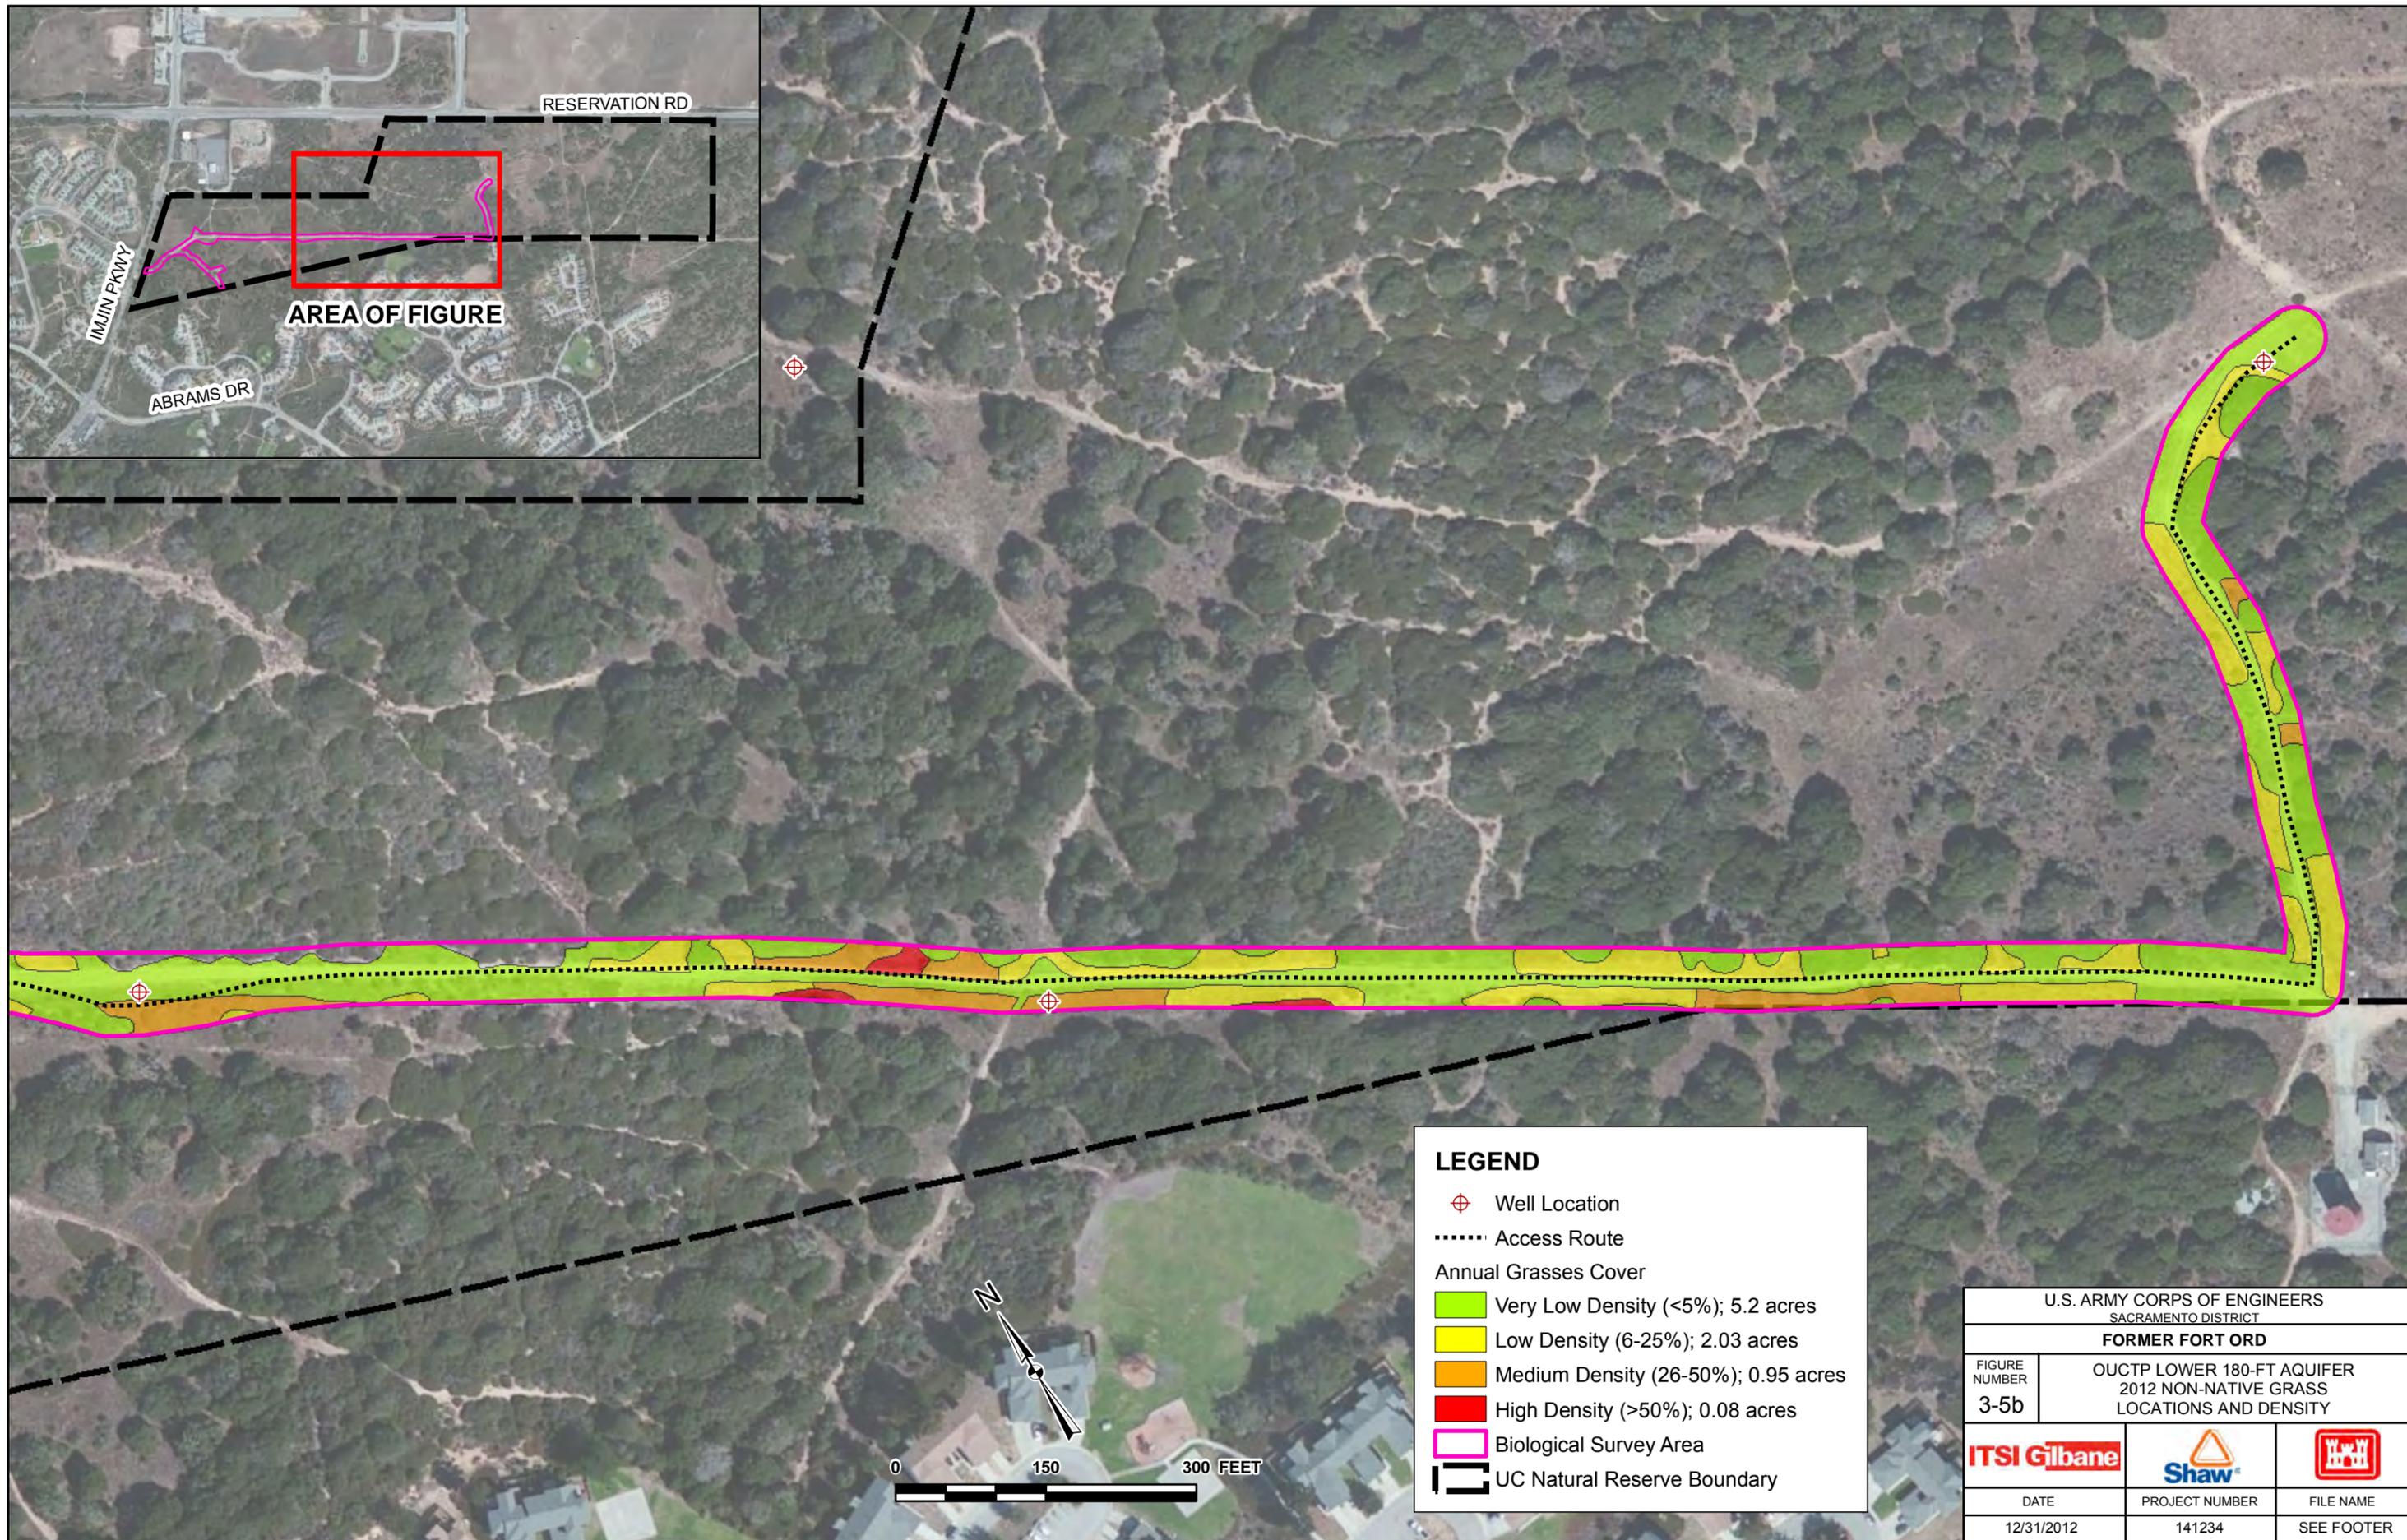
- Well Location
- Access Route
- Annual Grasses Cover**
- Very Low Density (<5%); 5.2 acres
- Low Density (6-25%); 2.03 acres
- Medium Density (26-50%); 0.95 acres
- High Density (>50%); 0.08 acres
- Biological Survey Area
- UC Natural Reserve Boundary

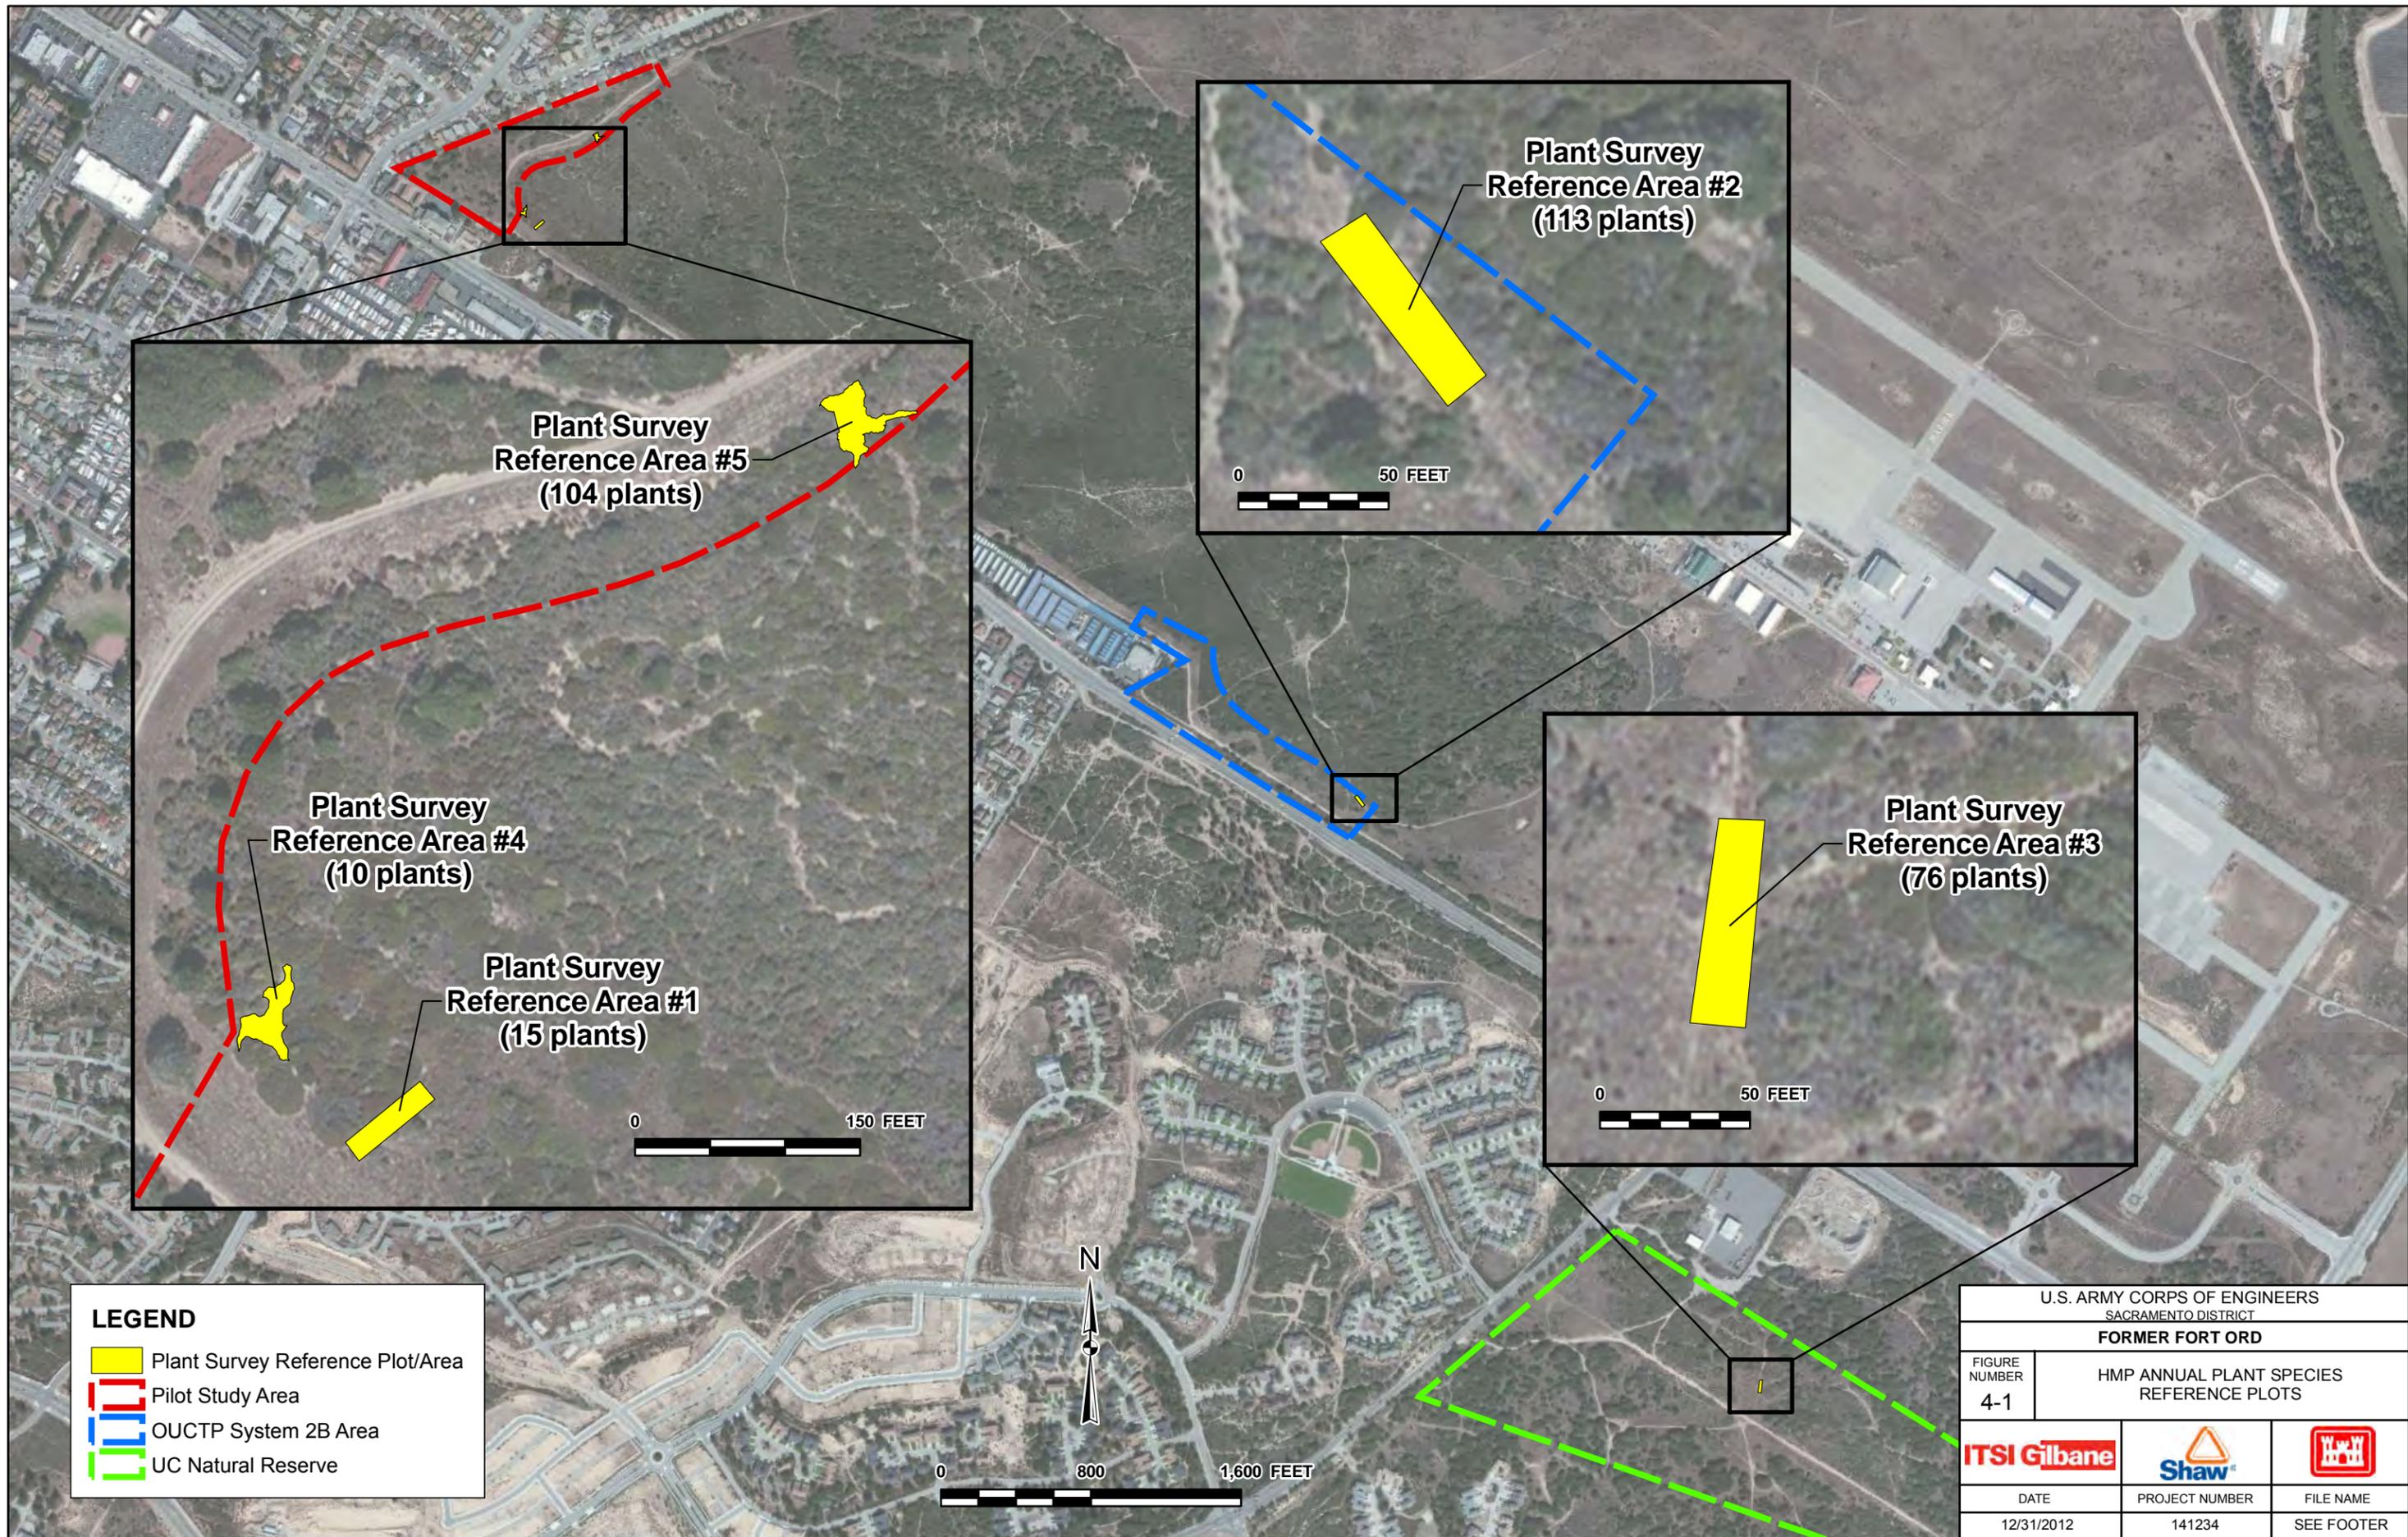
Variation in population abundance from year to year is particularly evident in sand gilia, and reference plots provide data on natural environmental factors, such as rainfall and temperature patterns. This makes it possible to separate out the effect of work impacts from variation due to natural environmental causes.

- Plant Survey Reference Plot/Area
- Pilot Study Area
- OUCTP System 2B Area
- UC Natural Reserve
