**Annual Report
Task Order 3
Former Fort Ord Site 39
Habitat Restoration
2012
Contract No. W91238-10-D-0003**

**FORMER FORT ORD
Monterey County, California**

Site 39 Habitat Restoration Annual Report Task Order 3

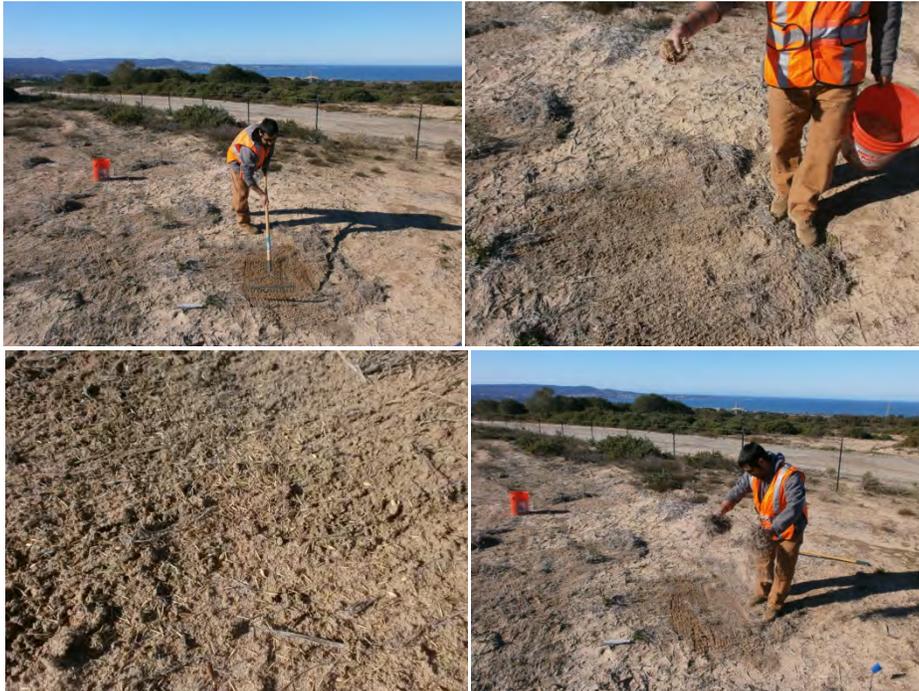
Polygons for HA 18

Work Performed at P 1, 6, and 7

- Raked off old straw
- Broadcast seed evenly or where appropriate
- Raked seed in
- Recast old straw

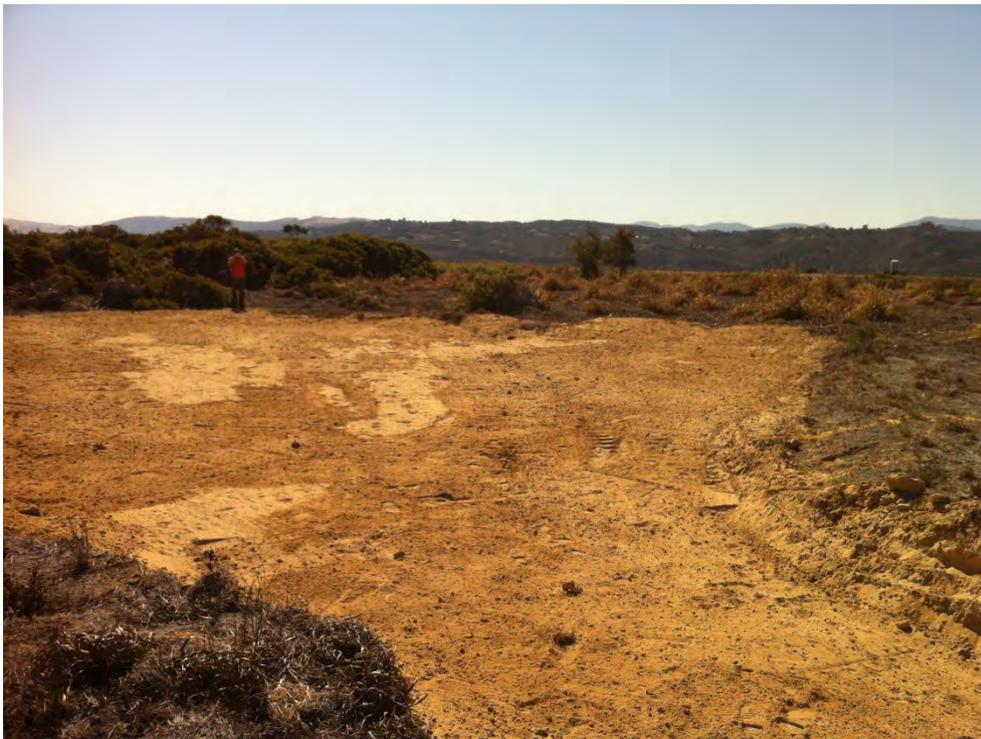
HA 29 Restoration Work Performed October 2, 2012

- Inspected polygon for installation of straw wattles and future seeding and planting locations.
- Inspected ponded area that was regraded (see photo below).

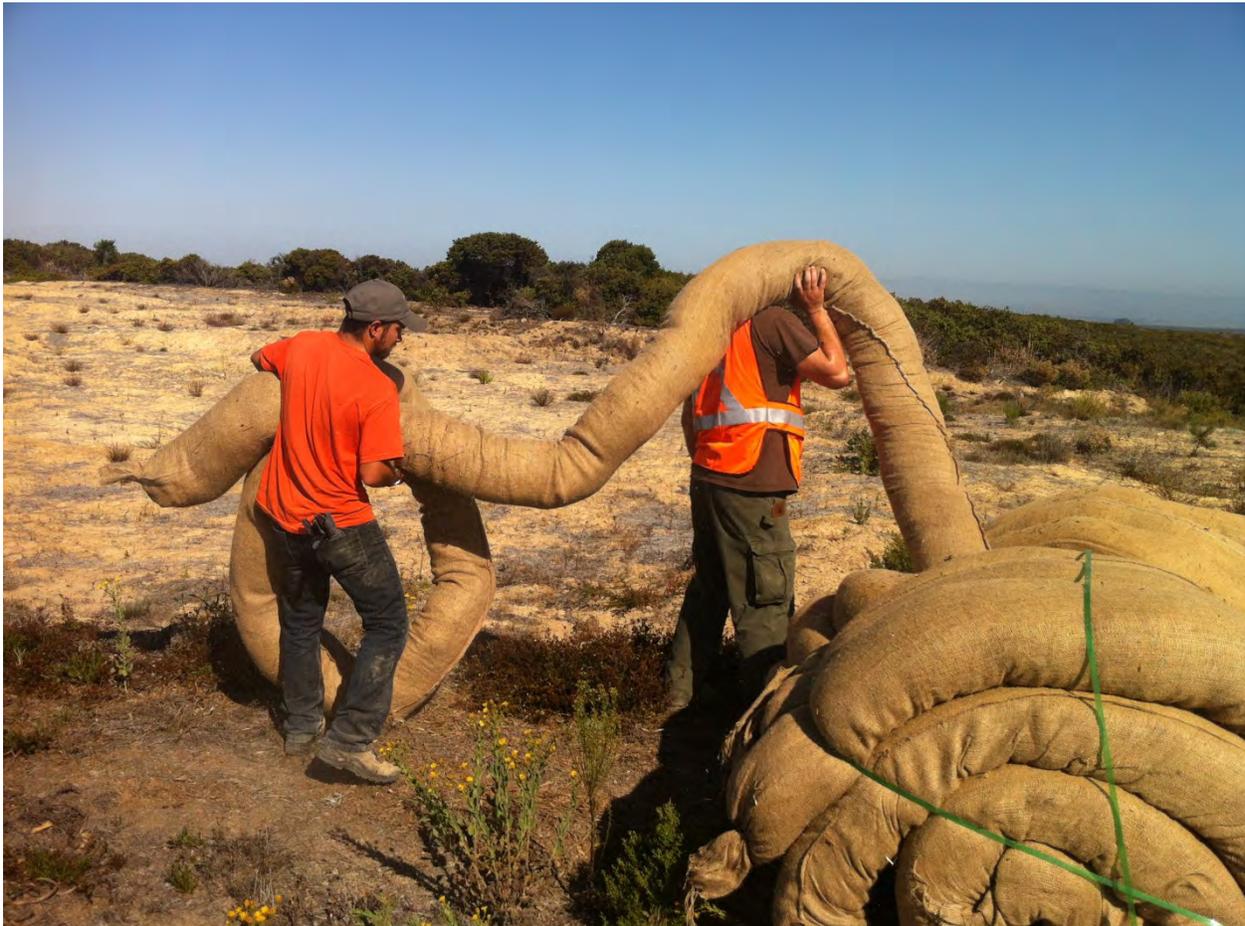
HA 29 Restoration Work Performed October 3, 2012

- Delivered straw wattles to site for erosion control.

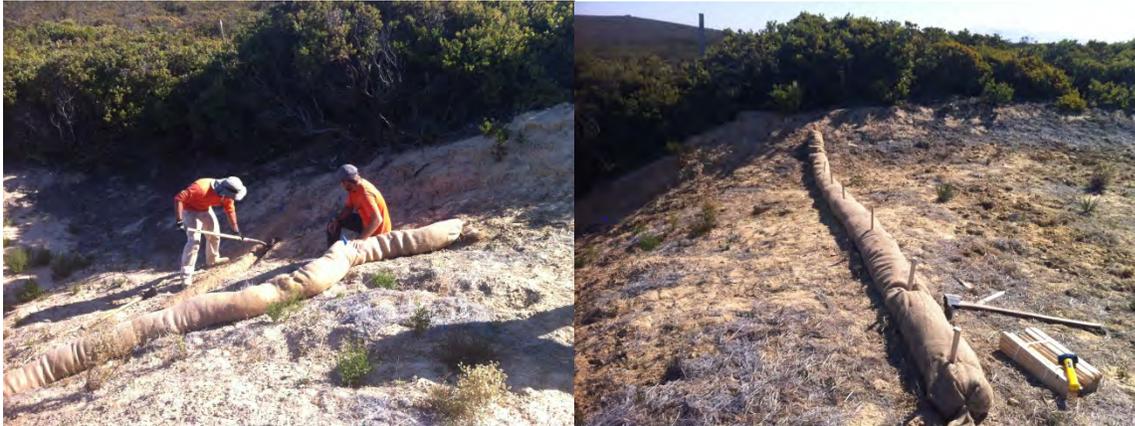
HA 29 Restoration Work Performed October 11, 2012

- Installed wattles and removed pampas grass.

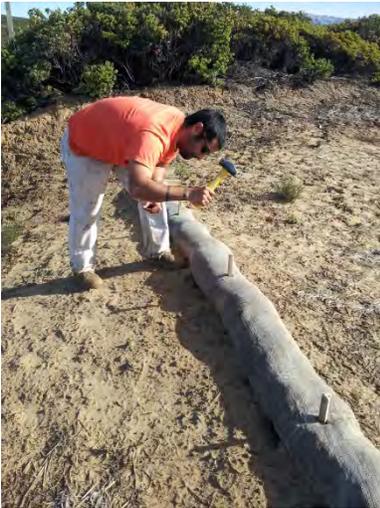
HA 29 Restoration Work Performed December 18, 2012

- Secured wattles with stakes.

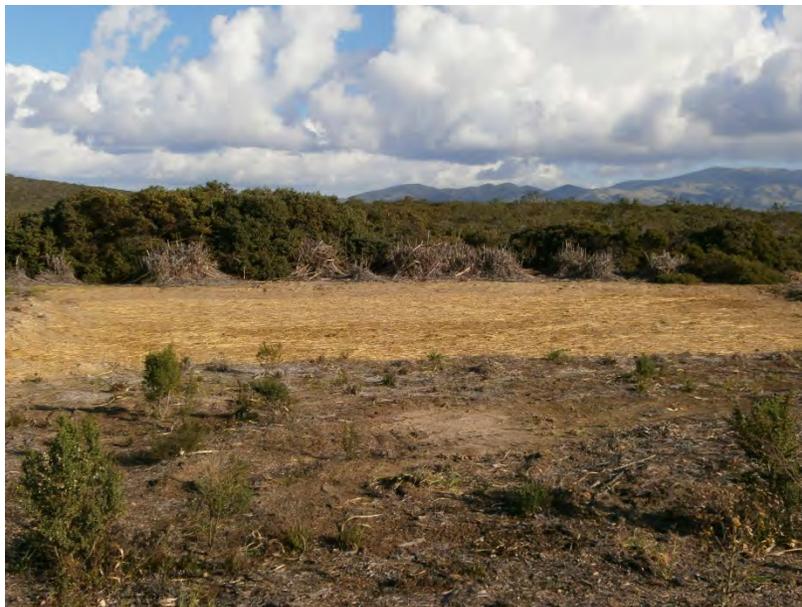
Work done at P1, P2, P3, and P4:

- Pampas grass was removed when encountered on the site during the broadcasting process.
- Old straw was raked off site.
- 100% seed target for HA 29 was broadcast evenly for each polygon.
- Broadcast seed was raked into the ground.
- Fresh straw was broadcast over P1, P2, P3, and P4.

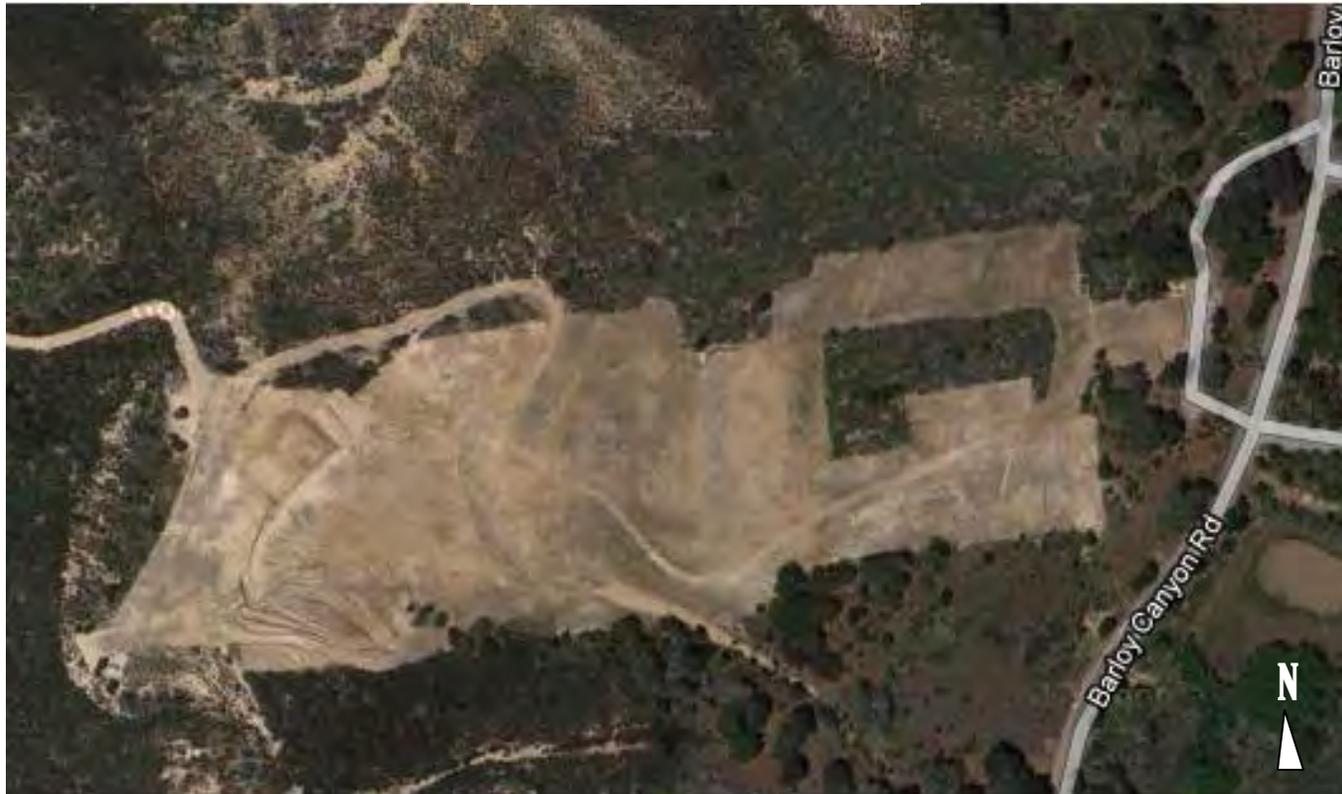
Aerial image of HA 34.

- HA 34 consists of one large continuous area with no sub-areas set aside for HMP forb broadcasting.
- HA 34 is approximately 9.5 acres.
- The immediate area surrounding the site consists of high quality habitat with manzanita/chamise chaparral and soft sage scrub being the dominant vegetation types. There is some oak woodland/oak savanna habitat at the base and southeastern portion.
- The site has been straw crimped with barley.
- Invasive species are relatively minor; there is some iceplant in the middle of the site, but no pampas grass, yet. Diligence will be taken to avoid invasive species impacts.
- Very little natural recruitment observed at the site.
- The site has serious erosion potential and has already experienced a couple of large events.
- Major grading and soil removal will be done to combat erosion potential.

HA 34 is sectioned into Treatment areas which designate the type of fiber matrix and seed mix applied. Swale sand coir fabric areas were arbitrarily numbered and broadcast with the appropriate seed mix and amount.

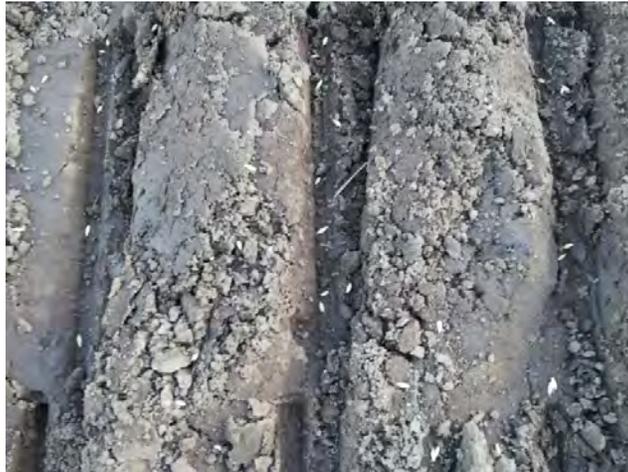
Hordeum seed in tire treads on road.

- Seeded the upper coir fabric area with ~12lbs of barley, focusing on the rills.
- Seeded the road with *Hordeum* starting at the top and working down.
- Discussed with hydromulch crew how to approach hydroseeding the lower 2/3 portion of HA 34.

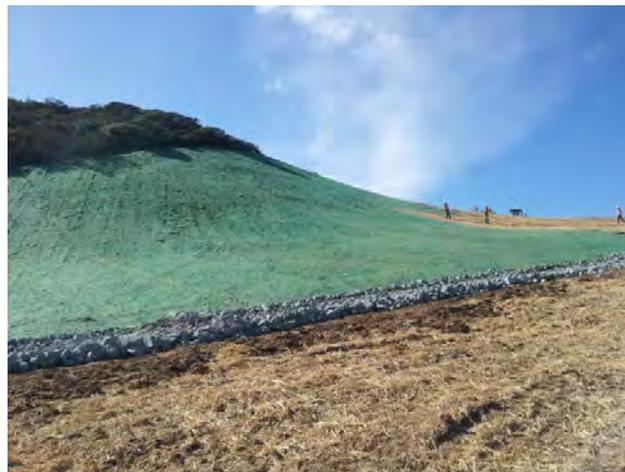
Upper Coir Fabric slope with hydromulch.

- Inspected coir fabric area for seed germination. Found evidence of minimal germination. Burleson recommended an application of bonded fiber matrix over fabric and broadcasting of additional barley seed in rill areas under the fabric.

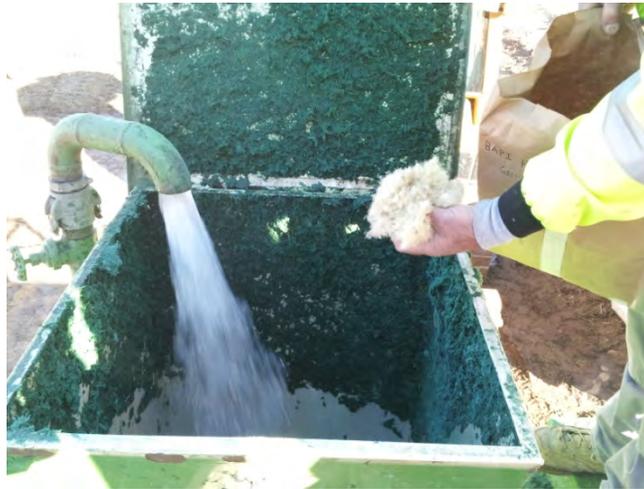
BAPI entering hydromulcher

- Used hydromulcher to disperse BAPI seed evenly on lower 2/3 portion of the site.

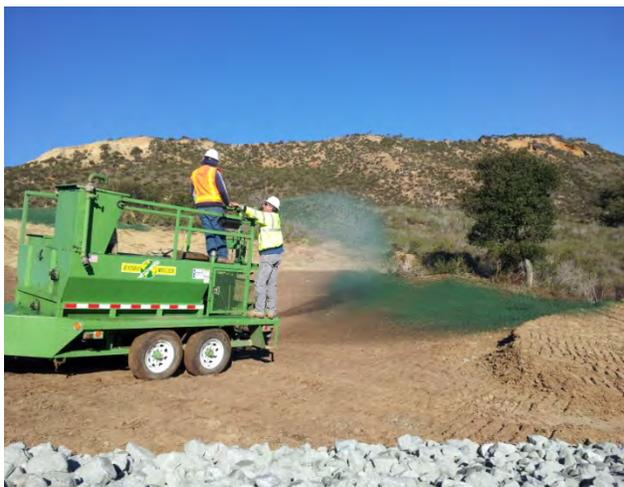
Hydro-mulching mid-site.

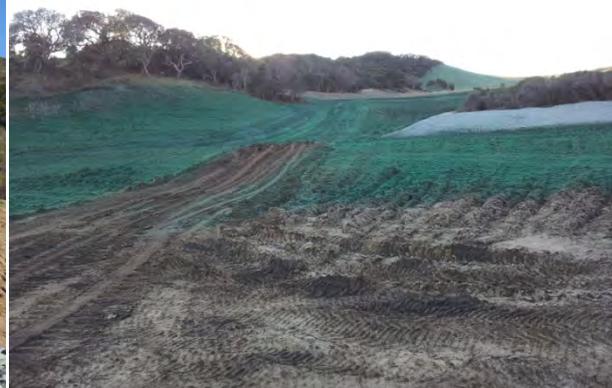
Lower-site post hydro-mulching

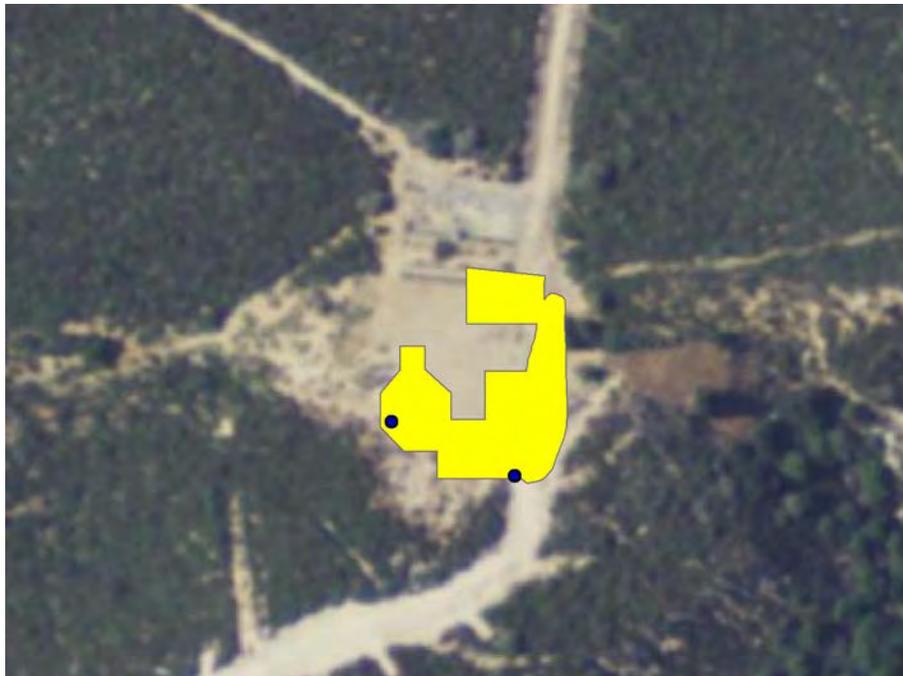
HA 36 Aerial Image (North is up).

- HA 36 consists of one polygon with no areas set aside for HMP forb broadcasting.
- HA 36 is approximately 0.39 acres.
- Isolated pampas grass plants are present around the site.
- The southern edge of the site has serious erosion issues.
- The immediate area around the site is low quality recently mowed chaparral.
- The polygon has straw crimped.
- The site is covered in bulldozer tracks and the soil is compacted.
- Very little natural recruitment observed at the site.

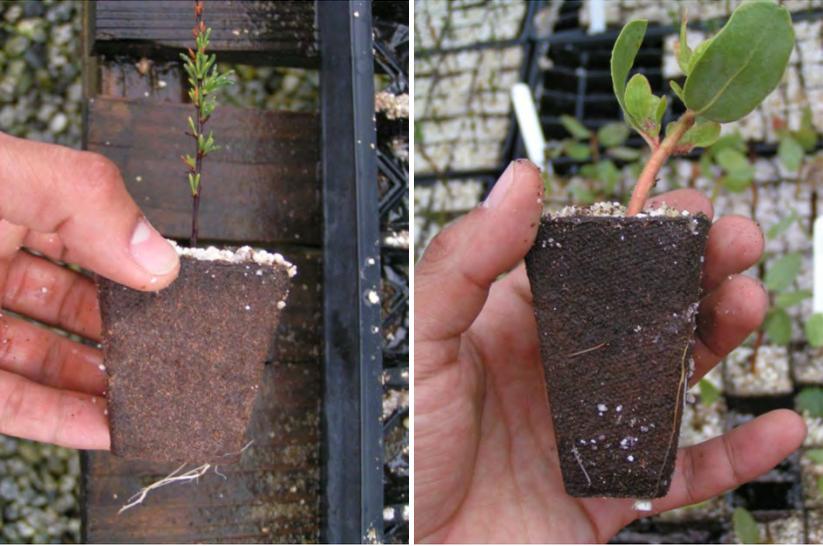
Photo Description	Photo
<p>Plant Material Storage, Processing, and Propagation</p> <p>Rooting <i>Adenostoma fasciculatum</i> (left) and <i>Arctostaphylos montereyensis</i> (right) from cuttings propagated in peat pots, November 2012.</p> <p style="text-align: center;">B-8</p>

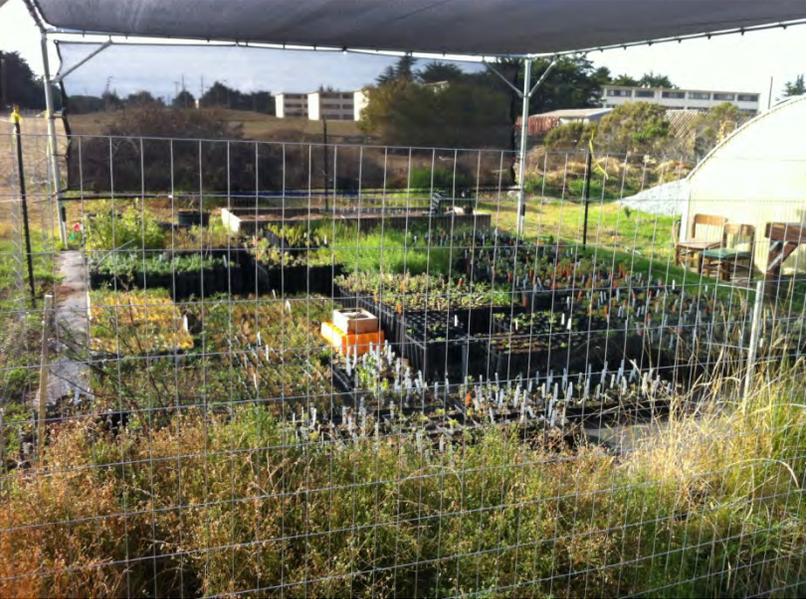
Photo Description	Photo
<p>Plant Material Storage, Processing, and Propagation</p> <p>Greenhouse shade structure with fencing to prevent herbivory of propagated species.</p> <p style="text-align: center;">B-12</p>

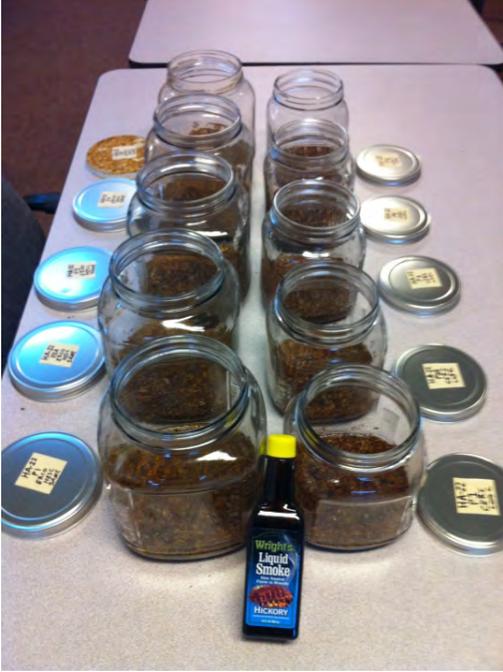
Photo Description	Photo
<p>Plant Material Storage, Processing, and Propagation</p> <p>Samples of seed mixes treated with liquid smoke.</p> <p style="text-align: center;">B-14</p>

E. fasciculata - grow trial test results using liquid smoke suggested that no additional treatment is necessary. There was no significant difference in mean observed germination of *E. fasciculata* in smoke treatment or control (DI) ($t = 1.5822$, $df = 2.358$, $p\text{-value} = 0.2355$). Results were in line with observations from Detka (2007). The seeds were sown directly into seed trays with conventional soil mixture and yielded germination rates exceeding 50%. Plants have been successfully re-potted and the species is responding well to hardening outside of the greenhouse environment. No additional grow trials are necessary and future propagation requires no additional seed treatment.

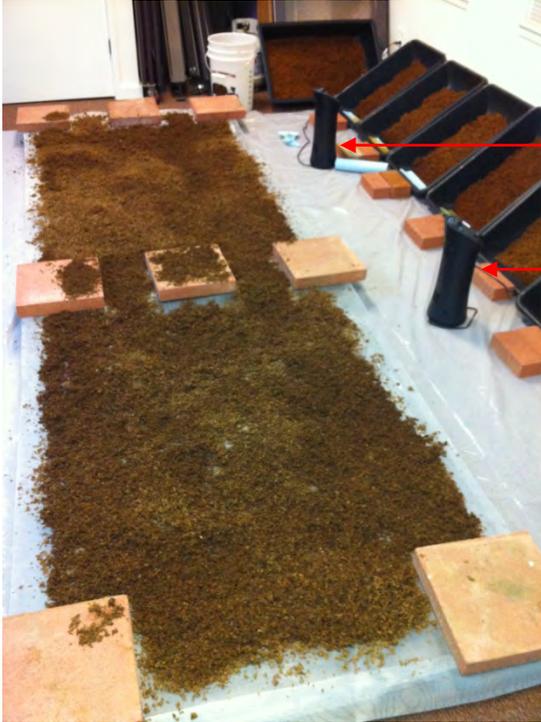
<p>Plant Material Storage, Processing, and Propagation</p> <p><i>Lotus scoparius</i> drying after treatment. Seed placed in bins with fan ventilation and on fine mesh elevated screens to allow for air flow, November 2012.</p> <p style="text-align: center;">B-15</p>

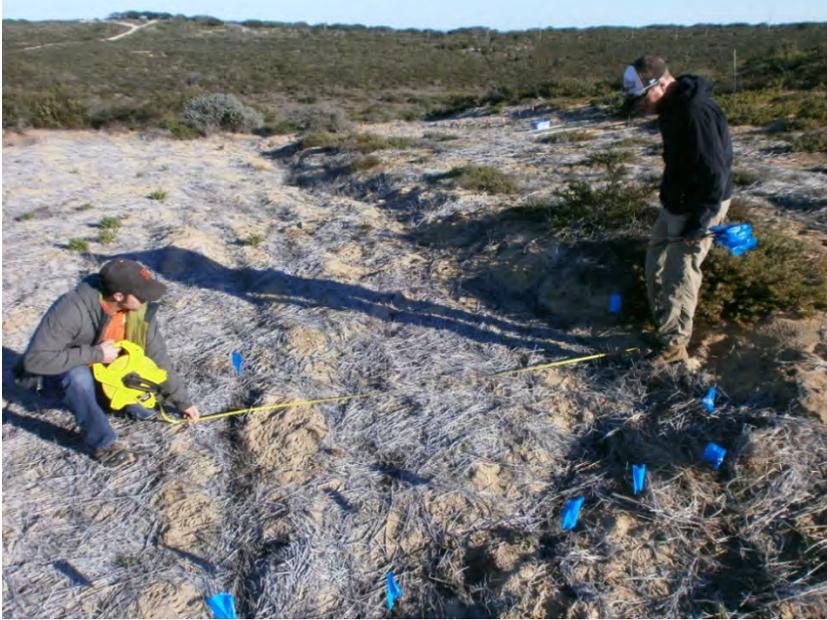
Photo Description	Photo
<p>Restoration Activities</p> <p>Burleson Horticultural Technician and Staff Biologist measuring HMP forbs broadcasting location at HA 43. Blue pin flags indicate HMP forbs broadcast location for future monitoring.</p> <p style="text-align: center;">D-2</p>

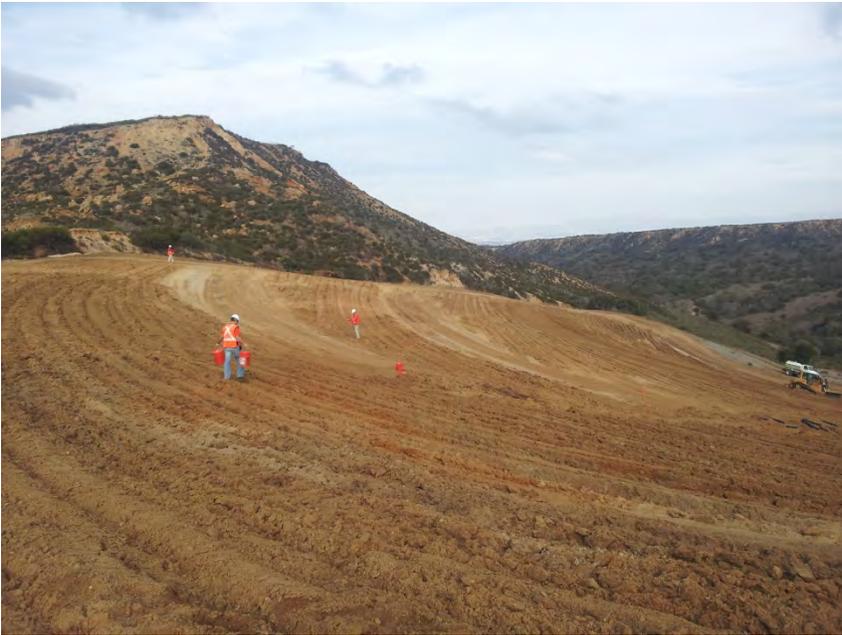
<p>Restoration Activities</p> <p>Upper section of HA34, after initial grading activities, prepared for seed broadcasting, November 2012.</p> <p style="text-align: center;">D-9</p>

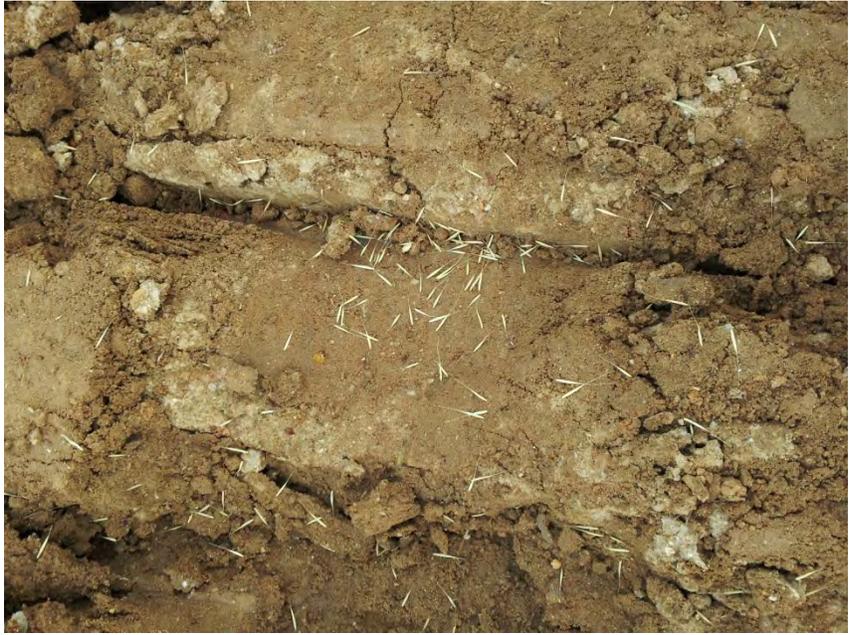
Photo Description	Photo
<p>Restoration Activities</p> <p>Example seed coverage and composition broadcast at HA34, November 2012.</p> <p style="text-align: center;">D-12</p>

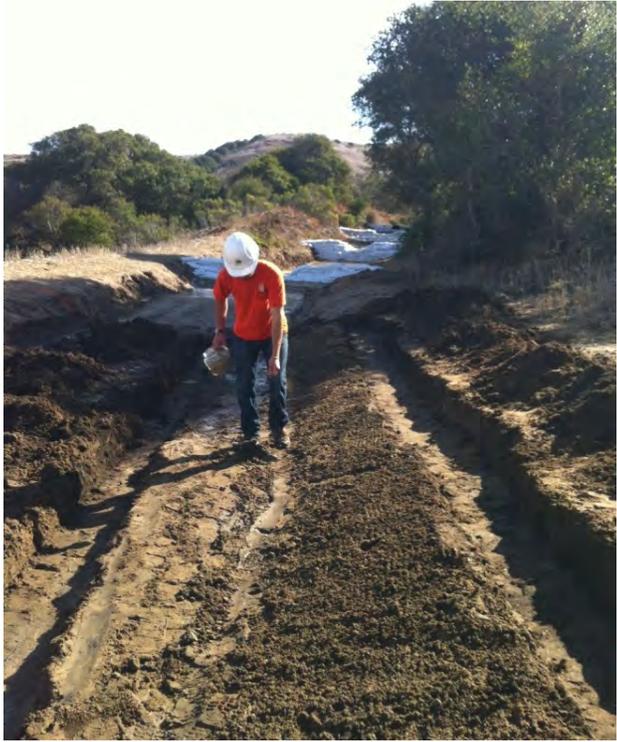
<p>Storm Related Erosion (at HA34)</p> <p>Erosion control method at HA34 using netting, photo showing scoured trench banks and erosion occurring underneath the coir fabric, December 2012.</p> <p style="text-align: center;">E-1</p>

- Photo documented erosion damage and loss of seed at site after rain event.

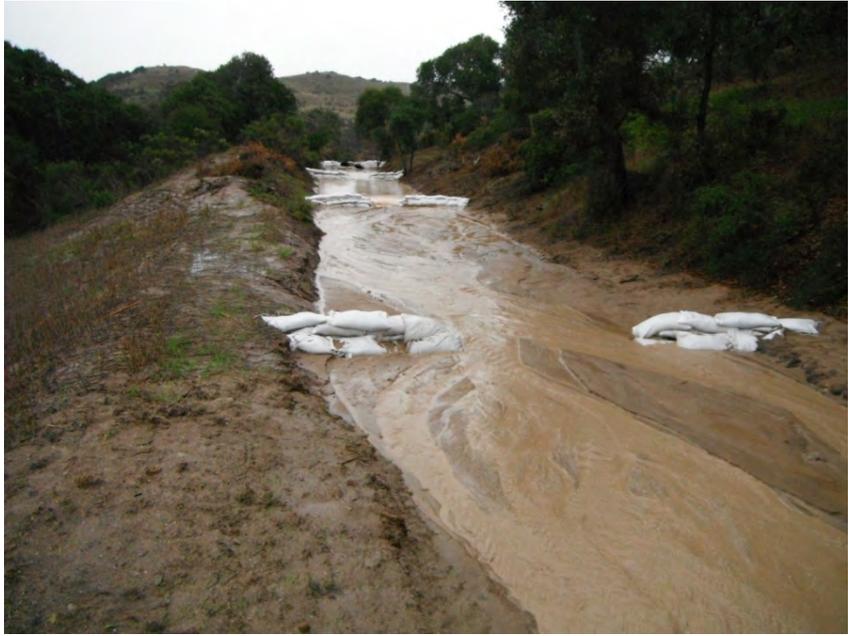
<p>Erosion Control Activities</p> <p>Establishing erosion control wattle spacing at HA29. Blue flags designate future placement of wattle, October 2012.</p> <p style="text-align: center;">F-1</p>

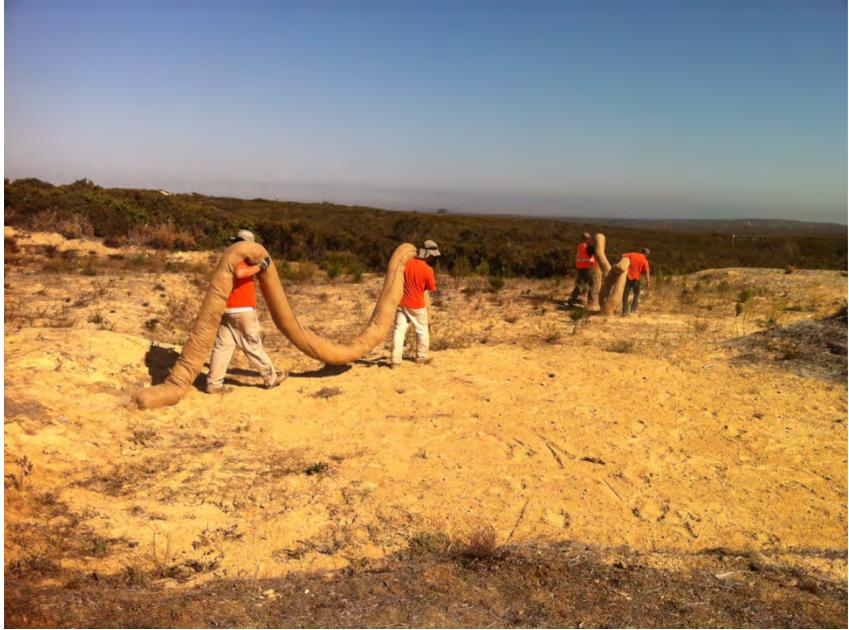
<p>Erosion Control Activities</p> <p>Burleson Horticultural Technicians excavating wattle footprint to provide erosion control stability, October 2012.</p> <p style="text-align: center;">F-3</p>

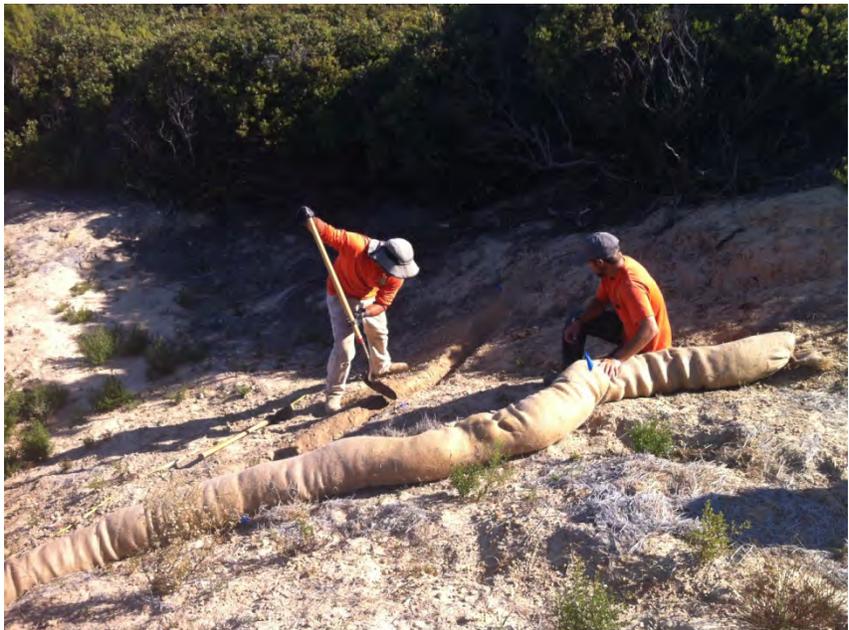
Photo Description	Photo
<p>Erosion Control Activities</p> <p>Burleson Horticultural Technicians stabilizing erosion control structures at HA29, October 2012.</p> <p style="text-align: center;">F-4</p>

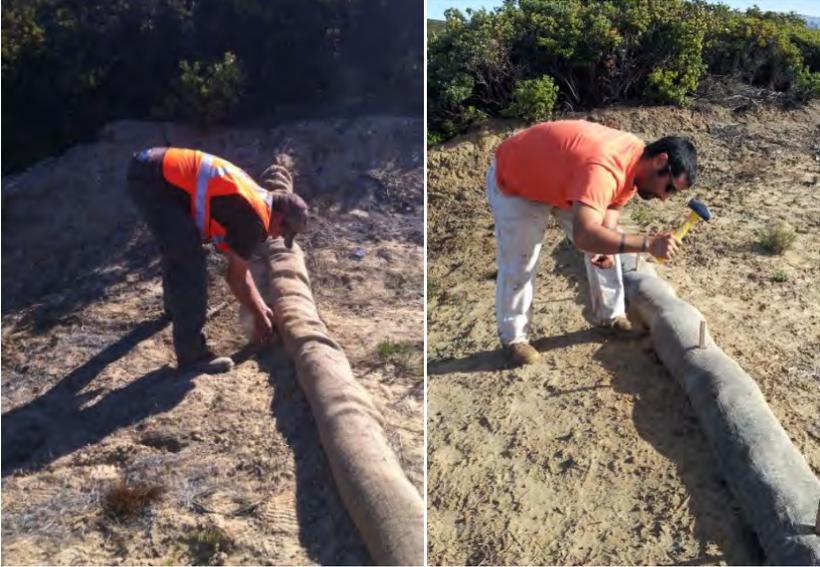
<p>Erosion Control Activities</p> <p>Effective wattle erosion control method showing the prevention of extended sediment transport after large storm event at HA39/40. Note coir fabric underneath wattles at far end, December 2012.</p> <p style="text-align: center;">F-5</p>

Burleson completed minor storm water related site repairs in 2012 under TO 4. Repair of erosion damage and implementation of erosion and sediment control Best Management Practices (BMP) were completed for HA 39/40 and HA 29. Activities included installing 50 linear feet of straw fiber rolls for HA 29 and installing 1,100 linear feet of fiber rolls and 1,518 square feet of coir fabric on HA 39/40. Erosion and sediment control BMP and seeding were installed according to documentation provided by USACE. Photographs of erosion control activities can be viewed in Appendix D.

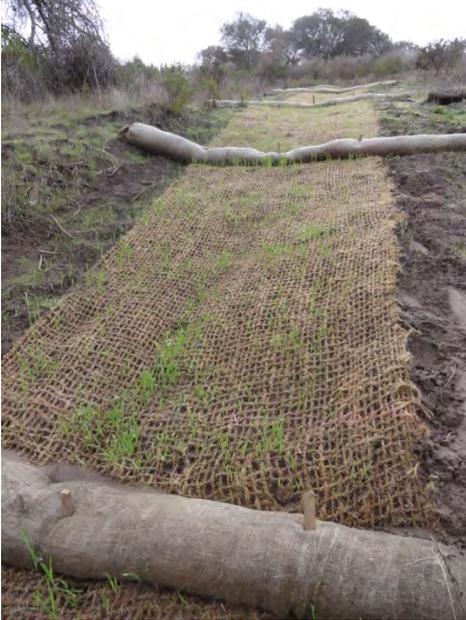
Photo Description	Photo
<p>Erosion Control Activities</p> <p>Effective erosion control method showing the prevention of extended sediment transport and sprouting of seed after large storm event at HA39/40, December 2012.</p> <p style="text-align: center;">F6</p>

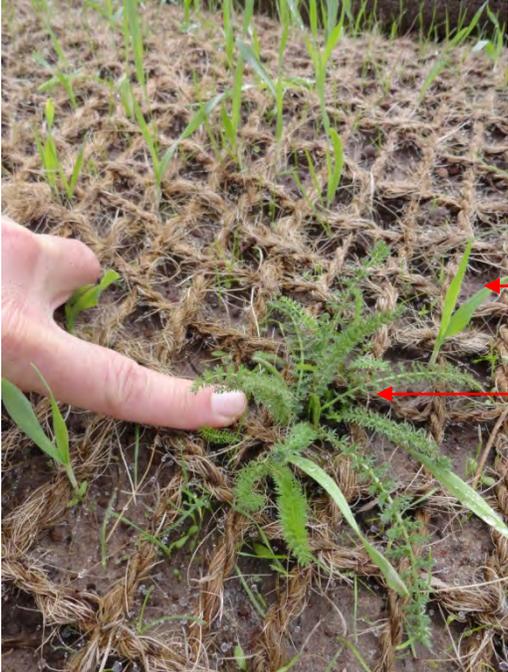
<p>Erosion Control Activities</p> <p>Seedlings sprouting as part of erosion control and habitat restoration at HA39/40, December 2012.</p> <p style="text-align: center;">F-7</p>
