2015 ANNUAL PLAN
FORMER FORT ORD SITE 39 HABITAT RESTORATION

**FINAL | 2015 ANNUAL REPORT
FORMER FORT ORD SITE 39 HABITAT RESTORATION
CONTRACT NO. W91238-14-D-0010-0001**

US Army Corps of Engineers
Sacramento District
1325 J Street
Sacramento, CA 95814-2922

Burleson Consulting Inc.
950 Glenn Drive, Suite 245
Folsom, CA 95630

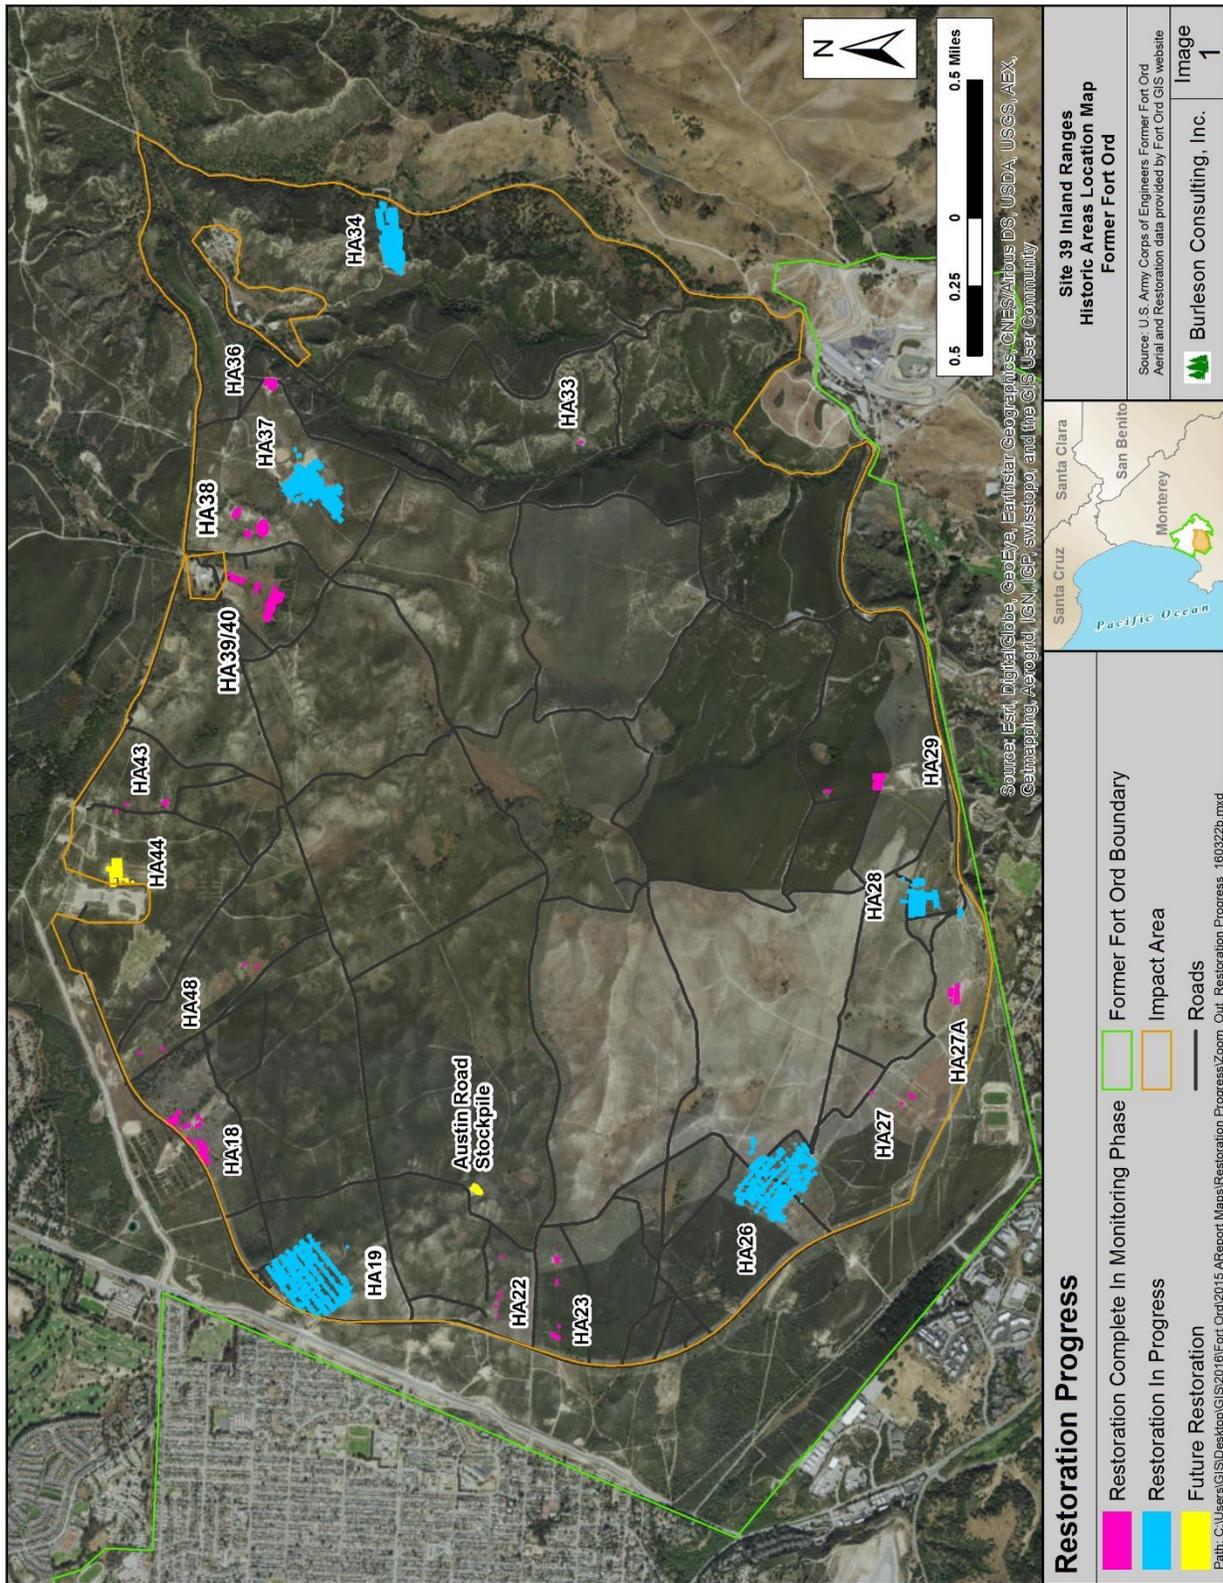
Image 1. Restoration Progress Map.

SSRPs have been developed for 18 HAs and one stockpile area requiring habitat restoration for 61.71 acres. The 19 SSRPs have prescribed passive restoration (seeding) to 31.87 acres and active restoration (seeding and planting) to 29.84 acres. Active restoration requires installation of approximately 52,000 plants. Image 1 presents the current status of restoration sites within Site 39 Inland Ranges.

Both active and passive restoration activities began in 2011 and are ongoing. By the end of the 2015 calendar year, approximately 42 acres had been seeded (passive restoration) and about 22,000 plants had been installed (active restoration). Twelve of the 19 restoration sites have received their full SSRP restoration prescription and are currently in a monitoring phase. Five of the sites have received some level of restoration and two sites have not received any restoration to date.

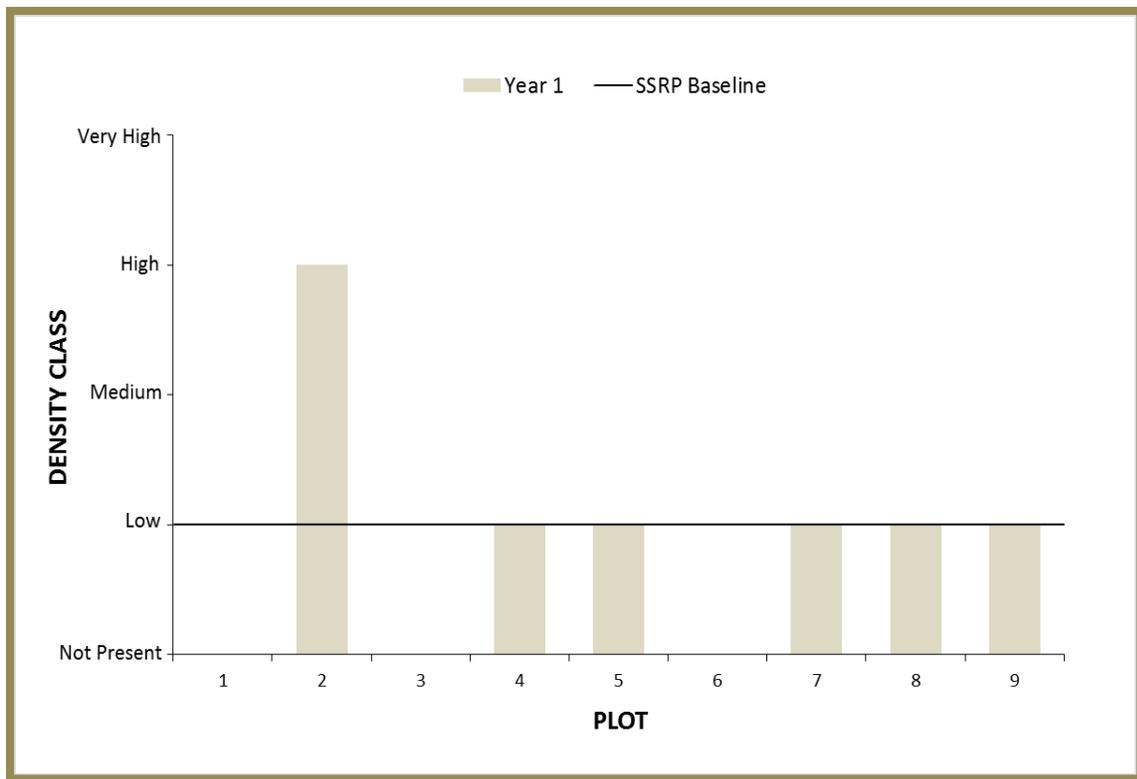
Nine sand gilia plots were surveyed for year 1 density at HA 19 in 2015. The plots are numbered 1-9 and are primarily located on the southwestern part of the site. SSRP baseline density class for sand gilia at HA 19 was low. Six of the nine plots met or exceeded the SSRP baseline density. Sand gilia was absent at plots 1, 3, and 6. Sand gilia was present in low density at plots 4, 5, 7, 8, and 9. Plot 2 had a high density of sand gilia. Graph 1 below represents all the sand gilia density data for HA 19. Table B-1 in Appendix B lists detailed results and Figure 8 in Appendix D show plot locations at HA 19.

Graph 1. HA 19 Comparison of Sand Gilia Density Classes to the SSRP Baseline Density Class for Year 1 at Restoration Plots 1-9.

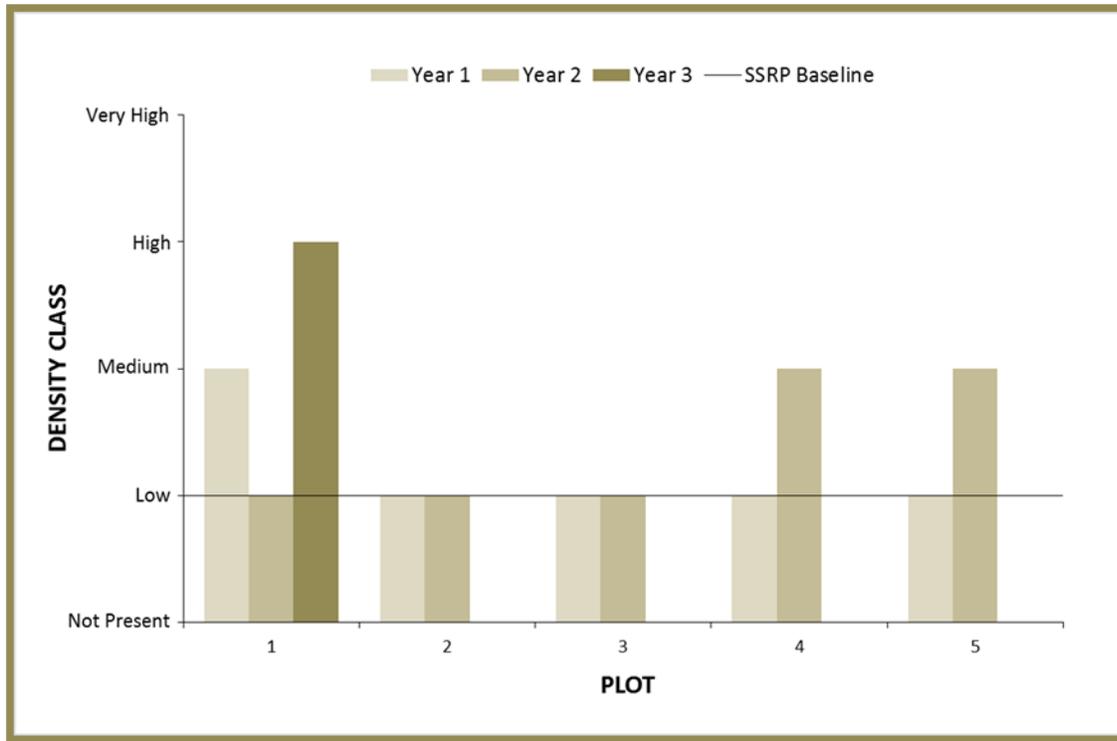
Five sand gilia plots are present at HA 39/40. In 2015, plot 1 was surveyed for year 3 density and plots 2 through 5 were surveyed for year 2 density. SSRP baseline density class for sand gilia at HA 39/40 was low. All five plots met or exceeded SSRP baseline density in 2015. Plot 1 year 3 density was high. Year 2 density at plots 2 and 3 were low, and year 2 density at plots 4 and 5 were medium. Graph 2 below represents all of the sand gilia density data for HA 39/40. Table B-1 in Appendix B lists detailed results and Figure 9 in Appendix D show plot locations at HA 39/40.

Graph 2. HA 39/40 Comparison of Sand Gilia Density Classes to the SSRP Baseline Density Class for Years 1, 2, and 3 at Restoration Plots 1-5.

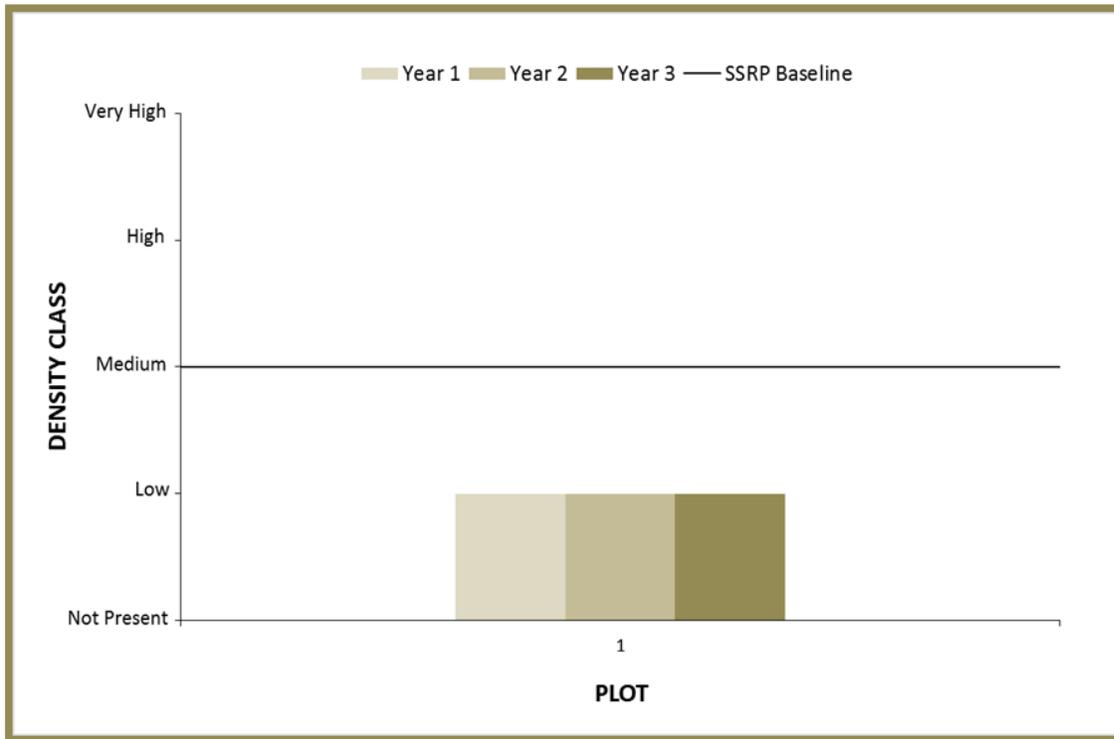
One sand gilia plot at HA 43 was surveyed for year 3 monitoring in 2015. SSRP baseline density class for sand gilia at HA 43 is medium. This plot had a low density for sand gilia for year 3. This plot has not met SSRP baseline density in years 1, 2, and 3. Graph 3 below represents all the sand gilia density data for HA 43. Table B-1 in Appendix B lists detailed results and Figure 10 in Appendix D shows plot location at HA 43.

Graph 3. HA 43 Comparison of Sand Gilia Density Classes to the SSRP Baseline Density Class for Years 1, 2, and 3 at Restoration Plot 1.

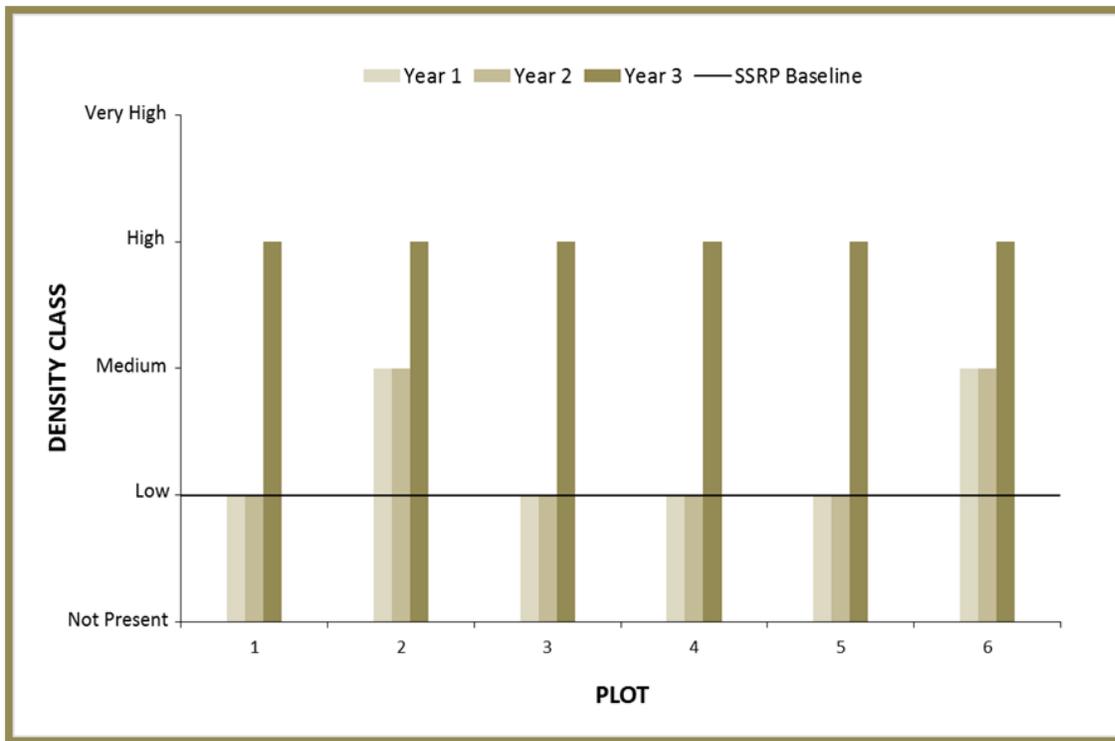
Year 3 monitoring occurred at six Monterey spineflower plots at HA 18 in 2015. SSRP baseline density for Monterey spineflower at HA 18 is low. The plots are scattered mainly around the northern section of the site in suitable habitat. All six plots had high densities of Monterey spineflower. All six have met or exceeded SSRP baseline density in years 1, 2, and 3. Graph 4 below represents all the Monterey spineflower density data for HA 18. Table B-2 in Appendix B lists detailed results and Figure 11 in Appendix D shows locations of the plots at HA 18.

Graph 4. HA 18 Comparison of Monterey Spineflower Density Classes to the SSRP Baseline Density Class for Years 1, 2, and 3 at Restoration Plots 1-6.

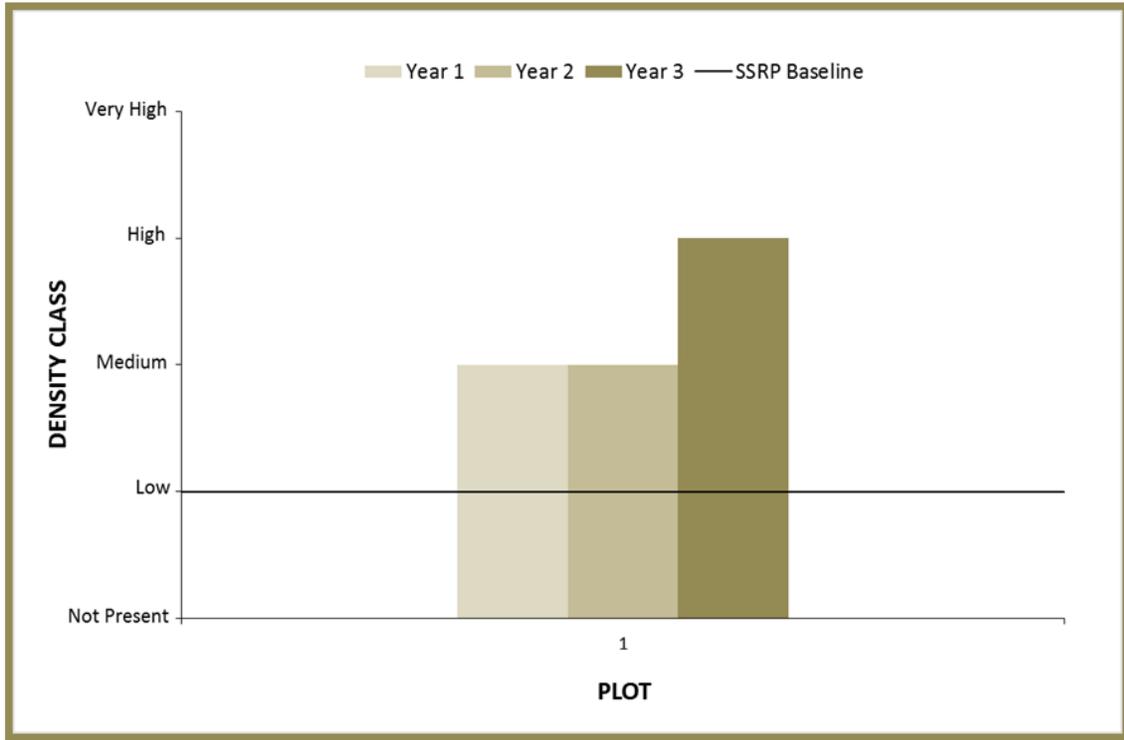
One Monterey spineflower plot at HA 22 was surveyed for year 3 monitoring in 2015. SSRP baseline density for Monterey spineflower at HA 22 is low. This plot had a high density of Monterey spineflower in 2015. This plot has exceeded SSRP baseline density in years 1, 2, and 3. Graph 5 below represents all Monterey spineflower density data for HA 22. Table B-2 in Appendix B lists detailed results and Figure 12 in Appendix D shows the location of the plot.

Graph 5. HA 22 Comparison of Monterey Spineflower Density Classes to the SSRP Baseline Density Class for Years 1, 2 and 3 at Restoration Plot 1.

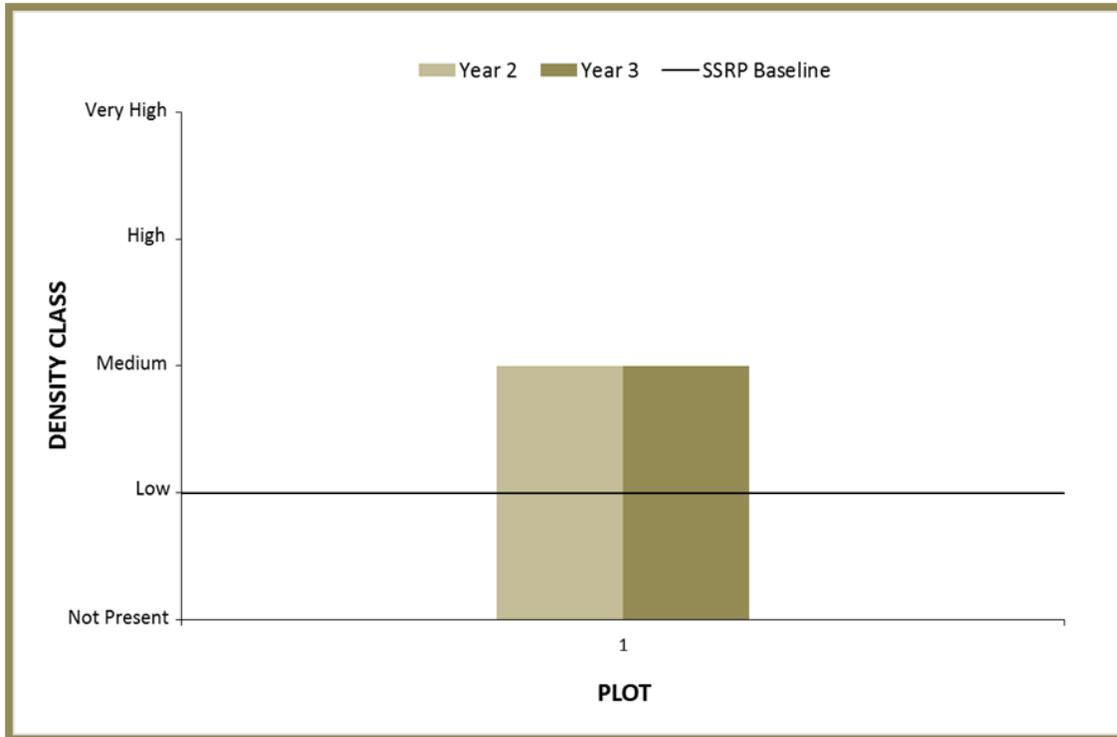
One Monterey spineflower plot at HA 23 was surveyed for year 3 monitoring in 2015. SSRP baseline density for Monterey spineflower at HA 23 is low. This plot had a medium density of Monterey spineflower in 2015. This plot exceeded SSRP baseline density in years 2 and 3. No data is available for year 1. The plot was inaccessible during the 2013 survey season due to mastication activities in the nearby burn unit. Graph 6 below represents all Monterey spineflower density data for HA 23. Table B-2 in Appendix B lists detailed results and Figure 13 in Appendix D shows location of the plot.

Graph 6. HA 23 Comparison of Monterey Spineflower Density Classes to the SSRP Baseline Density Class for Years 2 and 3 at Restoration Plot 1.

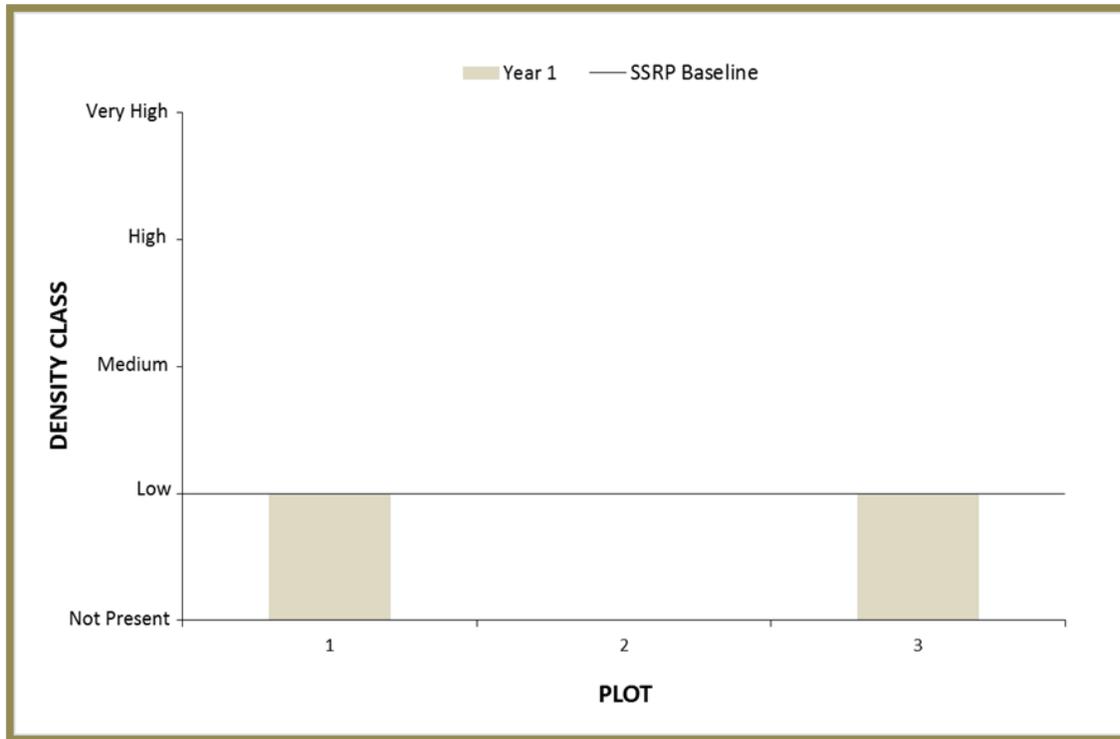
In 2015, three Monterey spineflower plots were surveyed for year 1 monitoring at HA 28. SSRP baseline density for Monterey spineflower at HA 28 is low. Plots 1 and 2 are located in the eastern part of the site and plot 3 is located in the northwestern part of the site. Monterey spineflower was present in low density at plots 1 and 3 and absent in plot 2. Graph 7 below represents all Monterey spineflower density data at HA 28. Table B-2 in Appendix B lists detailed results and Figure 14 in Appendix D shows locations of the plots at HA 28.

Graph 7. HA 28 Comparison of Monterey Spineflower Density Classes to the SSRP Baseline Density Class for Year 1 at Restoration Plots 1-3.

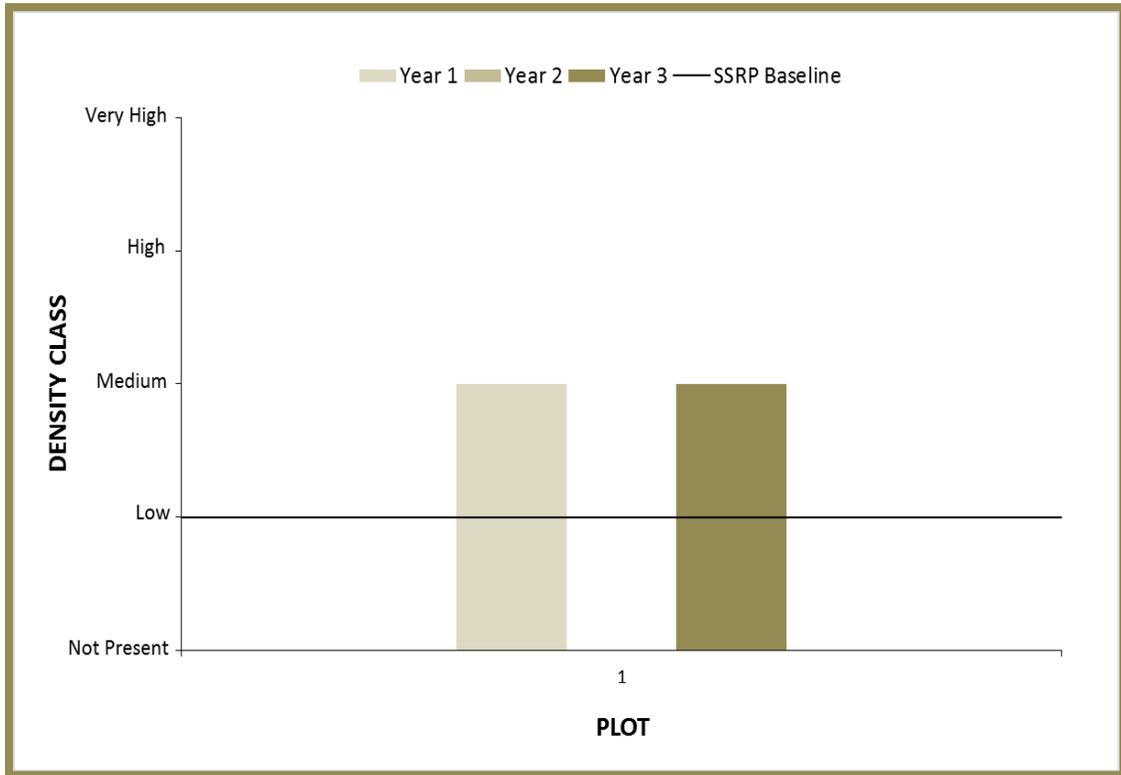
One Monterey spineflower plot at HA 33 was surveyed for year 3 monitoring in 2015. SSRP baseline density for Monterey spineflower at HA 33 is low. This plot had a medium density of Monterey spineflower in 2015. The plot exceeded SSRP baseline density in years 1 and 3, and was not present in year 2. Graph 8 below represents all Monterey spineflower density data at HA 33. Table B-2 in Appendix B lists detailed results and Figure 15 in Appendix D shows location of the plot.

Graph 8. HA 33 Comparison of Monterey Spineflower Density Classes to the SSRP Baseline Density Class for Years 1, 2, and 3 at Restoration Plot 1.

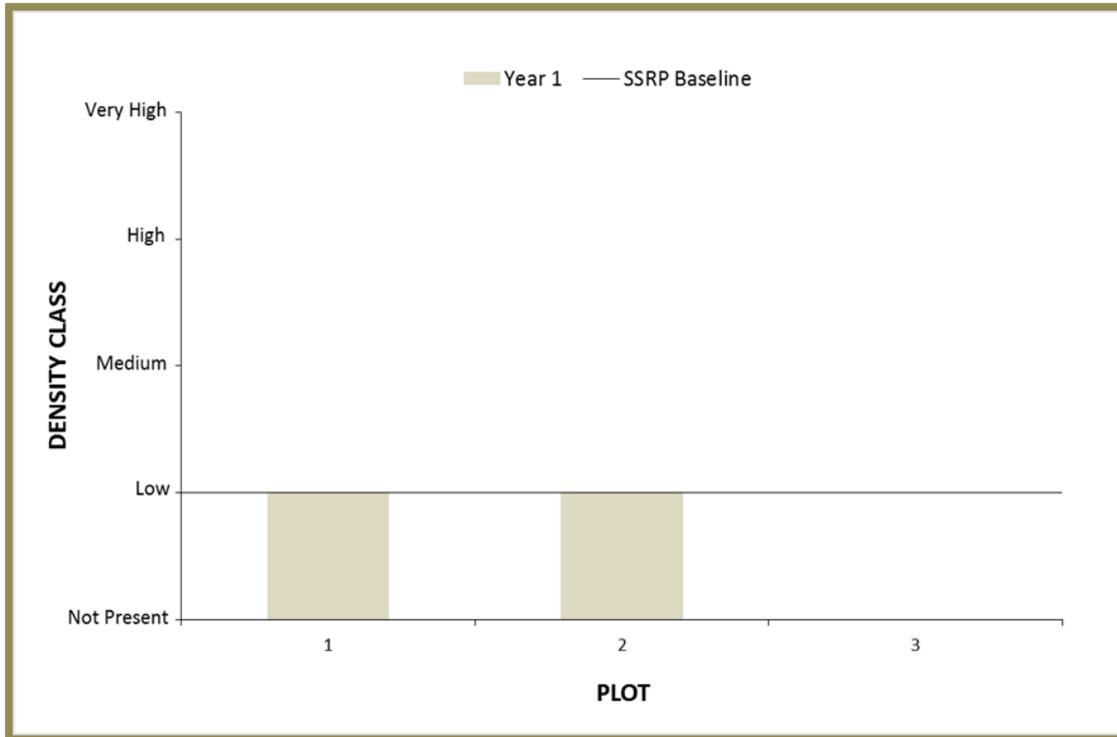
Four Monterey spineflower plots are present at HA 37. Year 1 monitoring was conducted at plots 1 through 3 in 2015. Plot 4 was created in November 2015. SSRP baseline density for Monterey spineflower at HA 37 was low. The plots are located in the southern part of the site in suitable habitat. Monterey spineflower was present in low density at plots 1 and 2 and was absent in plot 3. Graph 9 below represents all Monterey spineflower density data at HA 37. Table B-2 in Appendix B for lists detailed results and Figure 16 in Appendix D shows the locations of the plots in HA 37.

Graph 9. HA 37 Comparison of Monterey Spineflower Density Classes to the SSRP Baseline Density Class for Year 1 at Restoration Plots 1-3.

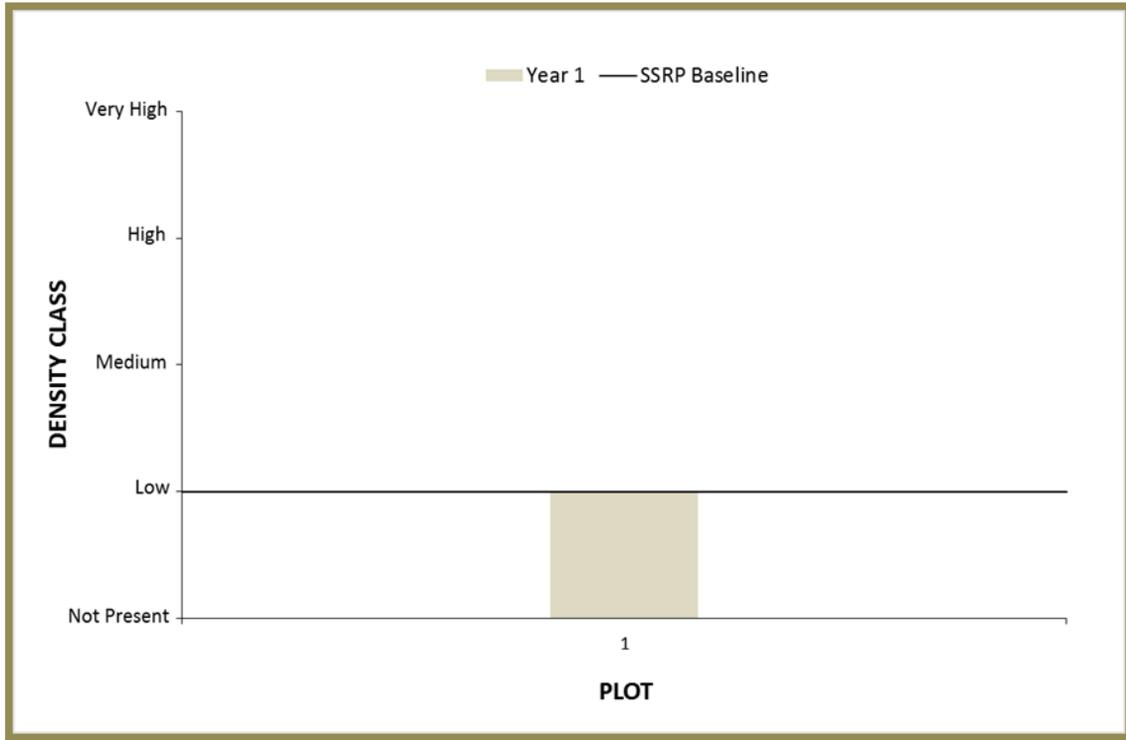
One Monterey spineflower plot at HA 38 was surveyed for year 1 monitoring in 2015. SSRP baseline density for Monterey spineflower at HA 38 is low. Monterey spineflower was present in low density in this plot located in the western part of the site. Graph 10 below represents all Monterey spineflower density data at HA 38. Table B-2 in Appendix B lists detailed results and Figure 17 in Appendix D shows the location of the plot.

Graph 10. HA 38 Comparison of Monterey Spineflower Density Classes to the SSRP Baseline Density Class for Year 1 at Restoration Plot 1.

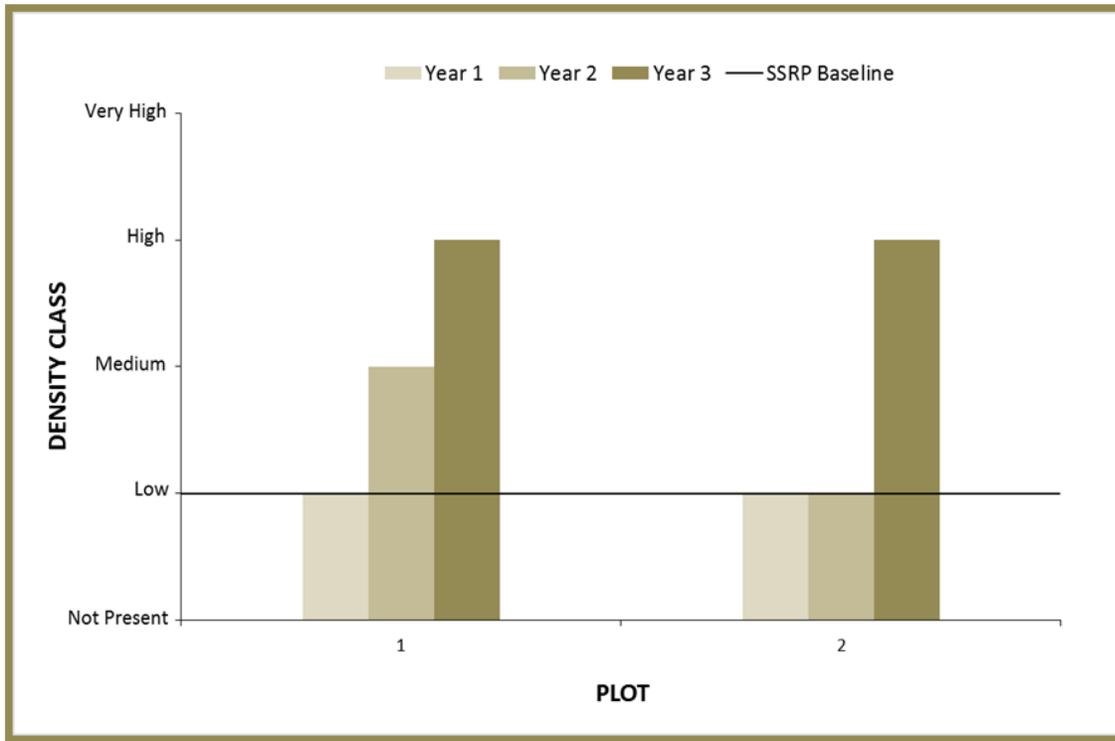
Graph 11. HA 39/40 Comparison of Monterey Spineflower Density Classes to the SSRP Baseline Density Class for Years 1, 2, and 3 at Restoration Plots 1 and 2.

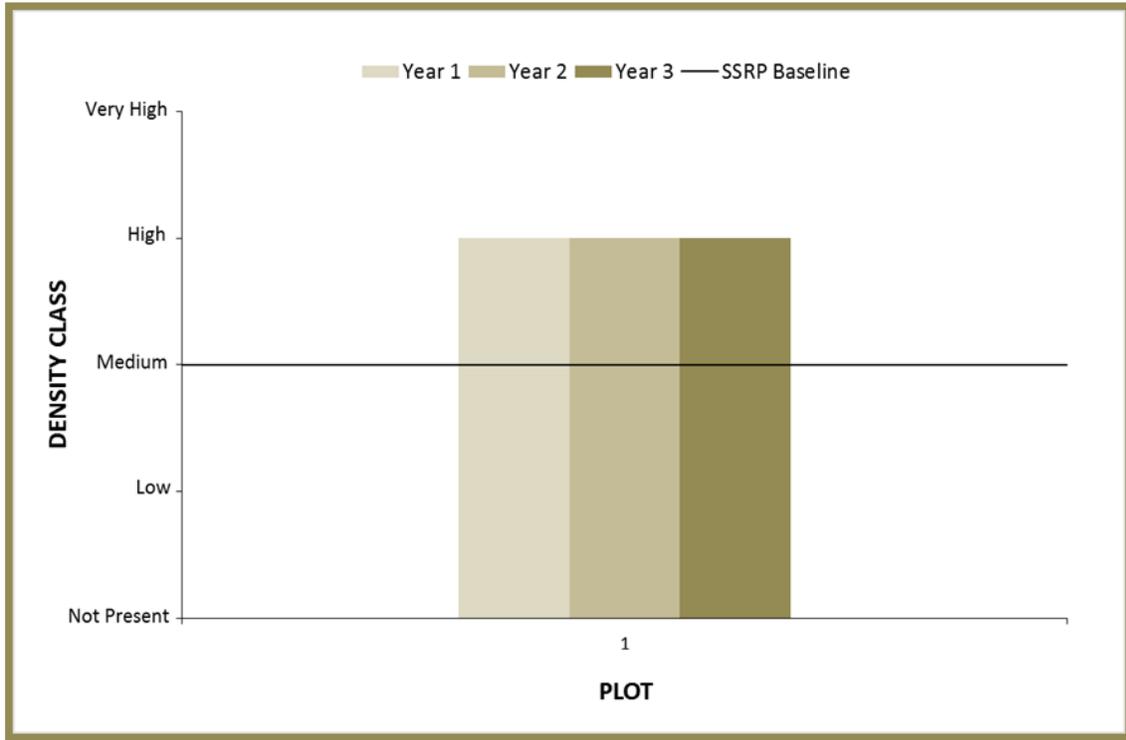
Graph 12. HA 43 Comparison of Monterey Spineflower Density Classes to the SSRP Baseline Density Class for Years 1, 2, and 3 at Restoration Plot 1.

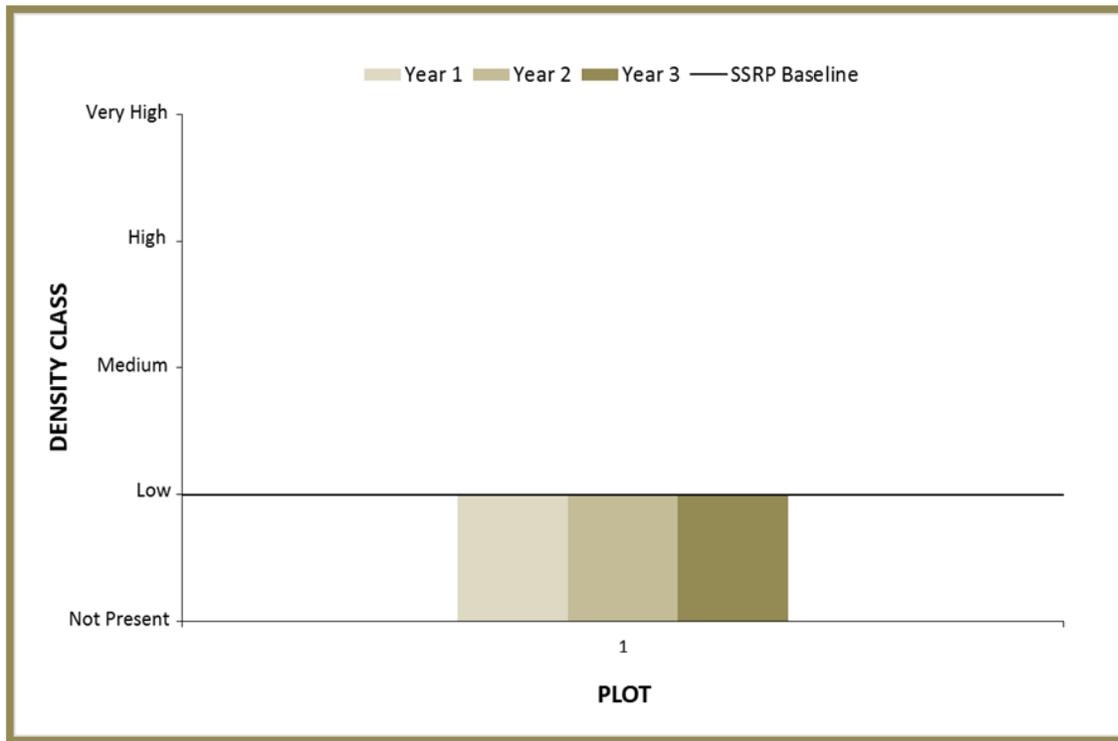
Graph 13. HA 39/40 Comparison of Seaside Bird’s Beak Density Classes to the SSRP Baseline Density Class for Years 1, 2, and 3 at Restoration Plot 1.

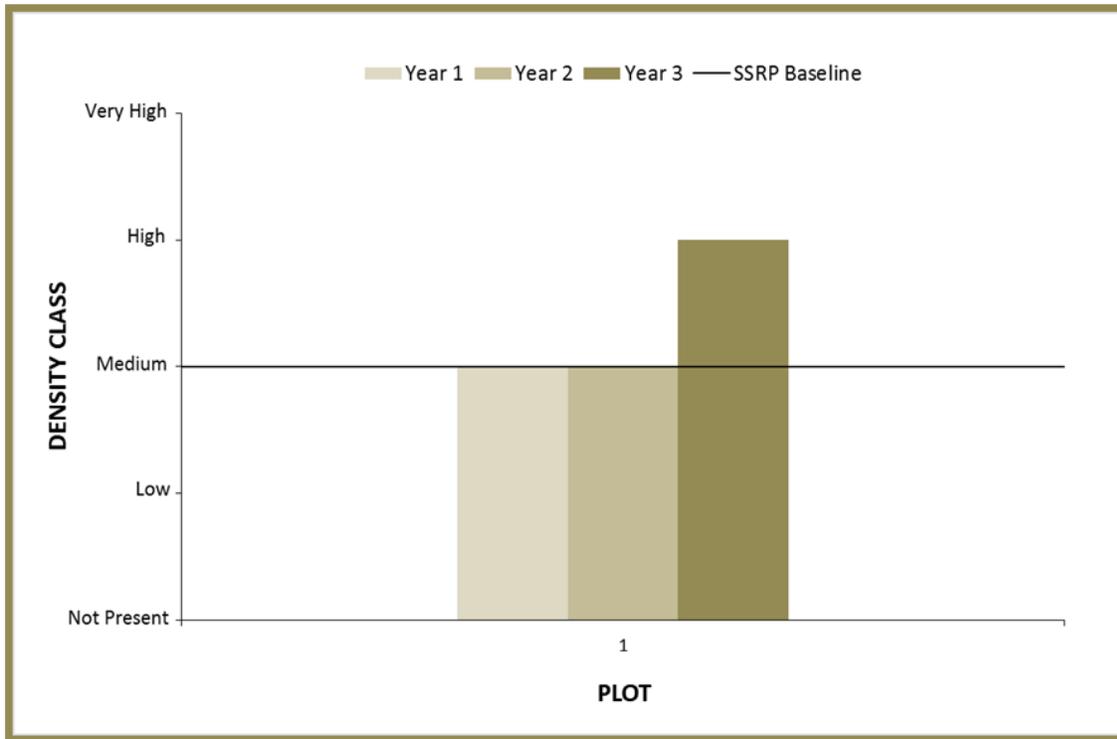
Graph 14. HA 43 Comparison of Seaside Bird’s Beak Density Classes to the SSRP Baseline Density Class for Years 1, 2, and 3 at Restoration Plot 1.

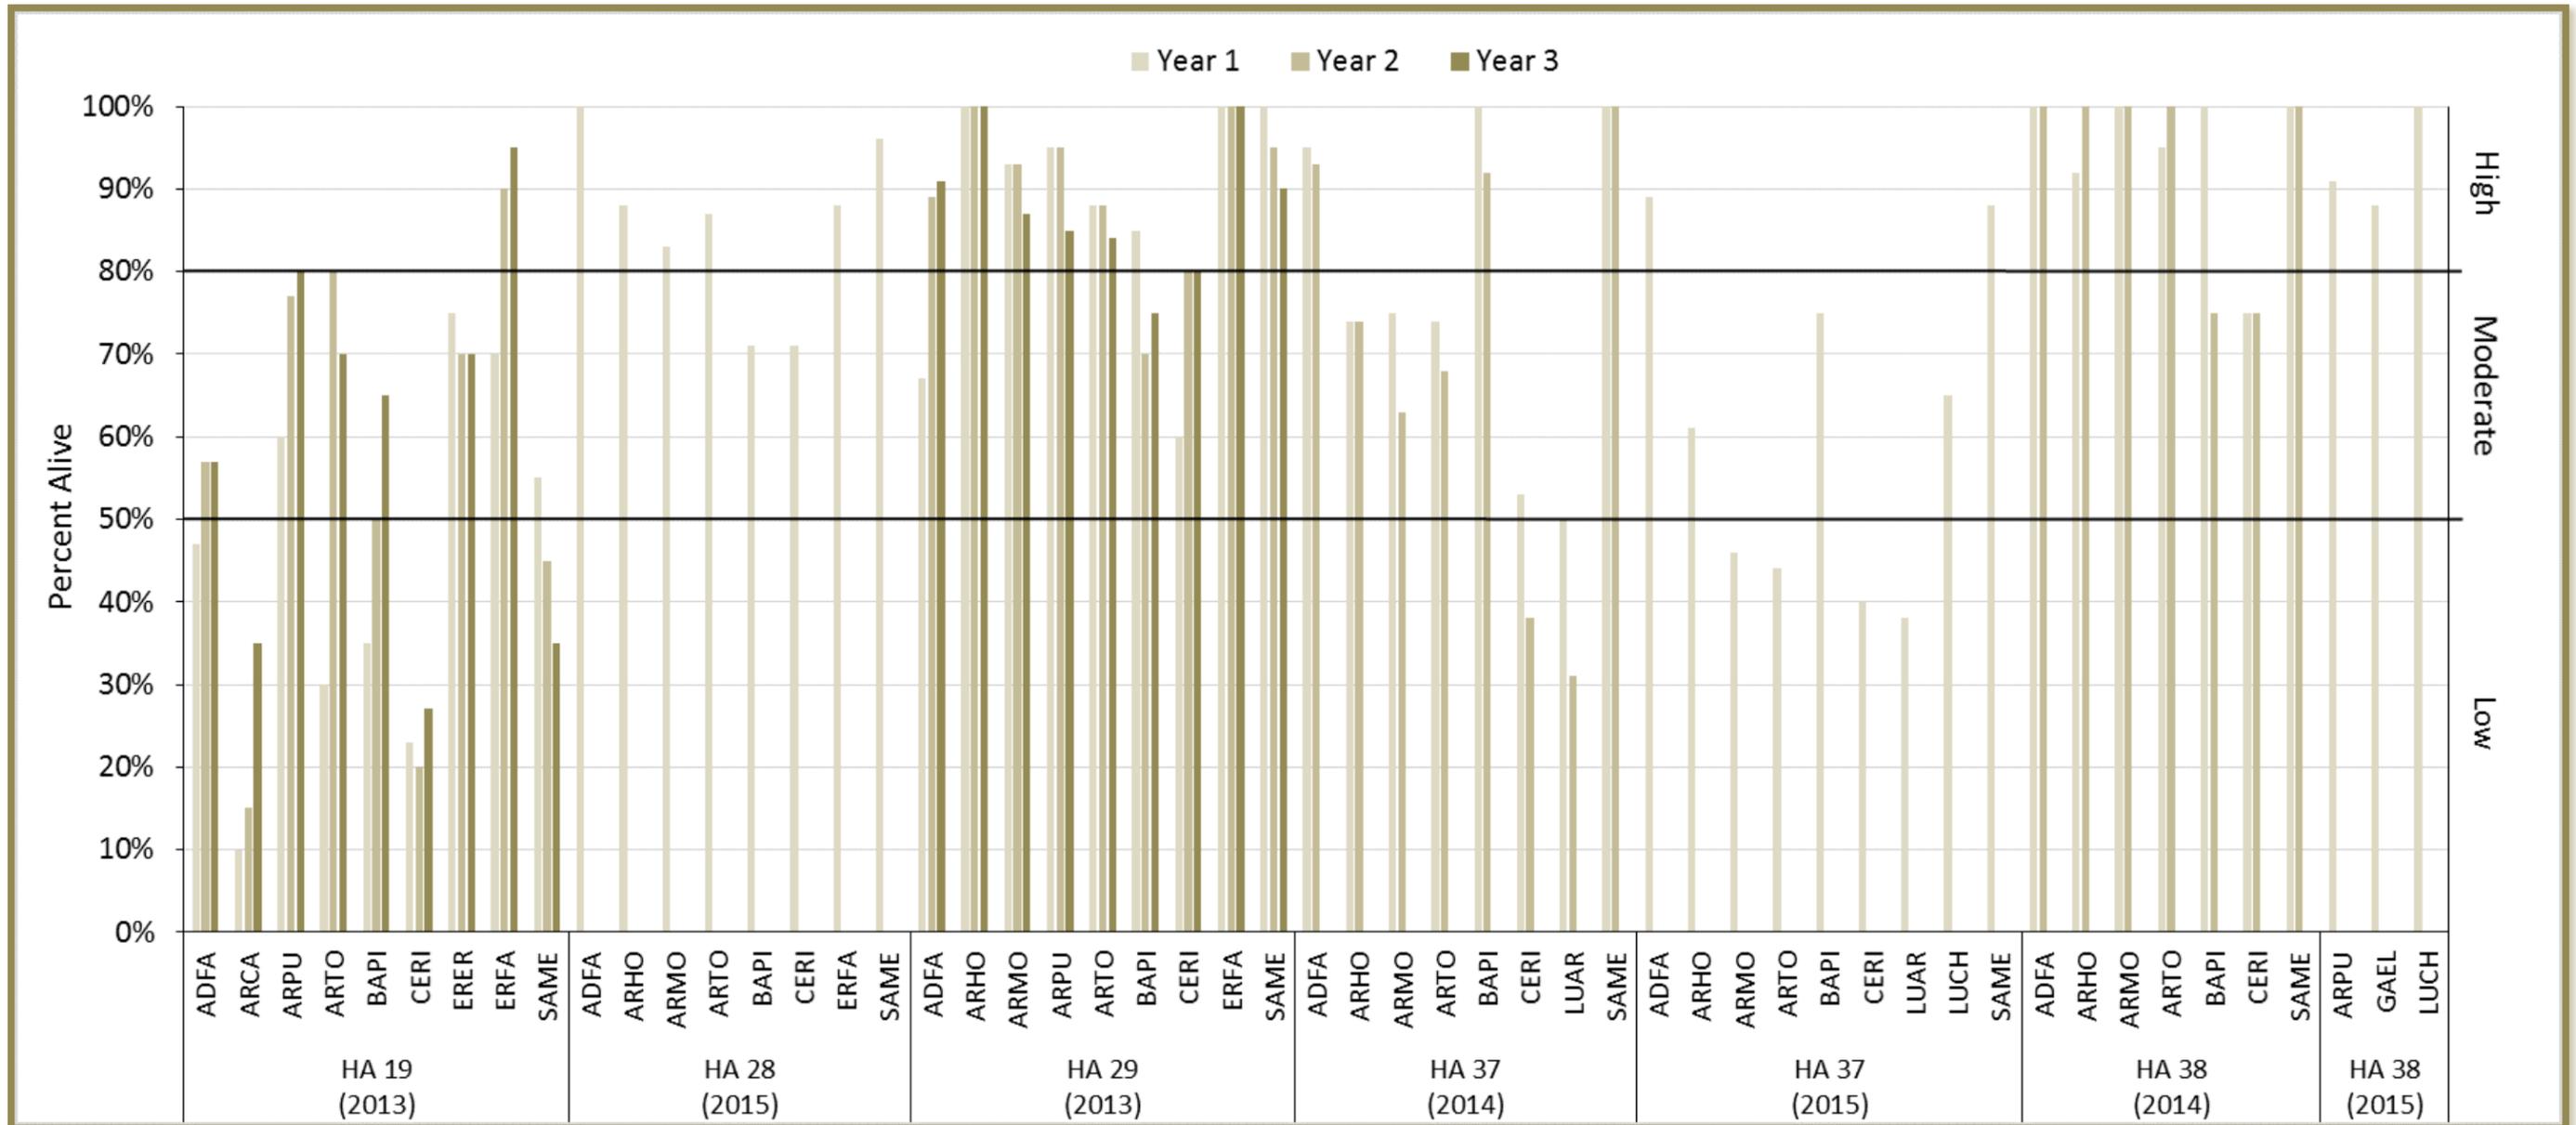
species at HAs 28, 29, and 38 was typically high with some moderate results. Plant survivorship success at HAs 19 and 37 however varies significantly between plant species and overall survivorship results are on the low end of moderate. These results indicate that restoration site conditions are a major factor in driving plant survivorship success. Further exploration of the characteristics of each site in comparison to each species, may provide a better understanding on what factors are impacting plant survivorship.

Graph 15. Plant Survivorship Results for All Restoration Sites and for All Years.

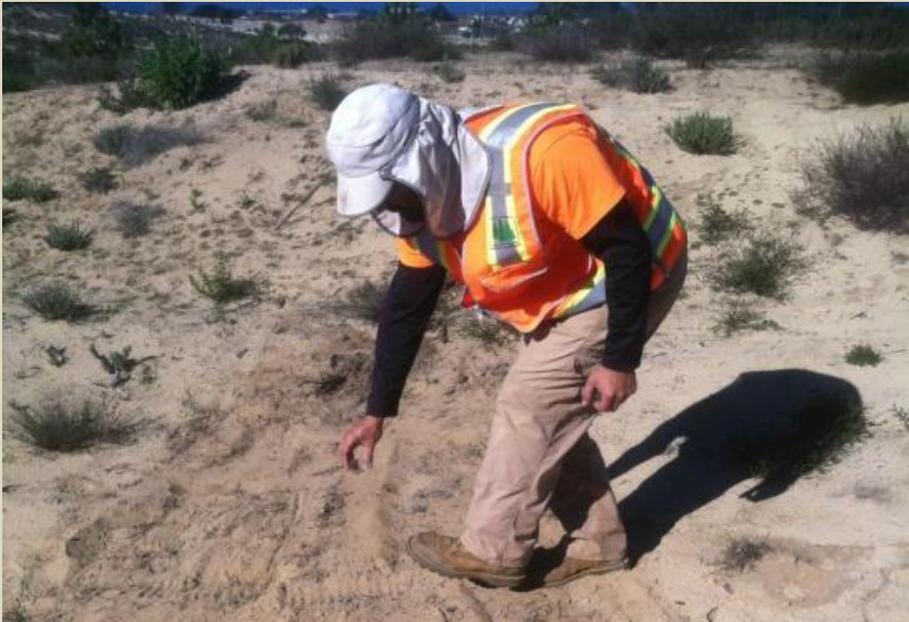
<p>Restoration Activities</p> <p>Broadcasting <i>Gilia tenuiflora</i> ssp. <i>arenaria</i> at HA 19.</p> <p>C-20</p>

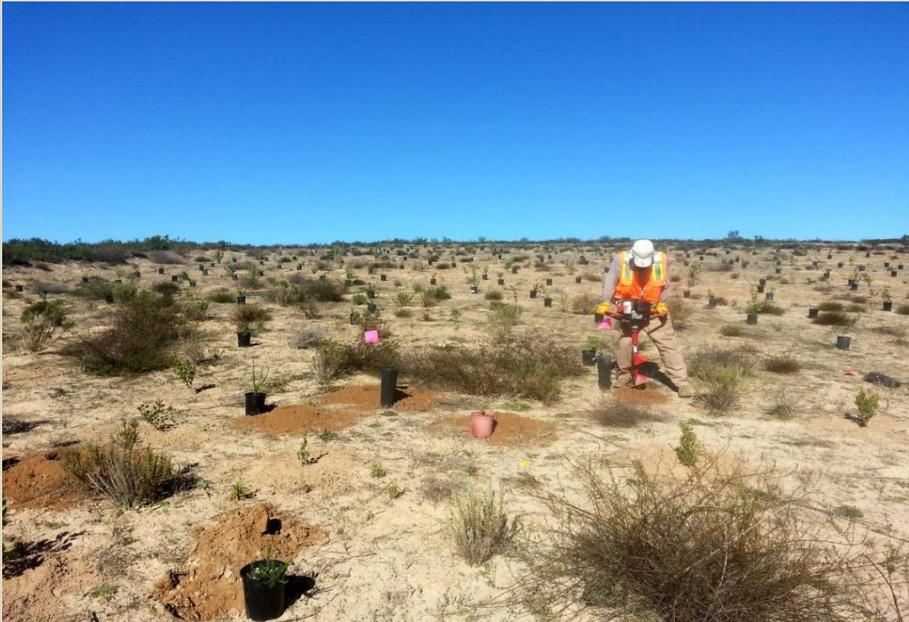
PHOTO DESCRIPTION	PHOTO
<p>Restoration Activities</p> <p>Digging holes with an auger for plant installation at HA 28.</p> <p>C-23</p>

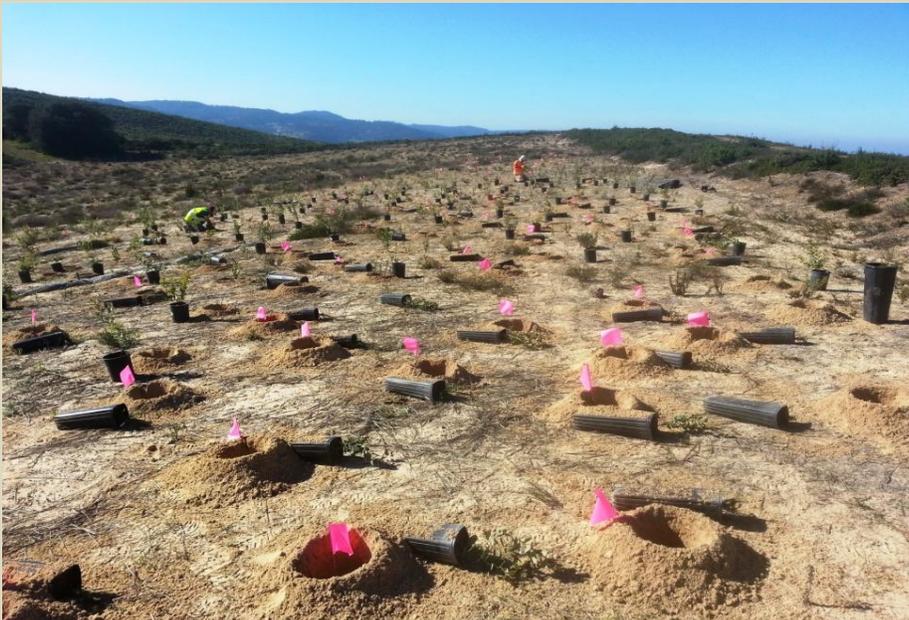
<p>Restoration Activities</p> <p>Staged plants in dug holes at HA 28.</p> <p>C-24</p>

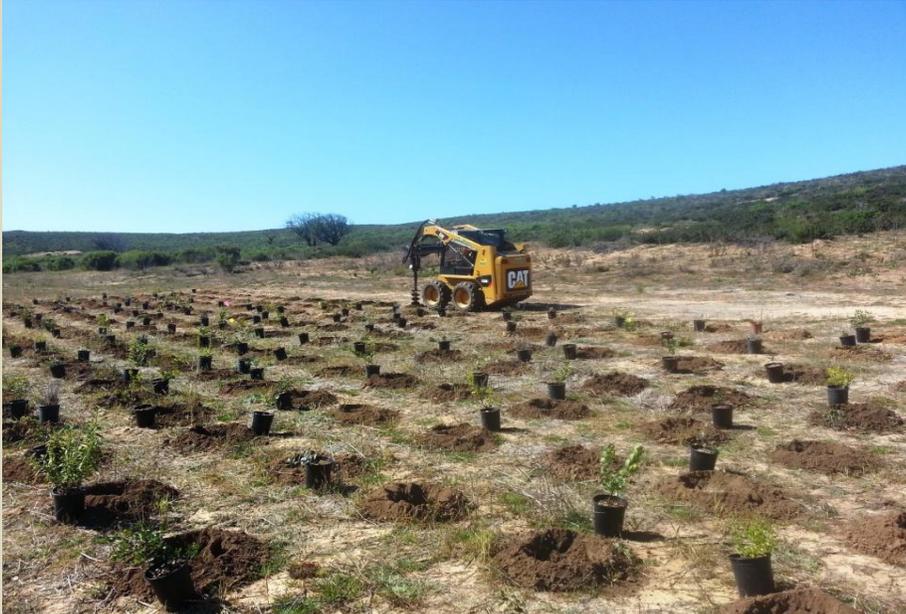
<p>Restoration Activities</p> <p>Bobcat with auger attachment digging holes for plant installation at HA 37.</p> <p>C-26</p>

In early 2015, Burleson installed 4,664 plants over approximately 2 acres at HA 37 as shown in Figure 6 in Appendix D. Due to compacted soil conditions at this site, a jackhammer and bobcat with an auger attachment were used. Plant targets for 2015 were met with the exception of two species: coast silk tassel (*Garrya elliptica*) and silver bush lupine (*Lupinus chamissonis*). The silver bush lupine missed target was due to low seed viability and the coast silk tassel missed target was due to low success from plant cuttings. These missed targets were substituted with other plant species suitable for HA 37. An additional 947 plants were installed at HA 37 to make up for the missed sandmat manzanita targets at HA 28, as discussed in Section 5.2.1. Table A-11 in Appendix A depicts the plant species and quantities planted at HA 37.

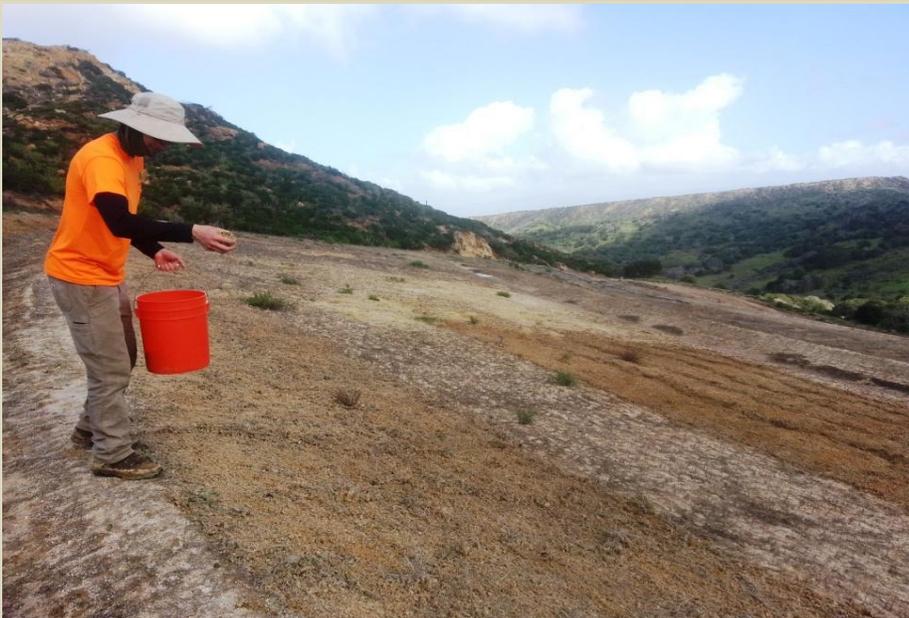
<p>Restoration Activities</p> <p>Seed broadcasting at HA 34.</p> <p>C-30</p>

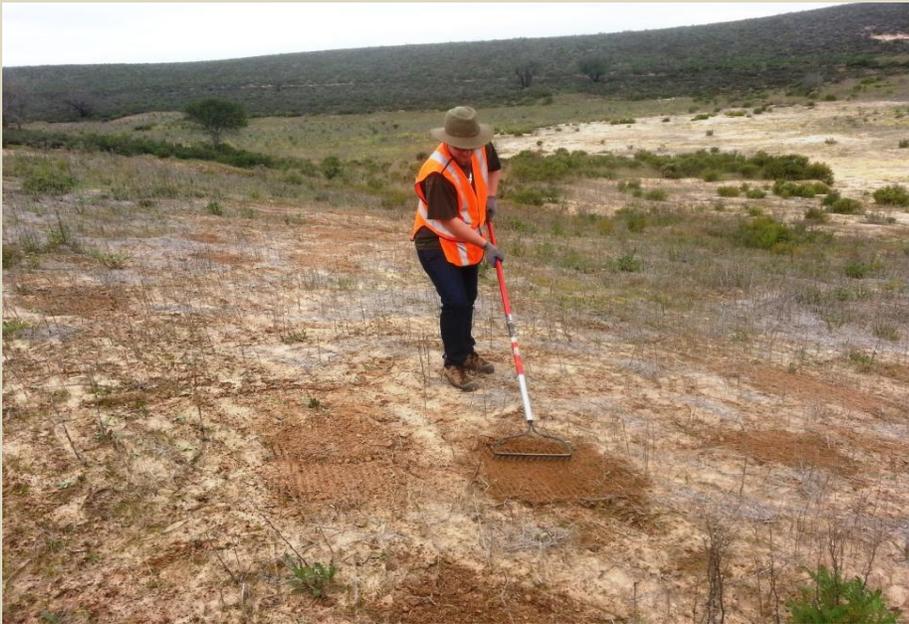
PHOTO DESCRIPTION	PHOTO
<p>Restoration Activities</p> <p>Selectively seeding <i>Chorizanthe pungens</i> var. <i>pungens</i> at HA 37.</p> <p>C-31</p>
