2015 ANNUAL PLAN
FORMER FORT ORD SITE 39 HABITAT RESTORATION

**FINAL | 2015 ANNUAL REPORT
FORMER FORT ORD SITE 39 HABITAT RESTORATION
CONTRACT NO. W91238-14-D-0010-0001**

US Army Corps of Engineers
Sacramento District
1325 J Street
Sacramento, CA 95814-2922

Burleson Consulting Inc.
950 Glenn Drive, Suite 245
Folsom, CA 95630

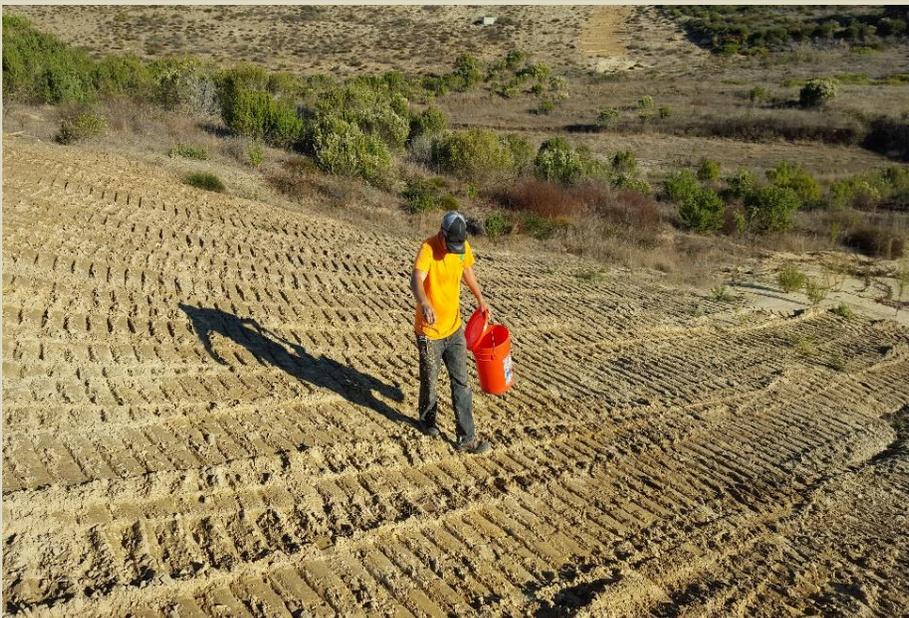
PHOTO DESCRIPTION	PHOTO
<p>Erosion Control Activities</p> <p>Digging trenches for straw wattles at HA 28.</p> <p>C-33</p>

Before the onset of the wet season, Burleson installed erosion control measures for minor stormwater related damage at HAs 28 and 37. Photographs C-33 through C-40 in Appendix C show erosion control field activities.

- Repaired approximately 200 linear feet of rill erosion ranging from 6"-36"
- Installed 550 linear feet of straw rolls
- Broadcast erosion control seed mix on 0.25 acre
- Broadcast and crimped straw mulch on 0.25 acre
- Installed 3,000 ft² of coir fabric

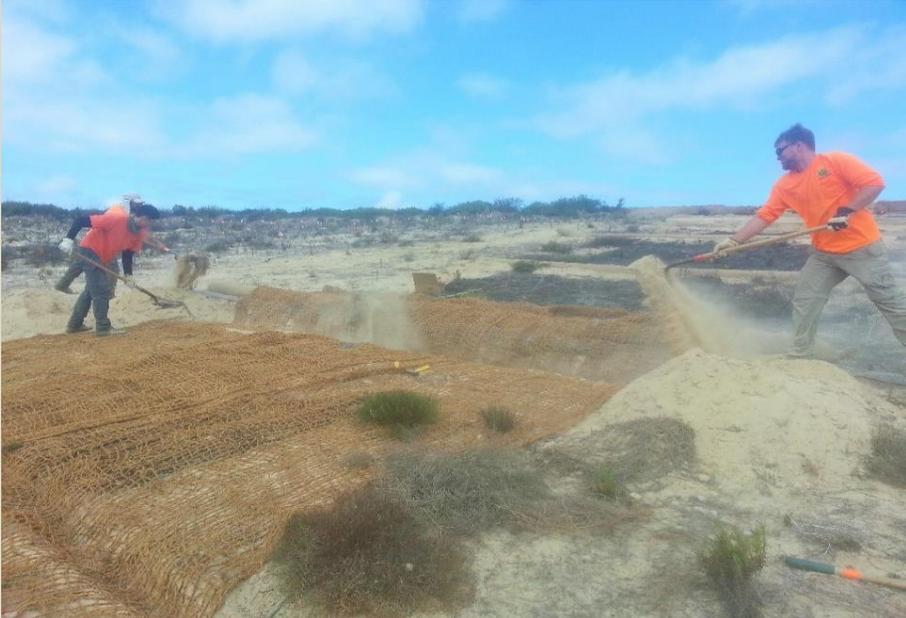
<p>Erosion Control Activities</p> <p>Filling the trench to key in the coir fabric at HA 28.</p> <p>C-34</p>

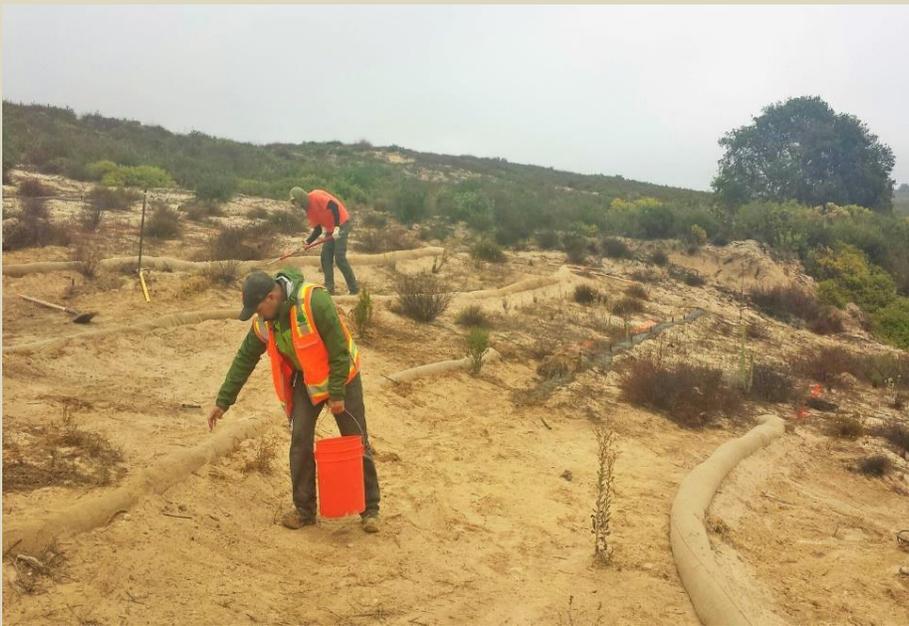
<p>Erosion Control Activities</p> <p>Coir fabric and straw wattles installed at HA 28.</p> <p>C-36</p>

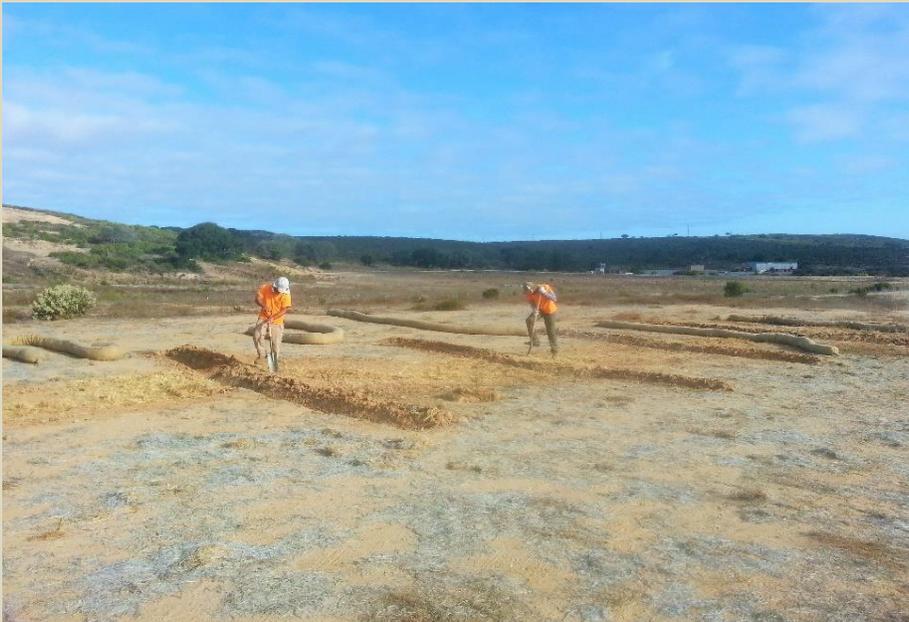
<p>Erosion Control activities</p> <p>Placing coir fabric down at HA 37.</p> <p>C-38</p>

- Repaired approximately 300 linear feet of rill erosion averaging 6"-12"
- Installed 1,450 linear feet of straw rolls
- Broadcast erosion control seed mix on 0.25 acre
- Broadcast and crimped straw mulch on 0.25 acre
- Installed 1,000 ft² of coir fabric

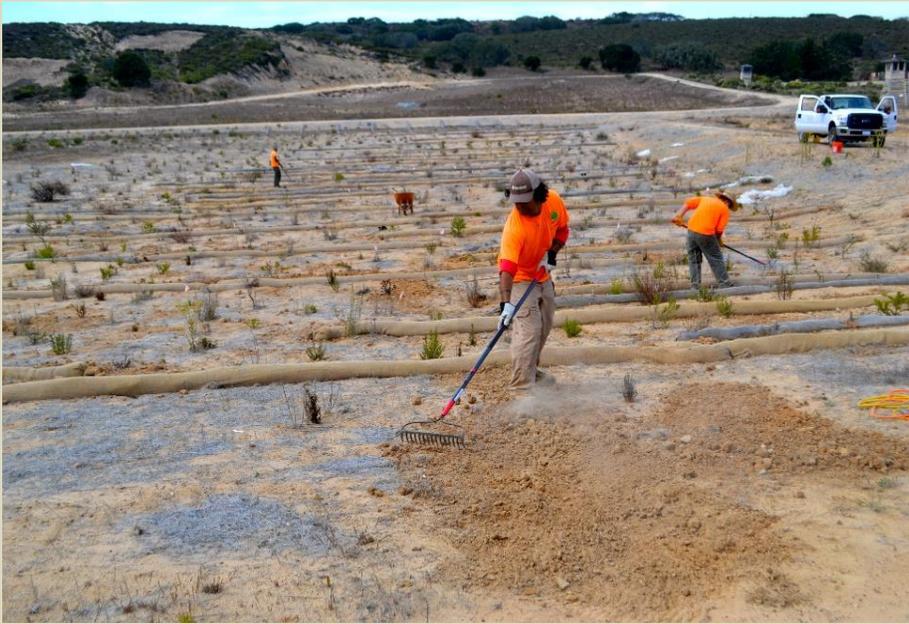
<p>Erosion Control Activities</p> <p>Wattles installed at HA 37 with casted <i>Hordeum</i> germinating behind the wattles.</p> <p>C-40</p>

Following erosion control repairs in the fall, several storm events occurred in late 2015, and no major erosion damage was observed at either site.

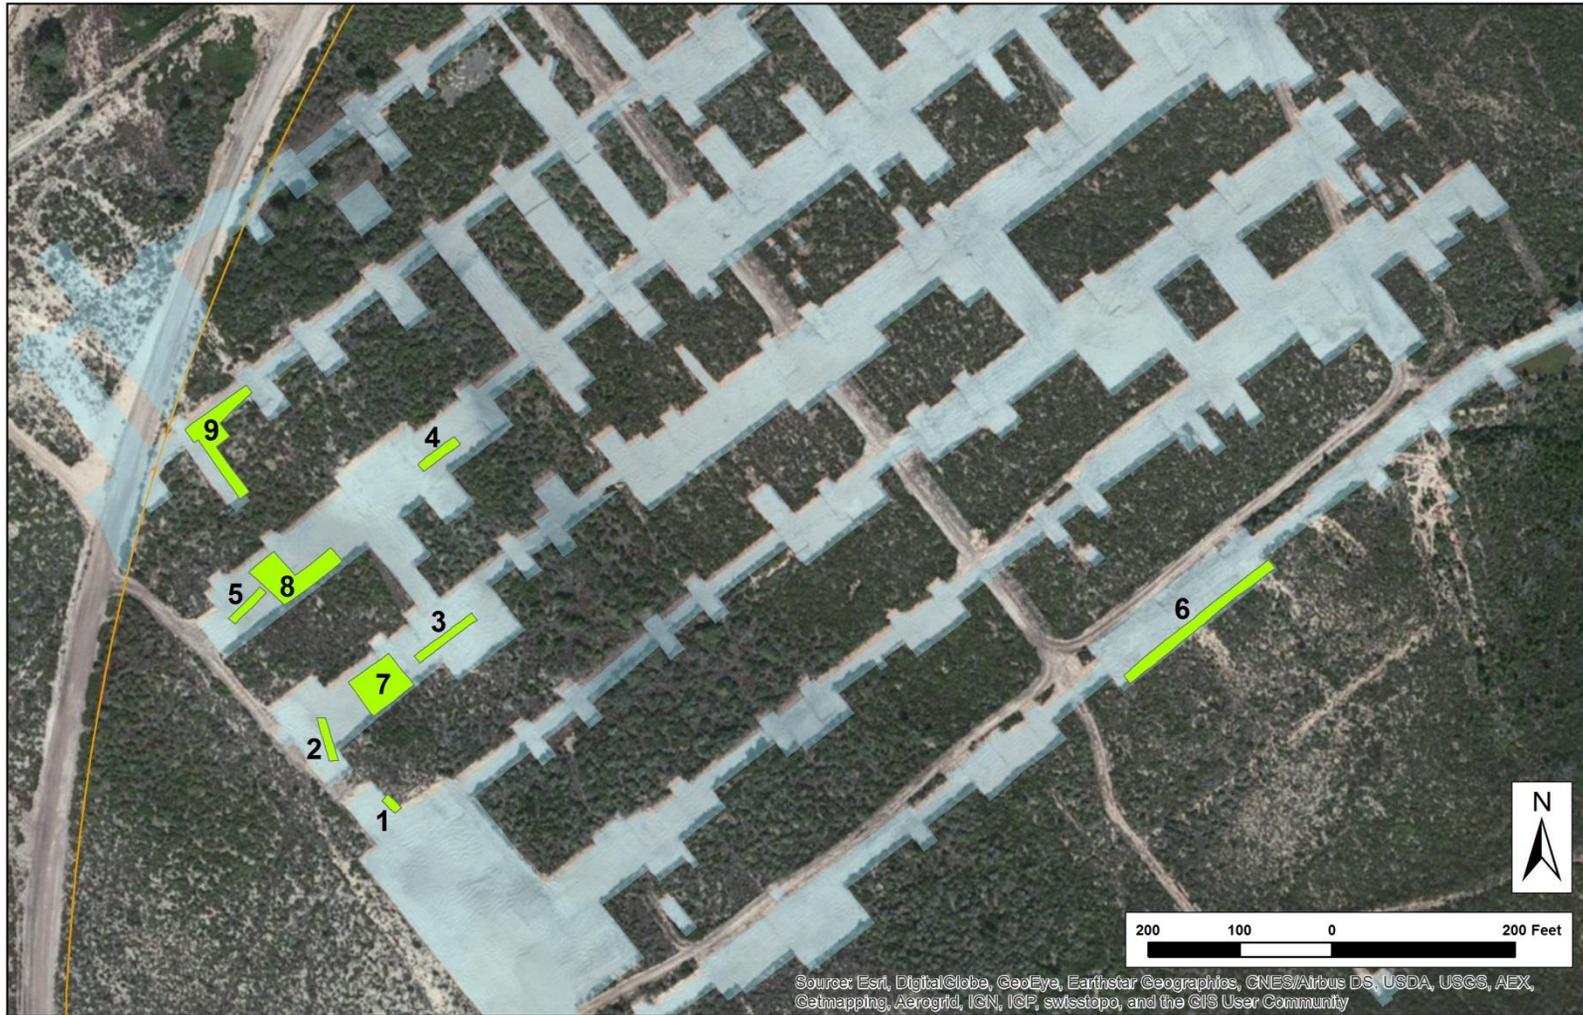
HA 19 2015 Sand Gilia Broadcast Plots			Site 39 Inland Ranges Historic Areas Location Map Former Fort Ord	
Sand Gilia Broadcast Plots (1-9)	Former Fort Ord Boundary		Source: U.S. Army Corps of Engineers Former Fort Ord Aerial and Restoration data provided by Fort Ord GIS website	
HA 19 Footprint	Impact Area	Burleson Consulting, Inc.	Figure 3

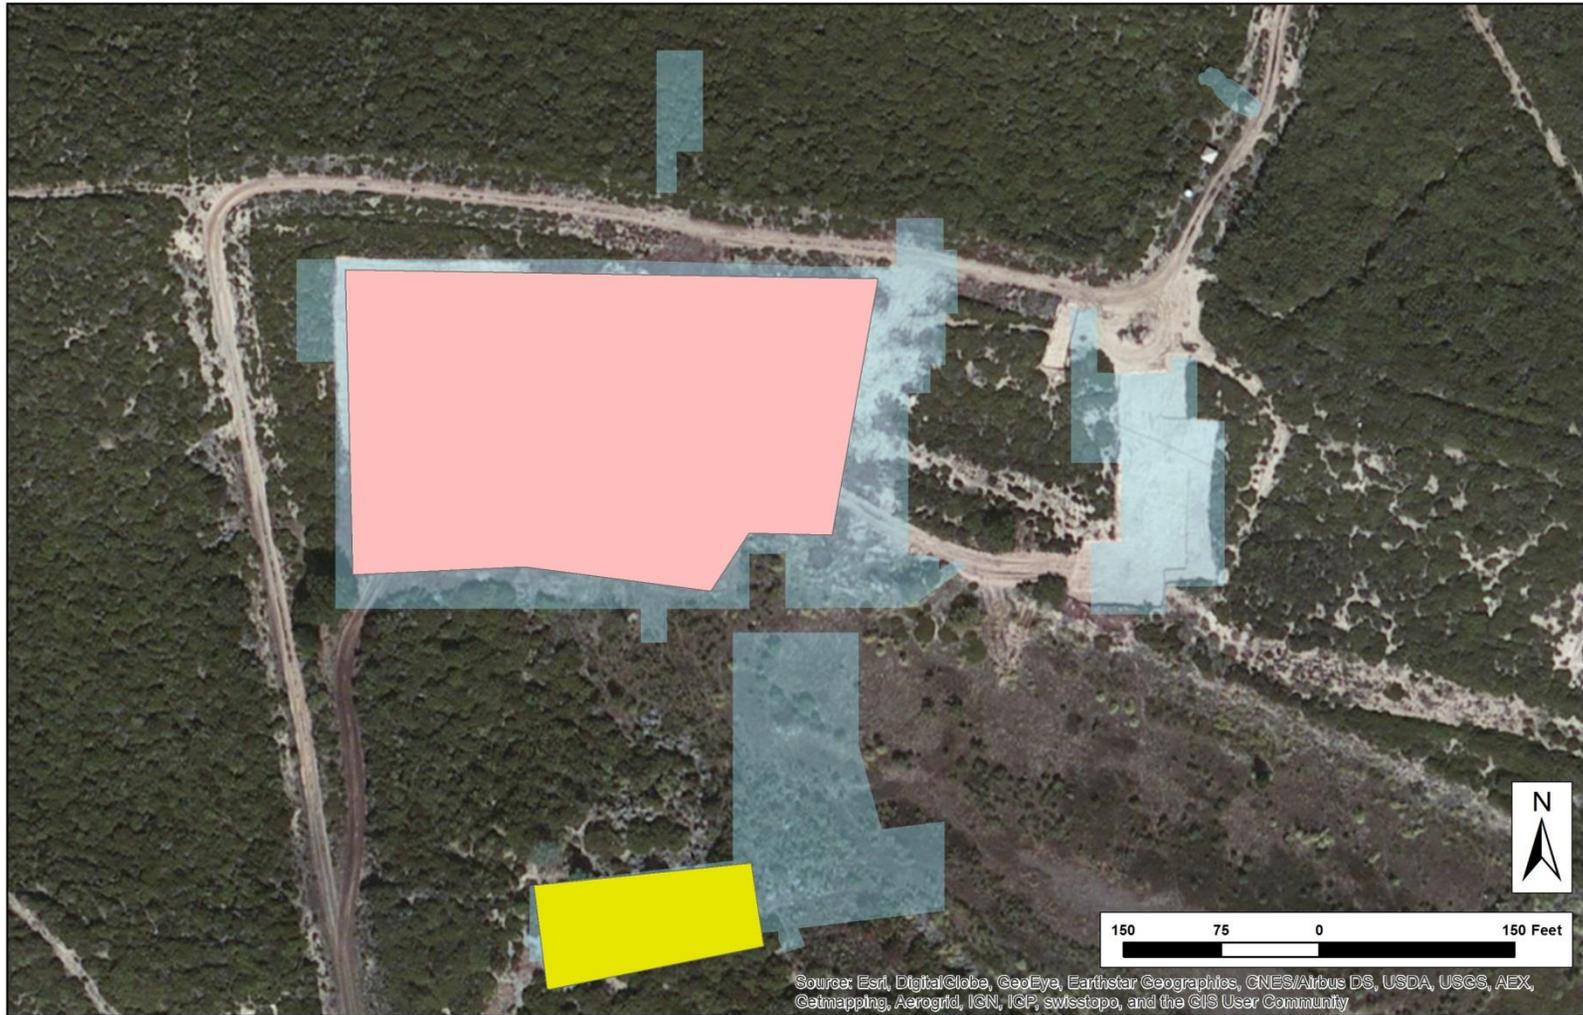
Burleson completed passive restoration activities in November 2015 at HA 28 to support erosion control repairs for Kemron, another USACE contractor. Burleson's senior biologists worked with USACE staff to develop a seed mix to sufficiently cover 0.36 acre. A small portion of common seed (non-HMP seed) collected for HA 26 was combined with production plot seed to develop the seed mix for HA 28. Burleson broadcast the mix over 0.36 acre on November 5, 2015. To create good seed-soil contact, Kemron mechanically drove the seed into the soil by track-walking over it with a dozer. In the days following, a heavy rainfall event washed a significant portion of the seed off site. Burleson broadcast additional seed on November 11, 2015. Kemron mechanically punched the seed into the soil and completed erosion control repairs. HA 28 seed mix species and quantities are presented in Table A-6 in Appendix A. See Figure 4 in Appendix D for specific seed broadcast locations at HA 28.

HA 28 2015 Restoration Activities				Site 39 Inland Ranges Historic Areas Location Map Former Fort Ord	
Planting Area	HA 28 Footprint	Impact Area		Source: U.S. Army Corps of Engineers Former Fort Ord Aerial and Restoration data provided by Fort Ord GIS website	
Passive Seeding	Former Fort Ord Boundary		Burleson Consulting, Inc.	Figure 4

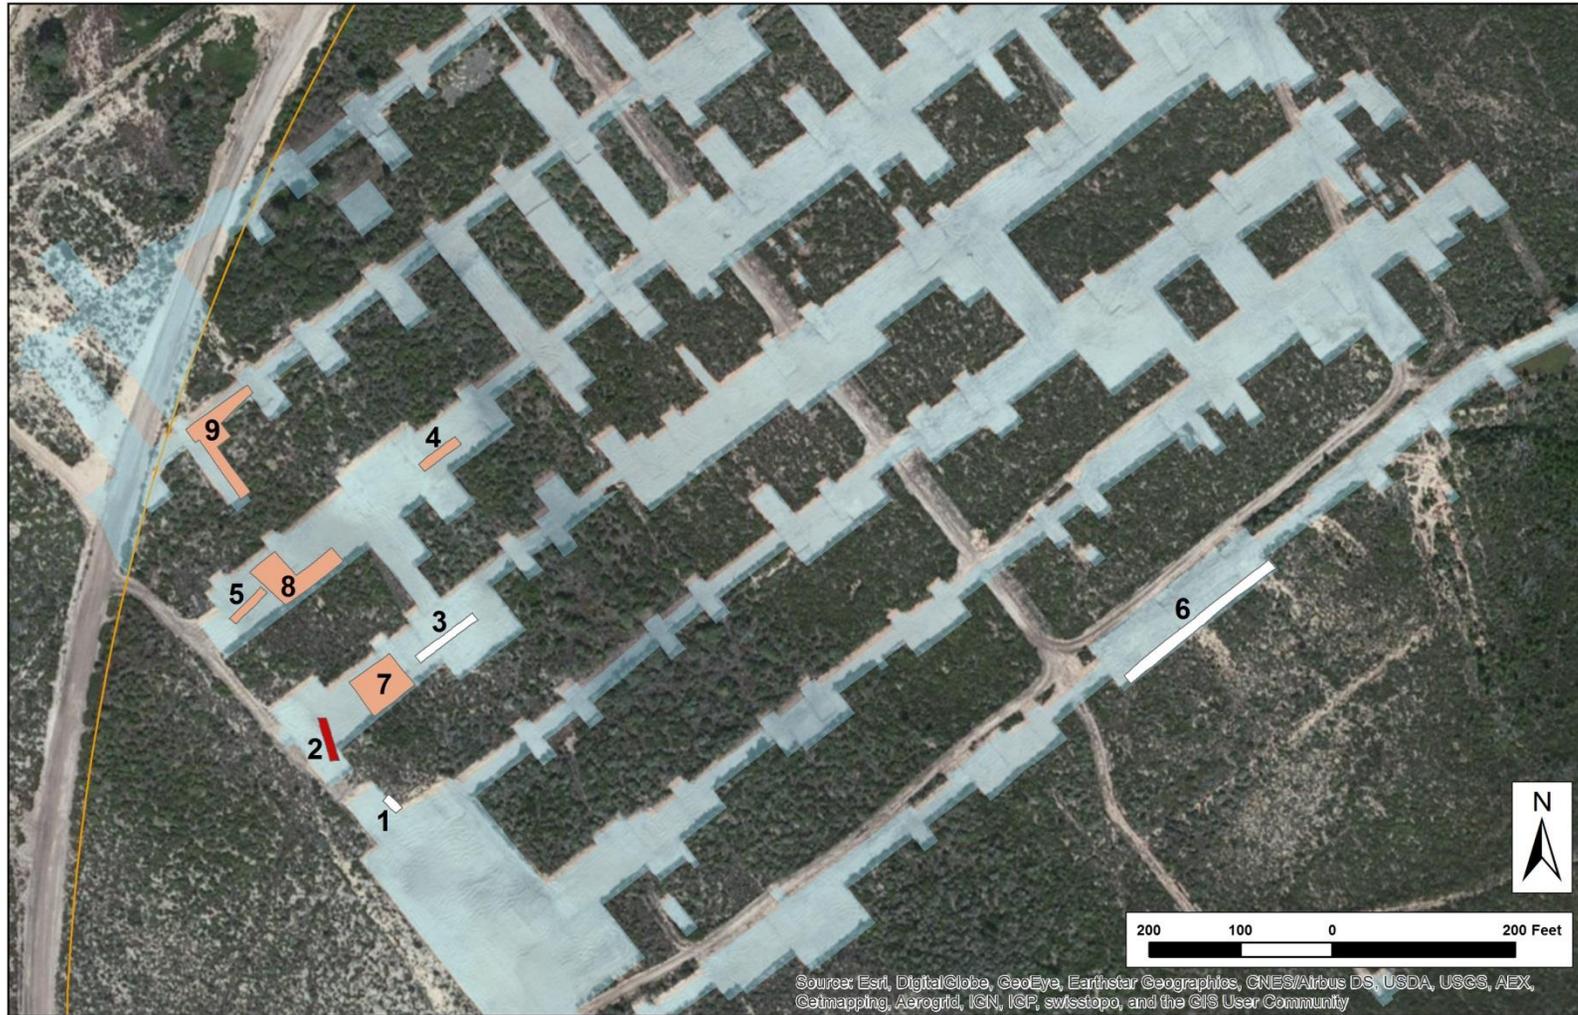
**Figure
7**

Path: C:\Users\GIS\Desktop\GIS\2016\Fort Ord\2015 AReport Maps\HA 38\MXD\Fig7 HA 38 2015 Restoration Activities 160328.mxd

In January 2015, 0.01 lb of the HMP forb Monterey spineflower was broadcast over 521 ft² at HA 38. Table A-9 in Appendix A illustrates species and amounts. See Figure 7 in Appendix D for seed broadcast locations.

Burleson completed active restoration activities at HA 38 in early 2015 by installing the remaining 2013-2014 plant targets for coast silk tassel, silver bush lupine, and sandmat manzanita. See Table A-12 in Appendix A for the plant species and quantities planted at HA 38. See Figure 7 in Appendix D for planting locations.

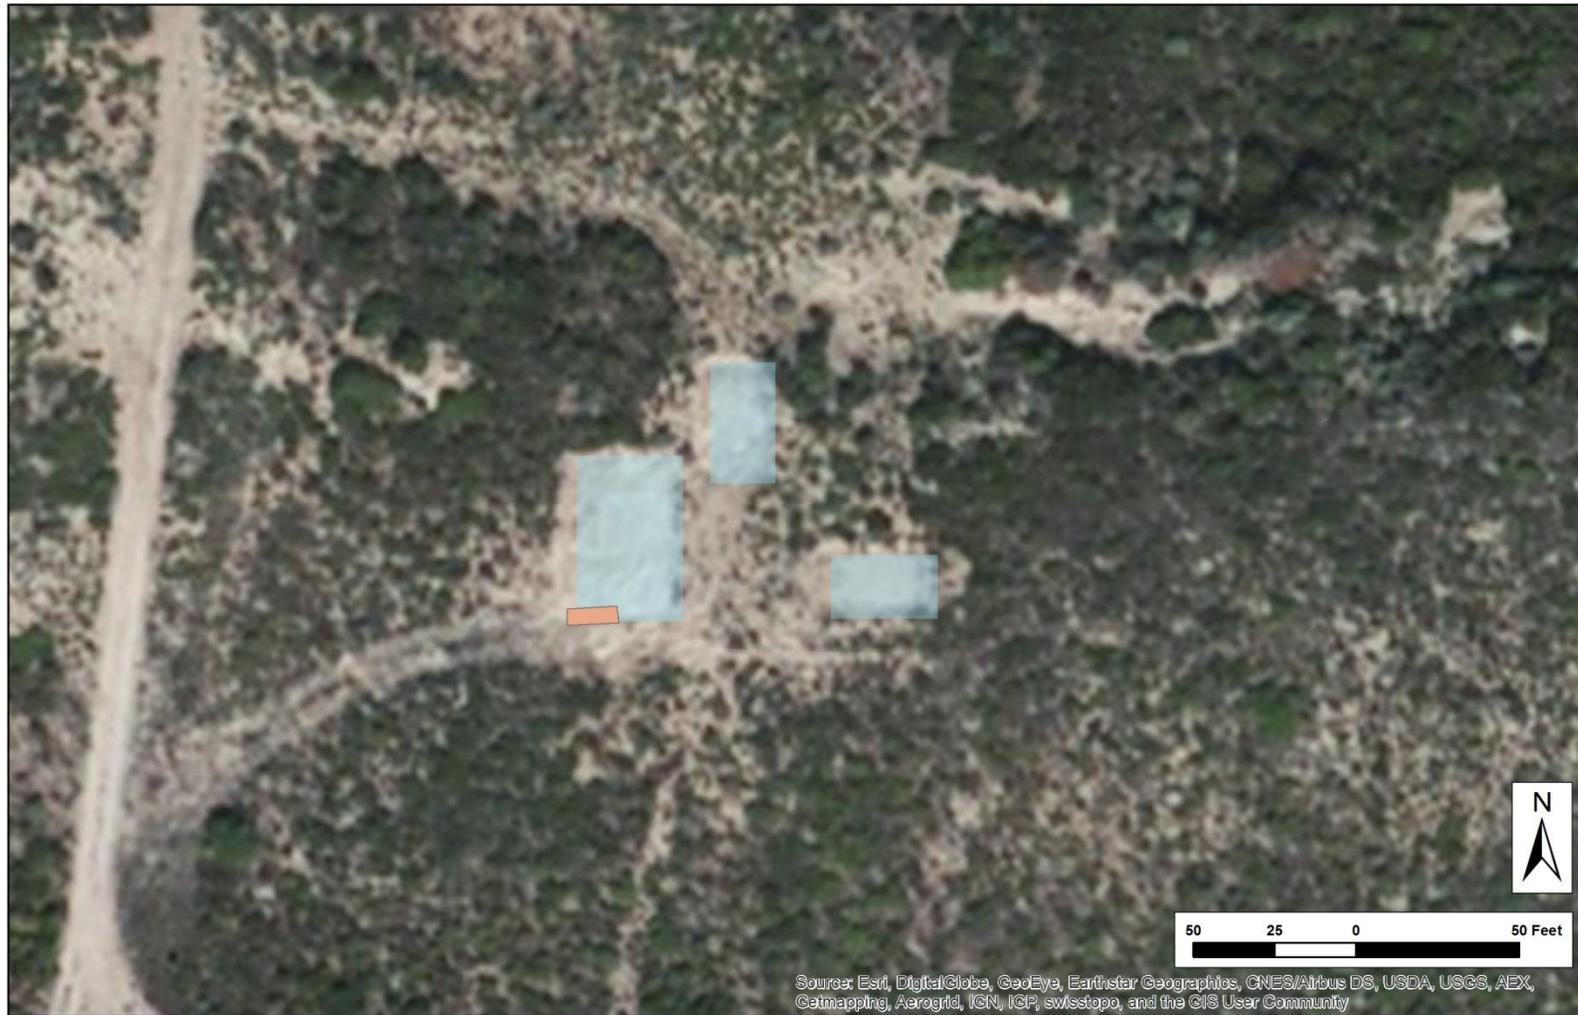
HA 39/40 Year 2 and 3 Sand Gilia Density Surveys

Site 39 Inland Ranges Historic Areas Location Map Former Fort Ord	
Source: U.S. Army Corps of Engineers Former Fort Ord Aerial and Restoration data provided by Fort Ord GIS website	
 Burleson Consulting, Inc.	Figure 9

Five sand gilia plots are present at HA 39/40. In 2015, plot 1 was surveyed for year 3 density and plots 2 through 5 were surveyed for year 2 density. SSRP baseline density class for sand gilia at HA 39/40 was low. All five plots met or exceeded SSRP baseline density in 2015. Plot 1 year 3 density was high. Year 2 density at plots 2 and 3 were low, and year 2 density at plots 4 and 5 were medium. Graph 2 below represents all of the sand gilia density data for HA 39/40. Table B-1 in Appendix B lists detailed results and Figure 9 in Appendix D show plot locations at HA 39/40.

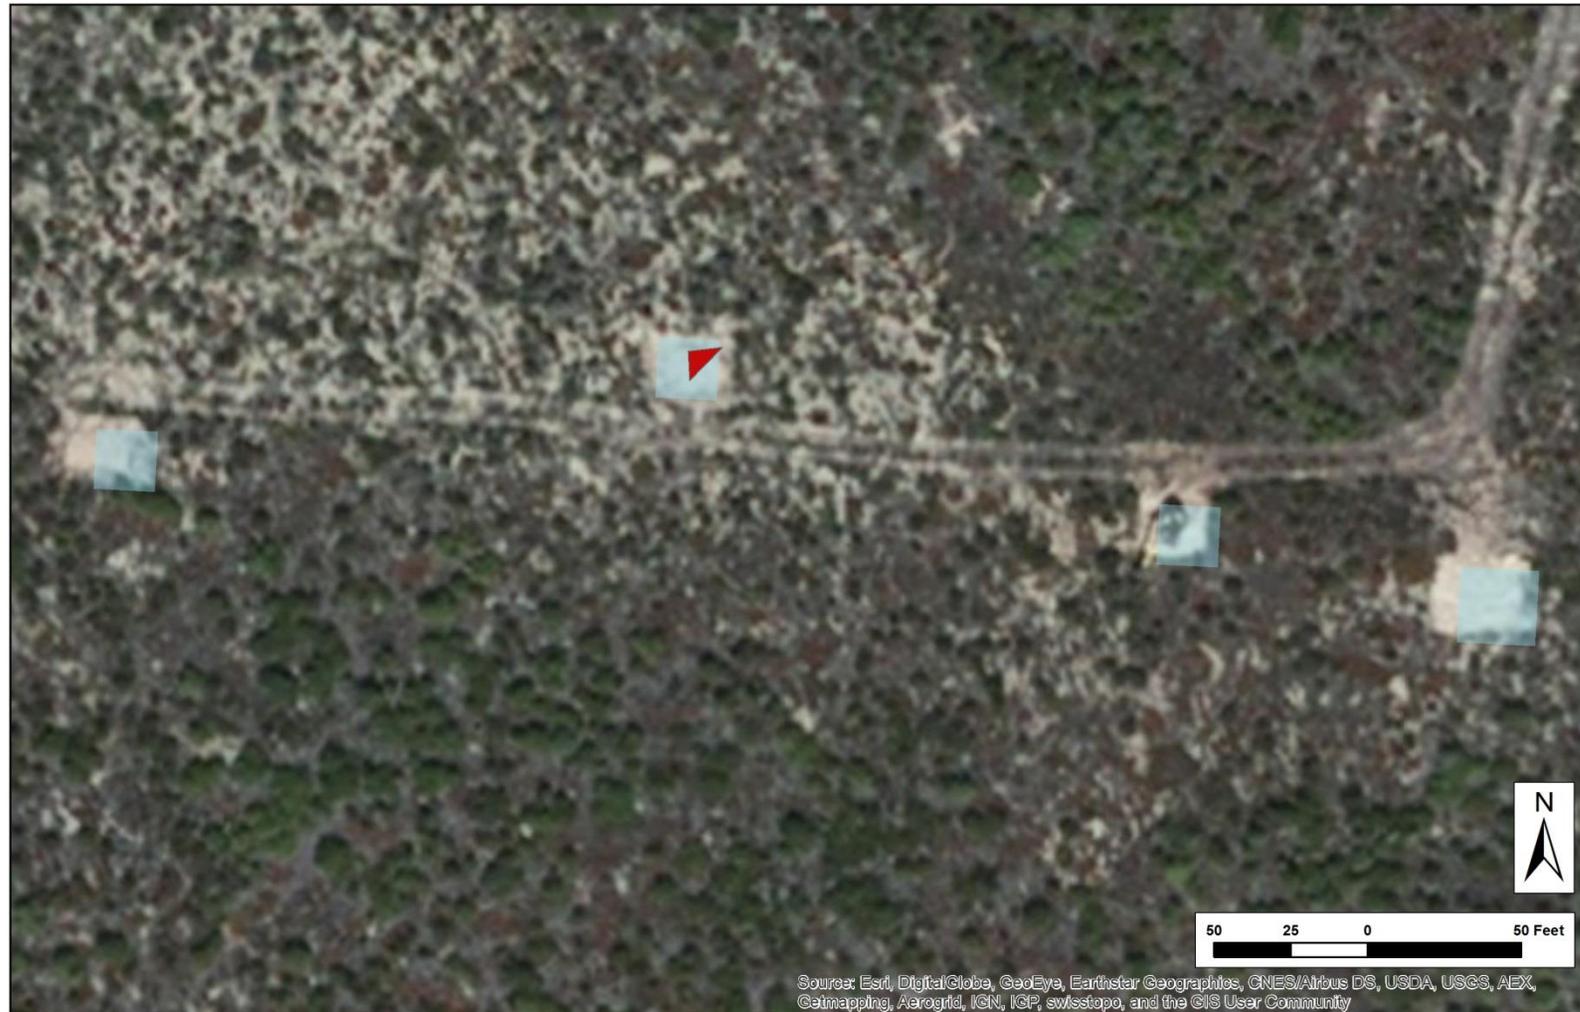
Path: C:\Users\GIS\Desktop\GIS\2016\Fort Ord\2015 AReport Maps\HA 18\MXD\Fig11_HA 18 Year 1 Monterey Spineflower Density Survey_160324.mxd

Year 3 monitoring occurred at six Monterey spineflower plots at HA 18 in 2015. SSRP baseline density for Monterey spineflower at HA 18 is low. The plots are scattered mainly around the northern section of the site in suitable habitat. All six plots had high densities of Monterey spineflower. All six have met or exceeded SSRP baseline density in years 1, 2, and 3. Graph 4 below represents all the Monterey spineflower density data for HA 18. Table B-2 in Appendix B lists detailed results and Figure 11 in Appendix D shows locations of the plots at HA 18.

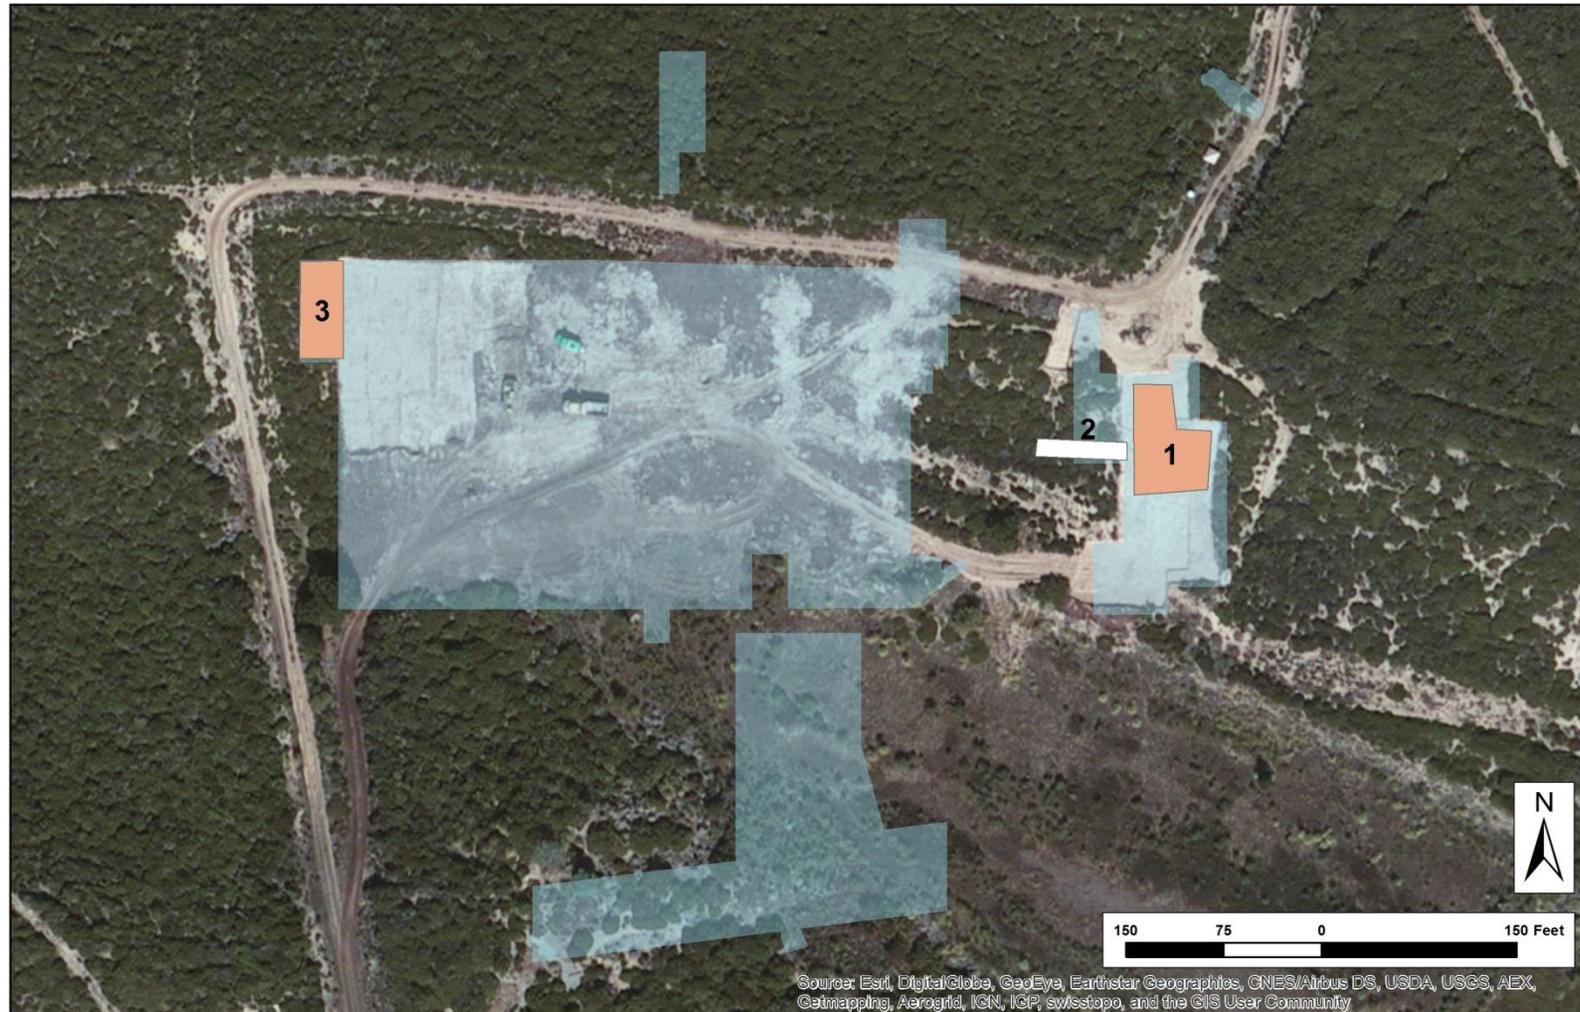
<h3>HA 23 Year 3 Monterey Spineflower Density Survey</h3>			<h3>Site 39 Inland Ranges Historic Areas Location Map Former Fort Ord</h3>	
<p>Density Classes</p> <ul style="list-style-type: none"> ■ High ■ Medium ■ Low Not Present 	<ul style="list-style-type: none"> HA 23 Footprint Former Fort Ord Boundary Impact Area 		<p>Source: U.S. Army Corps of Engineers Former Fort Ord Aerial and Restoration data provided by Fort Ord GIS website</p>	<p> Burleson Consulting, Inc. Figure 13</p>

One Monterey spineflower plot at HA 23 was surveyed for year 3 monitoring in 2015. SSRP baseline density for Monterey spineflower at HA 23 is low. This plot had a medium density of Monterey spineflower in 2015. This plot exceeded SSRP baseline density in years 2 and 3. No data is available for year 1. The plot was inaccessible during the 2013 survey season due to mastication activities in the nearby burn unit. Graph 6 below represents all Monterey spineflower density data for HA 23. Table B-2 in Appendix B lists detailed results and Figure 13 in Appendix D shows location of the plot.

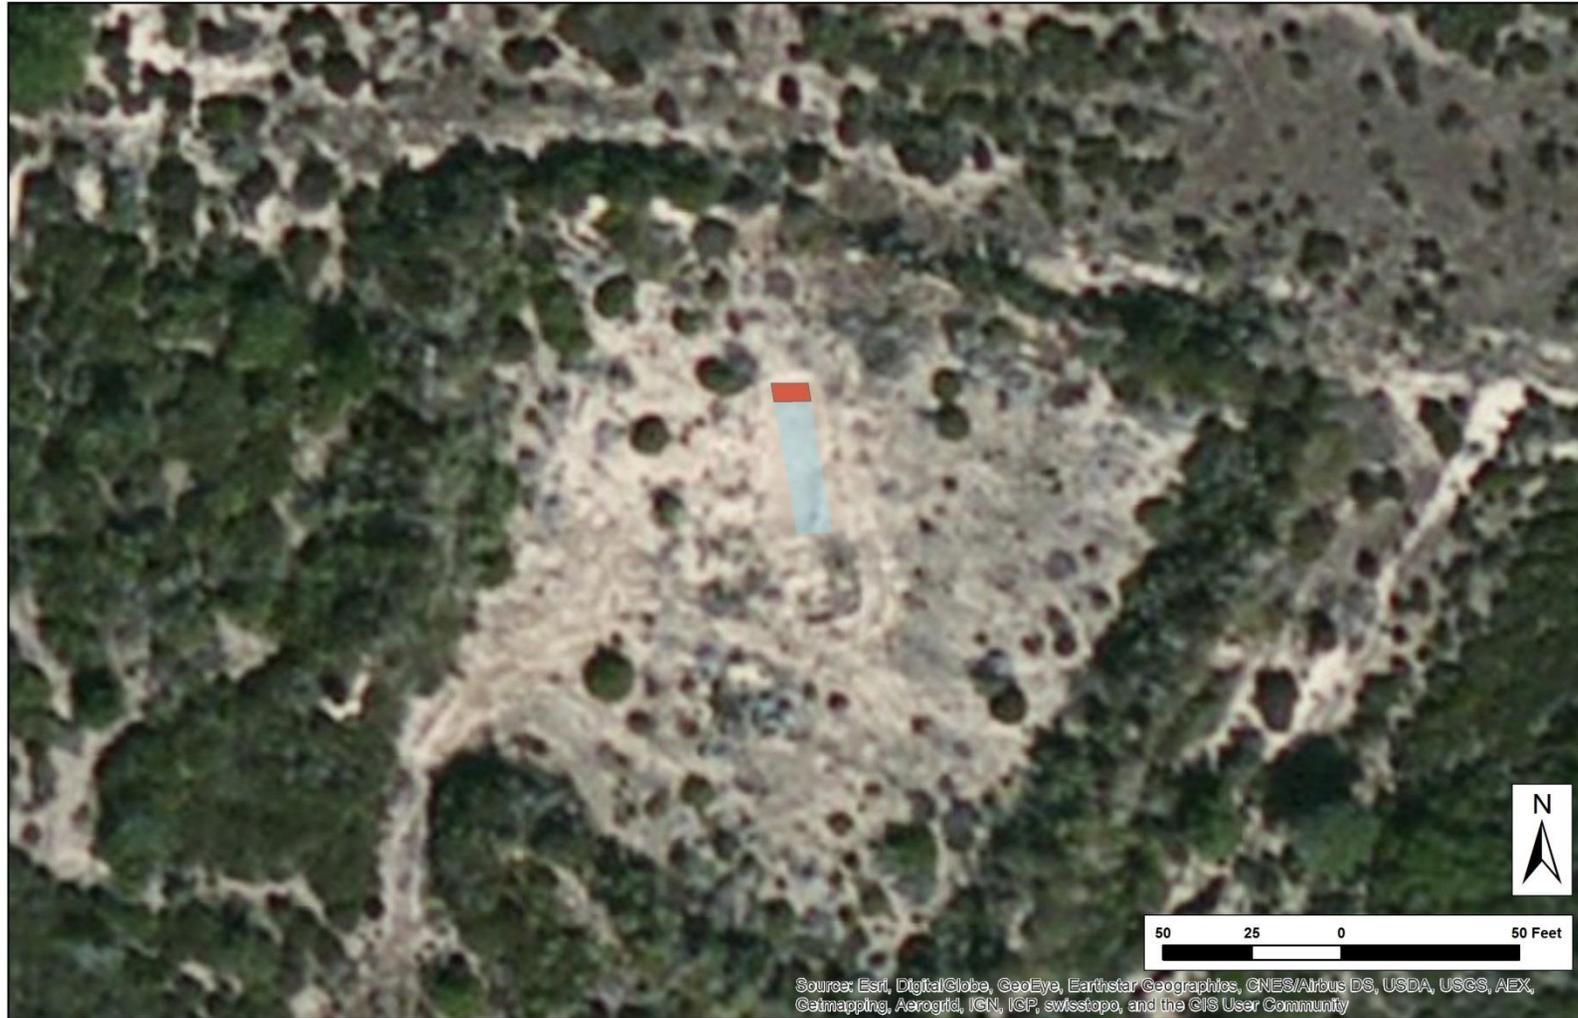
HA 28 Year 1 Monterey Spineflower Density Survey			Site 39 Inland Ranges Historic Areas Location Map Former Fort Ord	
Density Classes High Medium Low Not Present	1-3 Monterey Spineflower Plots HA 28 Footprint Former Fort Ord Boundary Impact Area		Source: U.S. Army Corps of Engineers Former Fort Ord Aerial and Restoration data provided by Fort Ord GIS website	Burleson Consulting, Inc.

Path: C:\Users\GIS\Desktop\GIS\2016\Fort Ord\2015 AReport Maps\HA 28\Fig14_HA 28 Year 1 Monterey Spineflower Density Survey_160324.mxd

In 2015, three Monterey spineflower plots were surveyed for year 1 monitoring at HA 28. SSRP baseline density for Monterey spineflower at HA 28 is low. Plots 1 and 2 are located in the eastern part of the site and plot 3 is located in the northwestern part of the site. Monterey spineflower was present in low density at plots 1 and 3 and absent in plot 2. Graph 7 below represents all Monterey spineflower density data at HA 28. Table B-2 in Appendix B lists detailed results and Figure 14 in Appendix D shows locations of the plots at HA 28.

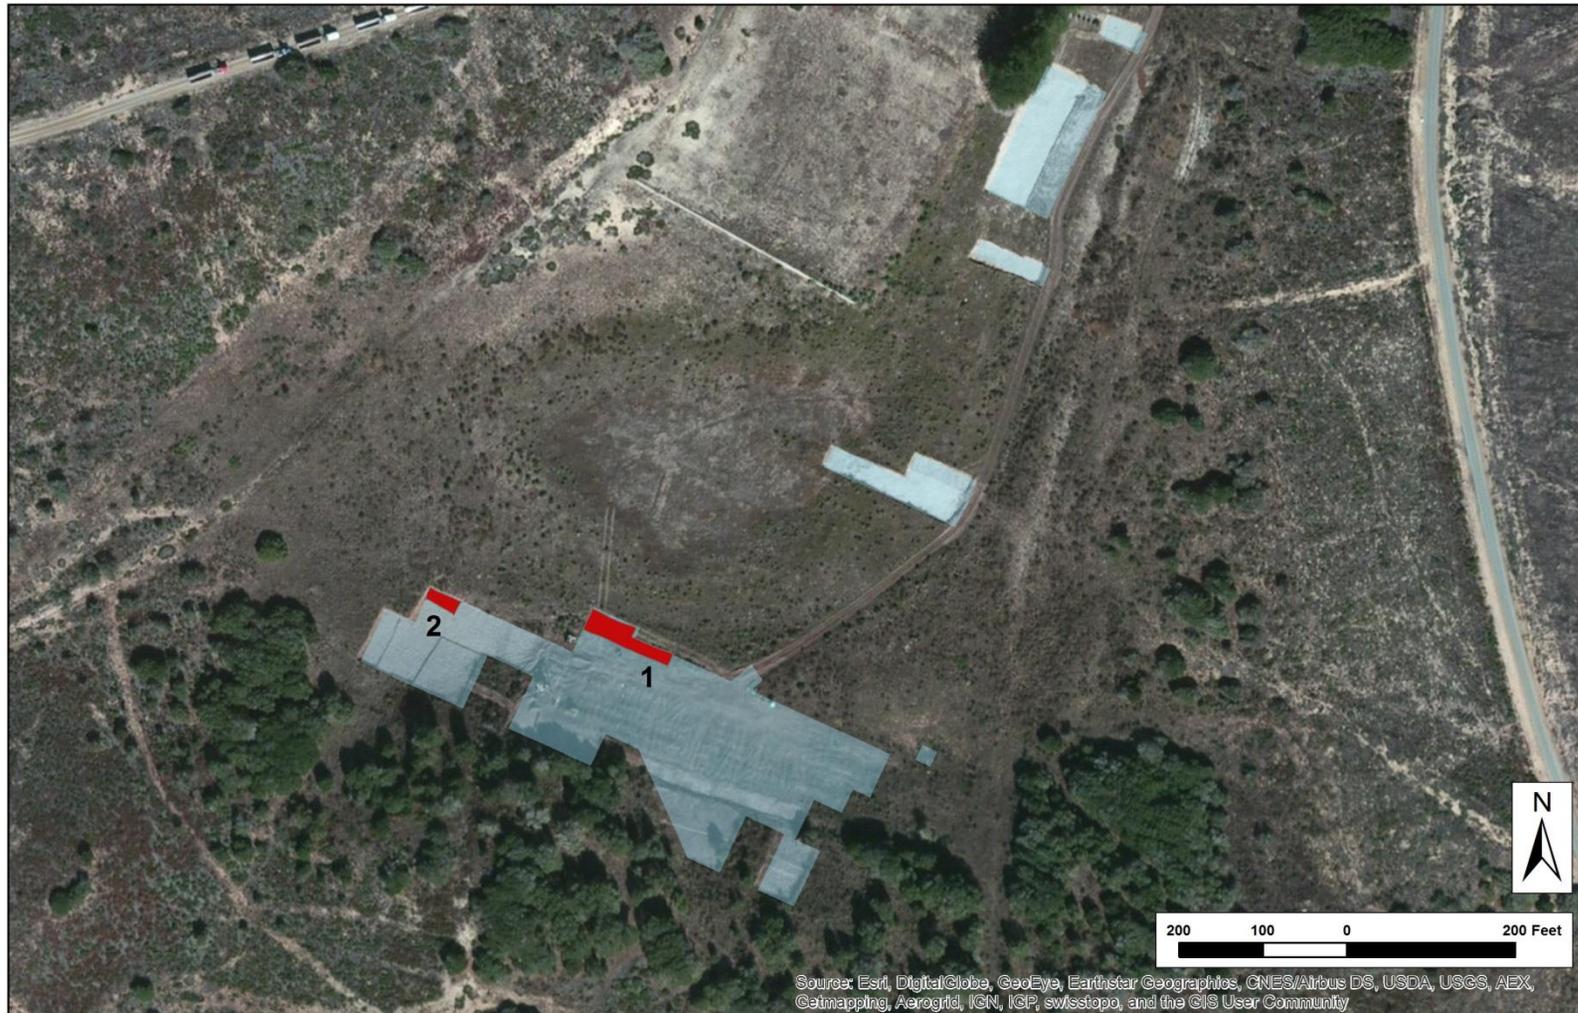
HA 38 Year 1 Monterey Spineflower Survey

Path: C:\Users\GIS\Desktop\GIS\2016\Fort Ord\2015 AReport Maps\HA 38\MXD\Fig17_HA 38 Year 1 Monterey Spineflower Survey_160324.mxd

One Monterey spineflower plot at HA 38 was surveyed for year 1 monitoring in 2015. SSRP baseline density for Monterey spineflower at HA 38 is low. Monterey spineflower was present in low density in this plot located in the western part of the site. Graph 10 below represents all Monterey spineflower density data at HA 38. Table B-2 in Appendix B lists detailed results and Figure 17 in Appendix D shows the location of the plot.
