2021-2022 ANNUAL BIOLOGICAL MONITORING REPORT
FORMER FORT ORD, CALIFORNIA

Indefinite Delivery Indefinite Quantity (IDIQ) Type Contract
for Base Realignment and Closure (BRAC) Support
at the Former Fort Ord, Monterey, California
Contract No. W9123820D0004
Task Order No. W9123821F0077

March 2023

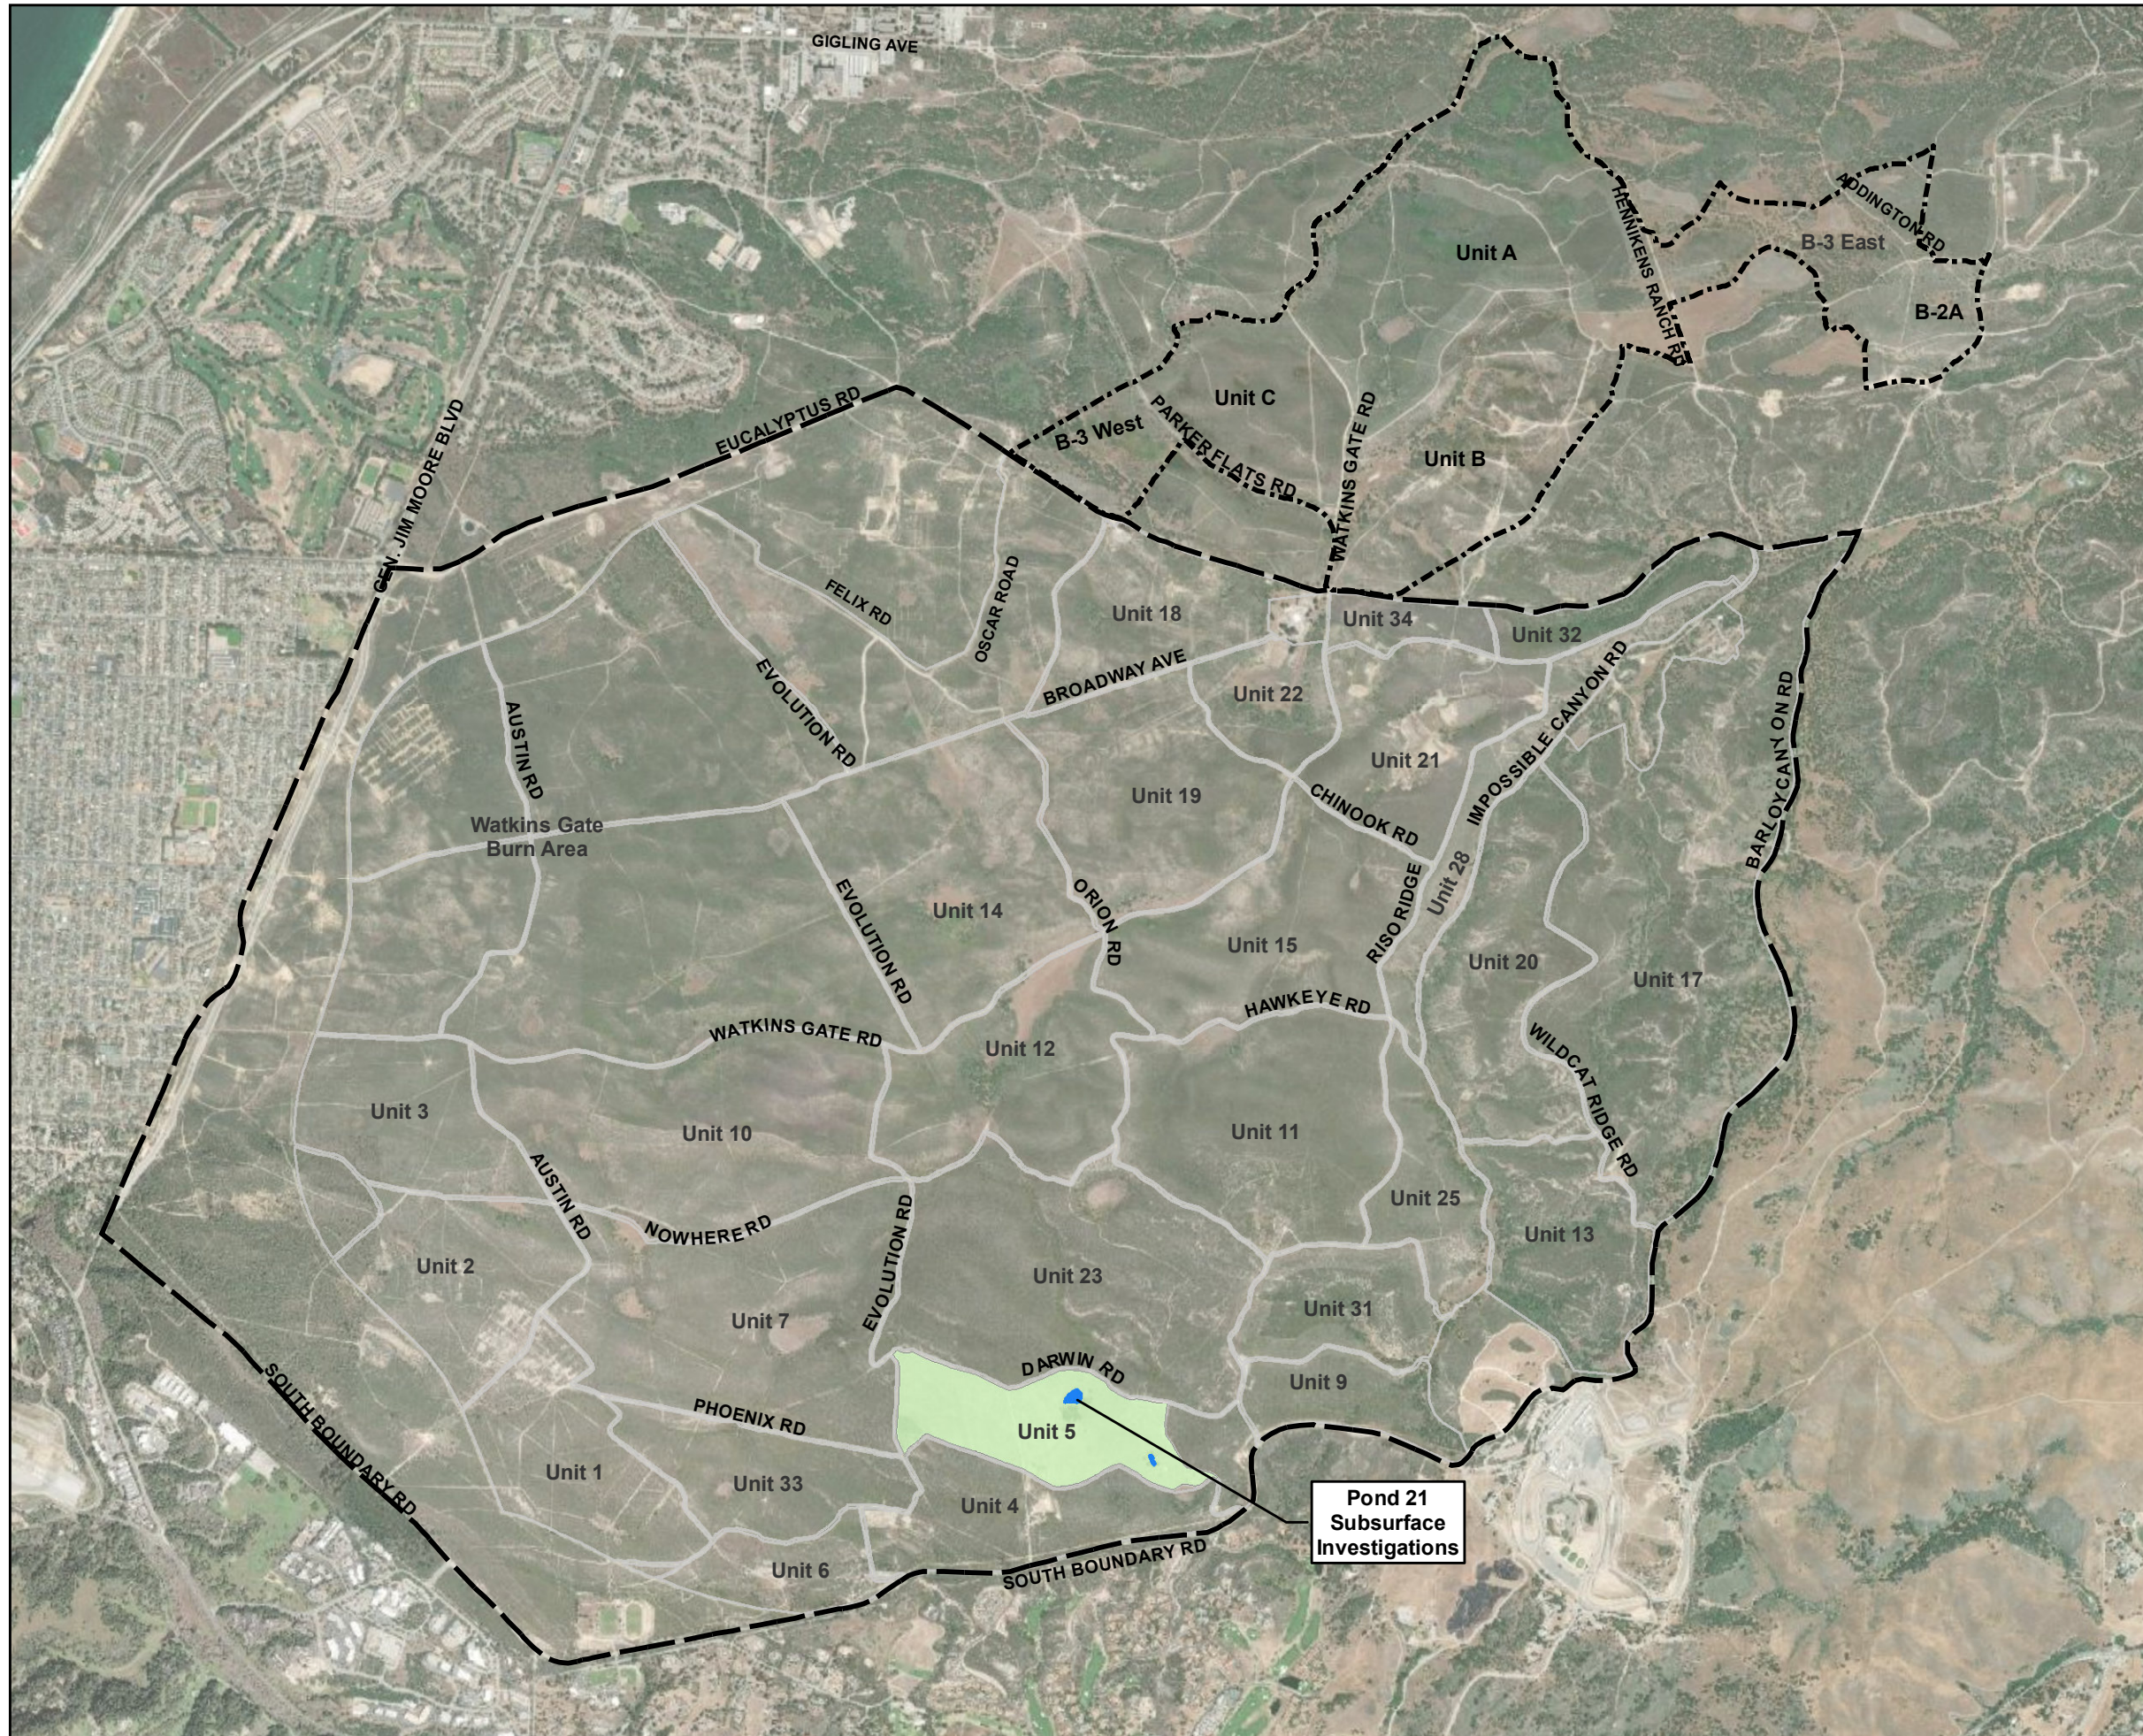
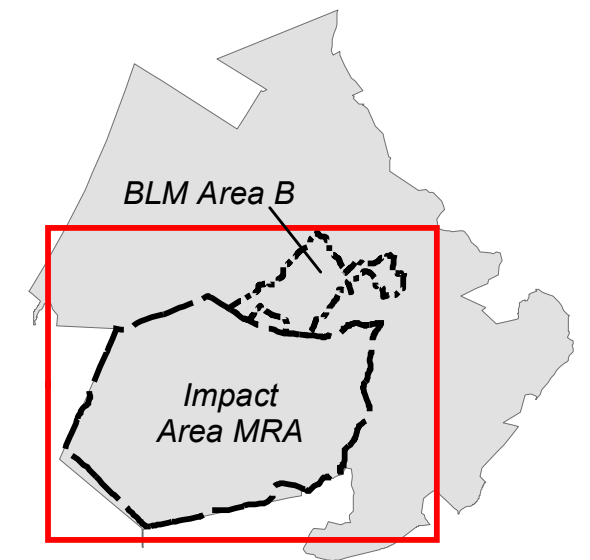
U.S. ARMY CORPS OF ENGINEERS SACRAMENTO DISTRICT		
FORMER FORT ORD		
FIGURE NUMBER 1-1	2021-2022 Annual Biological Monitoring Report Munitions Remediation Areas Where Biological Monitoring Occurred in 2021 & 2022	
DATE 3/8/2023	PROJECT NUMBER WP001	FILE NAME SEE FOOTER

The only work conducted by KEMRON in 2021 and 2022 was munitions remediation at Impact Area MRA Unit 5 ([Figure 1-1](#)). No work was conducted by KEMRON at soil remediation sites in 2021 or 2022, and no further discussion is provided in this report.

Impact Area MRA
	BLM Area B
	Burn Unit Boundaries
	Units Where Biological Monitoring Occurred

During 2021 and 2022, munitions and explosives of concern (MEC) remediation activities within the former Fort Ord Impact Area were conducted by KEMRON within Impact Area MRA Unit 5 (Figure 1-1). Activities conducted in Unit 5 in 2021 included:

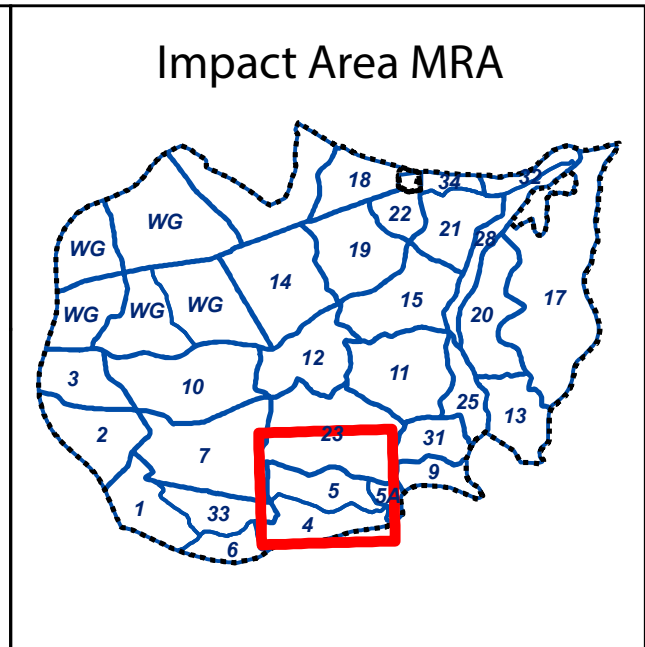
FIGURE NUMBER 2-1	2021-2022 Annual Biological Monitoring Report	
	2021 Unit 5 Vegetation Removal Areas

Vegetation Clearing Summary

- Manual Cut
- Mechanical Cut

Acres	Manual Cut	Mechanical Cut	Grand Total
Total	3.42	119.35	122.77

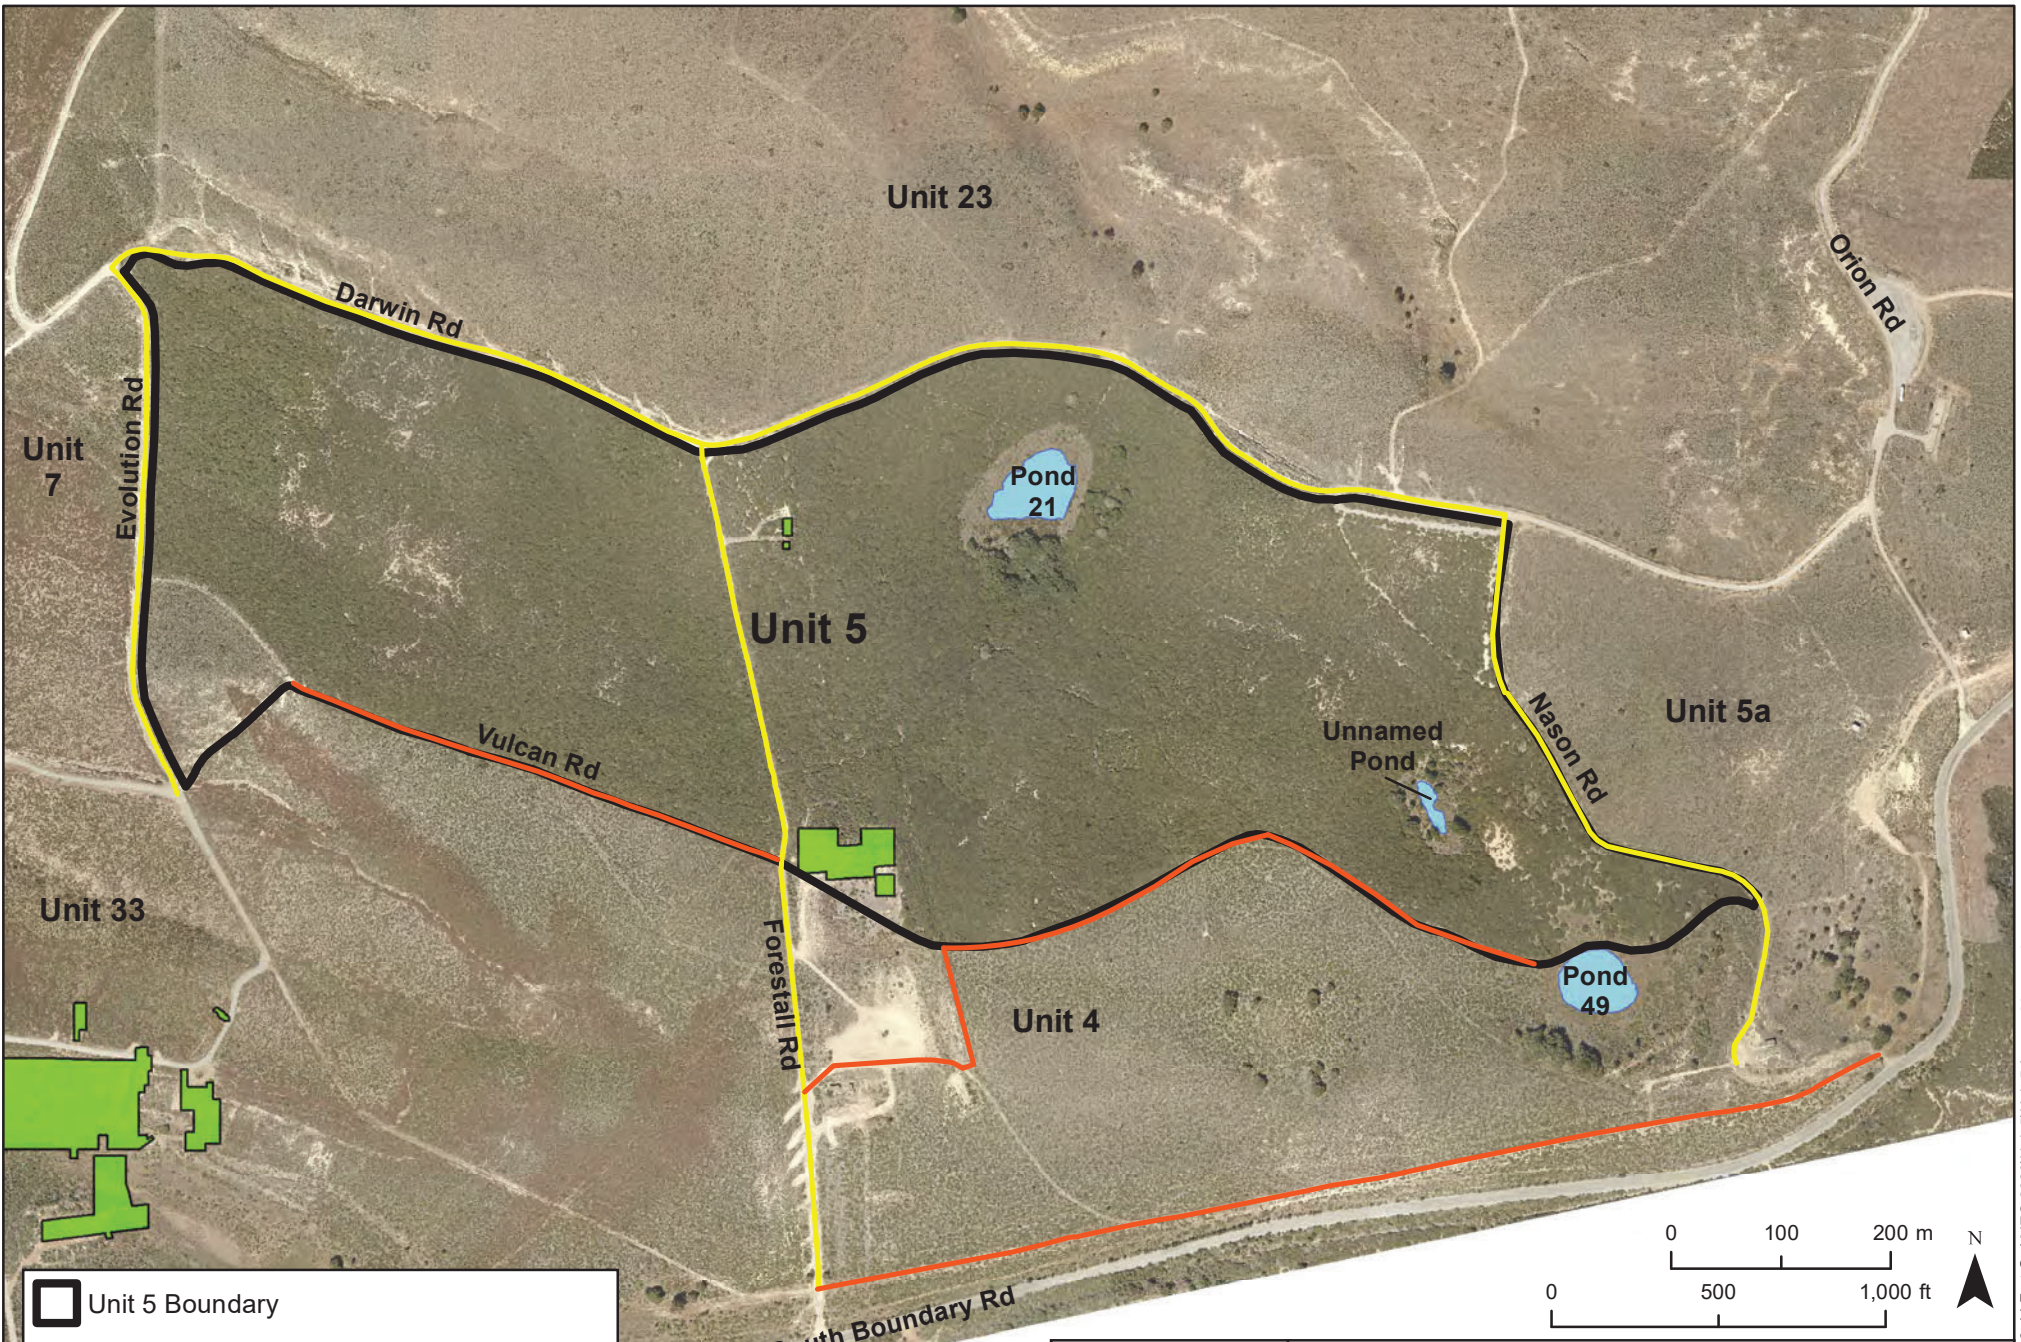
Unit 5 Boundary
-

Main Road
-

Approved Interior Access (As Needed Only)
-

Ponds
-

Restoration Areas (No Access)

- Vehicle access should be limited to existing roads and approved interior access roads (see attached Access Map). Use of interior access roads shall be minimized and used only when necessary. Parking of vehicles is allowed within fuel breaks along existing roads and on interior access roads.
- Heavy equipment transport from site to site must be along existing roads only.
- Equipment (skid steer) traffic to access any stockpiled vegetation shall be minimized to the greatest extent feasible.
- Restoration Areas shall not be used for access to other areas of the work area (see attached Sensitive Resources Map).

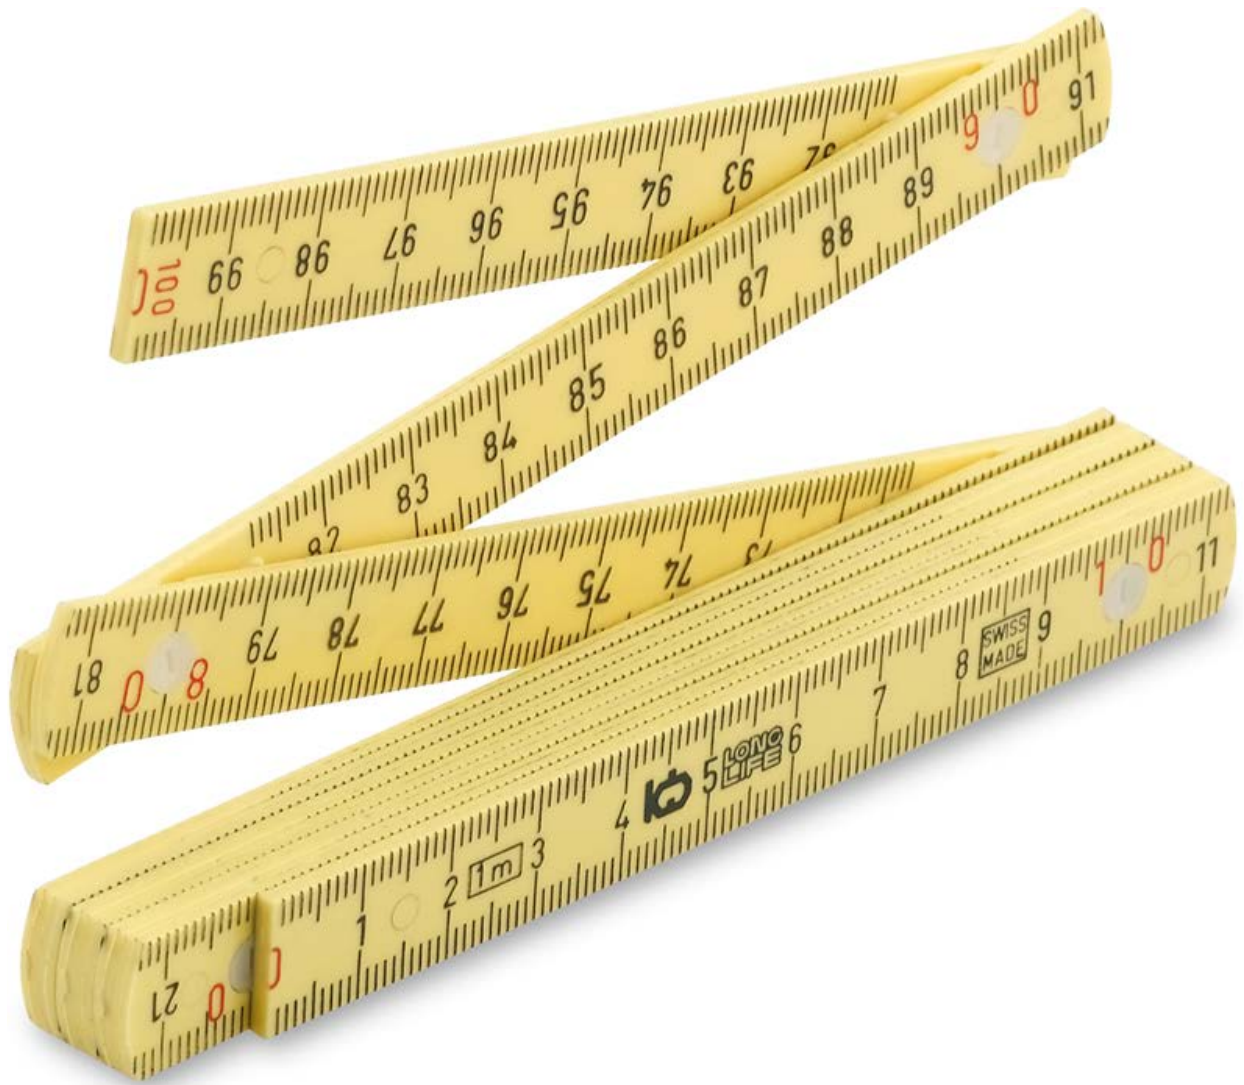
Photograph 1. Suggested example of an engineer's ruler.

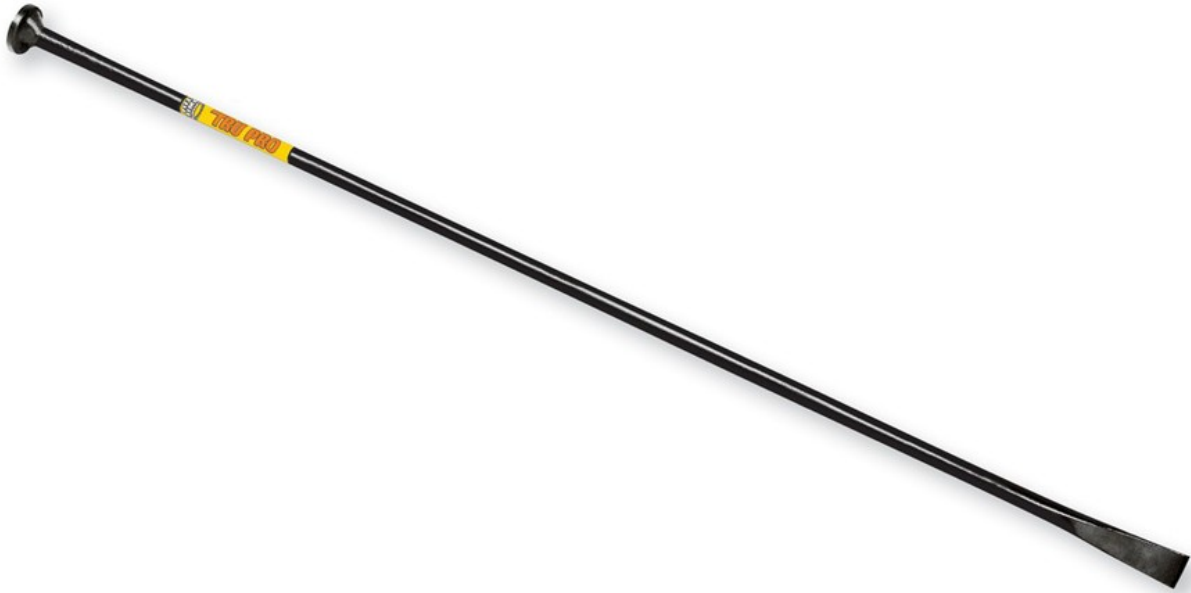
Photograph 2. Suggested example of a compaction and breaker bar.

6. The excavated area should be backfilled using soils in the reverse order that were excavated and were set aside. Each layer should be returned to its original position. During backfilling, the soil should be compacted at 6-inch intervals to help preserve the impermeability of the disturbed soil. Use enough water to moisten the soil, but not saturate it to ensure even compaction. Placement of hard chips may require breaking the large fragments of clay into smaller, more readily compacted pieces before placement. Use a compaction and breaker bar to compact the filled area uniformly, by dropping the bar 20 times from 1 foot height across the excavated area with the flat end (Photo 2). The final layer must be the top 6 inches saved from the surface. If vegetation was removed the clippings should be placed back on top of the excavation area.
