**2022 ANNUAL REPORT**  
**FORMER FORT ORD SITE 39 HABITAT RESTORATION**  
**CONTRACT NO. W91238-18-D-0007**  
**TASK ORDER W9123821F0083**

**FORMER FORT ORD**

**April 2023**

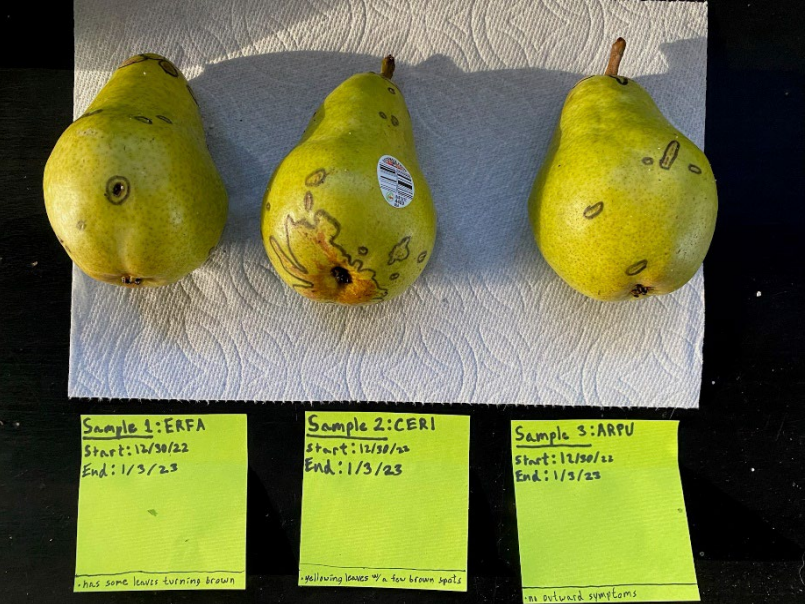
<p>Sample 1: ARMO Start: 9/26/22 End: 9/30/22 -no outward symptoms</p> <p>Sample 2: CER1 Start: 9/26/22 End: 9/30/22 -no outward symptoms</p> <p>Sample 3: CRSC Start: 9/26/22 End: 9/30/22 -no outward symptoms</p>
<p><b>Burleson Carmel Valley Native Plant Nursery</b></p> <p>Negative results of the December pear test. Pear test started in December, results in January.</p> <p><b>C-4</b></p>

<p>Sample 1: ERFA Start: 12/30/22 End: 1/3/23 -has some leaves turning brown</p> <p>Sample 2: CER1 Start: 12/30/22 End: 1/3/23 -yellowing leaves + a few brown spots</p> <p>Sample 3: ARPU Start: 12/30/22 End: 1/3/23 -no outward symptoms</p>

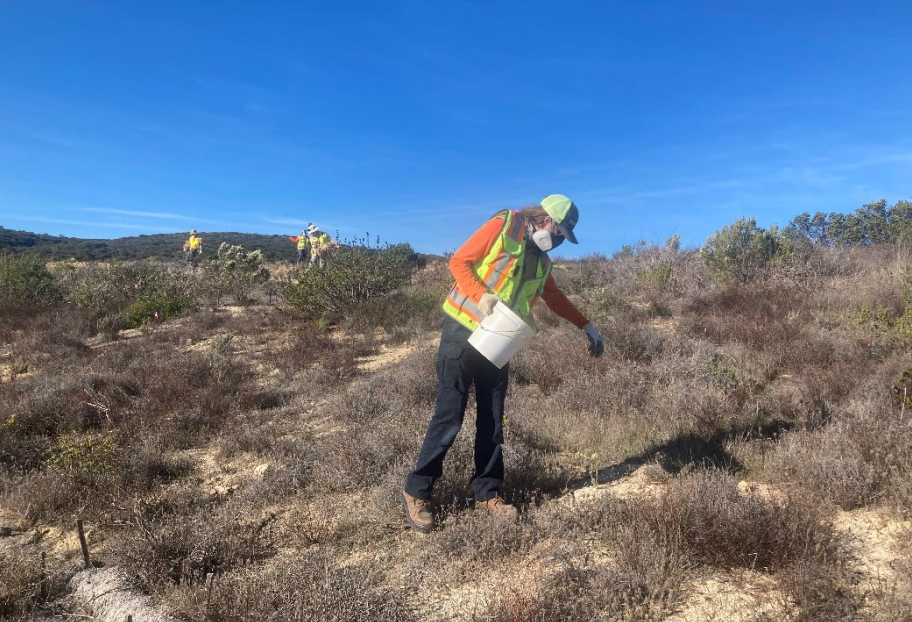
Photo Description	Photo
<p><b>Passive Restoration</b></p> <p>Burleson biologist applying seed at HA 34</p> <p><b>C-25</b></p>

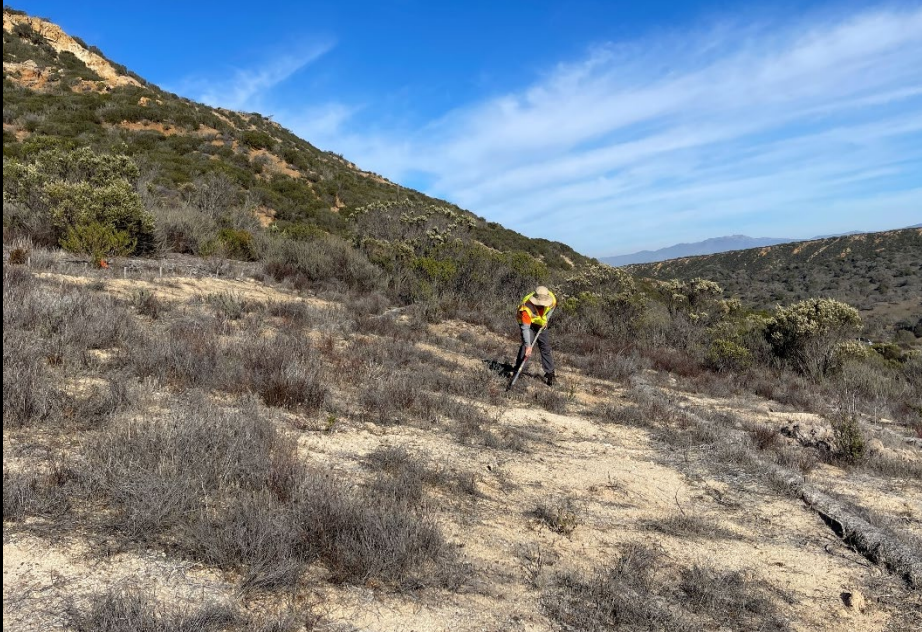
<p><b>Passive Restoration</b></p> <p>Burleson biologist raking seed at HA 34</p> <p><b>C-28</b></p>

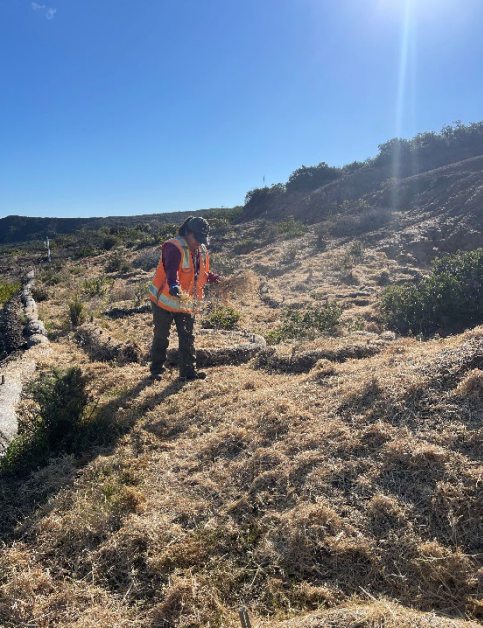
Photo Description	Photo	
<p><b>Erosion Control Repairs</b></p> <p>Burleson biologist covering production seed with straw at HA 36</p> <p><b>C-41</b></p>

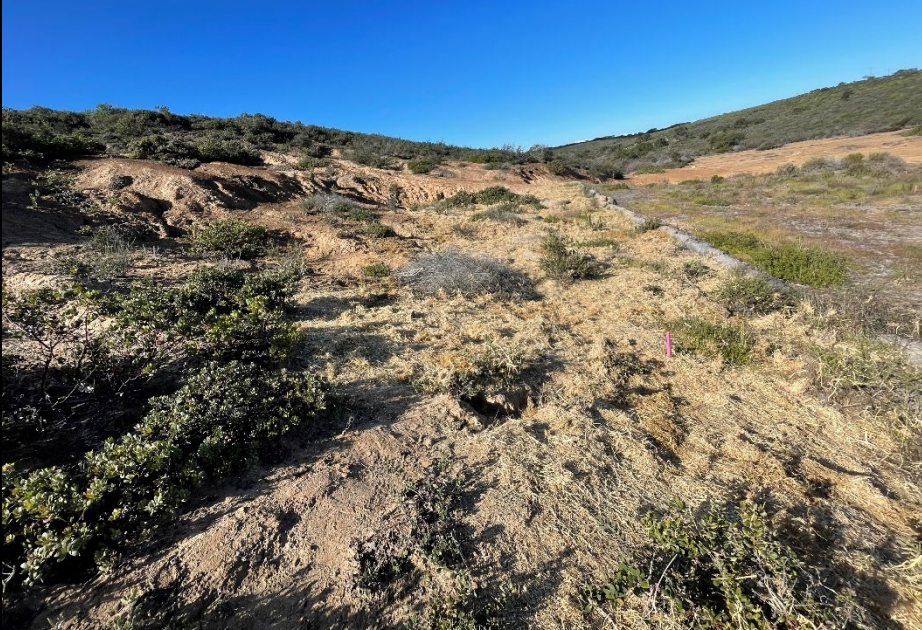
Photo Description	Photo
<p><b>Erosion Control Repairs</b></p> <p>Completed wattle installation at HA 37</p> <p><b>C-43</b></p>

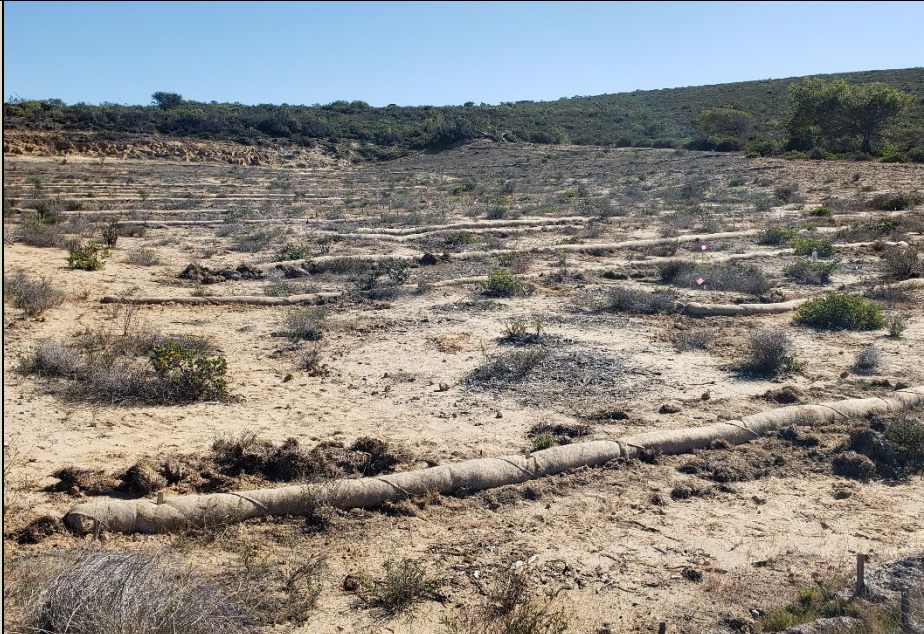
<p><b>Erosion Control Repairs</b></p> <p>Burleson biologists installing wattles at HA 37</p> <p><b>C-44</b></p>

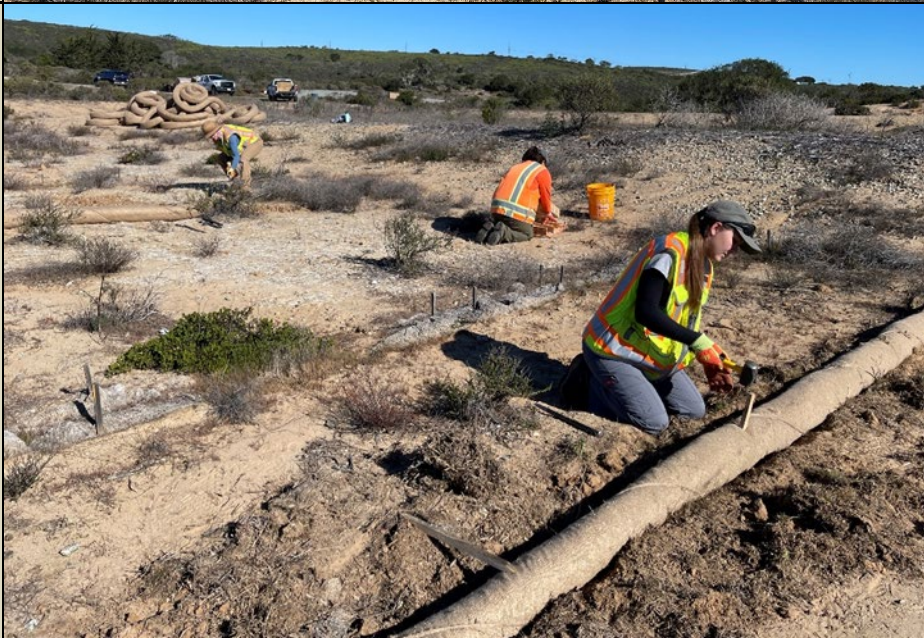
Photo Description	Photo
<p><b>Erosion Control Repairs</b></p> <p>Burleson biologist installing coir logs at HA 37</p> <p><b>C-45</b></p>

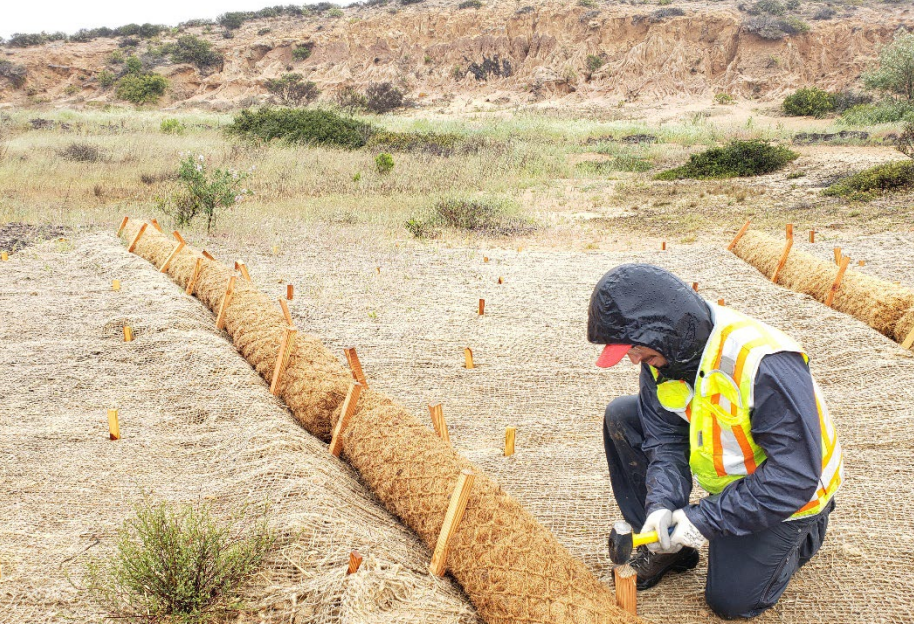
<p><b>Erosion Control Repairs</b></p> <p>Burleson biologist installing coir fabric at HA 37</p> <p><b>C-46</b></p>

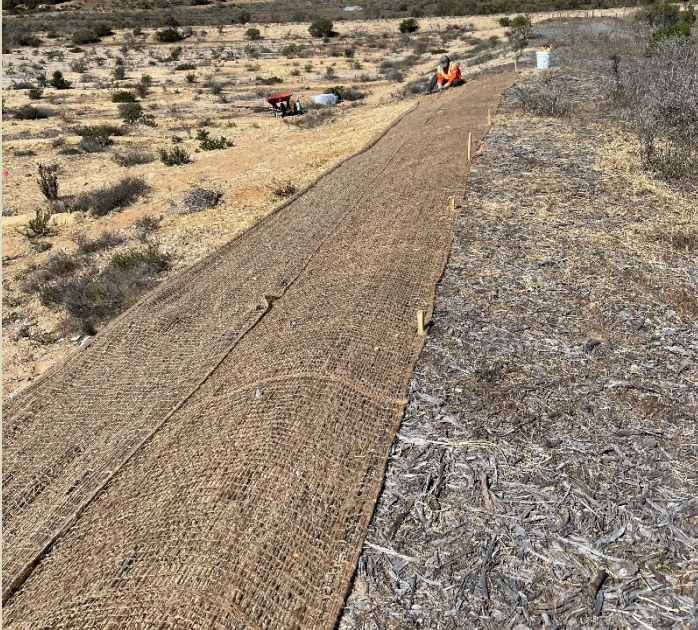
Photo Description	Photo
<p><b>Erosion Control Repairs</b></p> <p>Burleson biologists installing wattles at HA 34</p> <p><b>C-47</b></p>

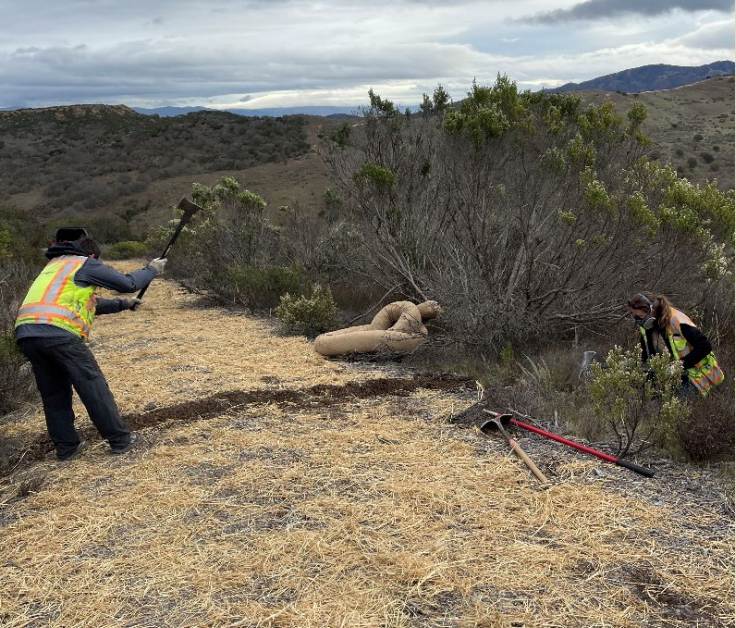
<p><b>Erosion Control Repairs</b></p> <p>Wattle installation at HA 37</p> <p><b>C-48</b></p>

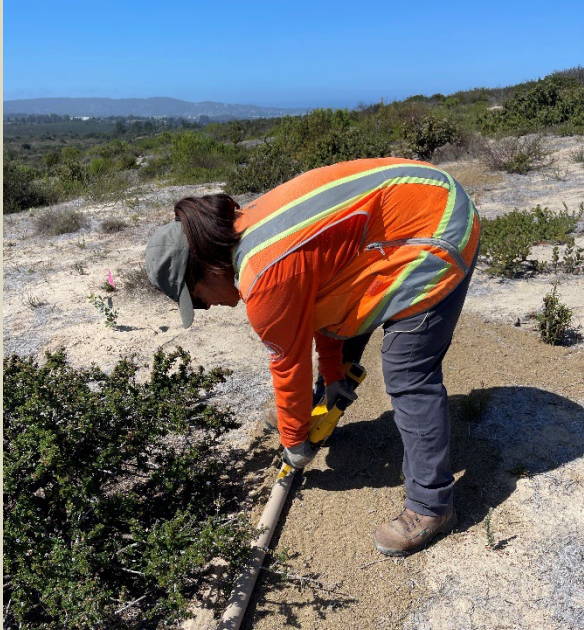
<p><b>Irrigation</b></p> <p>Burleson biologists using handheld saw to cut polyvinyl chloride pipes at HA 26</p> <p><b>C-50</b></p>

After the last irrigation event in February 2022, the system was dismantled. All materials including the PVC pipes, poly lines, spaghetti lines, emitters, and stakes were removed from the site. The two 3,000-gallon water tanks remain on site to be available to support the Army's Fort Ord Prescribed Burn Program.
