2024 ANNUAL REPORT
FORMER FORT ORD SITE 39 HABITAT RESTORATION
CONTRACT NO. W91238-23-D-0009
TASK ORDER W9123823F0042

2024 ANNUAL REPORT FORMER FORT ORD SITE 39 HABITAT RESTORATION

HARRIS ENVIRONMENTAL GROUP, INC.
650 N. 6TH AVENUE
TUCSON, ARIZONA 85705

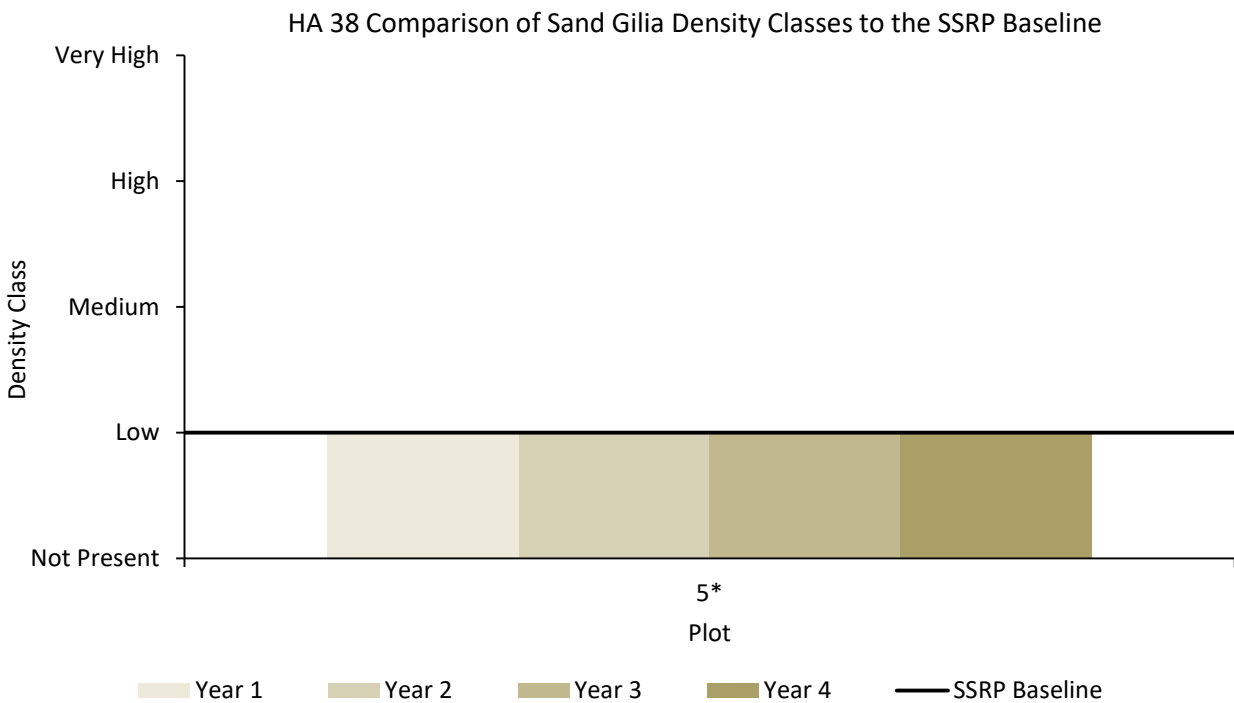
Figure 8-21. HA 38 Comparison of Sand Gilia Density Classes to the SSRP Baseline for Plot 5

There are five sand gilia restoration plots at HA 38 and are numbered 1-5. Plots 1-4 were seeded in 2017 while plot 5 was seeded in 2020. Plot 5 was monitored for year 4 in 2024, while plots 1-4 were not monitored since they did not fall on a monitoring year. Plot 5 is in a standalone area just northwest of the main restoration area, which contains plots 1-4 (Figure 8-22). Sand gilia density was low at plot 5 in 2024 (Figure 8-21).

* Plot 5 was established in 2020 and has only been monitored for years 1-4

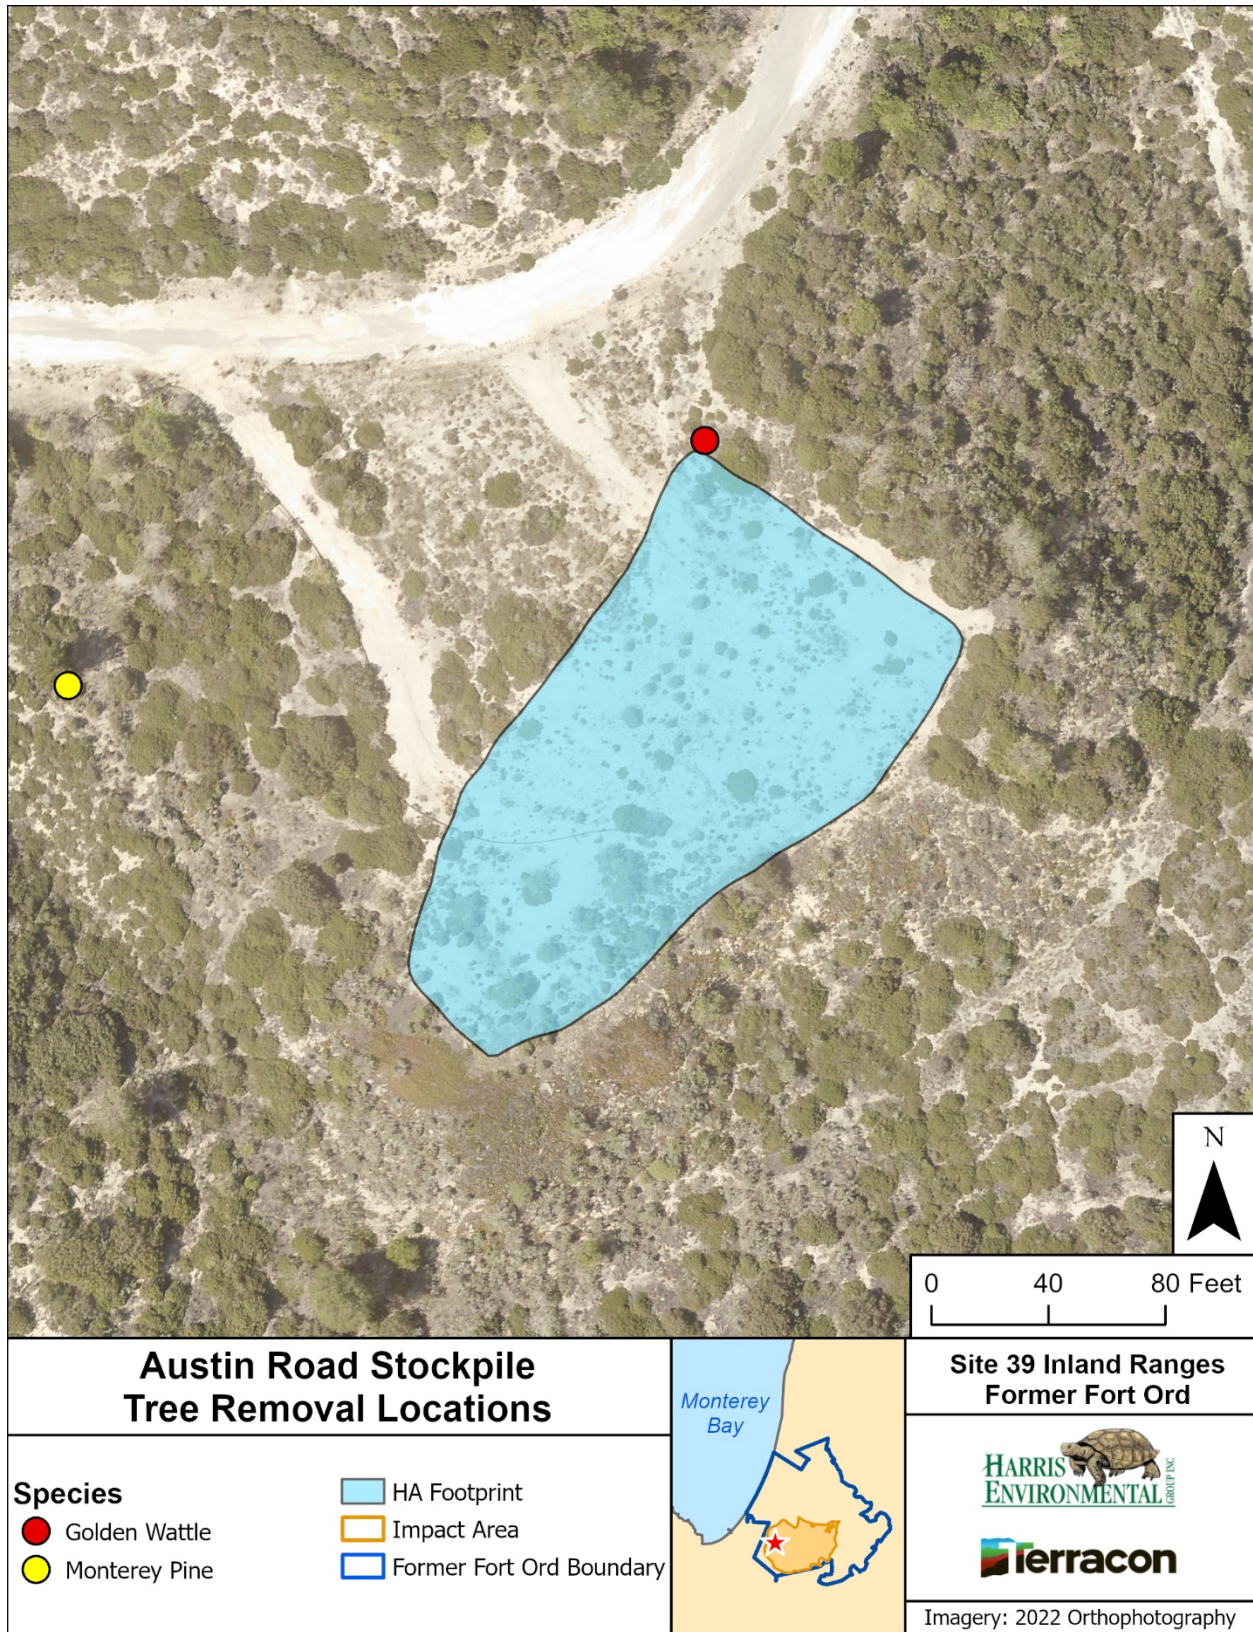
Figure 8-33. Tree removal locations at Austin Road Stockpile

Tree removal and herbicide application of cut stumps occurred at ARS in 2024. One Monterey pine and one golden wattle were felled at ARS. Tree removal locations are shown in Figure 8-33.

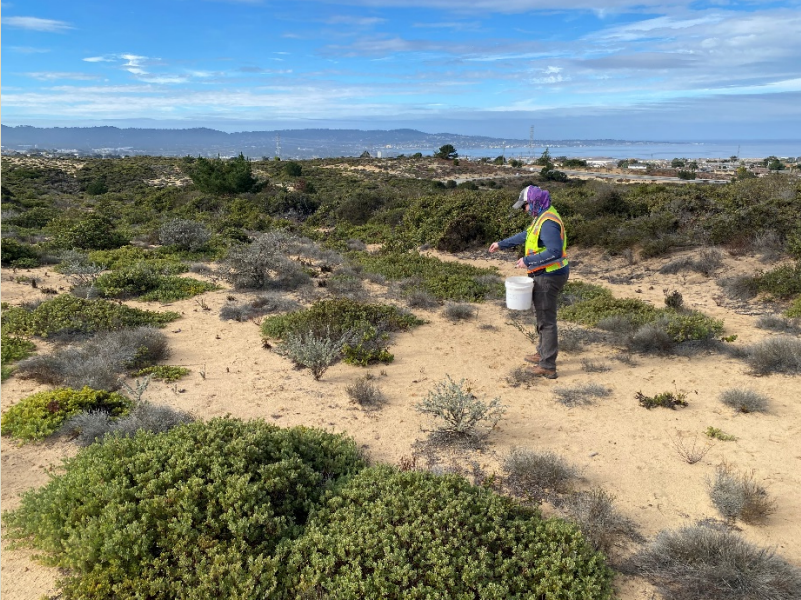
| Photo Description | Photo |
|---|---|
| <p>Passive Restoration</p> <p>A biologist broadcasting seed at HA 19 November 2024</p> <p>C-1</p> | A biologist wearing a purple shirt, a yellow safety vest, and a white bucket is standing in a desert landscape, broadcasting seed. The landscape is sandy with scattered green shrubs. In the background, there are mountains and a body of water under a blue sky with some clouds. |

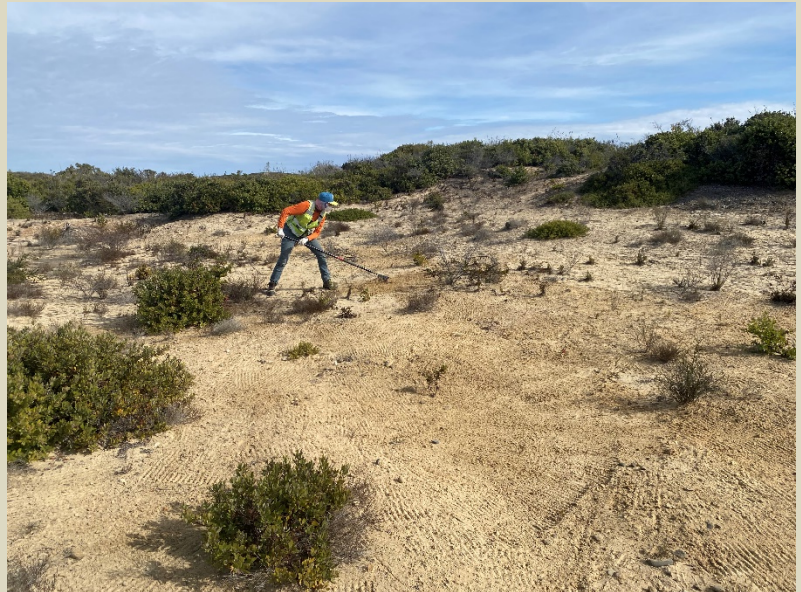
| Photo Description | Photo |
|---|---|
| <p>Passive Restoration</p> <p>A biologist rakes in seed at HA 26 November 2024</p> <p>C-2</p> | A biologist wearing an orange shirt, a blue cap, and a yellow safety vest is using a rake to spread seed on a sandy dune. The dune is covered with sparse green shrubs. The sky is blue with some clouds. |

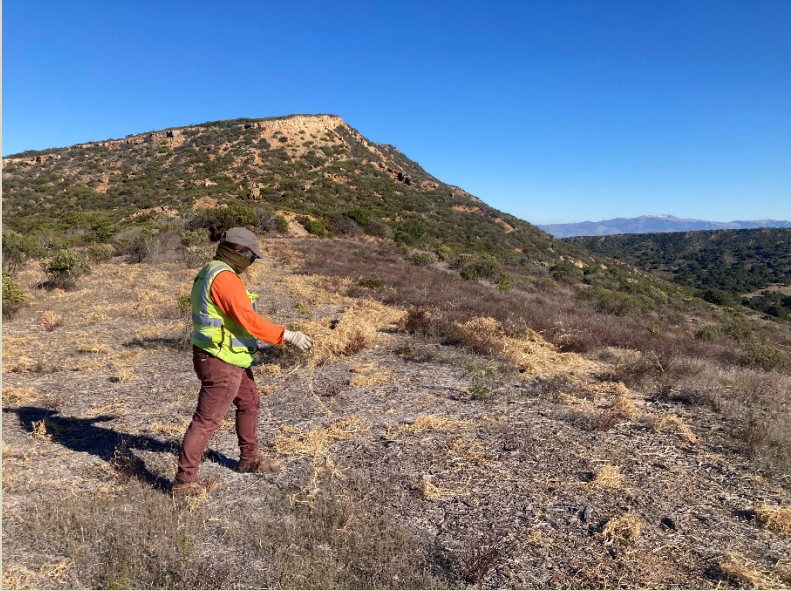
| Photo Description | Photo |
|--|---|
| <p>Passive Restoration</p> <p>A biologist covers the former road at HA 34 with straw after broadcasting seed in December 2024</p> <p>C-3</p> | A biologist wearing a high-visibility orange vest, a brown hat, and brown pants is walking on a dry, hilly landscape. They are holding a bundle of straw, preparing to cover the ground. The background shows a clear blue sky and distant hills. |

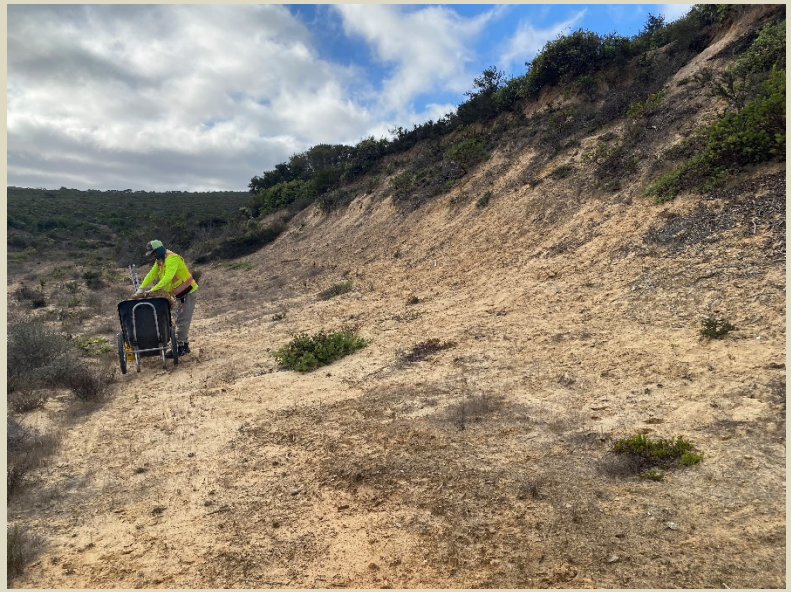
| Photo Description | Photo |
|--|---|
| <p>Passive Restoration</p> <p>Bare area in HA 37 before seed broadcast</p> <p>C-4</p> | A biologist wearing a high-visibility yellow vest, a green hat, and grey pants is pushing a black seed broadcast machine up a dry, hilly slope. The ground is mostly bare with some sparse vegetation. The sky is blue with scattered white clouds. |

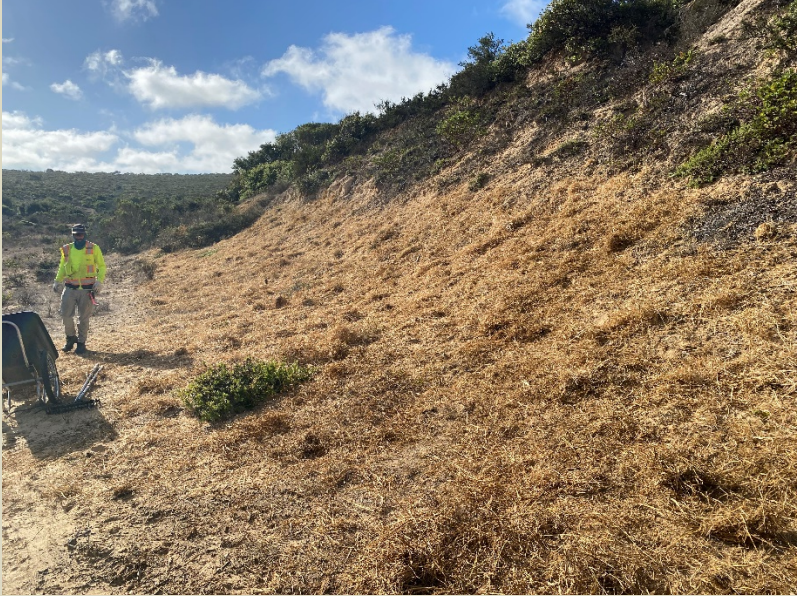
| Photo Description | Photo |
|---|---|
| <p>Passive Restoration</p> <p>Bare area fully covered with straw and seed for revegetation at HA 37</p> <p>C-5</p> | |

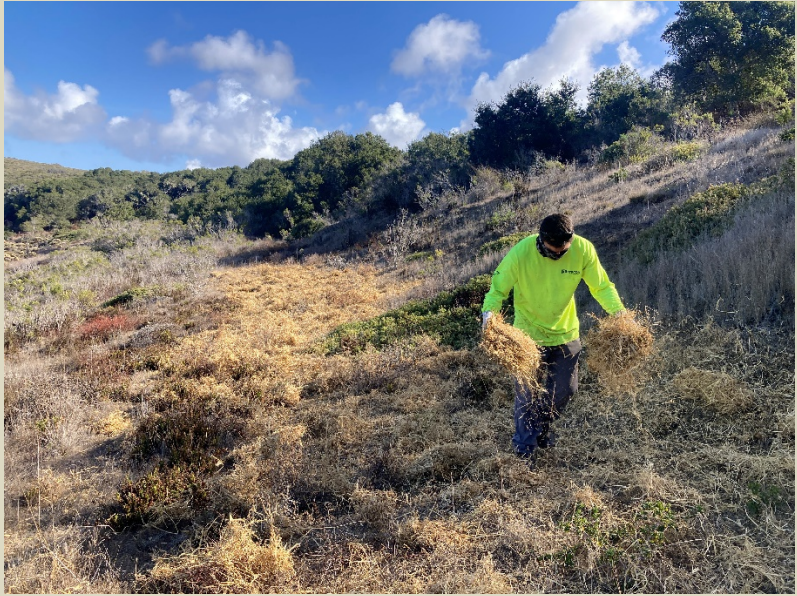
| Photo Description | Photo |
|---|---|
| <p>Passive Restoration</p> <p>A biologist spreads straw over an area broadcast with seed at HA 39/40 November 2024</p> <p>C-6</p> | |

- HA 39/40 – Install an additional transect in Plot 3 to better assess restoration progress, broadcast production seed to address native vegetative cover criterion (recommendation repeated from previous years). Installation planned for early Spring 2025, prior to year 13 monitoring activities.

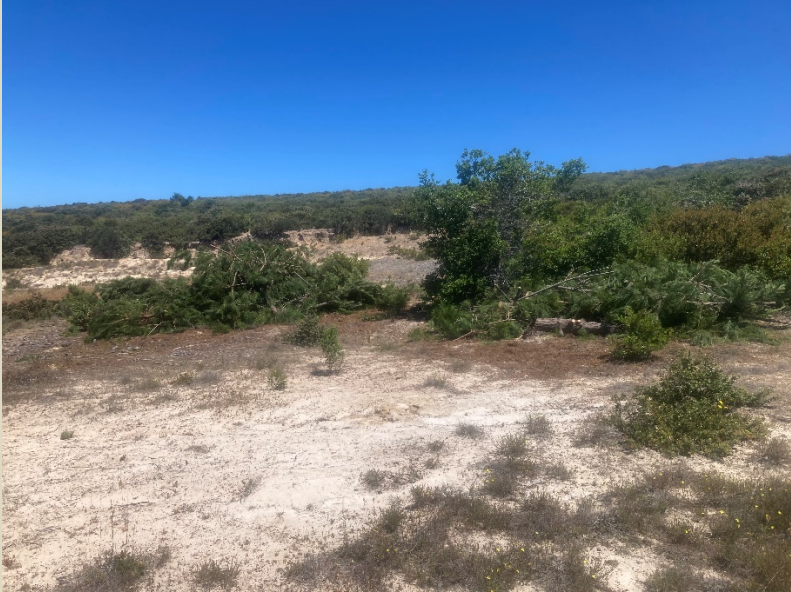
| Photo Description | Photo |
|--|--|
| <p>Caretaker of Previous HA</p> <p>After removal of Monterey Pines at HA 27A in June 2024</p> <p>C-7</p> | A wide-angle photograph showing a cleared area of land. The foreground is a mix of dry, light-brown soil and sparse, low-lying green shrubs. In the background, there is a line of denser green vegetation and a clear, bright blue sky. The terrain appears to be a gentle slope. |

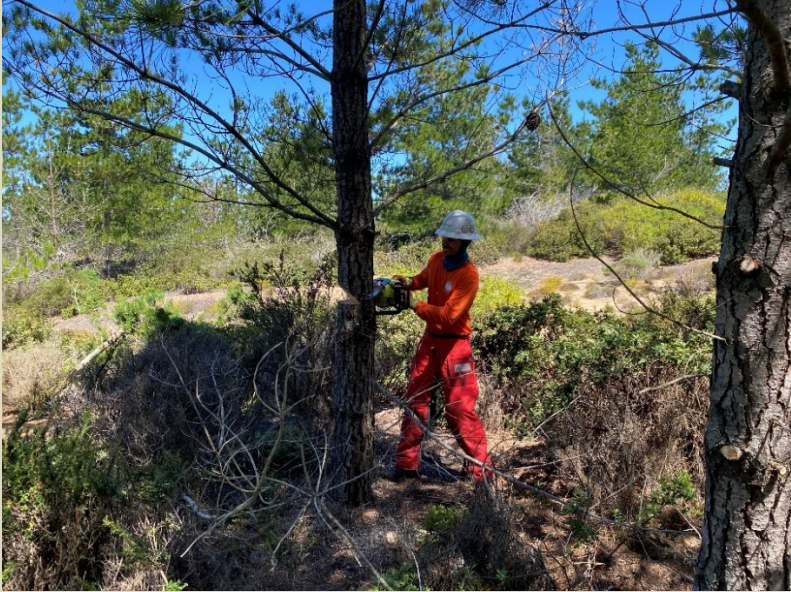
| Photo Description | Photo |
|--|--|
| <p>Caretaker of Previous HA</p> <p>Biologist making final cut with a chainsaw to fell a Monterey pine at HA 19 in June 2024</p> <p>C-8</p> | A photograph of a person wearing an orange long-sleeved shirt, orange pants, and a white hard hat. They are using a chainsaw to cut a large, dark-barked tree trunk. The person is standing in a wooded area with other trees and shrubs in the background. The sky is visible through the branches. |

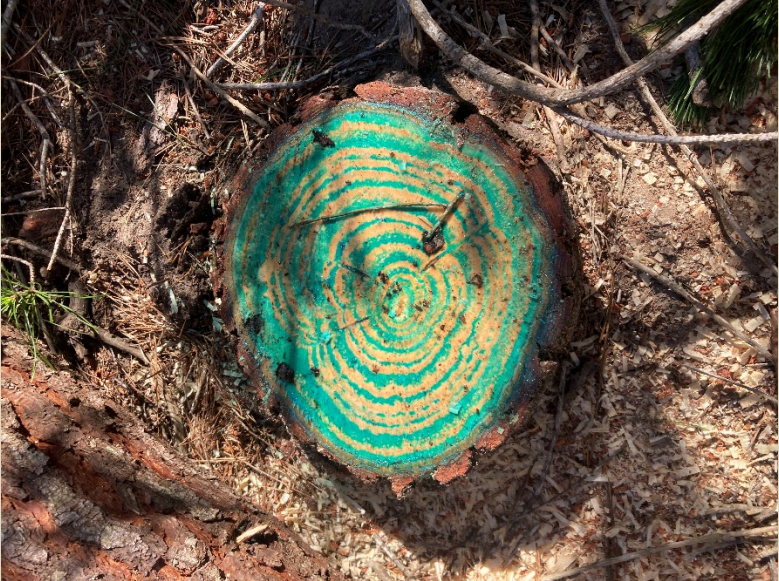
| Photo Description | Photo |
|--|---|
| <p>Caretaker of Previous HA</p> <p>Herbicide containing dye applied to felled Monterey pine stump in June 2024</p> <p>C-9</p> | |

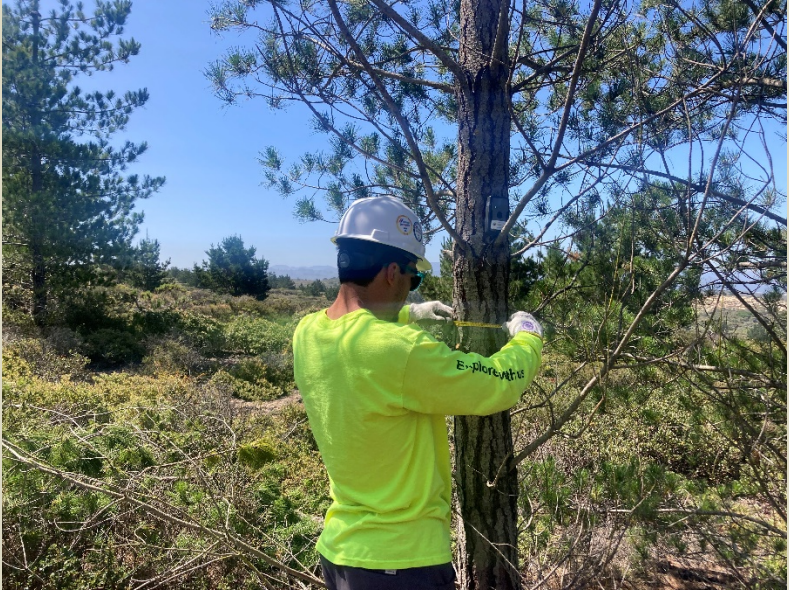
| Photo Description | Photo |
|--|---|
| <p>Caretaker of Previous HA</p> <p>Biologist measuring diameter at breast height before tree removal June 2024</p> <p>C-10</p> | |

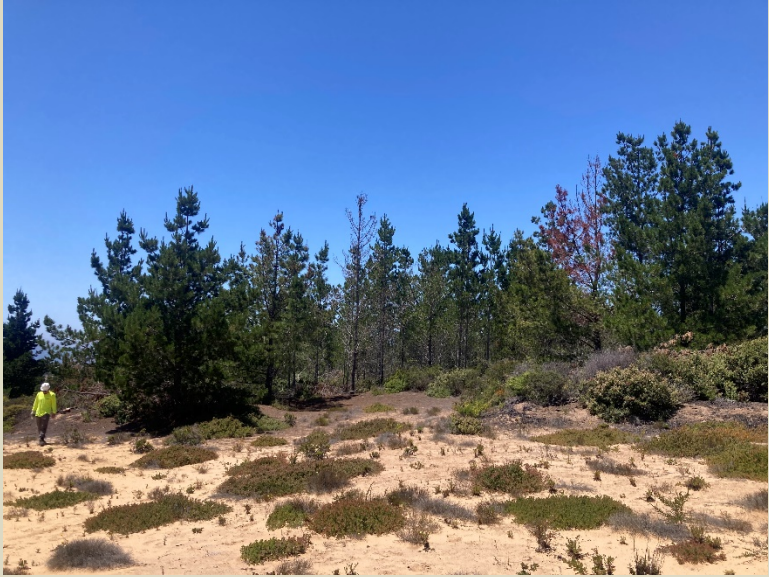
| Photo Description | Photo |
|---|---|
| <p>Caretaker of Previous HA</p> <p>Facing West towards the northwest corner of HA 19, Before 2024 tree removal in June 2024</p> <p>C-11</p> | |

- HA 19 – Continue removal of Monterey pines encroaching on the footprint of the HA and apply 20 percent glyphosate herbicide solution to cut stumps.
- HA 36 – Install an additional transect to better assess the site (recommendation from 2021 annual report). Installation planned for early Spring 2025, prior to year 13 monitoring activities.

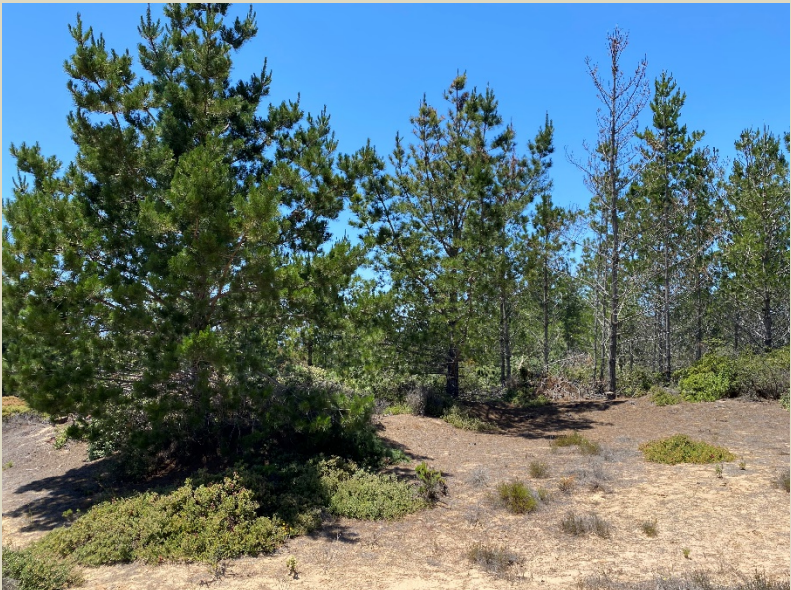
| Photo Description | Photo |
|---|---|
| <p>Caretaker of previous HA</p> <p>Facing West towards the northwest corner of HA 19, Before 2024 tree removal in June 2024</p> <p>C-12</p> | |

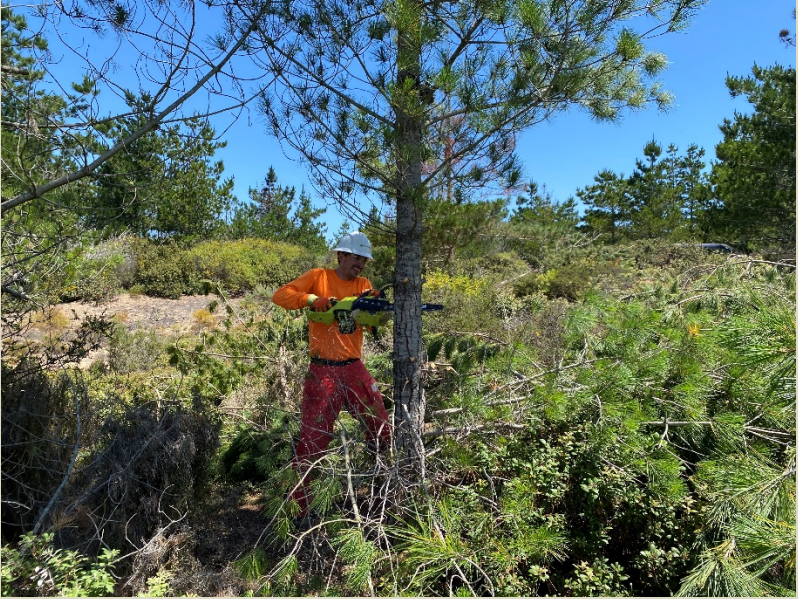
| Photo Description | Photo |
|--|---|
| <p>Caretaker of previous HA</p> <p>Biologist making a wedge cut with a chainsaw to fell a Monterey pine at HA 19 in June 2024</p> <p>C-13</p> | A photograph showing a biologist wearing an orange long-sleeved shirt, red pants, and a white hard hat. The biologist is standing on a grassy slope and using a chainsaw to make a wedge cut in the trunk of a Monterey pine tree. The background shows more trees and a clear blue sky. |

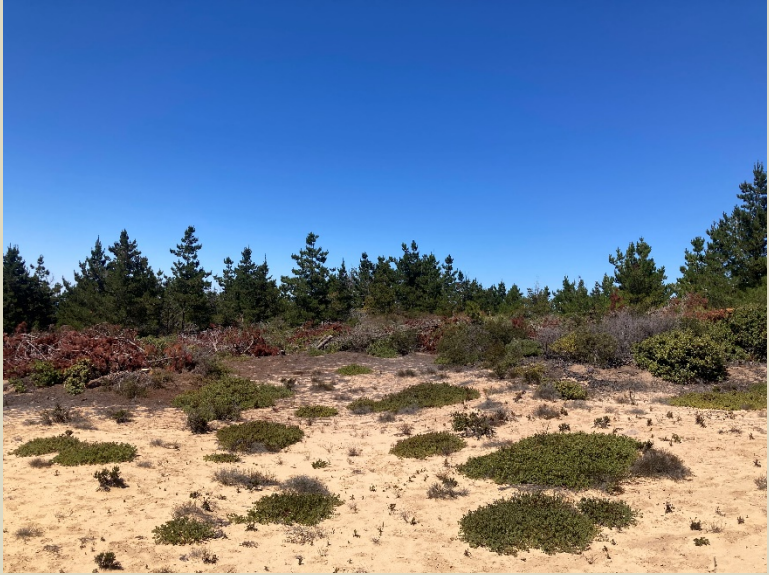
| Photo Description | Photo |
|---|---|
| <p>Caretaker of previous HA</p> <p>Facing West towards the northwest corner of HA 19, After 2024 tree removal in September 2024</p> <p>C-17</p> | |

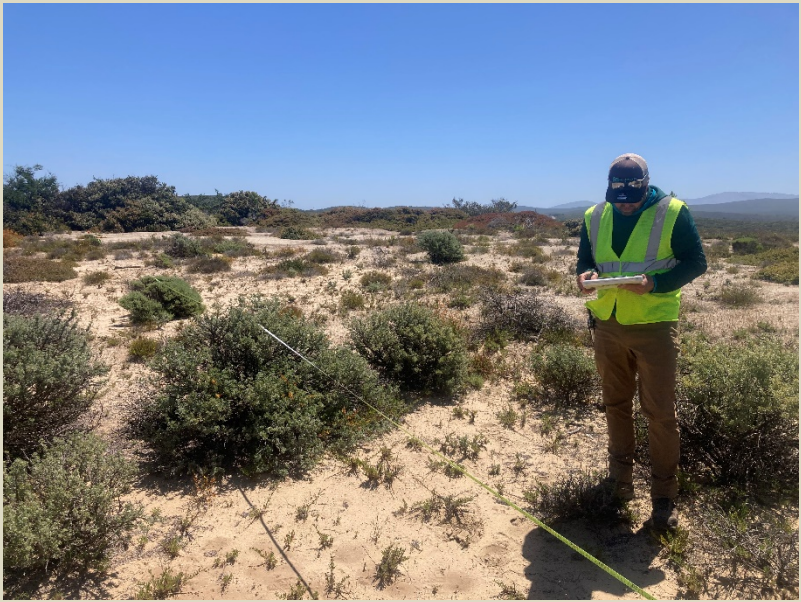
| Photo Description | Photo |
|--|---|
| <p>Monitoring</p> <p>Harris biologist recording transect data at Austin Road Stockpile in June 2024</p> <p>C-21</p> | |

Austin Road Stockpile will be monitored in 2025 by photo documentation and site visits. Table 8-81 summarizes the current status of Austin Road Stockpile including which success criteria were met based on 2024 monitoring and recommendations.

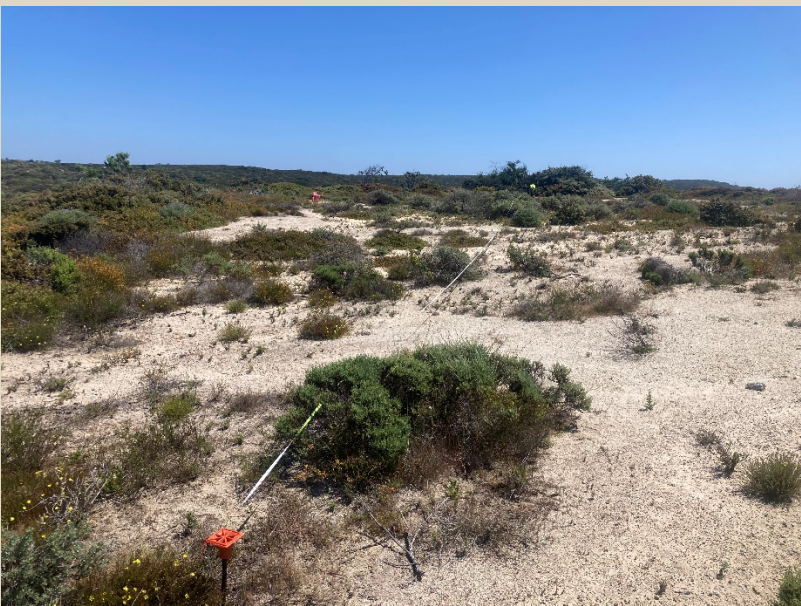
| Photo Description | Photo |
|--|---|
| <p>Monitoring</p> <p>Harris biologist/ecologist laying transect tape at Austin Road Stockpile in June 2024</p> <p>C-22</p> | |

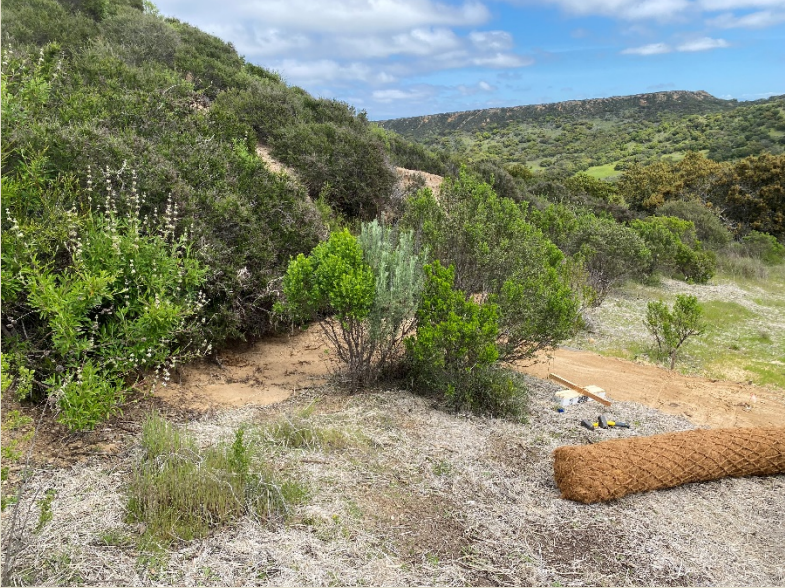
| Photo Description | Photo |
|---|--|
| <p>Erosion Control</p> <p>Before coir log installation at HA 34 in April 2024; large amount of sediment buildup observed from erosion</p> <p>C-25</p> | A photograph of a hillside with green shrubs and a large, light-brown, textured coir log lying on the ground in the foreground. The background shows a steep, eroded hillside under a blue sky with clouds. |

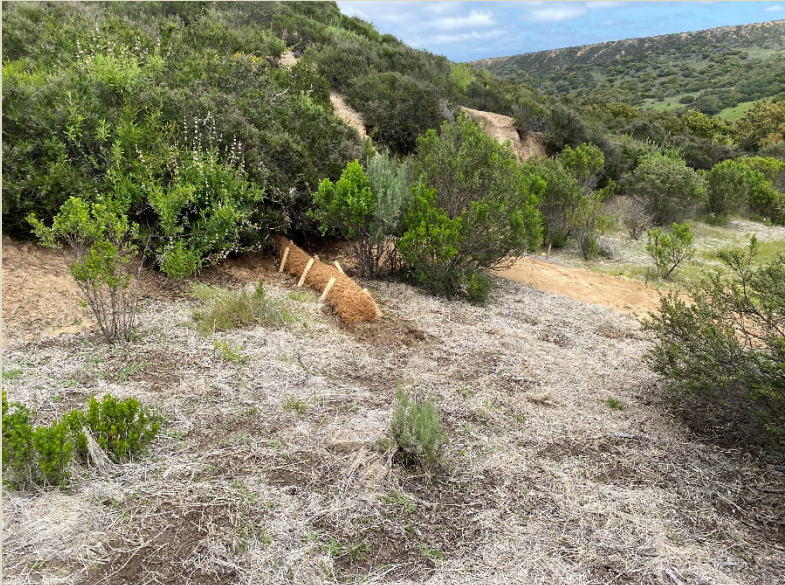
| Photo Description | Photo |
|---|--|
| <p>Erosion Control</p> <p>After coir log was installed in April 2024 at HA 34</p> <p>C-26</p> | A photograph of the same hillside as in C-25, but with the coir log now installed and secured with wooden stakes. The sediment buildup appears reduced, and the vegetation is more visible. |

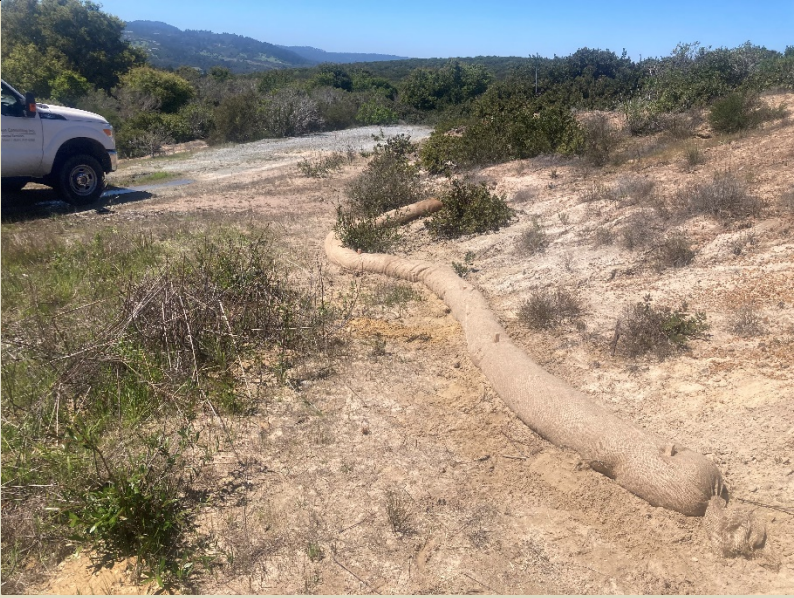
| Photo Description | Photo |
|--|---|
| <p>Erosion Control</p> <p>Newly installed wattle at HA 27A in April 2024</p> <p>C-27</p> | |

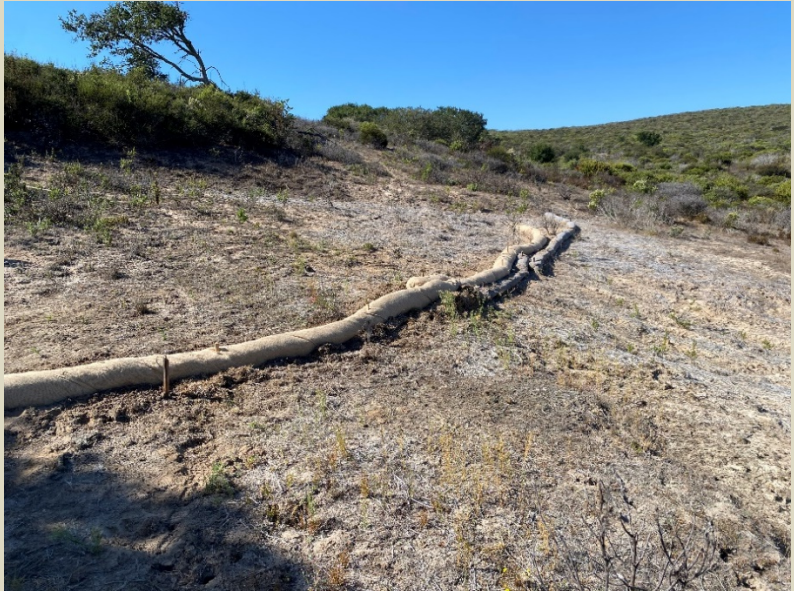
| Photo Description | Photo |
|--|---|
| <p>Erosion Control</p> <p>Newly installed wattles at HA 37 in October 2024</p> <p>C-28</p> | |

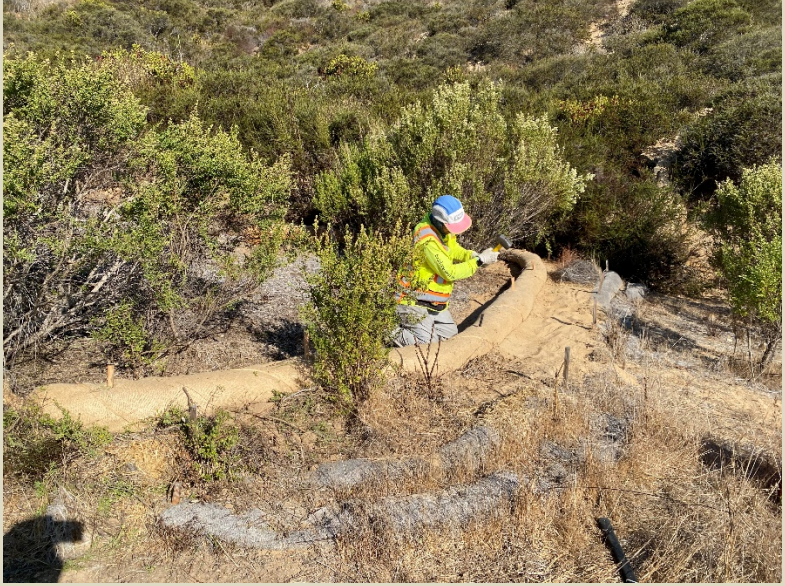
| Photo Description | Photo |
|---|---|
| <p>Erosion Control</p> <p>Biologist installing wattle at HA 34 in October 2024</p> <p>C-29</p> | |

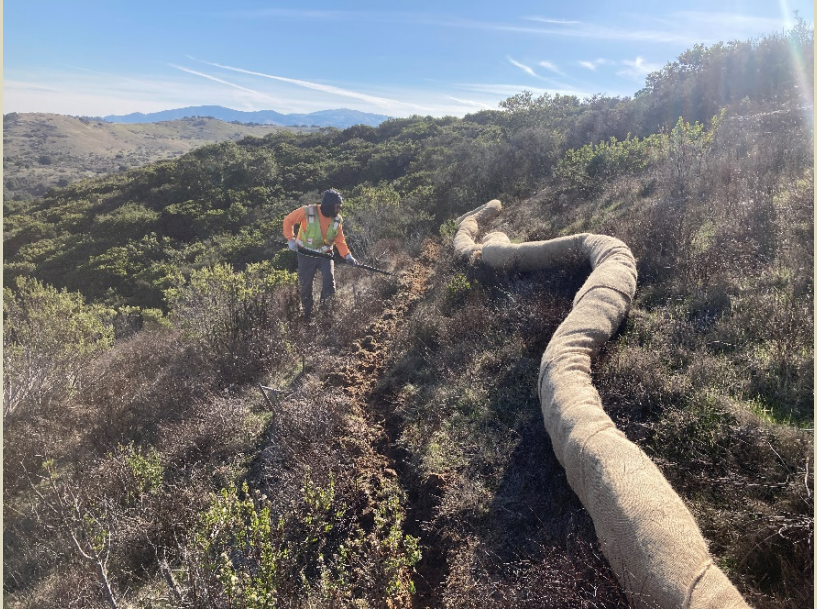
| Photo Description | Photo |
|---|---|
| <p>Erosion Control</p> <p>Biologist trenching an area to install the new wattle at HA 34 in December 2024</p> <p>C-30</p> | |

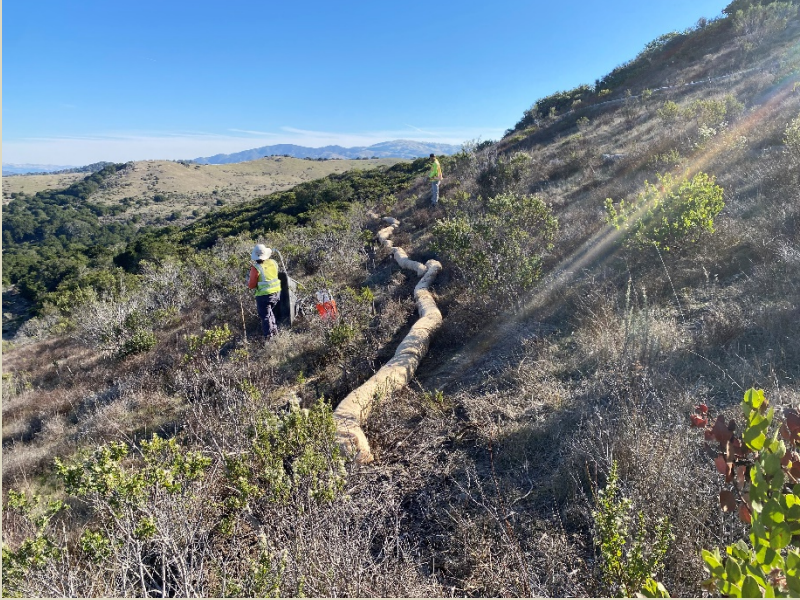
| Photo Description | Photo |
|---|---|
| <p>Erosion Control</p> <p>Newly installed wattle at HA 34 in December 2024</p> <p>C-31</p> | |

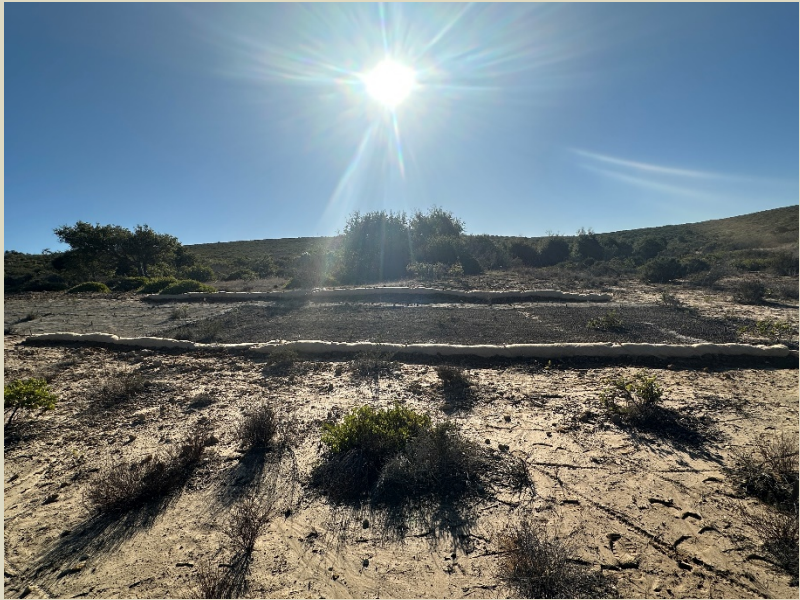
| Photo Description | Photo |
|---|---|
| <p>Erosion Control</p> <p>Newly installed wattles at HA 37 in December 2024</p> <p>C-32</p> | |

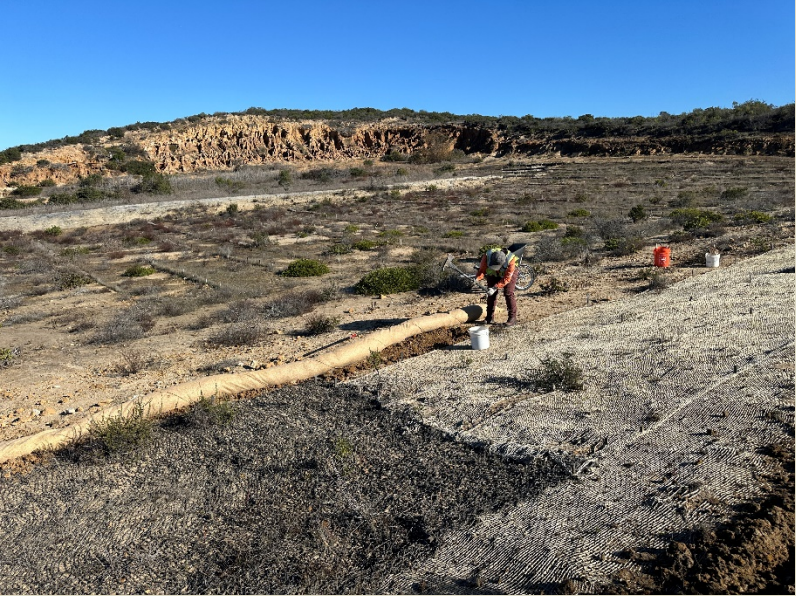
| Photo Description | Photo |
|--|---|
| <p>Erosion Control</p> <p>Wattle installation at HA 37 in December 2024</p> <p>C-33</p> | |
