NATURAL RESOURCE IMPACT MITIGATION CHECKLIST

ESCA MRA:	Parker Flats MRA, Residential Quality Assurance (RQA) Level 2 Digital Geophysical Mapping (DGM) Baseline Survey	Date:	19-Oct-12 [Updated from 25-Mar-09]
Work to be conducted:	This work implements the ESCA RQA Process addressing regulatory agency concerns regarding residual munitions and explosives of concern (MEC) risk in areas designated for future residential reuse after MEC investigations and removal actions have been completed. Approximately 12 acres of the Parker Flats MRA proposed residential reuse areas are recommended for further assessment during the RQA Pilot Study Implementation Phase Level 2 Baseline Digital Geophysical Mapping (DGM) Survey (Figure 1). Potential activities include: field staking; tree surveys and identification of dead or diseased trees and limbs by the Project Arborist; removal of surface vegetation including brush; tree limbing, cutting or removal as coordinated with SQB/Project Arborist; chipping of vegetation debris on site or removal of debris from the work area; erosion control measures (if required); and MEC field activities including instrument-aided investigation, target-specific excavatio

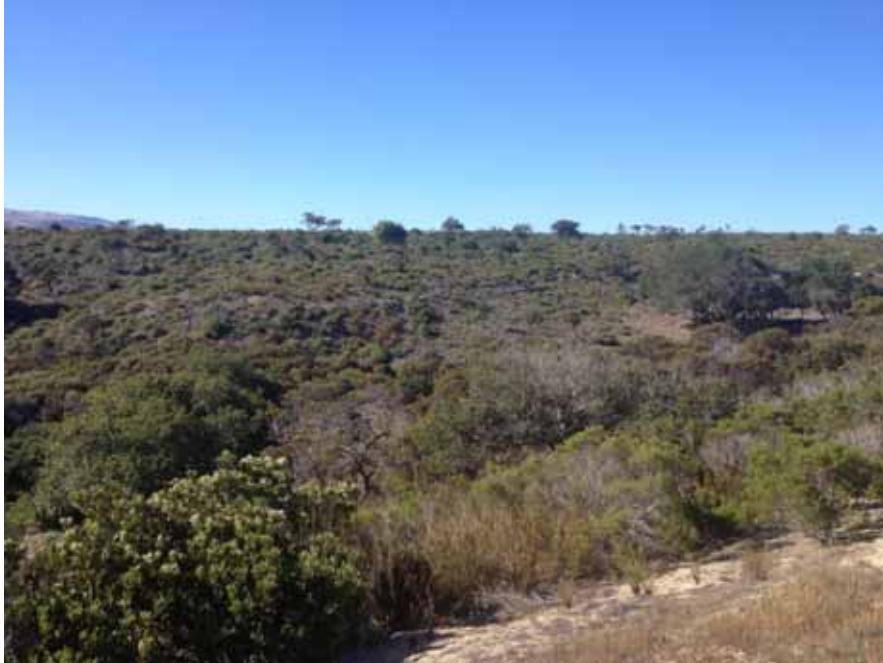
uncut within the four grid cells: C4F6A1, C4E5J0, C4E6J1, C4E6J2. See photos 1-3. All brush that was ground up with the attachment on the excavator was left in place and would server as a mulch to help prevent exrosion of the area.

1. FEG pre-brush cut June 27, 2013

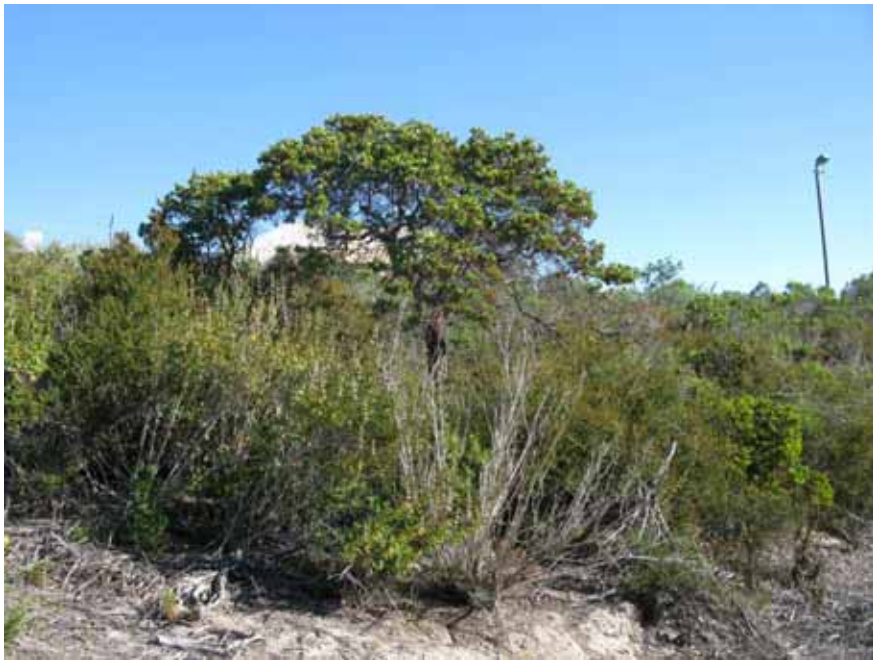
2. FEG pre-brush cut June 27, 2013

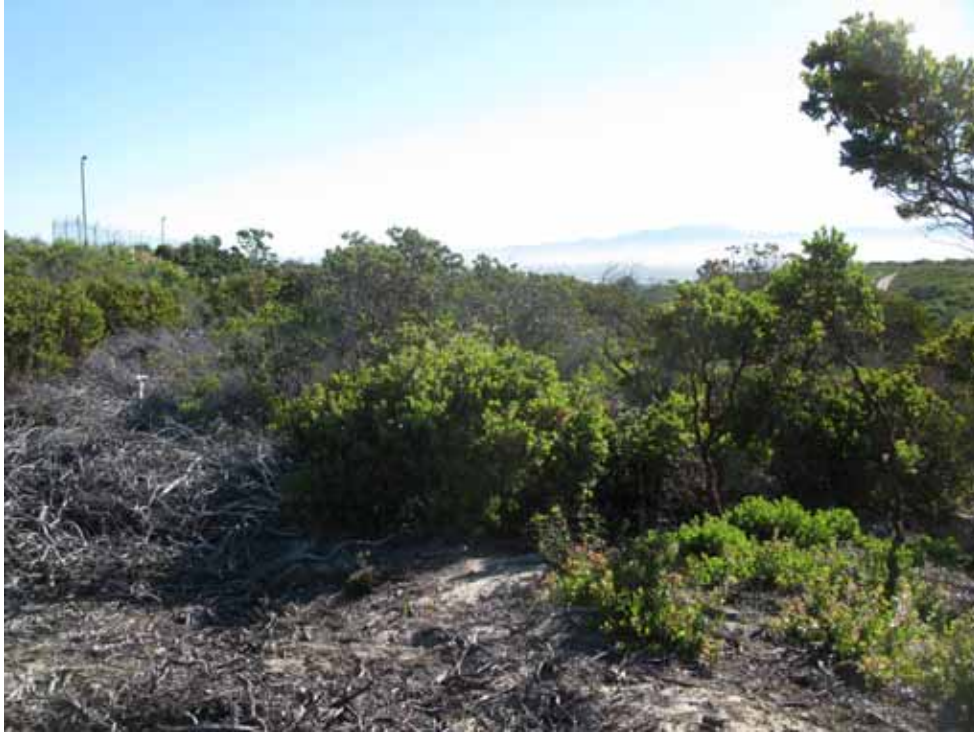
3. FEG pre-brush cut June 27, 2013

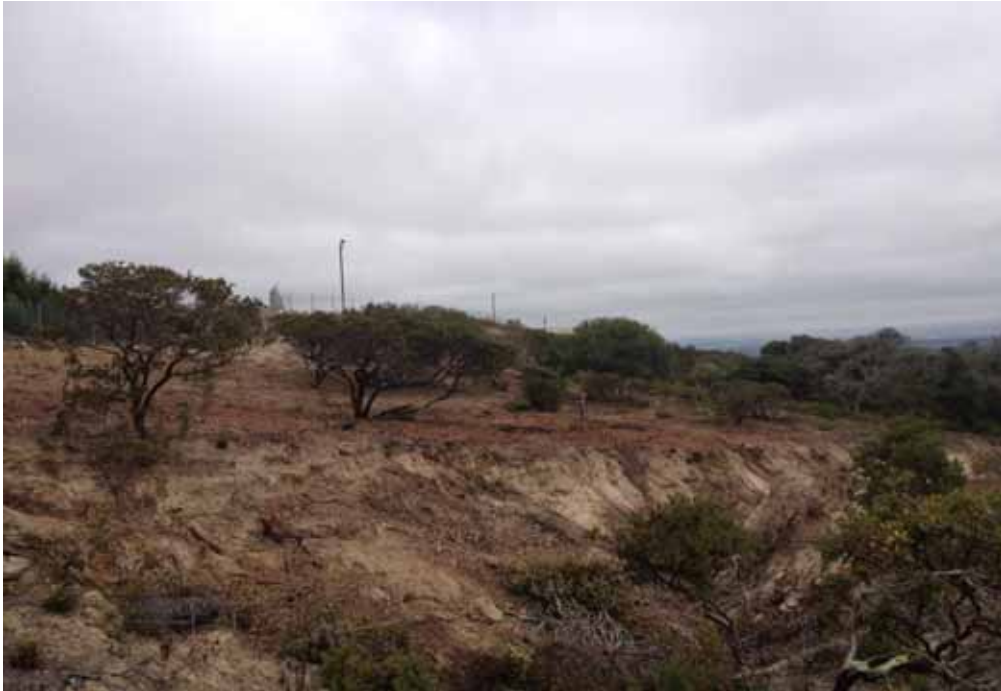
10:05 D. Muir and Mitch Siemens arrive in FEG at the location where brush cutting has occurred. The crew used an excavator with a grinding attachment on the arm to conduct the brush cutting. The tracks left from the excavator were observed to be minimal disturbance for ingress and egress with one path in and out of the site.

10:15 all oak trees with a diameter at breast height (DBH) of six inches or greater were left uncut and/or lower branches were trimmed up to prevent hazards. Several torro manzanitas (*Arctostaphylos montereyensis*) were left uncut. Approximately ten torro manzanitas were observed to be left

4. FEG post brush cutting July 11, 2013

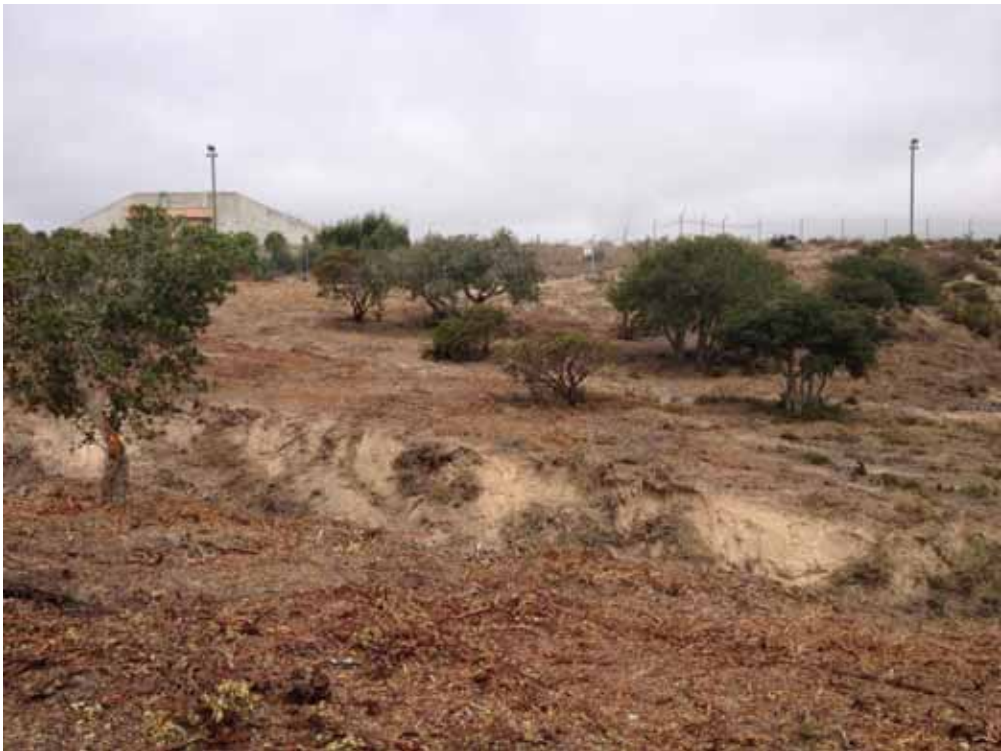
5. FEG post brush cutting July 11, 2013
