FORA ESCA REMEDIATION PROGRAM

Interim Remedial Action Completion Report Volume 1 – Interim Remedial Action Field Activities and Results

Interim Action Ranges Munitions Response Area Phase II

Former Fort Ord
Monterey County, California

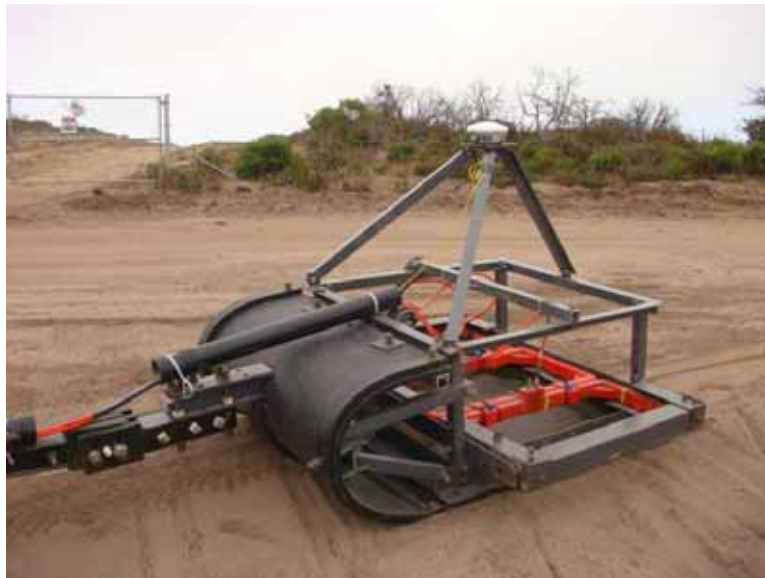
Photograph 3-1 – The FORA ESCA Sled in Multi-coil Configuration

The DGM survey activities were conducted using the Geonics EM61-MK2 time domain metal detector. A specially configured, multi-coil EM61-MK2 towed array platform (“the FORA ESCA Sled”) was used within the IAR MRA Phase II work areas. The EM61-MK2 is battery-powered and operates at a maximum output of 10,000 milliVolts (mV). When conductive objects are present below the instrument, the amplitude and decay time of the induced eddy currents vary in response to the size, mass, and orientation of the objects.

The FORA ESCA Sled, was designed, tested, and used during MEC remedial action field activities on ESCA property and was capable of meeting the project scope and data quality objectives (DQOs) as discussed in the Interim Action Work Plan. A photograph of the FORA ESCA Sled is shown in Photograph 3-1. During Design Study and Phase II Interim Action activities, the FORA ESCA Sled was used with a multi-coil configuration.

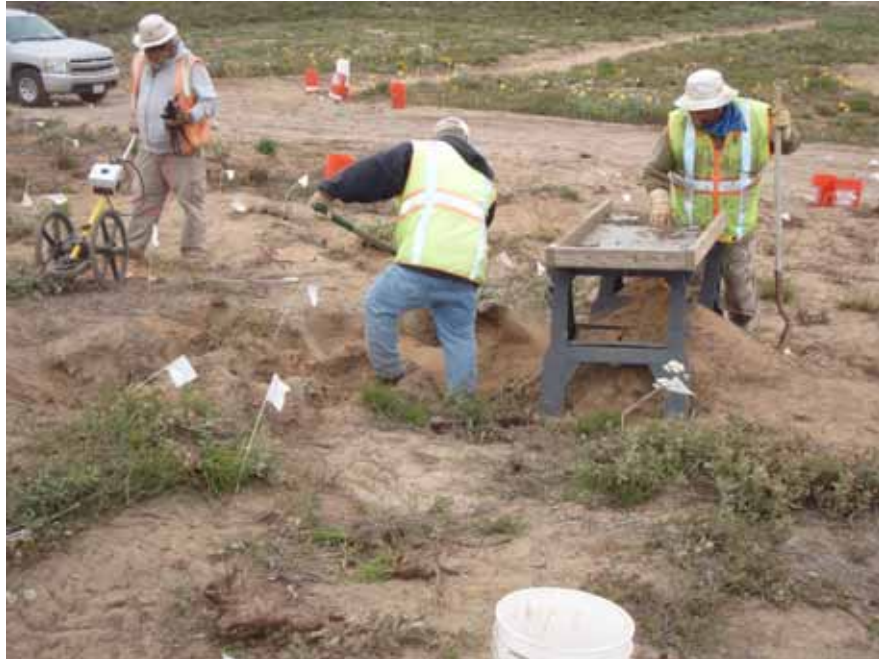
Photograph 3-2 – Hand Excavation of Anomalies

UXO Dig Teams consisting of UXO Technicians and equipment operators performed excavations at the target anomaly locations identified by the DGM survey. The target anomaly excavations were generally performed with hand tools, such as shovels. Photograph 3-2 shows the hand excavation of target anomalies. Those items considered too large or deep to be excavated by hand tools were investigated using heavy equipment, such as a backhoe.

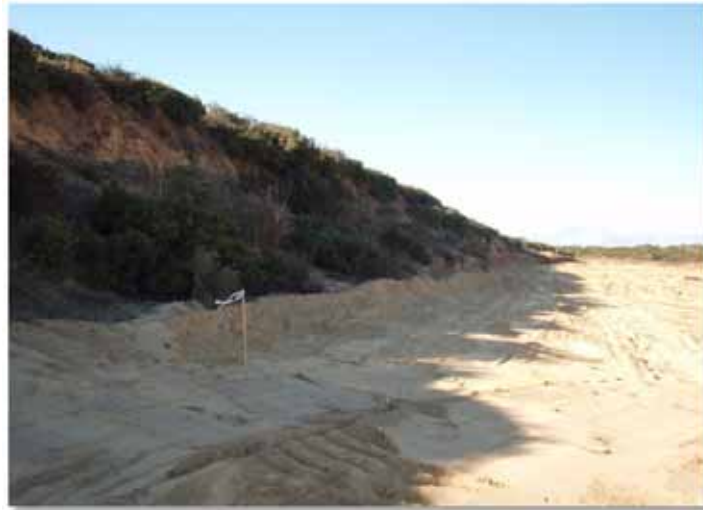
Photograph 3-3 – Range 47 SCA Sloped Escarpment

- A 0.5-acre area consisted of a sloped escarpment located in the southern portion of Range 47 SCA (shown in Photograph 3-3; Figure 3-3). The sloped escarpment was approximately 635 ft long and ranged from 15 to 20 ft in height. The slope angle was generally steep and there was slumping of soil at the toe of the slope. Parts of the slope were vegetated; however, there were several areas where no vegetation was present. A QB identified the soil as an area of low recruitment for vegetation. Due to the potential for the slope to contain sensitively-fuzed munitions (i.e., 40mm projectiles), excavation and sifting of soil from the sloped surface ranged from approximately 2 ft bgs at the bottom of the sloped escarpment to 4 ft bgs at the top of the escarpment, which was approximately 2,800 cubic yards of soil.

The sifted top soil (top 6 inches bgs) and subsoil (below 6 inches) were returned to the area of origin and depth from December 2012 to January 2013. The top soil from the 1.8-acre low recruitment area and the sloped escarpment soil, that were excavated and sifted, were used as subsoil (below 6 inches).
