## FORA ESCA REMEDIATION PROGRAM

# 2017 Annual Natural Resource Monitoring, Mitigation, and Management Report

Environmental Services Cooperative Agreement  
Remediation Program Munitions Response Areas

Former Fort Ord  
Monterey County, California

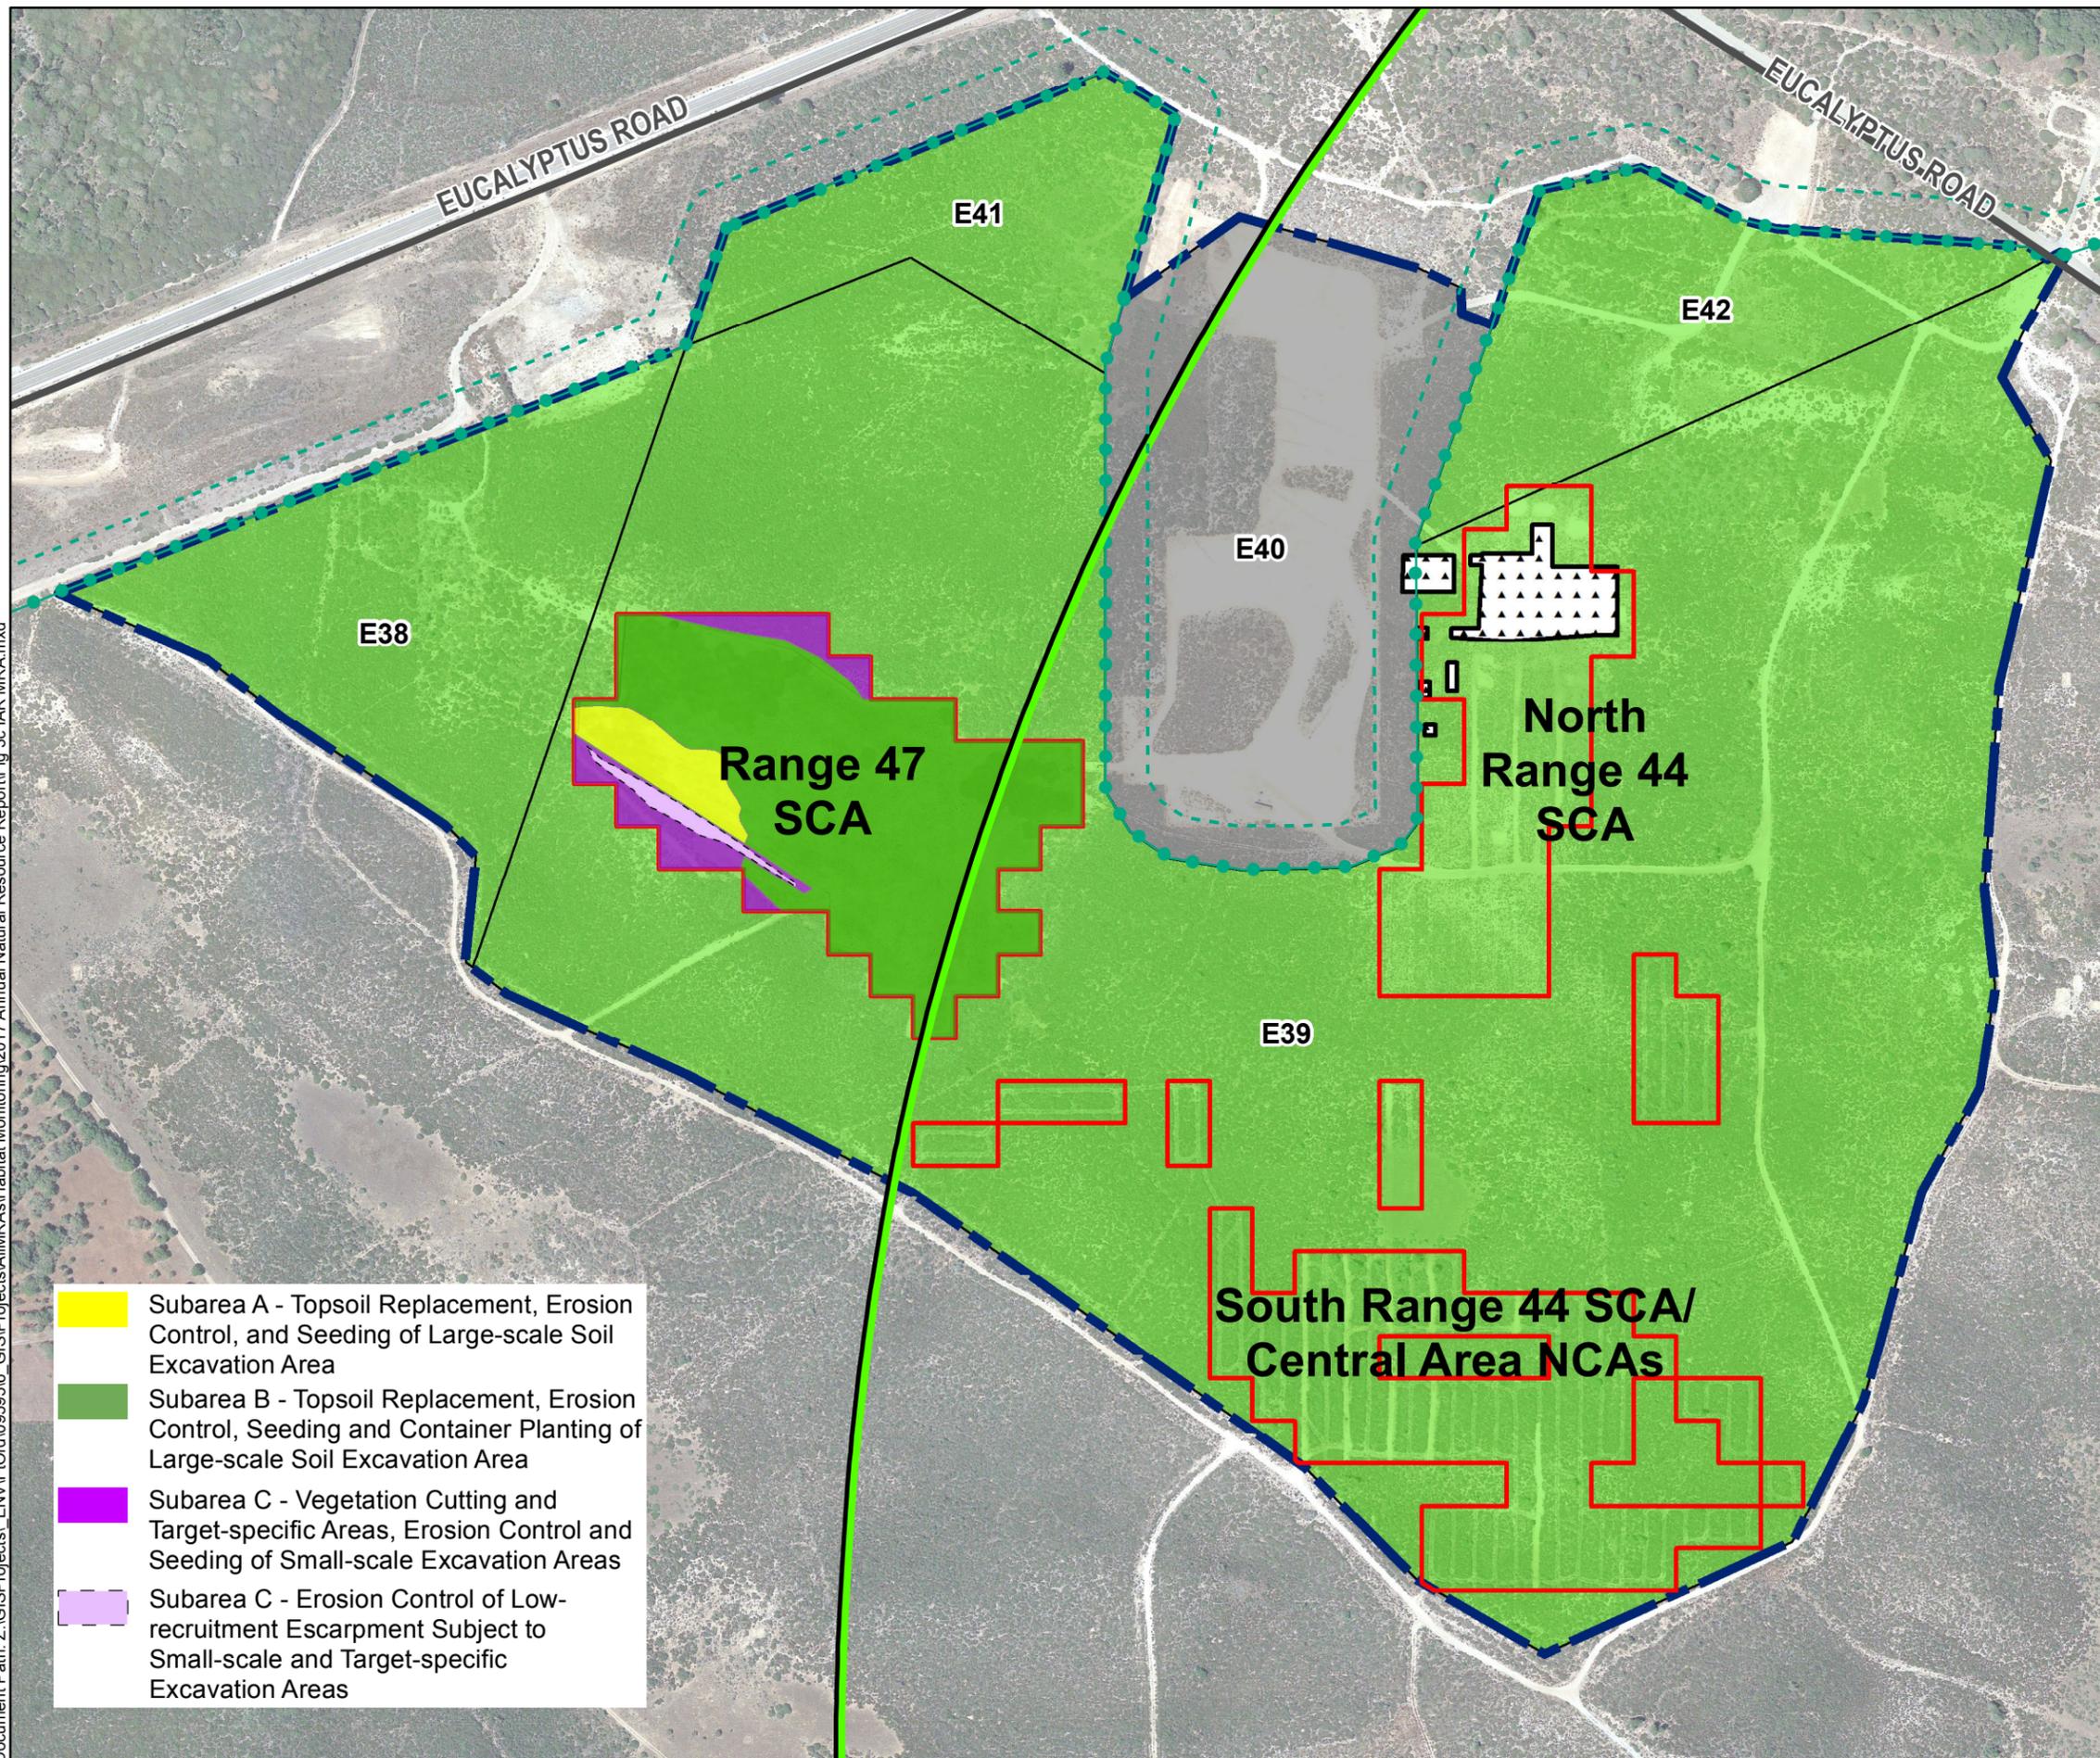
- Subarea A - Topsoil Replacement, Erosion Control, and Seeding of Large-scale Soil Excavation Area
- Subarea B - Topsoil Replacement, Erosion Control, Seeding and Container Planting of Large-scale Soil Excavation Area
- Subarea C - Vegetation Cutting and Target-specific Areas, Erosion Control and Seeding of Small-scale Excavation Areas
- Subarea C - Erosion Control of Low-recruitment Escarpment Subject to Small-scale and Target-specific Excavation Areas

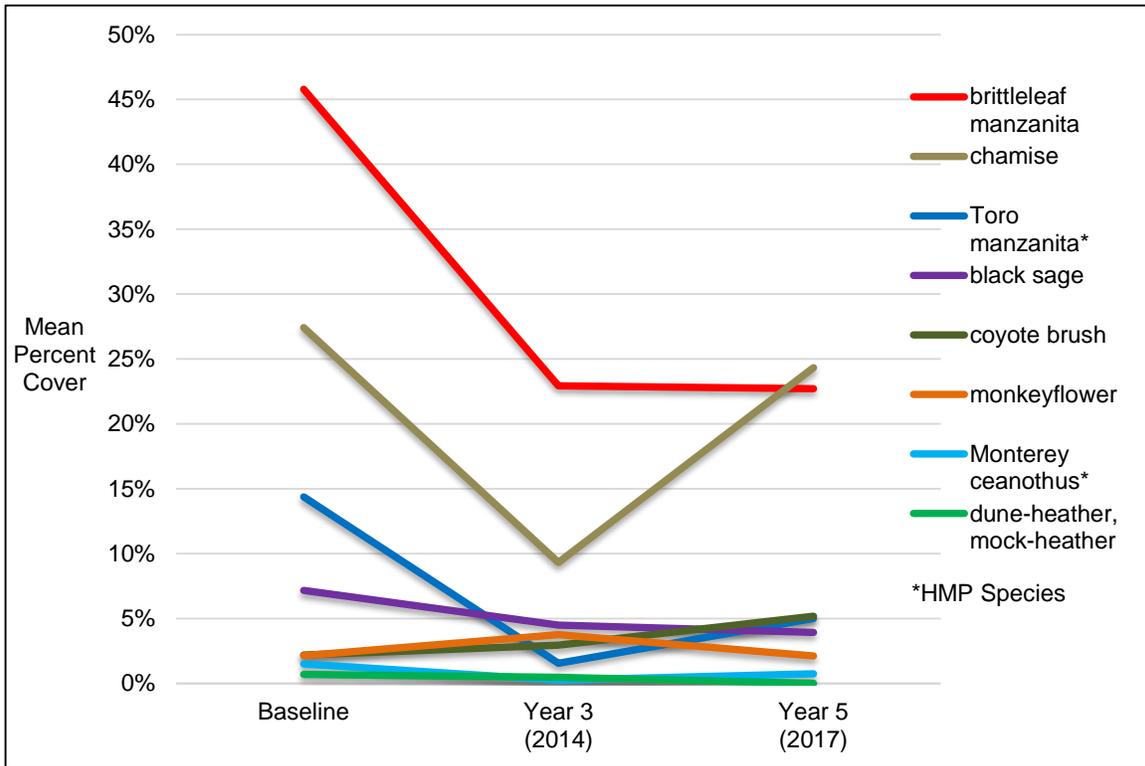
**Figure 10.**  
**Future East Garrison MRA – Mean Shrub Cover after Vegetation Cutting**

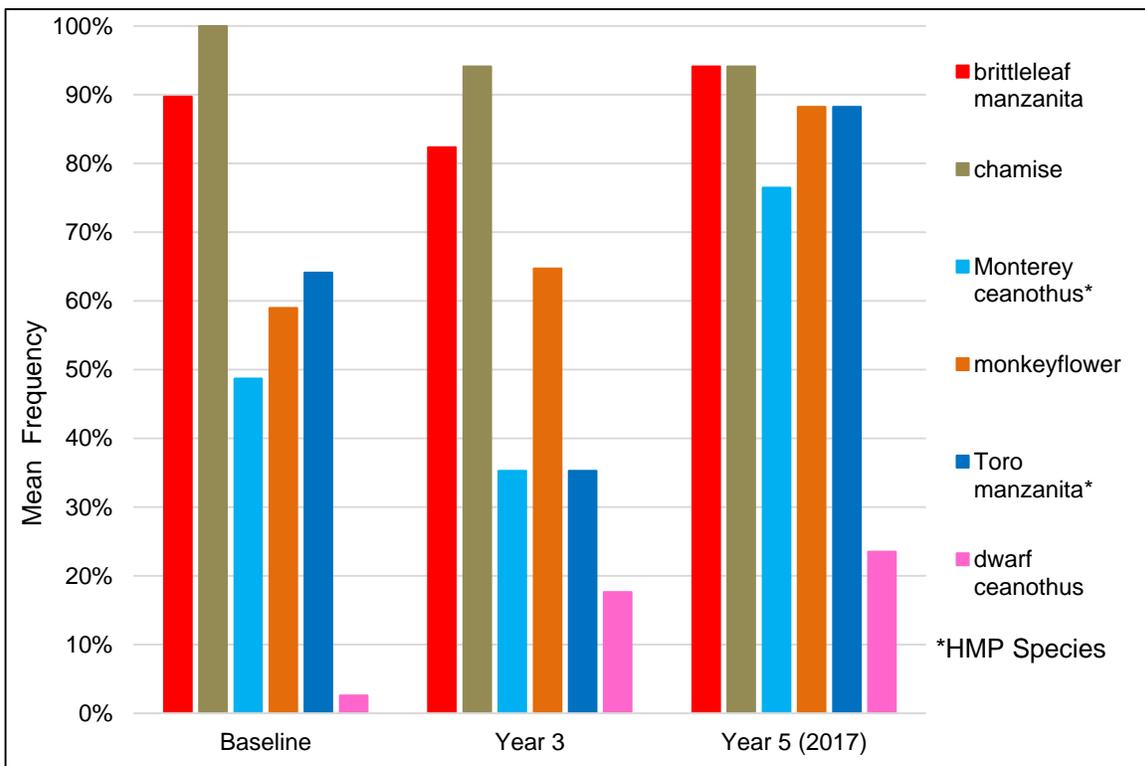
**Figure 11.**  
**Future East Garrison MRA – Mean Frequency of Shrub Species after Vegetation Cutting**

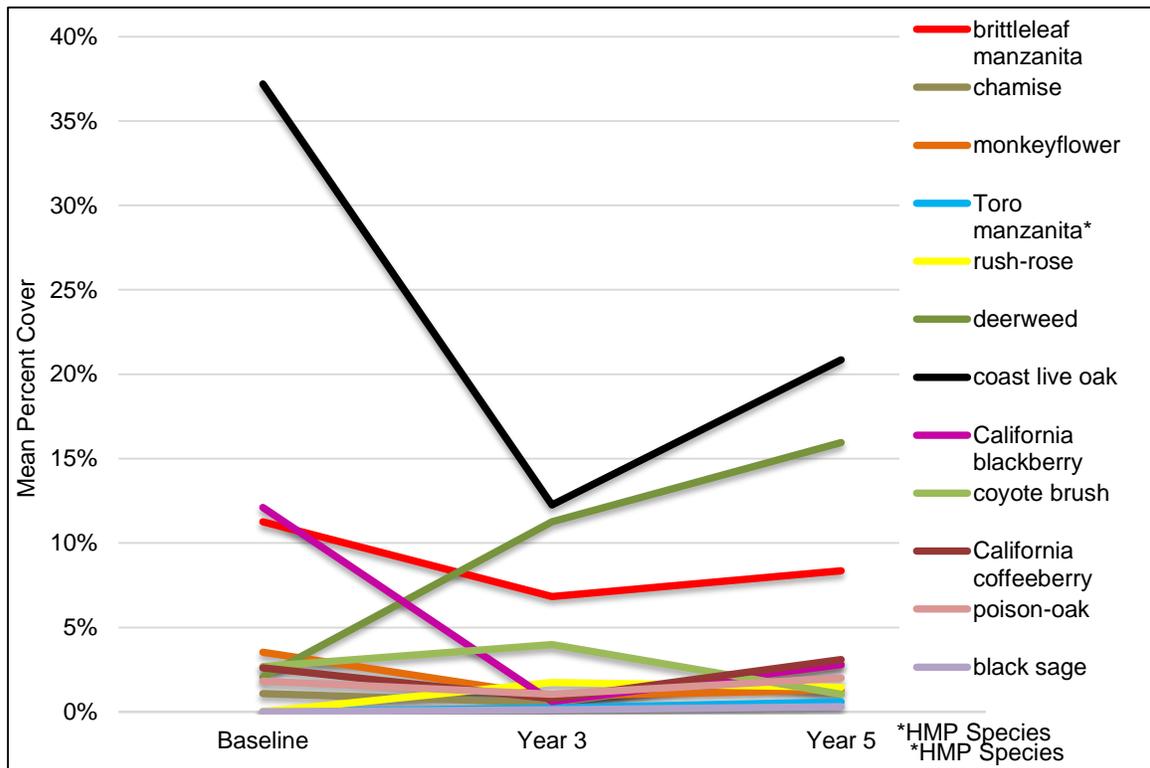
**Figure 12.**  
**Future East Garrison MRA – Mean Shrub Cover after Small-scale Excavation**

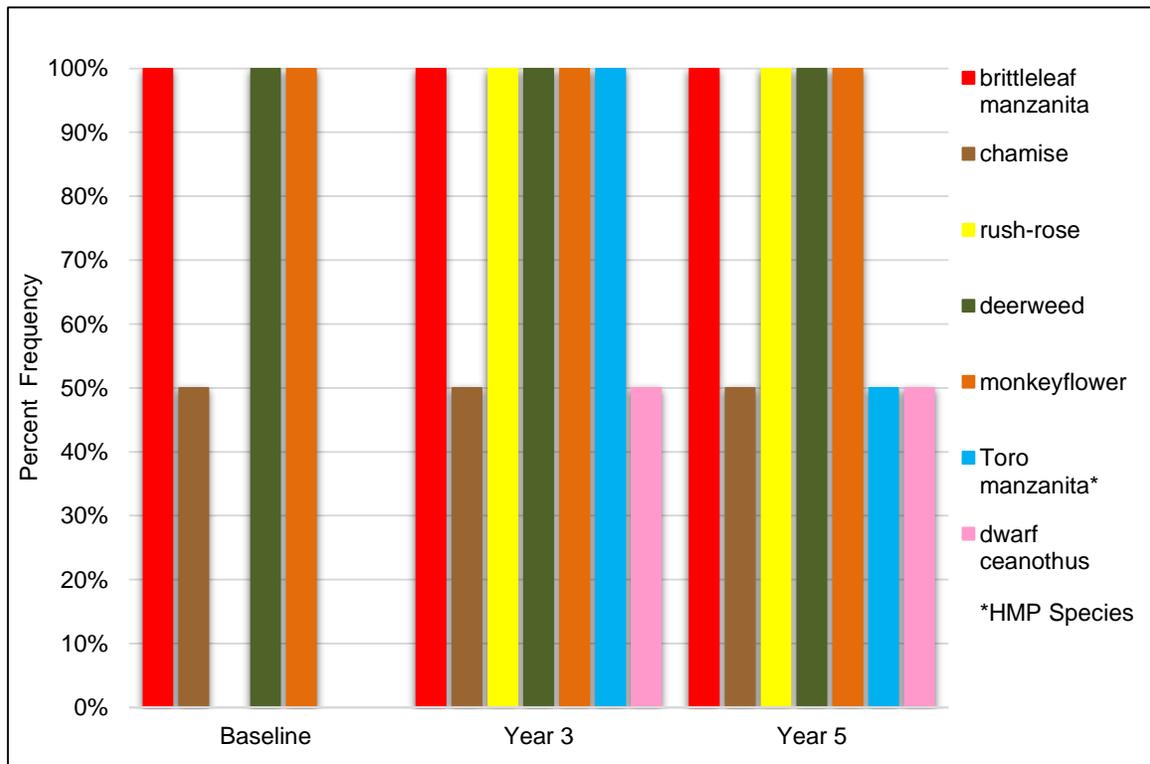
**Figure 13.**  
**Future East Garrison MRA – Mean Frequency of Shrub Species after Small-scale Excavation**

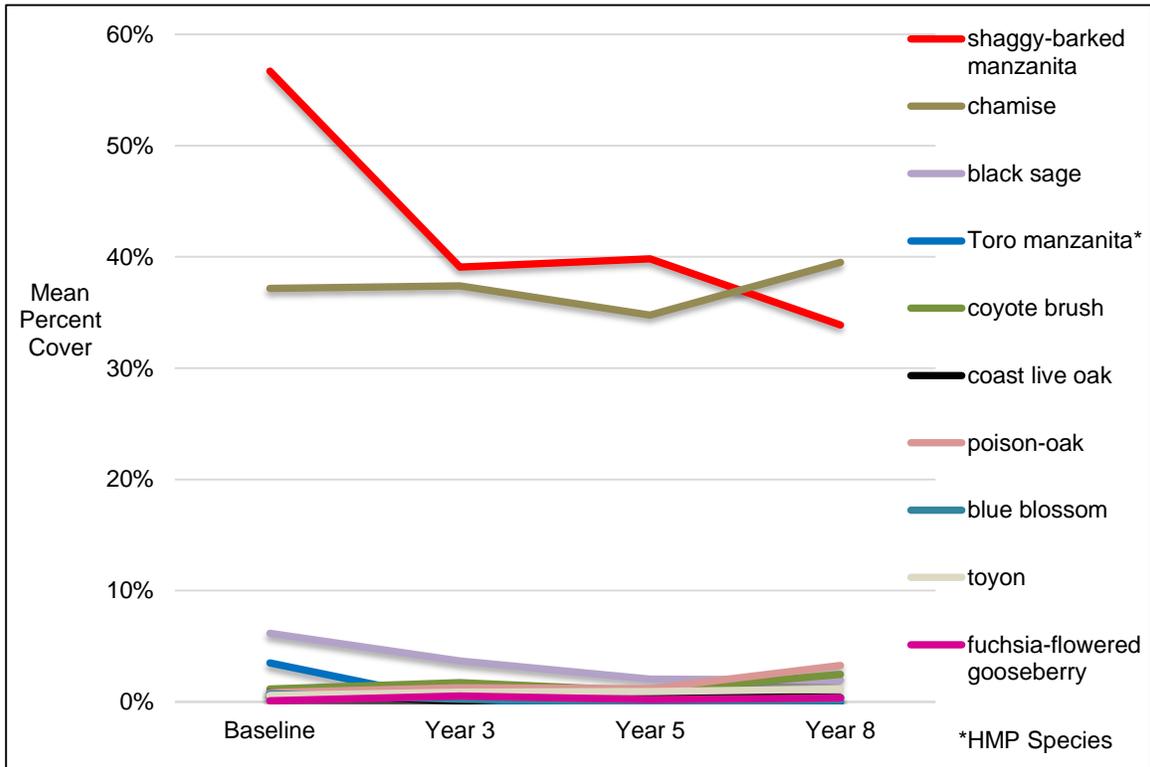
**Figure 14.**  
**Parker Flats MRA Phase II – Mean Shrub Cover after Vegetation Cutting in Central Maritime Chaparral**

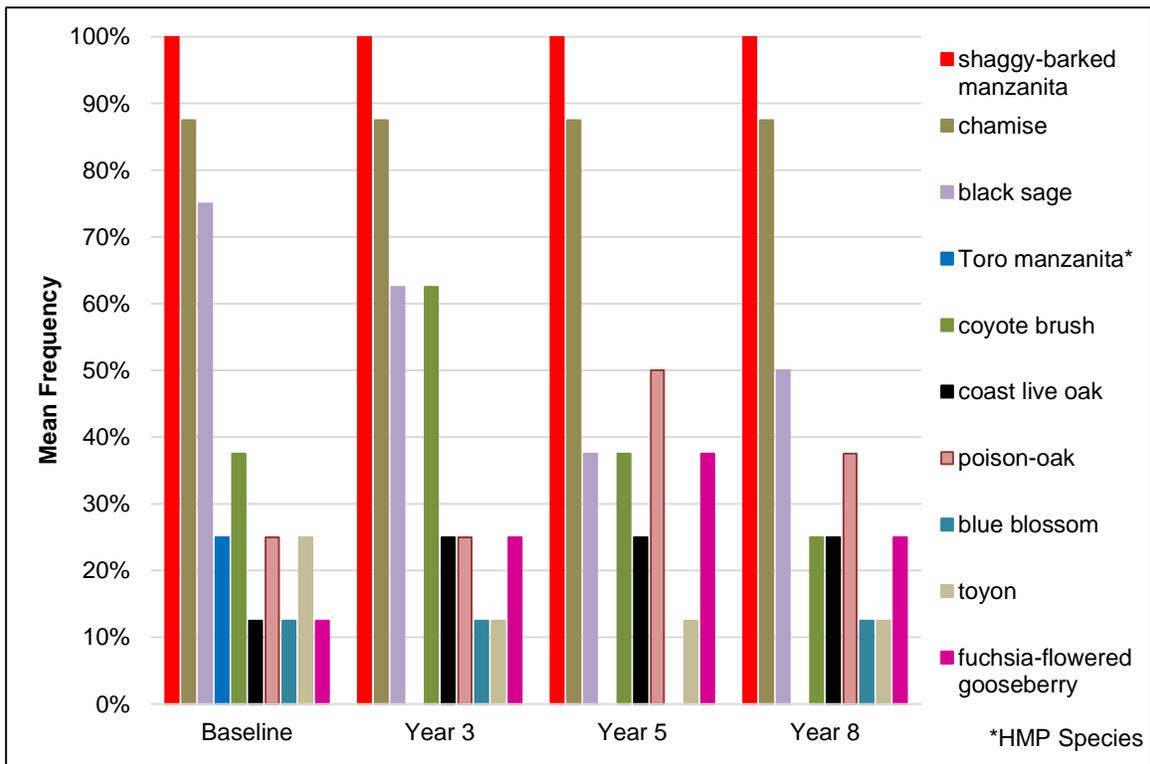
**Figure 15. Parker Flats MRA Phase II – Mean Frequency of Shrub Species after Vegetation Cutting in Central Maritime Chaparral**

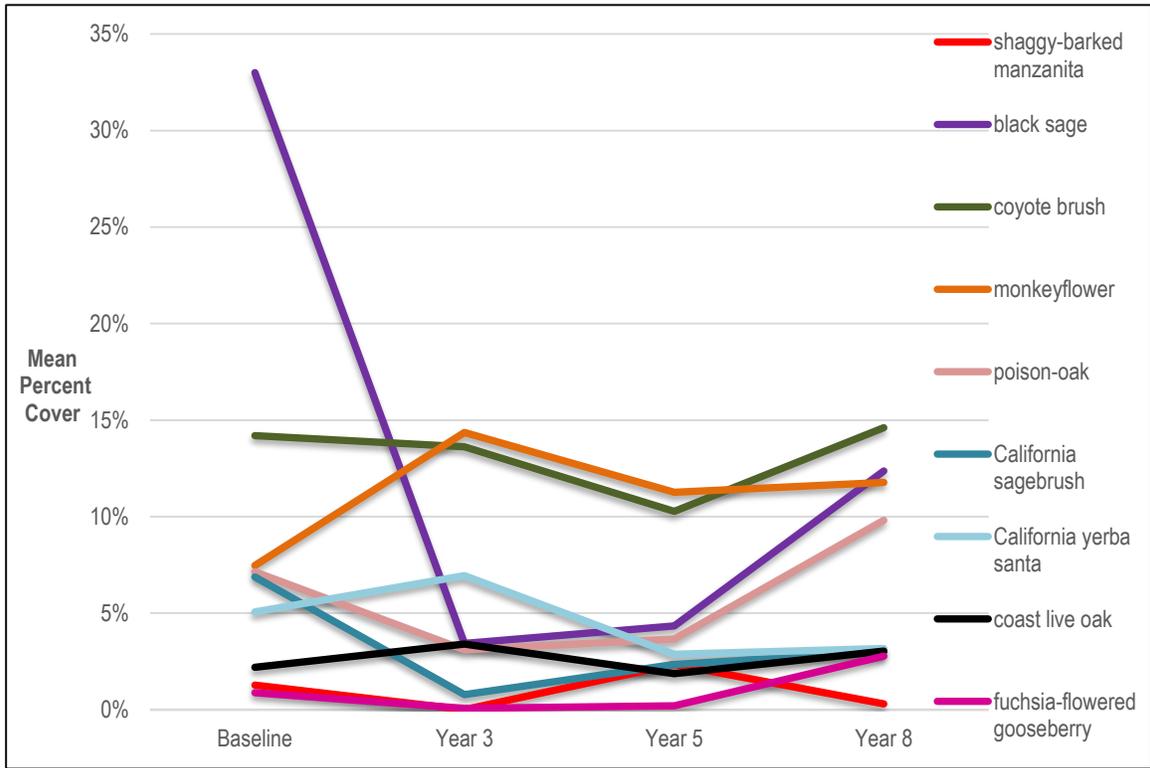
**Figure 16.**  
**Parker Flats MRA Phase II – Mean Shrub Cover after Vegetation Cutting in Central Coastal Scrub**

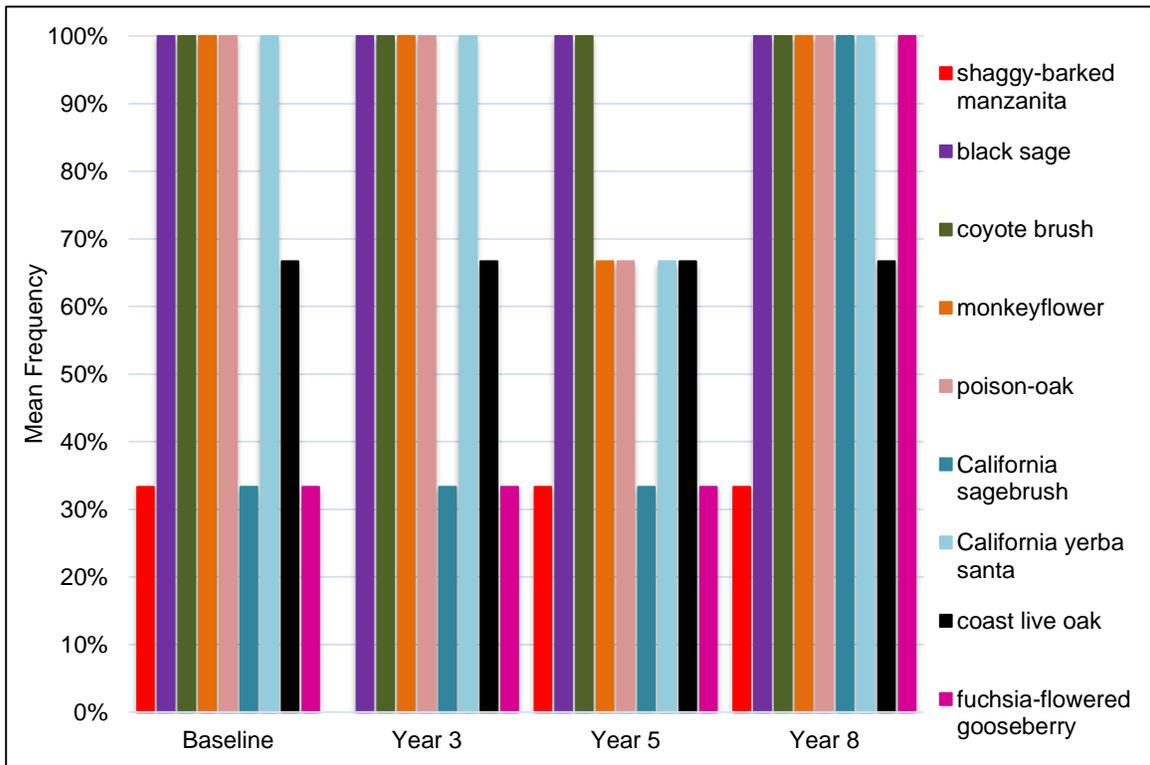
**Figure 17.**  
**Parker Flats MRA Phase II – Mean Frequency of Shrub Species after Vegetation Cutting in Central Coastal Scrub**

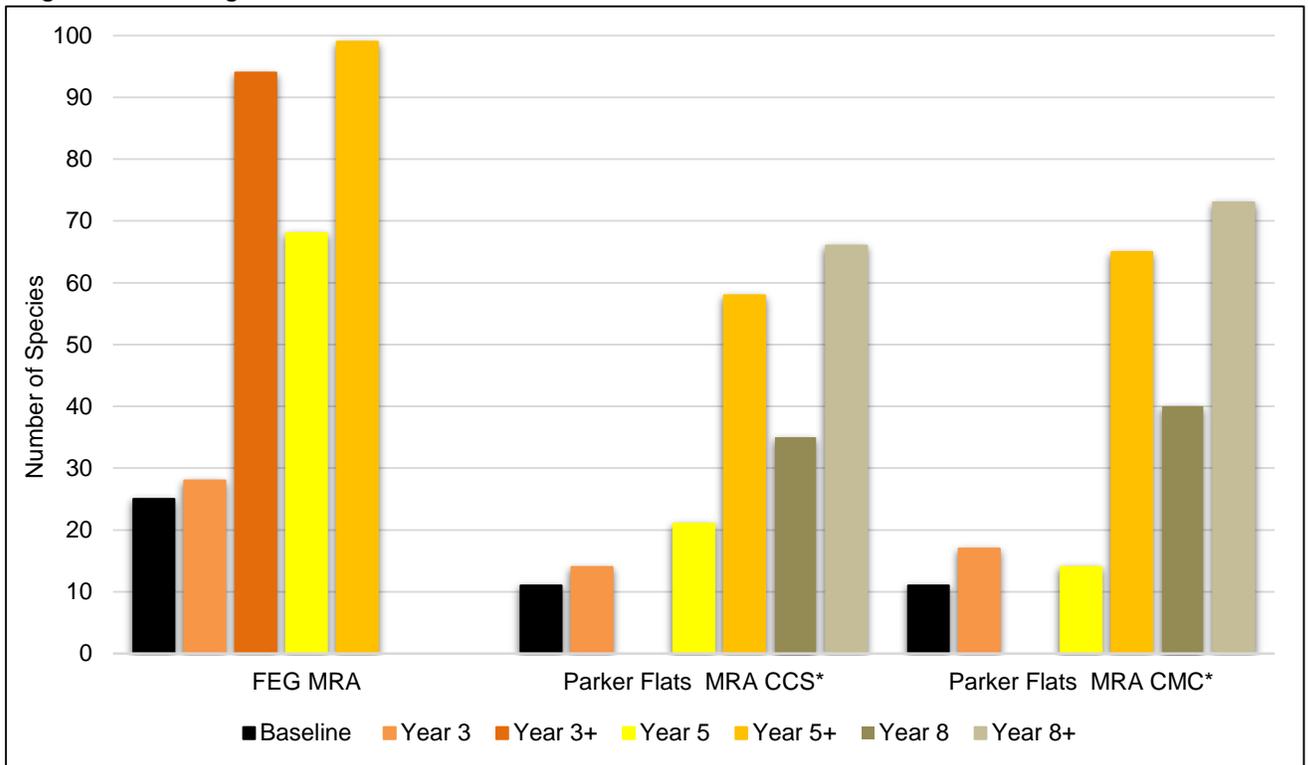
**Figure 18.**  
**Future East Garrison MRA and Parker Flats MRA - Native Species Richness before and after**  
**Vegetation Cutting in 2010 – 2016**

FEG and Parker Flats Monitoring occurs during Years 3, 5, and 8, therefore there are no data for Years 1, 2, 4, 6 and 7.

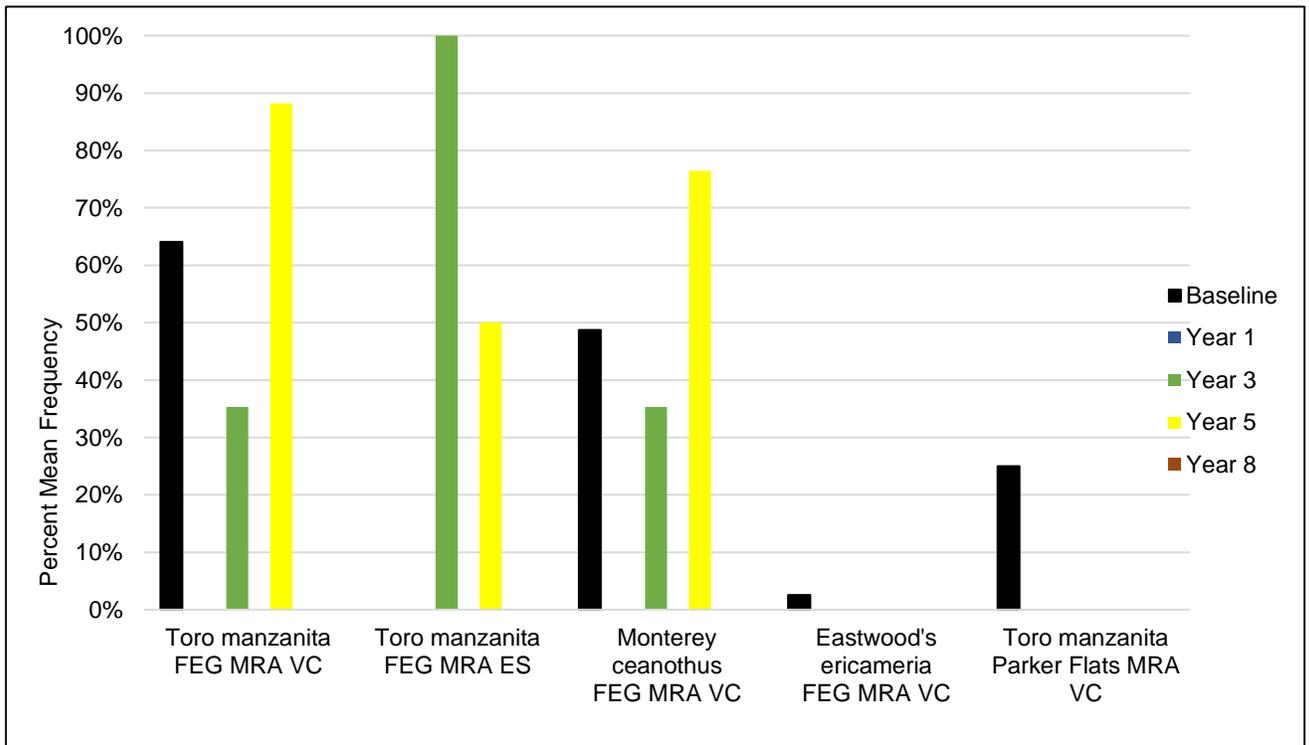
**Figure 19.**  
**Future East Garrison MRA and Parker Flats MRA - HMP Shrub Species Frequency in 2010 – 2017**

VC = Vegetation Cutting, ES = small-scale excavation

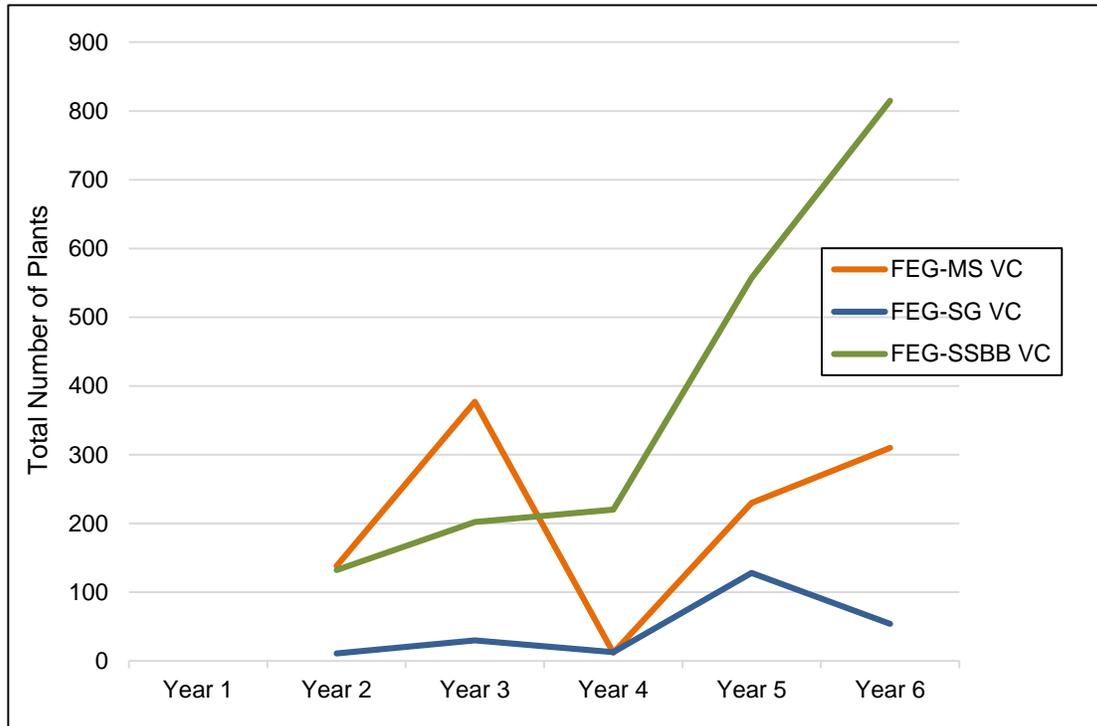
**Figure 20. Future East Garrison MRA – Total Number of HMP Herbaceous Species Year 2 – Year 6 after Vegetation Cutting**

MS = Monterey spineflower, SG = sand (Monterey) gilia, SSBB = seaside bird's-beak  
VC = vegetation cutting,

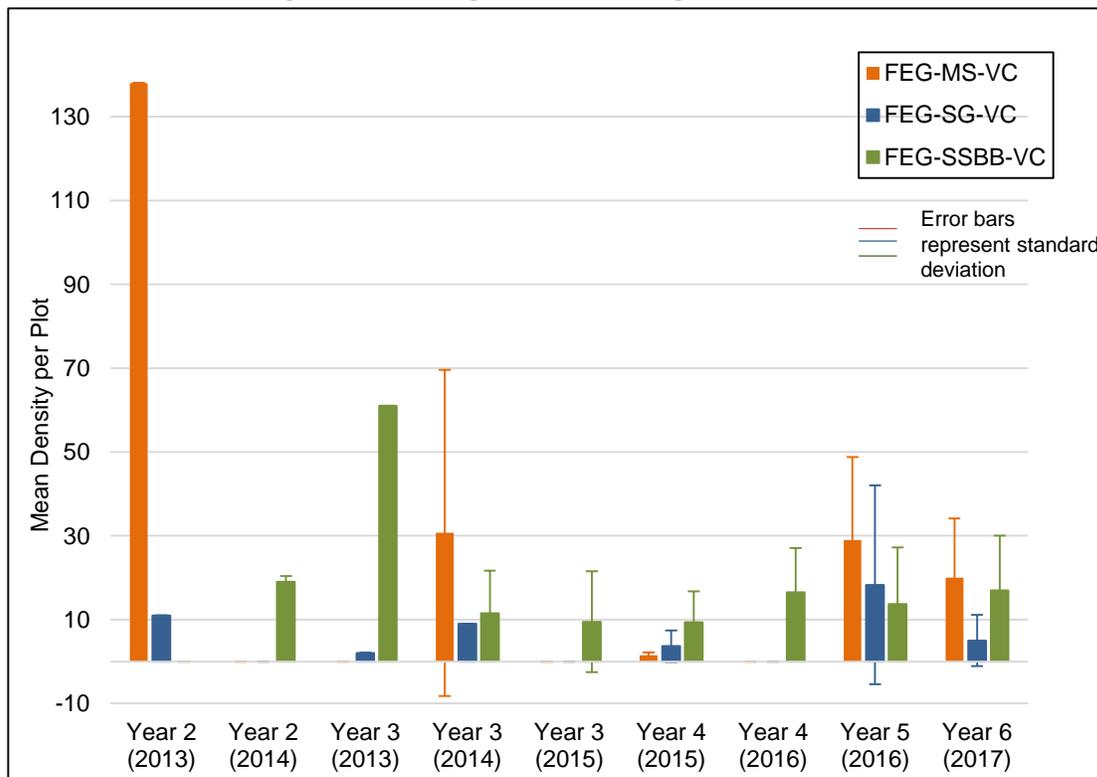
**Figure 21. Future East Garrison MRA – Mean Density per Plot of HMP Herbaceous Species In 2013 - 2017 after Vegetation Cutting in Year 2 through Year 6**

MS = Monterey spineflower, SG = sand (Monterey) gilia, SSBB = seaside bird's-beak VC = vegetation cutting  
'Year' represents number of years since vegetation was cut. The Year in parenthesis (e.g., 2013) is monitoring year.  
For example: Year 2 (2013) represents grids cut in 2011, Year 2 (2014) represent grids cut in 2012.

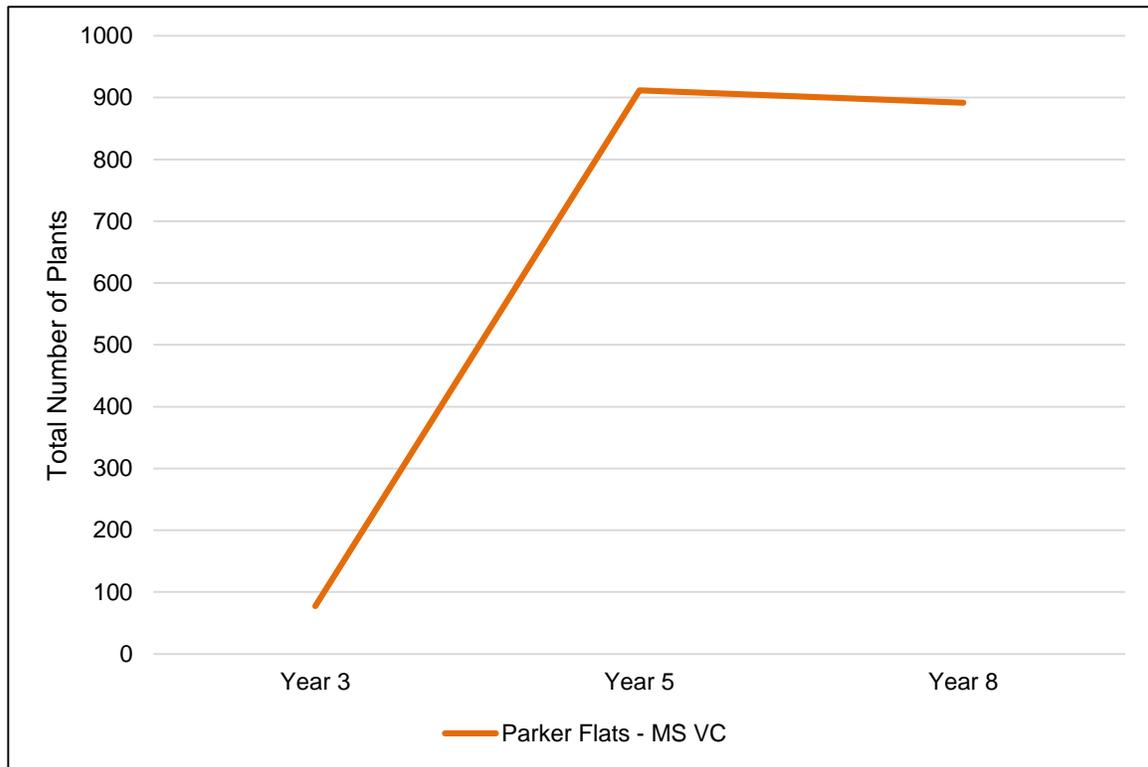
**Figure 22. Parker Flats MRA Phase II – Total Number of Monterey Spineflower Year 3 – Year 8 after Vegetation Cutting**

MS = Monterey spineflower  
 VC = vegetation cutting,

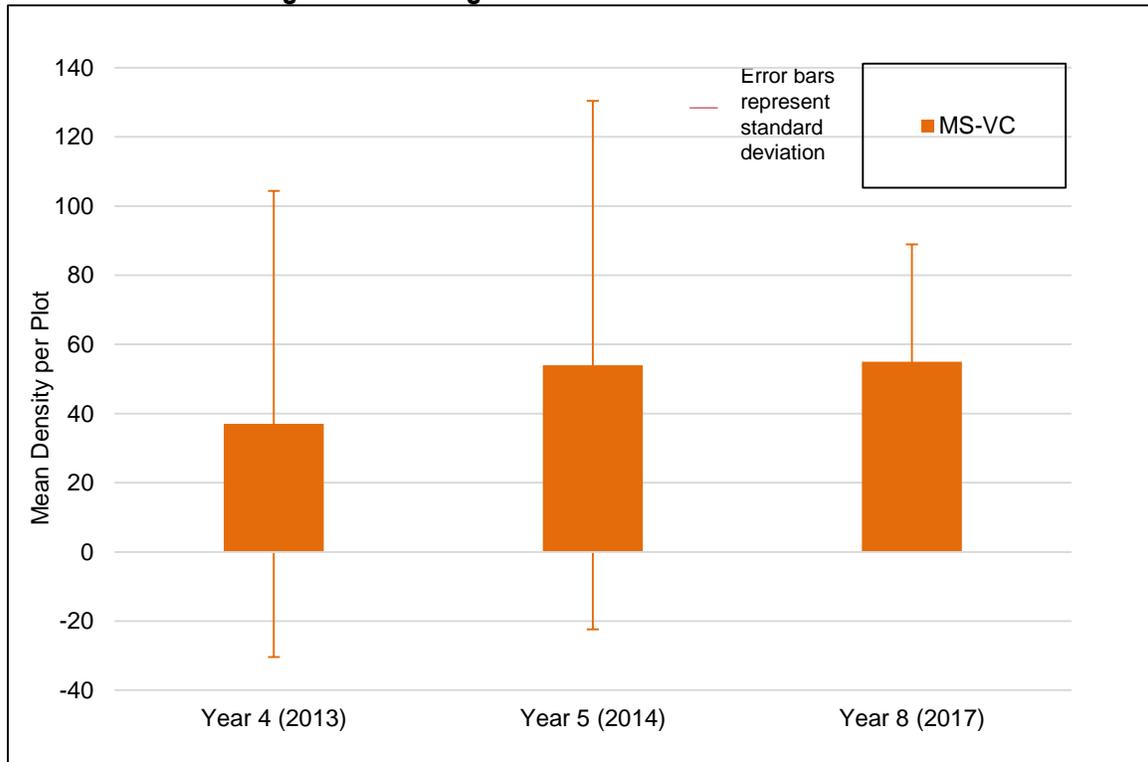
**Figure 23. Parker Flats MRA Phase II – Mean Density per Plot of Monterey Spineflower In 2012 - 2017 after Vegetation Cutting in Years 3-8**

MS = Monterey spineflower, VC = vegetation cutting  
 'Year' represents number of years since VC. The Year in parenthesis (e.g., 2012) is monitoring year.  
 For example: Year 2 (2013) represents grids cut in 2011, Year 2 (2014) represent grids cut in 2012.

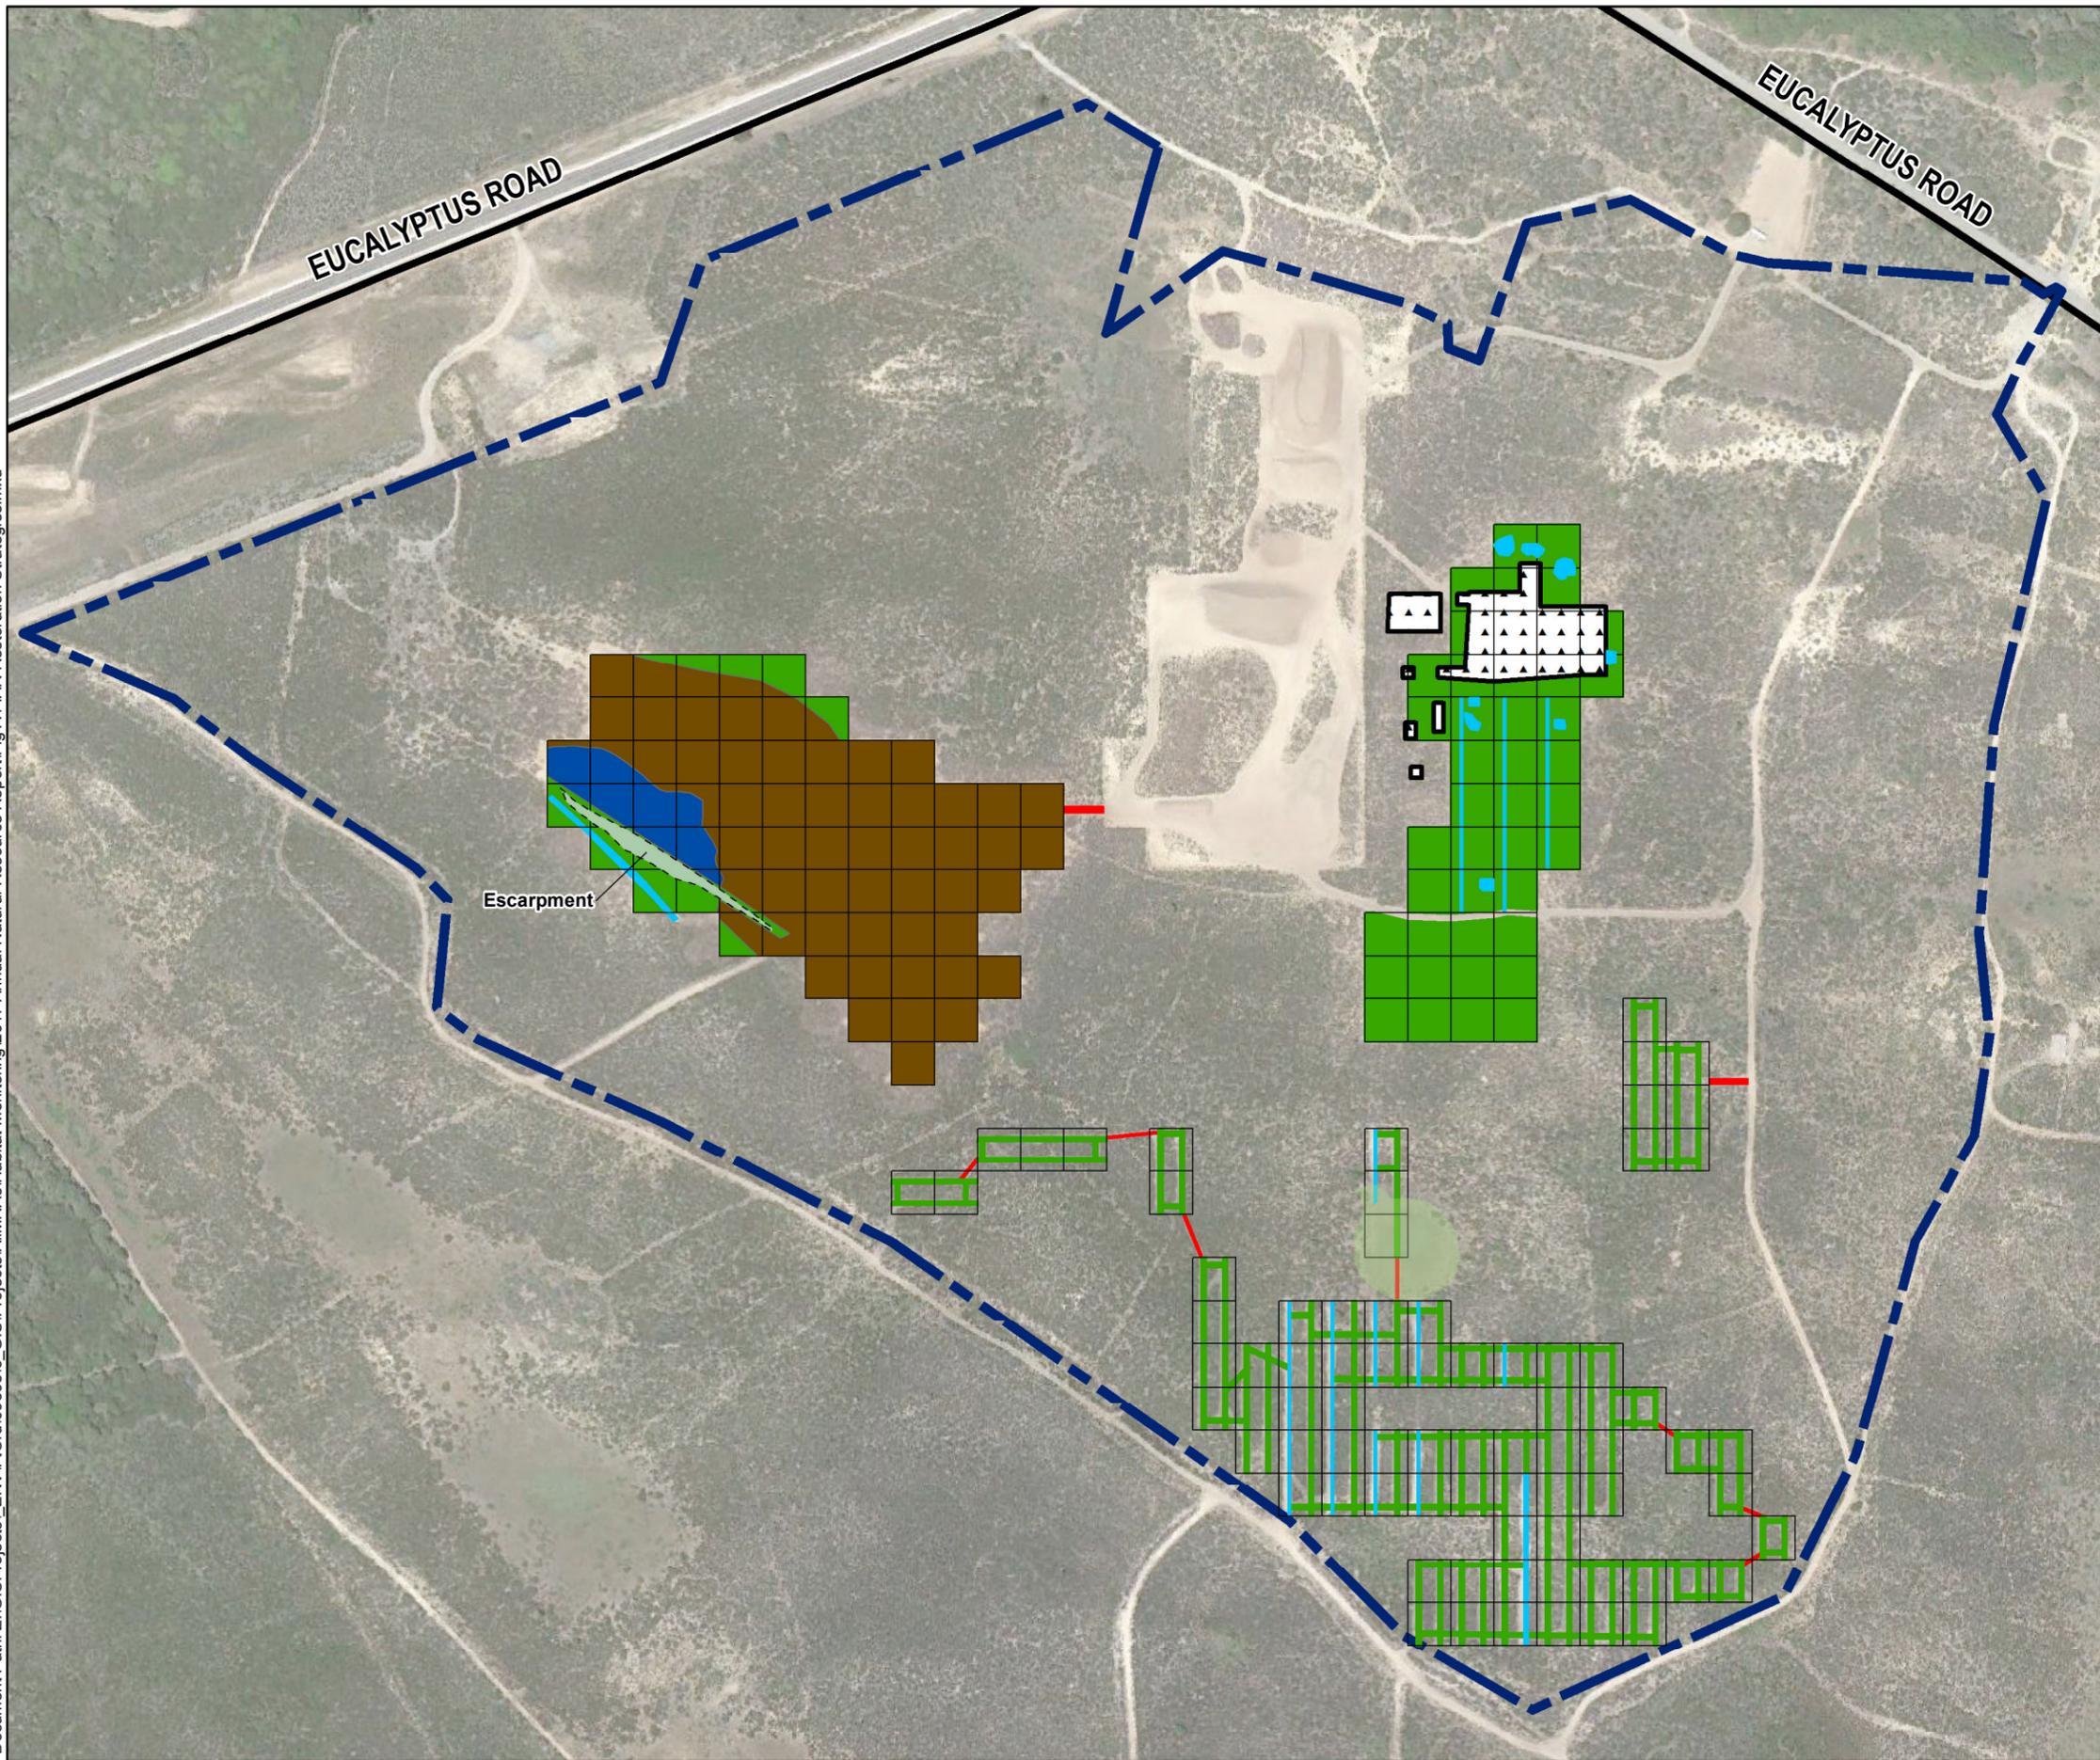
NOTE: Schematic representation of restoration activities in IAR MRA

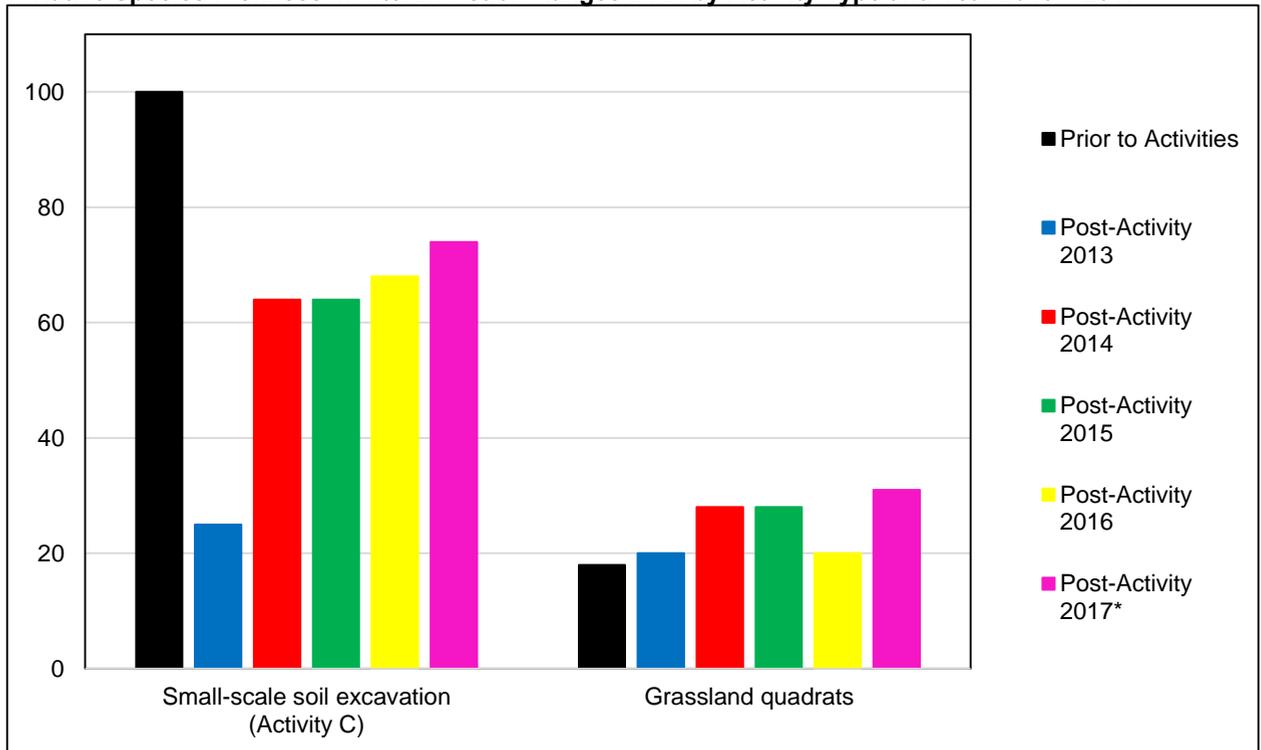
**Figure A7**  
**Native Species Richness in Interim Action Ranges MRA by Activity Type and Year 2010 – 2017**

\*In 2017, only Activity C transects were monitored

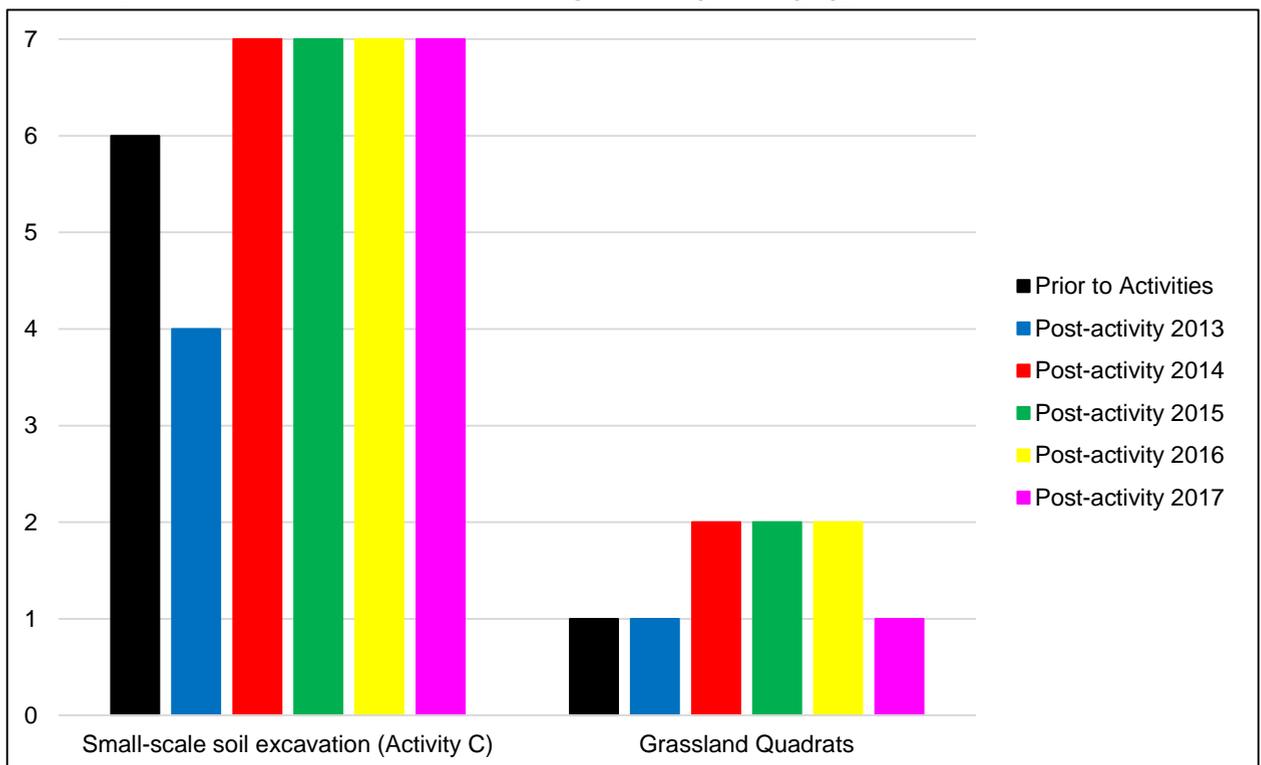
**Figure A8**  
**HMP Species Presence in Interim Action Ranges MRA by Activity Type and Year 2010 - 2017**

Maximum number of HMP species in Interim Action Ranges is seven.  
Observed HMP species sandmat manzanita, Monterey ceanothus, Eastwood's ericameria, Monterey spineflower, seaside bird's-beak, coast wallflower, and sand (Monterey) gilia.
