## FORA ESCA REMEDIATION PROGRAM

# 2017 Annual Natural Resource Monitoring, Mitigation, and Management Report

Environmental Services Cooperative Agreement  
Remediation Program Munitions Response Areas

Former Fort Ord  
Monterey County, California

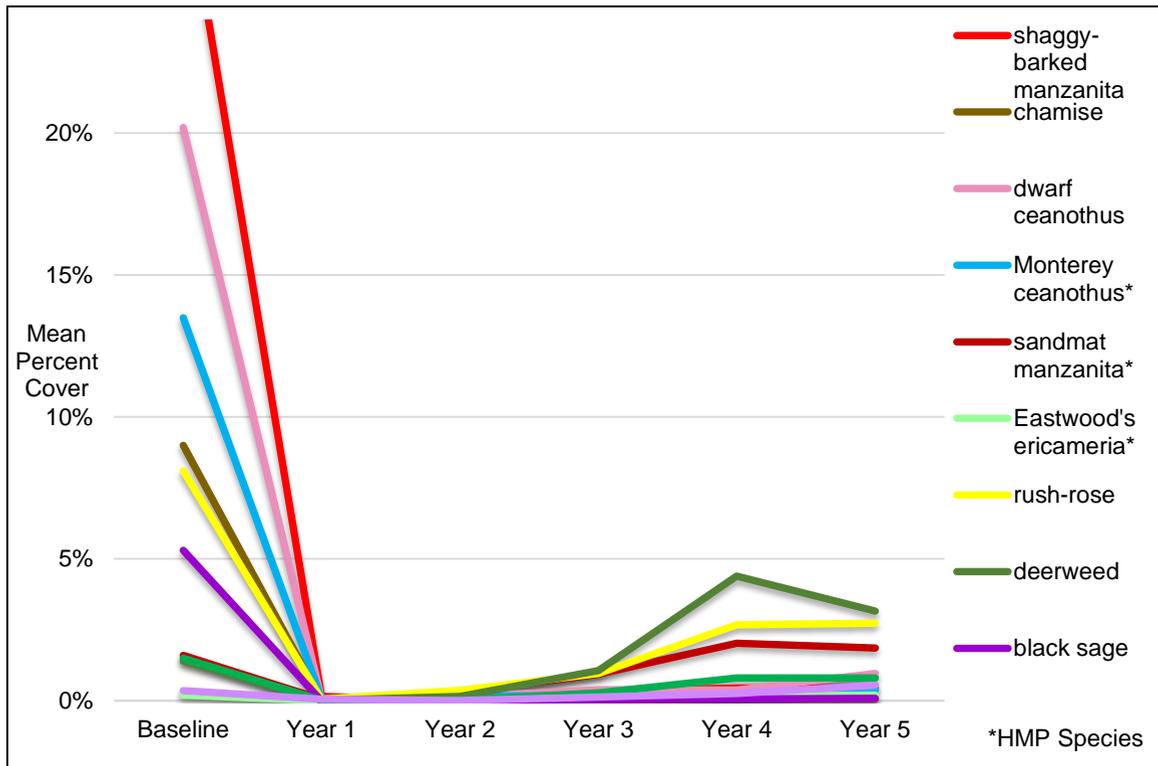
**Figure A9**  
North Range 44 SCA– Mean Shrub Cover after Small-scale Excavation

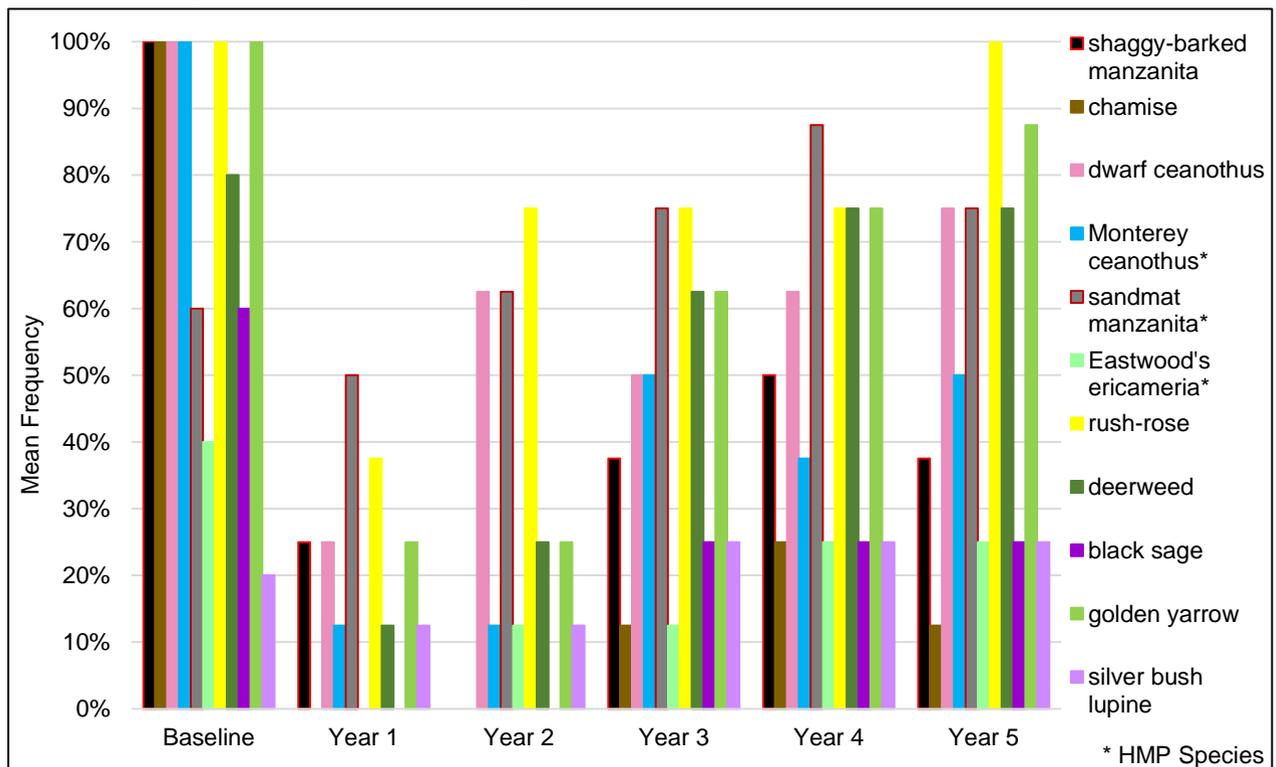
**Figure A10**  
North Range 44 SCA – Mean Frequency of Shrub Species after Small-scale Excavation

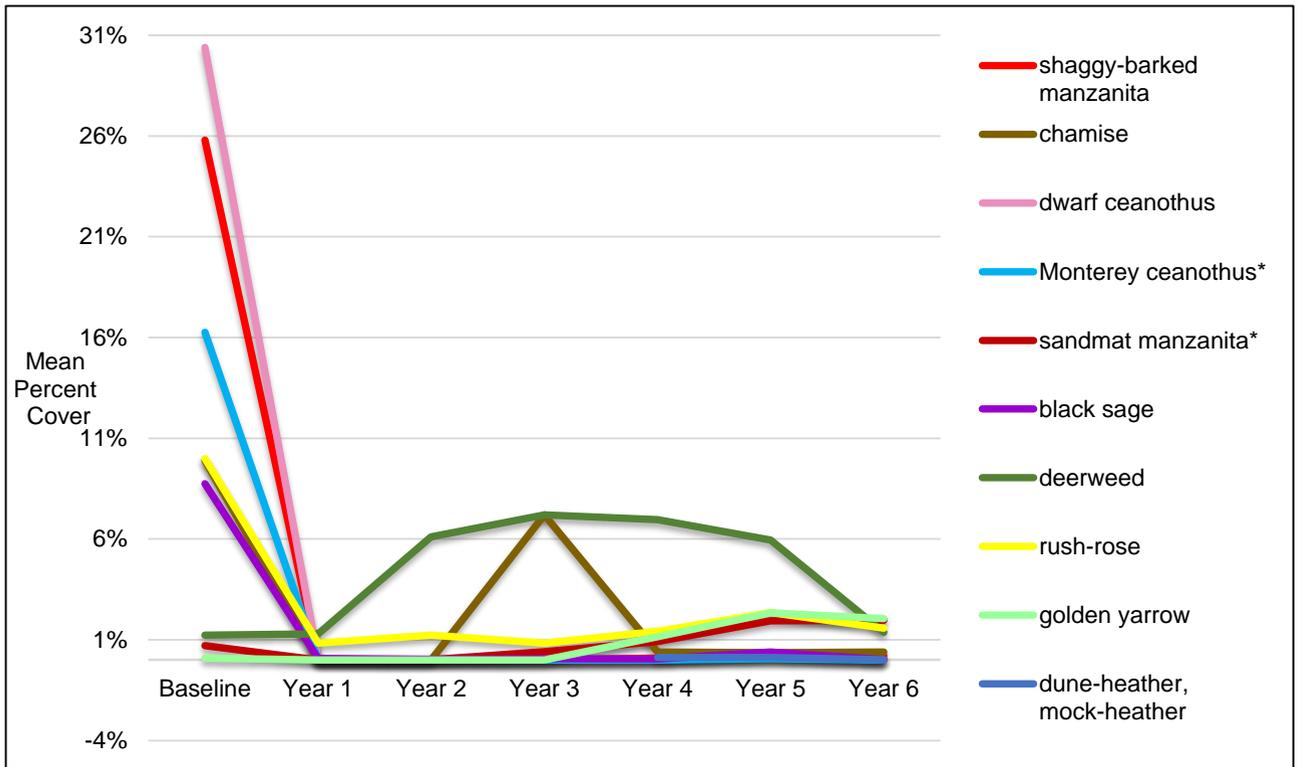
**Figure A11**  
South Range 44 SCA and Central NCAs – Mean Shrub Cover after Small-scale Excavation

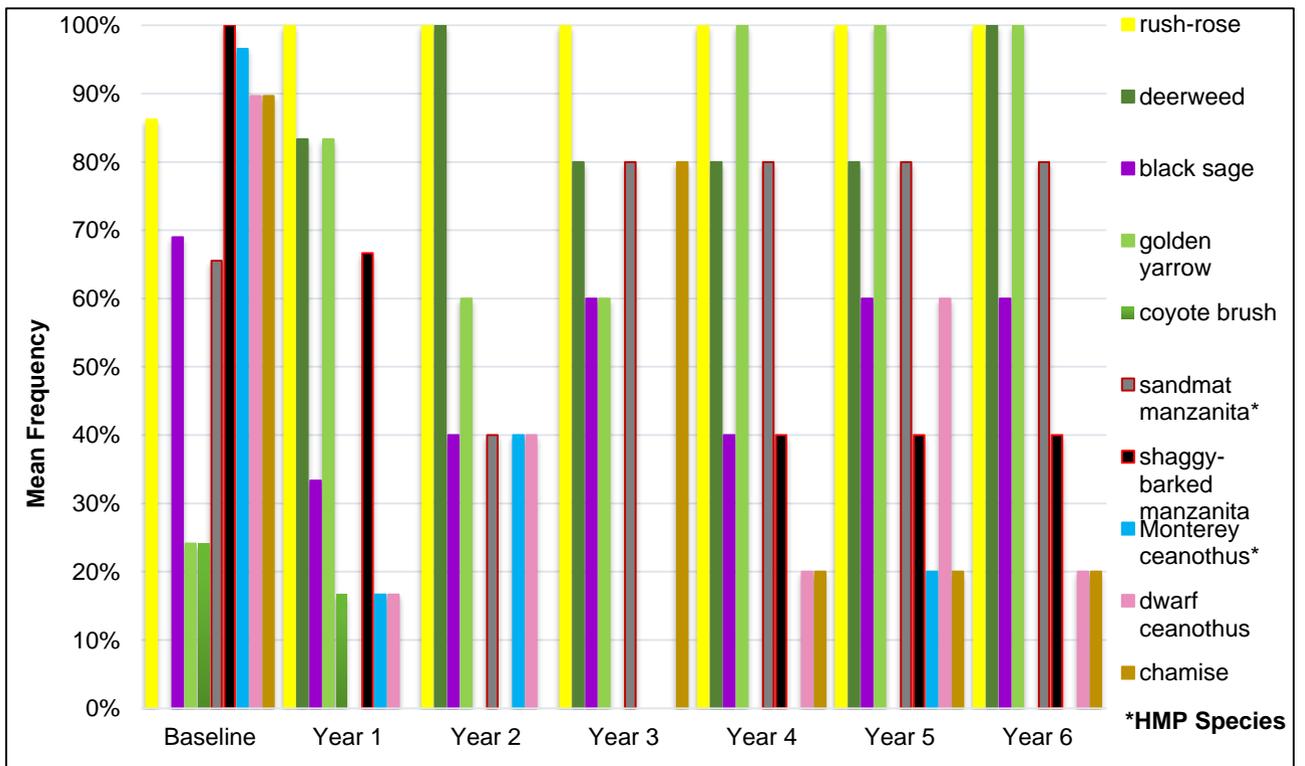
**Figure A12**  
South Range 44 SCA and Central NCAs – Mean Frequency of Shrub Species after Small-scale Excavation

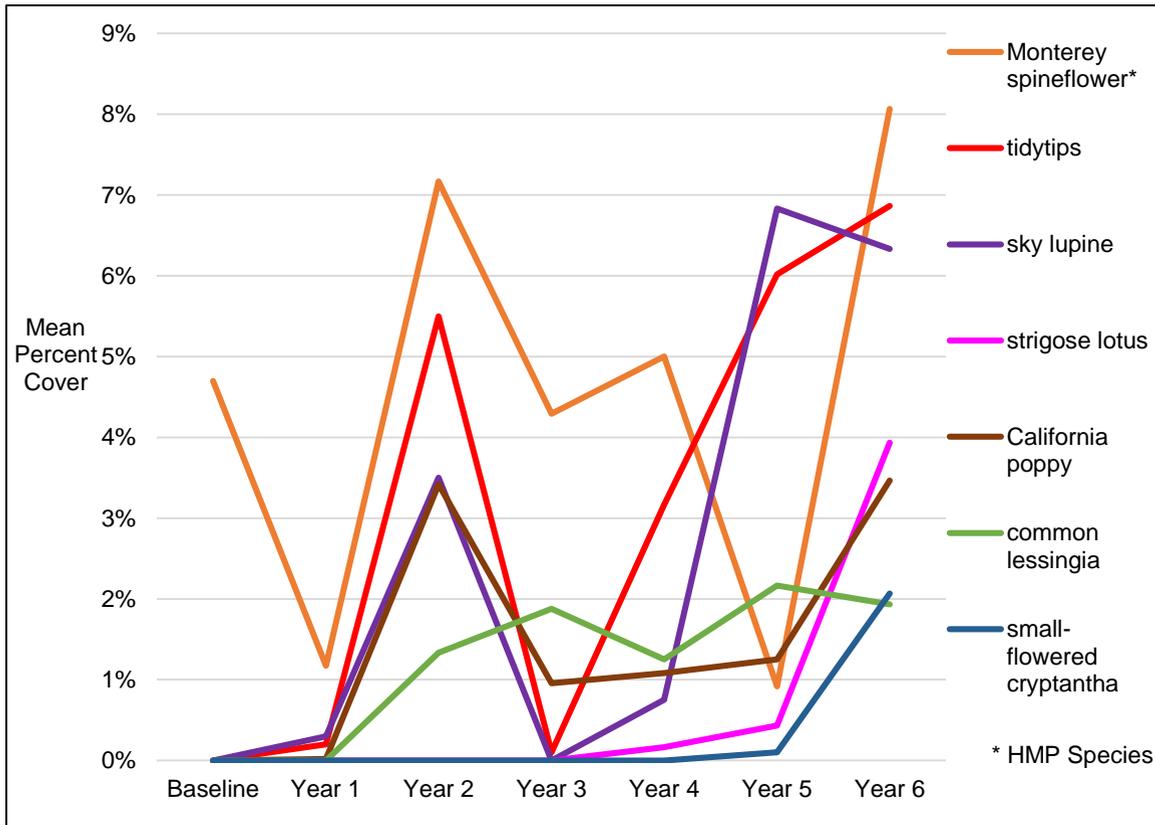
**Figure A13**  
**South Range 44 SCA and Central NCAs– Mean Herbaceous in Grassland Quadrats**

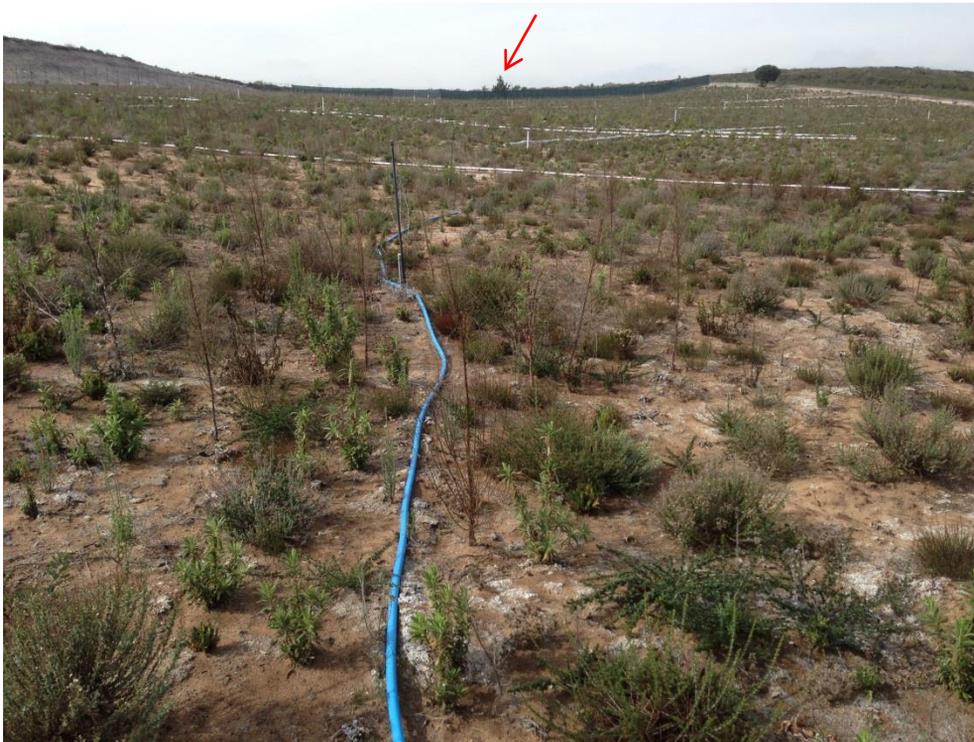
**Photograph 4**

Range 47  
Restoration Area.

Winter conditions;  
west facing photo  
point.

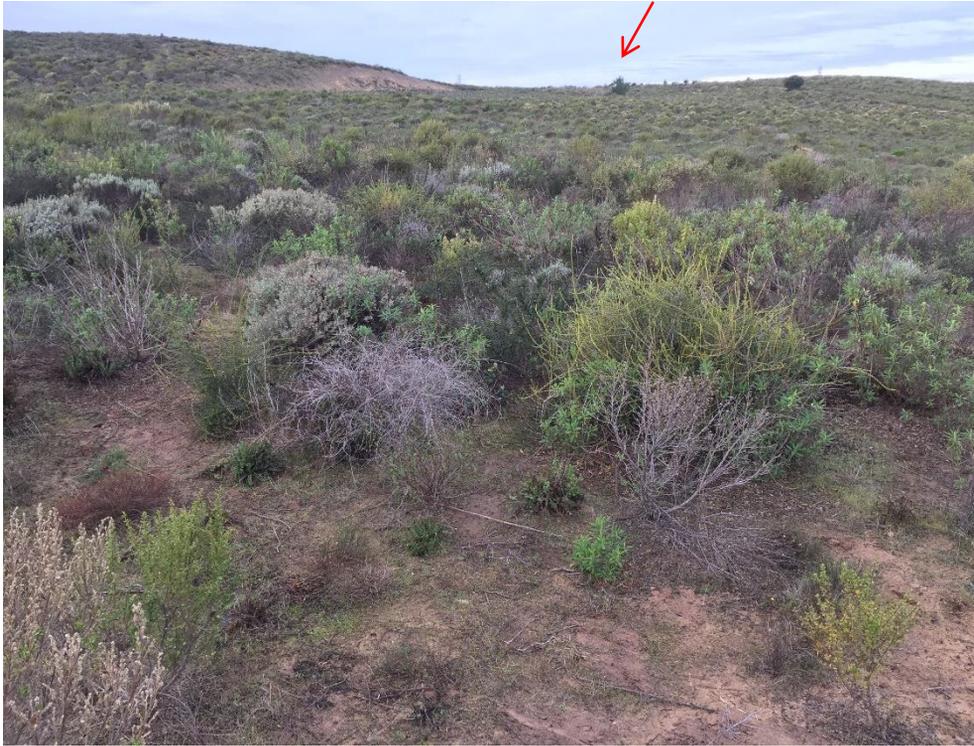
**Photograph 7**

Range 47  
Restoration Area.

Winter vegetation  
after removal of all  
infrastructure; west  
facing photo point.

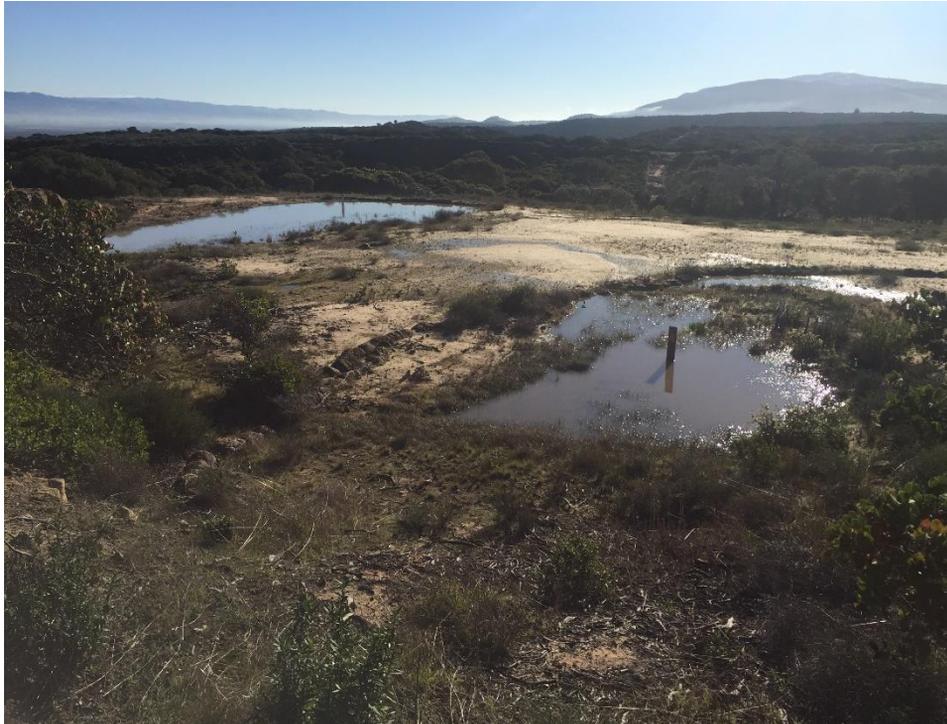
**Photograph 1**

Future East Garrison (FEG) Munitions Response Area (MRA), Grenade Range

Aquatic Feature AF09-2 (right) and restored aquatic feature AF09-1A during wet season

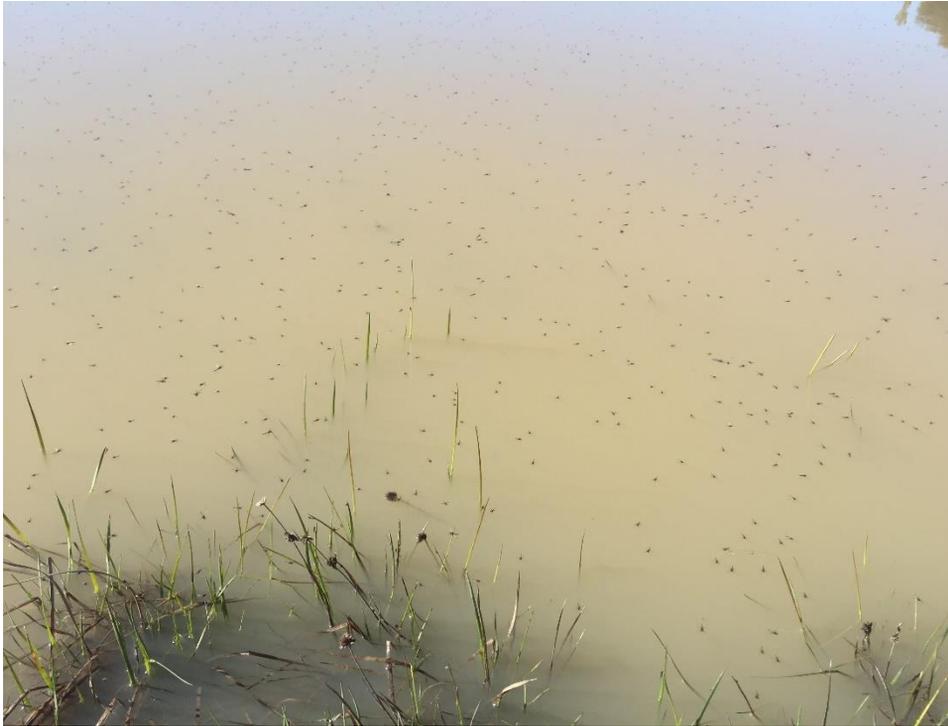
**Photograph 3**

FEG MRA,  
Grenade Range

Flies on restored  
Aquatic Feature  
AF09-1A during  
wet season

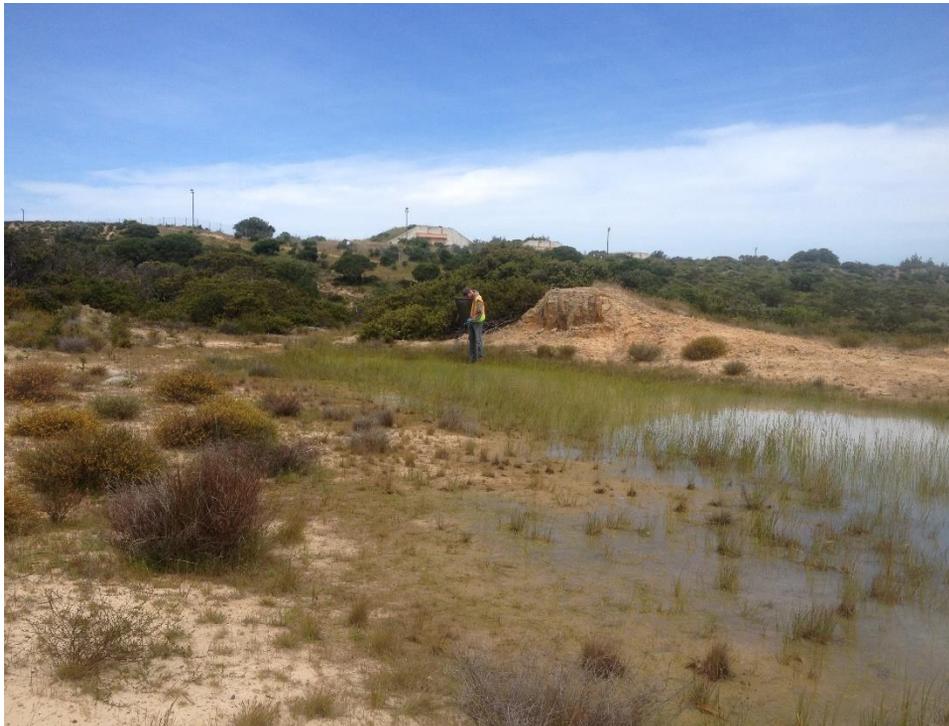
**Photograph 5**

FEG MRA,  
Grenade Range

ESCA RP qualified biologist surveying for California tiger salamander and California linderiella in restored Aquatic Feature AF09-1A.

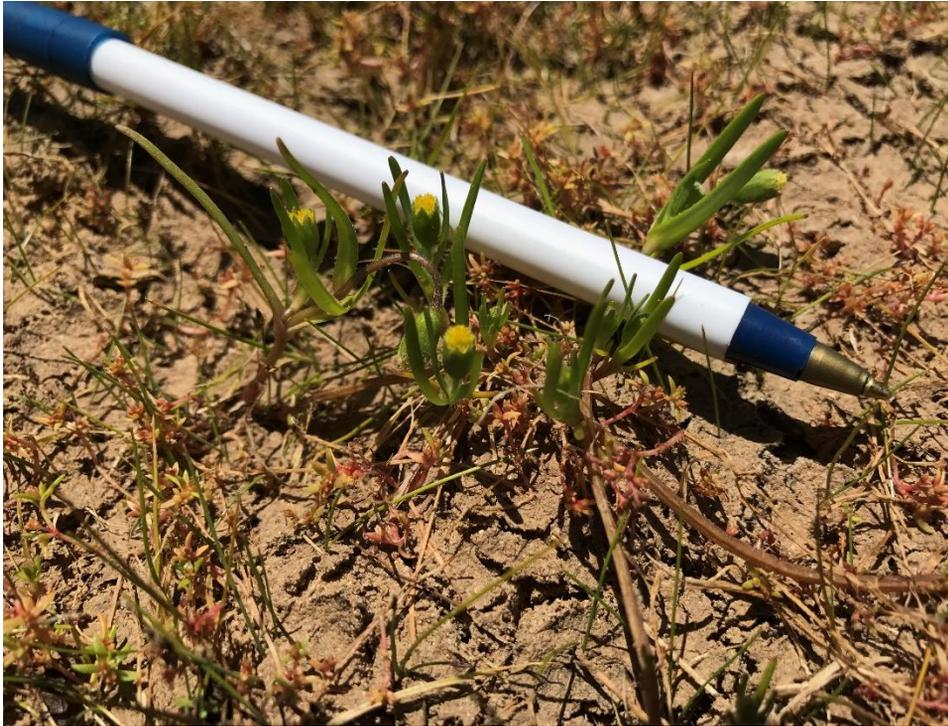
**Photograph 7**

FEG MRA,  
Grenade Range

Native vernal pool  
species smooth  
goldfields  
(*Lasthenia  
glaberrima*) and  
aquatic pygmy  
weed (*Crassula  
aquatica*) in  
restored Aquatic  
Feature AF09-1A

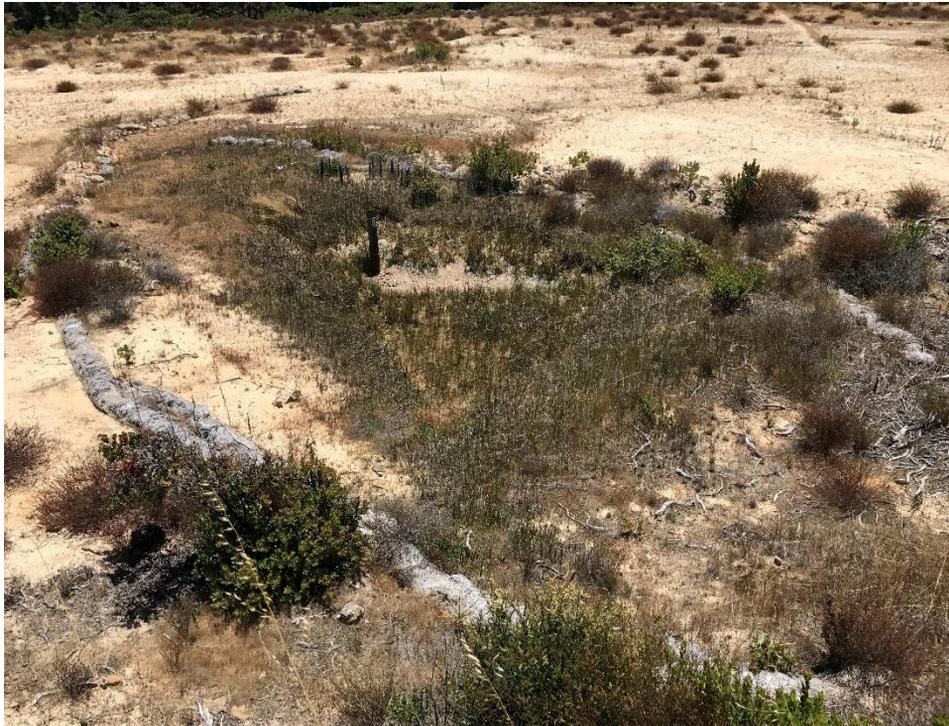
**Photograph 9**

FEG MRA,  
Grenade Range

Reference Aquatic  
Feature AF09-2  
shortly after drying.

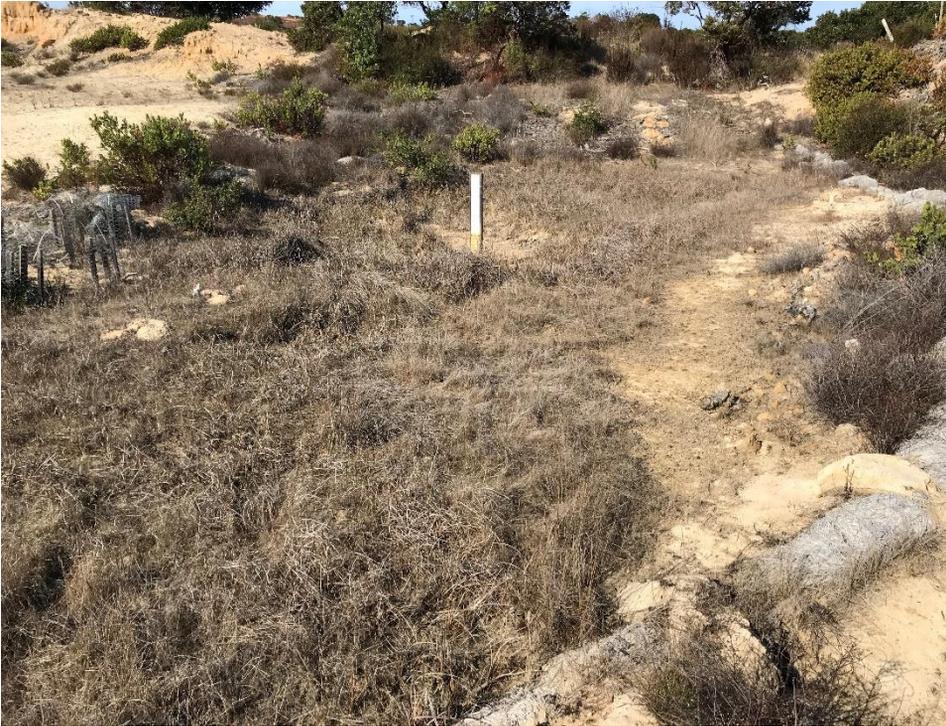
**Photograph 11**

FEG MRA,  
Grenade Range

Reference Aquatic  
Feature AF09-2  
during fall.

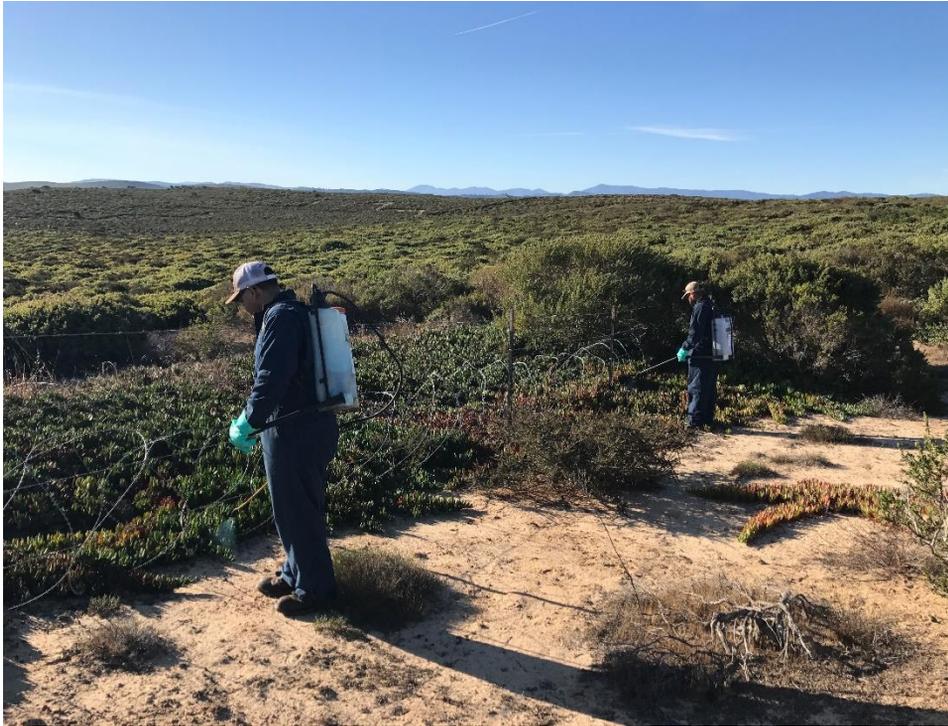
**Photograph 1**

Seaside Munitions Response Area (MRA) North Blue Line Road

Iceplant along the Natural Resource Management Area boundary sprayed with 3% glyphosate.

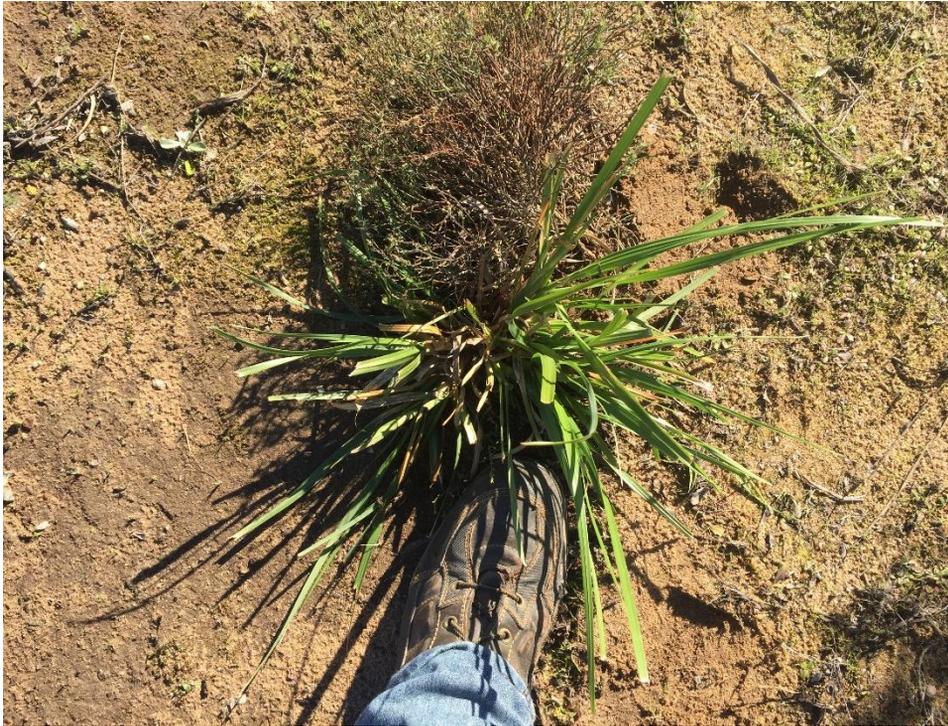
**Photograph 3**

Interim Action  
Ranges (IAR) MRA  
Range 47

Six pampas grass  
seedlings observed  
on east end of  
Range 47.

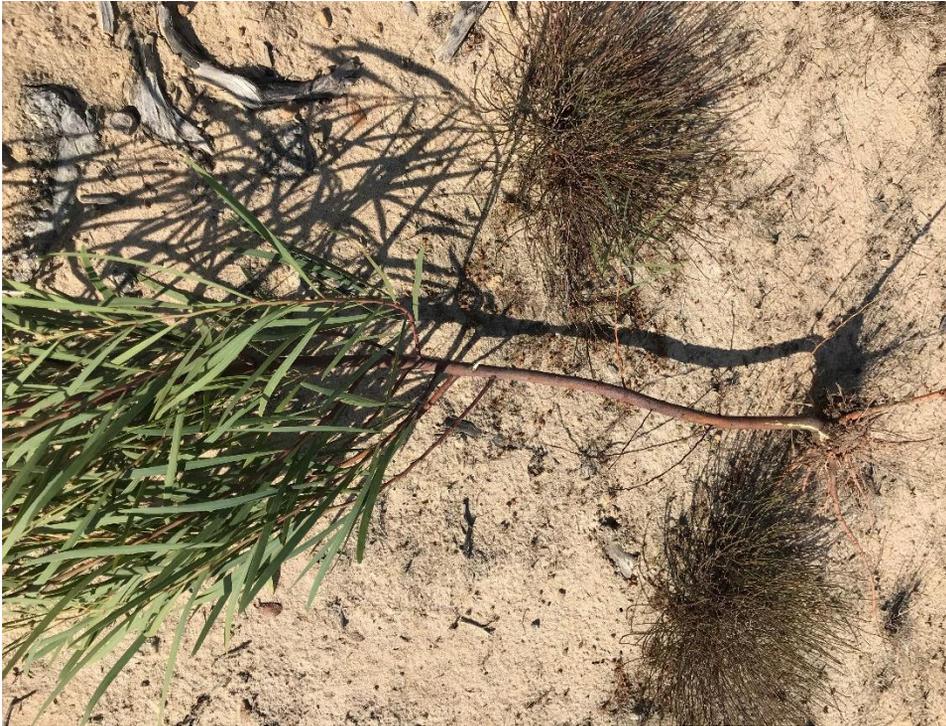
**Photograph 6**

IAR MRA  
Range 47-Subarea  
C (south side)

Dead and dying  
iceplant (red)  
recently sprayed  
with glyphosate.

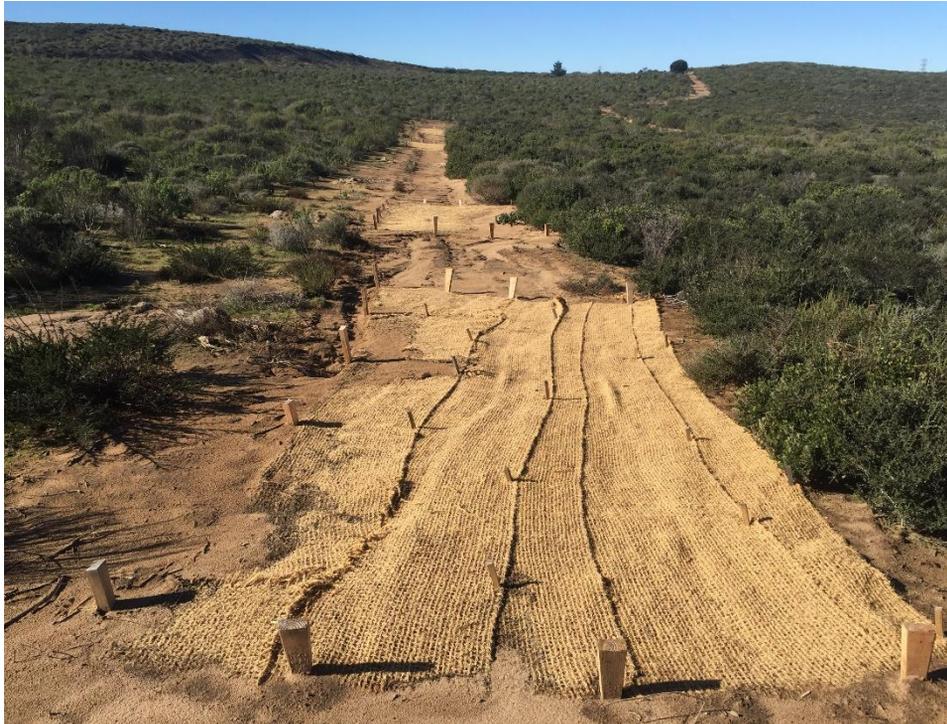
**Photograph 1**

Interim Action  
Ranges (IAR)  
Munitions Response  
Area (MRA)  
Range 47

Erosion control  
blanket functioning  
as designed after  
removal of  
perimeter fencing in  
the IAR MRA.

**Interim Action Ranges MRA** - There were no major erosion issues in the IAR during 2017. No erosion control BMP maintenance was needed (Figure 9b).

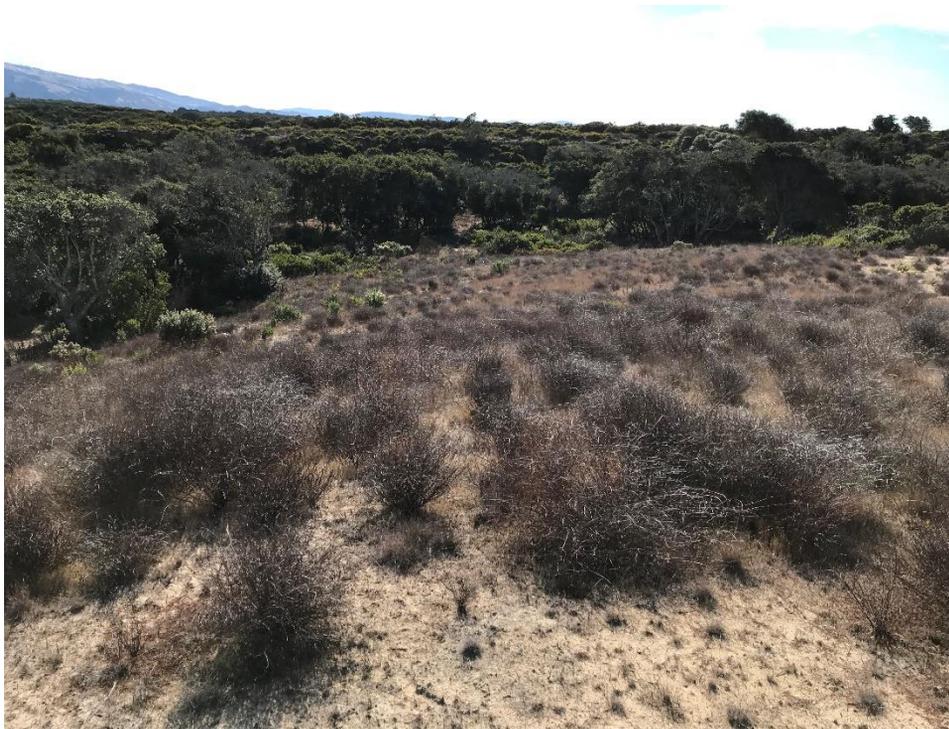
**Photograph 3**

Future East  
Garrison (FEG)  
MRA  
Grenade Range

East facing slope in  
Future East  
Garrison MRA  
Grenade Range is  
well vegetated and  
stable.

**Future East Garrison MRA** - There were no erosion issues in FEG during 2017. Broadcast and hydro-seeding efforts in 2013 and 2014 have been successful at vegetating much of the former grenade range, particularly on the steep eastern slope where native herbaceous and woody species have become widely established (Figure 9a). No erosion control BMP maintenance was needed in 2017.
