Technical Report

2023 Iso-Settlement Survey

Operable Unit 2 Landfills

Former Fort Ord, California

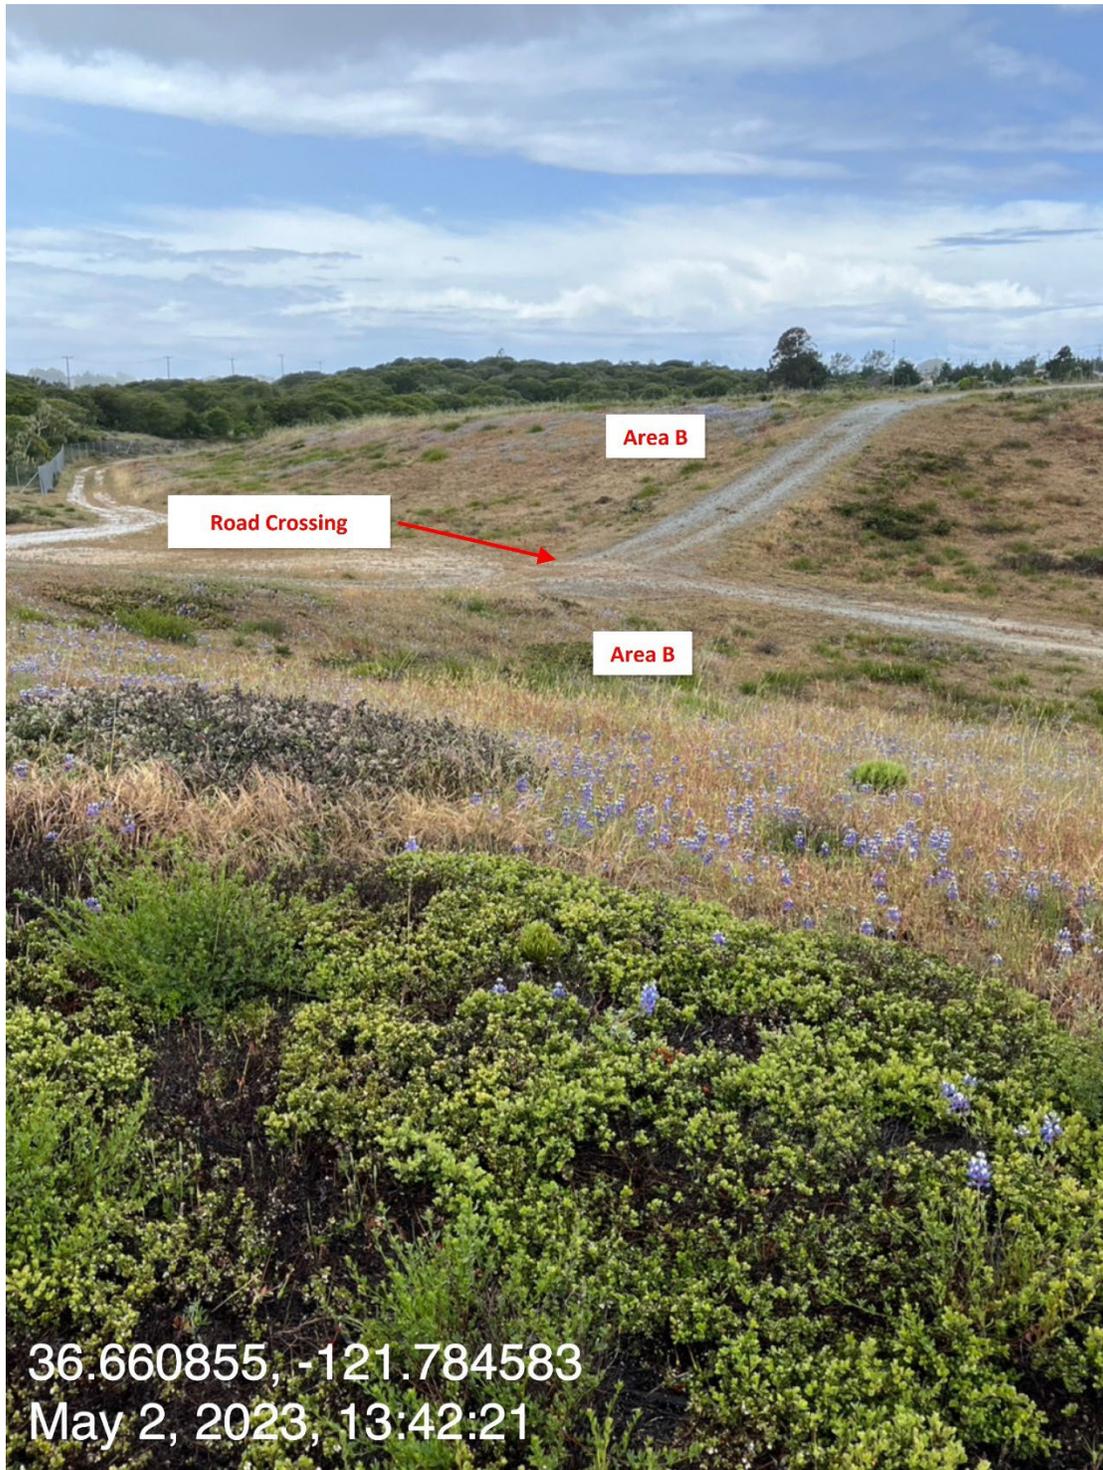
Photograph 1. Areas B/C Road Crossing

elevation of 1 foot to 2 feet relative to the 1999 base topography. The location with the most significant change in elevation is on the southeastern side of Area B where perimeter road improvements created a depression between Areas B and C as shown in Sheet C80 (Attachment C); however, this has not had an adverse effect on the engineered cover system, as shown in Photograph 1, and there is no evidence of ponding in this area requiring repairs to the engineered cover system (Ahtna, 2023b).

Area C accepted waste from 1966 to 1975 (Dames & Moore, 1993). The location with the most significant decrease in elevation is on the western side of Area C where perimeter road improvements created a depression between Areas B and C as shown in Sheet C80 (Attachment C); however, this has not had an adverse effect on the engineered cover system, as shown in Photograph 1, and there is no evidence of ponding in this area requiring repairs to the engineered cover system (Ahtna, 2023b). In addition, the northeastern corner of Area C exhibits increases in surface elevation of up to 4 feet when compared to the 1999 base topography that were likely the result of road construction and maintenance.

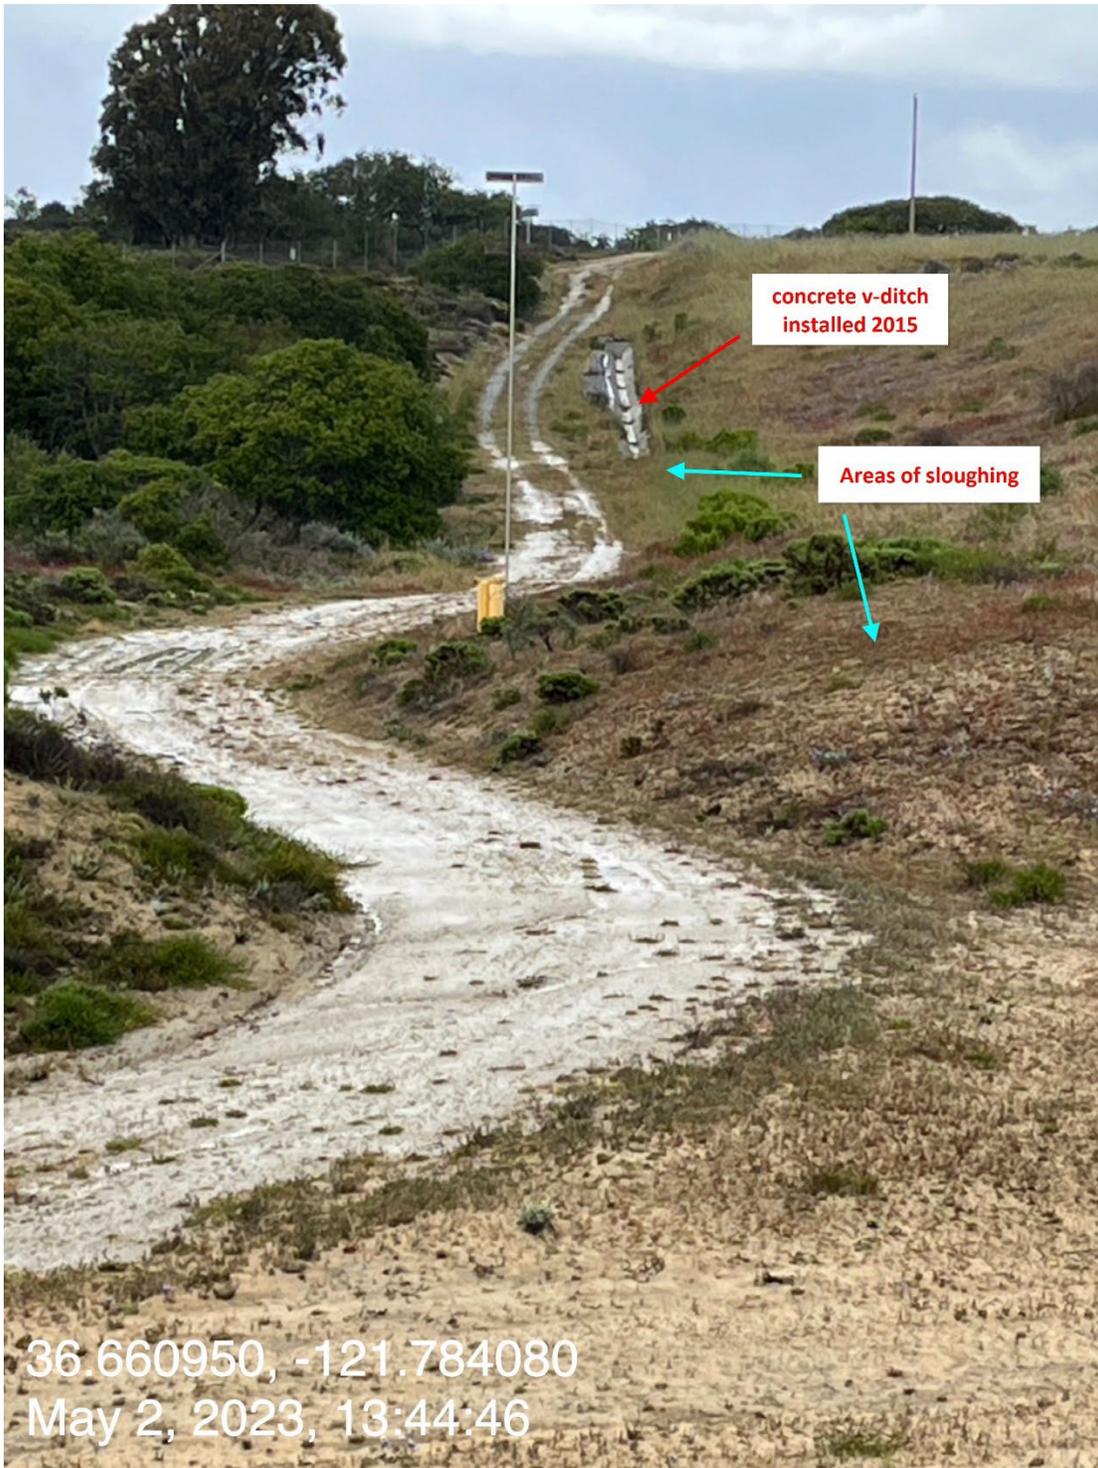
Photograph 2. Western Area D Concrete V-Ditch

decreases in elevation of 1 foot to 3 feet relative to the 1999 base topography. Repair of the vegetative cover on the northwestern slope included the placement of a concrete-lined drainage ditch to mitigate erosion (Photograph 2).

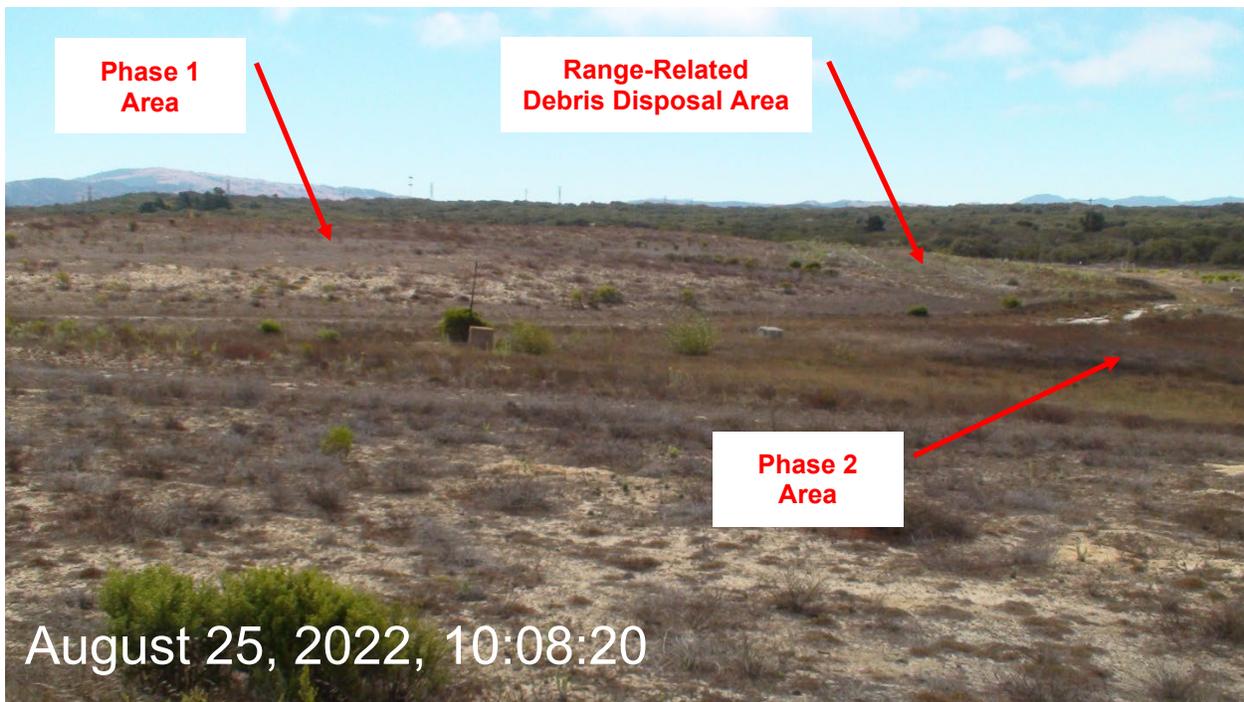
Photograph 3. Area E Phase 1 and Phase 2 Vertical Expansion Areas

At the western extent of the Phase 2 area, a trench was left in place so a new LLDPE geomembrane may be secured to the existing LLDPE geomembrane to cover additional remediation waste from the Site 39 Inland Ranges to be brought to Area E in the future. This “tie-in” trench is indicated by the narrow “open bracket” shape with surface elevations that are 1 foot to 3 feet lower than the 2003 base topography. Inspections of the OU2 Landfills after major storm events have found the subdrain system installed on the western slope of Area E is performing per design and no ponded water has been observed in the tie-in trench on the western side of Area E (Ahtna, 2023b).

Differential settlement related to waste decomposition could not be assessed for all of Area E because of the amount of construction changes that have occurred there since 1999; however, the change in elevation of less than one foot at the current and historical Area E settlement monuments is also consistent with expected long term consolidation settlement of the general fill and foundation layers combined with intermittent hydrocompaction due to wetting and drying of the vegetative cover, and indicates minimal settlement since 1999. Differential settlement at Area E may continue to be a challenge to assess because more remediation waste from the Site 39 Inland Ranges will be placed in the Phase 2 vertical expansion area within the next few years.

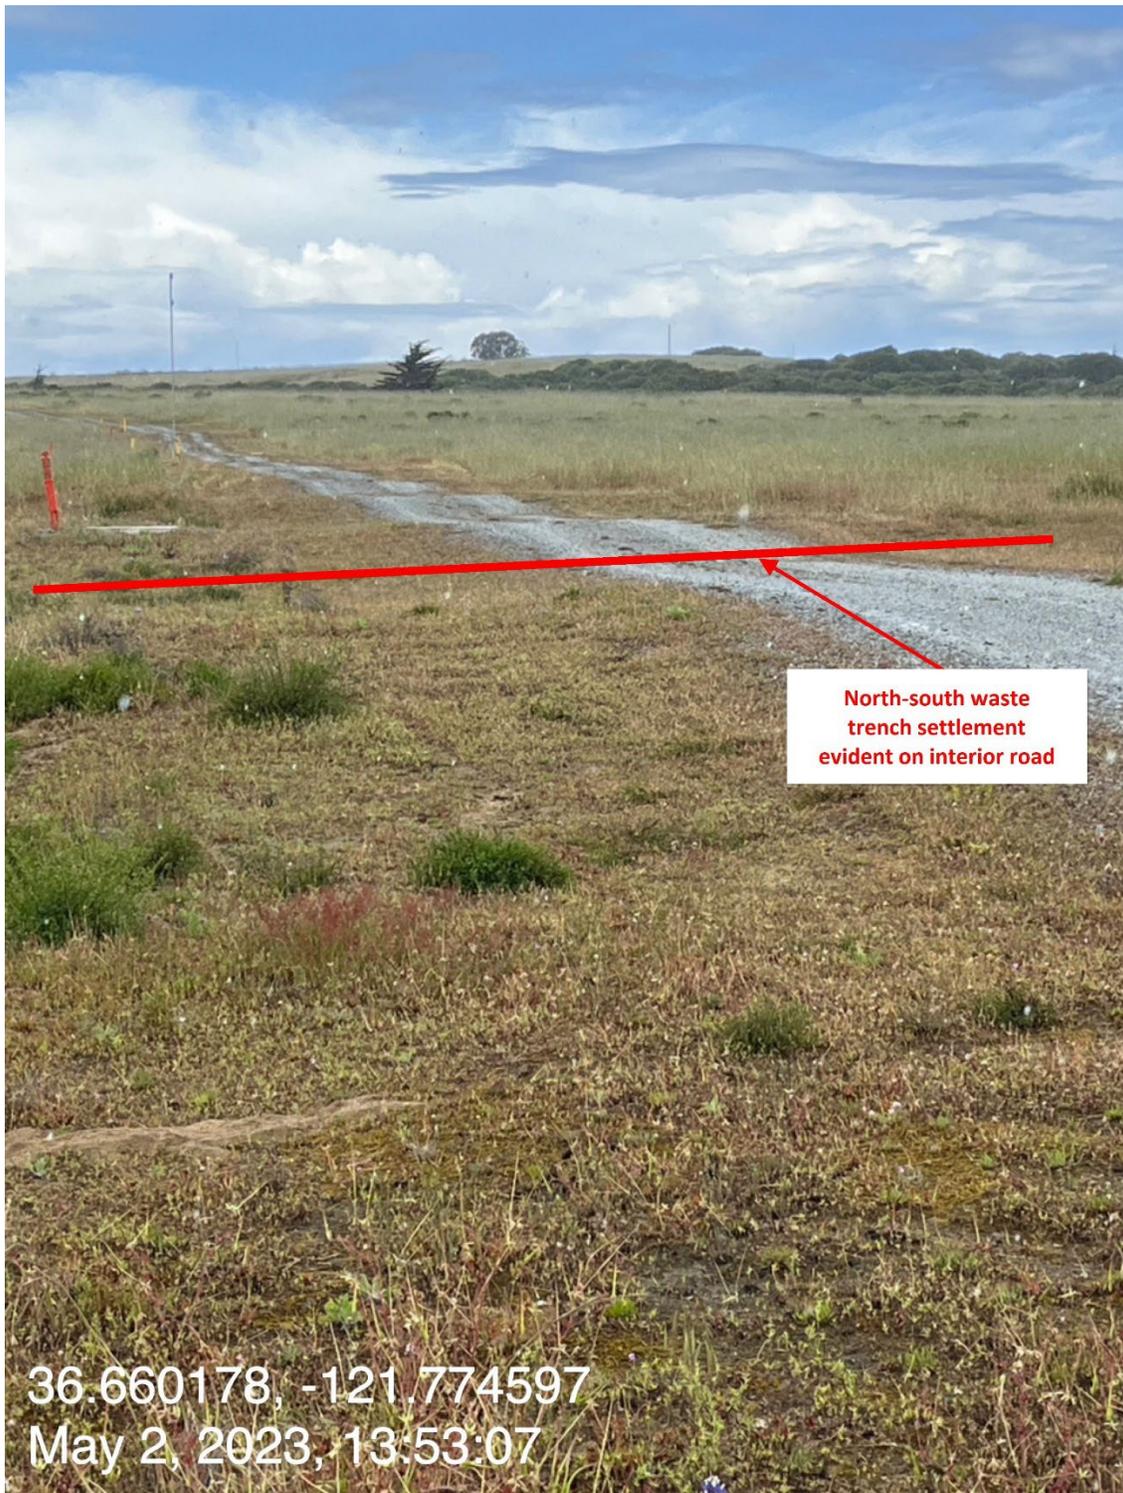
Photograph 4. Area F Waste Trench Settlement

Because Area F continued to receive decomposable waste until interim closure of the OU2 Landfills in 1987, this area showed evidence of settlement related to waste decomposition in areas that correspond to the locations of waste disposal trenches. However, no significant changes were observed in Area F when the 2023 surface elevations were compared to 1999 surface elevations.

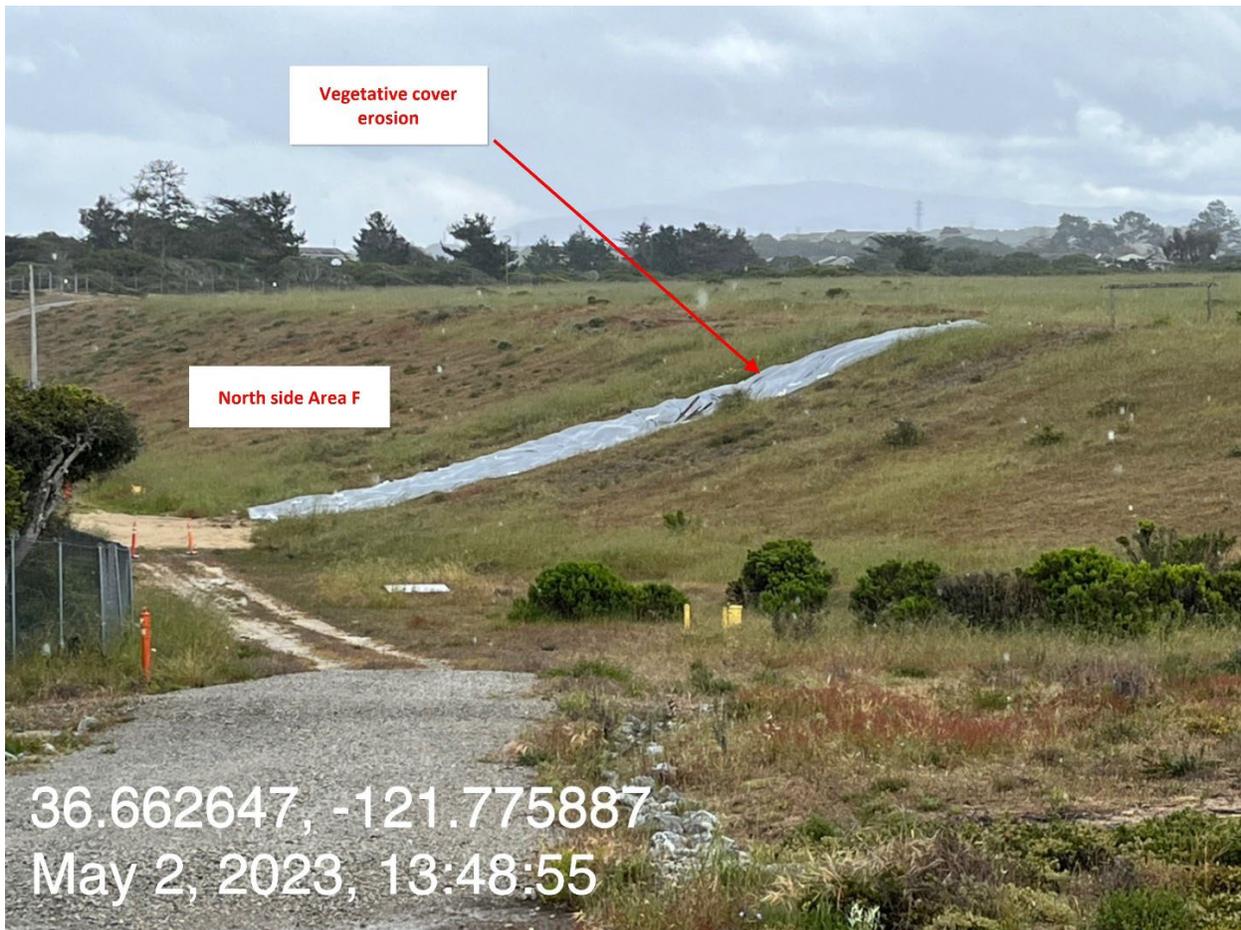
Photograph 5. Area F Vegetative Cover Erosion

Minor to significant sloughing of the vegetative cover has occurred on the northern slope of Area F resulting in decreases in elevation of 1 foot to 2 feet relative to the 1999 base topography. Repair of the vegetative cover on the northern slope included the placement of a subdrain system in 2017 to mitigate erosion (Ahtna, 2023b). An erosion channel in the vegetative cover on the northern slope of Area F, resulting from higher than average precipitation during the 2023 water year, is shown in Photograph 5 and is observable on the iso-settlement map in Attachment B. Repair of the vegetative cover in this area was completed in September 2023. There is no evidence of ponding in this area requiring additional repairs to the engineered cover system (Ahtna, 2023b).

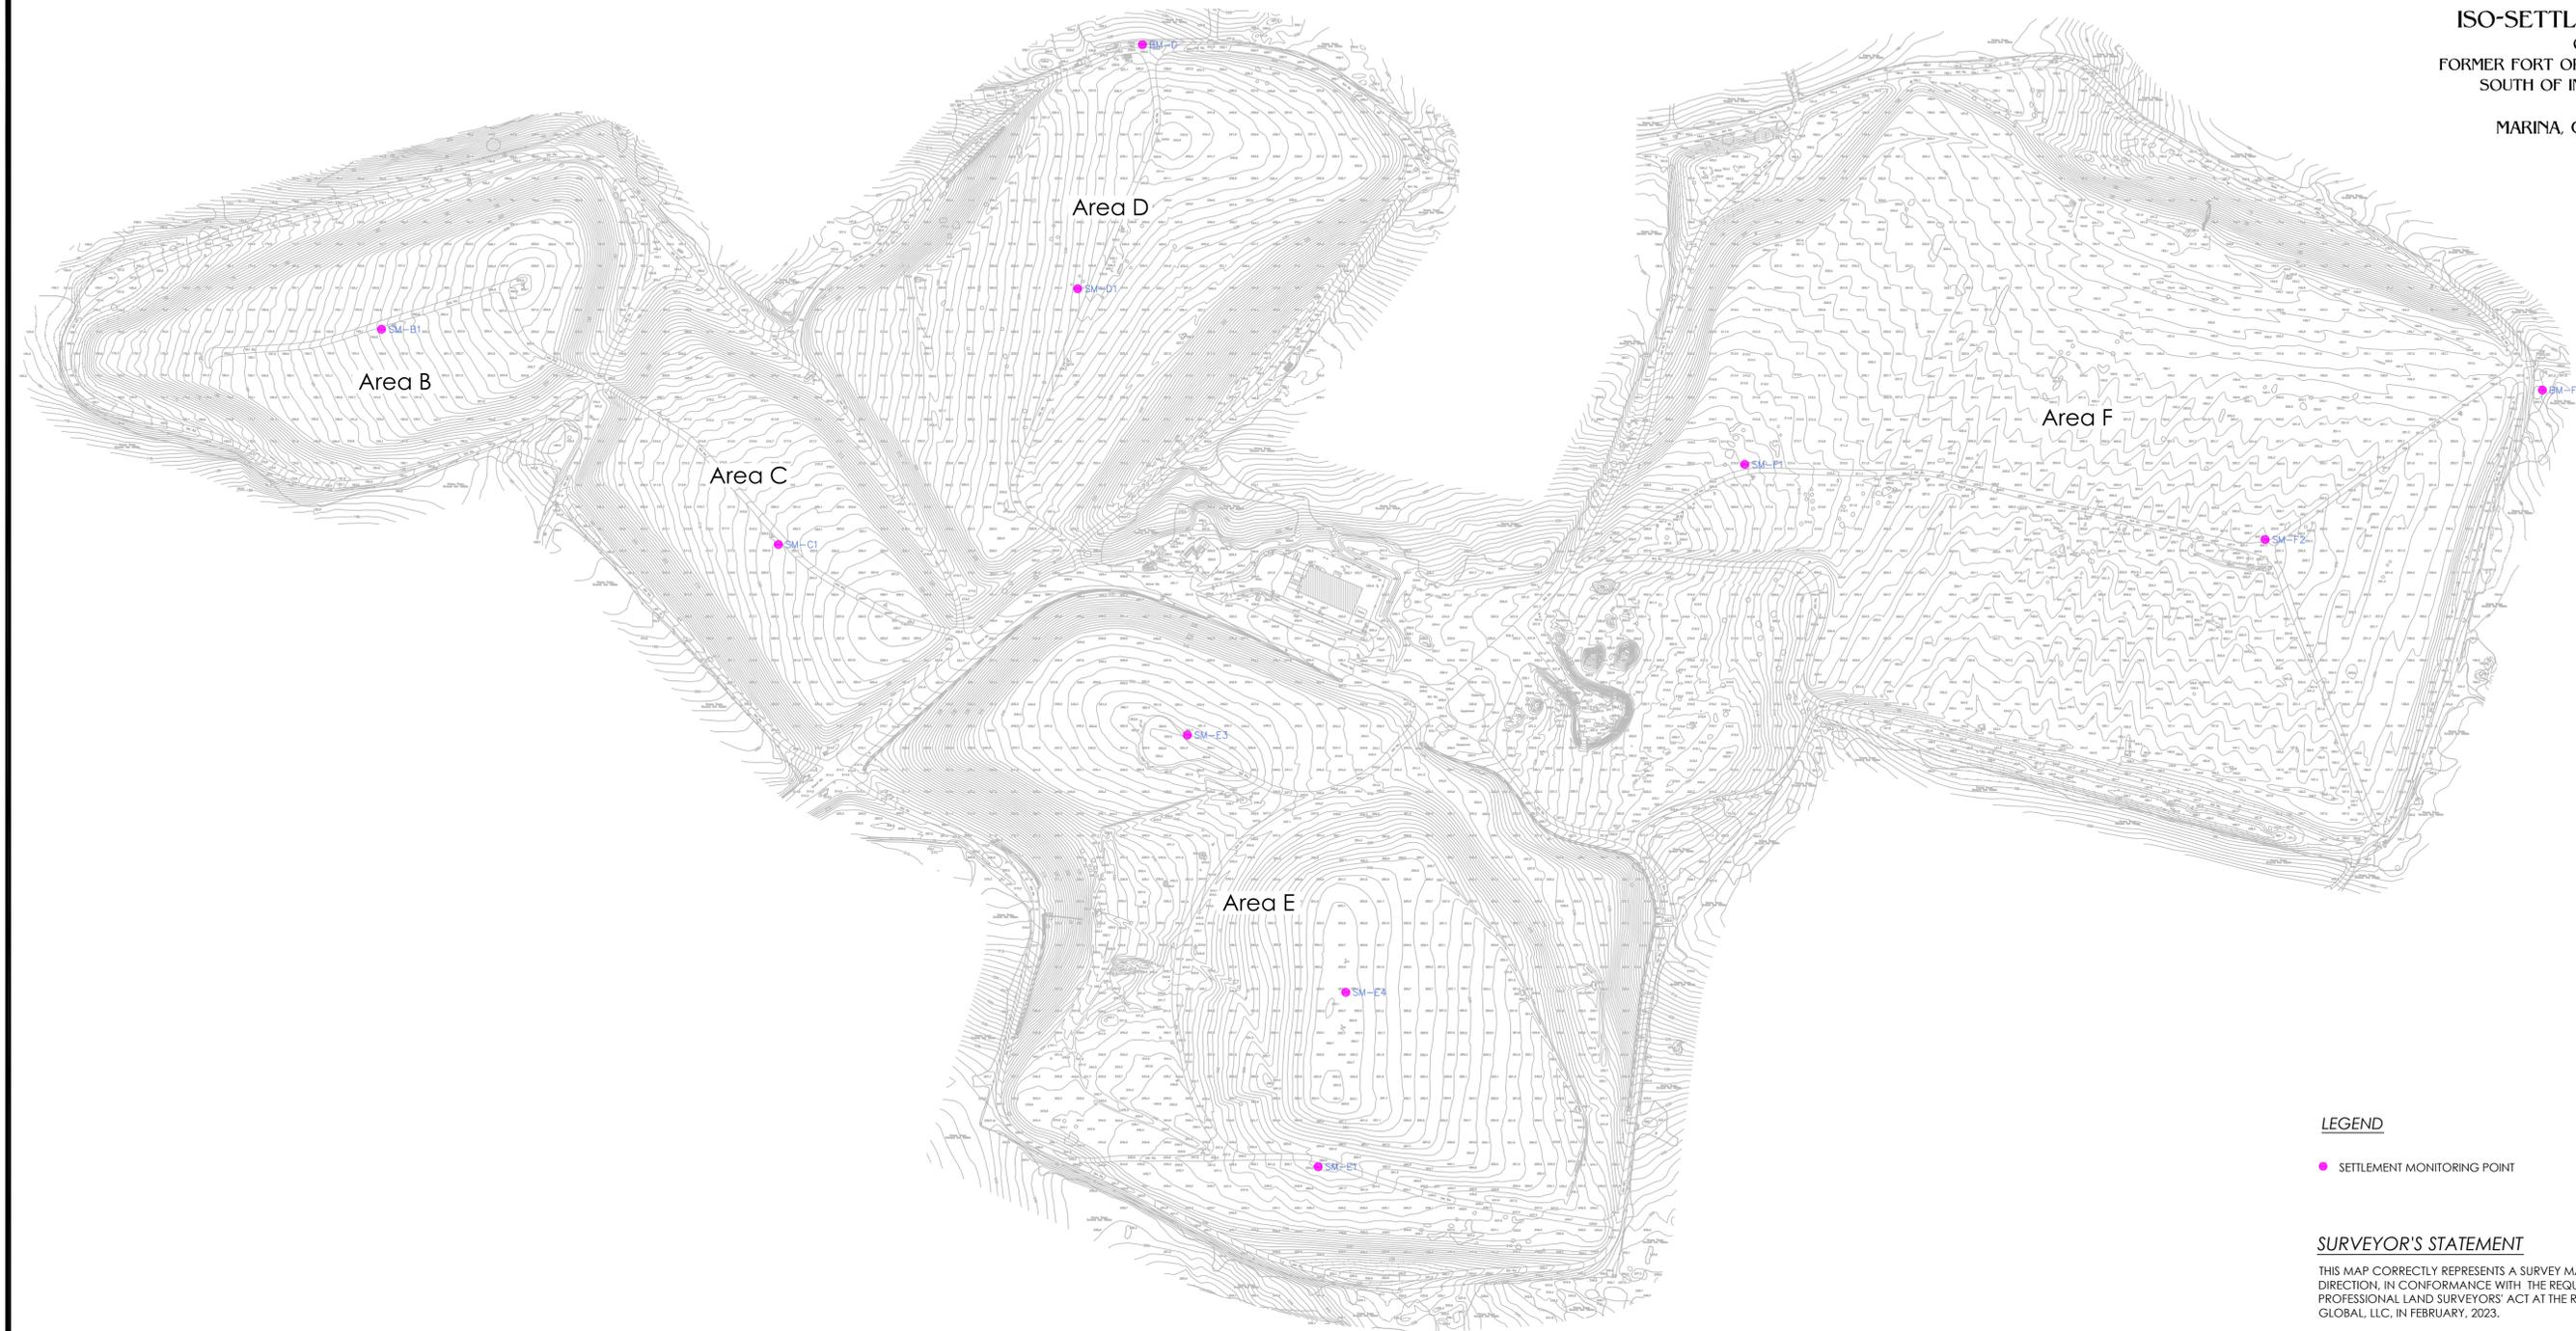
ISO-SETTLEMENT MAP
OF
FORMER FORT ORD OU-2 LANDFILLS
SOUTH OF IMJIN PARKWAY
MARINA, CALIFORNIA

We prepared the enclosed Iso-Settlement map that shows 2023 contours and their relationship to the 1999 baseline mapping for Areas B, C, D and F. Area E's baseline mapping is from 2003. The Iso-Settlement map indicates all areas where differential settlement has been noted since the baseline mapping.

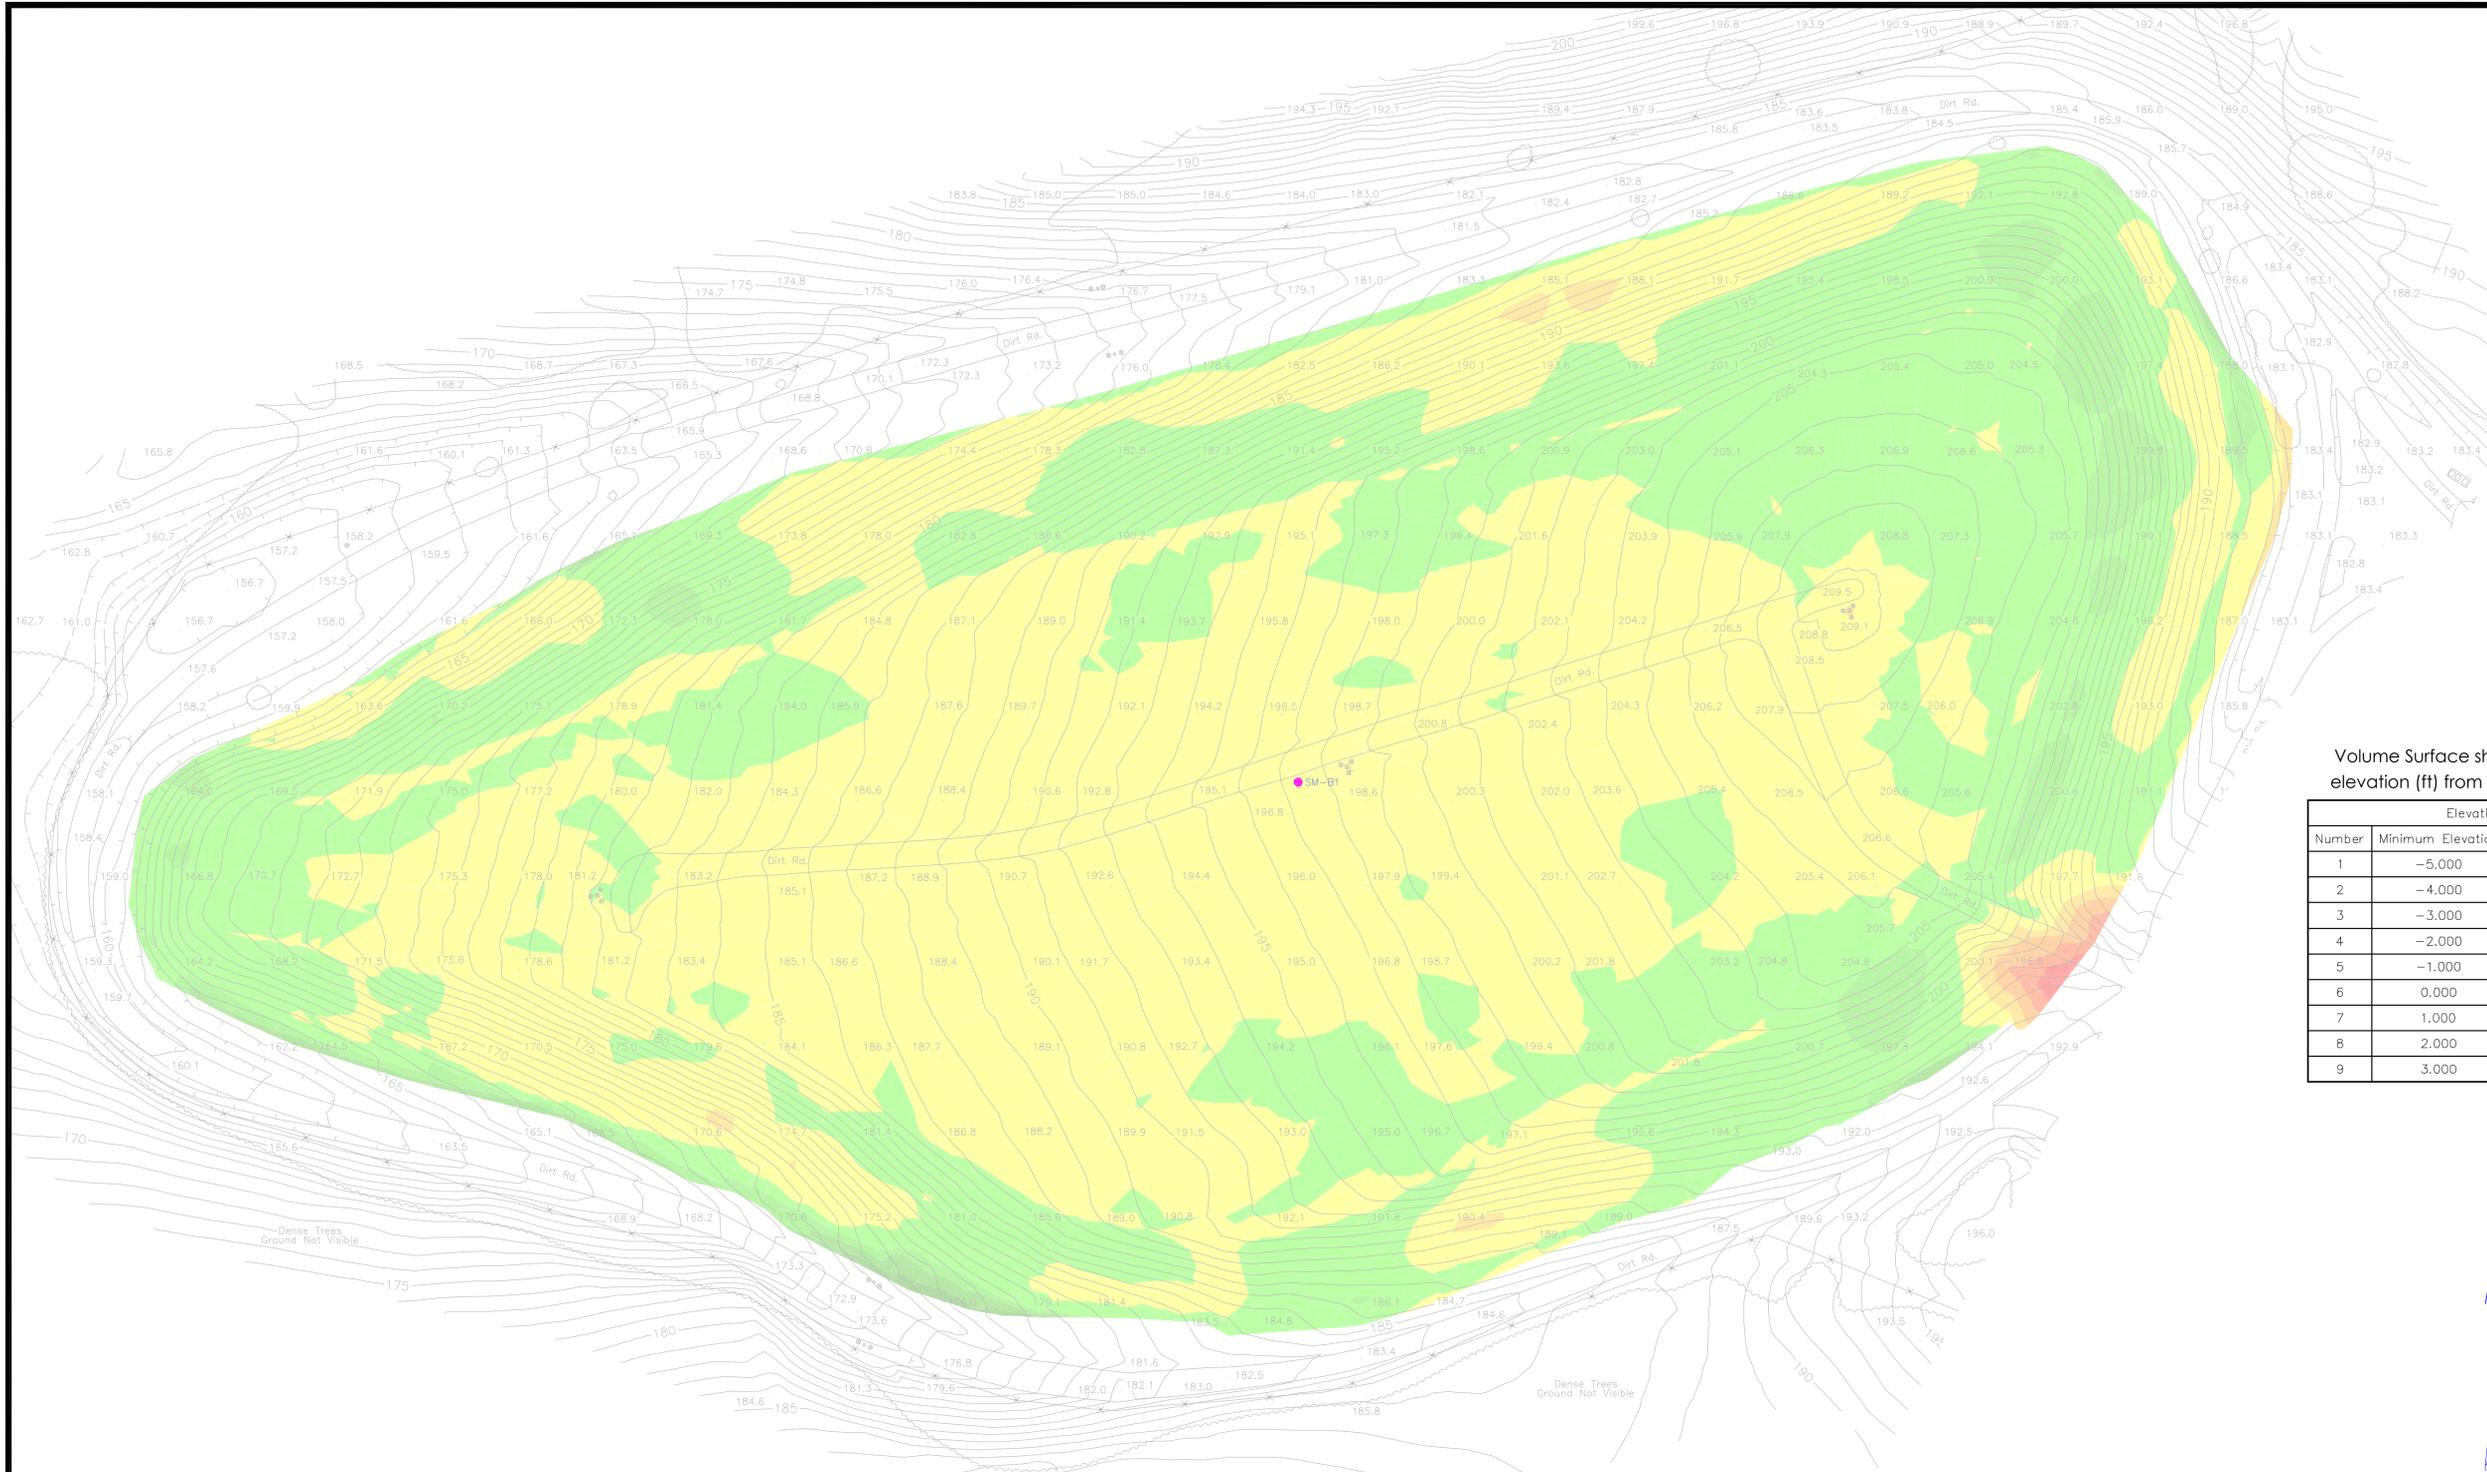
OU2 Landfill Area B

Settlement monument SM-B1 is in the middle of Area B (Attachment C, Sheet C80). In the 25-year period following placement of waste and the engineered cover system in Area B, the elevation of SM-B1 has declined 0.21 of a foot (2.5 inches) (Table 2). As shown on the iso-settlement map for Area B in Attachment B, elevation differentials between 1999 and 2023 over most of Area B have been less than 1 foot, with a maximum differential of -4 to -5 feet in the area of the perimeter road improvements noted above.

Volume Surface showing the change in elevation (ft) from 1999 to 2023 at Area B

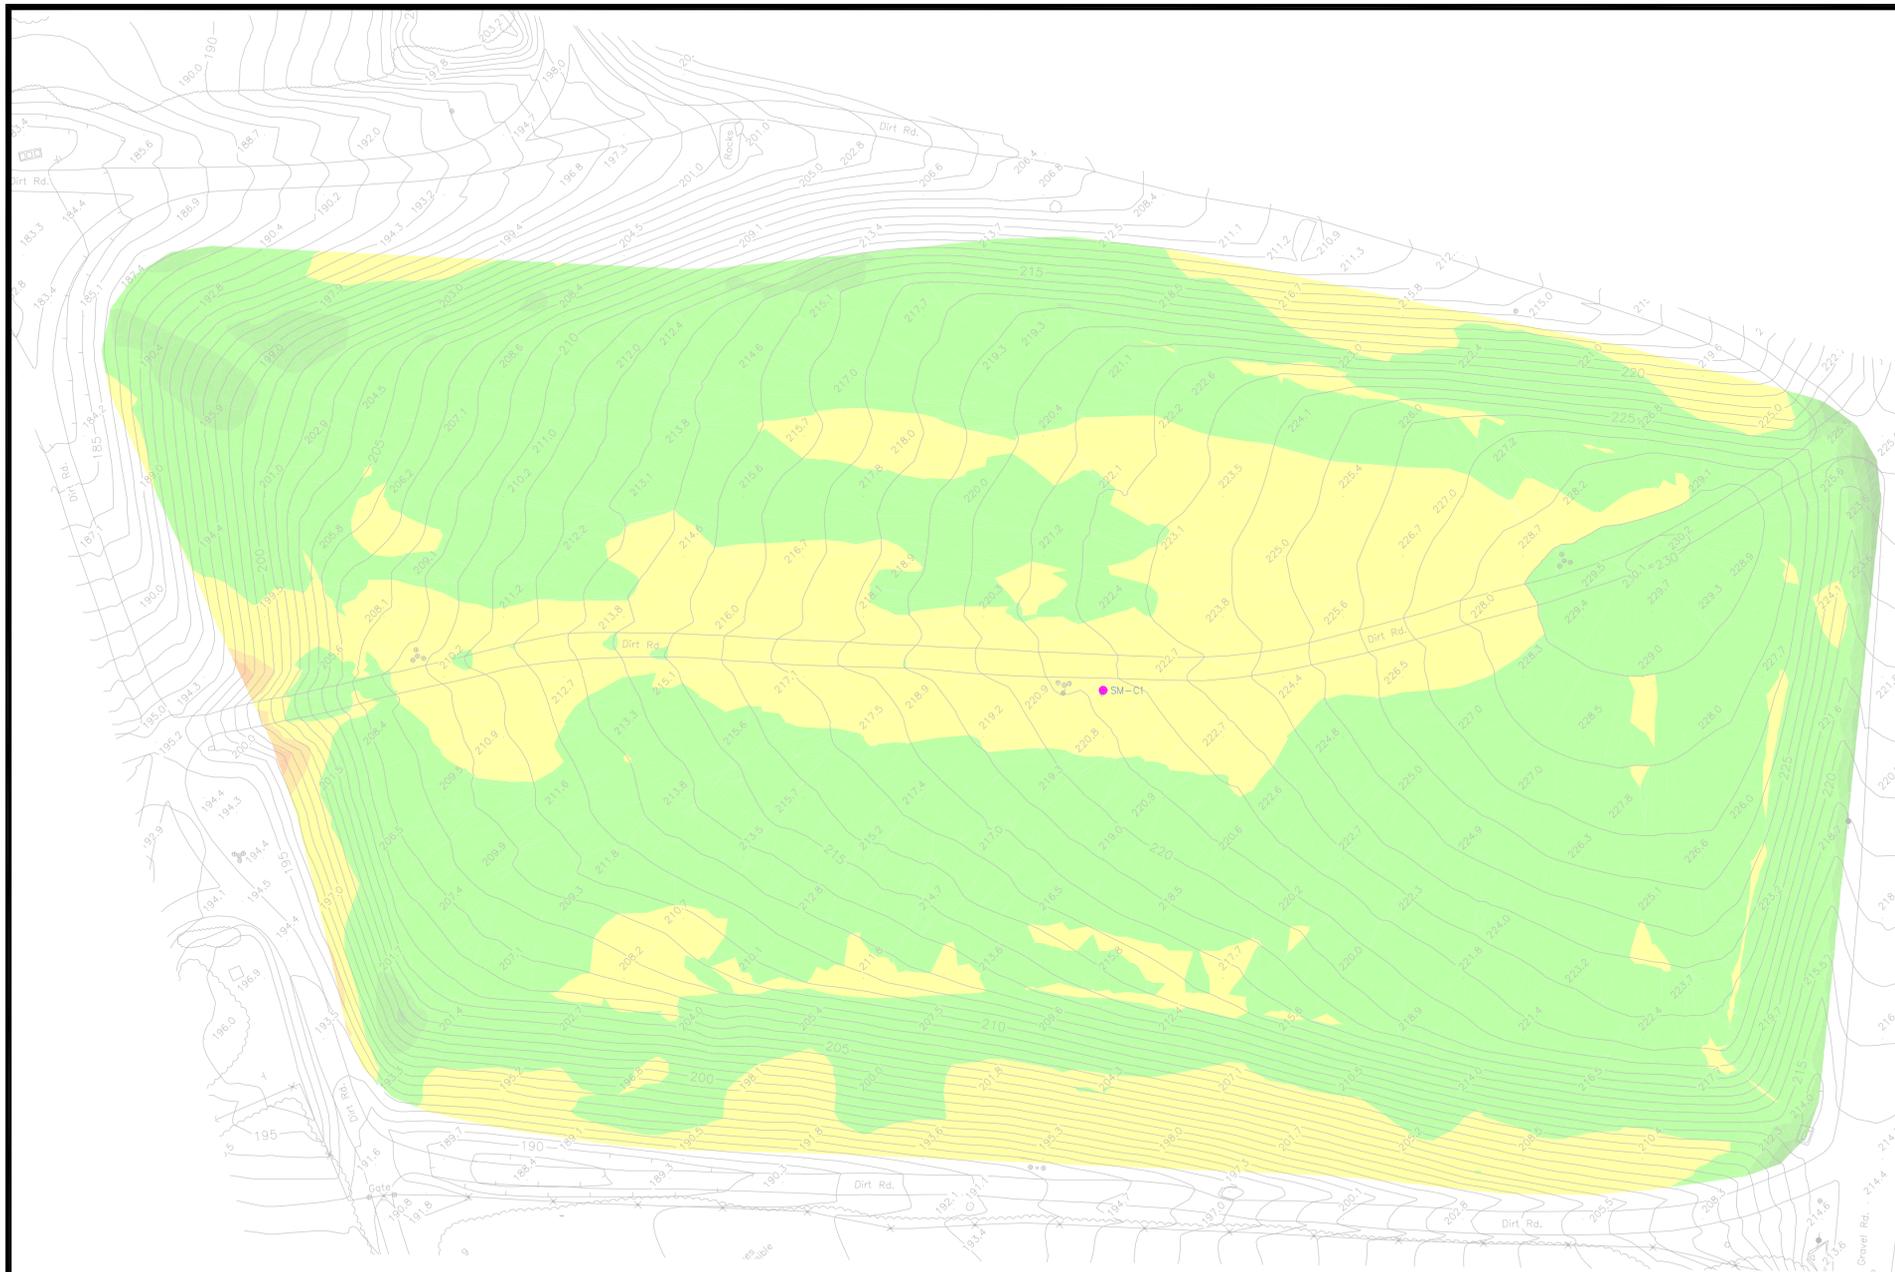
SCALE: 1" = 40' VIEW: AREA B DATE: March 14, 2023
 FILE NAME: 2023 Compilation.dwg JOB #19129 Sheet 2 of 6

**ISO-SETTLEMENT MAP
OF
FORMER FORT ORD OU-2 LANDFILLS
SOUTH OF IMJIN PARKWAY
MARINA, CALIFORNIA**

Table B. Settlement Monitoring Plate Data

Point #	Designation	2023 Measured Elevation (ft)	1999 Published Elevation (ft)	Difference (ft)
102	SM-B1	197.40	197.61	-0.21
103	SM-C1	221.25	221.47	-0.22
104	SM-D1	237.41	237.74	-0.33
105	SM-F1	217.68	218.09	-0.41
106	SM-F2	207.00	207.76	-0.76
107	SM-E1	253.87	254.54	-0.67
206	SM-E4	263.71	264.18B	-0.47
207	SM-E3	253.21	253.39A	-0.18

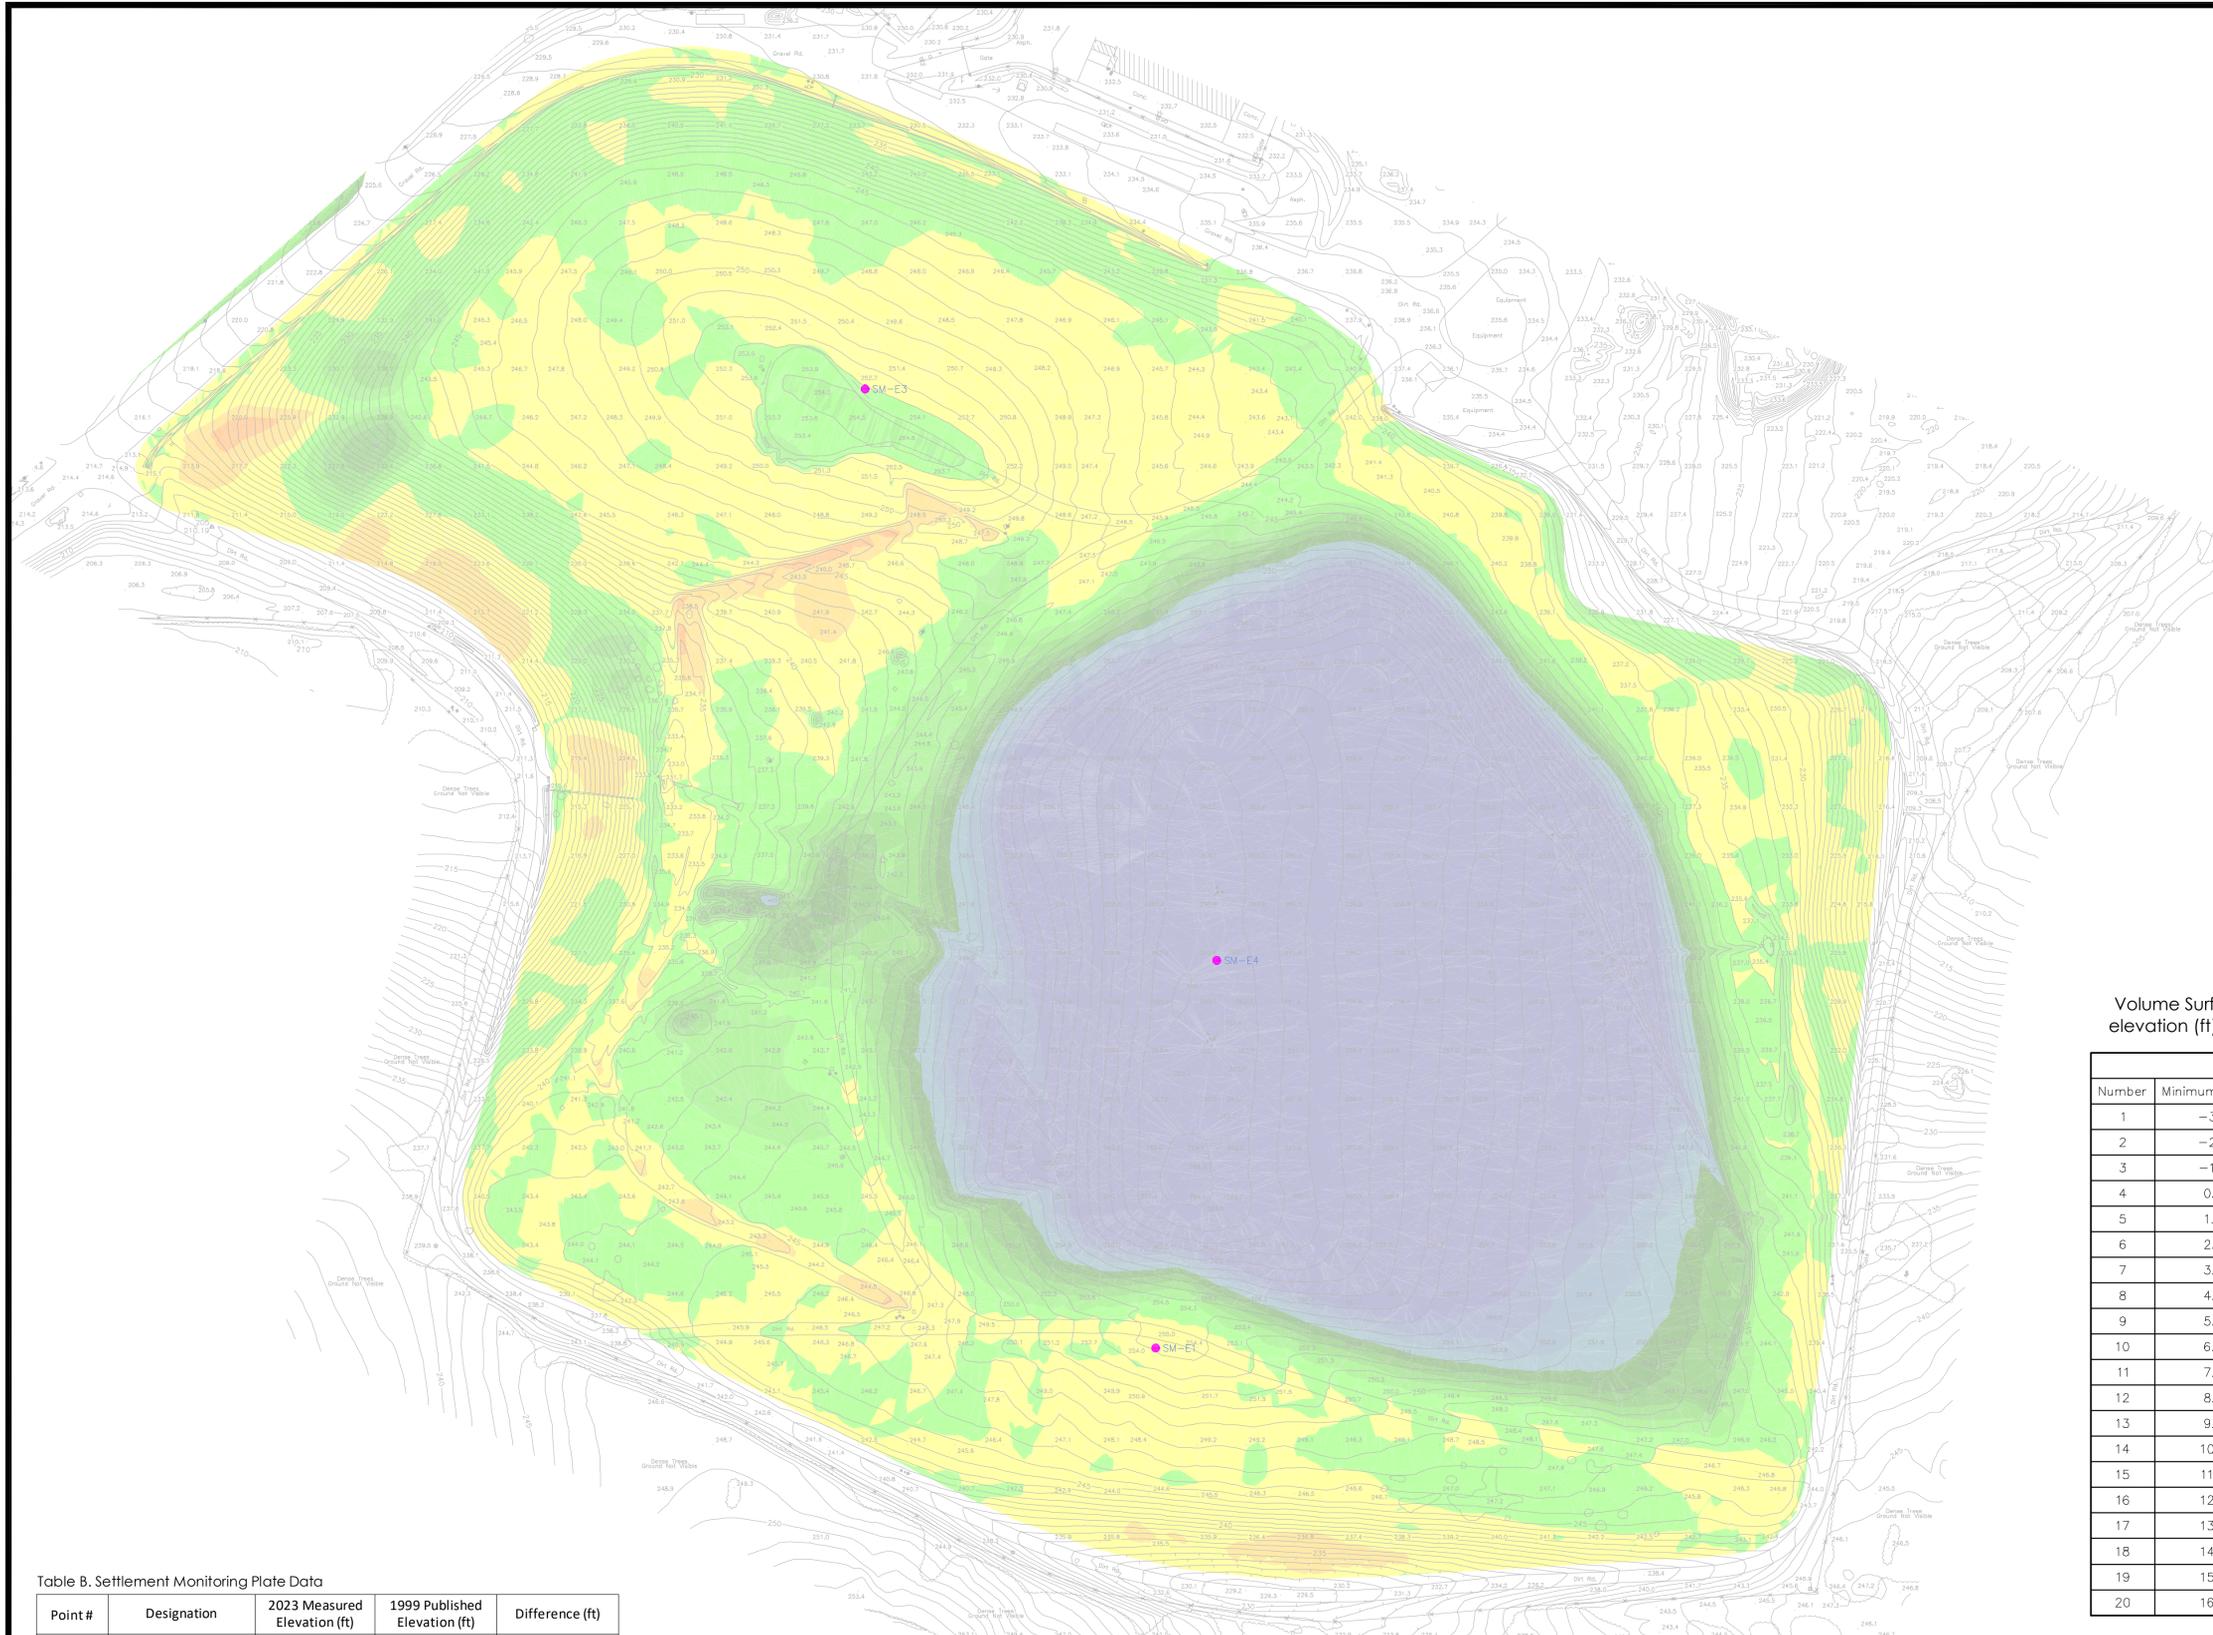
Volume Surface showing the change in elevation (ft) from 2003 to 2023 at Area E
