Technical Report

2023 Iso-Settlement Survey

Operable Unit 2 Landfills

Former Fort Ord, California

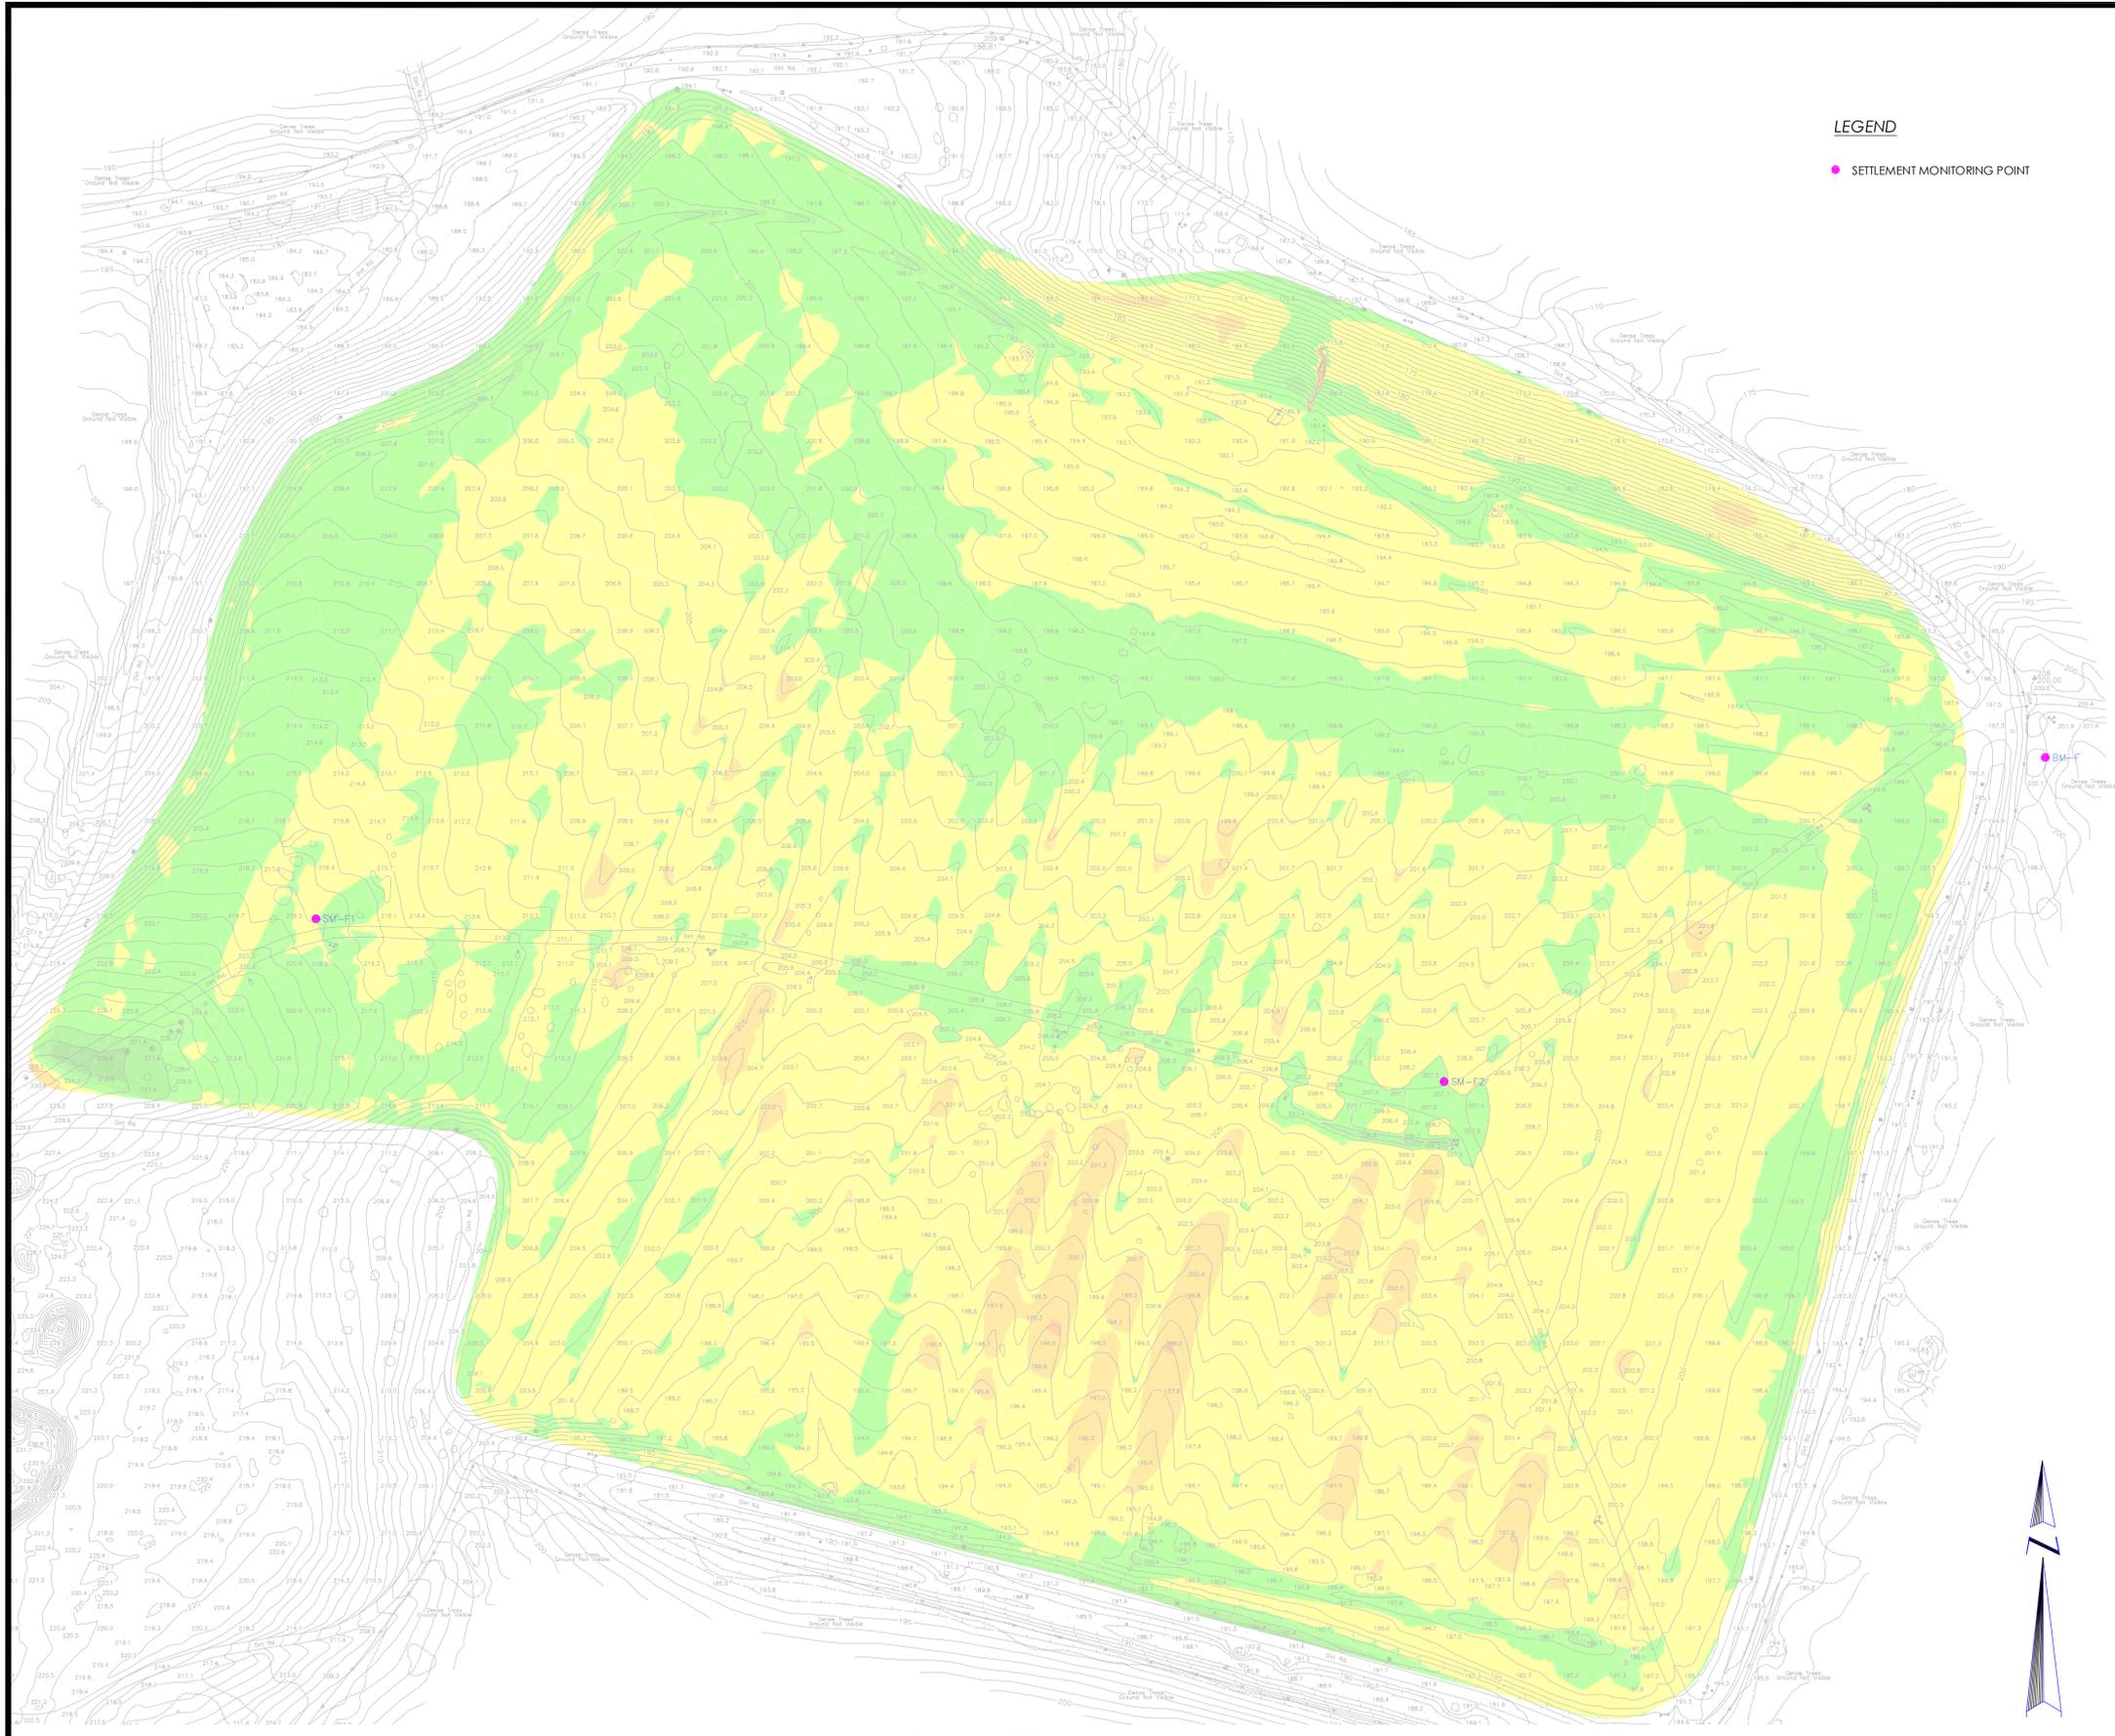
SCALE: 1" = 70' VIEW: AREA F DATE: March 14, 2023
 FILE NAME: 2023 Compilation.dwg JOB #19129 Sheet 6 of 6

OU2 Landfill Area F

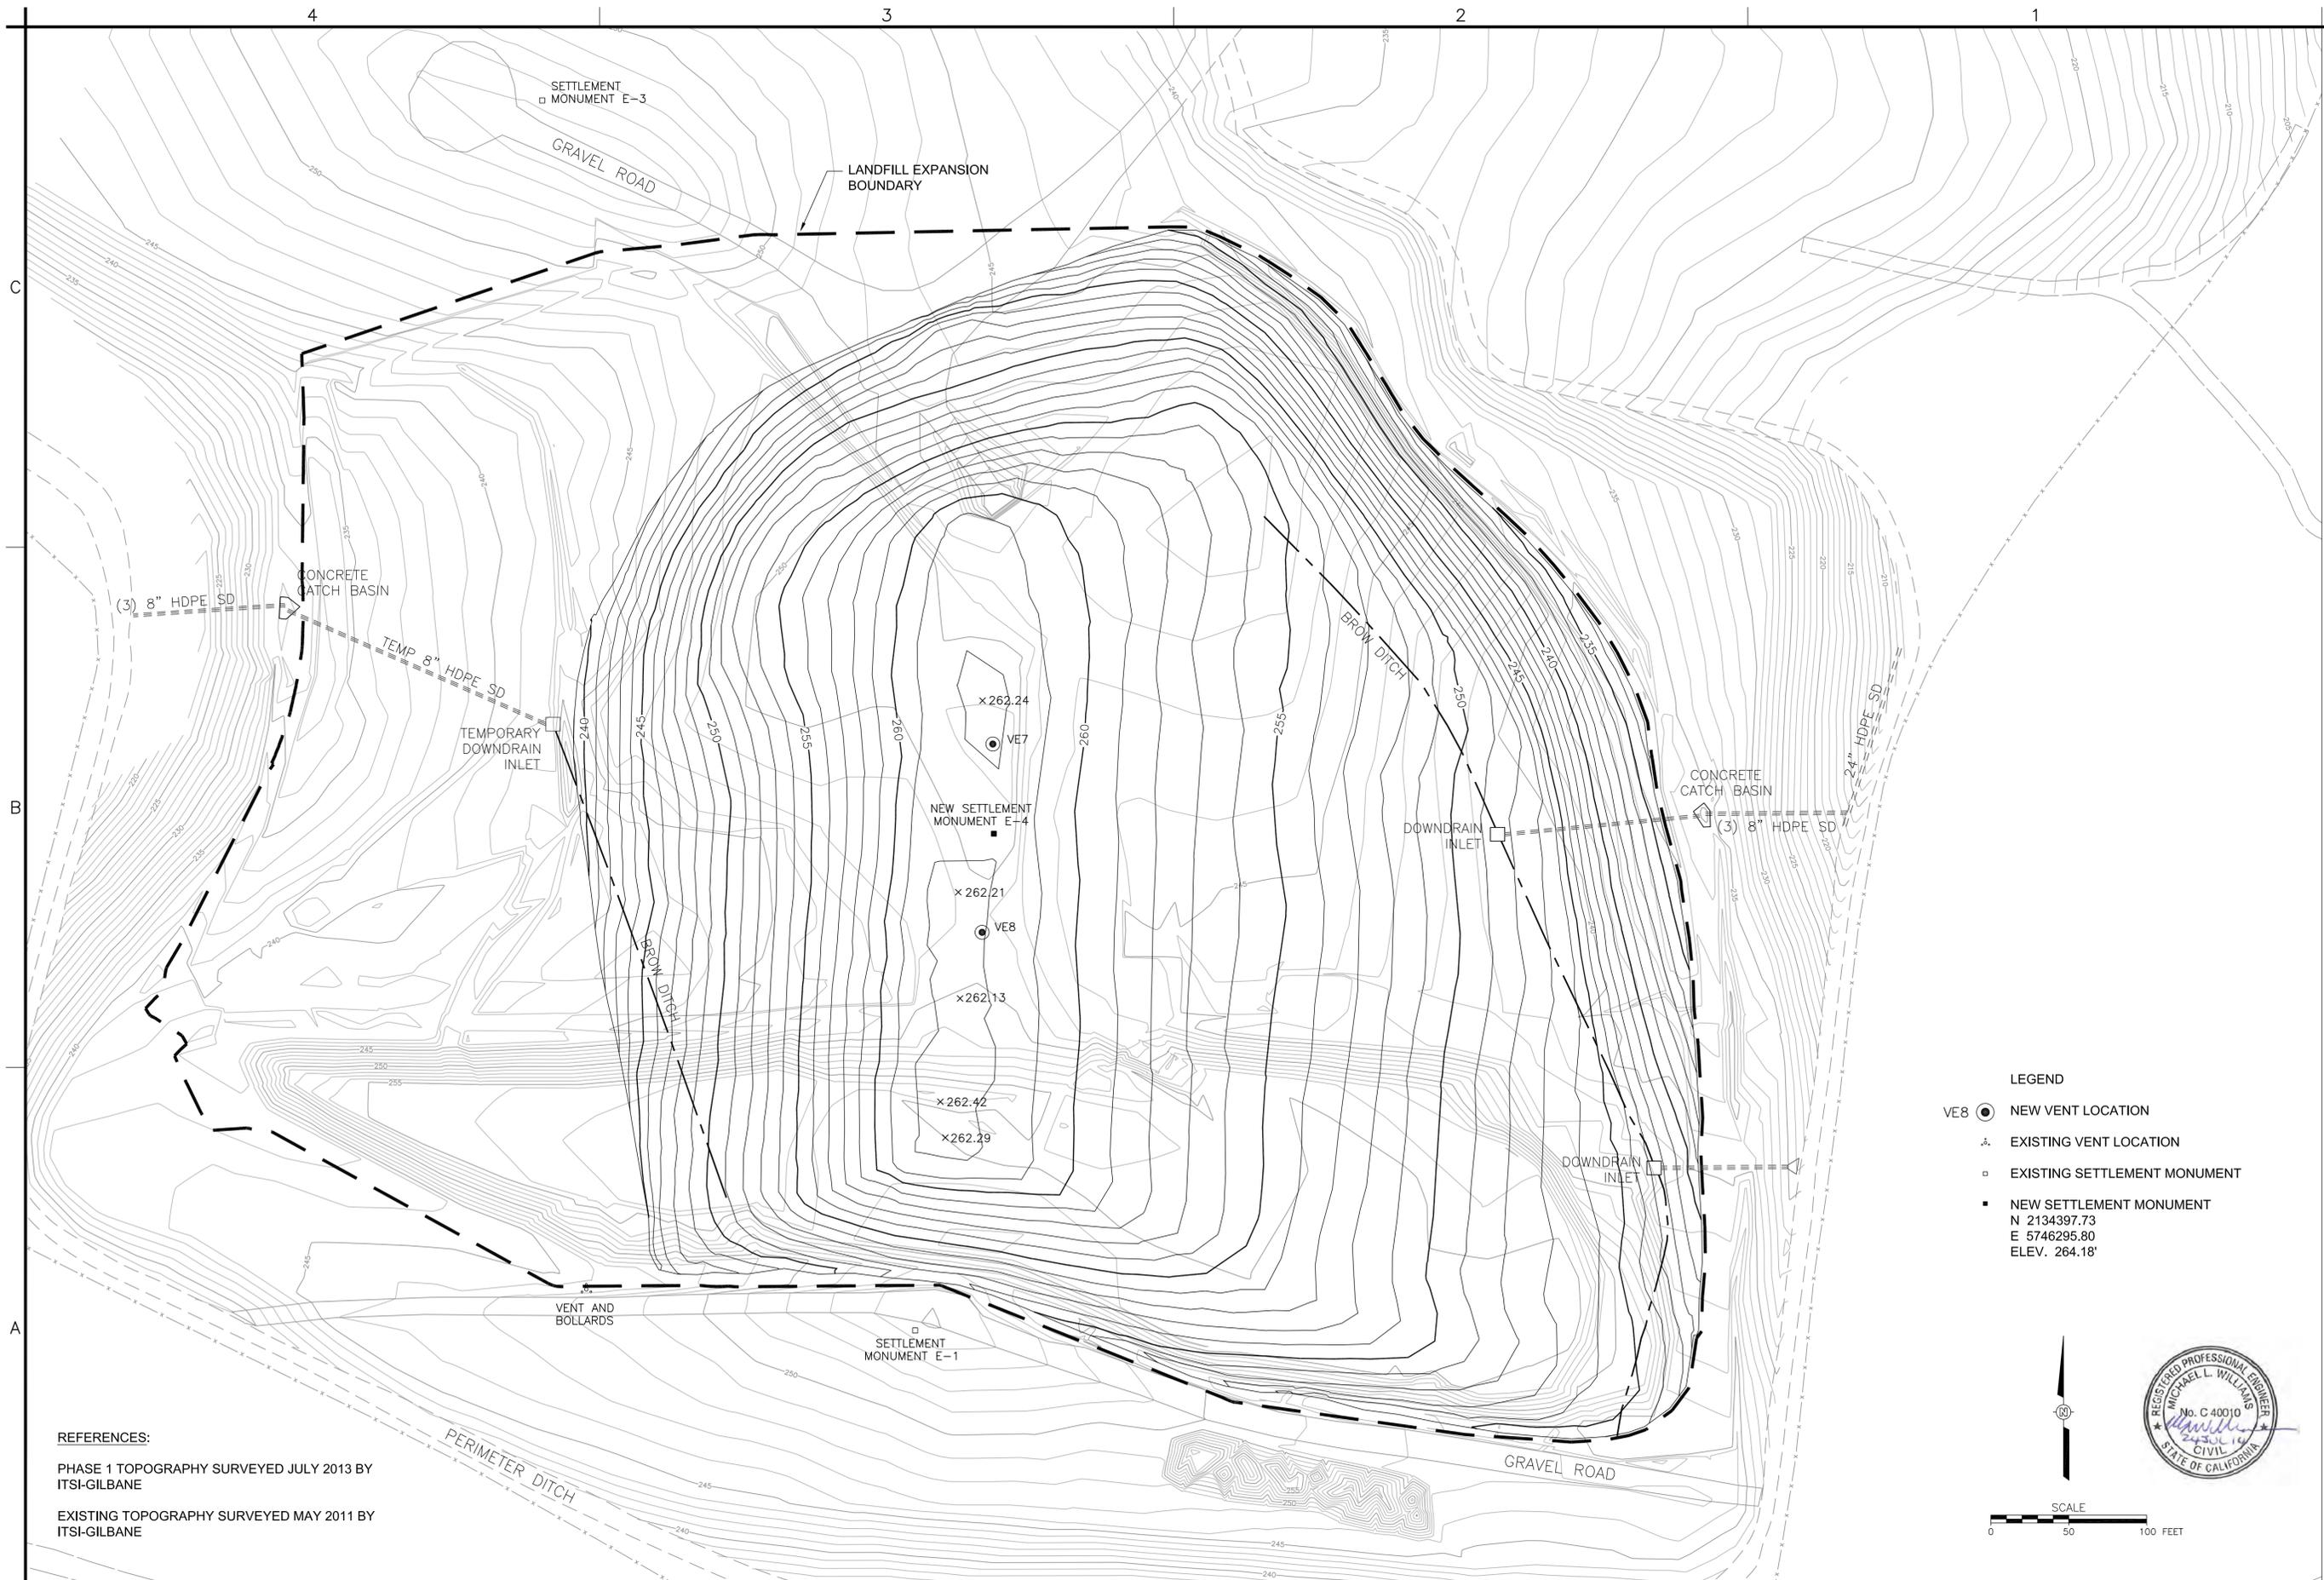
FINAL COVER TOPOGRAPHY
AREA E

FORT ORD OU2 LANDFILL CLOSURE

REFERENCES:
 PHASE 1 TOPOGRAPHY SURVEYED JULY 2013 BY
 ITSI-GILBANE
 EXISTING TOPOGRAPHY SURVEYED MAY 2011 BY
 ITSI-GILBANE
