**Final
Annual Report
Task Order 4
Former Fort Ord Site 39
Habitat Restoration
2013
Contract No. W91238-10-D-0002**

**FORMER FORT ORD
Monterey County, California**

Site 39 Habitat Restoration Annual Report Task Order 4

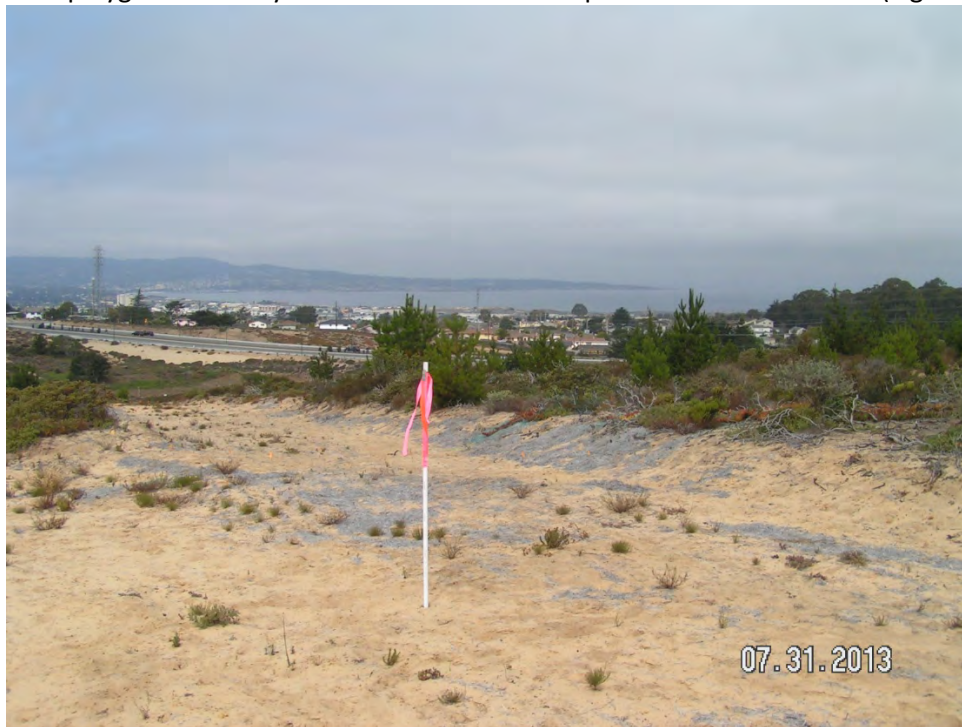
Figure 2. Polygon boundary marker.

1. Installed polygon boundary markers within 100 ft of perimeter Blueline Road (Figure 2).

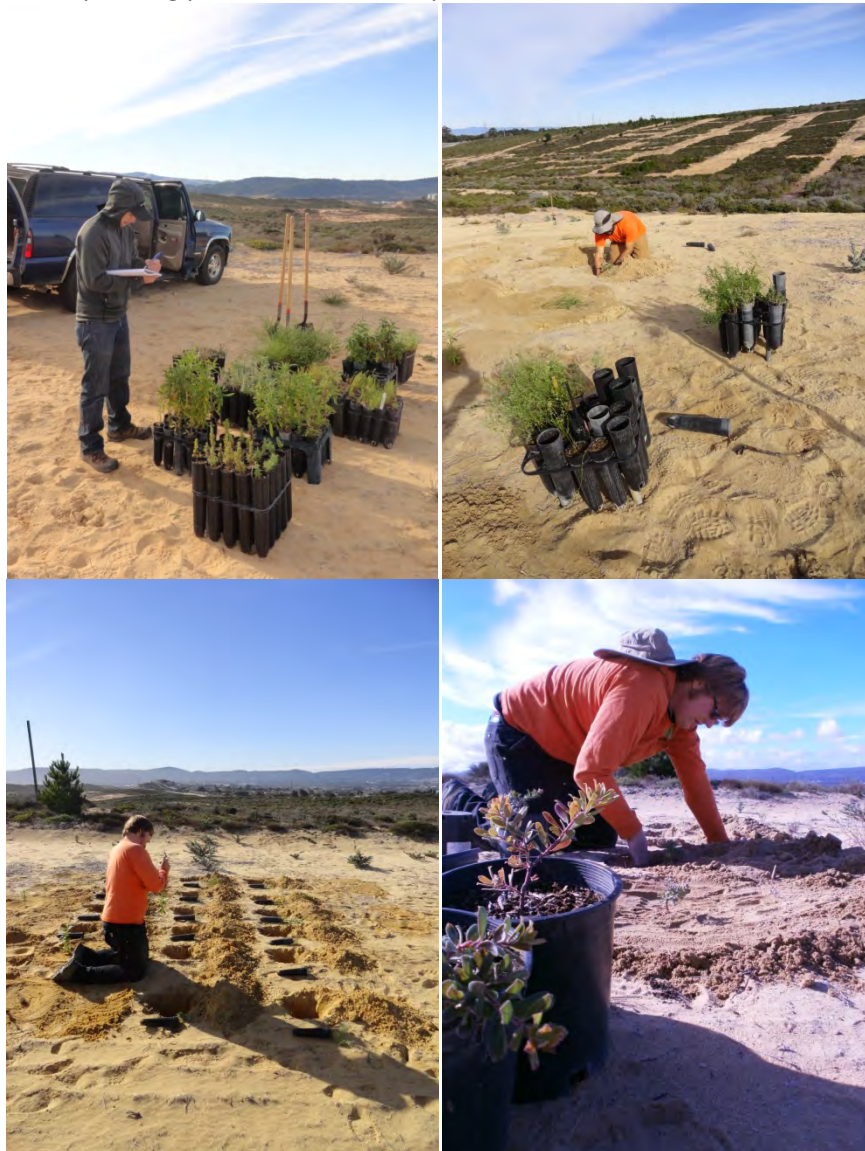
Figures 5, 6, 7 & 8. HA 19 active plant installation.

1. Started active planting phase: installed 180 plants.

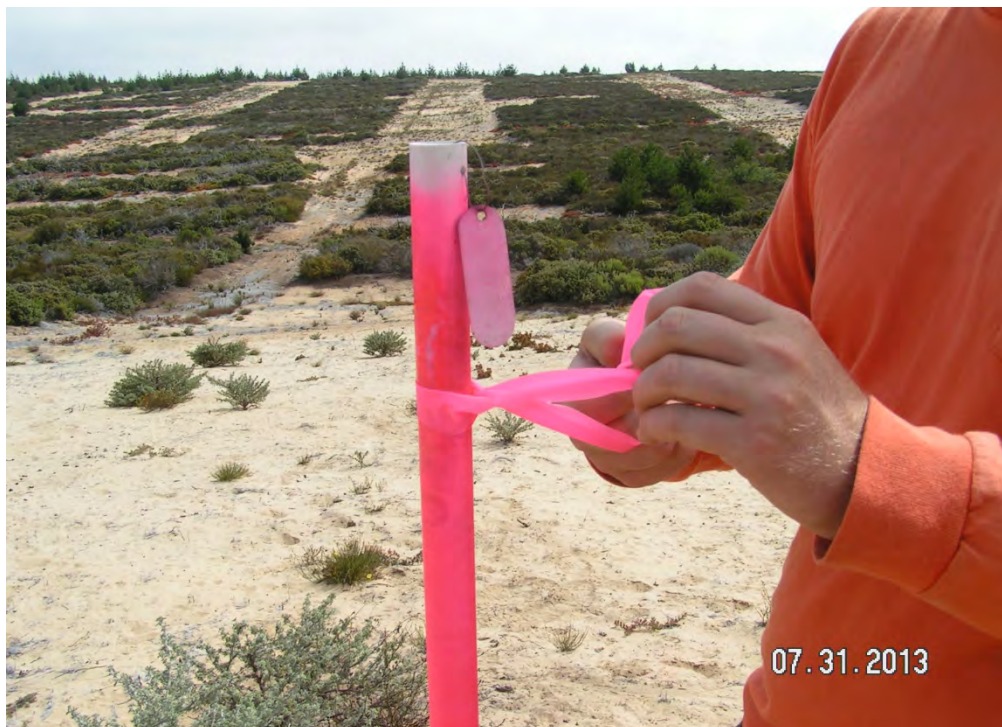
Figure 9. Boundary marker installation.

1. Installed polygon boundary markers within 100 ft of perimeter.

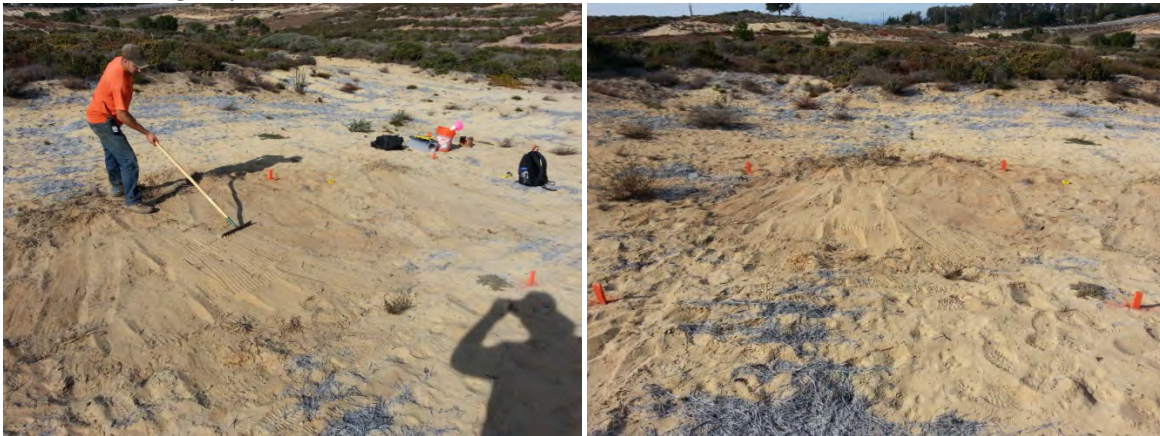
Figures 10 & 11. Sand gilia broadcast.

1. Broadcast 4 g Sand gilia over 2500 ft².
2. GPS Sand gilia plots.

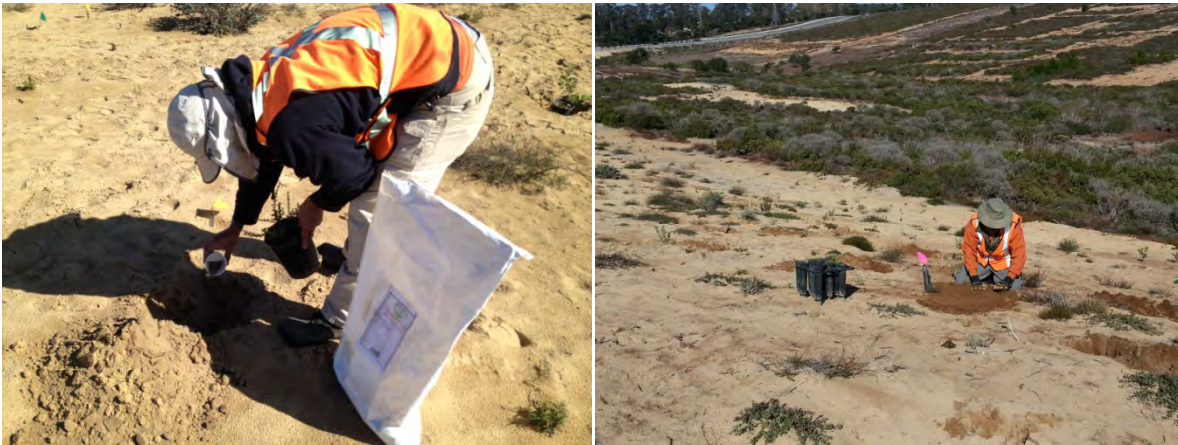
Figures 12 & 13. Mycorrhizal + fertilizer inoculation and plant installation.

1. Installed the remaining targets for ADFA, ARTO, ERE, ERER, ERCO, HOCU, and SAME. Included a mycorrhizal + fertilizer component to the all the plants.

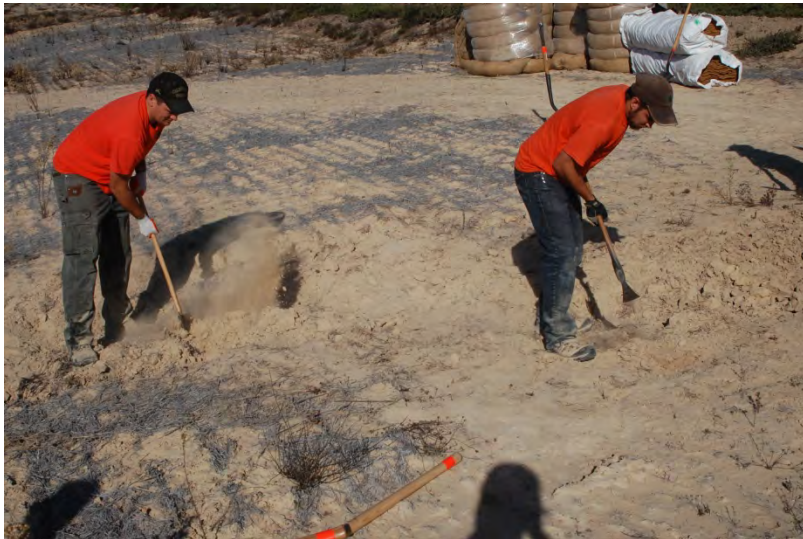
Figure 19. HA 28 rill and gully collapsing.

1. Collapsed rills and gullies.
2. Smoothed out area for coir fabric.
3. Dug trenches for straw wattles.
4. Installed several straw wattles.

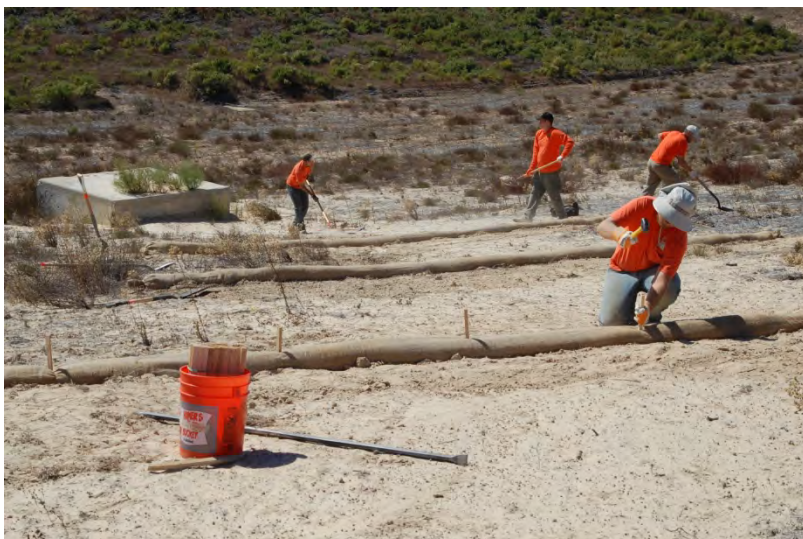
Figure 20. HA 28 wattle installation.

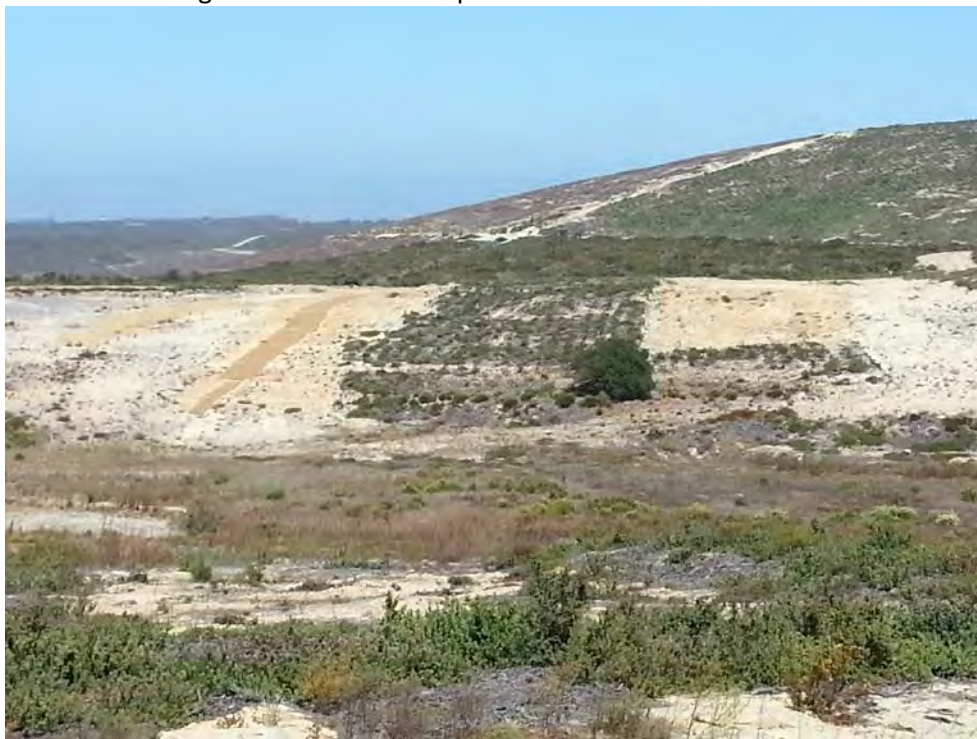
Figure 21. HA 28 completed erosion control footprint.

1. Finished installing straw wattles.
2. Finished installing coir fabric.
3. Finished seeding erosion control footprint.

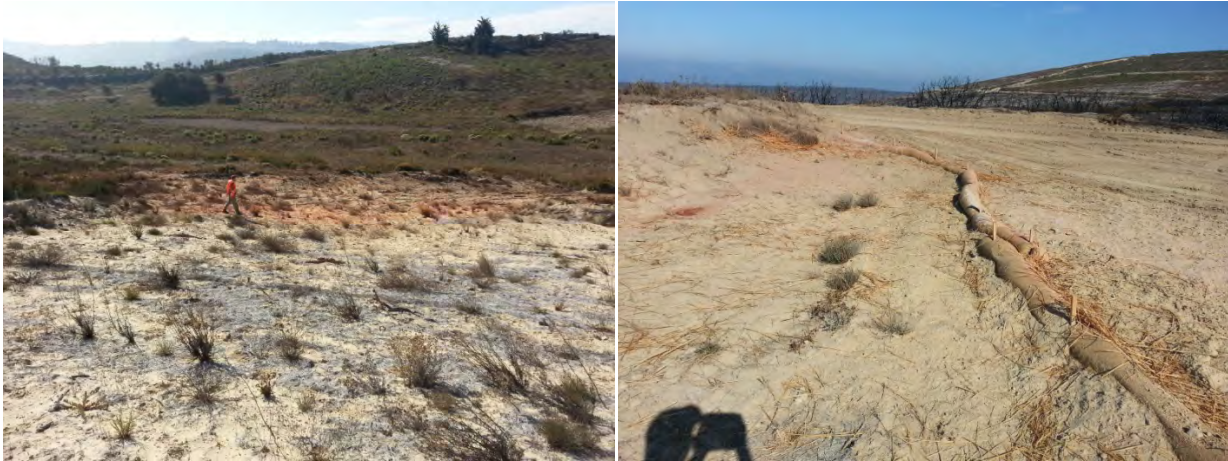
Figures 22 & 23. Areas covered with retardant during prescribed burn.

1. Inspected areas covered by fire retardant during prescribed burn.
2. Inspected burned chaparral north of the site.

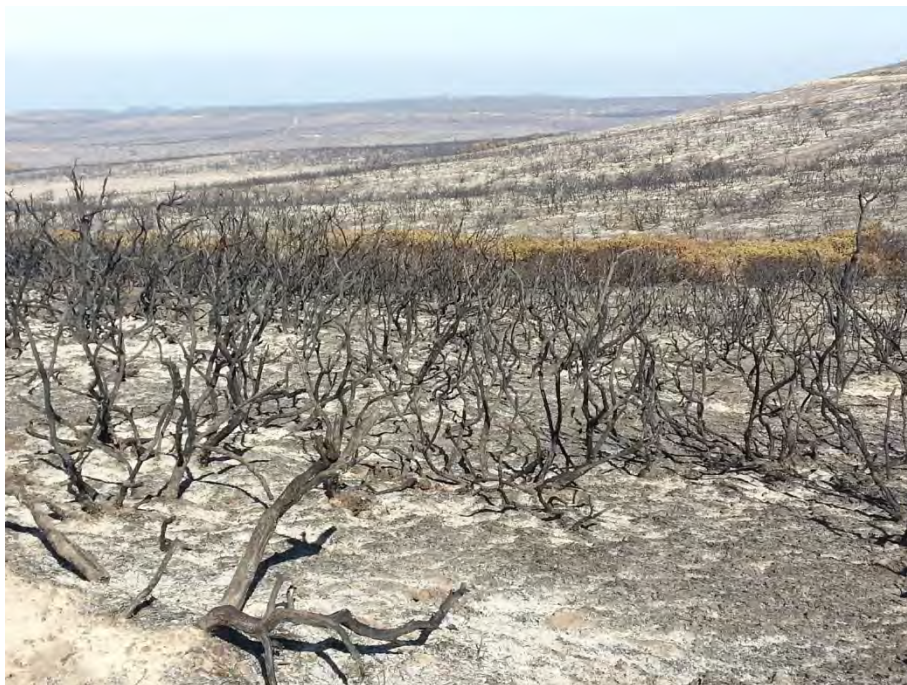
Figure 24. Burned area just north from HA 28.

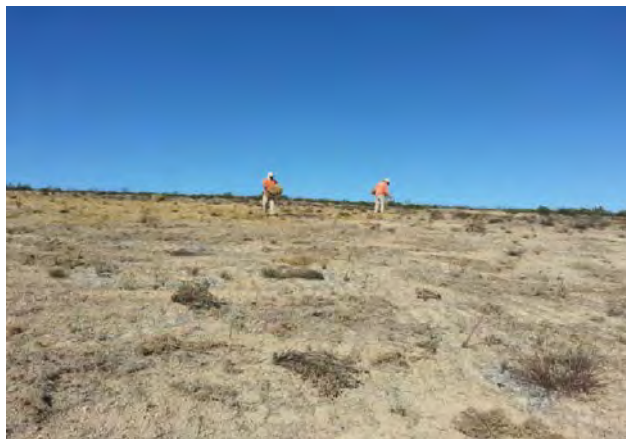
Figure 25. HA 28 seed and straw application.

1. Finished broadcast seeding the whole site.
2. Spread straw on site.

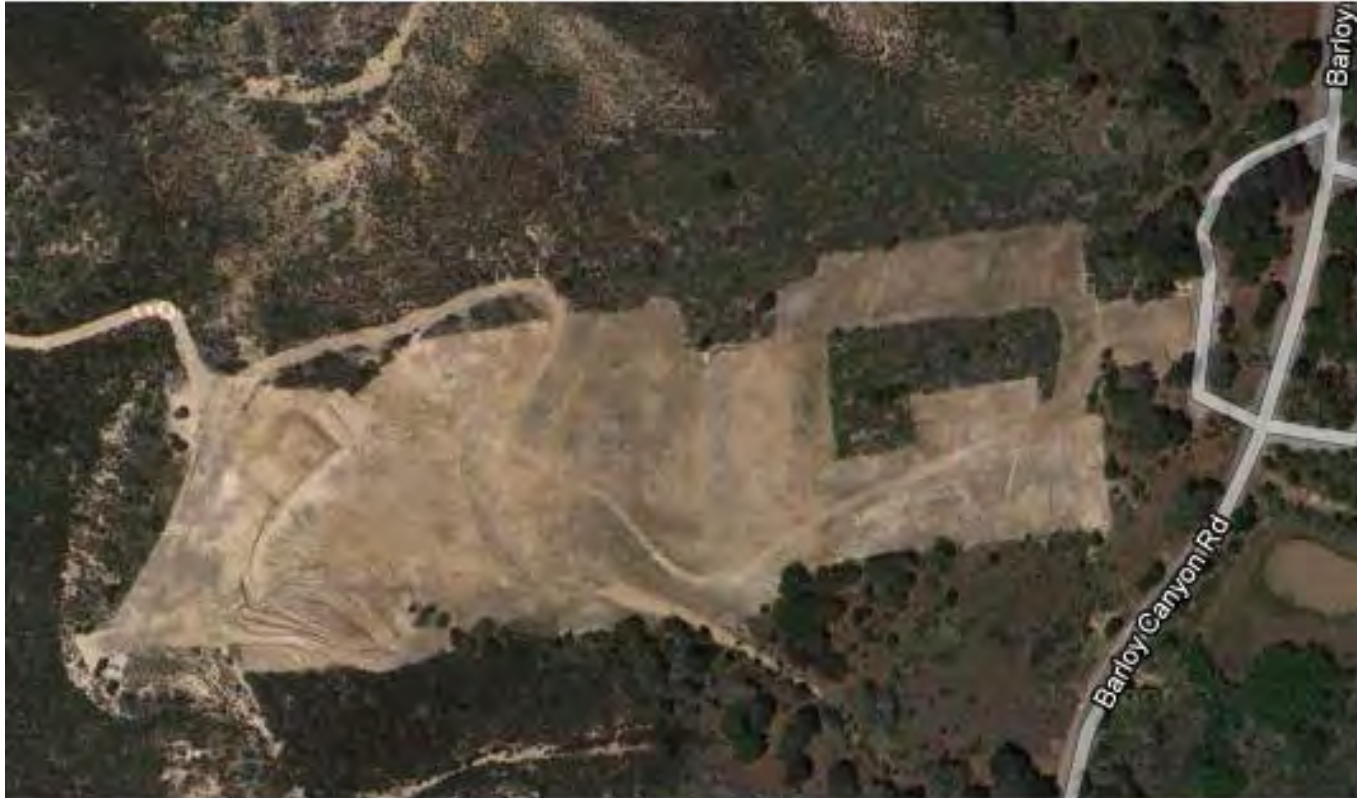
Figure 28. HA 34 restoration polygon.

- HA 34 consists of one large continuous area with no areas set aside for HMP forb broadcast (Figure 28).
- HA 34 is approximately 9.5 acres.
- The immediate area surrounding the site consists of high quality habitat; manzanita/chamise chaparral and soft sage scrub are the dominant vegetation types. There is some oak woodland/oak savanna habitat at the base and southeastern portion of the site.
- The site has been straw crimped with barley.
- The presence of invasive species is relatively minor; there is some ice plant in the middle of the site, but no pampas grass, yet. Diligence will be taken to avoid invasive species impacts.
- Very little natural recruitment observed at the site.
- The site has serious erosion potential and has already experienced a couple of large events.
- Major grading and soil removal was done to combat erosion.

- Received many erosion control repairs and hydromulch application with native seed mix provided by Burleson (Figure 29).

1. Conducted presence/absence visual survey.
2. Supplied ~ 5 acres of native seed mix and barley (Table 7) to ITSI/Gilbane/Perma Green for hydromulch application.

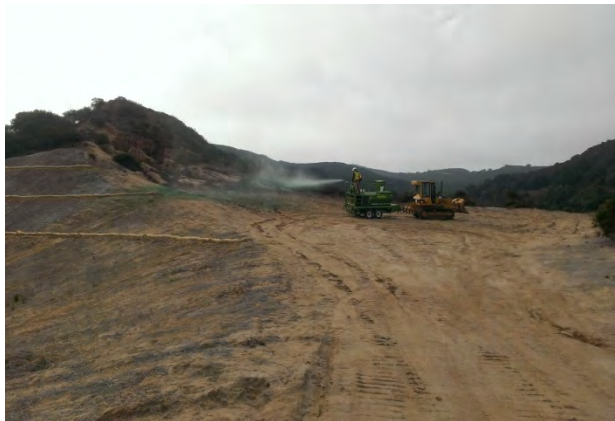
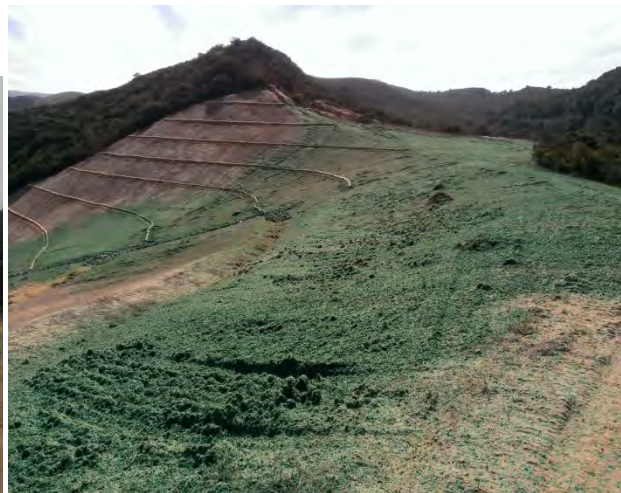
Figures 30 & 31. Hydroseeding at HA 34.

1. Assist hydroseeder in spreading native seed mix.

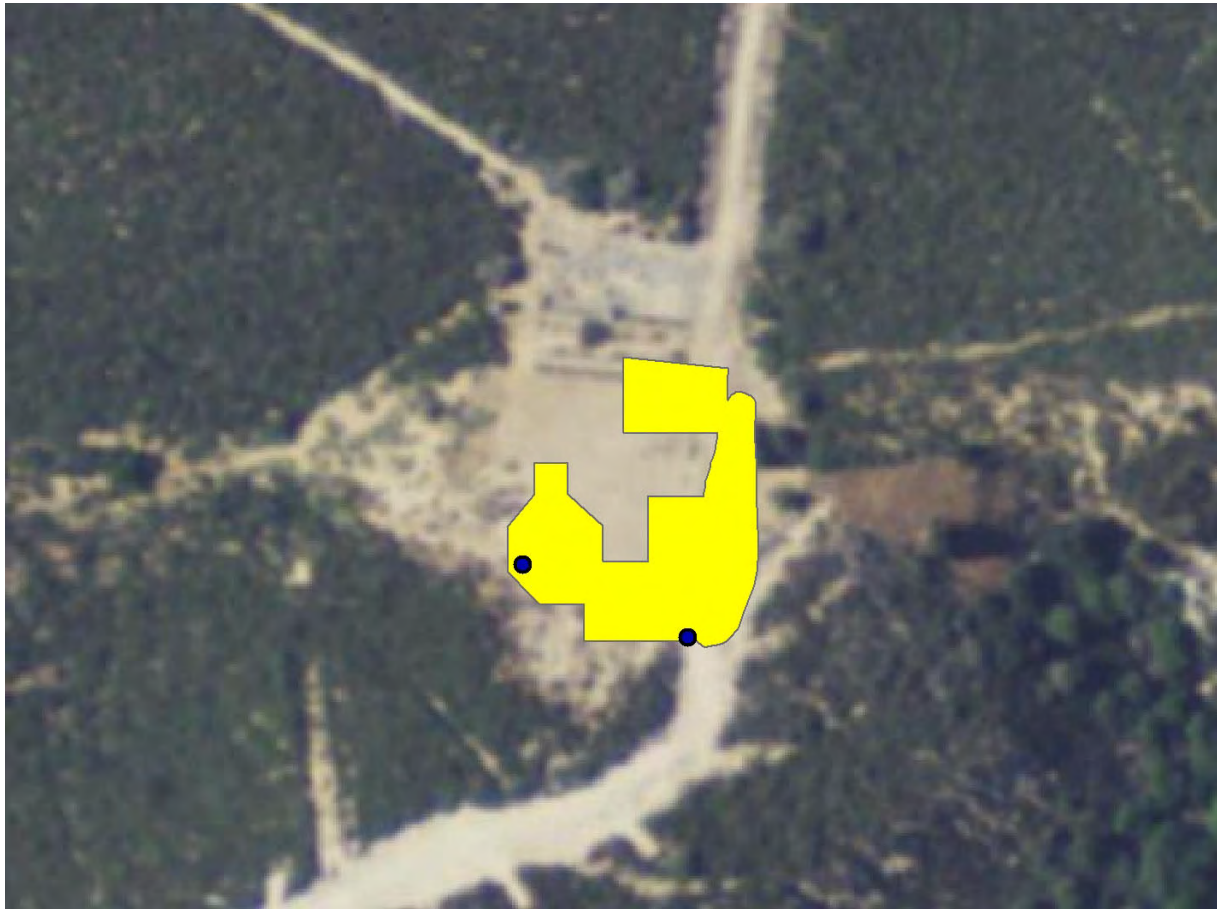
Figure 32. HA 36 restoration polygon.

- HA 36 consists of one polygon with no areas set aside for HMP forb broadcast (Figure 32).
- HA 36 is approximately 0.39 acres.
- Isolated pampas grass plants are present around the site.
- The southern edge of the site has serious erosion issues.
- The immediate area around the site is low quality, recently mowed chaparral.
- The polygon has straw crimped.
- The site is covered in bulldozer tracks and the soil is compacted.
- Very little natural recruitment observed at the site.

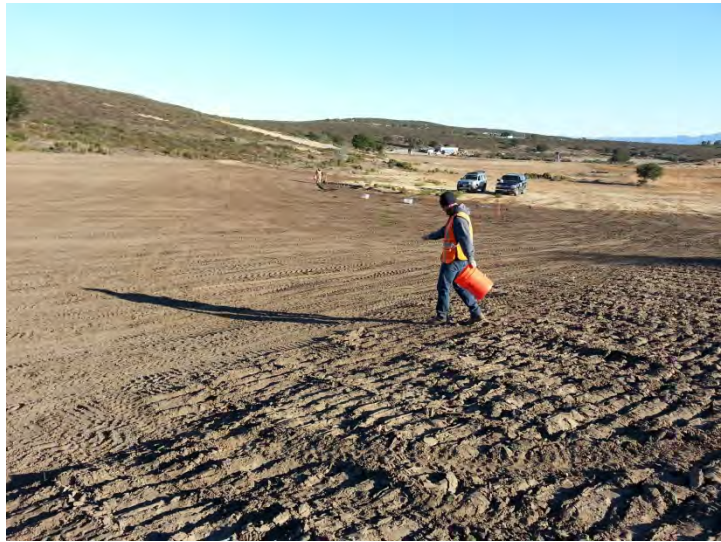
Figure 34. HA 37 seeding.

1. Broadcast seeded Elymus and Barley on about 1.5 acres near the Northern portion of the site.
2. ITSI/Gilbane water tank irrigated seeded area.

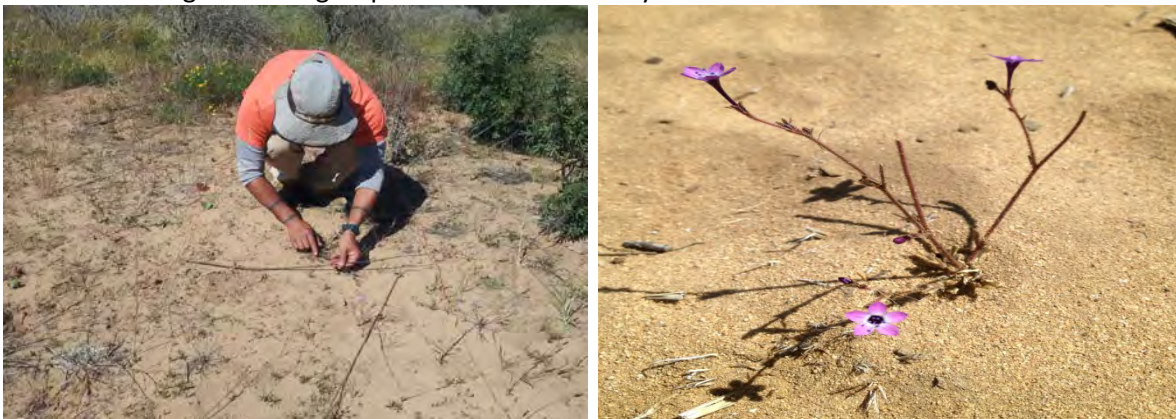
Figures 38 & 39. HA 39/40 Sand gilia density surveys.

1. Monitoring our Sand gilia plot to measure density.

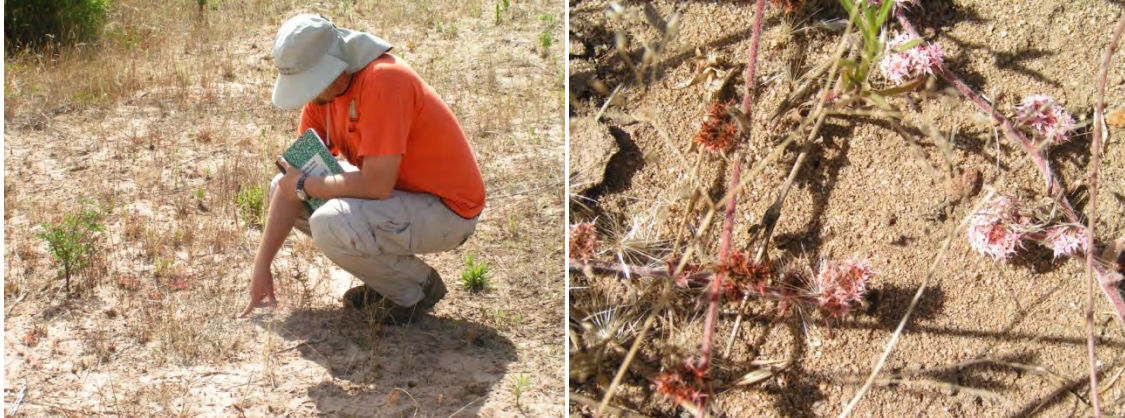
Figures 40 & 41. HA 39/40 Sand gilia density surveys.

1. Monterey Spineflower and Seaside bird's-beak density surveys.

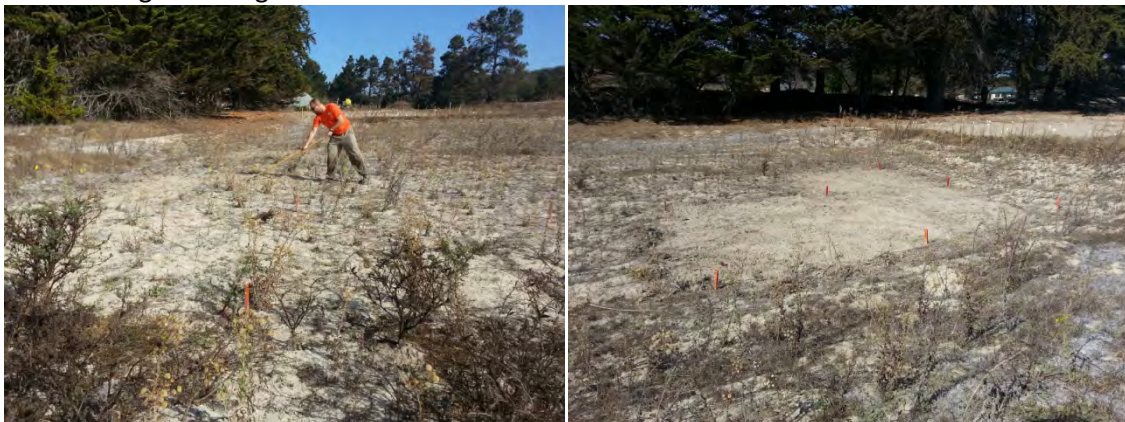
Figures 42 & 43. HA 39/40 Sand gilia plot creation.

1. Cast 9.8 g of Sand gilia seed over 2800 ft² area.

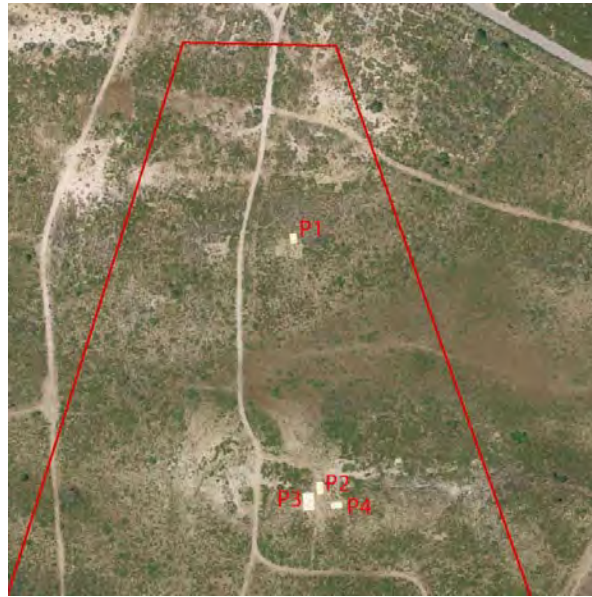
Figure 44. HA 43 restoration polygons.

- There are four polygons for HA-43: P1, P2, P3, and P4 (Figure 44).
- P1 will be divided into two areas to accommodate space for HMP forbs.
- P2 or P3 will be divided into two areas to accommodate space for HMP forbs
- P1A will be reserved for CORIL and will be placed in the north side of the polygon.
- P2A or P3A will be reserved for CHPUP and GITEA.
- The four polygons add up to 3,687.2 ft².
- Ice plant is minor issue on all polygons.
- All polygons have no erosion issues.
- All polygons are surrounded by high quality habitat.
- All polygons have straw that has been crimped.
- A modest amount of natural recruitment was observed in P2, P3, and P4.
- P1 had a strong natural recruitment for early colonizer species (HOCU, LOSC & HESC).

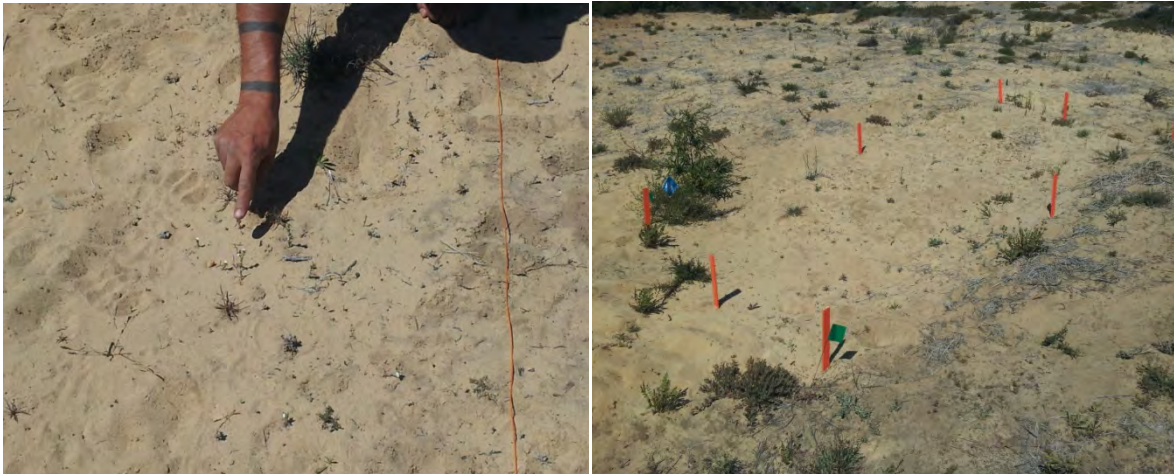
Figures 45 & 46. HA 43 Sand gilia density surveys.

1. Monitored our Sand gilia Plot.
2. Installed high visibility wood stakes around perimeter of Sand gilia plot.

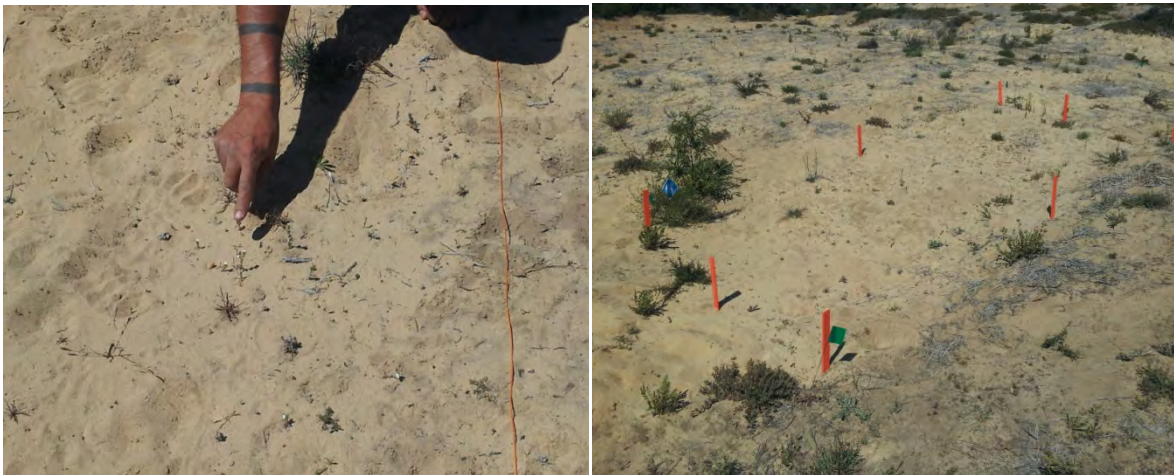
Figures 45 & 46. HA 43 Sand gilia density surveys.

1. Monitored our Sand gilia Plot.
2. Installed high vis wood stakes around perimeter of Sand gilia plot.

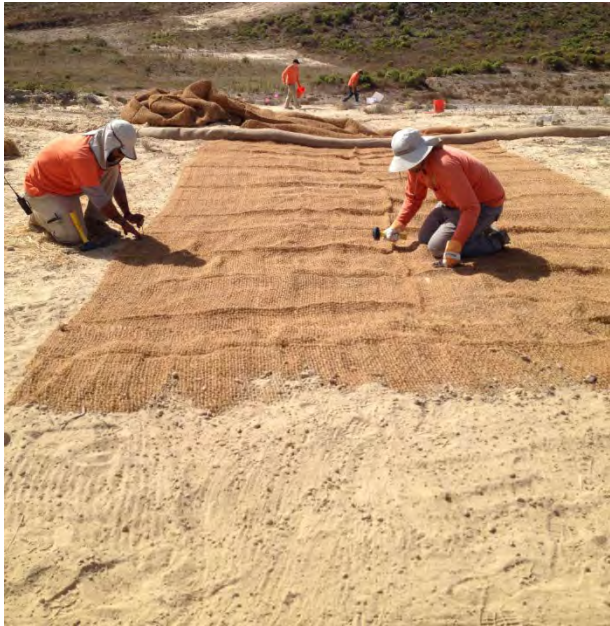
Photo Description	Photo
<p>Erosion Control Activities</p> <p>Burleson Horticultural Technicians installing coir fabric and straw wattles at HA 28 for erosion control.</p> <p style="text-align: center;">E-2</p>

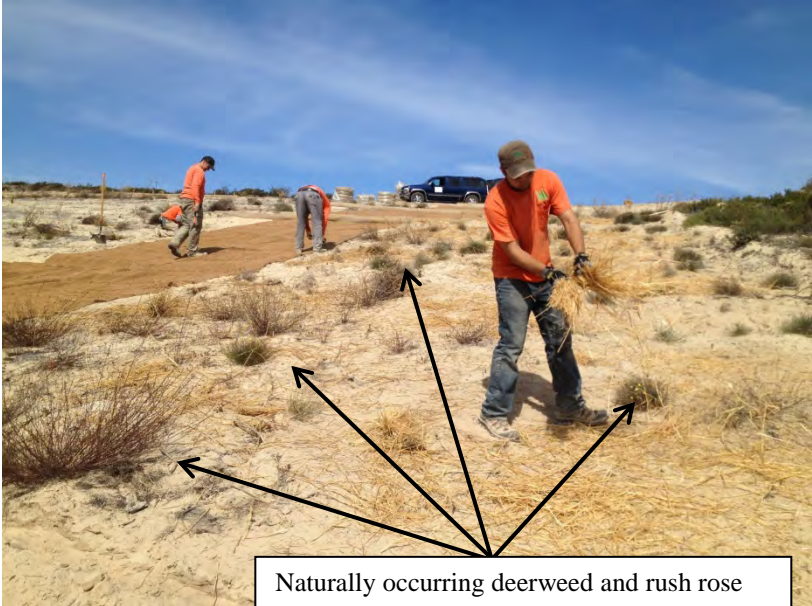
<p>Erosion Control Activities</p> <p>Burleson Horticultural Technicians broadcast straw mulch after erosion control activities were completed. Naturally recruited plant species can be seen in foreground.</p> <p style="text-align: center;">E-3</p>

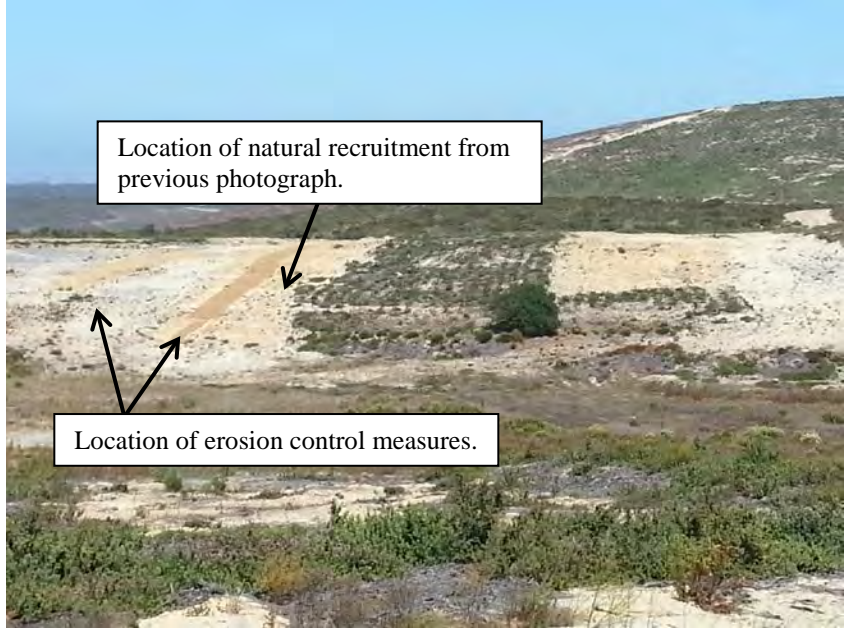
Photo Description	Photo
<p>Erosion Control Activities</p> <p>Overall view of HA 28 following erosion control activities.</p> <p style="text-align: center;">E-4</p>

<p style="text-align: center;">Location of natural recruitment from previous photograph.</p> <p style="text-align: center;">Location of erosion control measures.</p>
