**Subject:** 2015 Annual Biological Monitoring Report, Former Fort Ord, California

2015 ANNUAL BIOLOGICAL MONITORING REPORT  
FORMER FORT ORD, CALIFORNIA

WORLDWIDE ENVIRONMENTAL REMEDIATION SERVICES  
CONTRACT NO. W912DY-10-D-0024  
AND  
CONTRACT NO. W912DY-10-D-0027

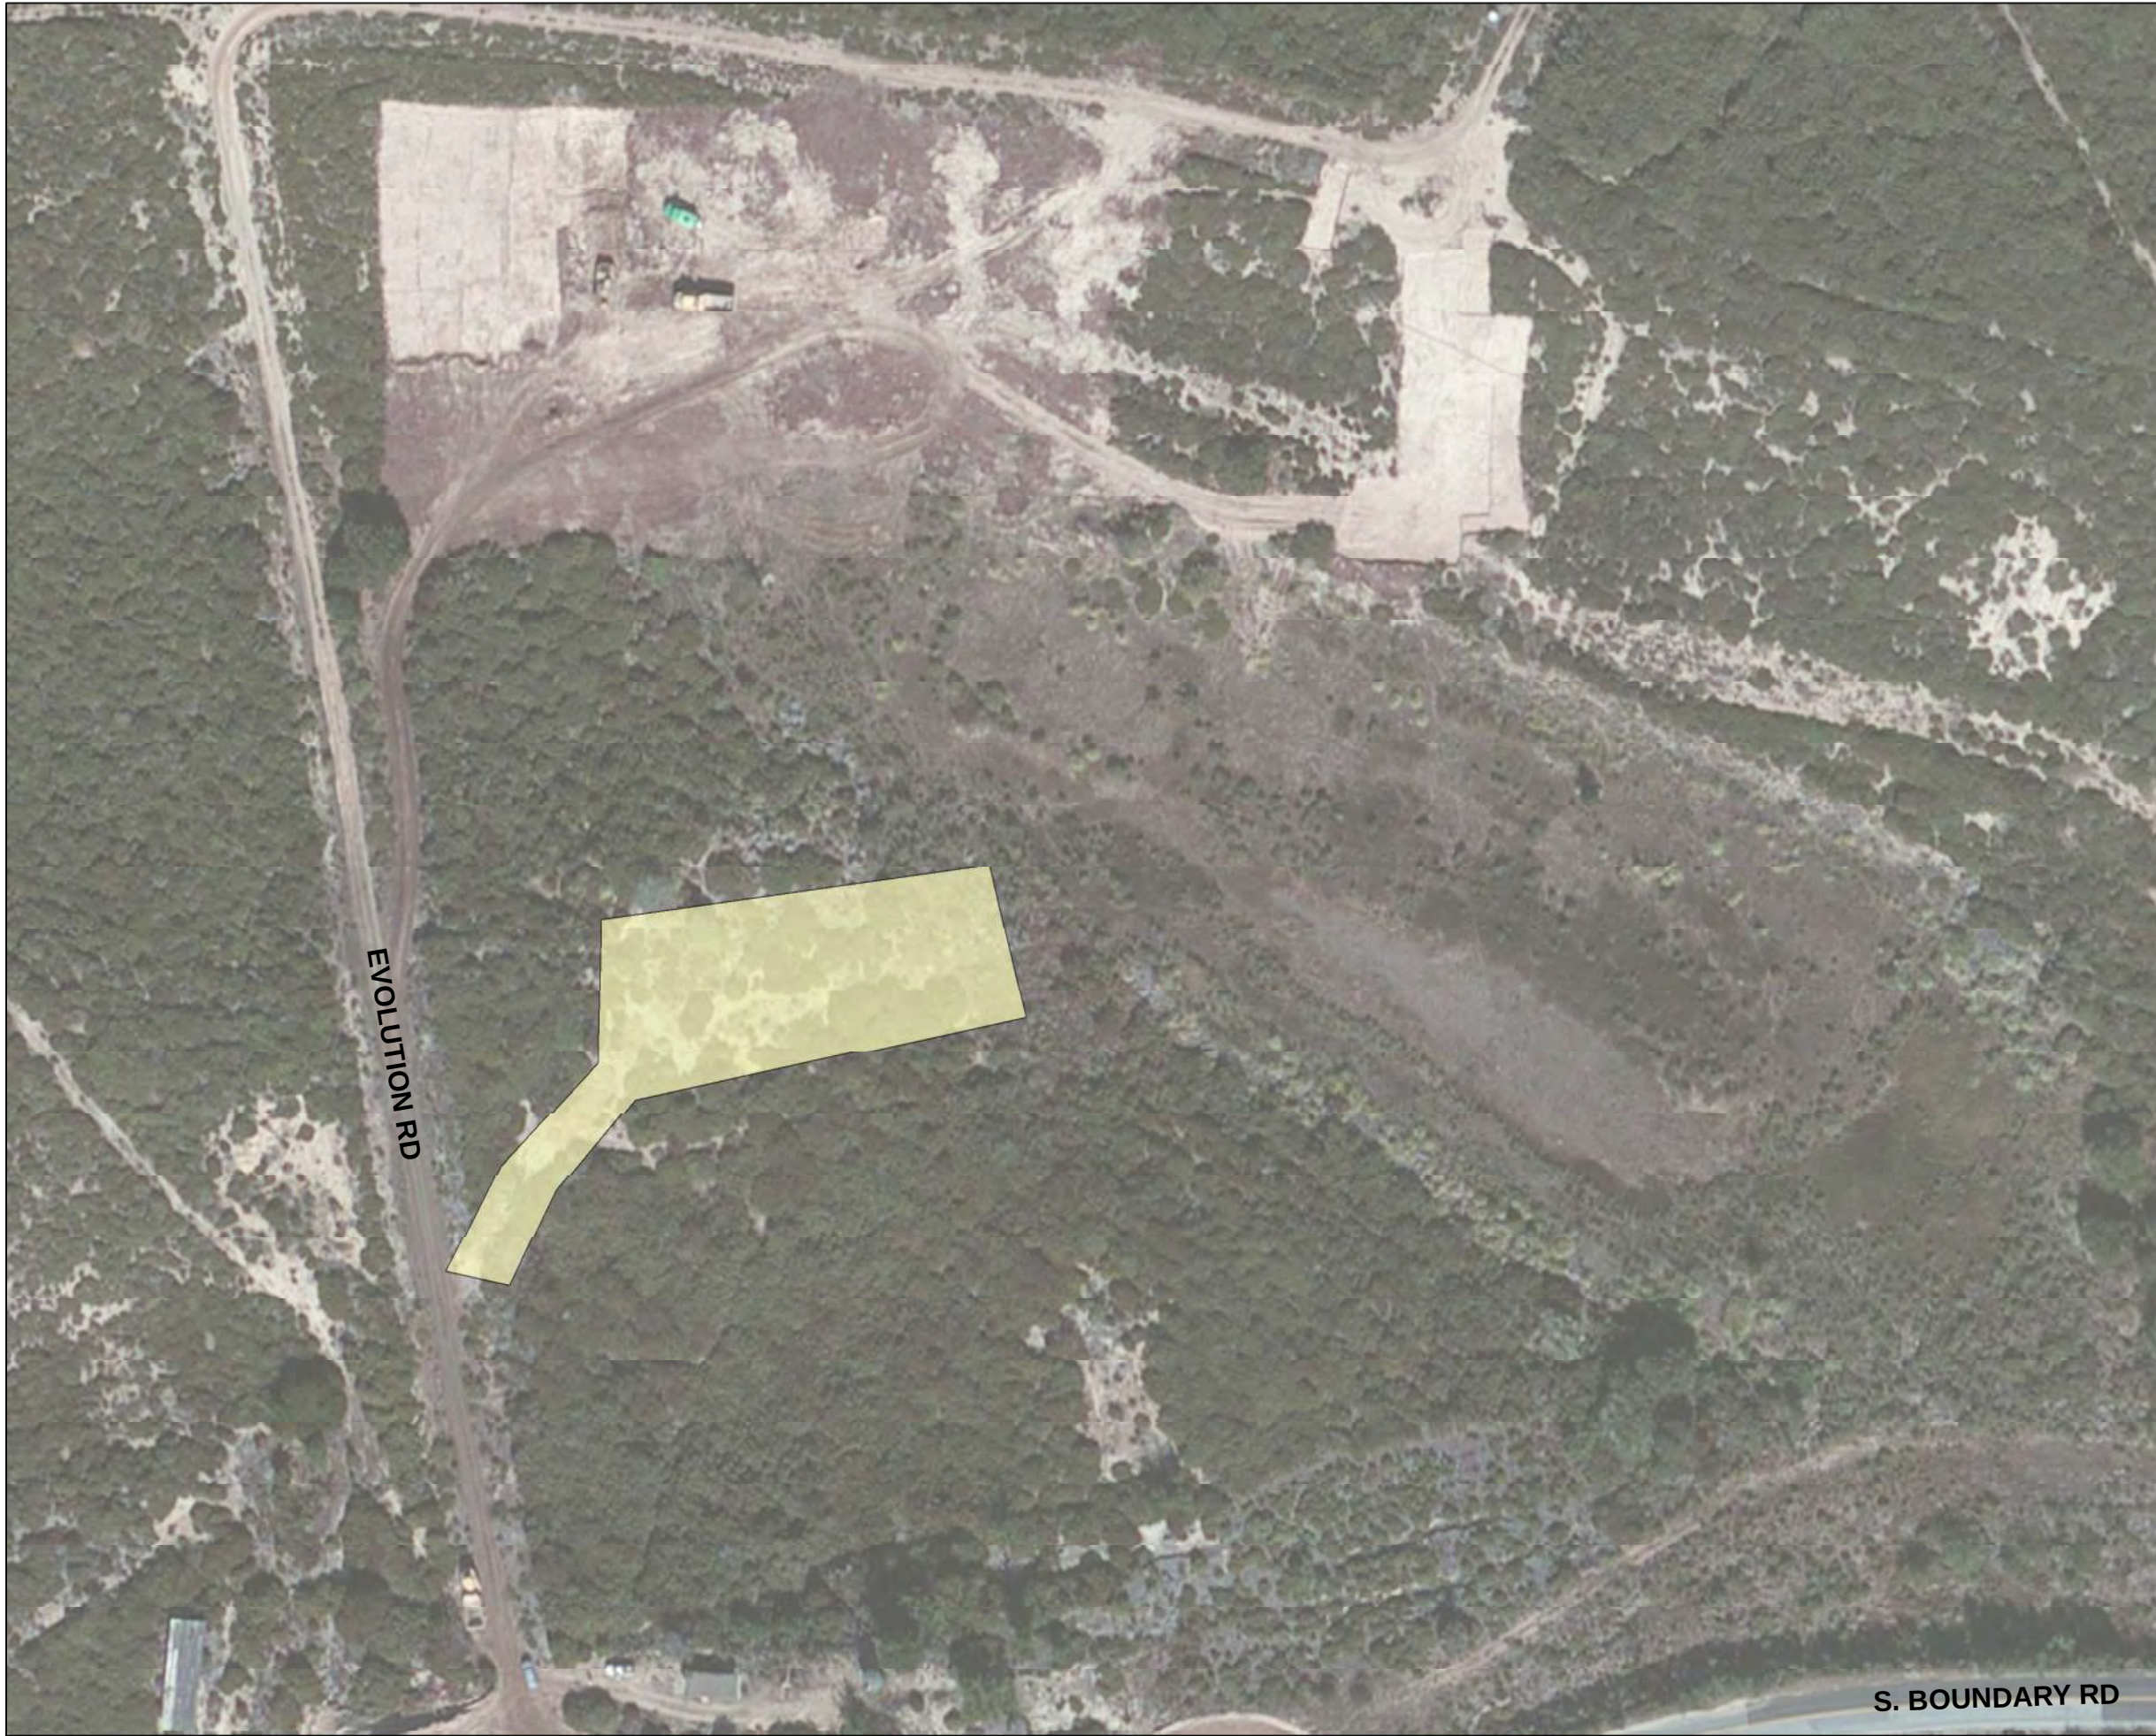
| FIGURE<br>NUMBER<br>2-4 | Biological Annual Report 2015<br>Erosion Repair Area Within HA 28 | |

Erosion Repair Areas

- Erosion problems were treated by a combination of light grading, woven coir fabric, straw wattles, sterile barley seed, and native plant seed. Additionally, 2015 was the first year that the Army utilized mulch for erosion control, which was obtained from

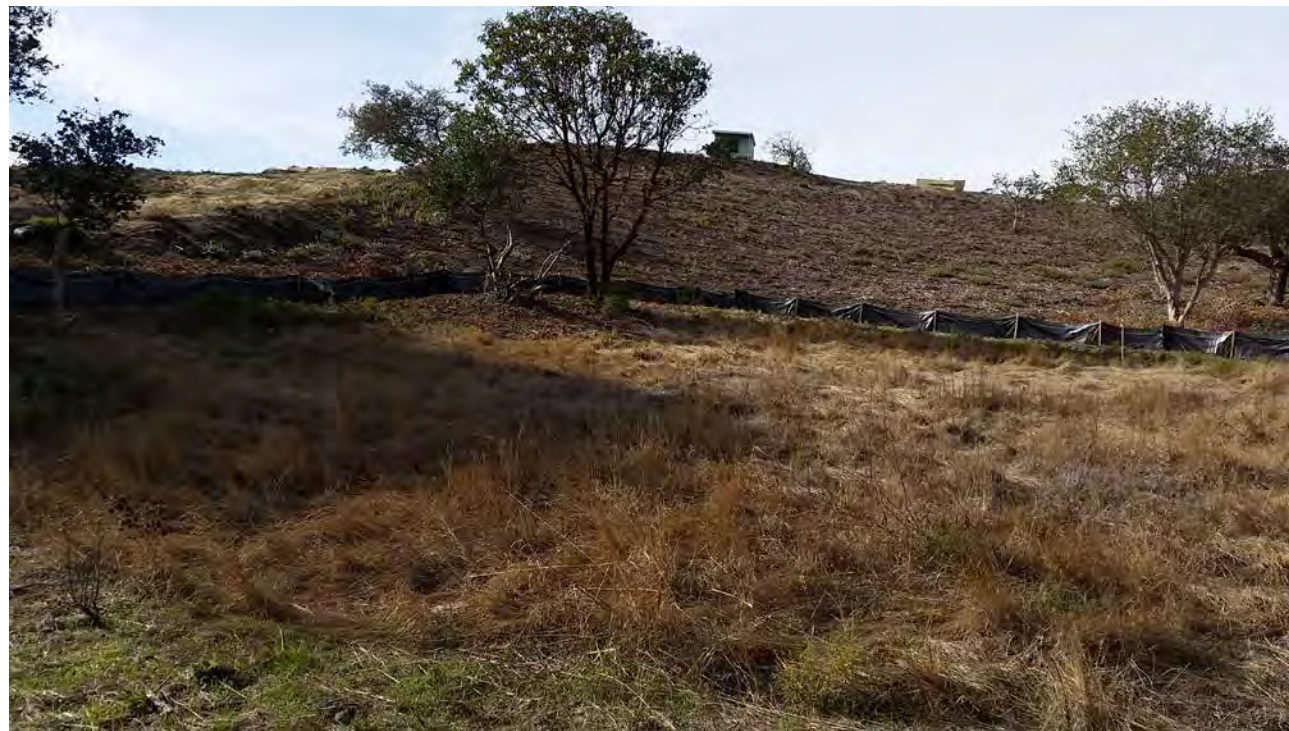
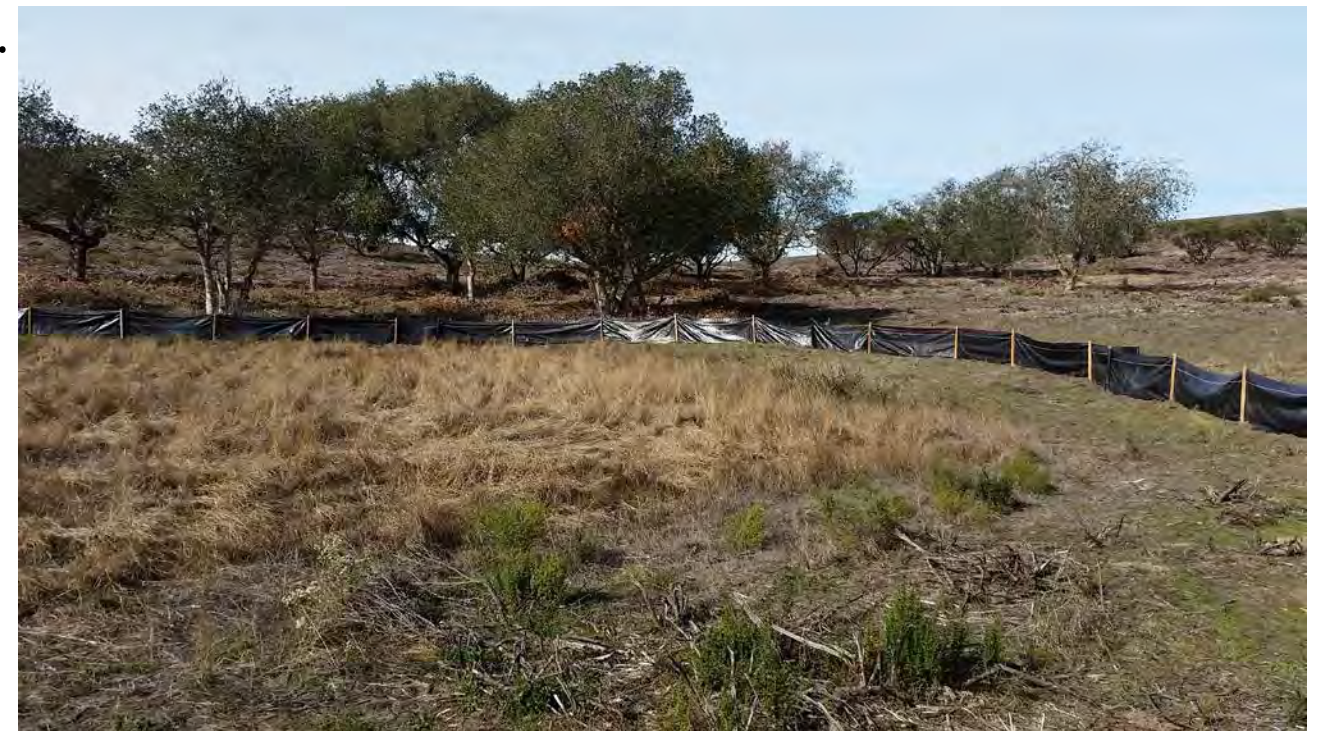
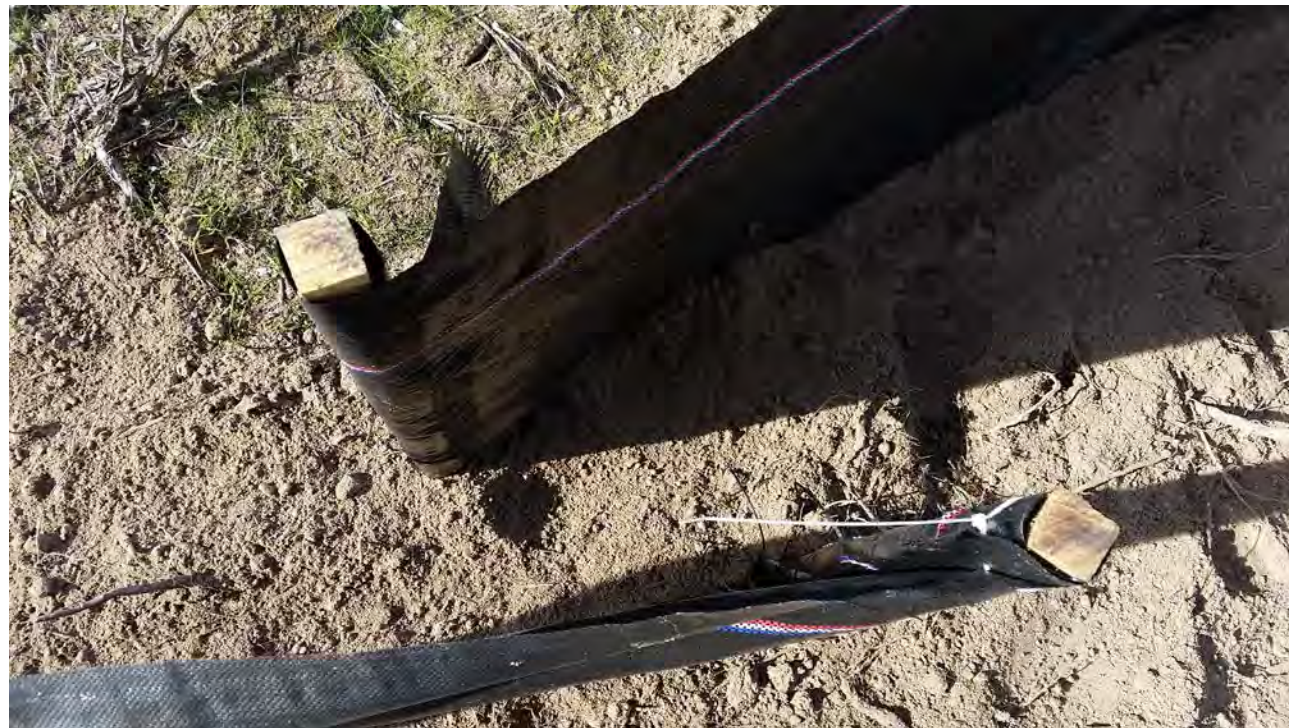
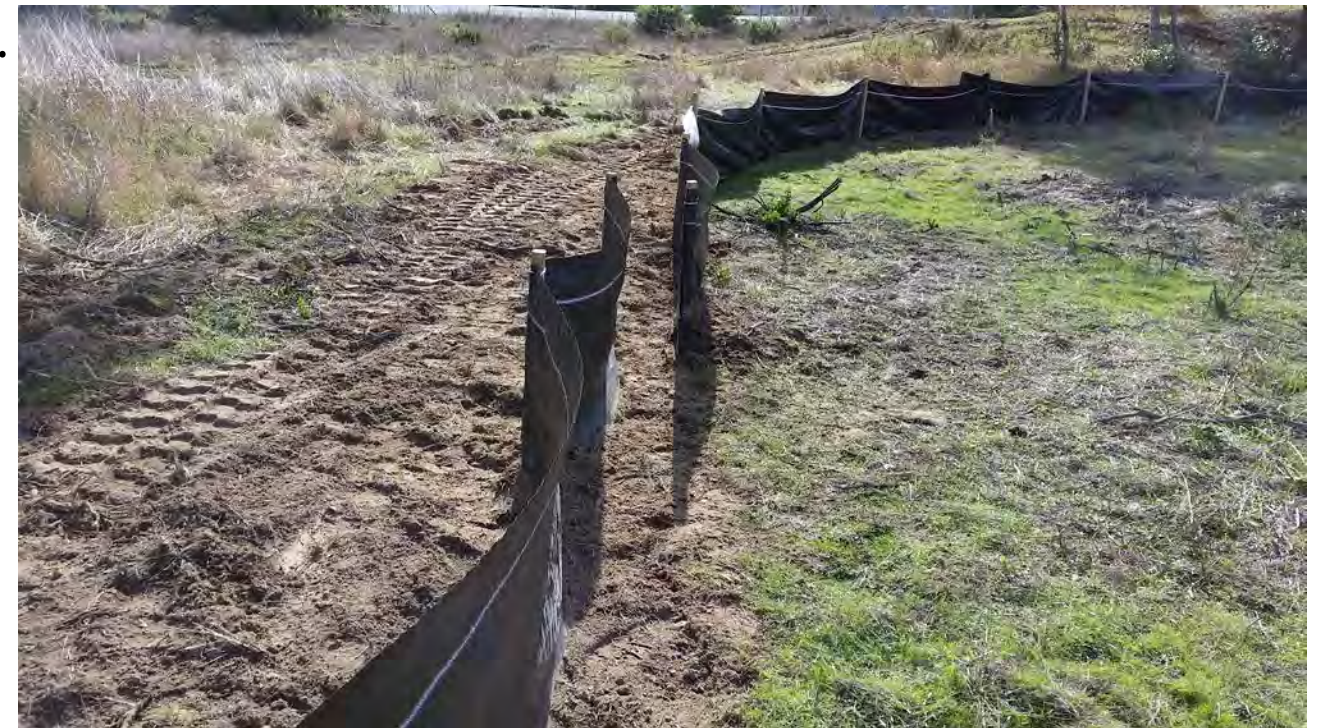
1. Silt fence looking northwest
2. Silt fence looking northeast
3. Gap between silt fence lengths
4. Gaps between silt fence lengths

fuelbreaks on steep slopes, water bars and straw mulch were installed to reduce erosion. Silt fencing was installed surrounding Pond 18 (outside of the wetland area) due to potential erosion concerns resulting from use of the adjacent access route and mastication of Unit 5a. Silt fence sections were 50 feet long and were installed in a manner that would not preclude use of the pond by CTS and other wildlife. The end of each fence length overlapped by approximately one-foot and a gap was left between the overlapping fence lengths to allow wildlife passage. Please refer to [Figure 3-3](#) for photographs of the silt fence installation at Pond 18.

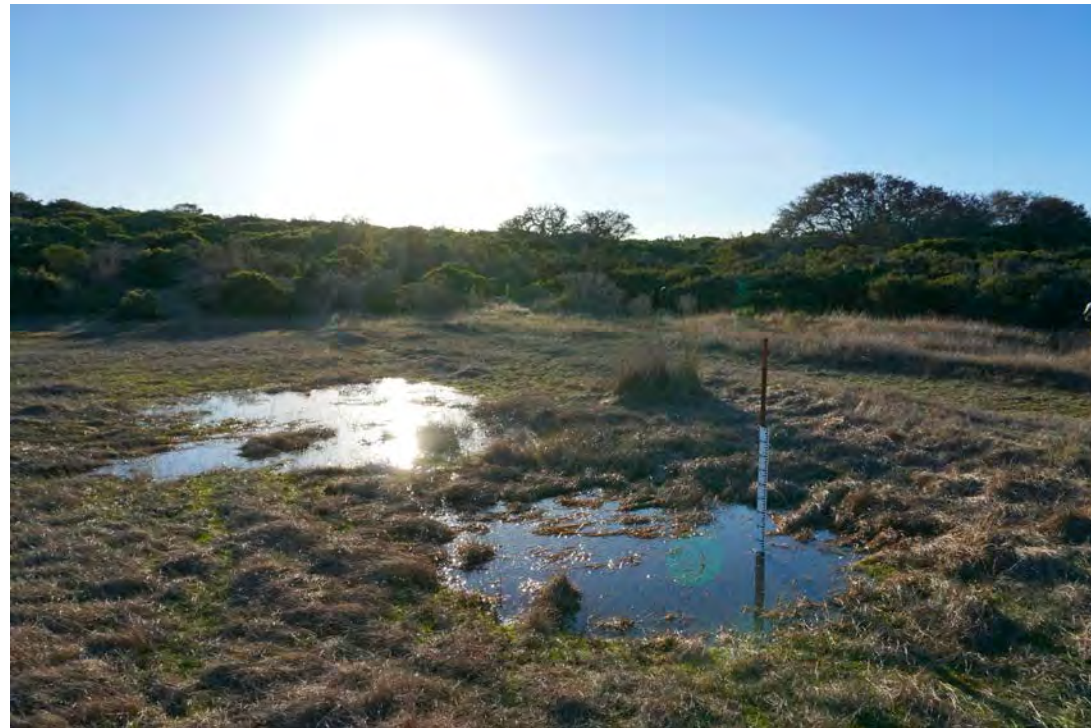
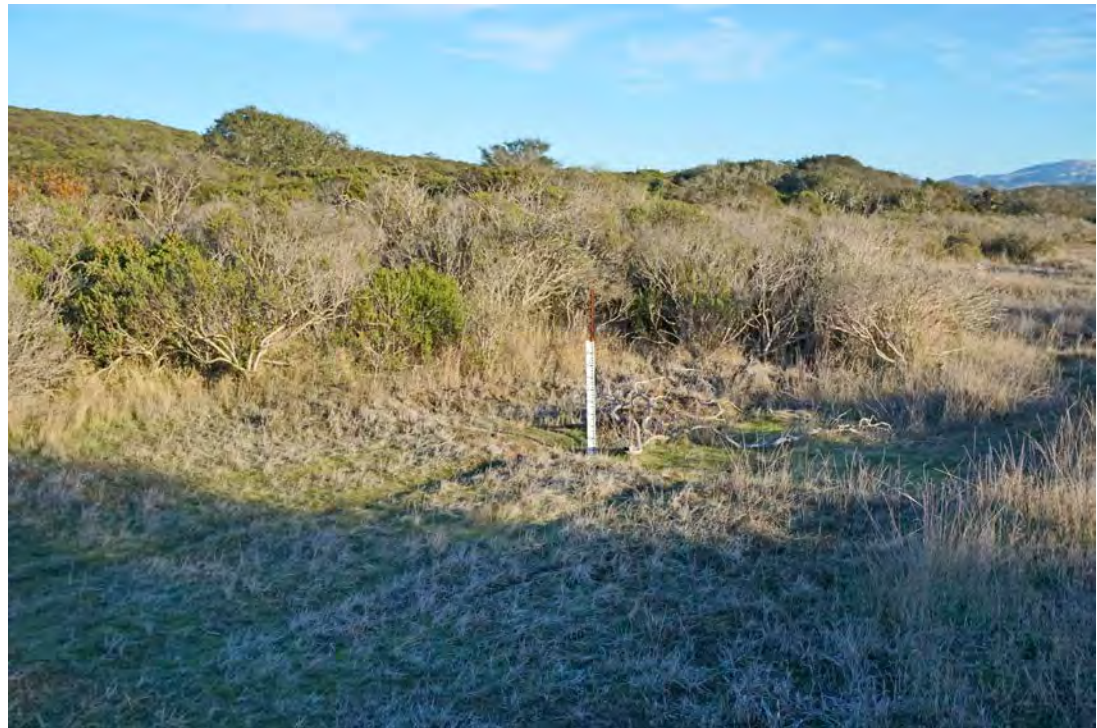
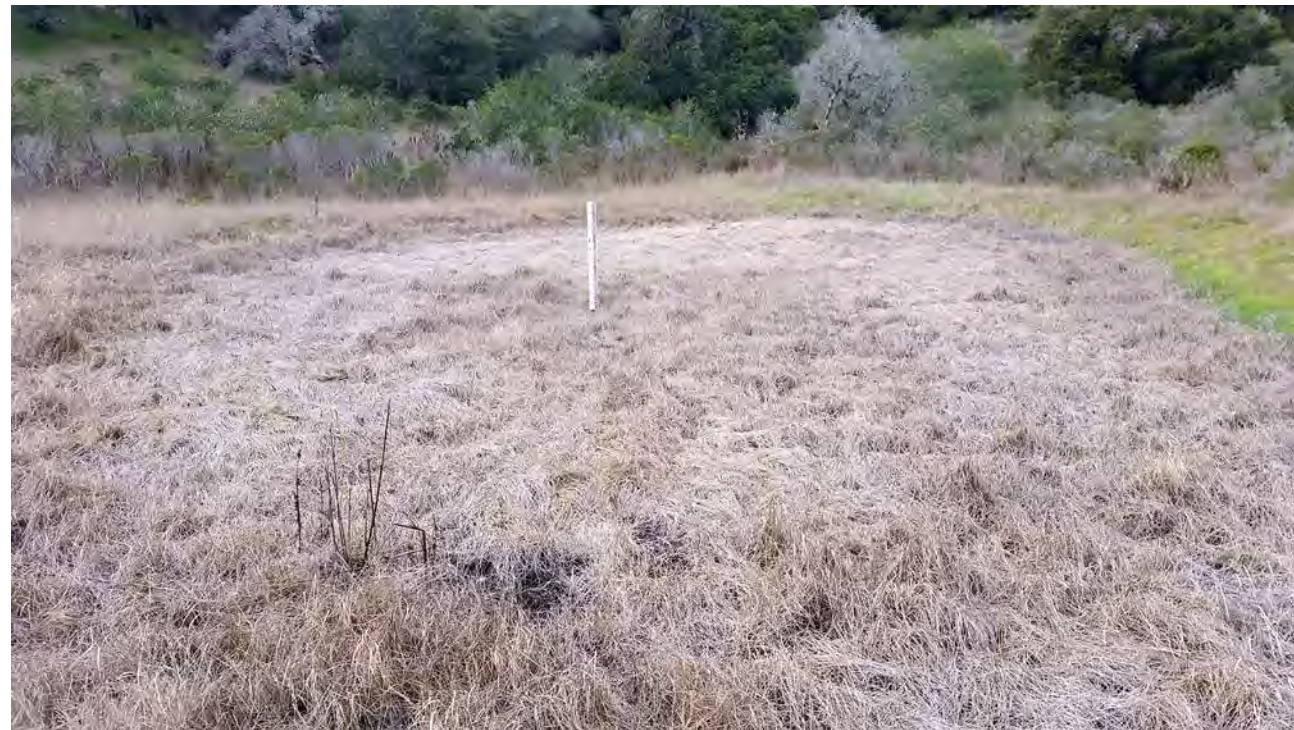
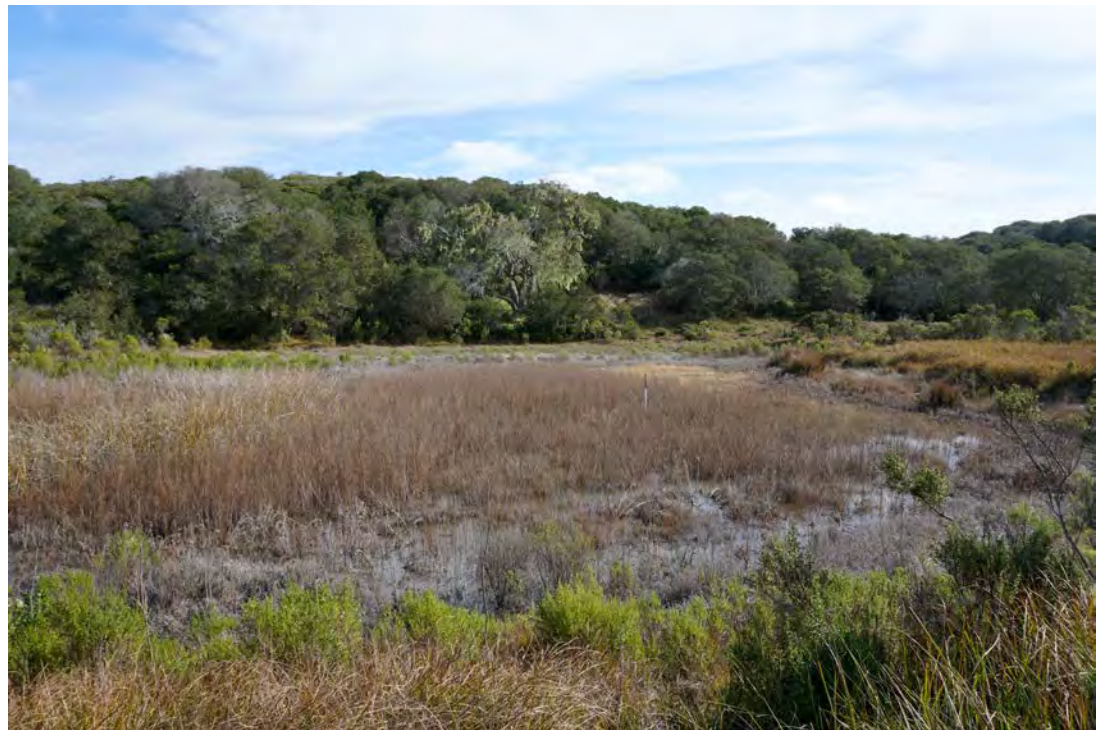
1. Pond 3N (Photo Date 12/16/15)
2. Pond 3S (Photo Date 12/16/15)
3. Pond 14 (Photo Date 12/21/15)
4. Pond 16 (Photo Date 1/14/16)

During 2015, KEMRON supported the Army's biological monitoring efforts by installing staff gauges in 18 ponds on the former Fort Ord ([Figures 3-4](#) and [3-5](#)). Thirteen of the ponds are located on Army property and the remaining five of the ponds are located on Bureau of Land Management (BLM) property<sup>1</sup>. Staff gauges were installed at the lowest point within each pond using a laser level, with the exception of four ponds where the lowest point was inaccessible due to overgrown vegetation (willows) or significant inundation. Each installation location was evaluated by an Unexploded Ordnance (UXO) technician to identify potential subsurface MEC and ensure that the staff gauges could be installed safely. [Table 3-1](#) is a summary of the staff gauge installation at each pond. Please refer to [Figure 3-5](#) for photographs of the staff gauges.

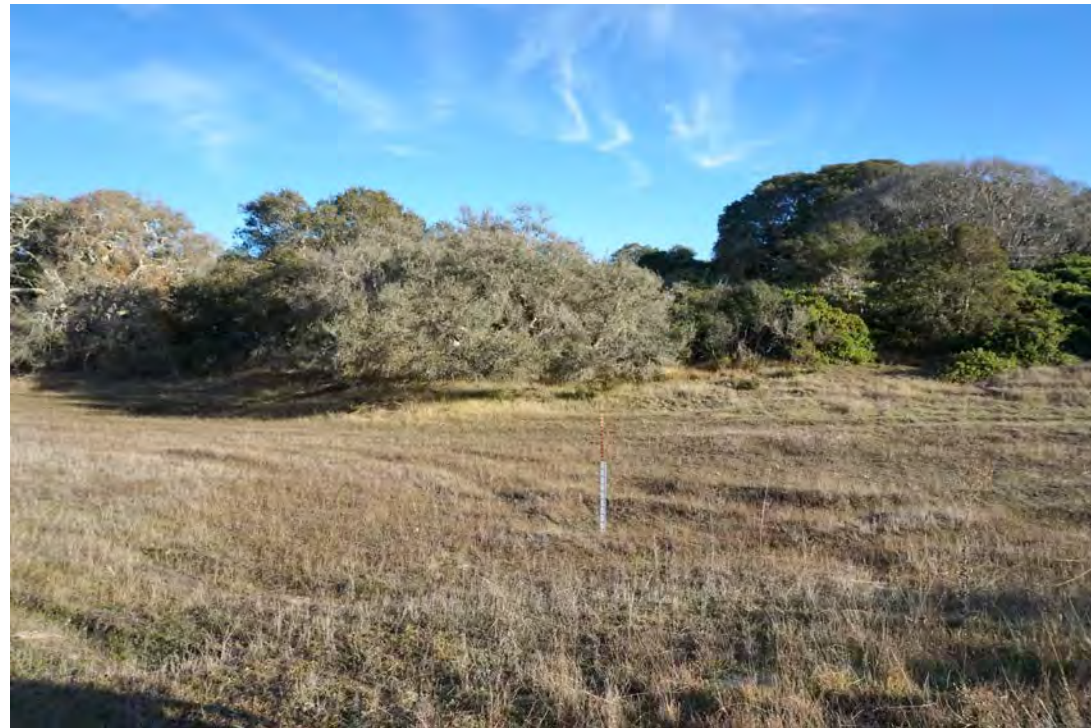
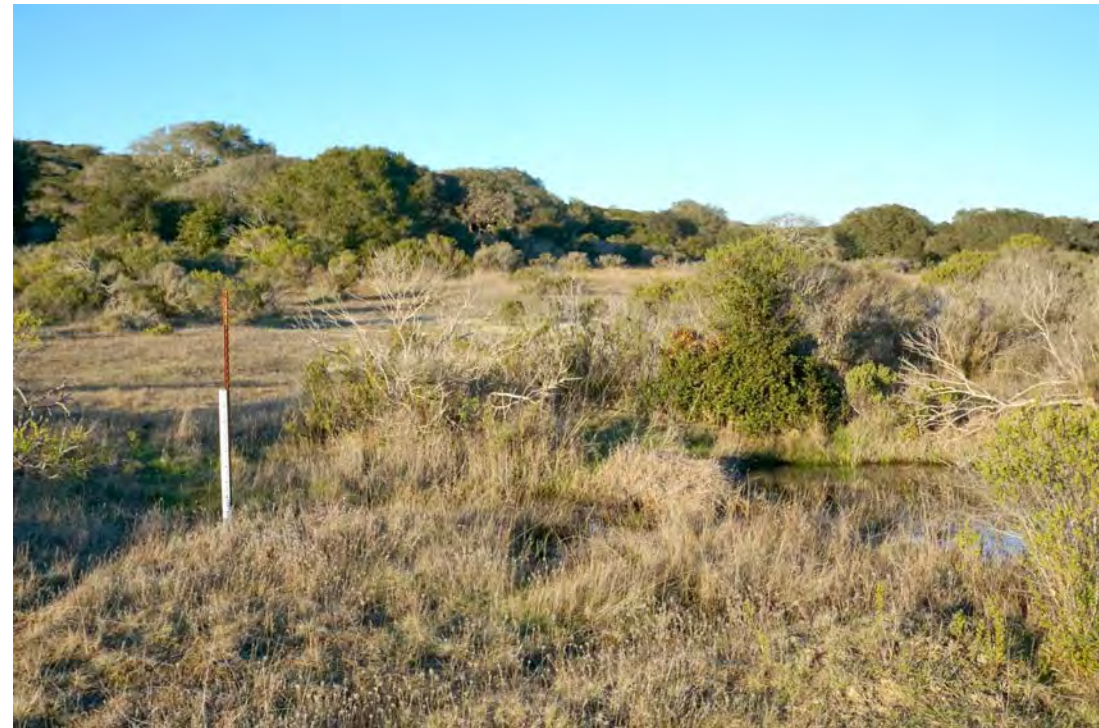
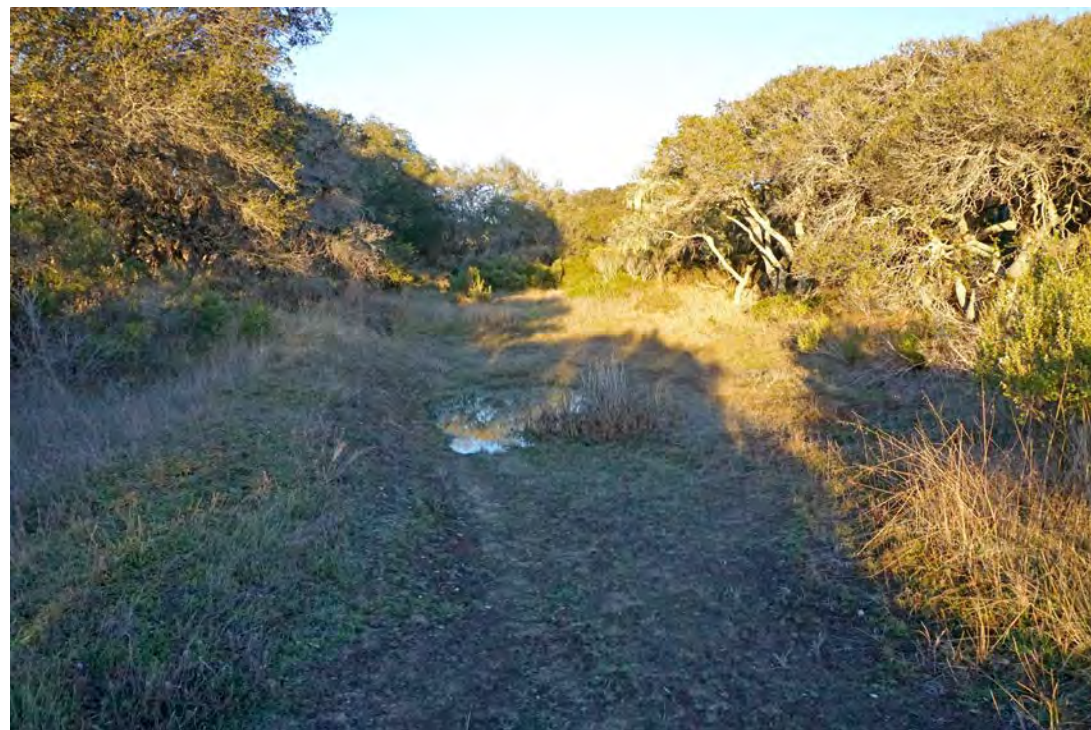
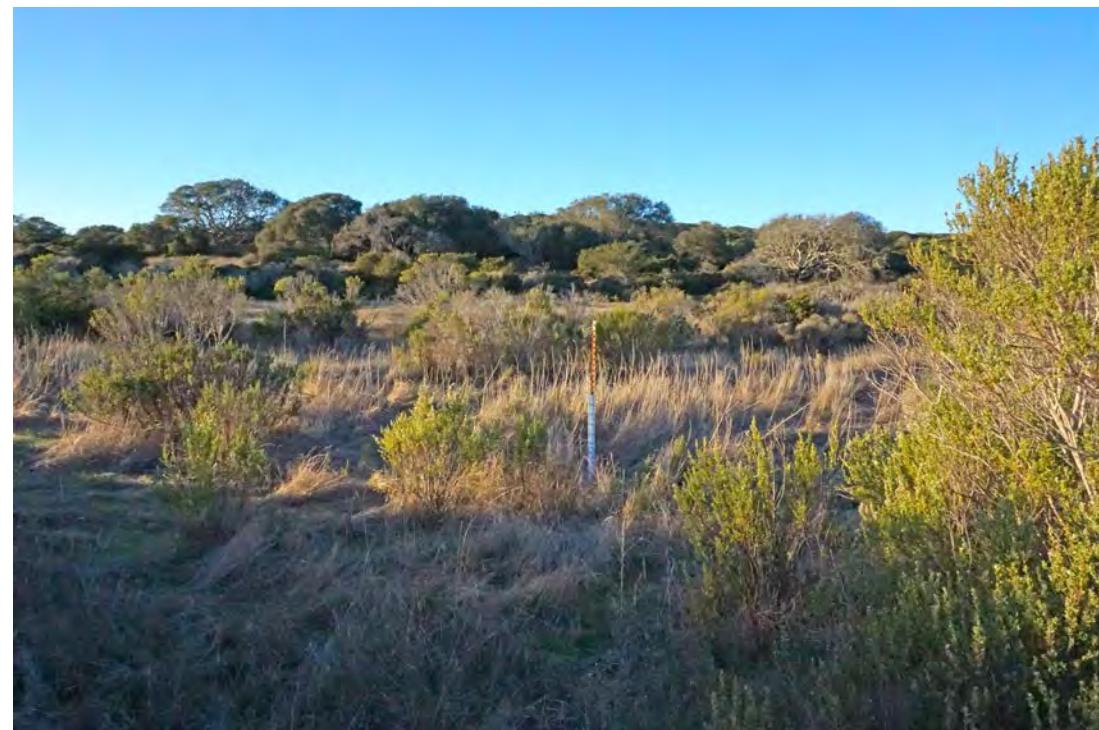
- 1. Pond 35(Photo Date 12/16/15)
- 2. Pond 39 (Photo Date 12/16/15)
- 3. Pond 40N (Photo Date 12/16/15)
- 4. Pond 40S (Photo Date 12/16/15)

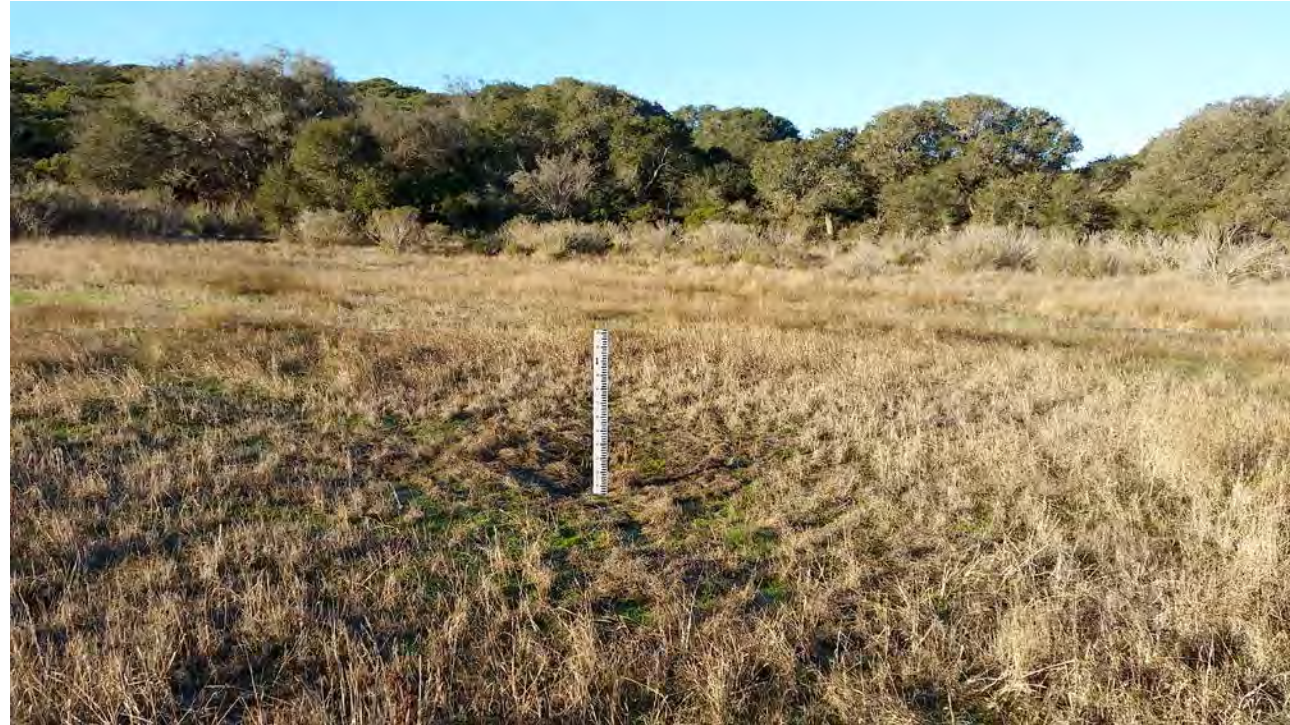
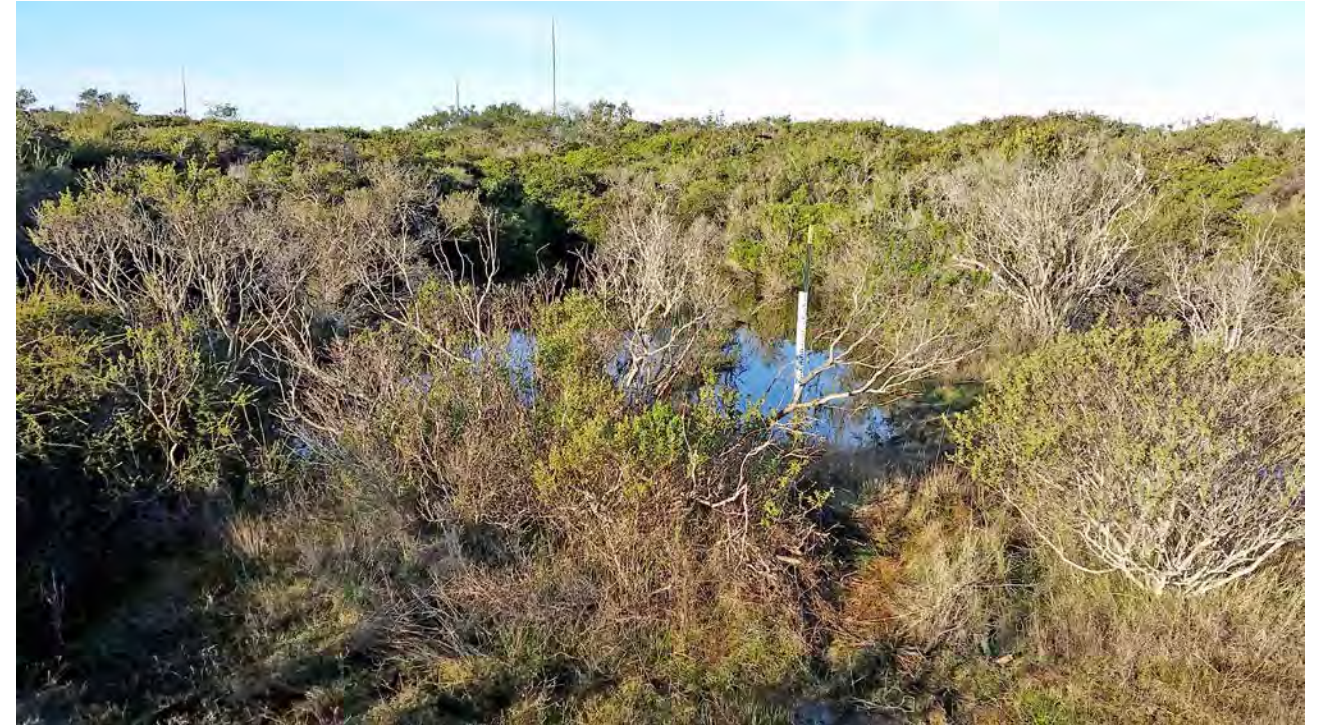
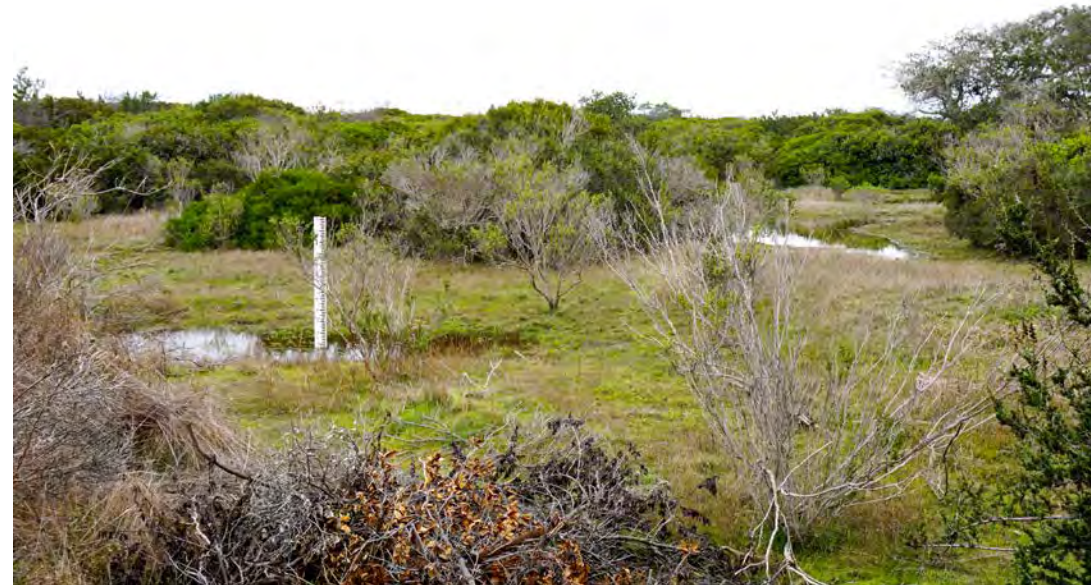
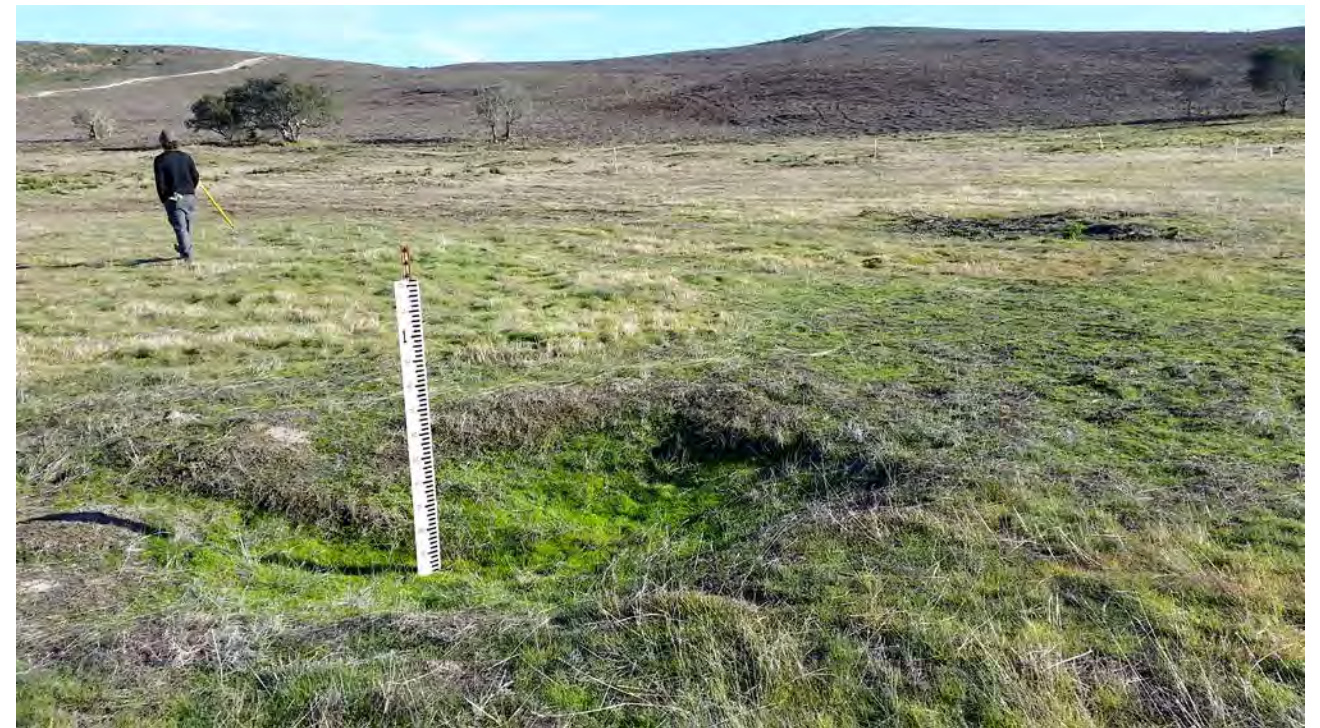
1. Pond 41(Photo Date 12/17/15)
2. Pond 43 (Photo Date 1/12/16)
3. Pond 44 (Photo Date 1/14/16)
4. Pond 54 (Photo Date 12/17/15)

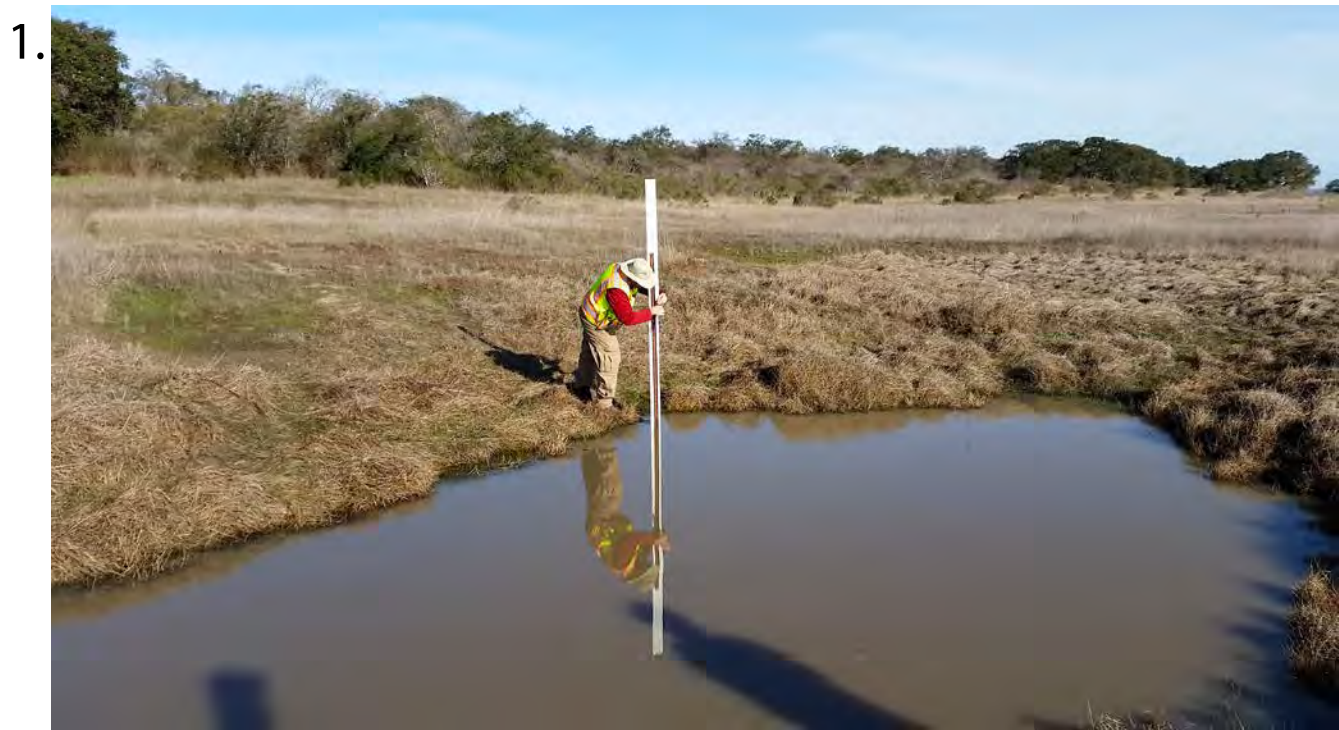
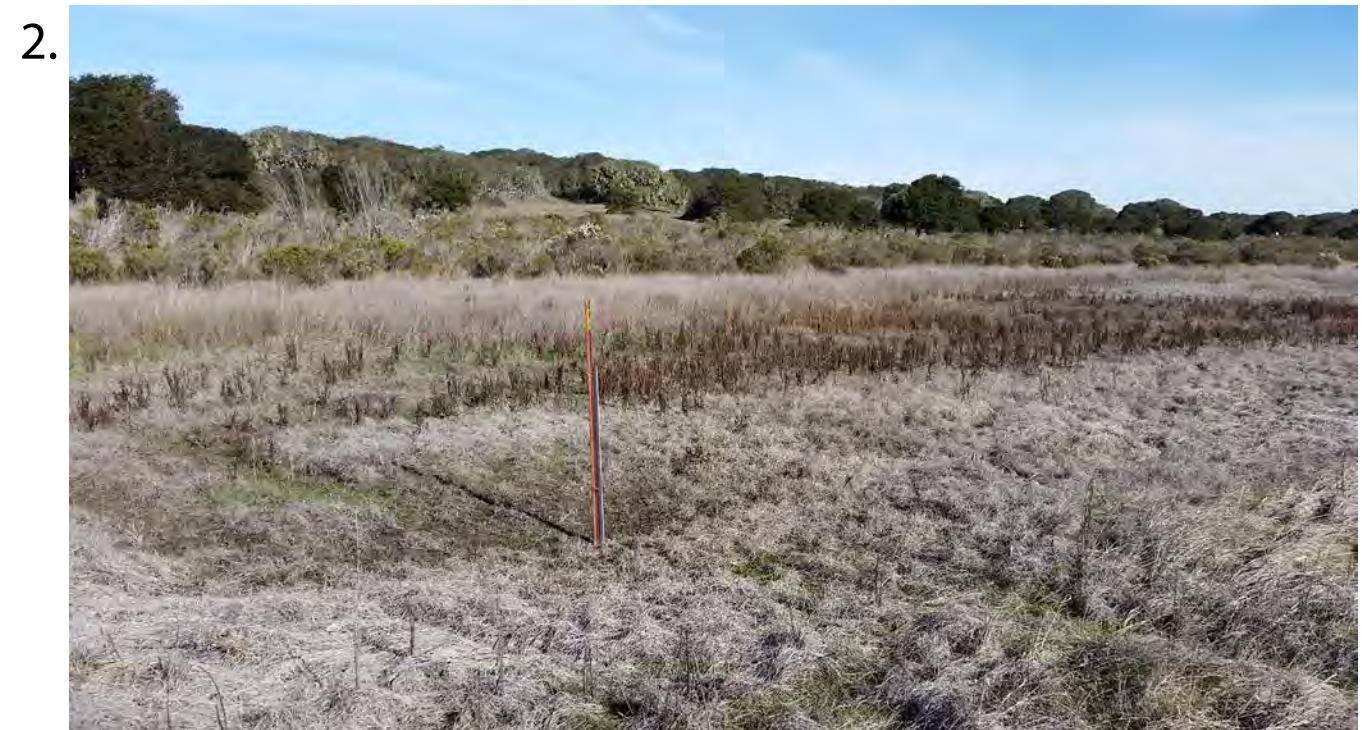
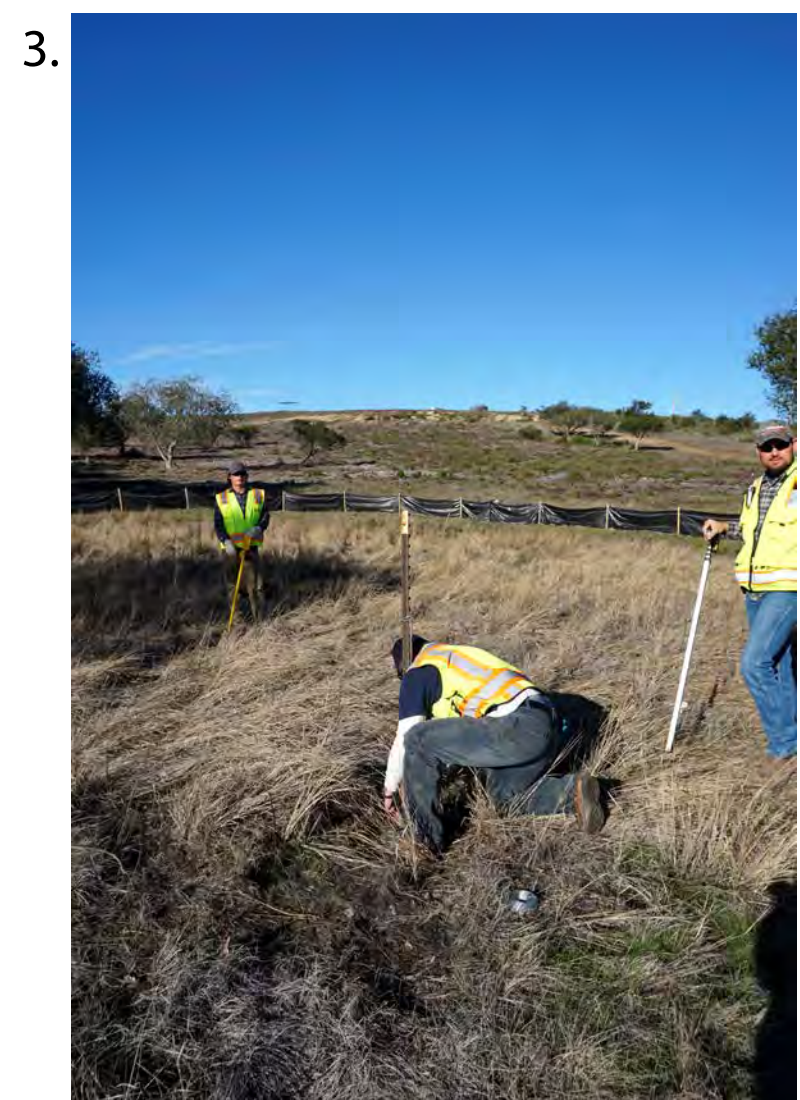
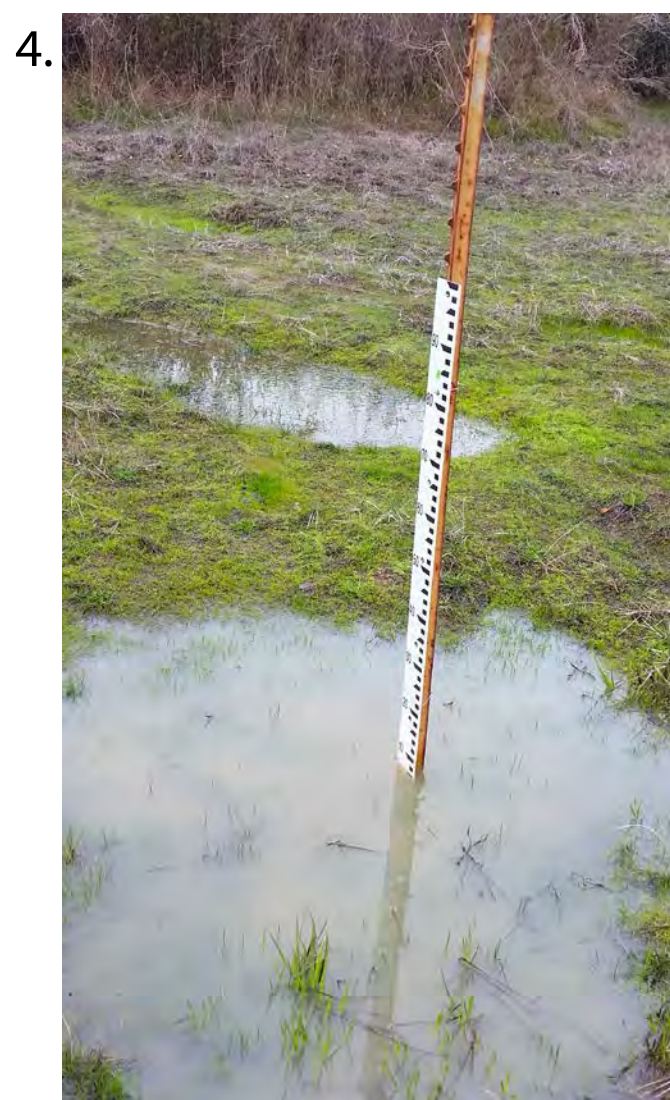
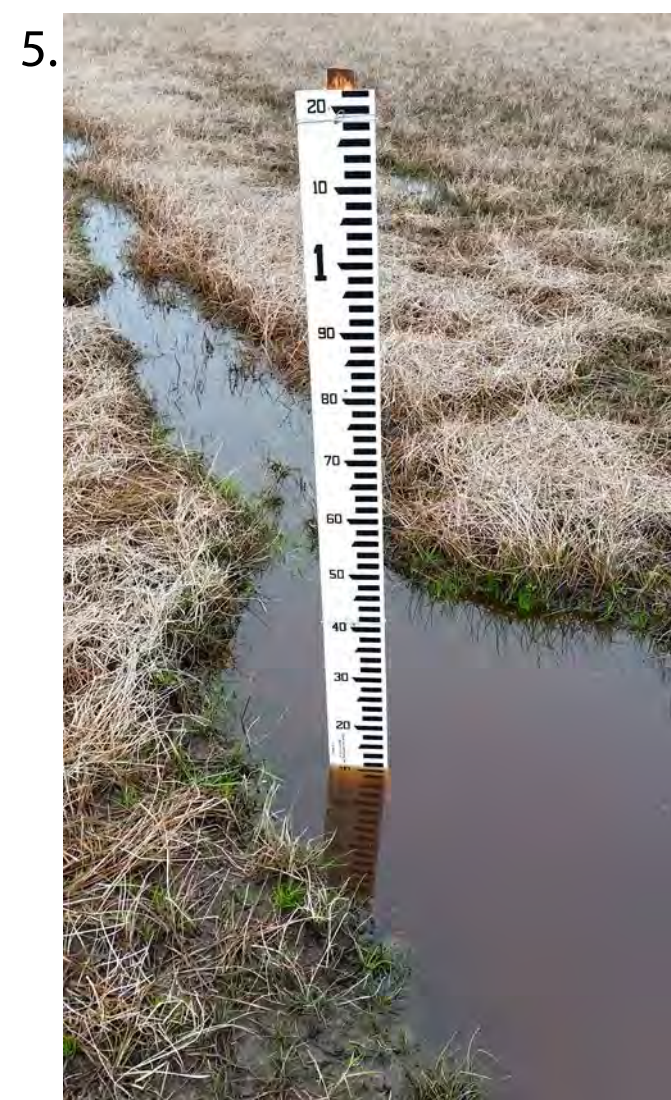
- 1. Machine Gun Flats (Photo Date 12/17/15)
- 2. Pond 101W (Photo Date 12/17/15)
- 3. Pond 18 (Photo Date 12/16/15)
- 4. Pond 42 (Photo Date 12/21/15)
- 5. Pond 60 (Photo Date 12/21/15)
