2016 ANNUAL BIOLOGICAL MONITORING REPORT
FORMER FORT ORD, CALIFORNIA

WORLDWIDE ENVIRONMENTAL REMEDIATION SERVICES
CONTRACT NO. W912DY-10-D-0027

Denise Duffy & Associates, Inc.
947 Cass Street, Suite 5
Monterey, California 93940

April 2017

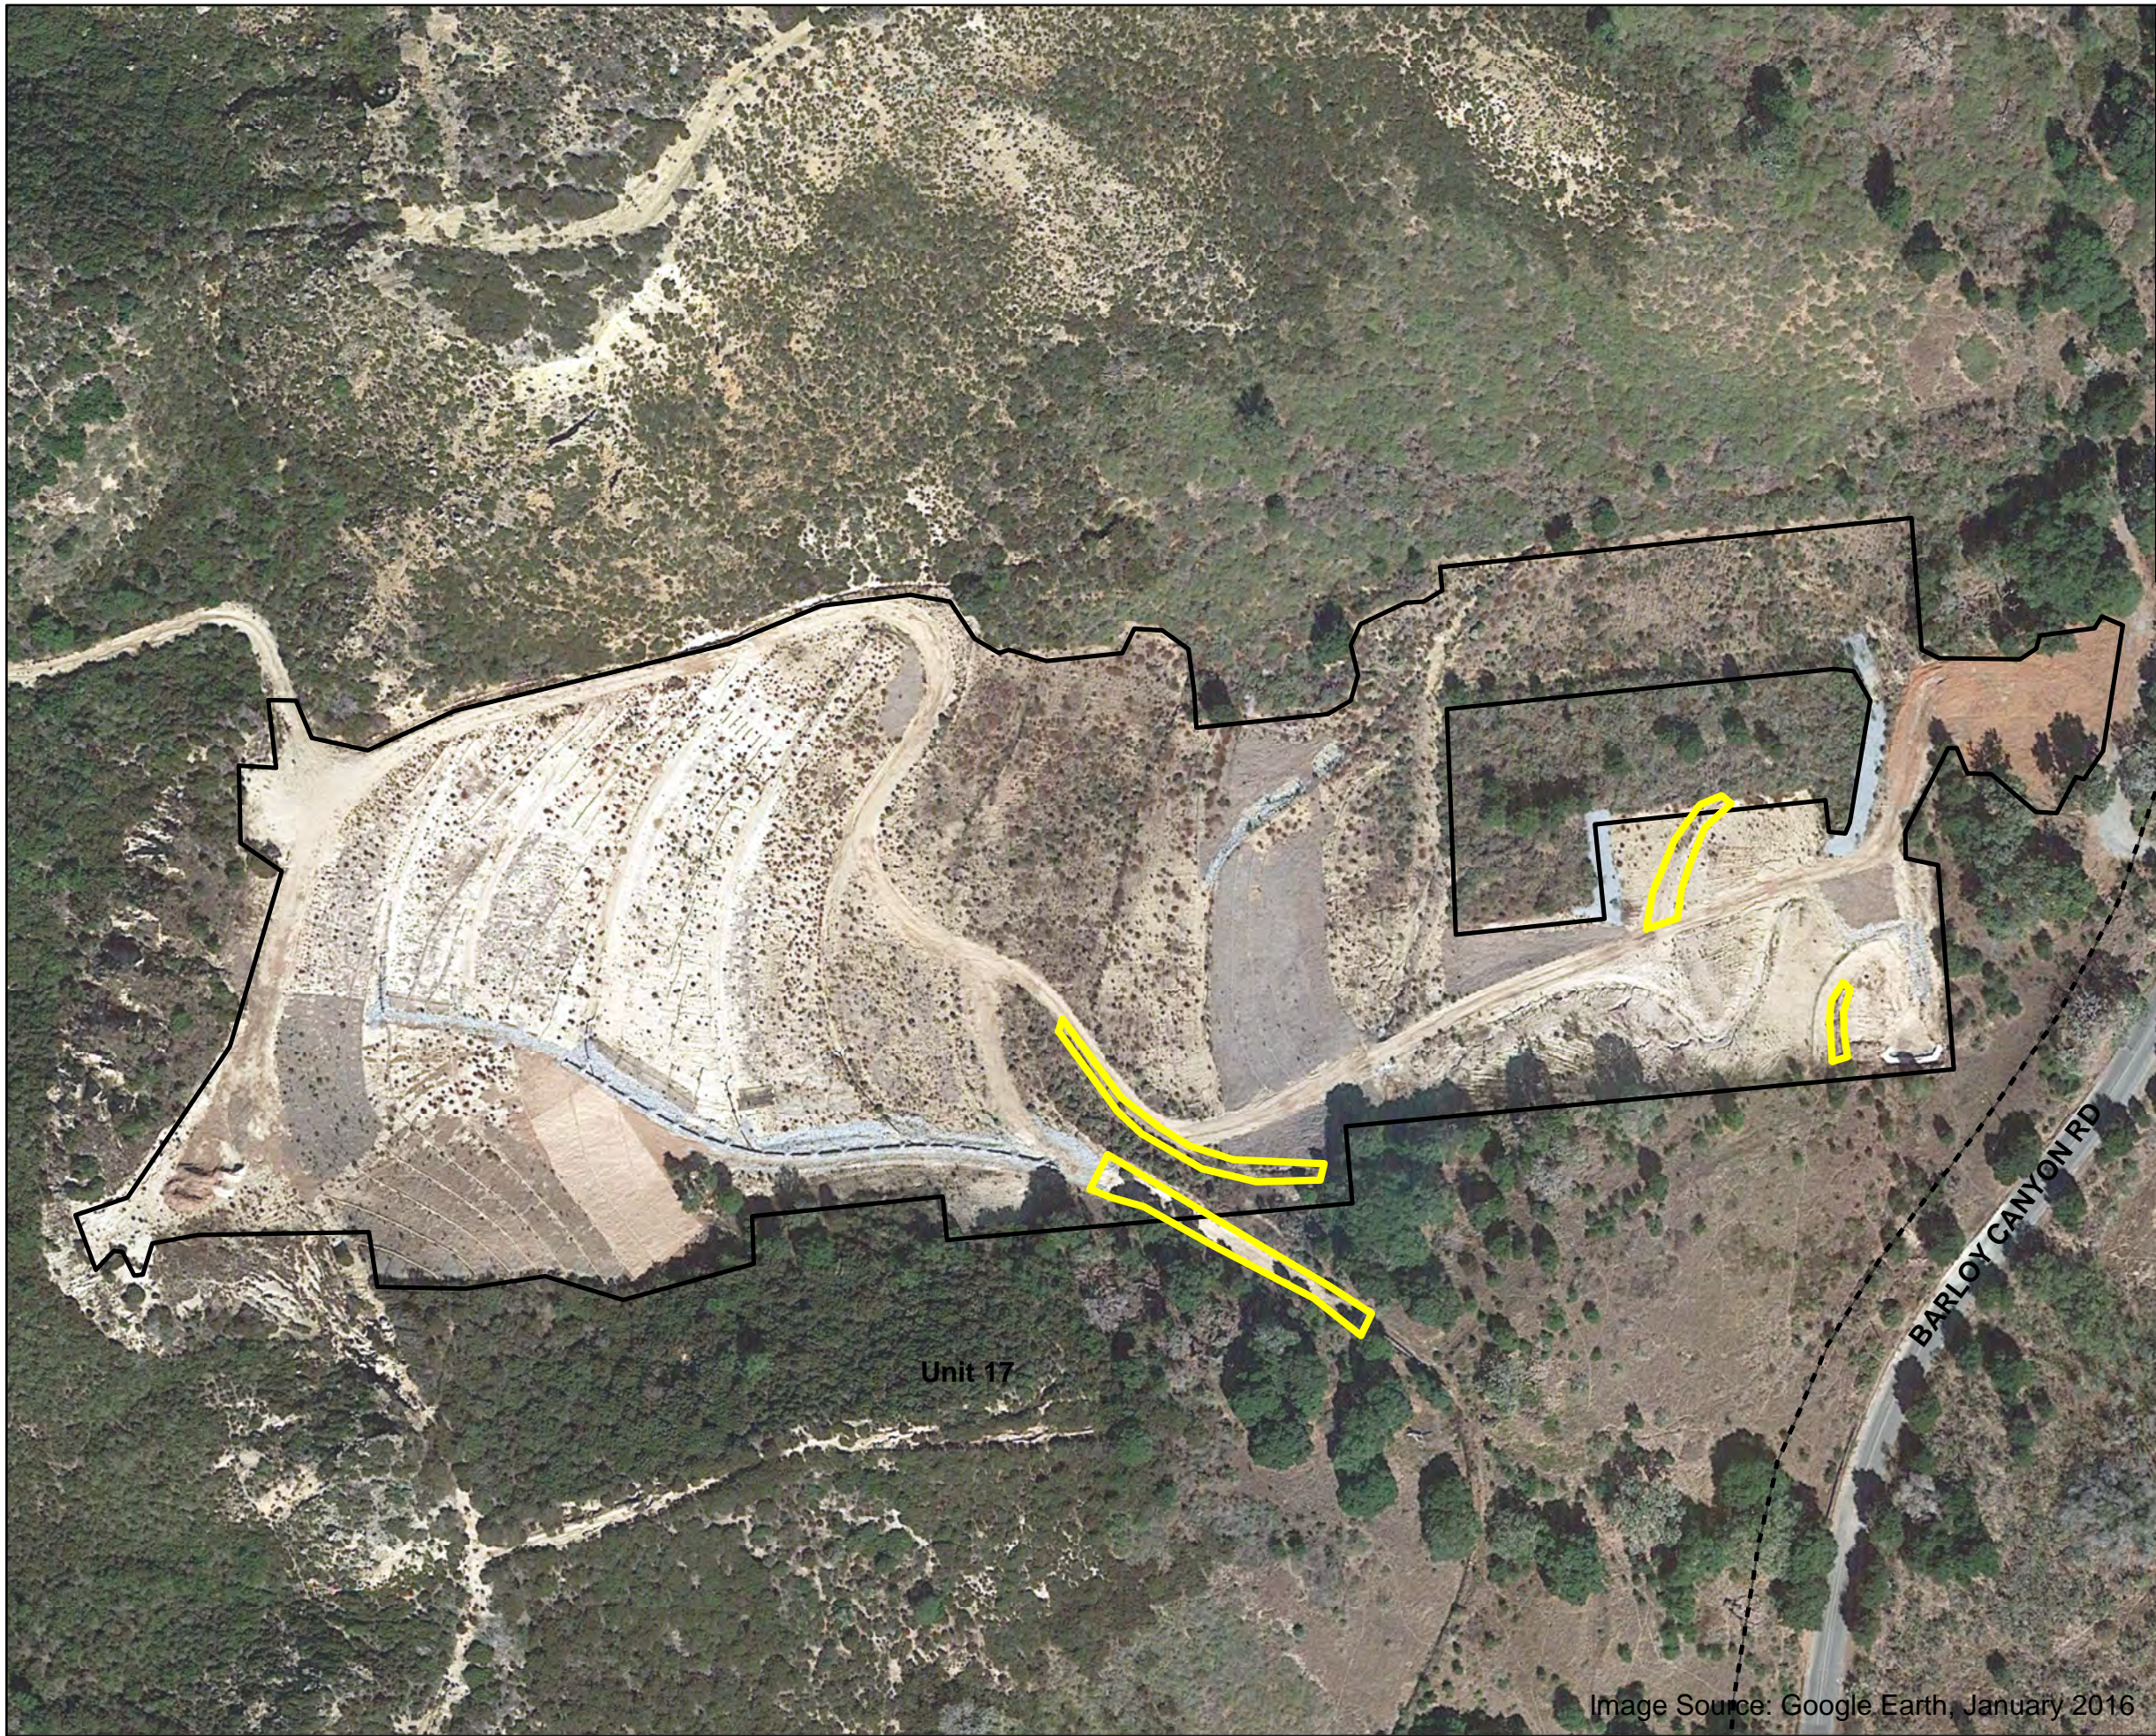
| FIGURE NUMBER 2-2 | 2016 Annual Biological Monitoring Report Erosion Repair Areas Within HA 34 | |

- Unit Boundaries
- Restoration Area
- 2016 Erosion Control Areas

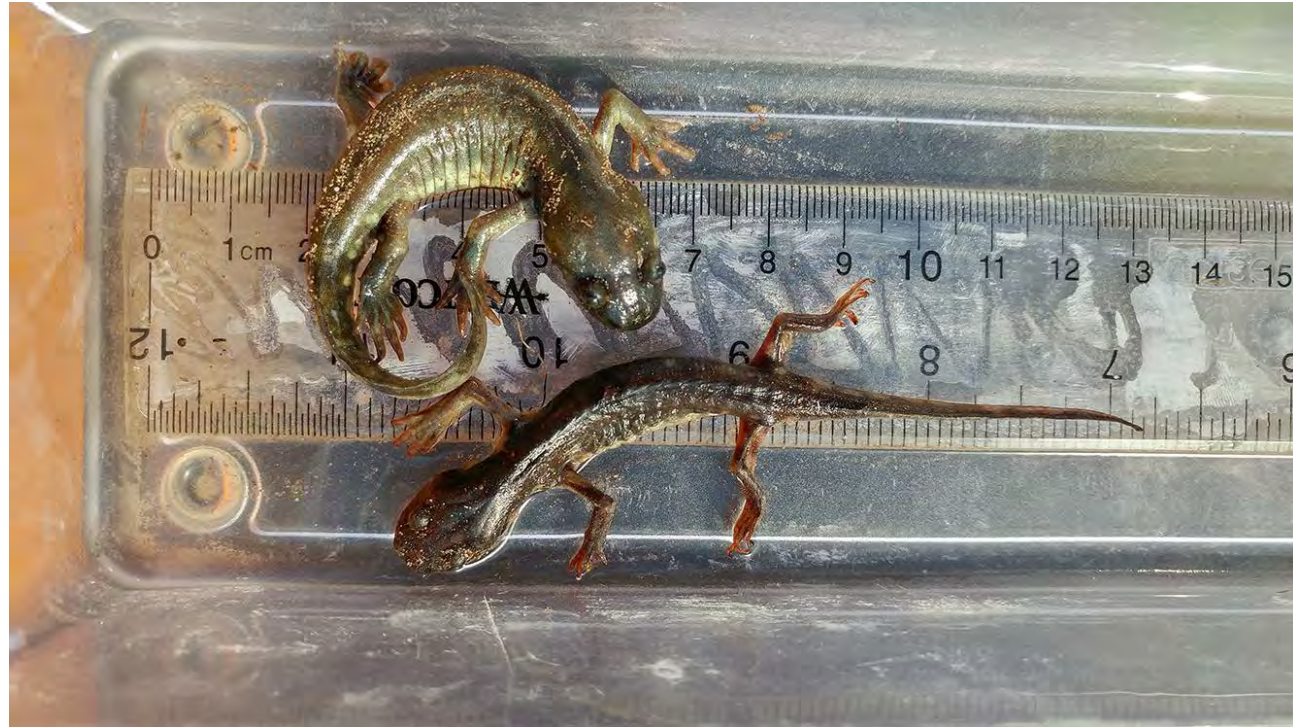
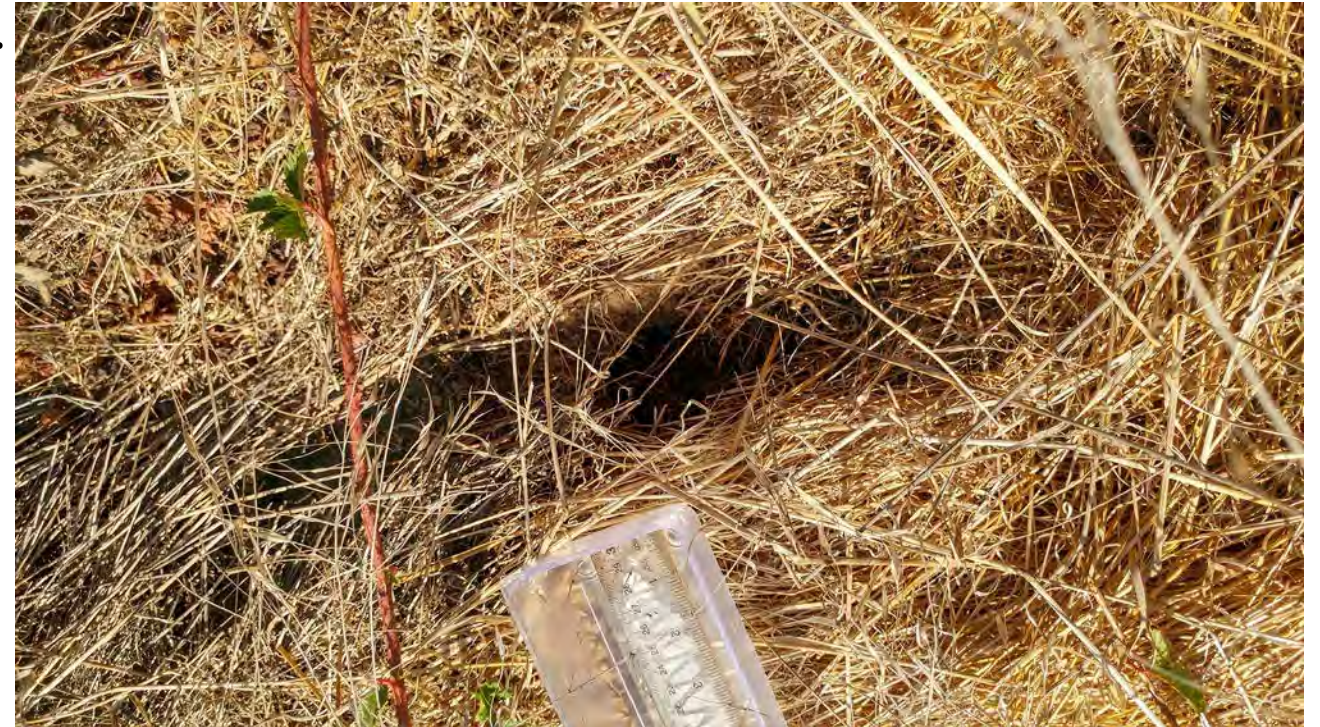
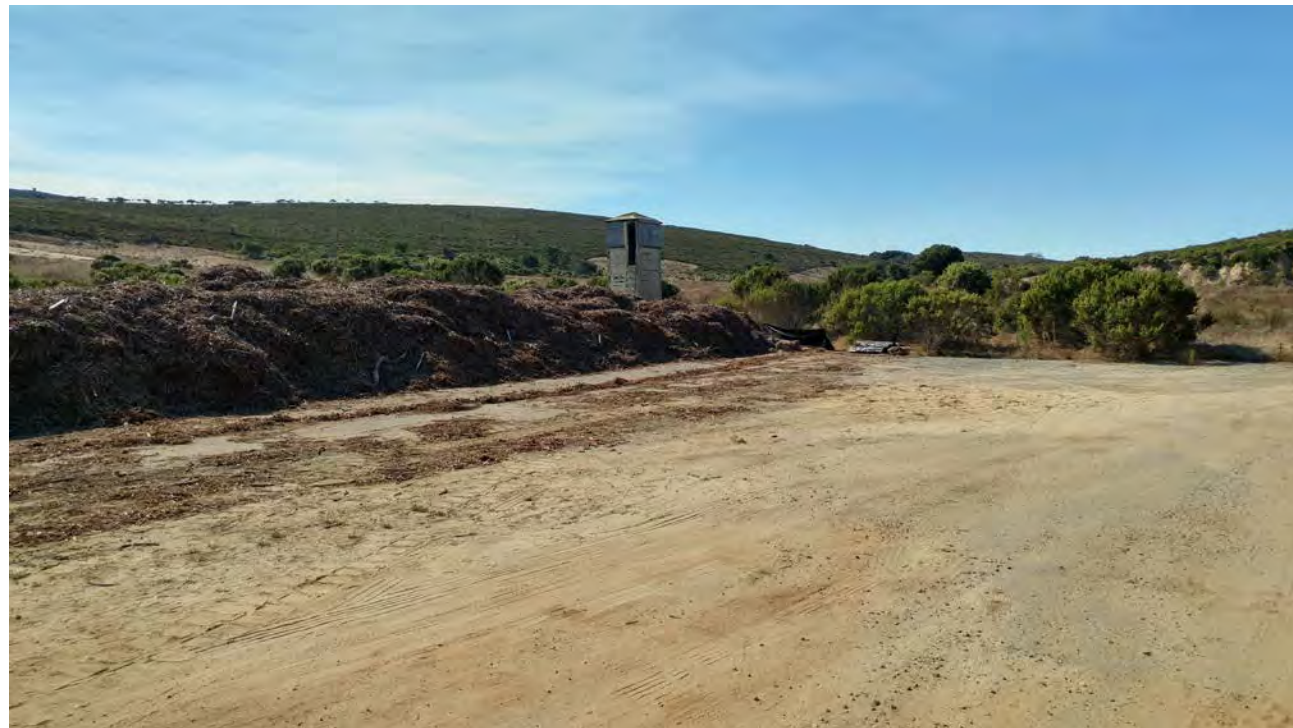
On September 28, 2016, two juvenile CTS were found on the interior of a silt fence surrounding a mulch pile at HA-37, located approximately 200 feet from Pond 10 (Figure 3-4). The mulch was being temporarily stockpiled for use in erosion control within and around the HA 37 restoration area, as described above in Section 2.0. The individuals were covered by a small amount of mulch that was being used to weight the edges of the silt fencing. One individual was found by the work crew as a portion of silt fence was being moved in order to access the mulch pile with the tractor. Work was stopped in the area and the Project Biologist, Jami Davis, was called to the site. Upon arrival, the Project Biologist identified that the CTS was dead; however, the individual appeared to be desiccated but uninjured (Figure 3-5a). The encounter occurred following a four-day stretch of above average temperatures for the region. As such, the work activities did not result in direct mortality of the individual; however, because the CTS was found within the silt fencing, the mortality was an indirect result of work activities. The Project Biologist proceeded to sift through the mulch that was piled on the other portions of the silt fencing and found one additional CTS. This individual was alive, active, and uninjured.

1. Live and dead CTS encountered on September 28, 2016
2. Small mammal burrow CTS was relocated to
3. Mulch pile at HA 37

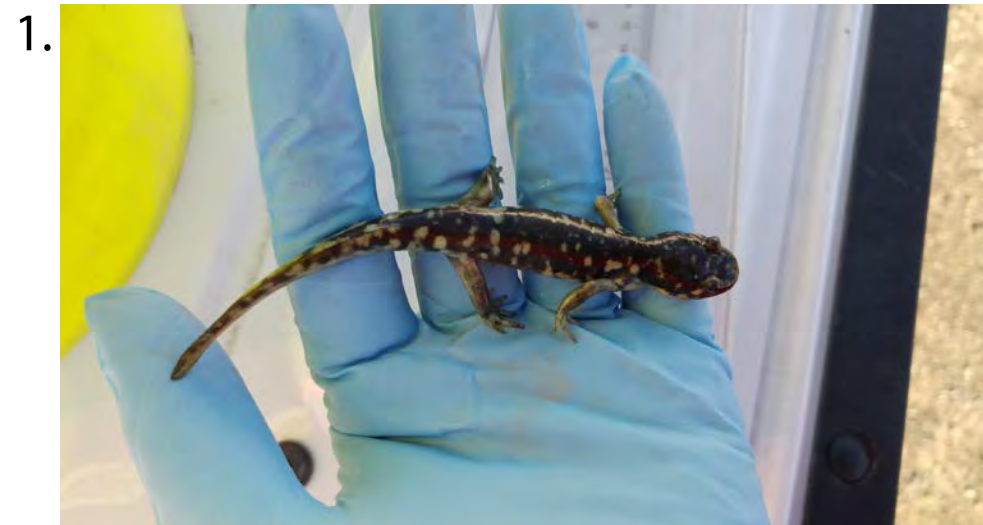
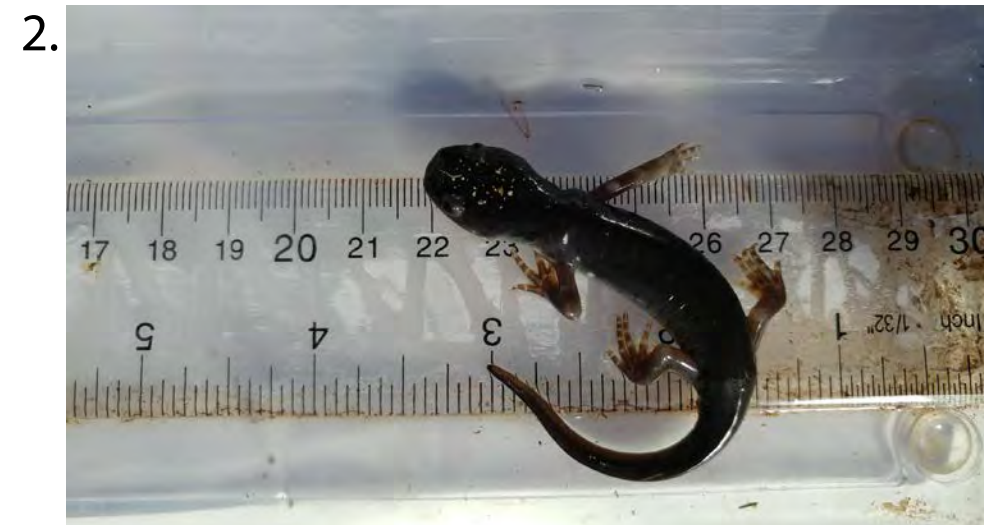
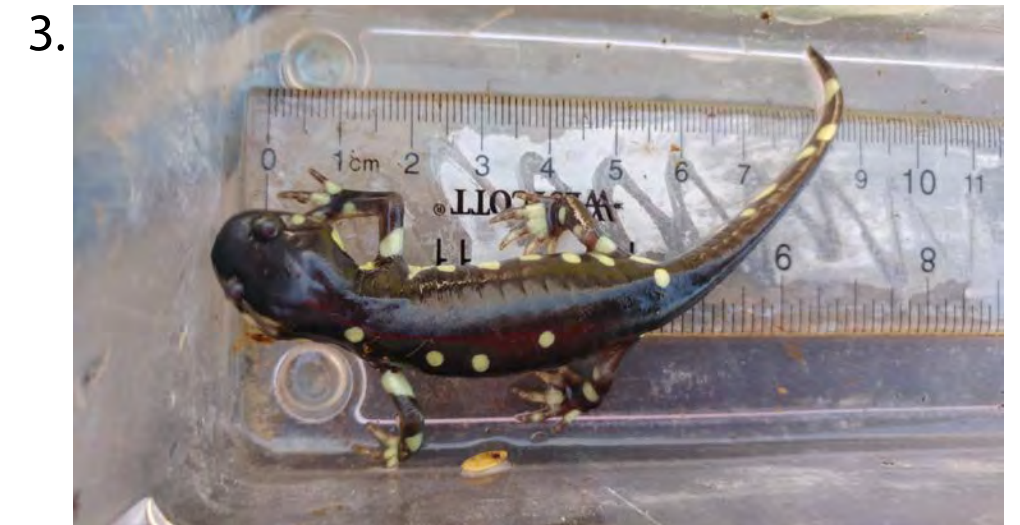
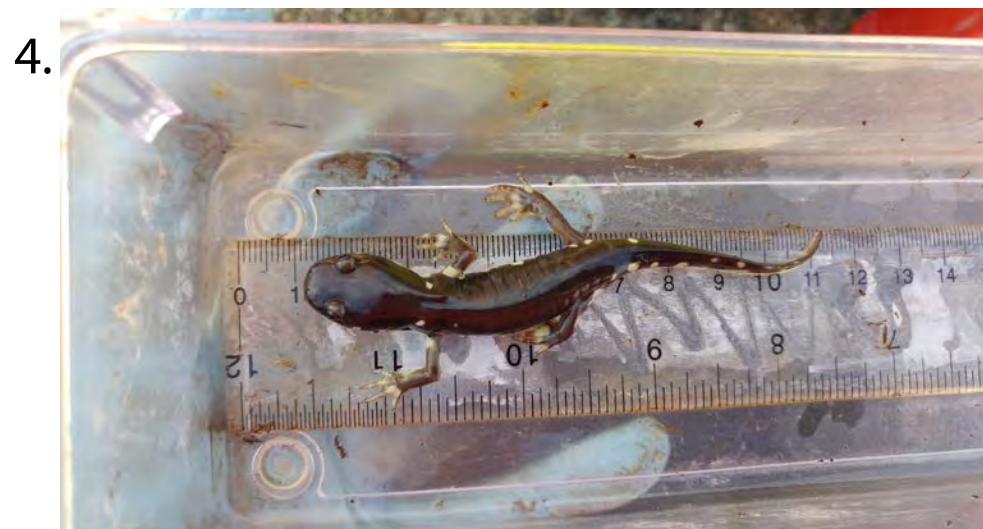
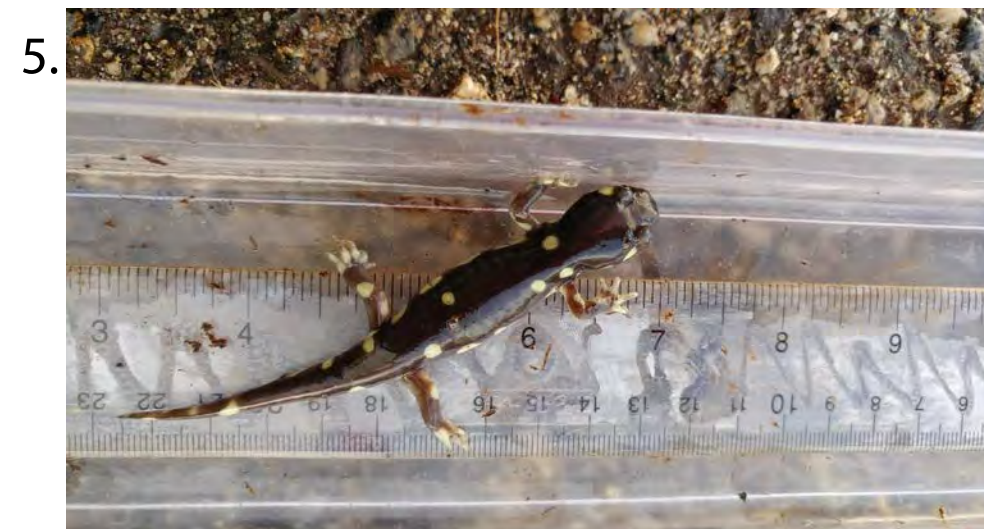
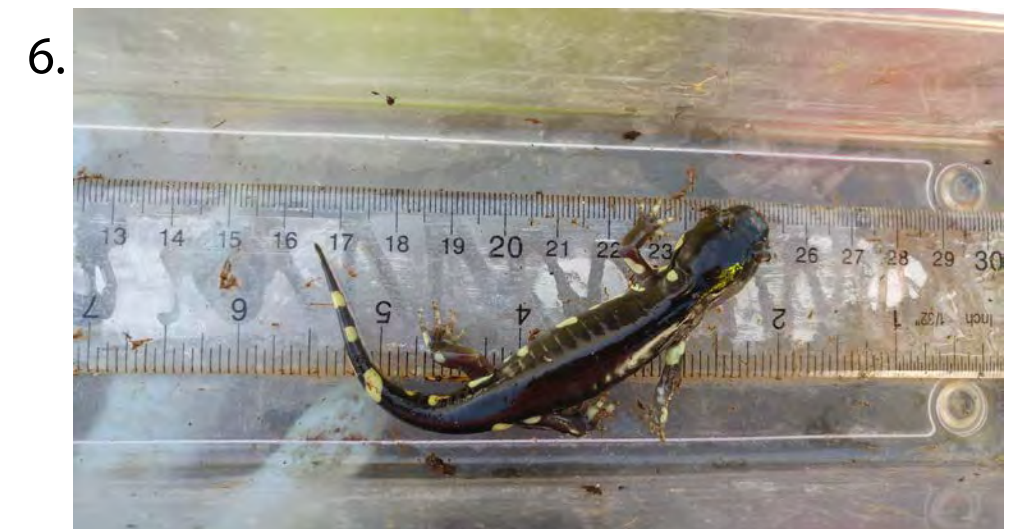
On October 17, 2016, 18 juvenile CTS were found underneath straw bales that were piled in the middle of the asphalt near HA 37, located approximately 60 feet from Pond 10 (Figure 3-4). The straw bales were left over from erosion work being conducted within the HA 37 restoration area, as described above in Section 2.0, and the crew was removing them from the site. The crew alerted the Project Biologist upon initial detection and stopped work in the area. The Project Biologist arrived on site approximately five minutes after detection and monitored as the crew turned over the remaining straw bales. The Project Biologist then sifted through the wet, decaying bottoms of the straw bales to remove any other CTS present prior to removing the straw bales from the site.

Of the 18 CTS encountered, 13 were alive and five were dead. Most of the live individuals were found in the wet, decaying bottoms of the straw bales. As the Project Biologist sifted through the material; however, a few of the live individuals were found on the ground as the straw bales were turned over by the crew. Four of the dead individuals were found on the ground as the straw bales were turned over; the fifth dead individual was found buried in a dry part of a straw bale. Three of the dead individuals were desiccated and two were decomposing. No CTS were killed during the process of removing the straw bales and the five individuals were dead upon detection. The encounter came following a weekend precipitation event of approximately one inch of rain; however, as evidenced by the presence and condition of the dead individuals, and the proximity to Pond 10 where CTS were observed breeding in the spring, it is likely these individuals had found shelter under the straw bales prior to the rain event. As such, the work activities did not result in direct mortality of the individuals; however, because the CTS were found under the stockpiled straw bales, the mortalities were an indirect result of work activities.

1-6. Live CTS #1-6 encountered on October 17, 2016

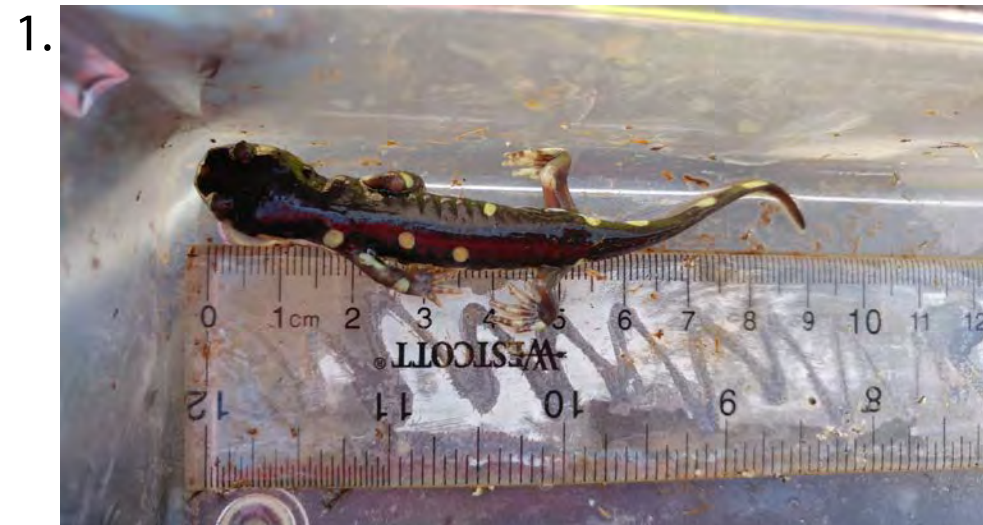
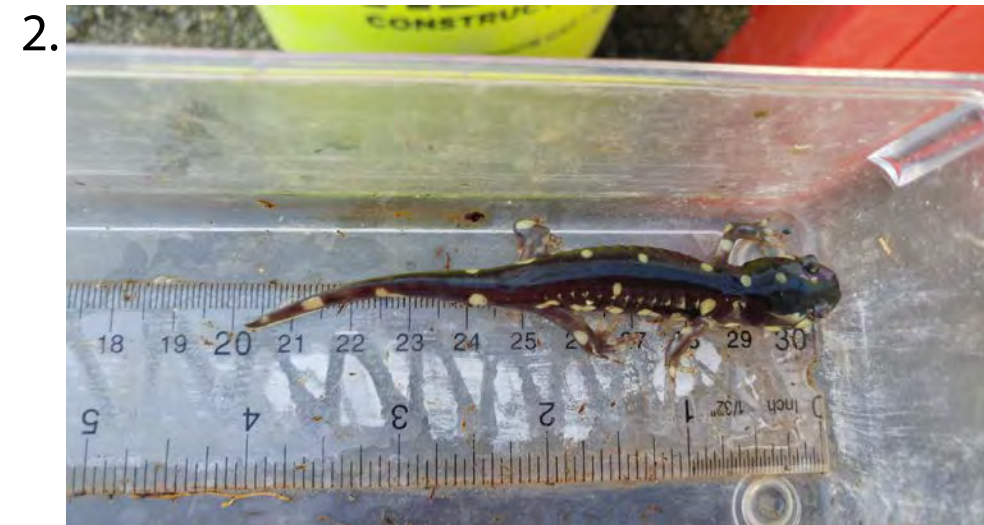
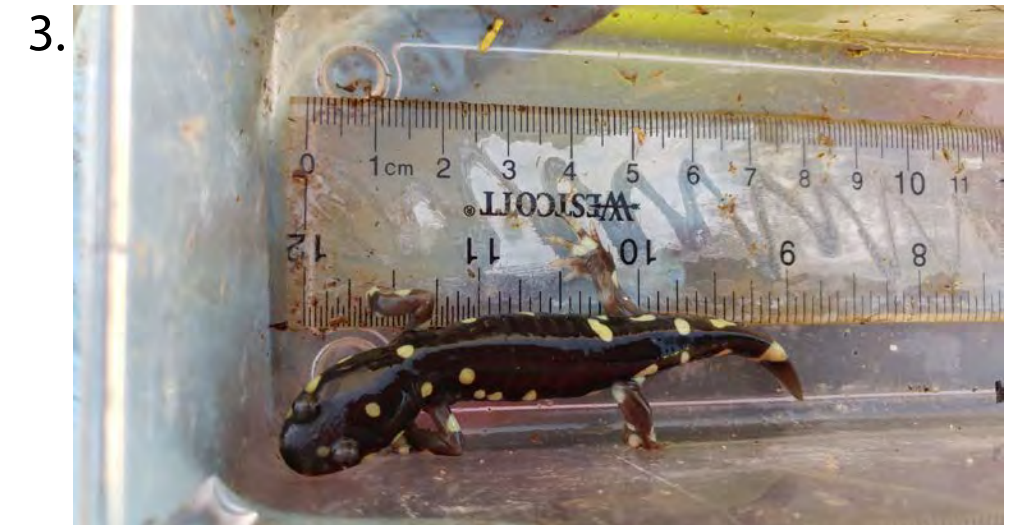
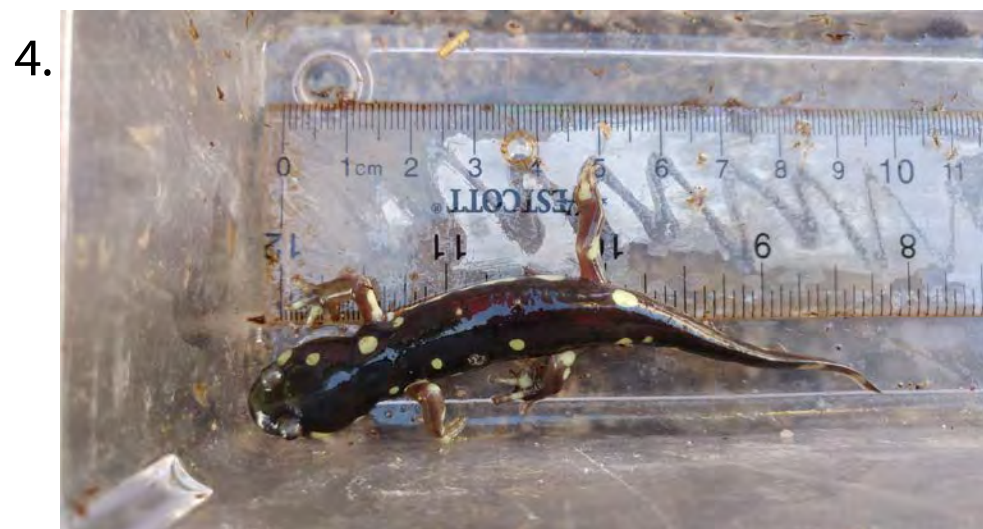
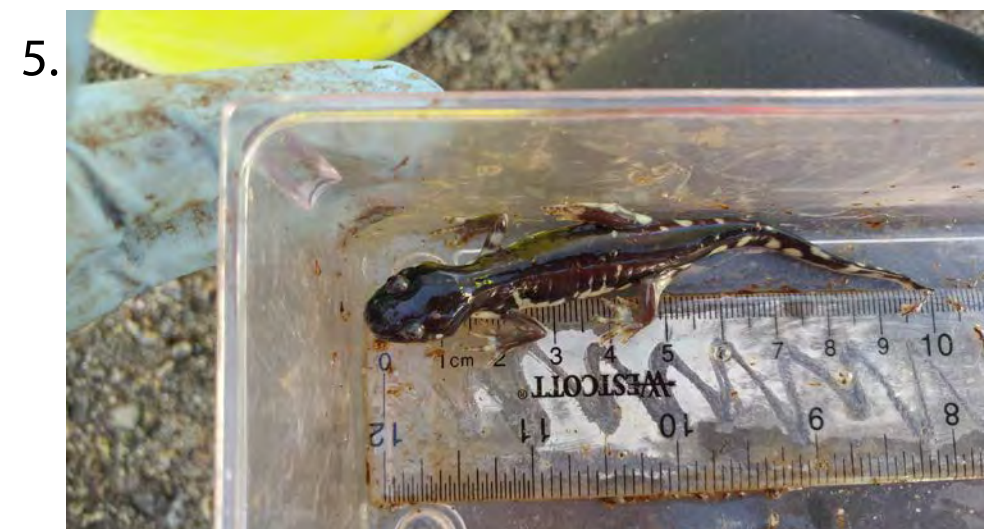
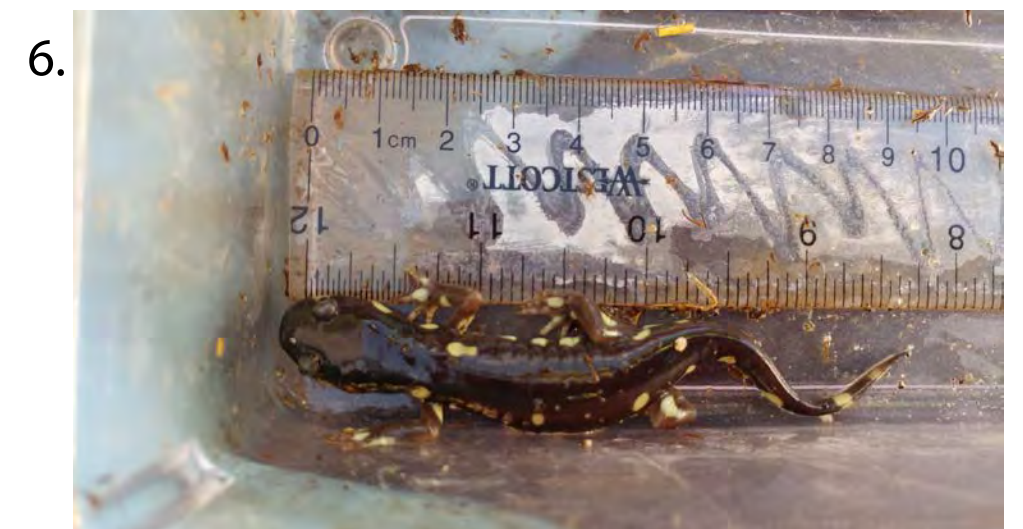
1-6. Live CTS #8-13 encountered on October 17, 2016

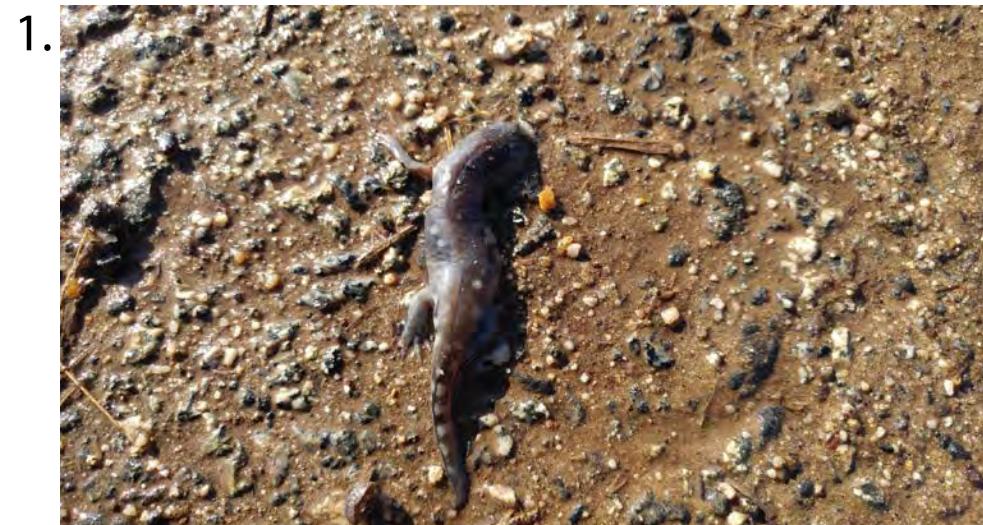
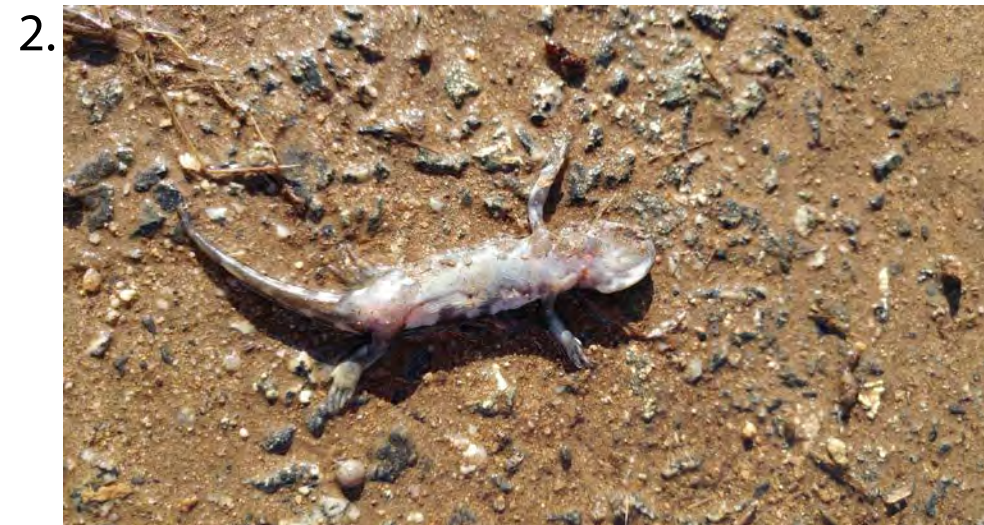
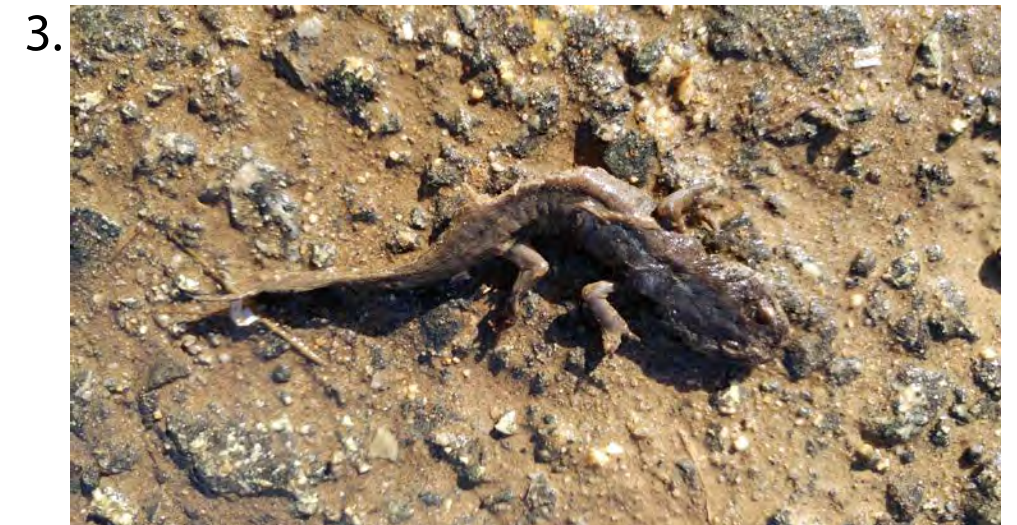
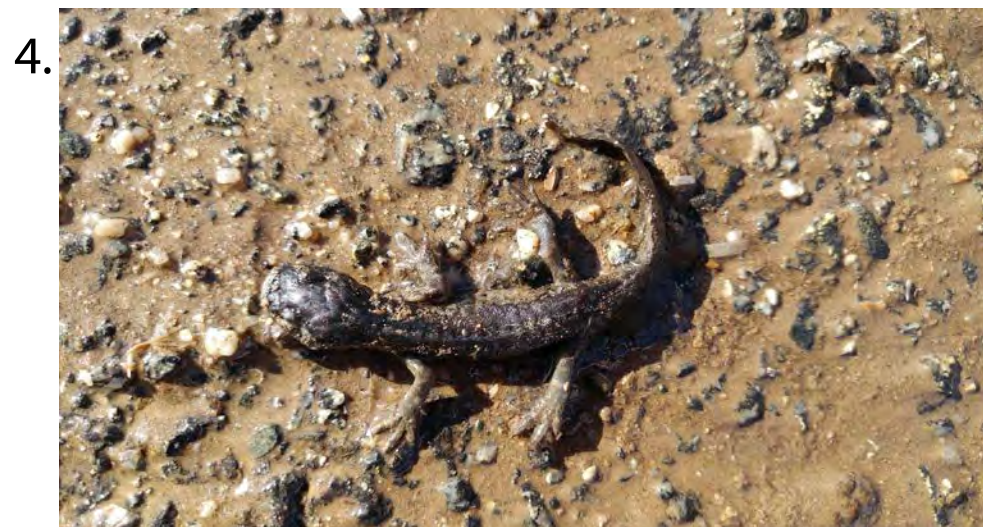
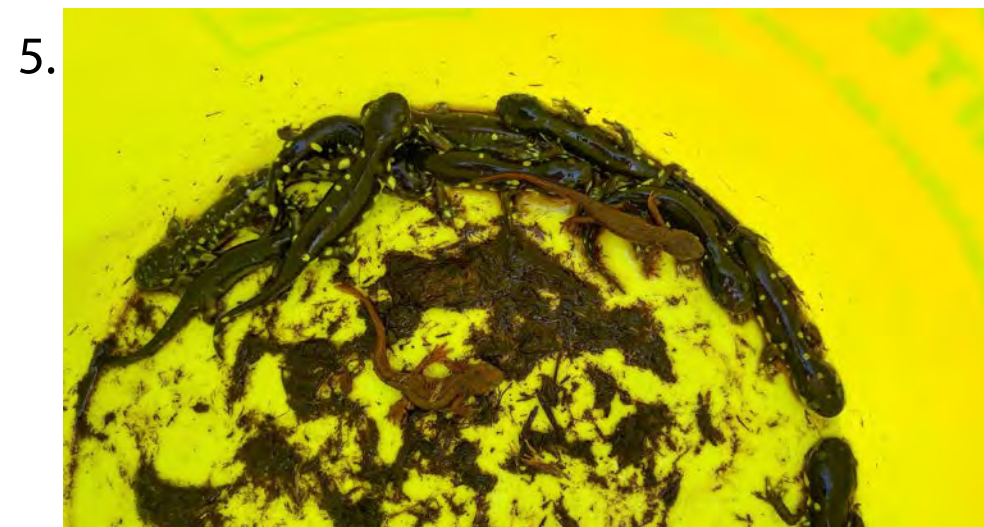
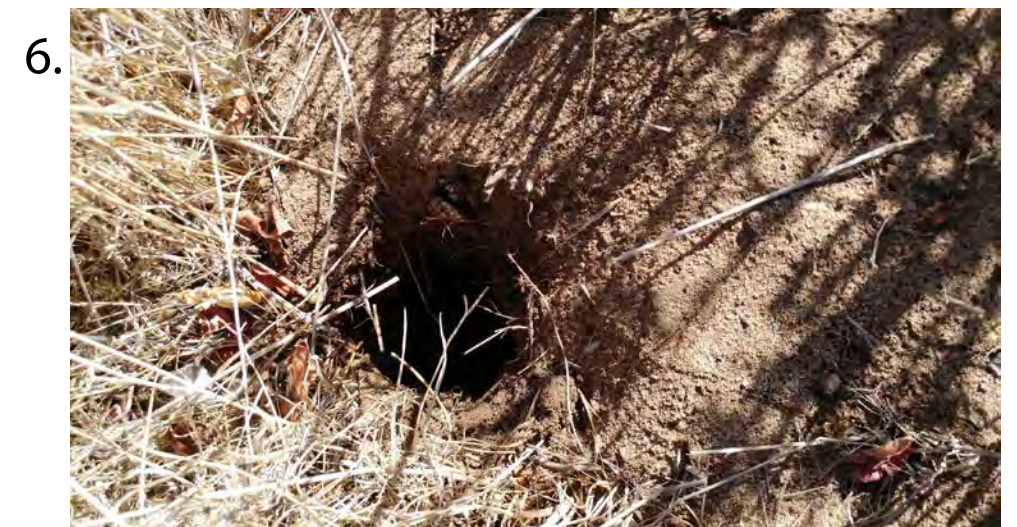
Other species observed included two juvenile California newts (*Taricha torosa*), one juvenile California red-sided garter snake (*Thamnophis sirtalis infernalis*), and several mice. The newts and garter snake were relocated outside of the work and staging area.

1-4. Dead CTS #14 and #16-18 encountered on October 17, 2016
 5. CTS and California newt in bucket before relocation
 6. Example of small mammal burrow where live CTS were released

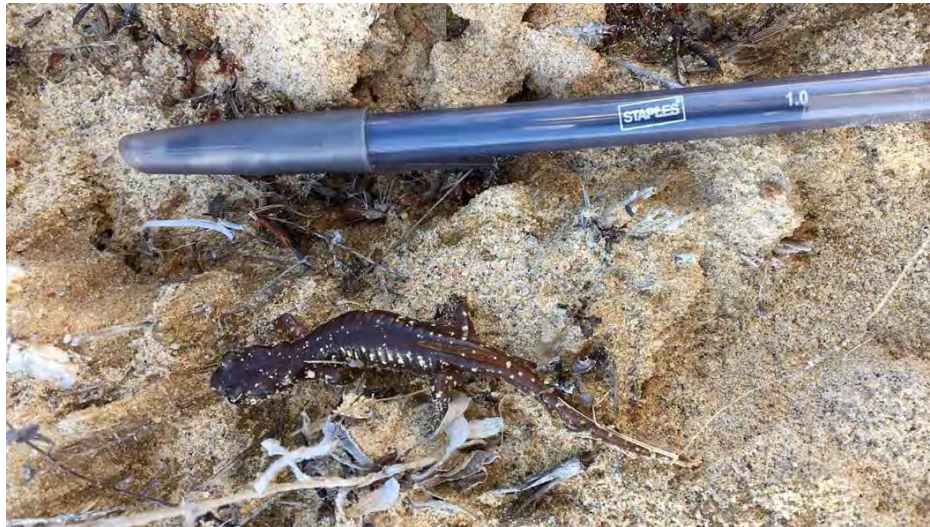
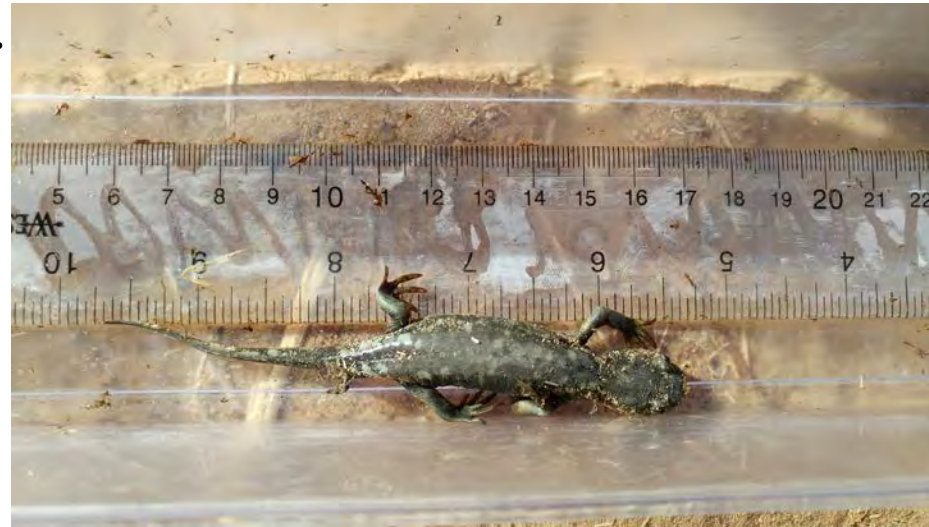
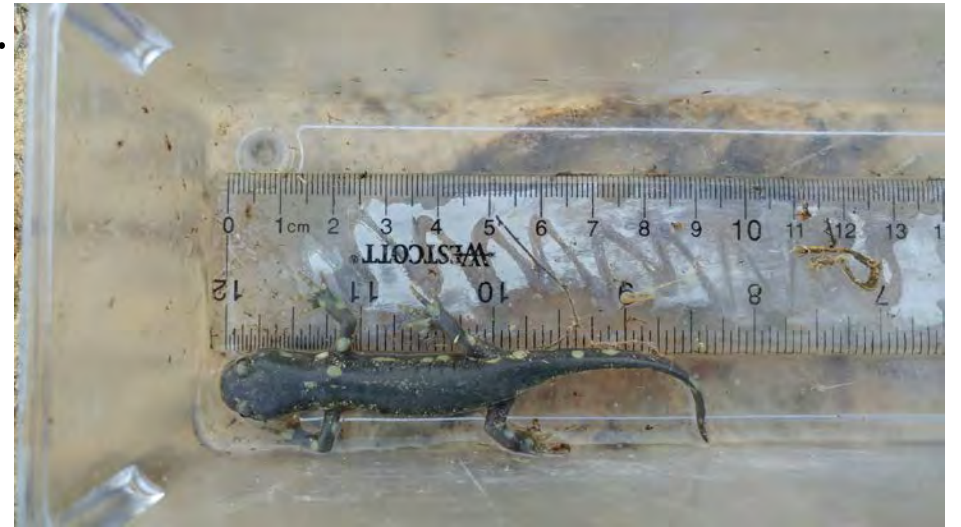
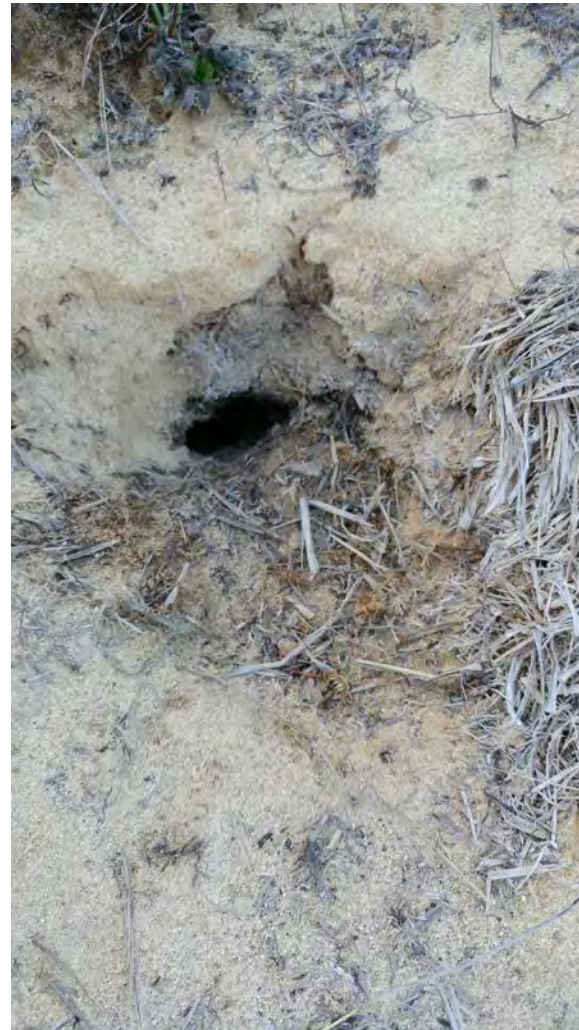
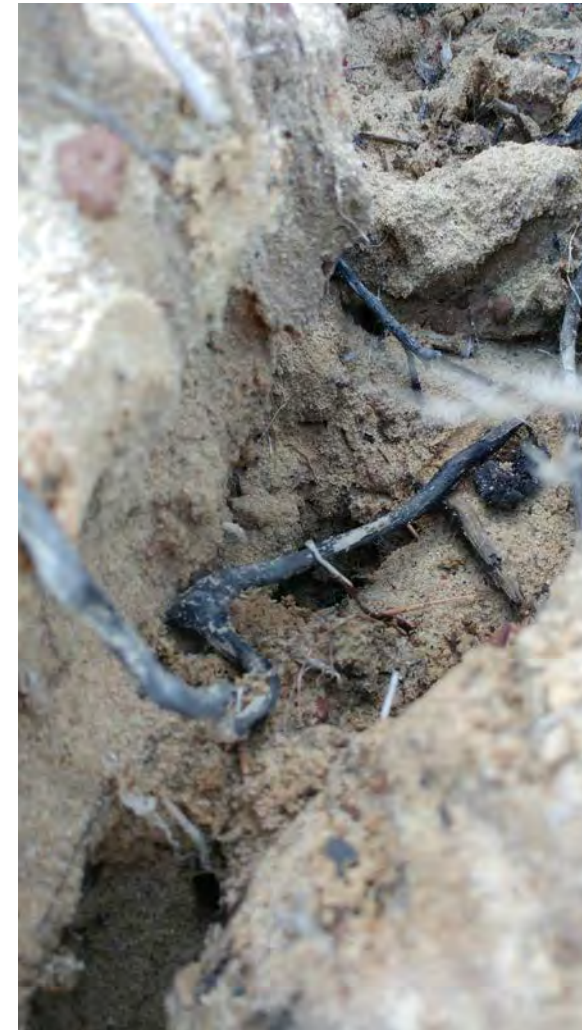
On October 18, 2016, two juvenile CTS were found adjacent to and underneath straw wattles that were stockpiled at HA 37, located approximately 600 feet from Pond 10 (Figure 3-4). The straw wattles were being temporarily stockpiled for use in erosion control within and around the HA 37 restoration area, as described above in Section 2.0. The crew observed a salamander walking away from the straw wattle pile after they started moving the wattles. Work was stopped in the area and the Project Biologist was called to the site. The crew watched the individual as it moved up the slope away from the straw wattle stockpile area and out of the work area. Because the individual removed itself from the work area, the crew continued to move the straw wattles and encountered another salamander. They stopped work again until the Project Biologist arrived. The Project Biologist monitored as the crew turned over the remaining straw wattles and one more CTS was encountered. The individual that removed itself from the work site was

not able to be located by the Project Biologist upon arrival as it had found cover; however, the crew had taken a picture of the individual, which was determined to be an arboreal salamander (*Aneides lugubris*) by the Project Biologist (Figure 3-5e).

1. Arboreal salamander encountered on October 18, 2016
 2-3. CTS encountered on October 18, 2016
 4-5. Small mammal burrows where CTS were released
