2016 ANNUAL BIOLOGICAL MONITORING REPORT
FORMER FORT ORD, CALIFORNIA

WORLDWIDE ENVIRONMENTAL REMEDIATION SERVICES
CONTRACT NO. W912DY-10-D-0027

Denise Duffy & Associates, Inc.
947 Cass Street, Suite 5
Monterey, California 93940

April 2017

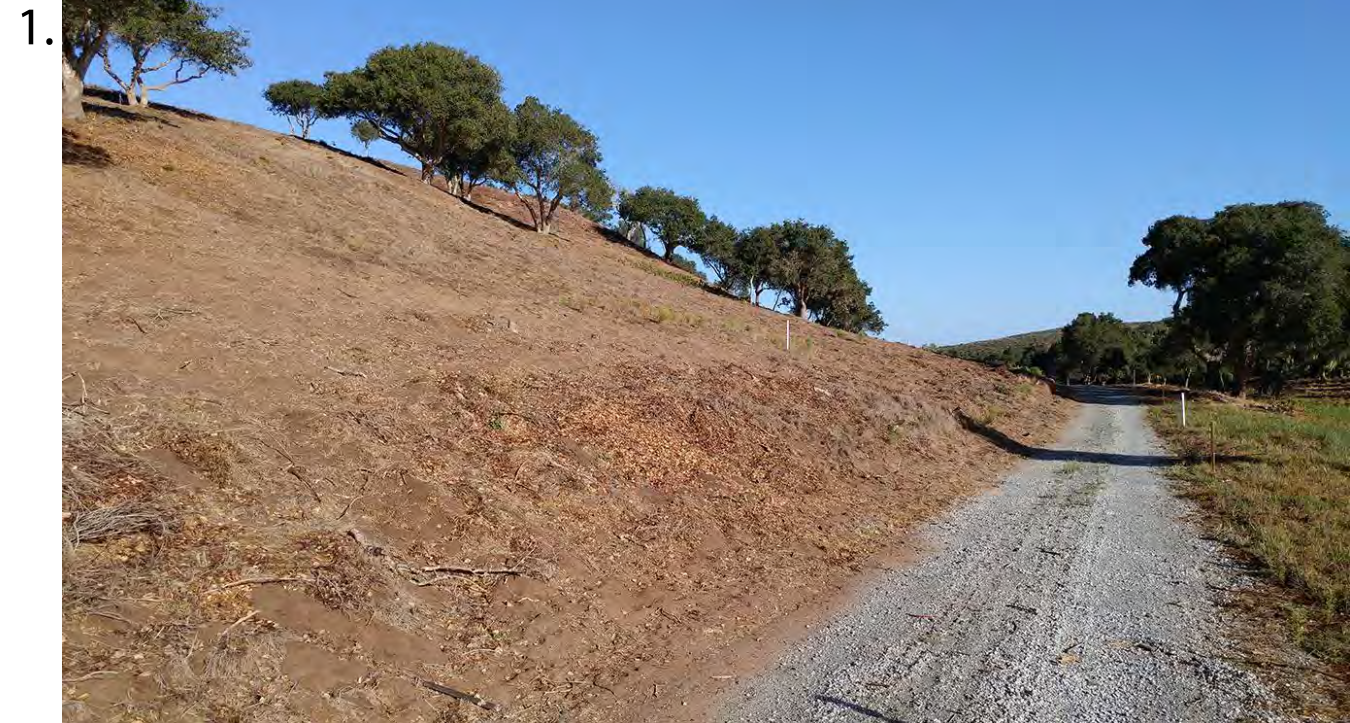
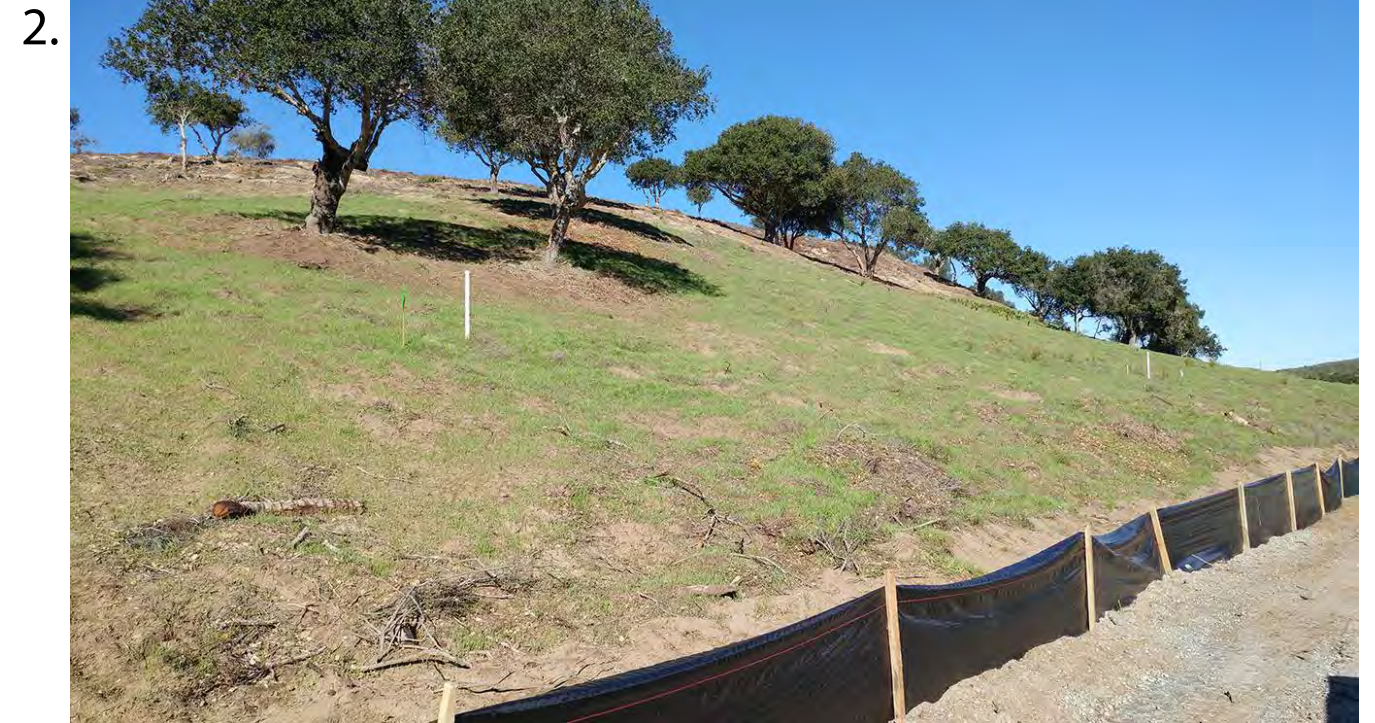
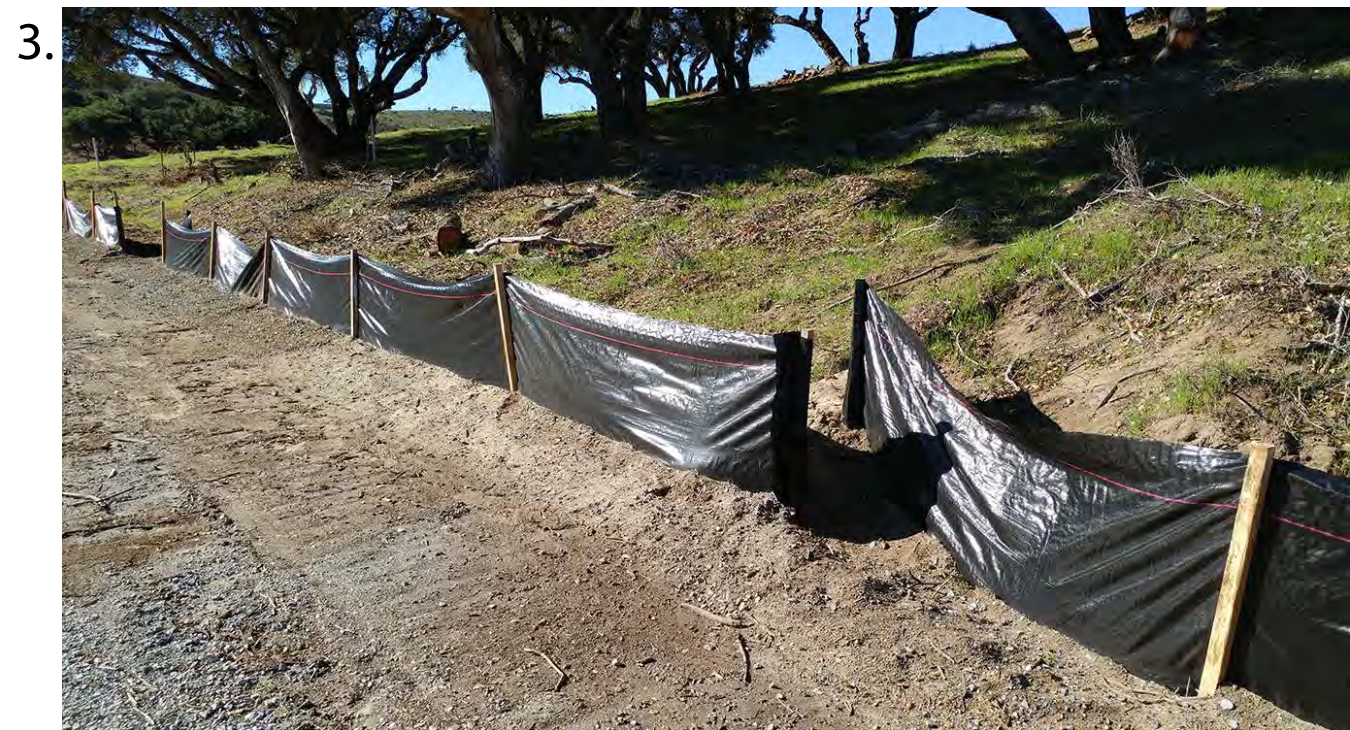
1. Unit 25 hillside October 17, 2016
2. Unit 25 hillside regrowth and silt fence looking northwest
3. Gap between silt fence lengths
