2017 ANNUAL BIOLOGICAL MONITORING REPORT FORMER FORT ORD, CALIFORNIA

May 2018

WORLDWIDE ENVIRONMENTAL REMEDIATION SERVICES
CONTRACT NO. W912DY-10-D-0027

Denise Duffy & Associates, Inc.
947 Cass Street, Suite 5
Monterey, California 93940

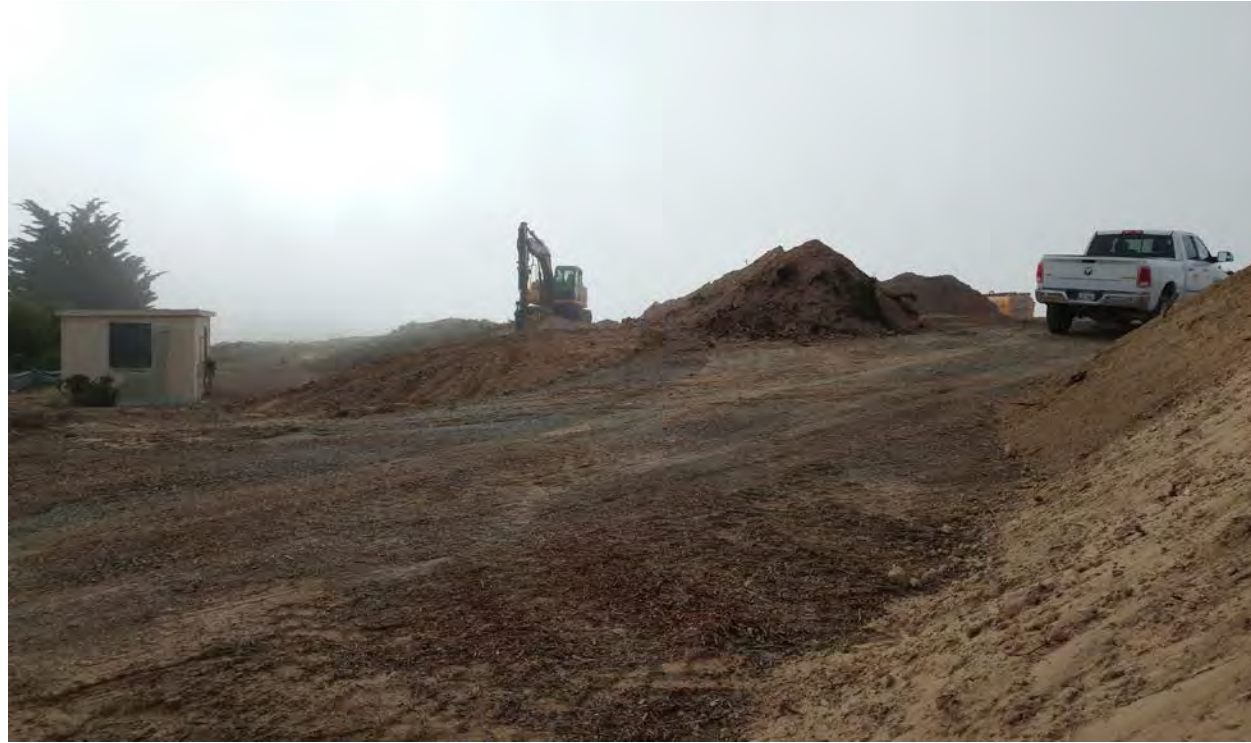
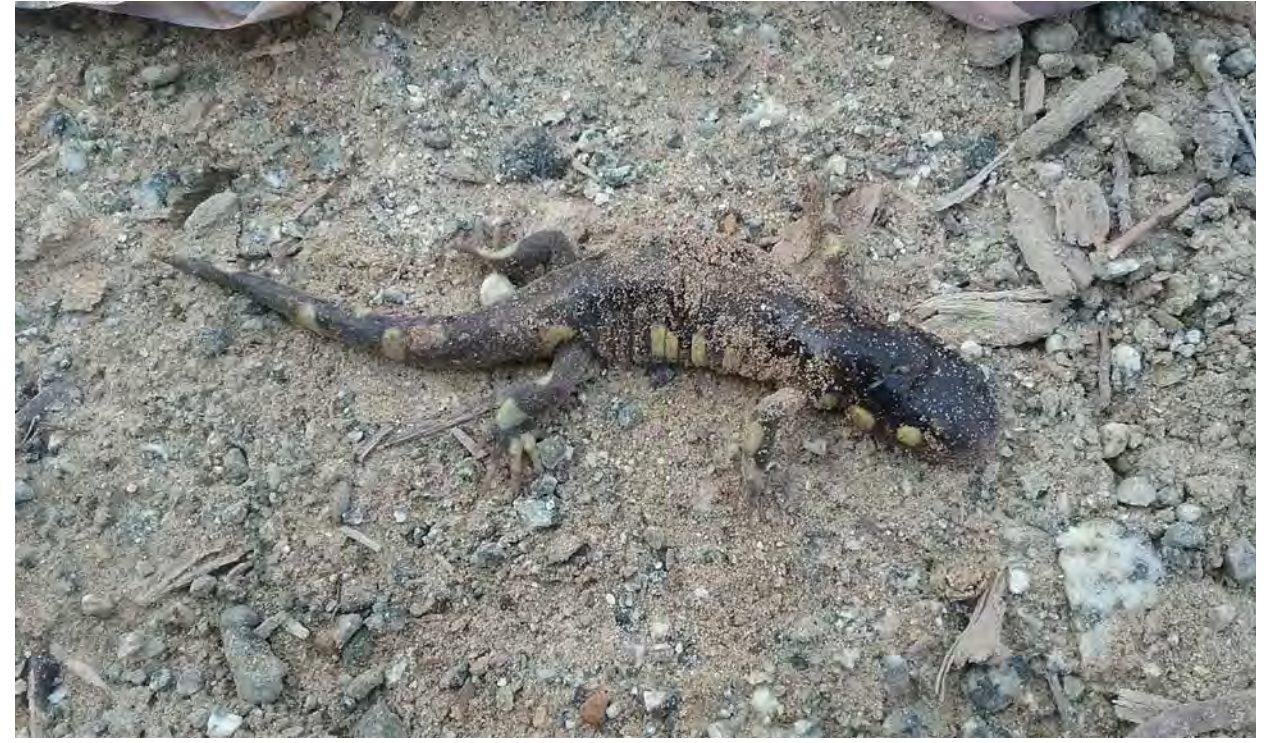
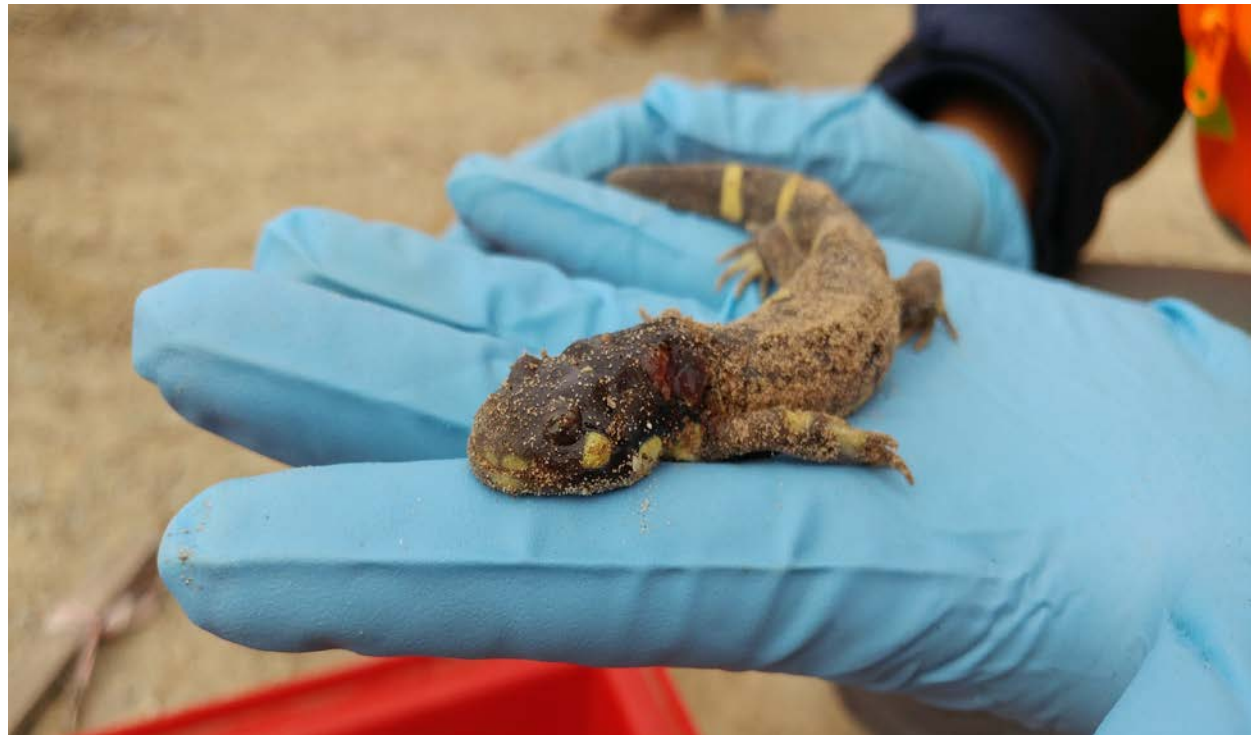
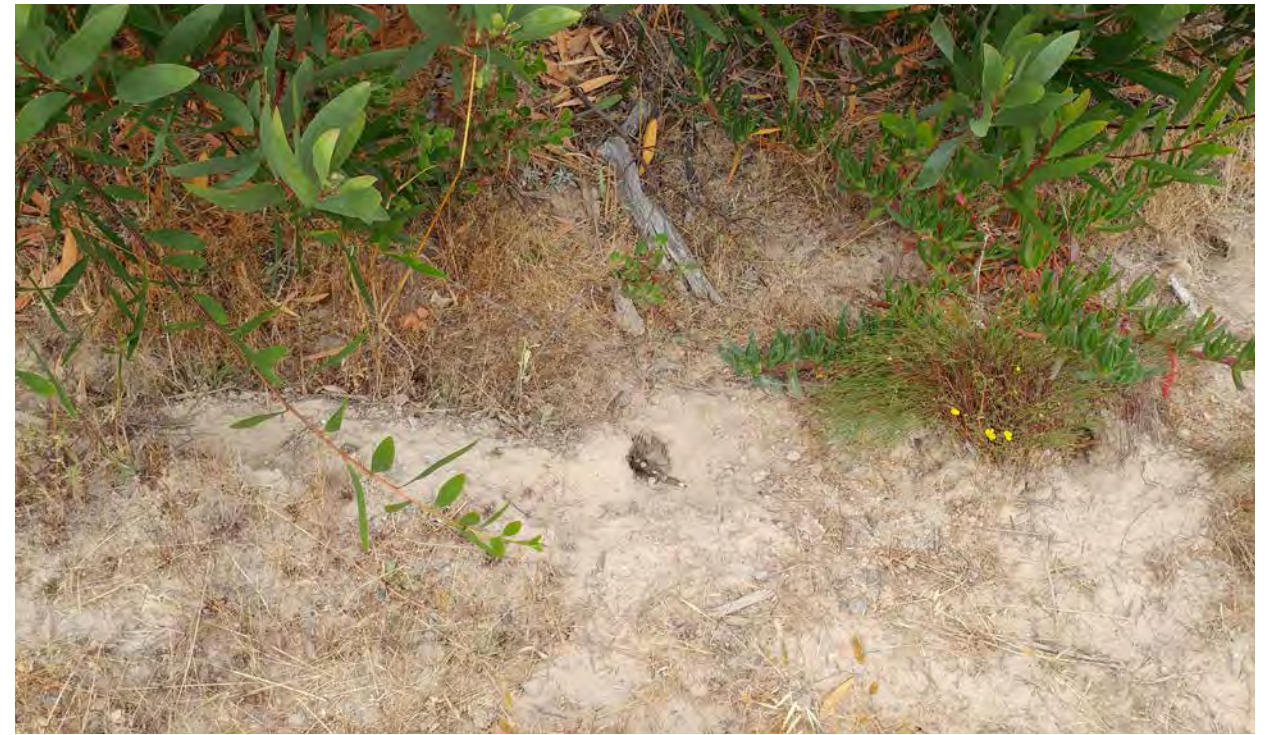
On July 11, 2017, one young-of-the-year CTS was found in a disturbed area (the Evolution Road work area near Pond 30) where grading for a road re-route, soil borrow for erosion repair projects, and mulch stockpiling was occurring. The individual was found adjacent to a soil stockpile by the site contractor upon arriving at the site in the morning; the soil in the area had been disturbed the previous day. The work area was located approximately 315 feet from Pond 30 (Figure 3-7). Exclusionary silt fencing had been installed the week prior to commencement of work activities, and as such it is likely that the CTS was present within the area prior to silt fence installation.

Work was stopped in the area and the Project Biologists, Jami Colley and Shaelyn Hession, were called to the site. Upon arrival, the Project Biologists identified that the CTS was alive; however, an injury was present behind the head and consisted of a portion of the left front leg structure protruding through the skin. The exact cause of the injury is unknown, as no work had yet been conducted on that day. It is possible that the individual suffered the injury on the previous day by equipment being used for soil grading activities or it may have been predated on. The Project Biologist measured, weighed, and photographed the individual (Figure 3-8). The measurements for the CTS were: 130mm total length, 75mm snout-vent length, and 13.6g.

1. Work area where CTS was encountered on July 11, 2017.
2. CTS as it was encountered.
3. CTS as it was being measured by the biologist. Note: An injury was present behind the head and consisted of a portion of the left front leg structure protruding through the skin.
4. CTS relocated to a mammal burrow outside of the work area.

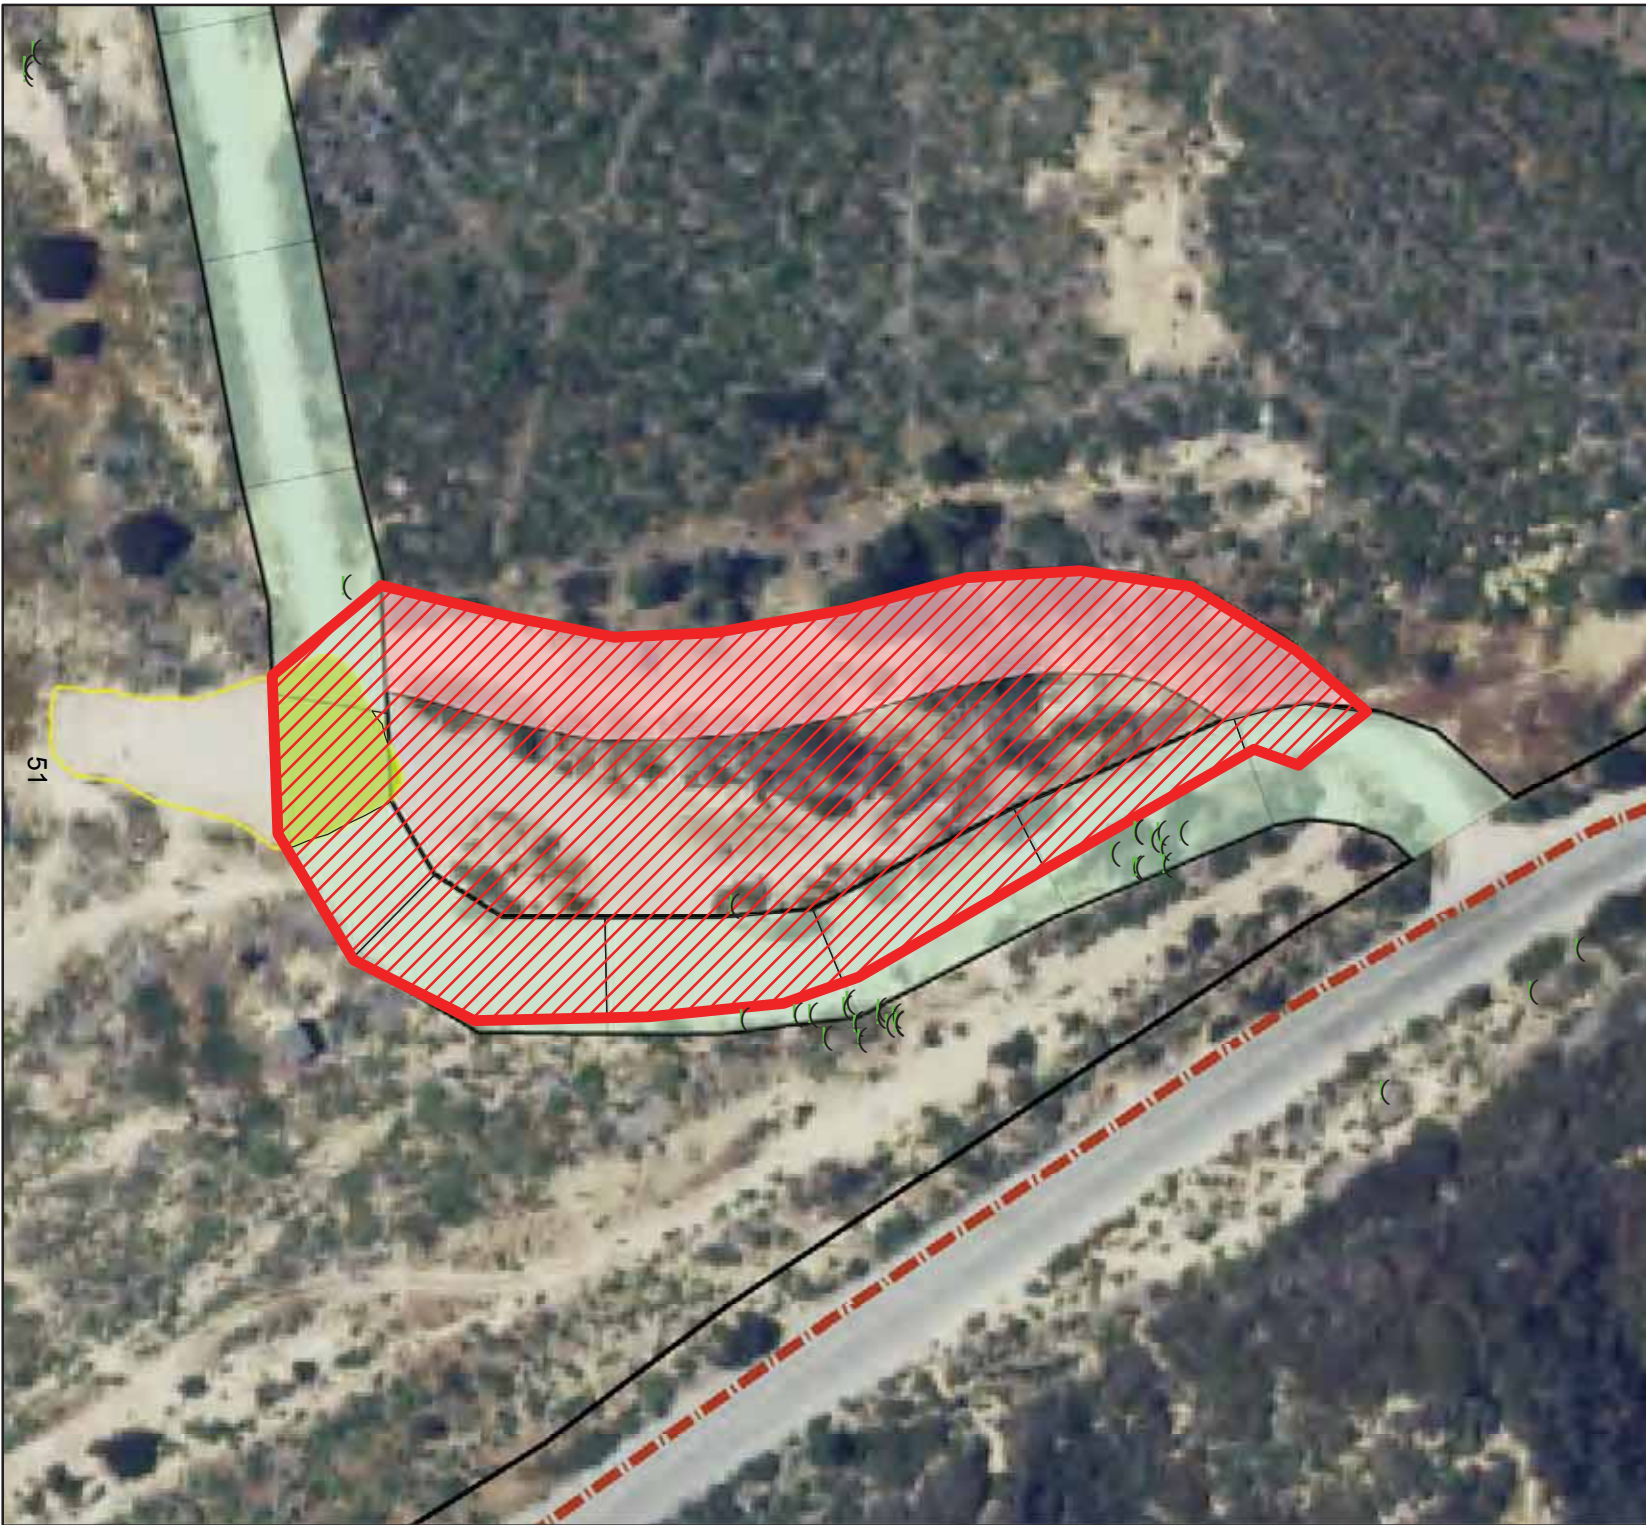
Figure 1

- Evolution Rd Stabilization Remedy**
- Yadon's piperia
 - Proposed Work Area
 - Fuelbreak Restoration
 - Existing 45' Fuelbreak
 - HA28 Passive Restoration
 - HA28 Restoration Affected Area
 - Approx Fuelbreak Re-route
 - Historic Impact Area

PRINT DATE: 3/6/2017	SOURCE OF DATA: Fort Ord Geodatabase
AERIAL PHOTOGRAPHY: 2016 NAIP	SCALE: 1:1,000
DRAWN BY: Bartholomew.L.Kowalski@usace.army.mil	
FILE: G:\Temp\Bart\mxds\Evolution Reroute Borrow Site_Fig1.mxd

- No vegetation removal shall occur in the habitat reserve areas from approximately February 1 to May 31 due to the presence of Monterey spineflower and sand gilia (see Figure 1).

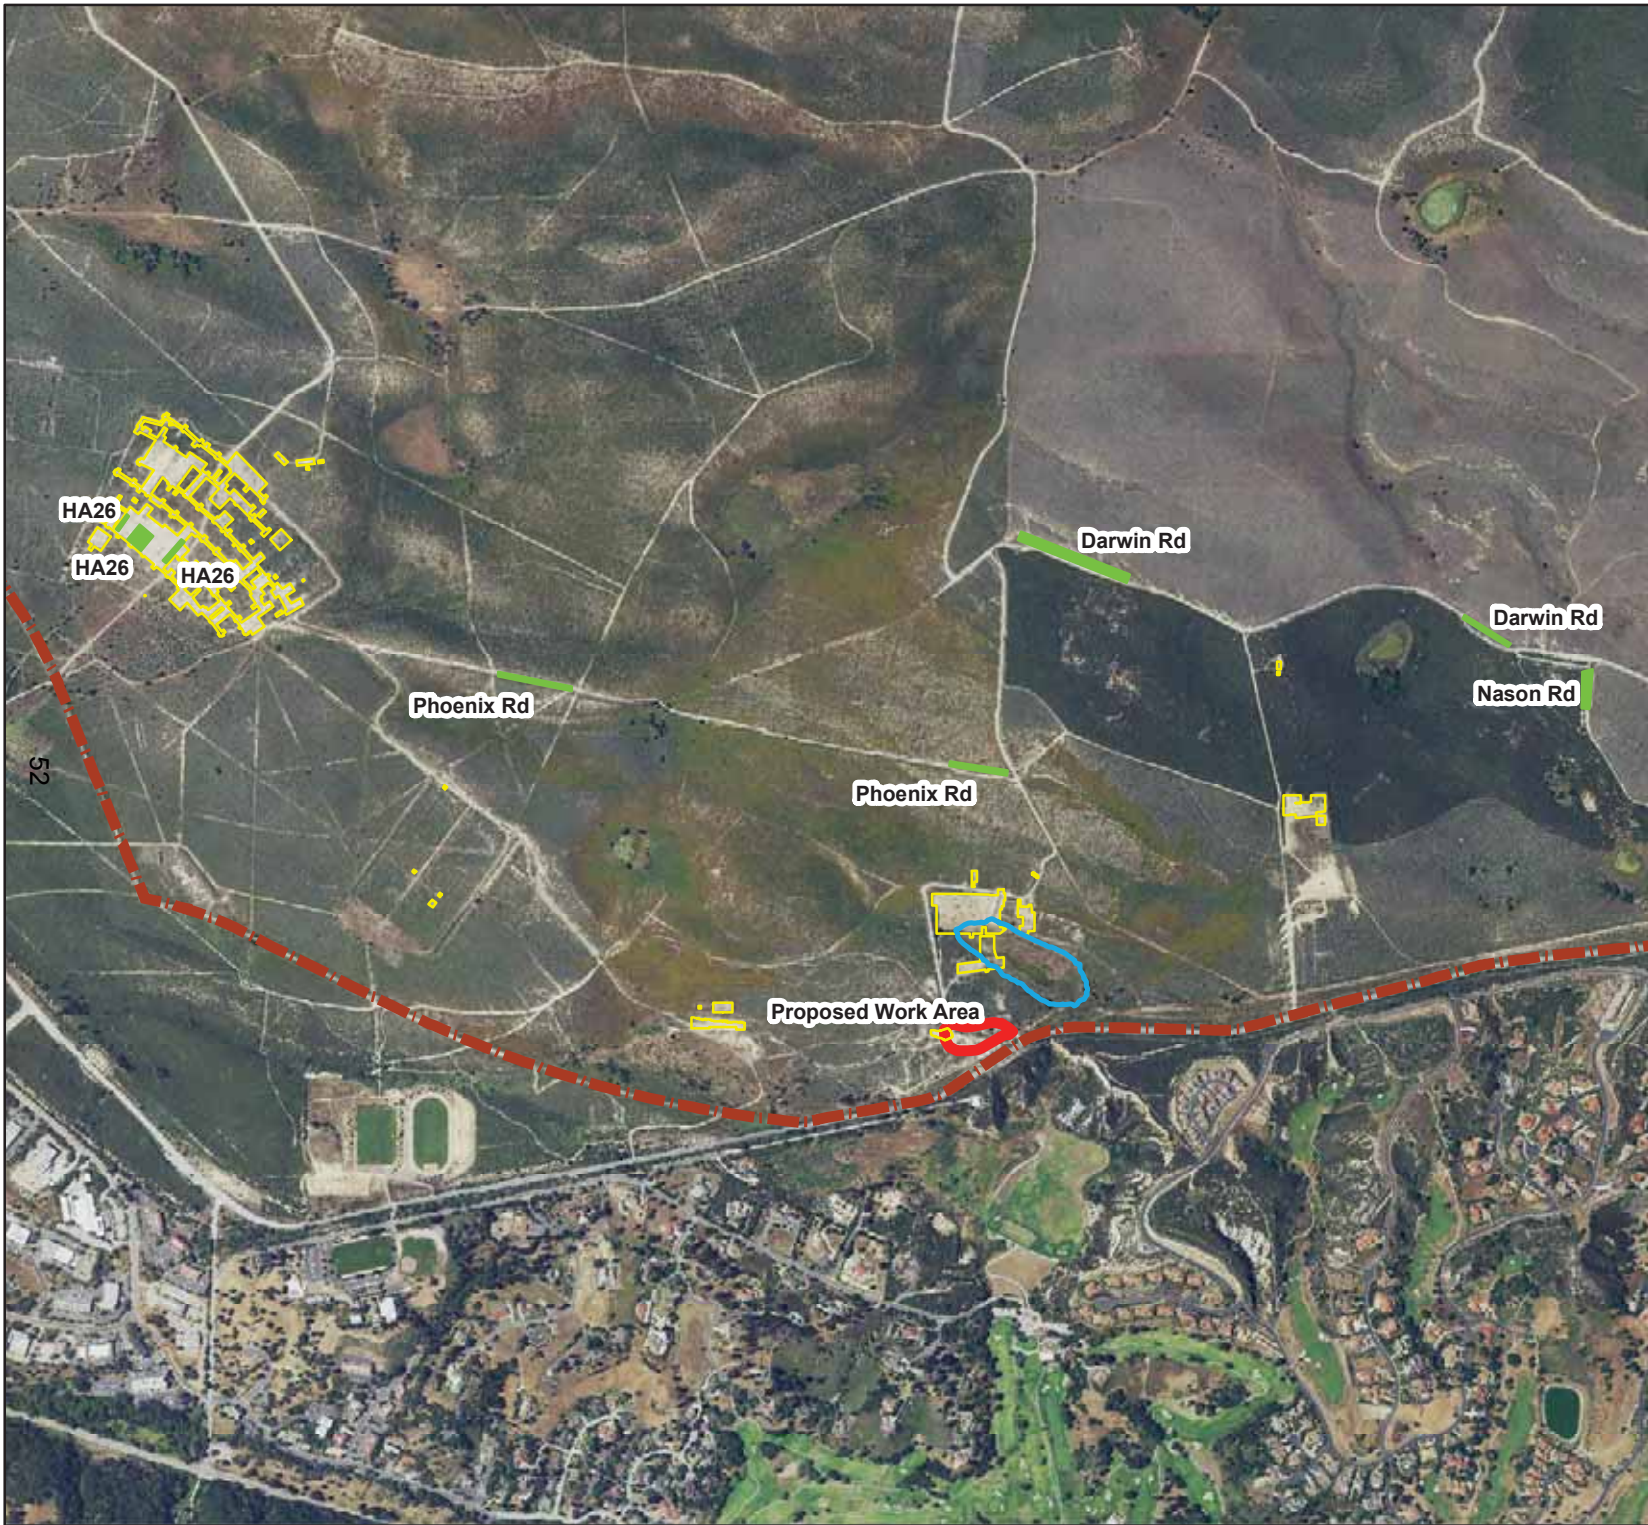
Figure 2

- Evolution Rd Stabilization Remedy**
-

PRINT DATE: 3/3/2017	SOURCE OF DATA: Fort Ord Geodatabase
AERIAL PHOTOGRAPHY:	SCALE: 1:16,000
DRAWN BY: Bartholomew.L.Kowalski@usace.army.mil	
FILE: G:\Temp\Bart\mxds\Evolution Reroute Borrow Site_Fig2.mxd

- Piling of cut vegetation in areas known to support Monterey spineflower and/or sand gilia (see Figure 2) shall be reduced to the greatest extent feasible. Boundaries of HMP grids near hand-cut areas shall be staked and flagged (pink and black striped flagging) prior to vegetation removal in the area to indicate areas that should be avoided to the greatest extent feasible.

- No work shall occur in flagged areas of Yadon's piperia or the grid containing Seaside bird's-beak until it has been determined by the Project biologist that the plants are no longer blooming and have set seed (approximately August/September) (see Figure 2).
