2019 ANNUAL REPORT
FORMER FORT ORD SITE 39 HABITAT RESTORATION
CONTRACT NO. W91238-18-D-0007
TASK ORDER W9123818F0090

US Army Corps of Engineers
Sacramento District
1325 J Street
Sacramento, CA 95814-2922

Burleson Consulting Inc.
1900 Garden Road, Suite 210
Monterey, CA 93940

April 2020

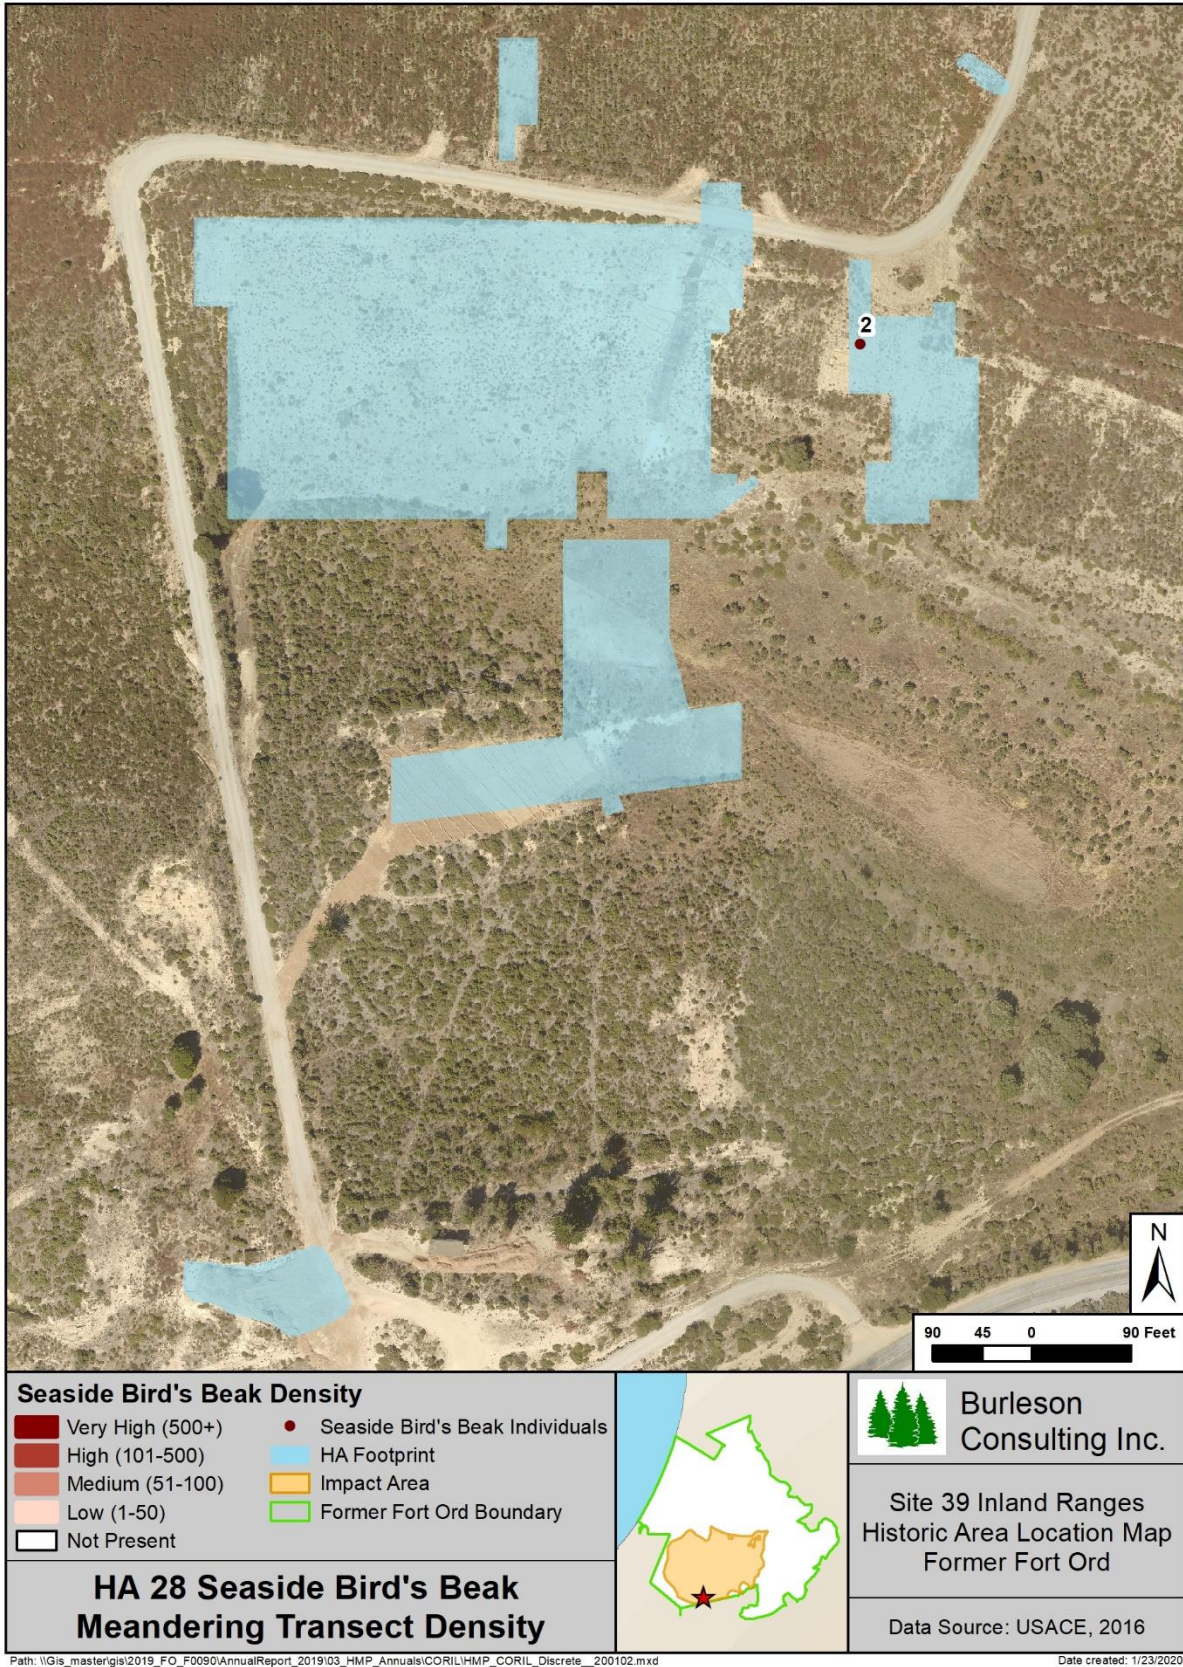
Figure 9-22. HA 28 Seaside Bird's Beak Meandering Transect Density Map

Two individual plants of seaside bird's beak were mapped (see Figure 9-22). Densities and acreages were not calculated because no discrete patches were observed. No seaside bird's beak was mapped in 2018 and it is not an SSRP required species at HA 28.

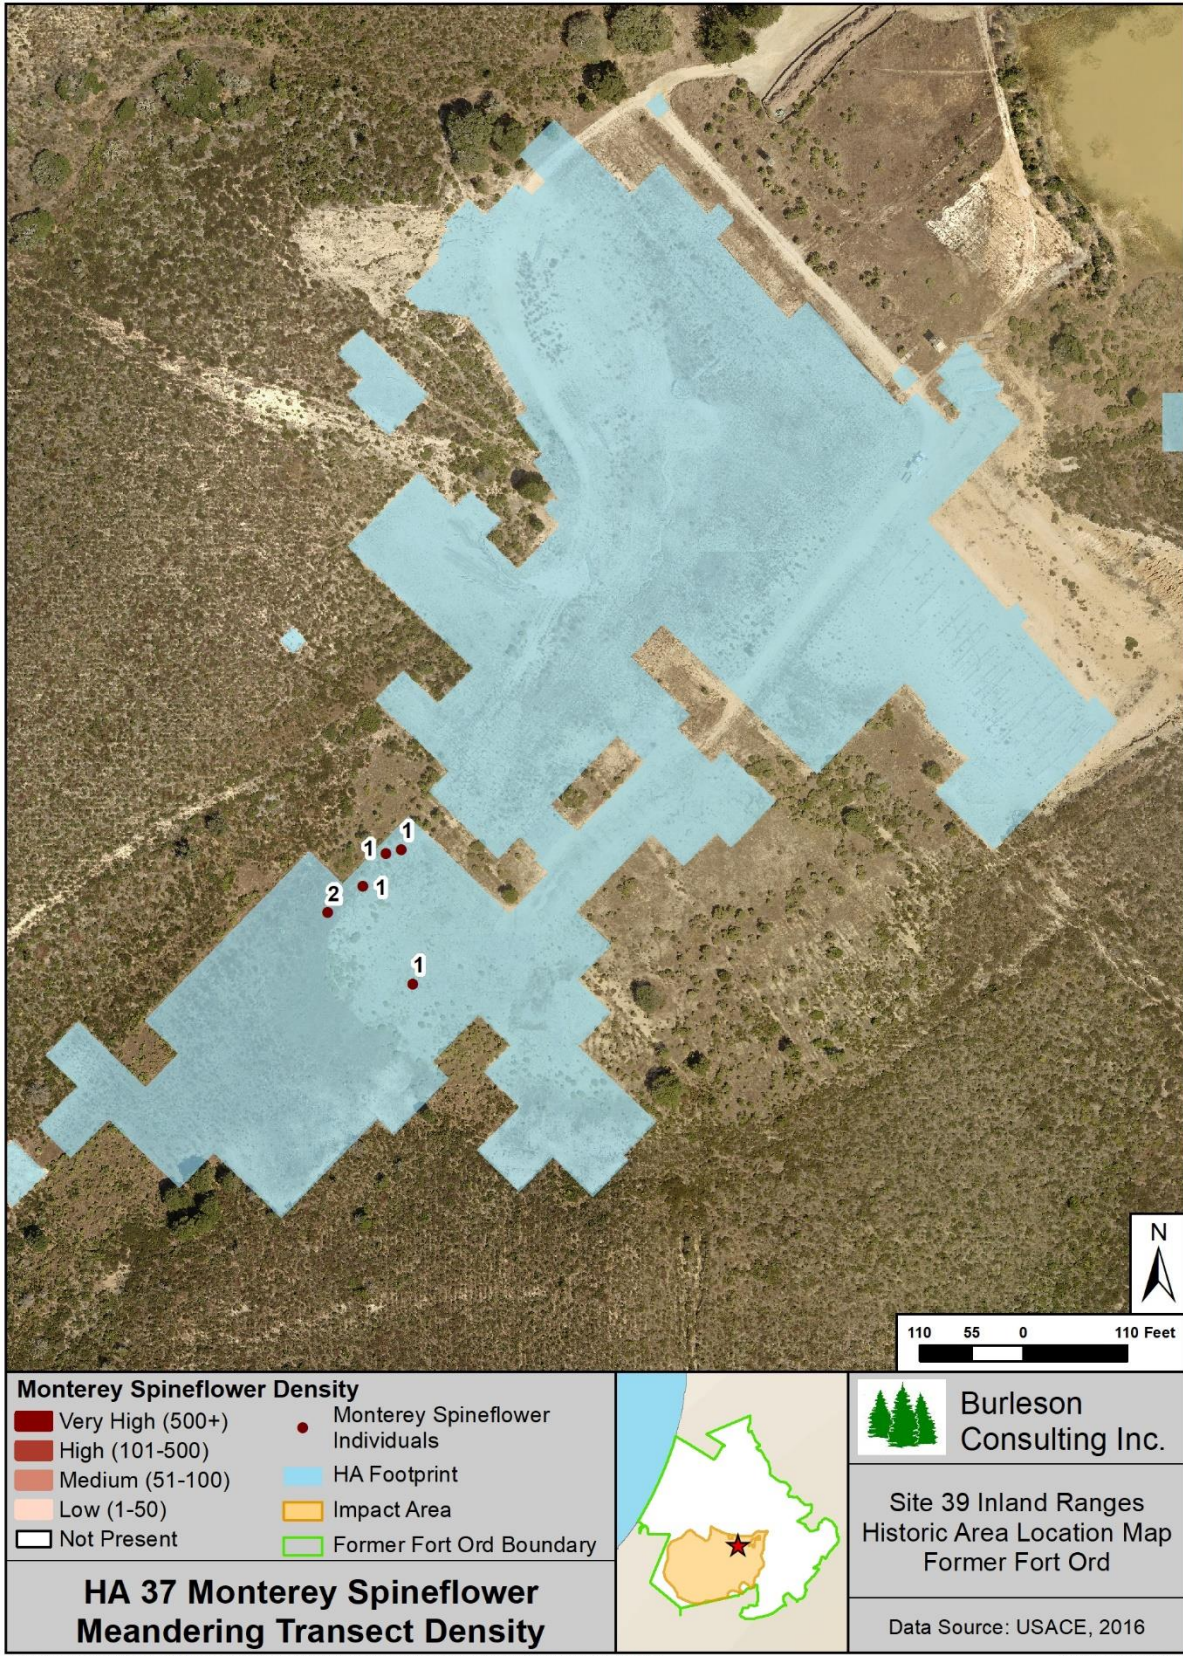
Figure 9-36. HA 37 Monterey Spineflower Meandering Transect Density Map

Six individual plants of Monterey spineflower were counted and mapped at HA 37 in 2019 (see Figure 9-36). Densities and acreages were not calculated because no discrete patches were observed. There were no individuals observed outside the restoration plot in 2018.

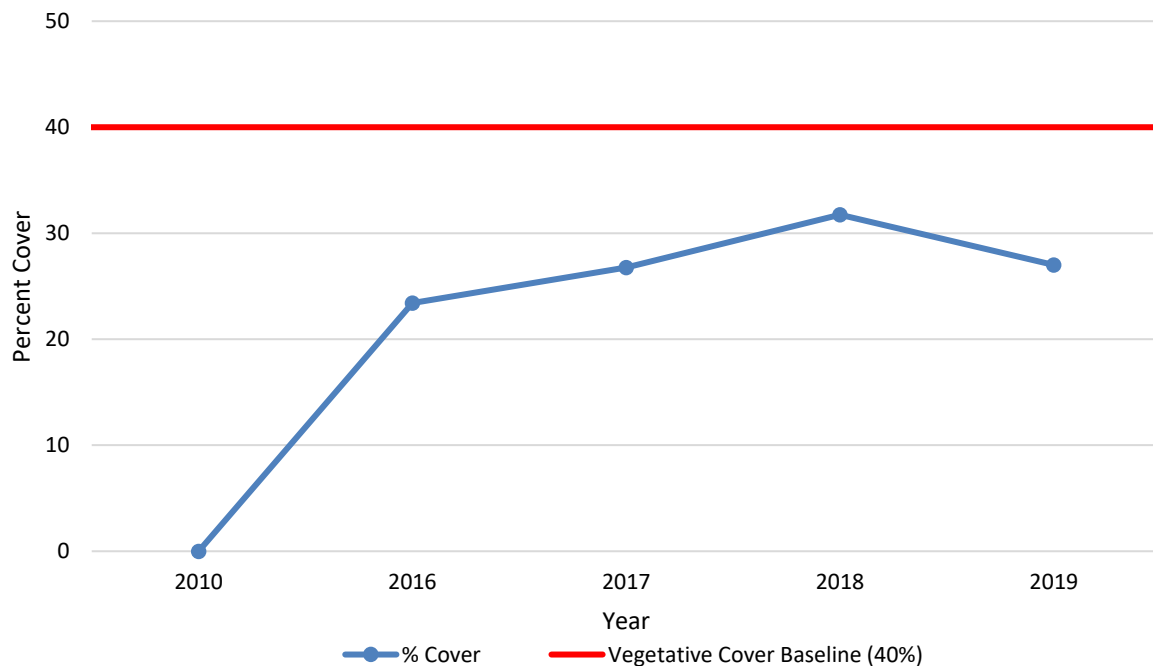
Figure 9-38. Native Vegetative Cover Compared to the Success Criterion at HA 37

Line-intercept transect surveys provide vegetative cover data for multiple objectives outlined in the SSRP. For Objective 1, the data must meet or exceed 40% for native species listed as part of the plant palette. This list includes 22 shrub and perennial species presented in Table 2 of the HA 37 SSRP (Burlison, 2013). Currently the HA contains 27.01% cover; therefore, this success criterion was not met. In 2018, vegetative cover was 31.74%; cover decreased by 4.74% (see Figure 9-38). The decrease in native species cover could in part be caused by an 8.85% decrease in deerweed from 2018 to 2019.

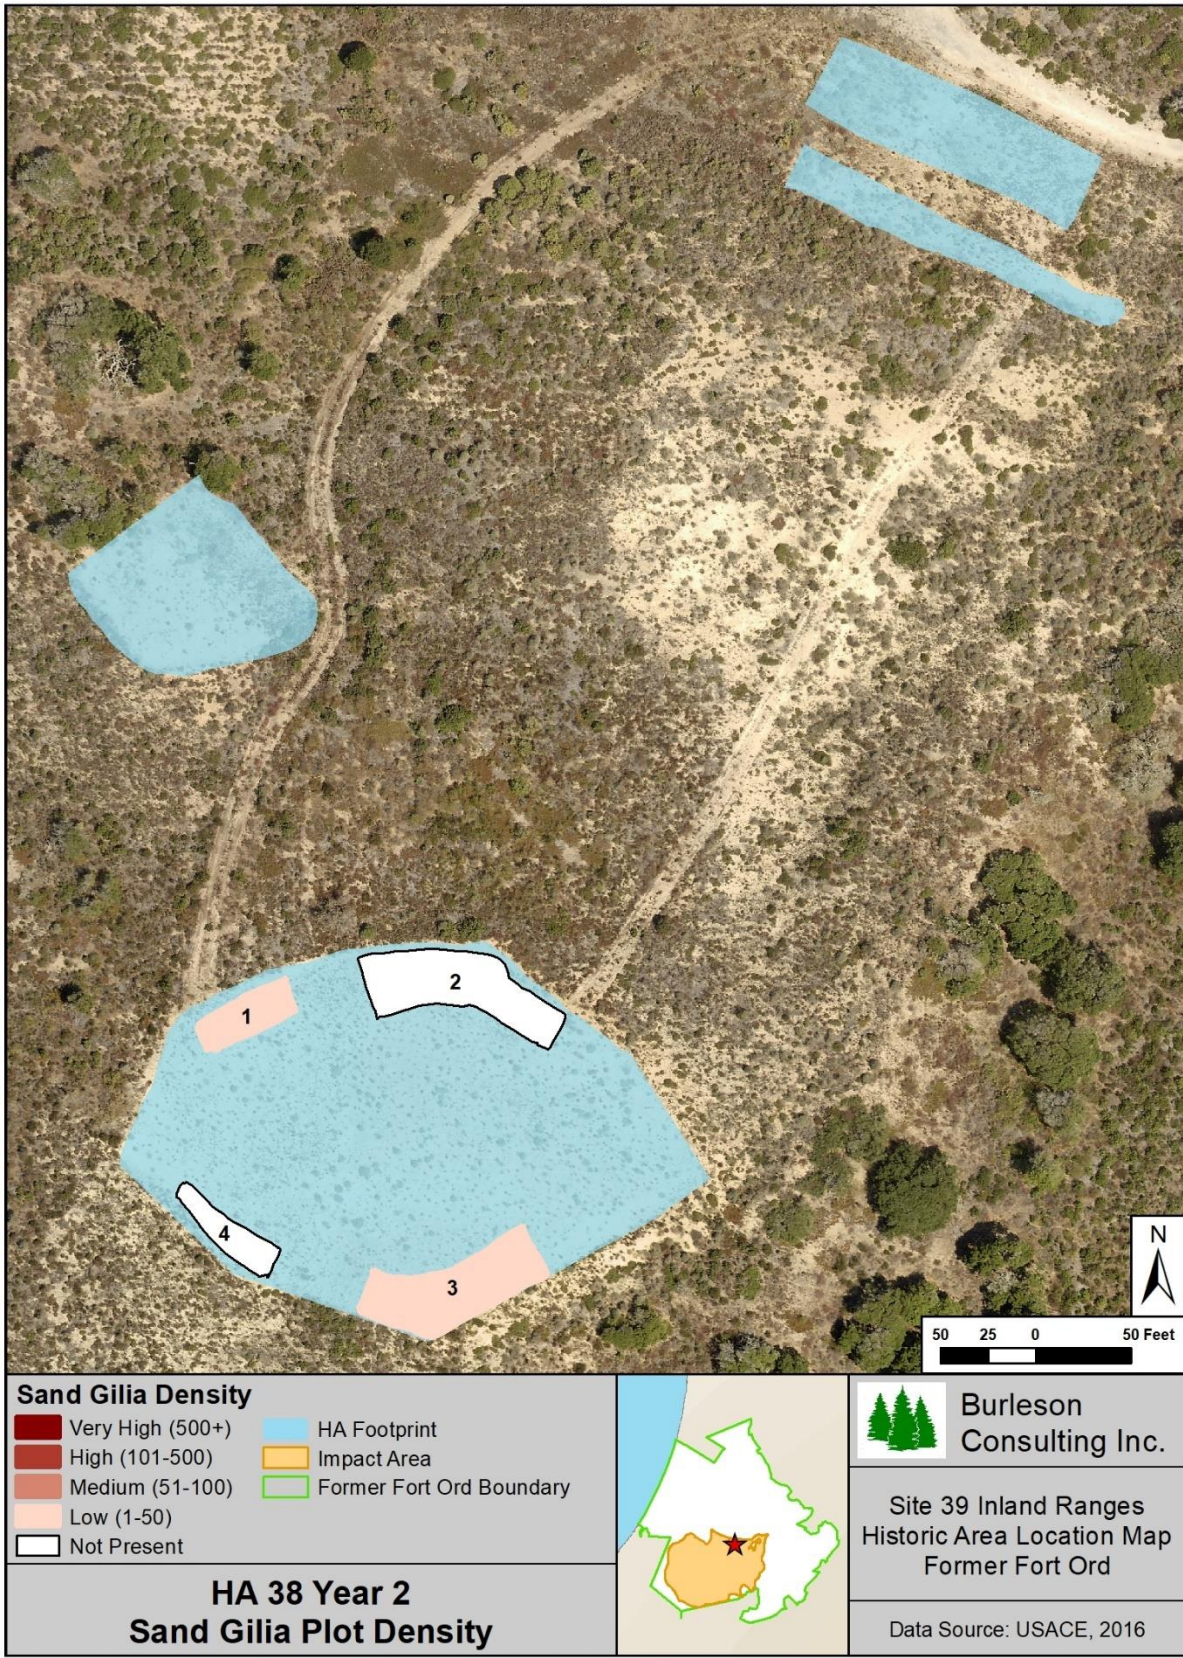
Figure 9-44. HA 38 Year 2 Sand Gilia Plot Density Map

Four sand gilia restoration plots were monitored for year 2 density at HA 38 in 2019. The plots are numbered 1-4 on Figure 9-44 and are located throughout HA 38. Sand gilia density was low at Plots 1 and 3. Sand gilia was not present at Plot 2 in year 2 where it was observed in year 1, and not at Plot 4 in either year. Figure 9-43 presents sand gilia restoration plot densities for HA 38.

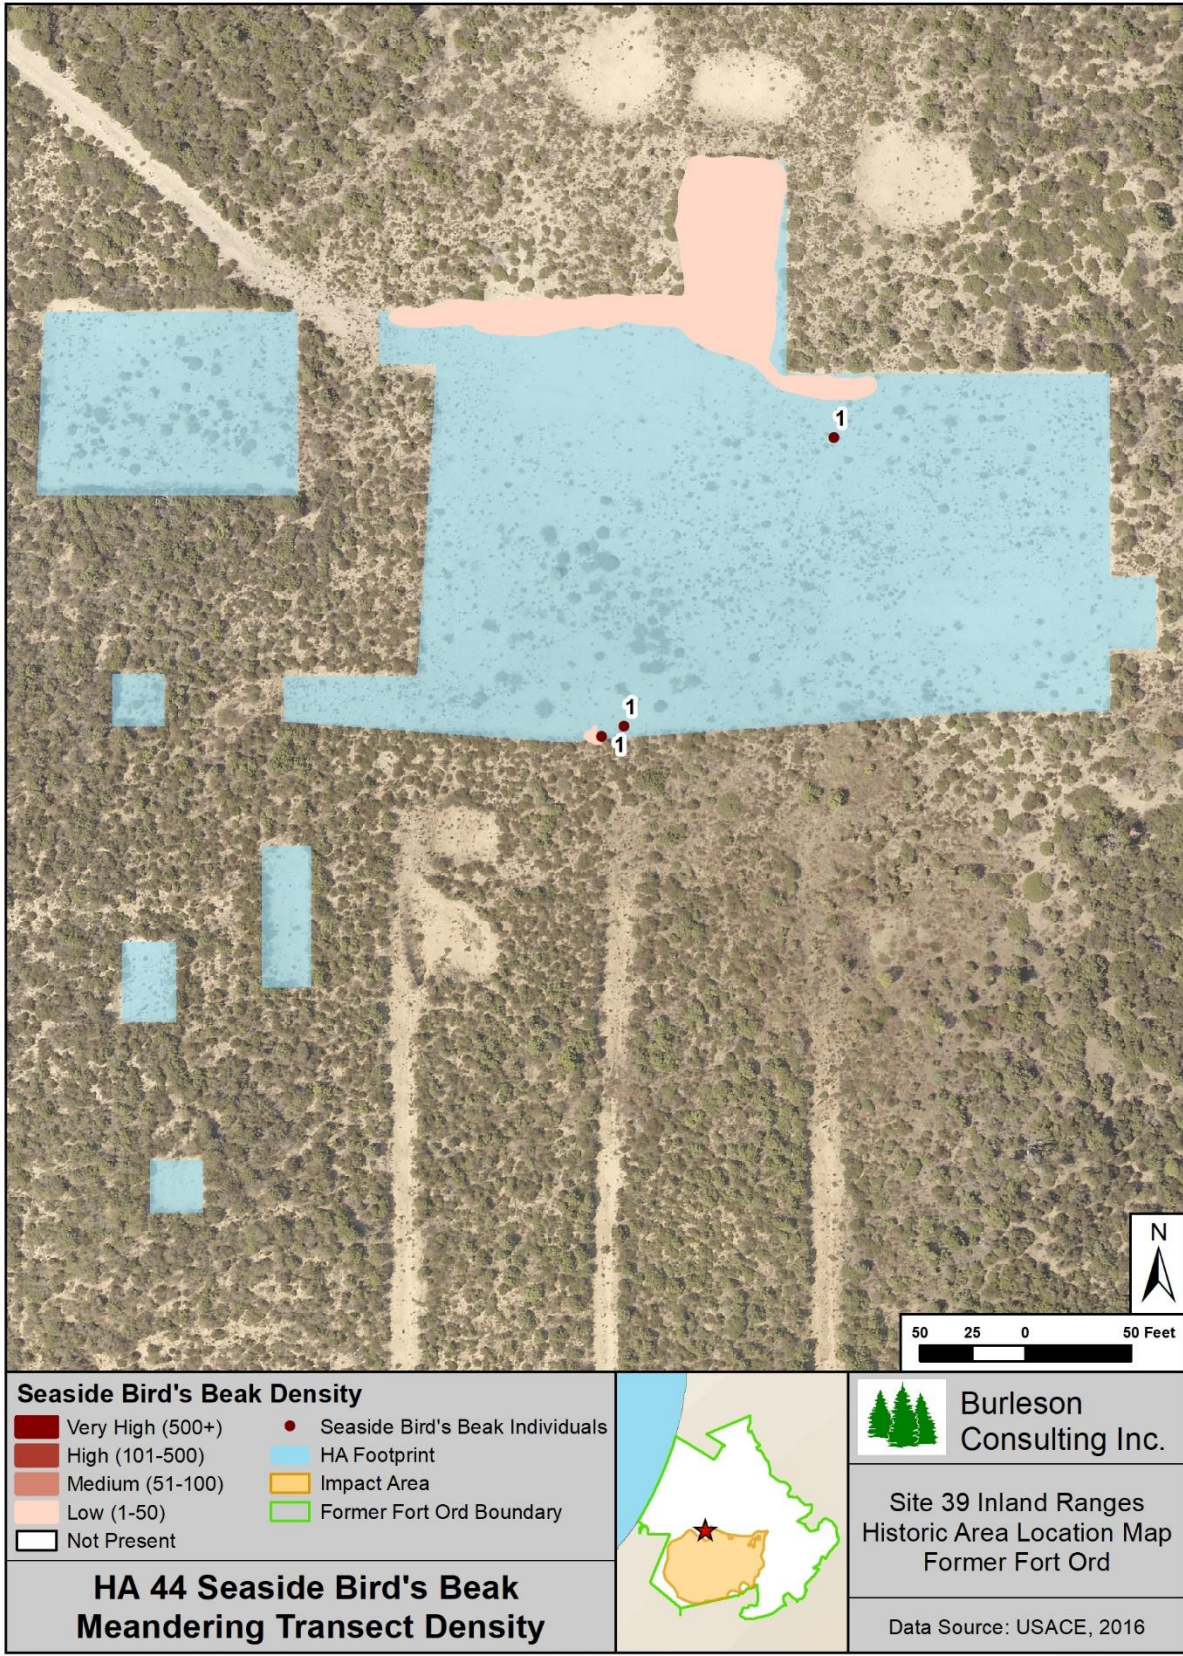
Figure 9-58. HA 44 Seaside Bird's Beak Meandering Transect Density Map

Three individual plants and two discrete patches of seaside bird's beak were mapped, and individuals counted within each patch (see Figure 9-58). The density was low and the total acreage of seaside bird's beak patches with a density at or above the SSRP baseline density class of low was 0.14 acre. From 2018 to 2019, the density range remained the same and acreage above the SSRP baseline increased.

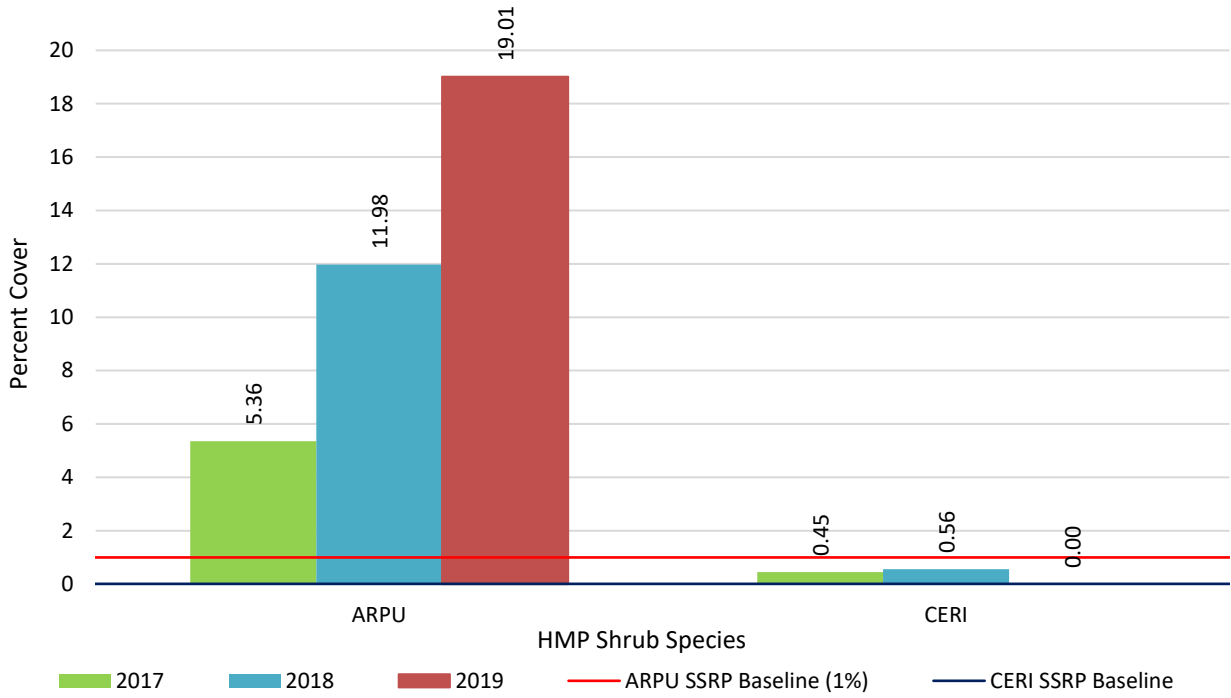
Figure 9-66. HMP Shrub Species Comparison to Success Criteria at HA 48

The decrease in Monterey ceanothus cover may be due to UXO cleanup activities. The area containing transect T01 was partially masticated, requiring replacement of the transect endpoint. The accuracy of the GPS unit used during replacement has an accuracy of ±1.0 m, which could cause the transect line to fall in a slightly different location. It is also possible that the Monterey ceanothus that was previously on the transect line was masticated. Monterey ceanothus was still present in the restoration area.

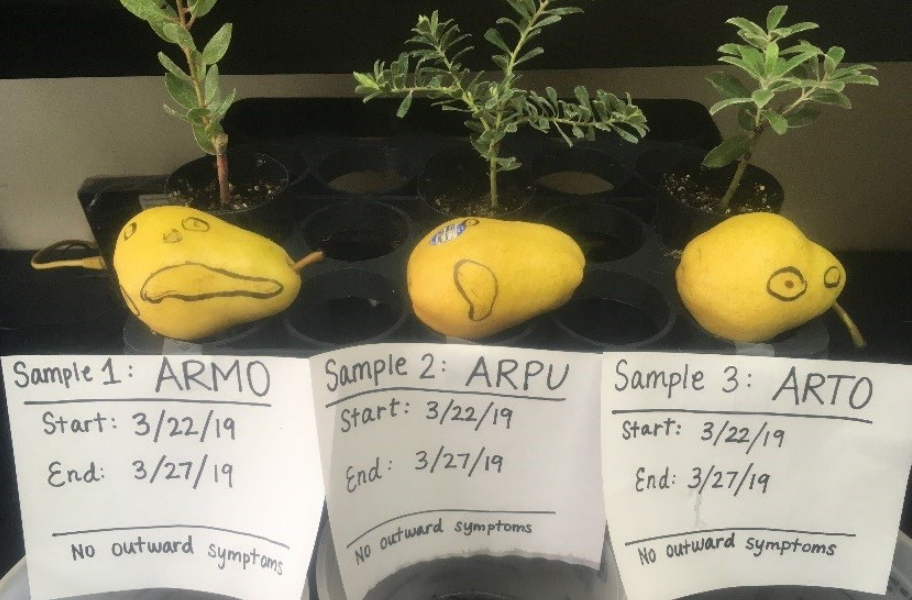
| Photo Description | Photo |
|--|--|
| <p>Burleson Carmel Valley Native Plant Nursery</p> <p>Negative results of the March pear test</p> <p>C-1</p> | <p>Sample 1: ARMO Start: 3/22/19 End: 3/27/19 No outward symptoms</p> <p>Sample 2: ARPU Start: 3/22/19 End: 3/27/19 No outward symptoms</p> <p>Sample 3: ARTO Start: 3/22/19 End: 3/27/19 No outward symptoms</p> |

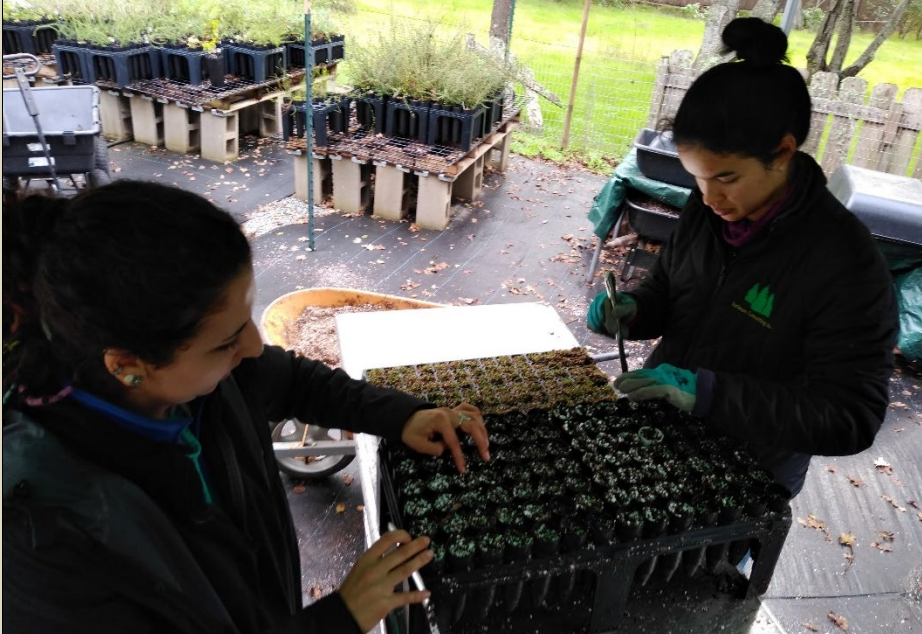
| Photo Description | Photo |
|---|---|
| <p>Plant Propagation</p> <p>Burleson biologists transplanting Eastwood's goldenbush</p> <p>C-15</p> | A photograph showing two individuals in a nursery setting. They are working with a large black tray filled with small, dark-colored plants. The background shows several other trays of plants on wooden pallets, suggesting a propagation or transplanting activity. |

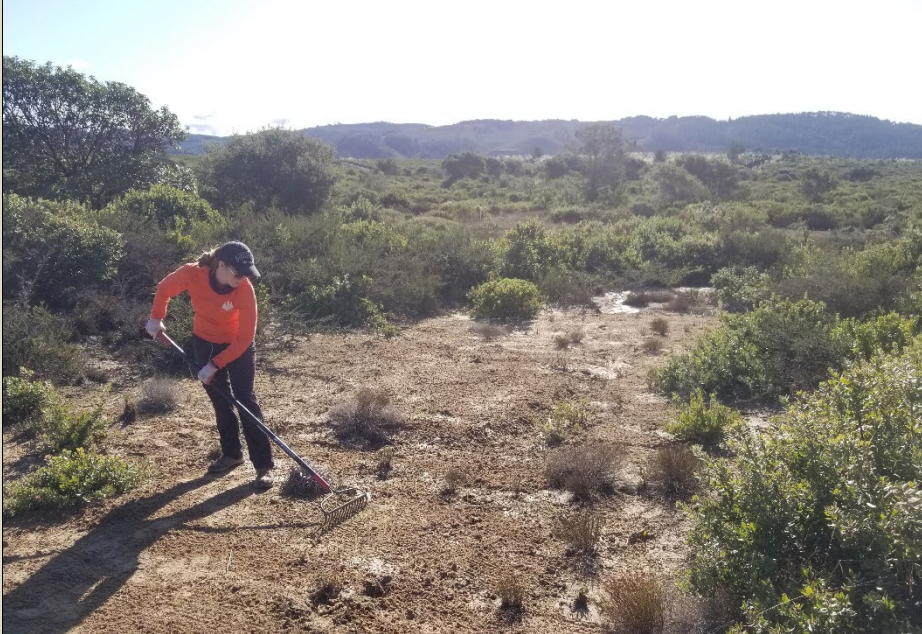
| Photo Description | Photo |
|--|---|
| <p>Passive Restoration</p> <p>Burleson biologist raking in seed at HA 26</p> <p>C-23</p> | |

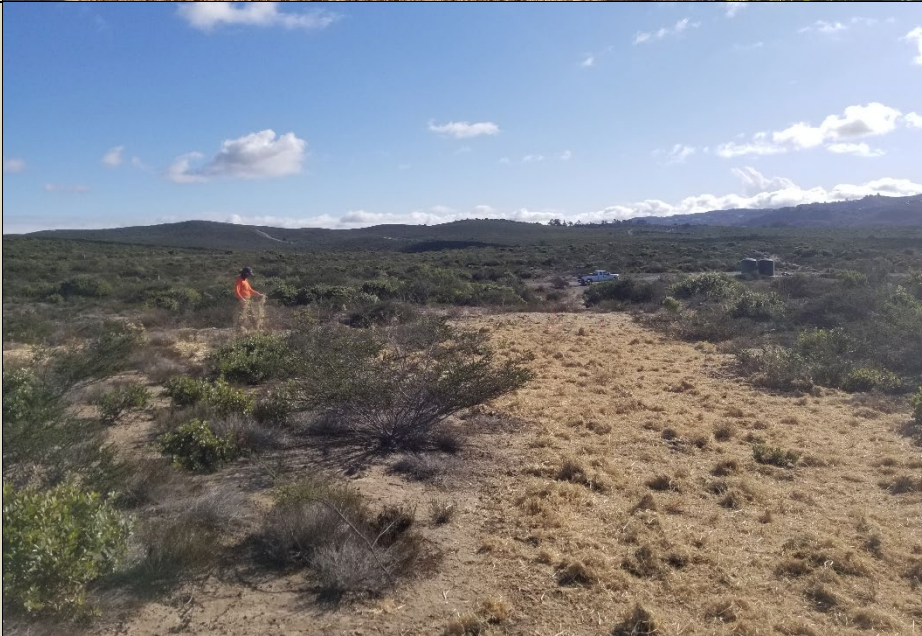
| Photo Description | Photo |
|--|---|
| <p>Passive Restoration</p> <p>Burleson biologist covering seed with straw at HA 26</p> <p>C-24</p> | |

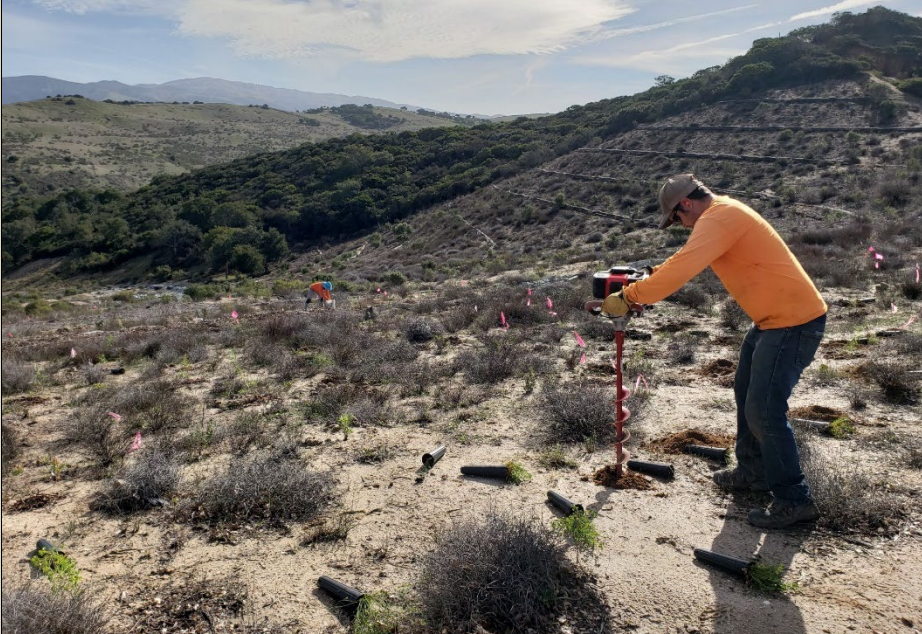
| Photo Description | Photo |
|--|--|
| <p>Active Restoration</p> <p>Burleson biologist using an auger for plant installation at HA 34</p> <p>C-33</p> | A biologist wearing an orange long-sleeved shirt, blue jeans, and a cap is using a red auger to install a plant in a field. The field is covered with dry brush and small green plants. In the background, there are rolling hills under a blue sky with some clouds. |

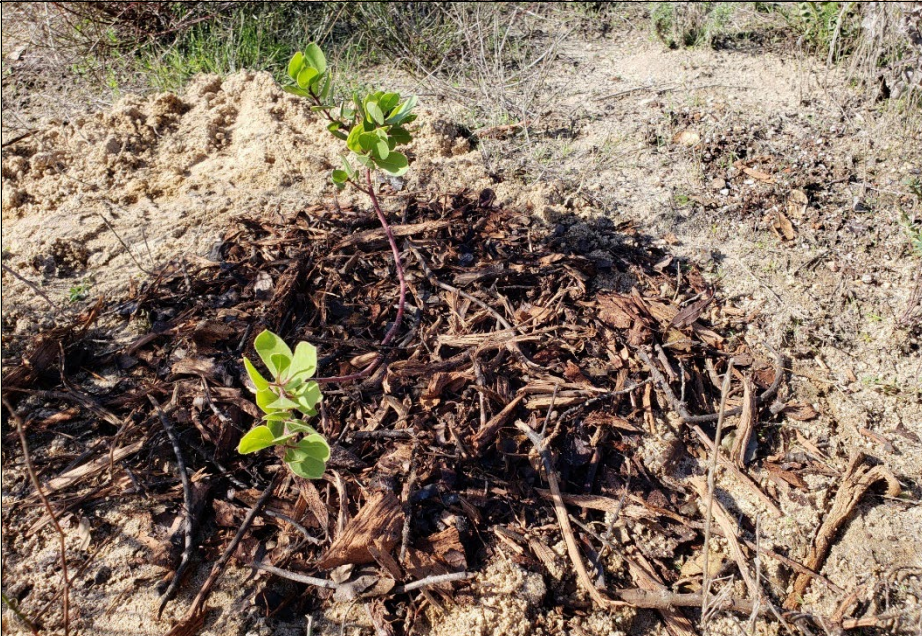
| Photo Description | Photo |
|--|--|
| <p>Active Restoration</p> <p>Finished plant installation at HA 34</p> <p>C-34</p> | A close-up view of a young plant with green leaves growing in a mulched area. The mulch is made of dry sticks and twigs. The ground is sandy and rocky. |

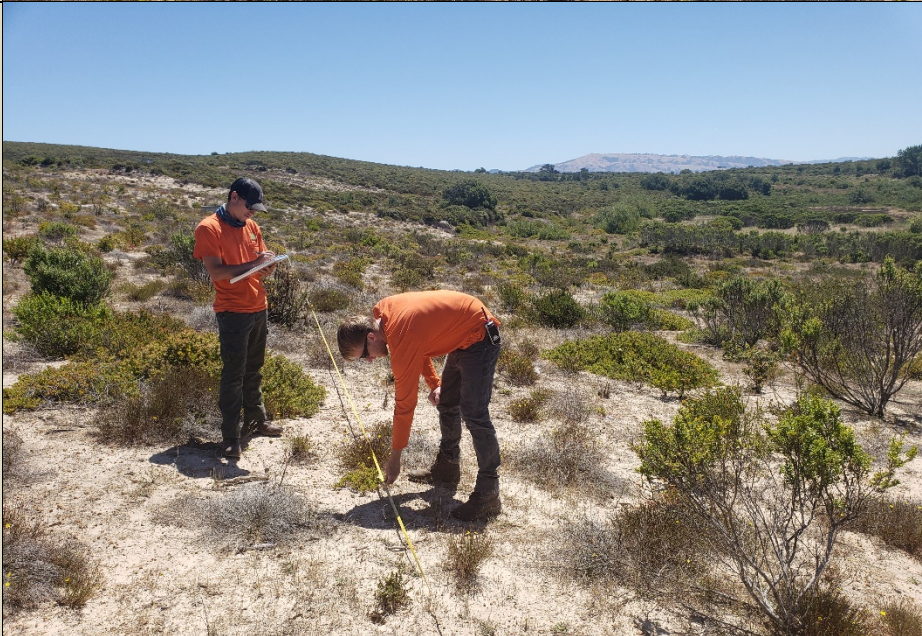
| Photo Description | Photo |
|--|--|
| <p>Monitoring</p> <p>Burleson biologists conducting vegetative cover transect surveys</p> <p>C-38</p> | <p>A photograph showing two people in orange shirts and dark pants conducting a survey in a field of low-lying vegetation. One person is standing and holding a clipboard, while the other is bent over, measuring a plant with a yellow measuring tape. The background shows a vast, open landscape under a clear blue sky.</p> |

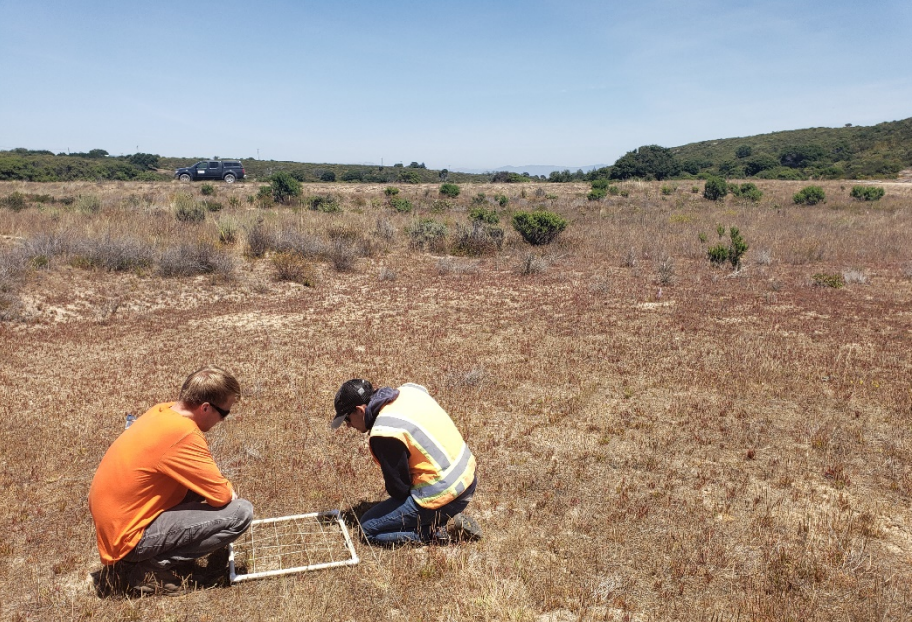
| Photo Description | Photo |
|--|---|
| <p>Monitoring</p> <p>Burleson biologists conducting vegetative cover quadrat surveys</p> <p>C-39</p> | A wide-angle photograph of a field with sparse, dry vegetation. Two individuals are kneeling on the ground, working with a white quadrat frame. One person is wearing an orange shirt, and the other is wearing a high-visibility yellow vest over a dark shirt. In the background, a dark vehicle is parked on a dirt path, and a clear blue sky is visible above a distant horizon line. |

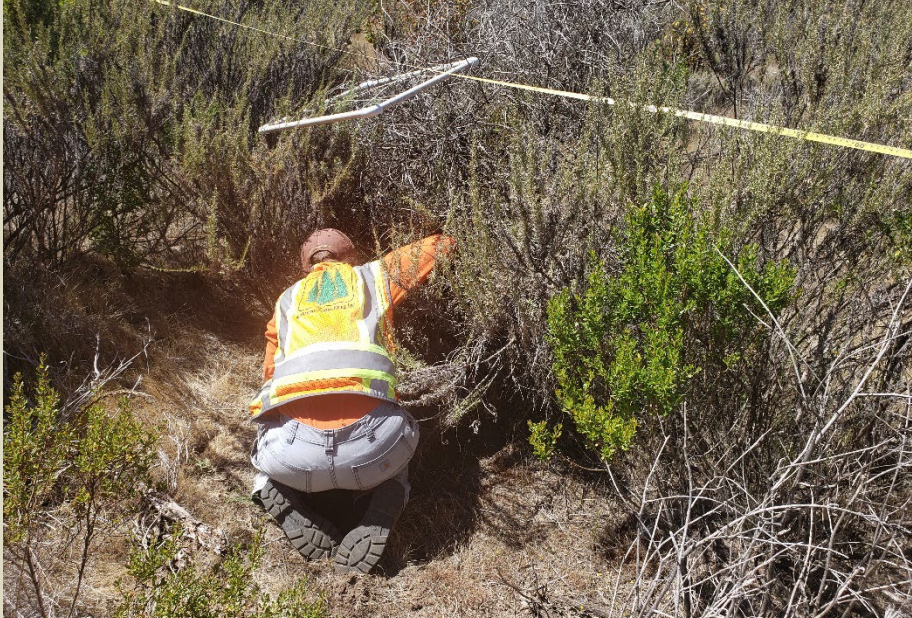
| Photo Description | Photo |
|--|---|
| <p>Monitoring</p> <p>Burleson biologist conducting vegetative cover quadrat survey in shrubs</p> <p>C-40</p> | A close-up photograph of a biologist wearing a high-visibility yellow vest and a hat, kneeling in a dense thicket of shrubs. The biologist is positioned behind a white quadrat frame. A yellow caution tape is stretched across the scene, marking the survey area. The vegetation consists of various green and brown shrubs. |

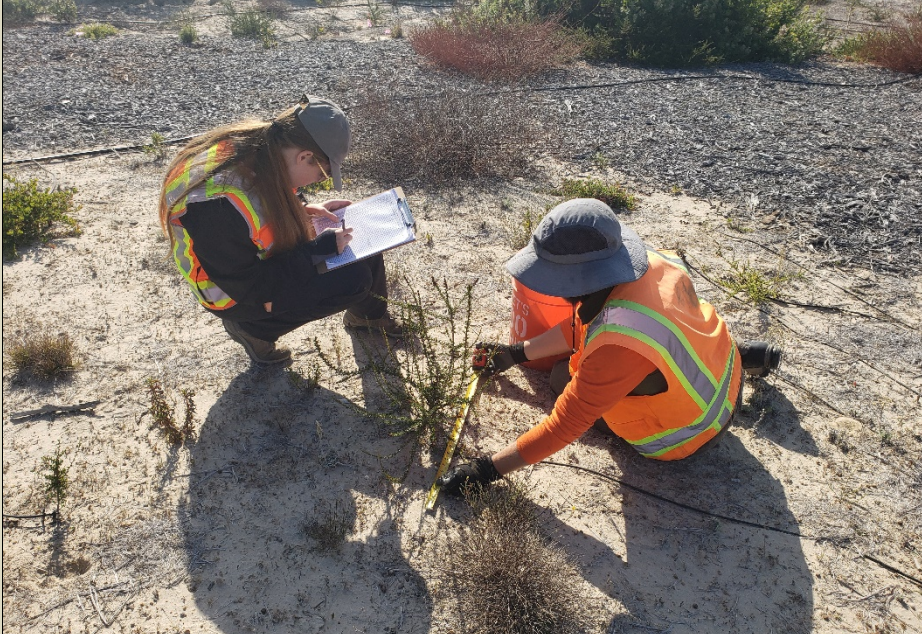
| Photo Description | Photo |
|--|--|
| <p>Monitoring</p> <p>Burleson biologists conducting plant survivorship surveys</p> <p>C-41</p> | A photograph showing two individuals in safety vests and hats working in a field. One person is kneeling and holding a clipboard, while the other is kneeling and measuring a small plant with a yellow measuring tape. The ground is sandy and sparsely vegetated. |

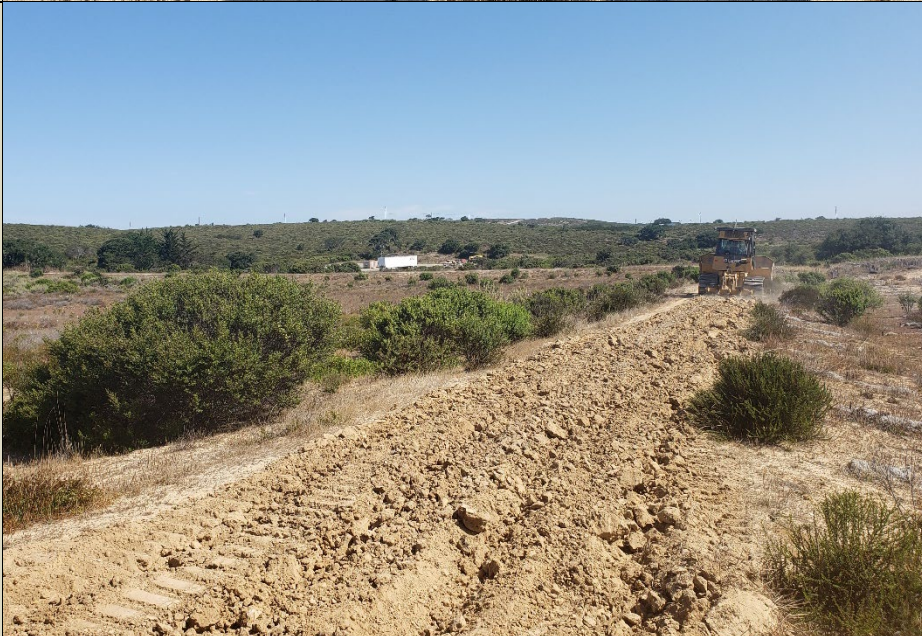
| Photo Description | Photo |
|--|--|
| <p>Erosion Control Repairs</p> <p>Bulldozer ripping access road at HA 37</p> <p>C-42</p> | A wide-angle photograph of a dirt road under construction or repair. A bulldozer is visible in the distance, working on the road. The surrounding area is a flat, open field with sparse vegetation under a clear blue sky. |

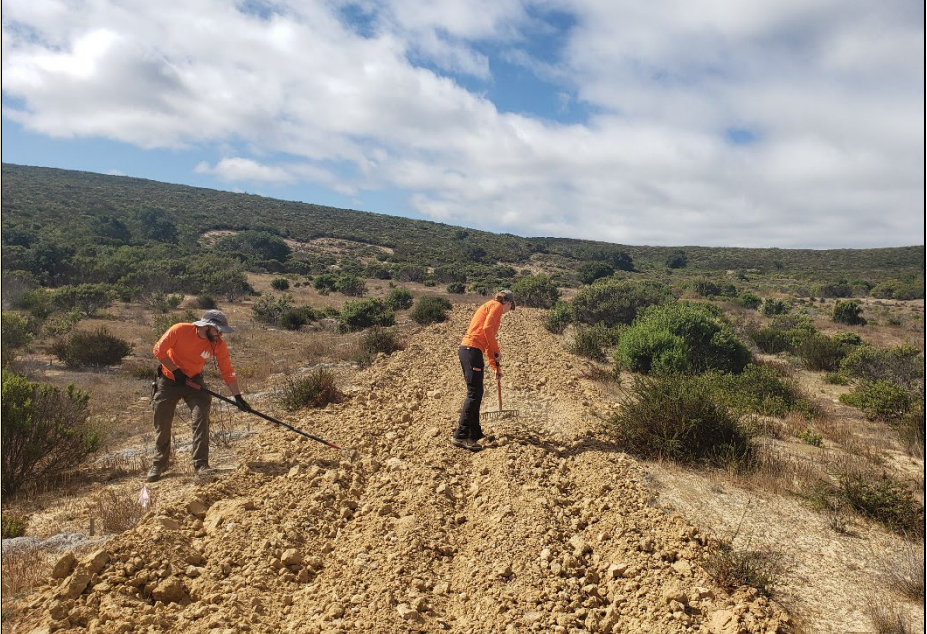
| Photo Description | Photo |
|--|---|
| <p>Erosion Control Repairs</p> <p>Burleson biologists raking production seed into access road at HA 37</p> <p>C-43</p> | A photograph showing two workers in orange shirts and hats raking a dirt path in a field. The path is made of loose soil and is being prepared for seed. The background shows a hilly landscape with sparse vegetation under a blue sky with scattered clouds. |

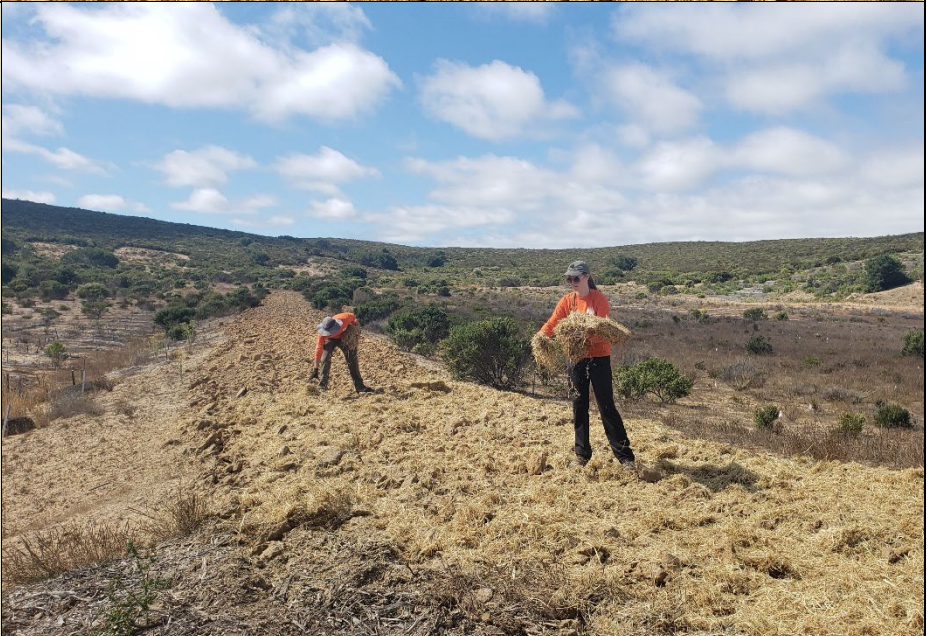
| Photo Description | Photo |
|--|---|
| <p>Erosion Control Repairs</p> <p>Burleson biologists covering seed with straw</p> <p>C-44</p> | A photograph showing two workers in orange shirts and hats covering a dirt path with straw. One worker is in the foreground holding a large bundle of straw, while the other is further down the path. The path is covered with a layer of straw. The background shows a hilly landscape with sparse vegetation under a blue sky with scattered clouds. |

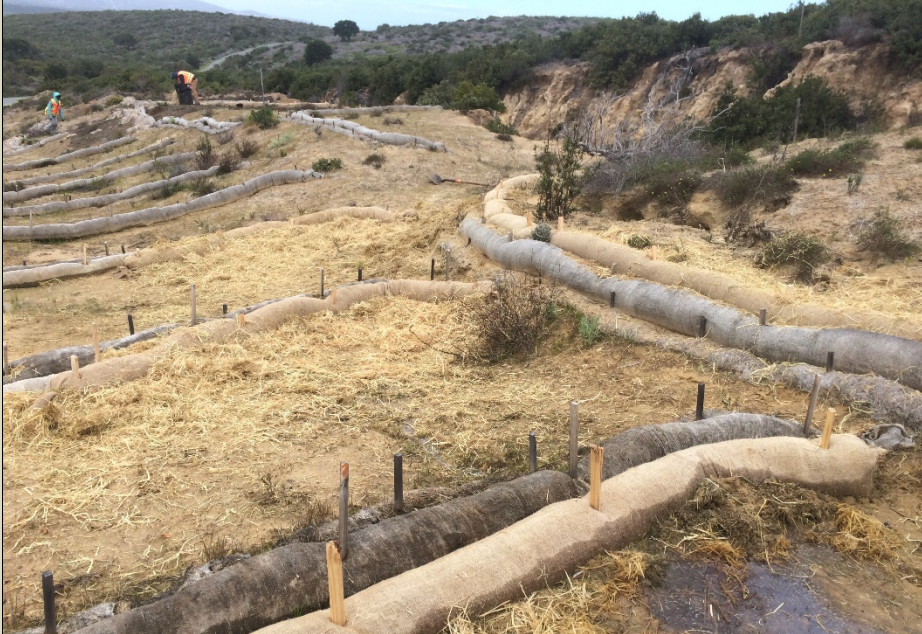
| Photo Description | Photo |
|--|---|
| <p>Erosion Control Repairs</p> <p>Wattles installed at HA 27A</p> <p>C-45</p> | |

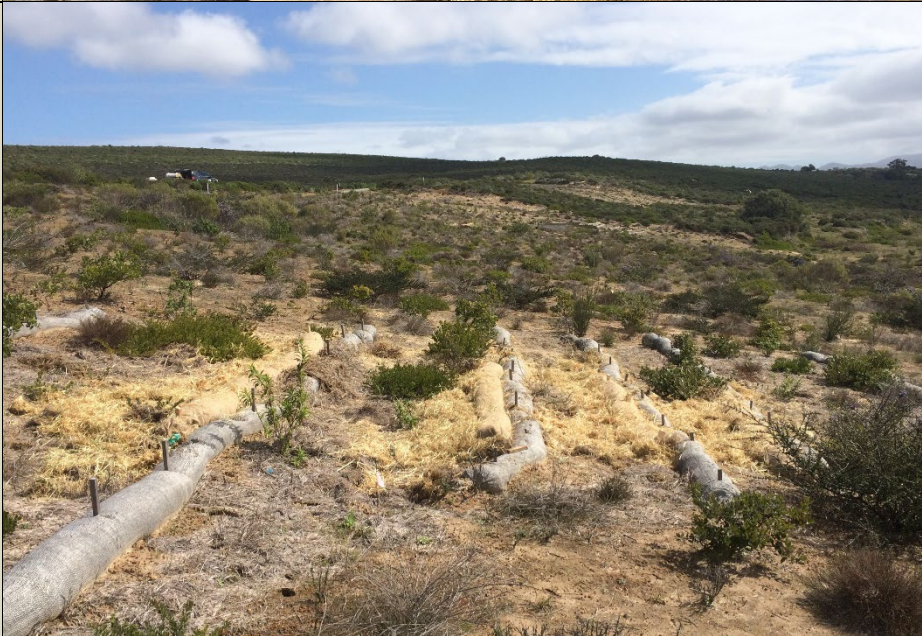
| Photo Description | Photo |
|--|---|
| <p>Erosion Control Repairs</p> <p>Wattle installation and rill repair at HA 28</p> <p>C-46</p> | |

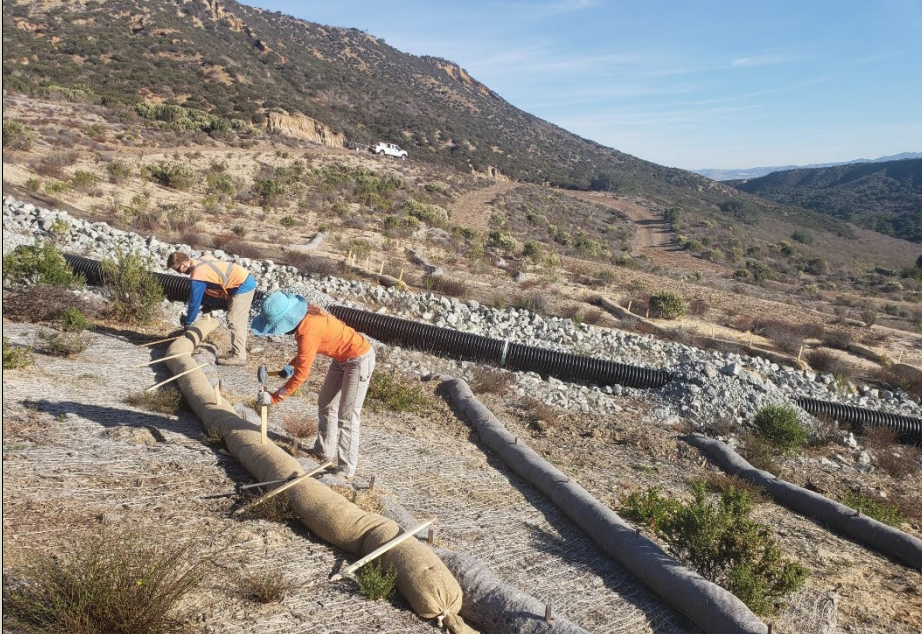
| Photo Description | Photo |
|---|---|
| <p>Erosion Control Repairs</p> <p>Burleson biologists installing wattles at HA 34</p> <p>C-47</p> | A photograph showing two workers in orange shirts and blue hats installing long, cylindrical erosion control wattles on a dry, rocky hillside. The background features a large, rocky mountain under a clear blue sky. |

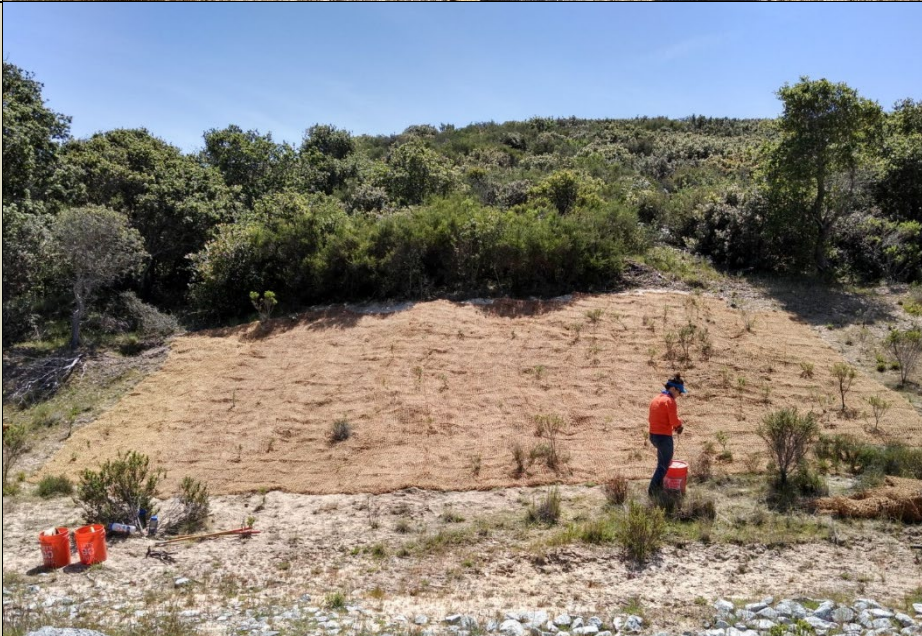
| Photo Description | Photo |
|---|---|
| <p>Erosion Control Repairs</p> <p>Installation of coir fabric at HA 34</p> <p>C-48</p> | A photograph showing a worker in an orange shirt and blue hat installing coir fabric on a hillside. The fabric is laid out in a grid pattern on the ground. In the foreground, there are several orange buckets and some tools. The background shows a dense forest of green trees. |

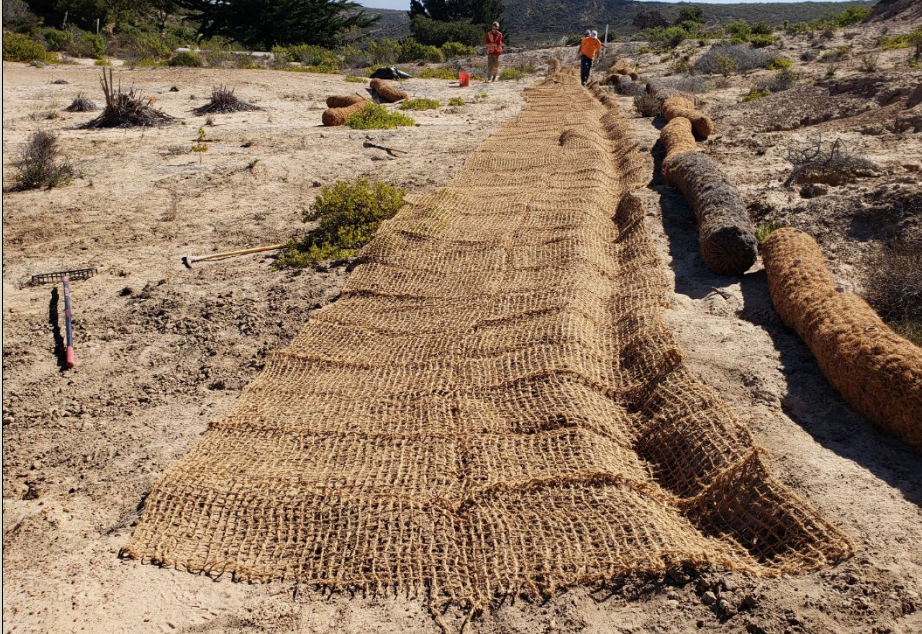
| Photo Description | Photo |
|---|---|
| <p>Erosion Control Repairs</p> <p>Installation of coir fabric and logs at HA 36</p> <p>C-49</p> | A wide-angle photograph showing a long, narrow path of erosion control fabric and logs laid out on a dry, sandy slope. The fabric is a light brown, woven material, and the logs are large, dark brown logs. The path is flanked by dry, sandy soil and sparse vegetation. In the background, two workers in orange shirts are visible, and the terrain is hilly and arid. |
