2019 ANNUAL REPORT
FORMER FORT ORD SITE 39 HABITAT RESTORATION
CONTRACT NO. W91238-18-D-0007
TASK ORDER W9123818F0090

US Army Corps of Engineers
Sacramento District
1325 J Street
Sacramento, CA 95814-2922

Burleson Consulting Inc.
1900 Garden Road, Suite 210
Monterey, CA 93940

April 2020

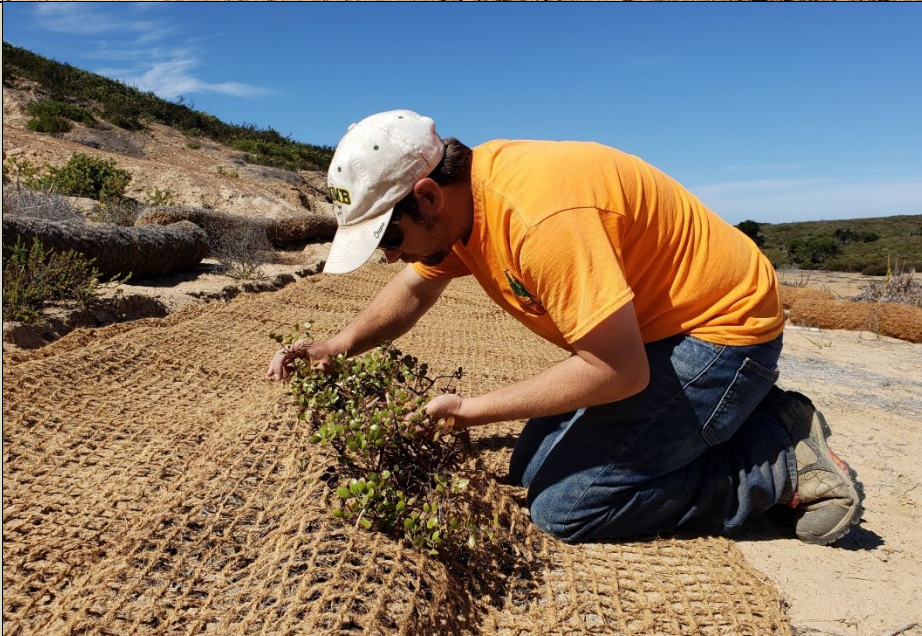
| Photo Description | Photo |
|---|---|
| <p>Erosion Control Repairs</p> <p>Burleson biologist installing fabric around established plants at HA 36</p> <p>C-50</p> | A close-up photograph of a biologist in an orange shirt and white cap kneeling on the ground, installing fabric around a small plant. The biologist is wearing a white cap with 'BMB' on it. The fabric is a light brown, woven material, and the plant is a small, green, leafy shrub. The background shows a dry, sandy slope with sparse vegetation. |

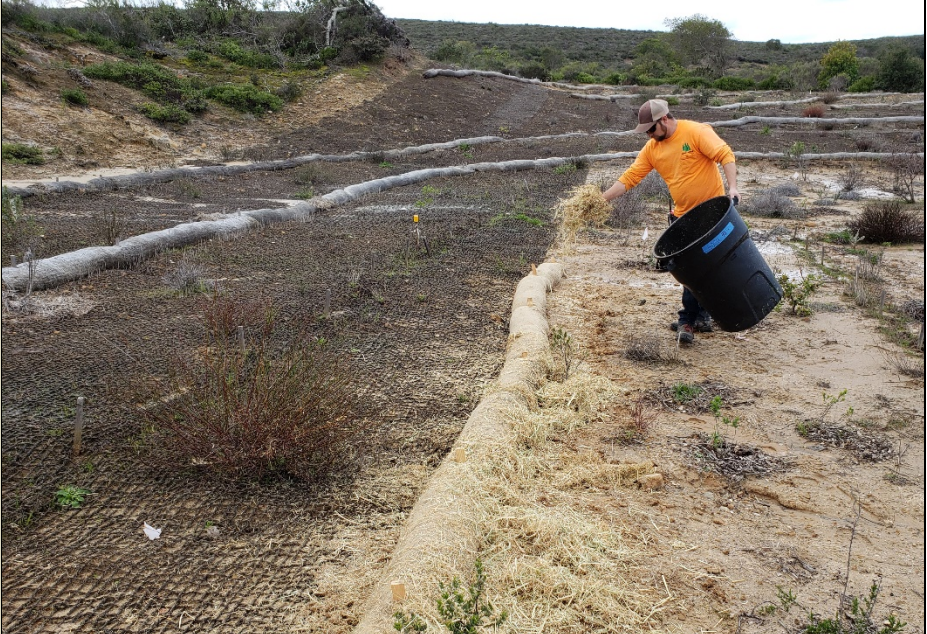
| Photo Description | Photo |
|---|--|
| <p>Erosion Control Repairs</p> <p>Burleson biologist covering seed at the base of wattle installation</p> <p>C-51</p> | A biologist wearing an orange long-sleeved shirt and a cap is kneeling on a dirt path, spreading straw or hay over a wattle installation. The wattle is made of logs laid across a slope. The background shows a dry, hilly landscape with sparse vegetation. |

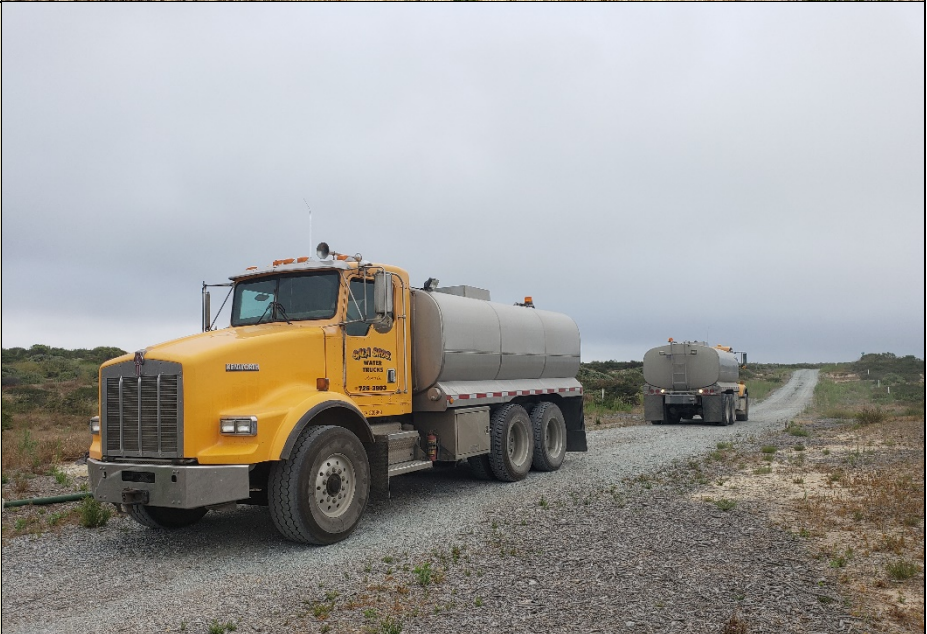
| Photo Description | Photo |
|---|--|
| <p>Irrigation</p> <p>Sala Brothers Water Trucking filling up water tanks at HA 26</p> <p>C-52</p> | A large yellow water truck with a silver tank is parked on a gravel road. Another similar truck is visible in the distance. The sky is overcast and the surrounding area is a dry, open field. |

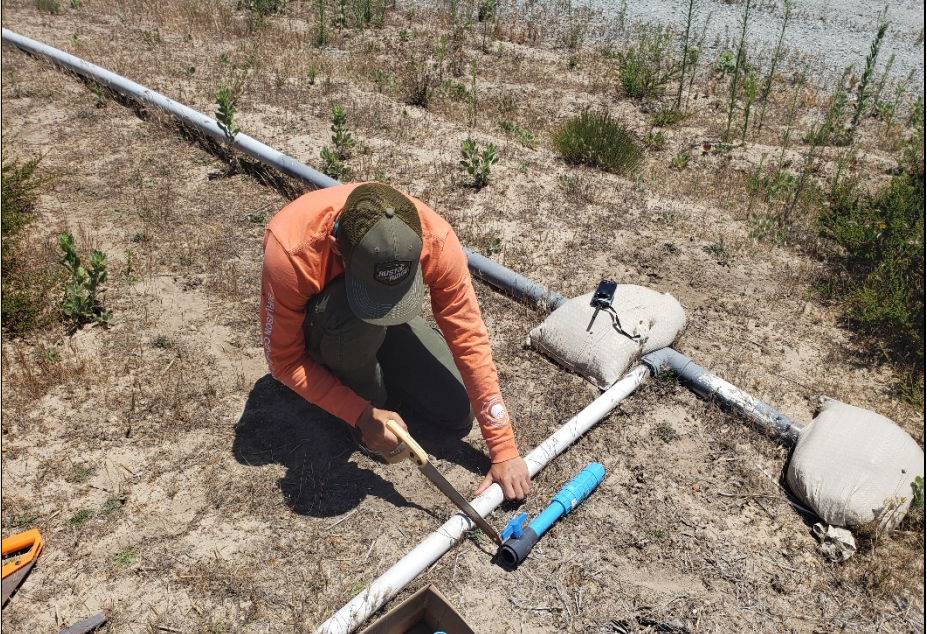
| Photo Description | Photo |
|--|---|
| <p>Irrigation</p> <p>Burleson biologist installing a ball valve to a lateral line on the western side of the irrigation system</p> <p>C-53</p> | |

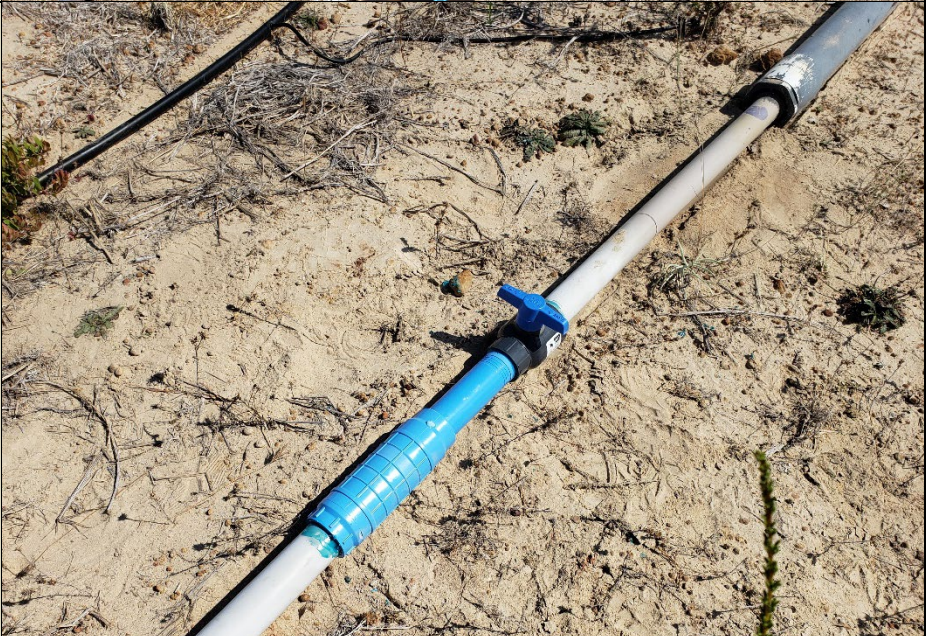
| Photo Description | Photo |
|--|---|
| <p>Irrigation</p> <p>Installed ball valve on lateral line</p> <p>C-54</p> | |

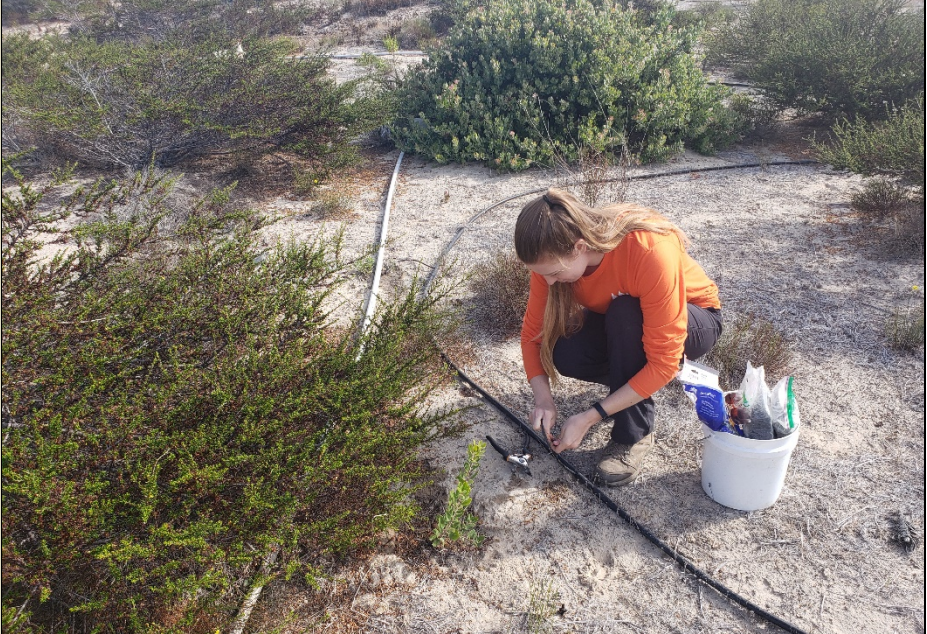
| Photo Description | Photo |
|--|--|
| <p>Irrigation</p> <p>Burleson biologist repairing an emitter</p> <p>C-55</p> | A biologist wearing an orange long-sleeved shirt and dark pants is kneeling on sandy ground. She is focused on repairing a black emitter connected to a drip irrigation line. A white bucket containing various supplies is placed on the ground to her right. The background shows sparse, low-lying vegetation and a clear sky. |

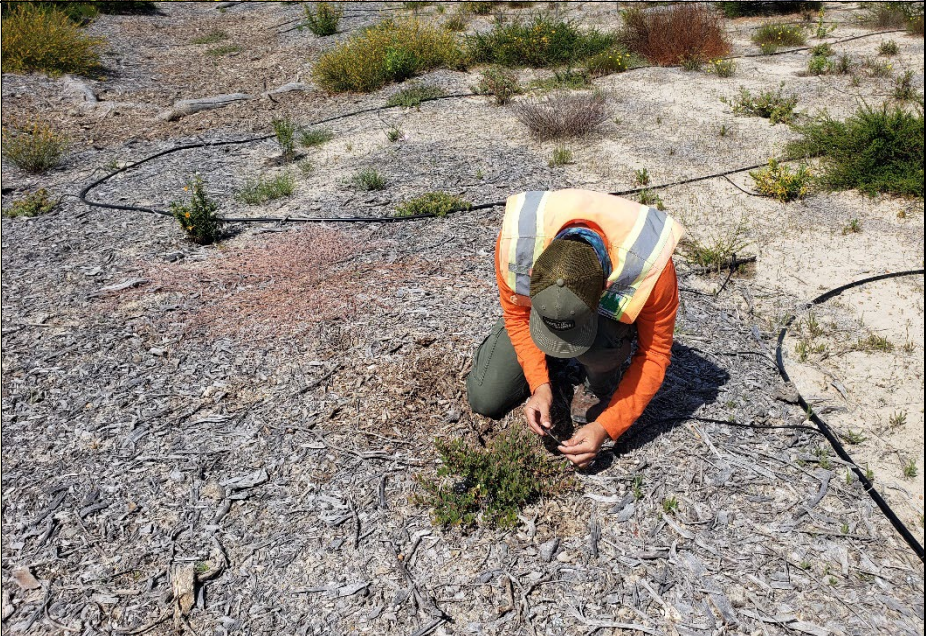
| Photo Description | Photo |
|--|--|
| <p>Irrigation</p> <p>Burleson biologist installing a new emitter</p> <p>C-56</p> | A biologist wearing a high-visibility orange and yellow safety vest over an orange shirt and a dark cap is kneeling on a rocky, gravelly surface. She is working on a black emitter connected to a drip irrigation line. The ground is covered with small rocks and some sparse, dry vegetation. The background shows a similar rocky terrain with scattered plants. |

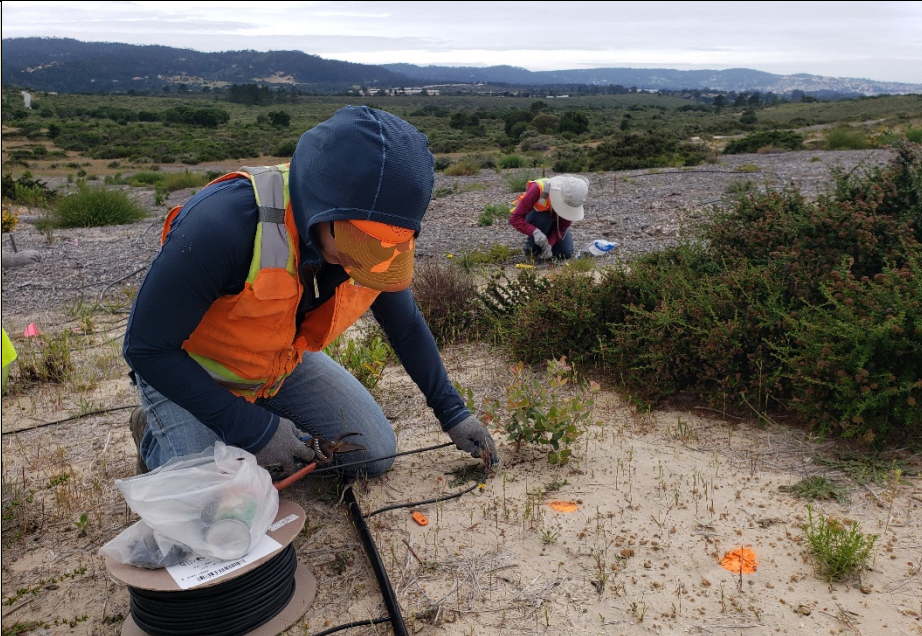
| Photo Description | Photo |
|--|---|
| <p>Irrigation</p> <p>Burleson biologist installing new drip lines</p> <p>C-57</p> | |

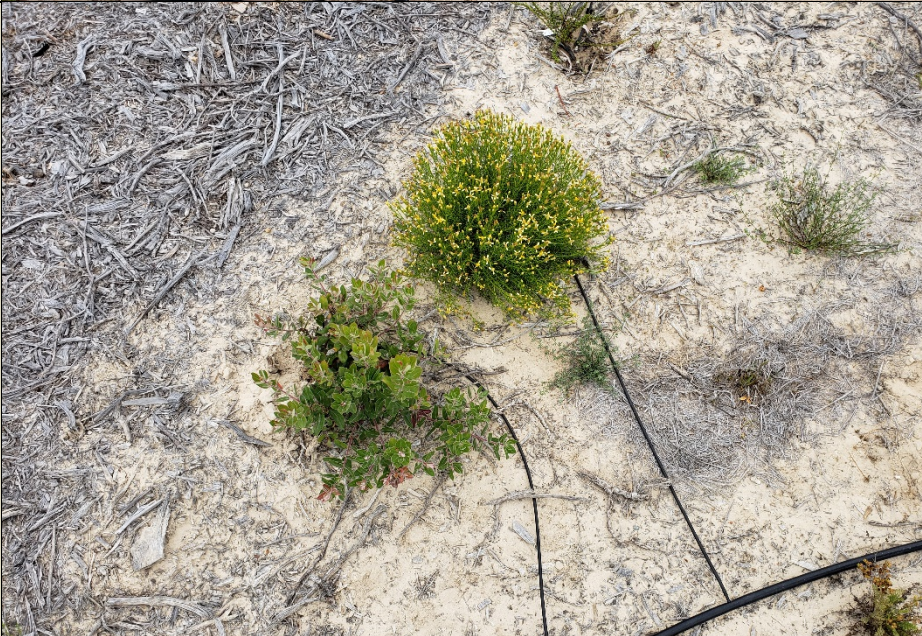
| Photo Description | Photo |
|--|---|
| <p>Irrigation</p> <p>Irrigated Eastwood's goldenbush and shaggy-bark manzanita (<i>Arctostaphylos tomentosa</i>)</p> <p>C-58</p> | |

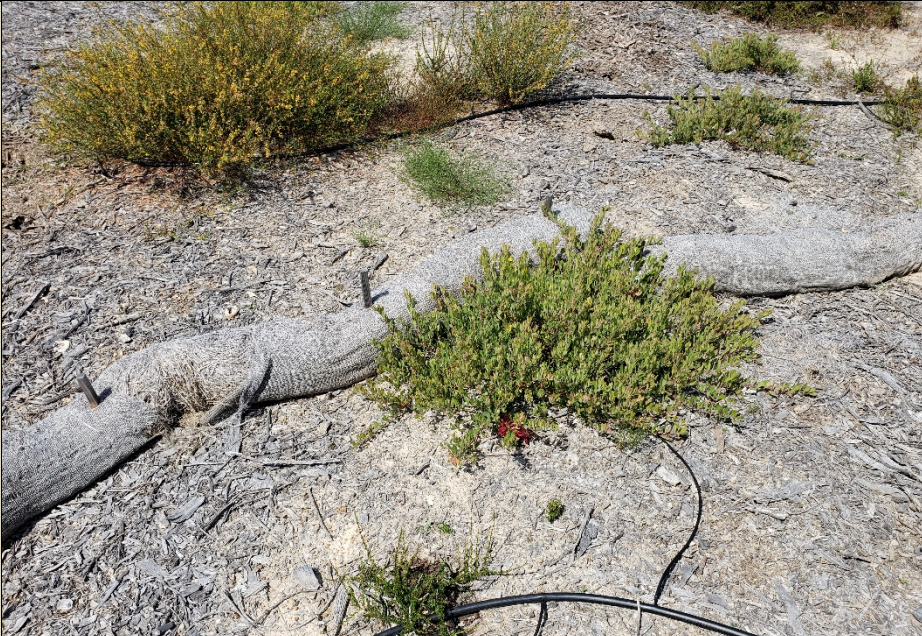
| Photo Description | Photo |
|--|---|
| <p>Irrigation</p> <p>Irrigated sandmat manzanita growing upslope of wattle</p> <p>C-59</p> | |

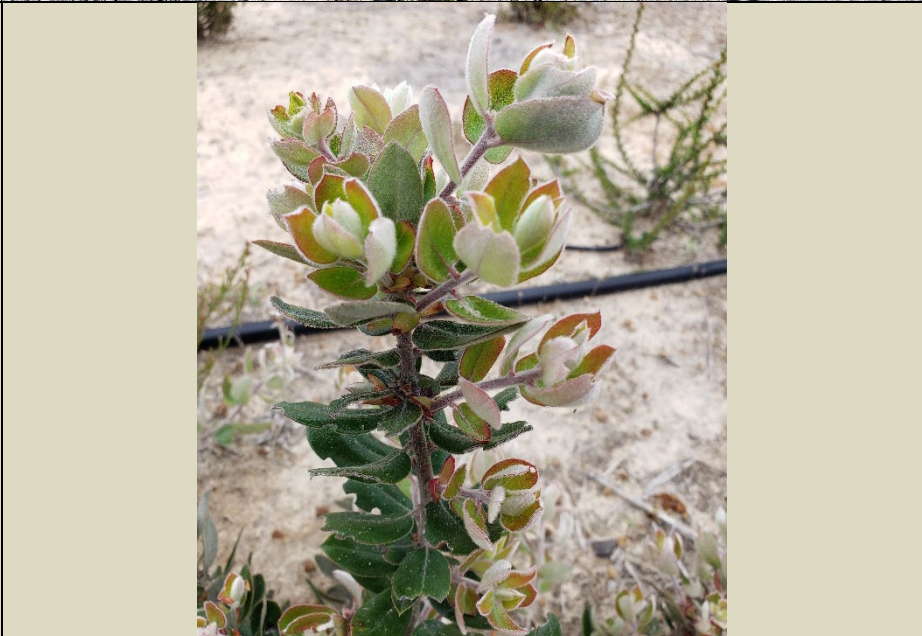
| Photo Description | Photo |
|--|---|
| <p>Irrigation</p> <p>New growth on irrigated shaggy-bark manzanita</p> <p>C-60</p> | |

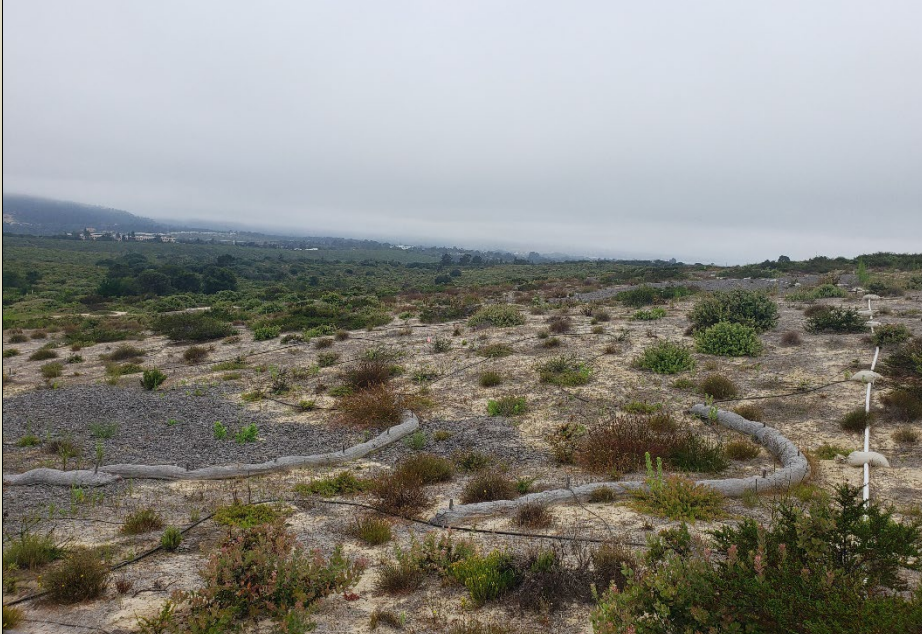
| Photo Description | Photo |
|---|---|
| <p>Irrigation</p> <p>West side of irrigation system</p> <p>C-61</p> | A wide-angle photograph showing a landscape with sparse, low-lying vegetation and patches of bare soil. A large, grey, flexible irrigation pipe runs across the middle ground, curving to the right. In the background, there are rolling hills and a distant town under a cloudy sky. |

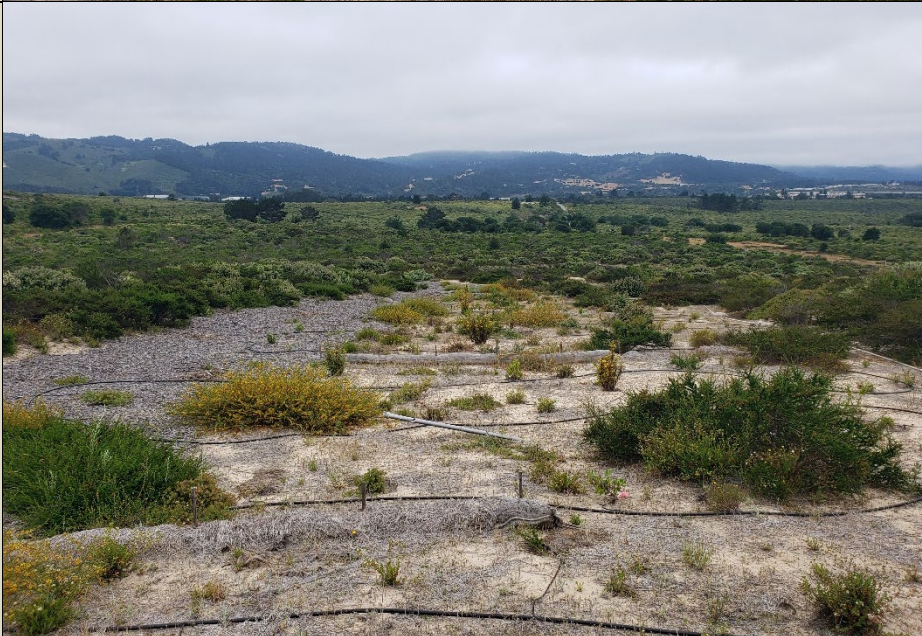
| Photo Description | Photo |
|---|---|
| <p>Irrigation</p> <p>East side of irrigation system</p> <p>C-62</p> | A photograph showing a similar landscape to C-61, but from a different perspective. The ground is covered with sparse green and yellowish vegetation. A large, grey, flexible irrigation pipe runs across the foreground. The background shows rolling hills and a distant town under a cloudy sky. |

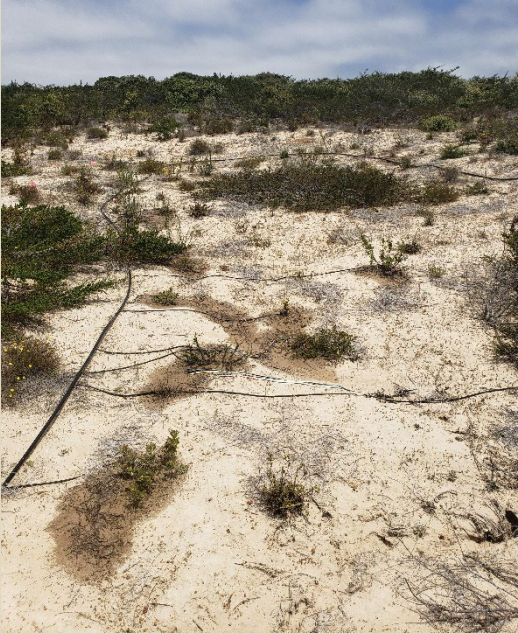
| Photo Description | Photo |
|---|---|
| <p>Irrigation</p> <p>Upslope of west side of irrigation system receiving water</p> <p>C-63</p> | |
