FORA ESCA REMEDIATION PROGRAM

Technical Information Paper

Phase II Seaside Munitions Response Area Roadway Alignment and Utility Corridor (Pollution Report and Removal Action Activity Report)

Former Fort Ord
Monterey County, California

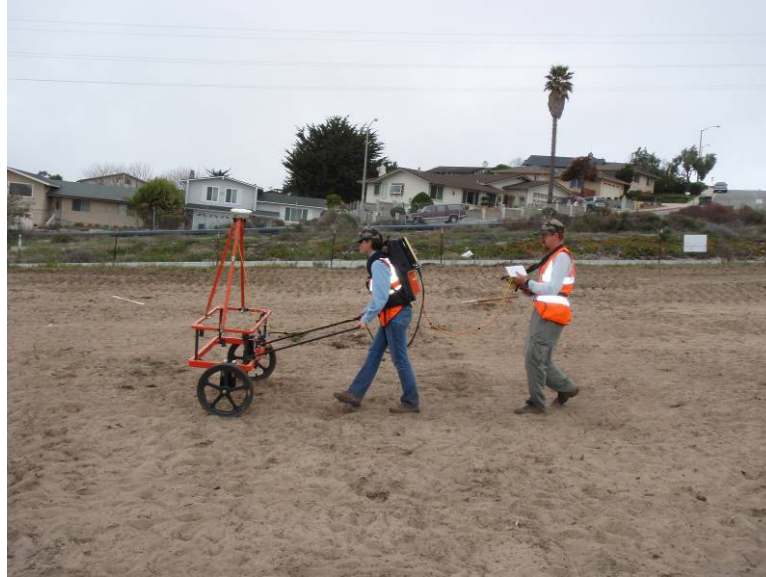
Photograph 3-1 - EM61-MK2 man-towed single-array system

The Geonics Limited, EM61-MK2 is a high-sensitivity ferrous and nonferrous metal detector. Electromagnetic surveys were performed using a man-towed single-array system (shown in Photograph 3-1), or a vehicle-towed multi-array system based on site conditions and survey area (shown in Photographs 3-2 and 3-3). The EM61-MK2 is battery-powered and operates at a maximum output of 10,000 millivolts. This man-towed system consists of two 1 x 0.5 meter air-cored coils with the top coil 28 centimeters (cm) above the bottom coil. The transmitter generates a pulsed magnetic field that induces eddy currents in conductive objects within the subsurface. These currents are proportional to the conductive nature of the material below the instrument. When conductive objects are present below the instrument, the amplitude and decay time of the induced eddy currents vary in response to the size, mass, and orientation of the objects. The bottom receiver coil measures the amplitude of these eddy currents at 216-, 366-, 660-, and 1,266-microsecond (μ sec) intervals (time gates) during the decay period. The top coil measures the response at the same 660- μ sec time gate as the bottom coil. Data were collected from the bottom coil in the standard four-time-gate mode. The operating height of the standard single-unit EM61-MK2 was 16 inches above ground surface and the towed array was 10 inches above the ground surface. The effective detection depth for the EM61-MK2 is a function of target characteristic (i.e., composition, size, mass, and orientation) and geological noise.

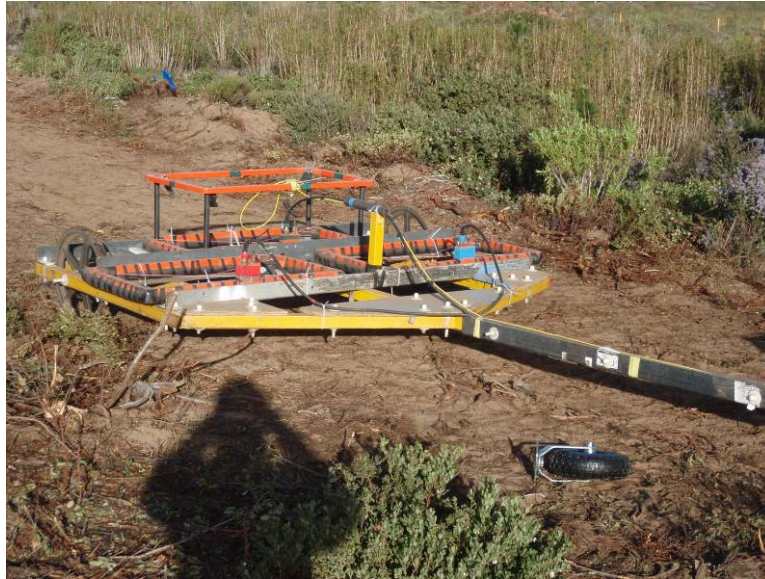
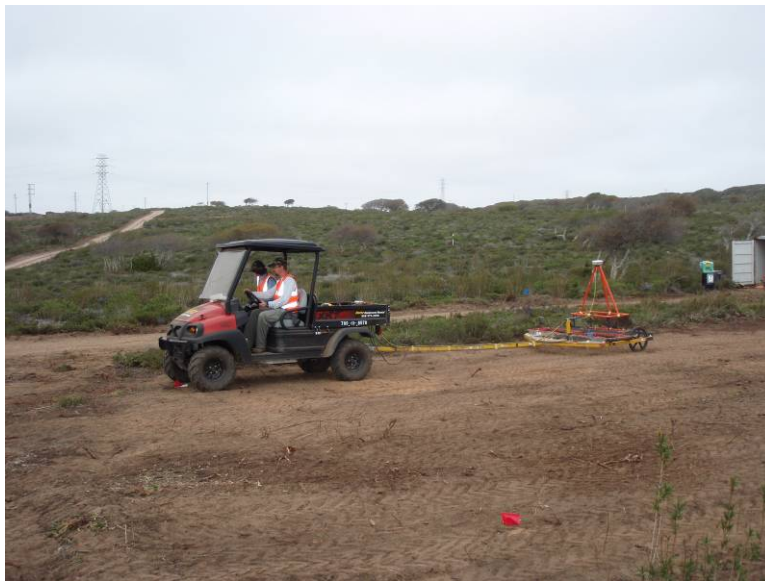
Photograph 3-2 - EM61-MK2 vehicle-towed multi-array system

Photograph 3-3 - EM61-MK2 vehicle-towed multi-array system

The vehicle-towed system is comprised of an array of three EM61-MK2 coils mounted on a fiberglass frame, interfaced with a survey-grade global positioning system (GPS) to provide precise navigation and geographical positioning of detected anomalies. The complete array is towed by a (diesel) all-terrain vehicle (shown in Photographs 3-2 and 3-3). The array is a fabrication of nonmetallic composite fiberglass frame and axles and Kevlar wheel bearing to virtually eliminate metal-induced noise. A multi-port hub, which provides a direct interface between the GPS and the geophysical sensors, streams both positional and sensor information directly into a field laptop computer. The data are logged into ruggedized field laptop computers using specialized software. This configuration provides real-time monitoring of navigational tracking, sensor status, and anomaly responses to the field crew.

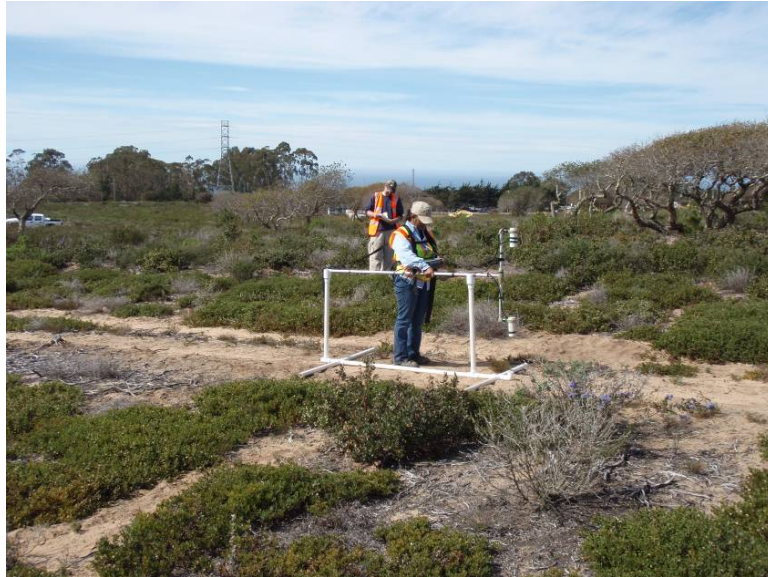
Photograph 3-4 – G-858 Magnetometer

Magnetometer surveys were performed using a Geometrics Model G-858 Cesium Vapor Magnetometer. Measurements of the magnetic field were collected using two sensors in gradiometer configuration. A Geometrics G-856 base station magnetometer was used to monitor diurnal variation in the ambient local magnetic field (daily fluctuations of 20 to 60 nanoTeslas [nT]) that occurred during the course of the survey. Photograph 3-4 shows the G-858 configuration. Prior to surveying, both instruments were time-synchronized and programmed following the manufacturer's instruction manual. The G-858 consoles were programmed to acquire data at a rapid 0.1-second cycle time (10 readings per second). The

G-856 base station was set at a fixed location to collect total field readings at 20-second intervals. The Geometrics Model G-858 Cesium Vapor Magnetometer was interfaced with a Trimble RTK, GPS to provide navigation. The standard height of the magnetometer surveys was 12 inches above ground surface, with a sensor separation of 2 feet (0.6 meter).

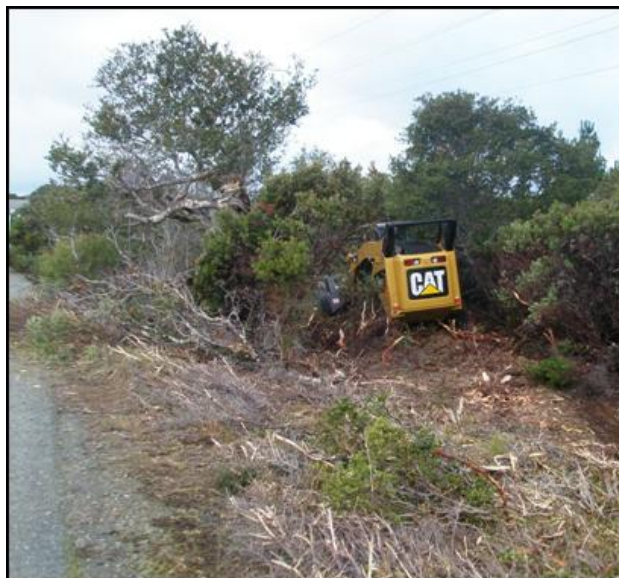
Photograph 3-5 – Brush cutting activities north of Eucalyptus Road

Brush cutting activities occurred within the SCA boundaries, the roadway alignment and along a 30-foot-wide section of the entire length of the utility corridor. Photograph 3-5 shows brush cutting activities that occurred north of Eucalyptus Road. The 30-foot-wide section of vegetation was cut within the Seaside MRA along the boundary with the NRMA as a fire-line fuel break, in accordance with the HMP requirements. The fire-line fuel break extends along the southern border of MRS-15SEA.3 and MRS-15SEA.4 and bends south along the eastern boundaries of MRS-15SEA.1 and MRS-15SEA.2 (along the boundary with the NRMA), which corresponds with the location of the planned utility corridor.

Prior to brush cutting, a UXO Technician II used a magnetometer to aid in searching the vegetation for surface MEC. Vegetation cutting was followed by root mass removal outside of the SCA boundaries within the limits of grading for the roadway alignment. The majority of brush cutting activities were complete in January 2008. In June 2008, Ahtna remobilized to the site to cut remaining brush along the existing fence line to prepare for DGM activities in this area.

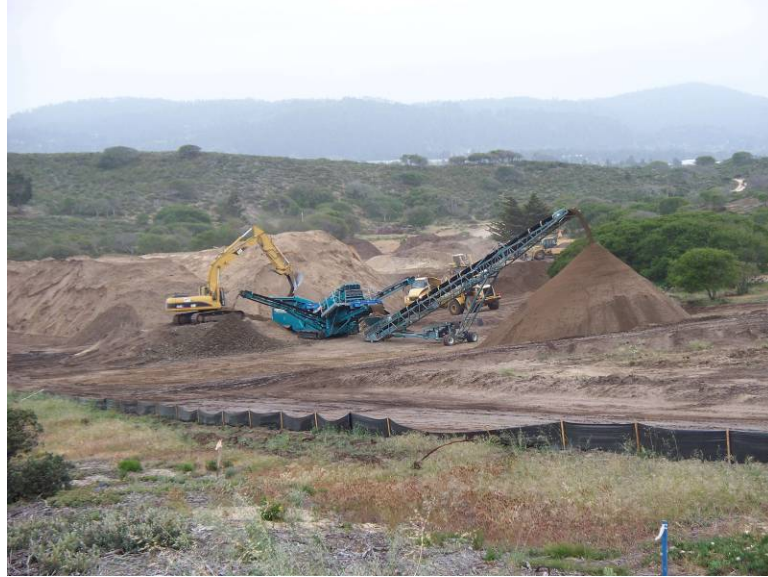
Photograph 3-14 – Sifting plant operations

Figure 3-14 shows a schematic of the sifting equipment used to remove metal items (potential MEC) and oversize items greater than 3/4 inch or greater than 3/8 inch following the installation of the Speedharp-type screen as approved by FVF SEAMRA-002. The excavated soil sifting process was as follows:

1. The excavated material was introduced into the feed hopper/grizzly using an armored loader. Material greater than 6 inches in size was rejected and discharged to one side of the grizzly. This was the first of the five material types generated. This oversized material was transported to a separate staging area and was 100% inspected in the morning and afternoon by trained UXO Technicians. Materials removed by the sifting plant were segregated and managed accordingly. The Senior UXO Supervisor (SUXOS) was immediately notified if MEC items were recovered.

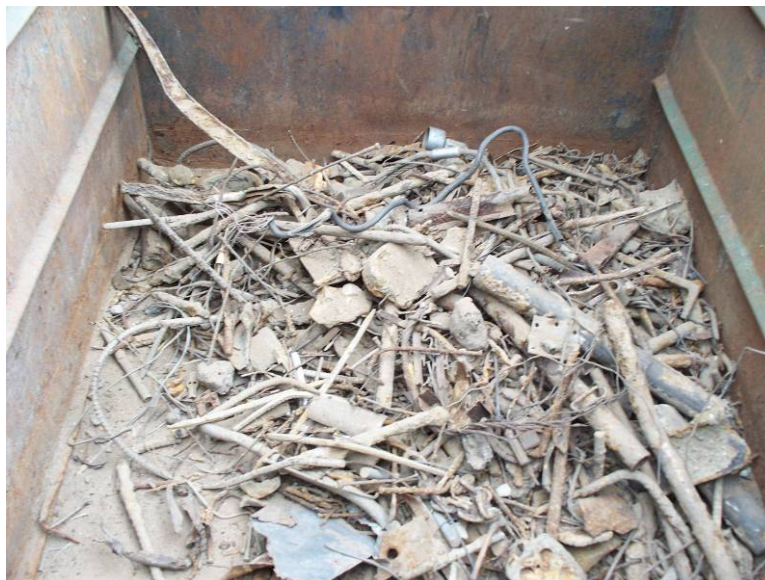
Photograph 3-15 – Metal recovered from the first magnet of the sifting plant

2. The material passing the 6-inch grizzly was less than 6 inches and fell into the feed hopper and onto a heavy duty conveyor belt, which led to the first magnet. The magnet collected ferrous metal items and discharged the metal into a scrap bin container using a small conveyor rotating around the magnet into a scrap bin container (See Photograph 3-15). This was the second of the five material types generated. Depending on the quantity of metal collected, the bin was inspected and transported at least daily to the staging area for sorting and was 100% inspected in the morning and afternoon by UXO Technicians. Materials (MEC, MD, and non-MEC-related scrap) were segregated and managed accordingly. The SUXOS was immediately notified if MEC items were recovered.

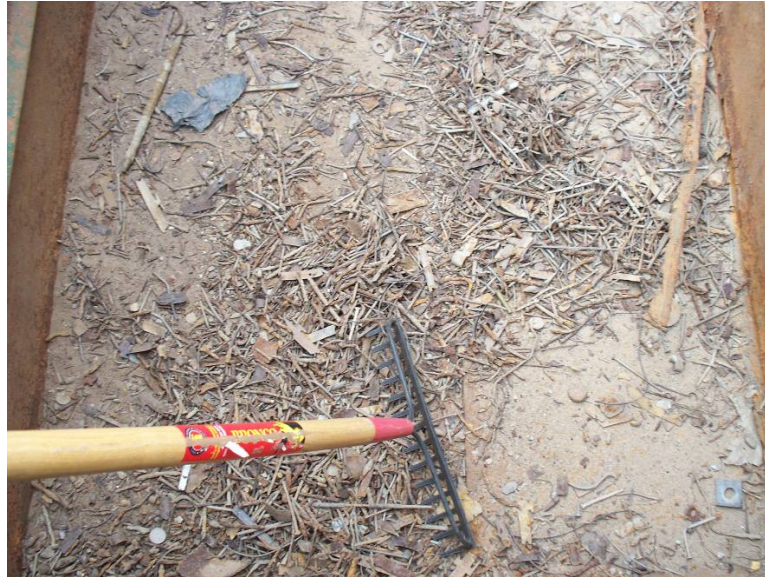
Photograph 3-16 – Metal recovered from the second magnet of the sifting plant

4. The material that passed through the bottom screen (< 3/4-inch material or <3/8-inch material after approval of FVF SEAMRA-002) was then passed along a heavy duty conveyor belt and passed under a second magnet. The second magnet removed any ferrous metal and a small conveyor discharged the metal into a separate scrap bin container (see Photograph 3-16). This was the fourth of the five material types generated. This < 3/4-inch or <3/8-inch material was then transported to the sorting area and was 100% inspected in the morning and afternoon by trained UXO Technicians. Materials (UXO, MEC, MD, and non-MEC-related scrap) were segregated and managed accordingly. The SUXOS was immediately notified if MEC items were recovered.

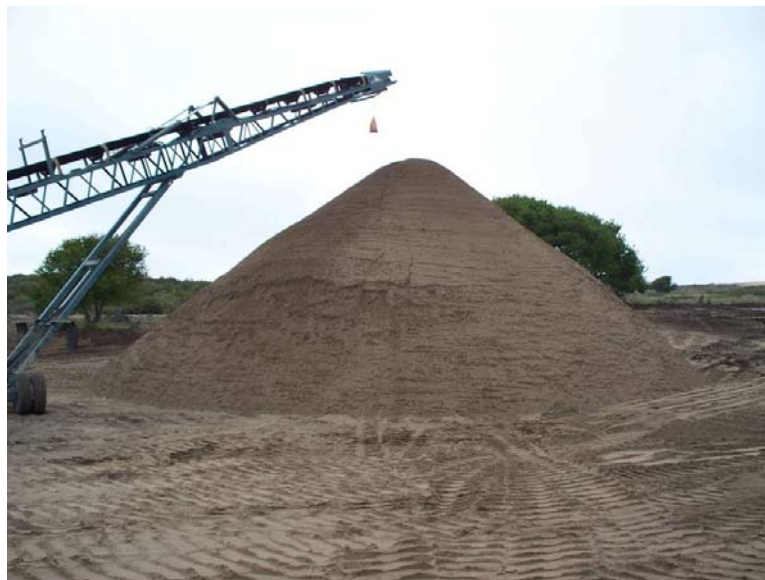
Photograph 3-17 – Final screened material from the sifting plant

5. Any material that passed through the bottom vibrating screen and past the second magnet was considered the final screened material. This material consisted only of material that was less than 3/4 inch in size or less than 3/8 inch in size following the approval of FVF SEAMRA-002 (Photograph 3-17). Morning and afternoon inspections of the final sifted soil were conducted by taking approximately 15 cy of sifted soil, spreading it into a thin lift, and inspecting the soil visually and with the assistance of handheld instruments (Schonstedt magnetometers and Whites all-metals detectors) for the presence of items/metal larger than 3/4 inch. Photograph 3-18 shows two UXO Technicians conducting this inspection using a Schonstedt magnetometer and Whites all-metals detectors. The SUXOS was immediately notified if MEC items were recovered.

The final screened material was conveyed onto conical-shaped stockpiles by a stacking conveyor as shown in Photograph 3-17. Soil sifted each morning was segregated from soil sifted each afternoon. After the inspection step for the sifted soil was performed, along with a satisfactory recovery of seed items introduced to the sifting plant during the time when the stockpile was generated (described in Section 4.1), the sifted soil stockpile was loaded into off-road haul trucks. Sifted soil was transported and placed within the cleared and grubbed roadway alignment along GJMB or Eucalyptus Road in areas where additional fill soil is needed for the planned roadway construction project as requested by FORA. Sifted soil was not placed outside of the roadway alignment. The Army requested use of oversize reject materials (materials rejected by the 6-inch, 2-inch, or 3/8-inch sifting screen), which had been generated by sifting operations for use in fuel break repair projects on the inland ranges of the former Fort Ord.

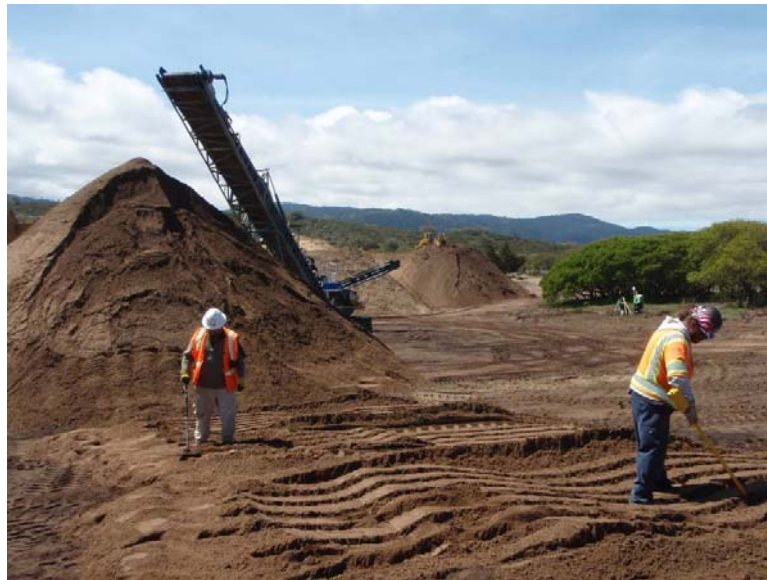
Photograph 3-18 – Inspection of sifted soil; Inspection was conducted twice daily for a portion of each stockpile of sifted soil generated

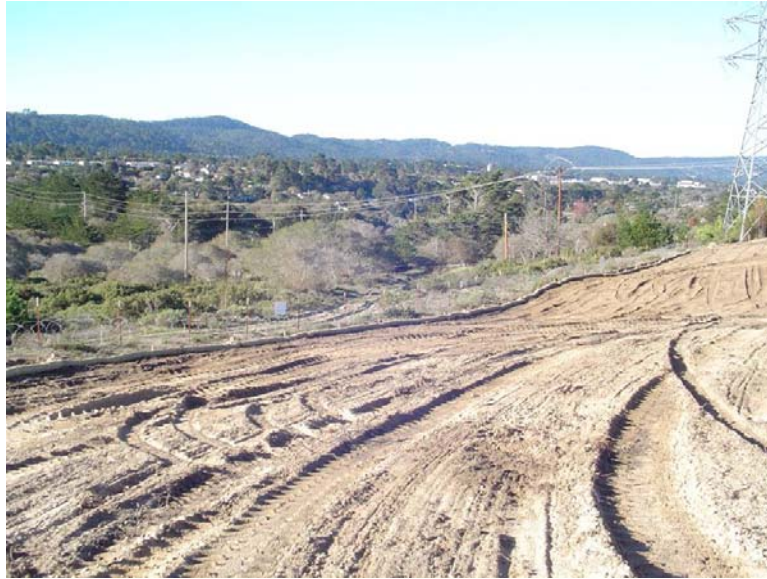
Photograph 3-22 – BMPs (straw wattles) installed adjacent to GJMB

The ESCA RP Team prepared a Stormwater Pollution Prevention Plan (SWPPP) for the clearing and grubbing operations performed within the roadway alignment (LFR 2008). The plan included descriptions of how Best Management Practices (BMPs) would be implemented at the site to manage soil erosion and surface runoff within the limits of clearing and grubbing activities discussed in Section 3.5. The SWPPP also identified an inspection and maintenance schedule and sampling protocols in the event stormwater pollution impacts were suspected. BMPs implemented at the site consisted of installation of straw wattles (see Photograph 3-22) along the southern end of the roadway alignment at the border of the Seaside MRA, grading of steeply-sloped areas to minimize off-site surface runoff, and construction of berms and swales downgradient from disturbed soil areas along the existing GJMB and Eucalyptus Road. The Water Pollution Control Manager identified in the SWPPP was responsible for conducting weekly inspections during the rainy season (October 15–April 15) and biweekly inspections during the non-rainy season (April 15–October 15). BMPs were maintained to ensure that they were functioning as intended and designed.

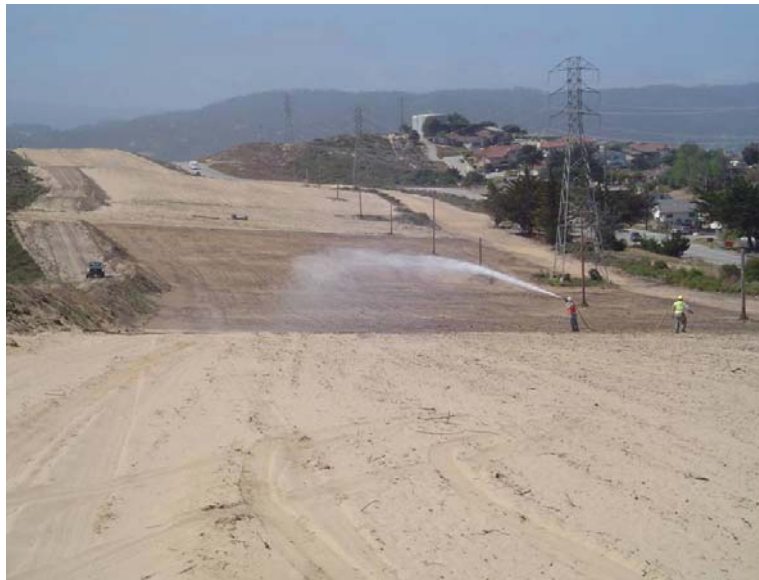
Photograph 3-24 – Soil Stabilization Activities to Minimize Wind Erosion

Gorilla-Snot® is an eco-safe, biodegradable, liquid copolymer used to stabilize and solidify soil for the purposes of erosion control and dust suppression. Once applied to the soil, the copolymer molecules coalesce forming bonds between the soil or aggregate particles. The key advantage of Gorilla-Snot® originates with its long, nanoparticle molecular structure that links and cross-links together. As the water dissipates from the soil or aggregate, a durable and water-resistant matrix of flexible solid-mass is created. Once cured, Gorilla-Snot® becomes completely transparent.

The product was applied in May 2008 and is expected to provide wind erosion protection for a minimum of six months or until the next rainy season.

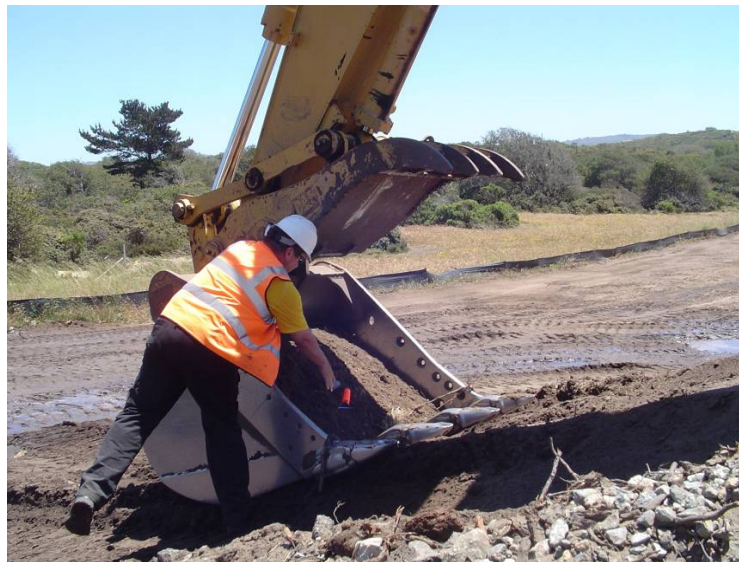
Photograph 4-1 – Placement of QC seeds into excavator bucket for feeding into sifting plant

A total of three seeded QC items were introduced to the sifting plant twice daily, typically in the morning and afternoon to check for proper operation of the sifting plant. The three simulant seeds consisted of the following: 1) a piece of rebar that was ½ inch in diameter and 12 inches long; 2) an inert 57mm projectile; and 3) a pipe that was 2 inches in diameter and 5 inches long. The seeds were introduced by the excavator into the sifting plant grizzly. The sifting plant was turned on for operation, and then inspected for recovery of the seeds. Photographs 4-1 and 4-2 show a UXO Technician placing the seeds into the excavator bucket and the recovery of the seeds in the magnet recovery bin. All three QC seeds were successfully recovered twice daily by the sifting plant throughout the course of sifting operations. QC seed tests were recorded for documentation purposes. QC inspections were documented in a Daily Quality Control Inspection Report – Soil Sifting Operations. Copies of these daily inspection reports are included in Appendix J.

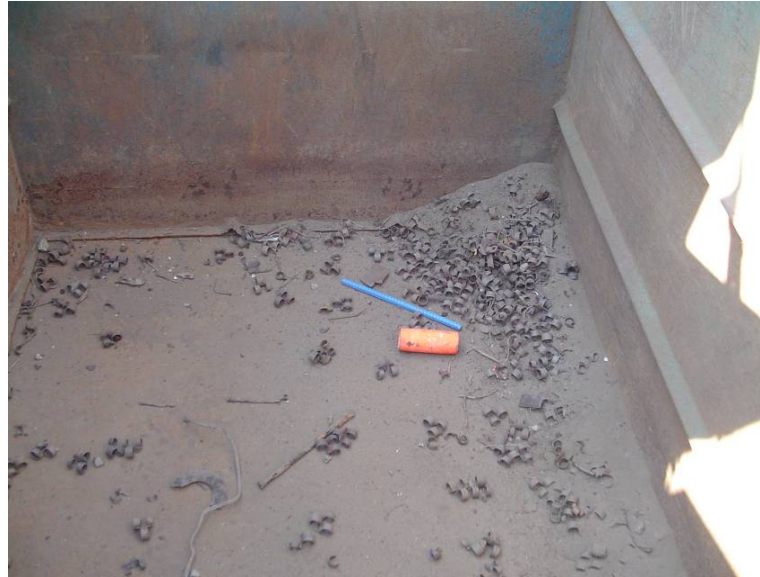
Photograph 4-2 – View of two QC seeds recovered from the first magnet.

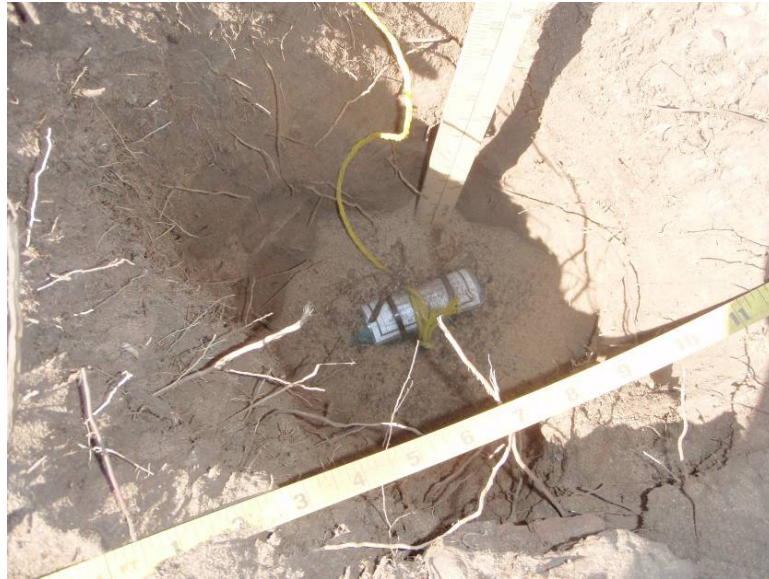
Photograph 4-3 – View of recovered blind QC seed item in a DGM anomaly location.

The seeds were placed using a survey-grade GPS. The blind seeds consisted of a 1 1/2-inch by 5-inch pipe, to simulate a 37mm projectile. Each seed was painted Orange and a laminated UXOQCS business card including a control number (ESCA-SEA-019) was zip tied to the pipe for identification. UXO Technicians were shown the blind seed items so they could positively identify a seed, if excavated. Photograph 4-3 shows a recovered blind QC seed item.

The seeds were buried at a depth interval between 6 and 12 inches, which is within the geophysical limits of 100% probability of detection of 16.06 inches for a 37mm projectile. The location of the seed items was not known to the on-site project personnel. QC and QA personnel reviewed the DGM data against the seed locations. The blind seeds placed in SCAs within the roadway alignment were detected within the reacquisition metric identified in the geophysical test plot report. Detection results of each QC seed item are detailed in Table 4-1. The minimum offset was 0.05 foot and the maximum was 1.87 feet. The average offset for the group was 1.19 feet. Consistent with the known seed results these values reflect the high level of accuracy achieved for the navigation, detection, and anomaly selection processes over the duration of the field effort.
