FORA ESCA REMEDIATION PROGRAM

Technical Information Paper

Phase II Seaside Munitions Response Area Outside Roadway Alignment and Utility Corridor (Pollution Report and Removal Action Activity Report)

Former Fort Ord
Monterey County, California

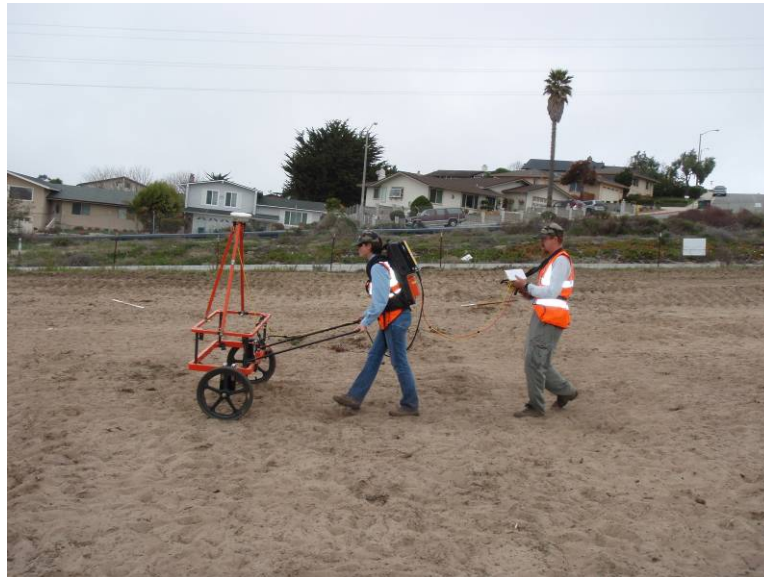
Photograph 3-1 - EM61-MK2 manually towed single-array system

The manually towed single-array system consists of two 1 by 0.5 meter air-cored coils with the top coil 28 centimeters (cm) above the bottom coil. The transmitter generates a pulsed magnetic field that induces eddy currents in conductive objects within the subsurface. These currents are proportional to the conductive nature of the material below the instrument. When conductive objects are present below the instrument, the amplitude and decay time of the induced eddy currents vary in response to the size, mass, and orientation of the objects. The bottom receiver coil measures the amplitude of these eddy currents at 216-, 366-, 660-, and 1,266-microsecond (μsec) intervals (time gates) during the decay period. The top coil measures the response at the same 660- μsec time gate as the bottom coil. Data were collected from the bottom coil in the standard four-time-gate mode.

The manually towed cart single-array instrument was set to digitally record and store data at 10 readings per second (Hz) in an Allegro data logger. The readings were adjusted (nulled) to a common zero background at a low background area to level datasets according to site-specific conditions. The operating height of the manually towed single-array EM61-MK2 was 16 inches above ground surface.

Electromagnetic surveys were performed using a manually towed single-array system (shown in Photograph 3-1), or a vehicle-towed multi-array system, based on site conditions and survey area (shown in Photographs 3-2 and 3-3) as described in the following subsections.

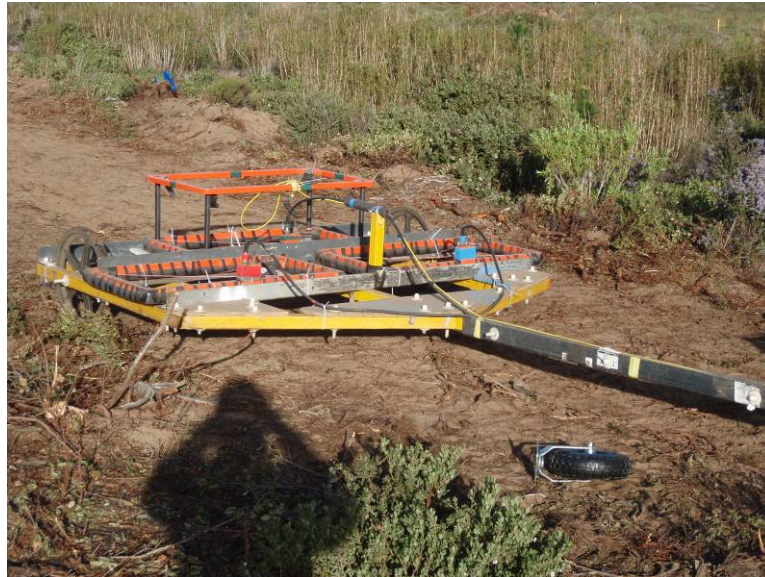
Photograph 3-2 - EM61-MK2 vehicle-towed multi-array system

The vehicle-towed-array was also set to record and store data at 10 Hz, in a field laptop computer. Data corrections for the towed-array were made during the post-processing stage.

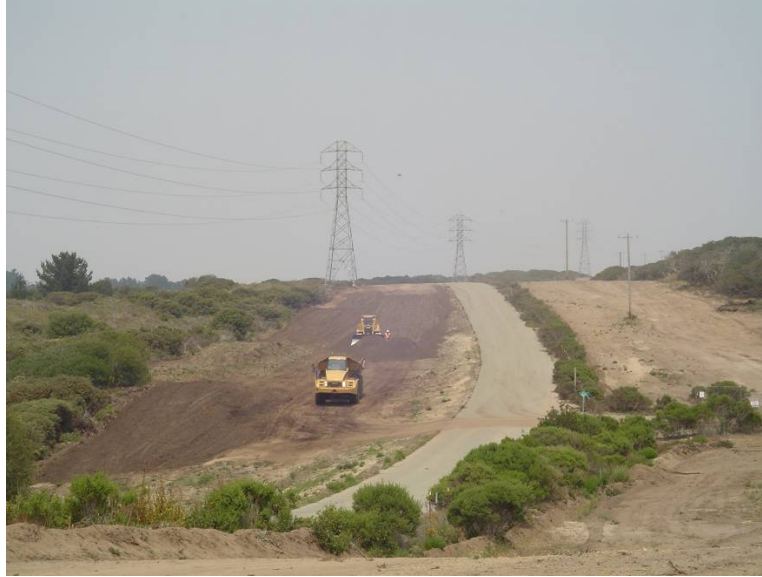
Photograph 3-12 – SCA polygon scraping activities

Scraped soil was loaded onto haul trucks and transported to a soil stockpile staging area in Seaside MRS-15SEA.1. The locations of the sifting plant and soil stockpile staging area are shown on Figure 3-13. The soil was staged in discrete stockpiles by MRS (MRS-15SEA.1 through MRS-15SEA.4).

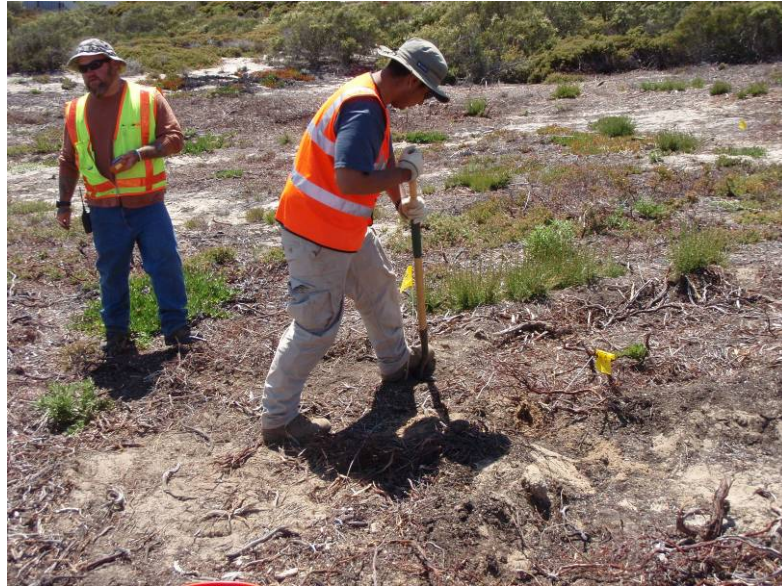
Photograph 3-19 - View of Anomaly Investigation Activities

At the end of each day, the data were uploaded to an Access database. The results of the target anomaly excavations are provided in Section 5.4. The handheld Schonstedt magnetometer was utilized to “clear the hole” of ferrous material. The Whites all-metals detectors were used to further investigate locations for nonferrous objects. An EM61-MK2 was used to resolve any NCs that the detectors could not resolve.

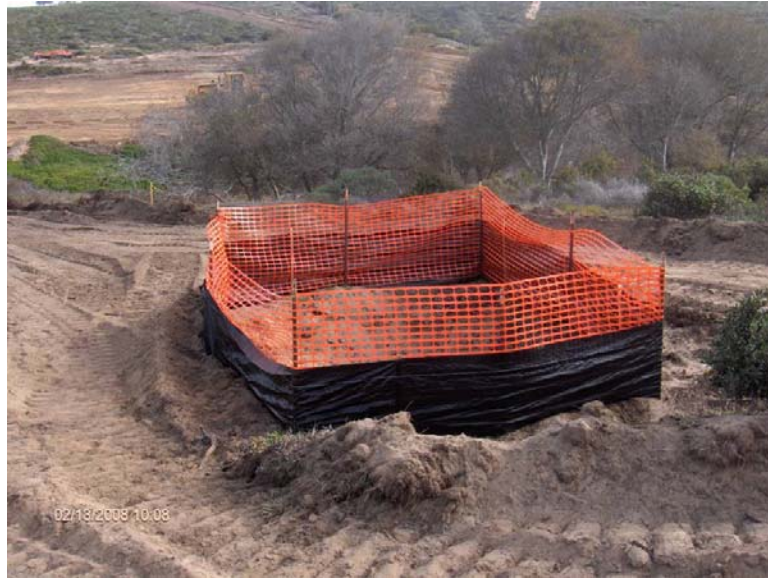
Photograph 3-21 – SCA excavation with silt fencing for protection of CTS

- Minimized vegetation removal and cutting where possible while ensuring that the required work could be completed to the extent feasible.
- ESCA RP Team qualified field biologists were on site during the rainy season to monitor SCA excavations within the limits of the areas identified as potential California tiger salamander breeding habitat (located on MRS-15SEA.1 and a small portion of MRS-15SEA.2) – refer to Photograph 3-21 for an example of an excavation protected with silt fencing to prevent entrance by the CTS.
- Awareness training for the CTS and other sensitive animal and plant species was provided for all field personnel by the ESCA RP qualified field biologists.
- Erosion control measures were installed within the Seaside MRA to reduce erosion.

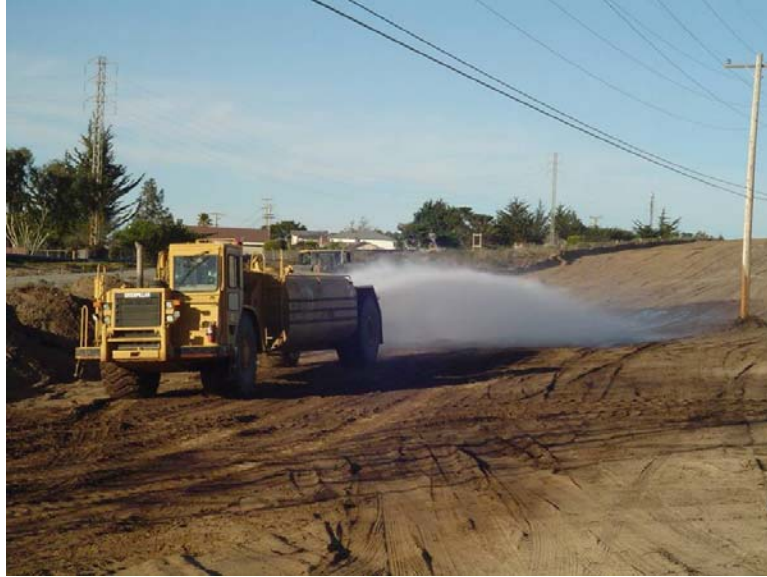
Photograph 3-23 – Water spraying activities to minimize fugitive dust

This section presents the dust minimization, controls, and monitoring activities that were implemented during the project activities. The ESCA RP Team implemented dust controls during site operations consisting of spraying water along the haul routes, work areas, and stockpiled soil introduced to the sifting plant, as needed to minimize fugitive dust. In addition, heavy equipment speeds were monitored to minimize dust emissions. Photograph 3-23 shows the water spraying activities employed to minimize fugitive dust.

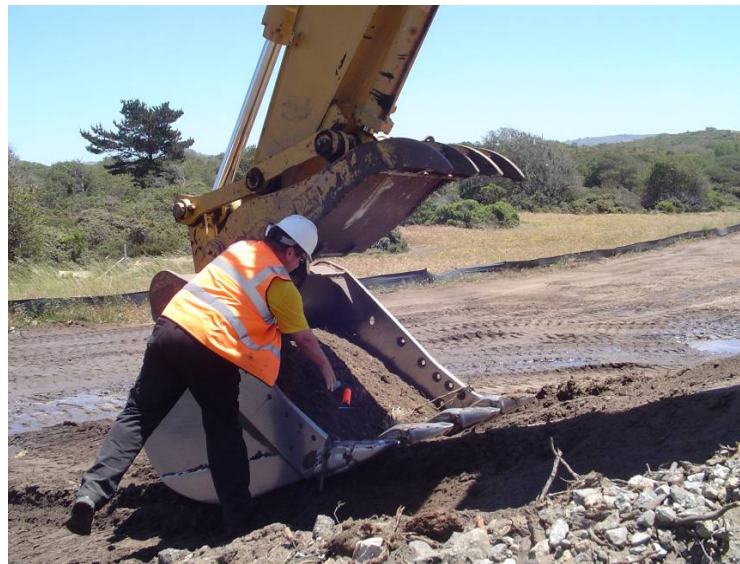
Photograph 4-1 – Placement of QC seeds into excavator bucket for feeding into sifting plant

A total of three seeded QC items were introduced to the sifting plant twice daily when material was being sifted, typically in the morning and afternoon to check for proper operation of the sifting plant. The three simulant seeds consisted of the following: 1) a piece of rebar that was 1/2 inch in diameter and 12 inches long; 2) an inert 57mm projectile; and 3) a pipe that was 2 inches in diameter and 5 inches long. The seeds were introduced by the excavator into the sifting plant grizzly. The sifting plant was turned on for operation, and then inspected for recovery of the seeds. Photographs 4-1 and 4-2 show a UXO Technician placing the seeds into the excavator bucket and the recovery of the seeds in the magnet recovery bin. All three QC seeds were successfully recovered twice daily by the sifting plant throughout the course of sifting operations. QC seed tests were recorded for documentation purposes. QC inspections were documented in a Daily Quality Control Inspection Report – Soil Sifting Operations. Copies of these daily inspection reports are included in Appendix J.

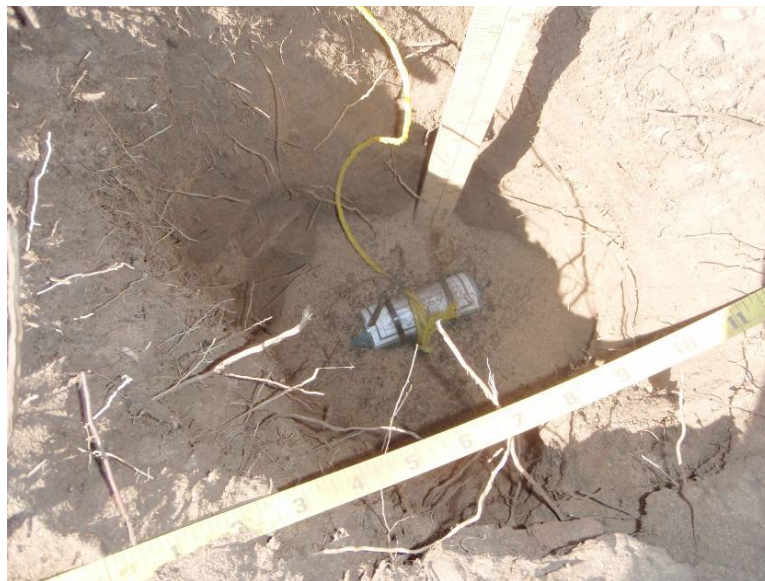
Photograph 4-3 – View of recovered blind QC seed item in a DGM anomaly location

The seeds were buried at a depth interval between 6 and 12 inches, which is within the geophysical limits of 100% probability of detection of 16.06 inches for a 37mm projectile. The location of the seed items was not known to the on-site project personnel. QC and QA personnel reviewed the DGM data against the seed locations. The blind seeds placed in SCAs outside the roadway alignment and utility corridor were detected within the reacquisition metric identified in the Geophysical Test Plot Report. Detection results of each QC seed item are detailed in Table 4-1. The minimum offset was 0.00 foot and the maximum was 1.00 foot. The average offset for the group was 0.32 foot. These values were consistent with the known seed results and reflect the high level of accuracy achieved for the navigation, detection, and anomaly selection processes over the duration of the field effort.
