Report Title: **Technical Memorandum
Fort Ord
May 9, 2019 Gasoline Spill
Seaside, California**

Technical Memorandum
Fort Ord
May 9, 2019 Gasoline Spill
Seaside, California

This technical memorandum describes the vehicle accident that occurred on May 9, 2019 and the voluntary response activities which included gasoline-contaminated soil removal, laboratory analysis and site restoration. This Technical Memorandum will be provided to the County of Monterey Certified Unified Program Agency (CUPA).

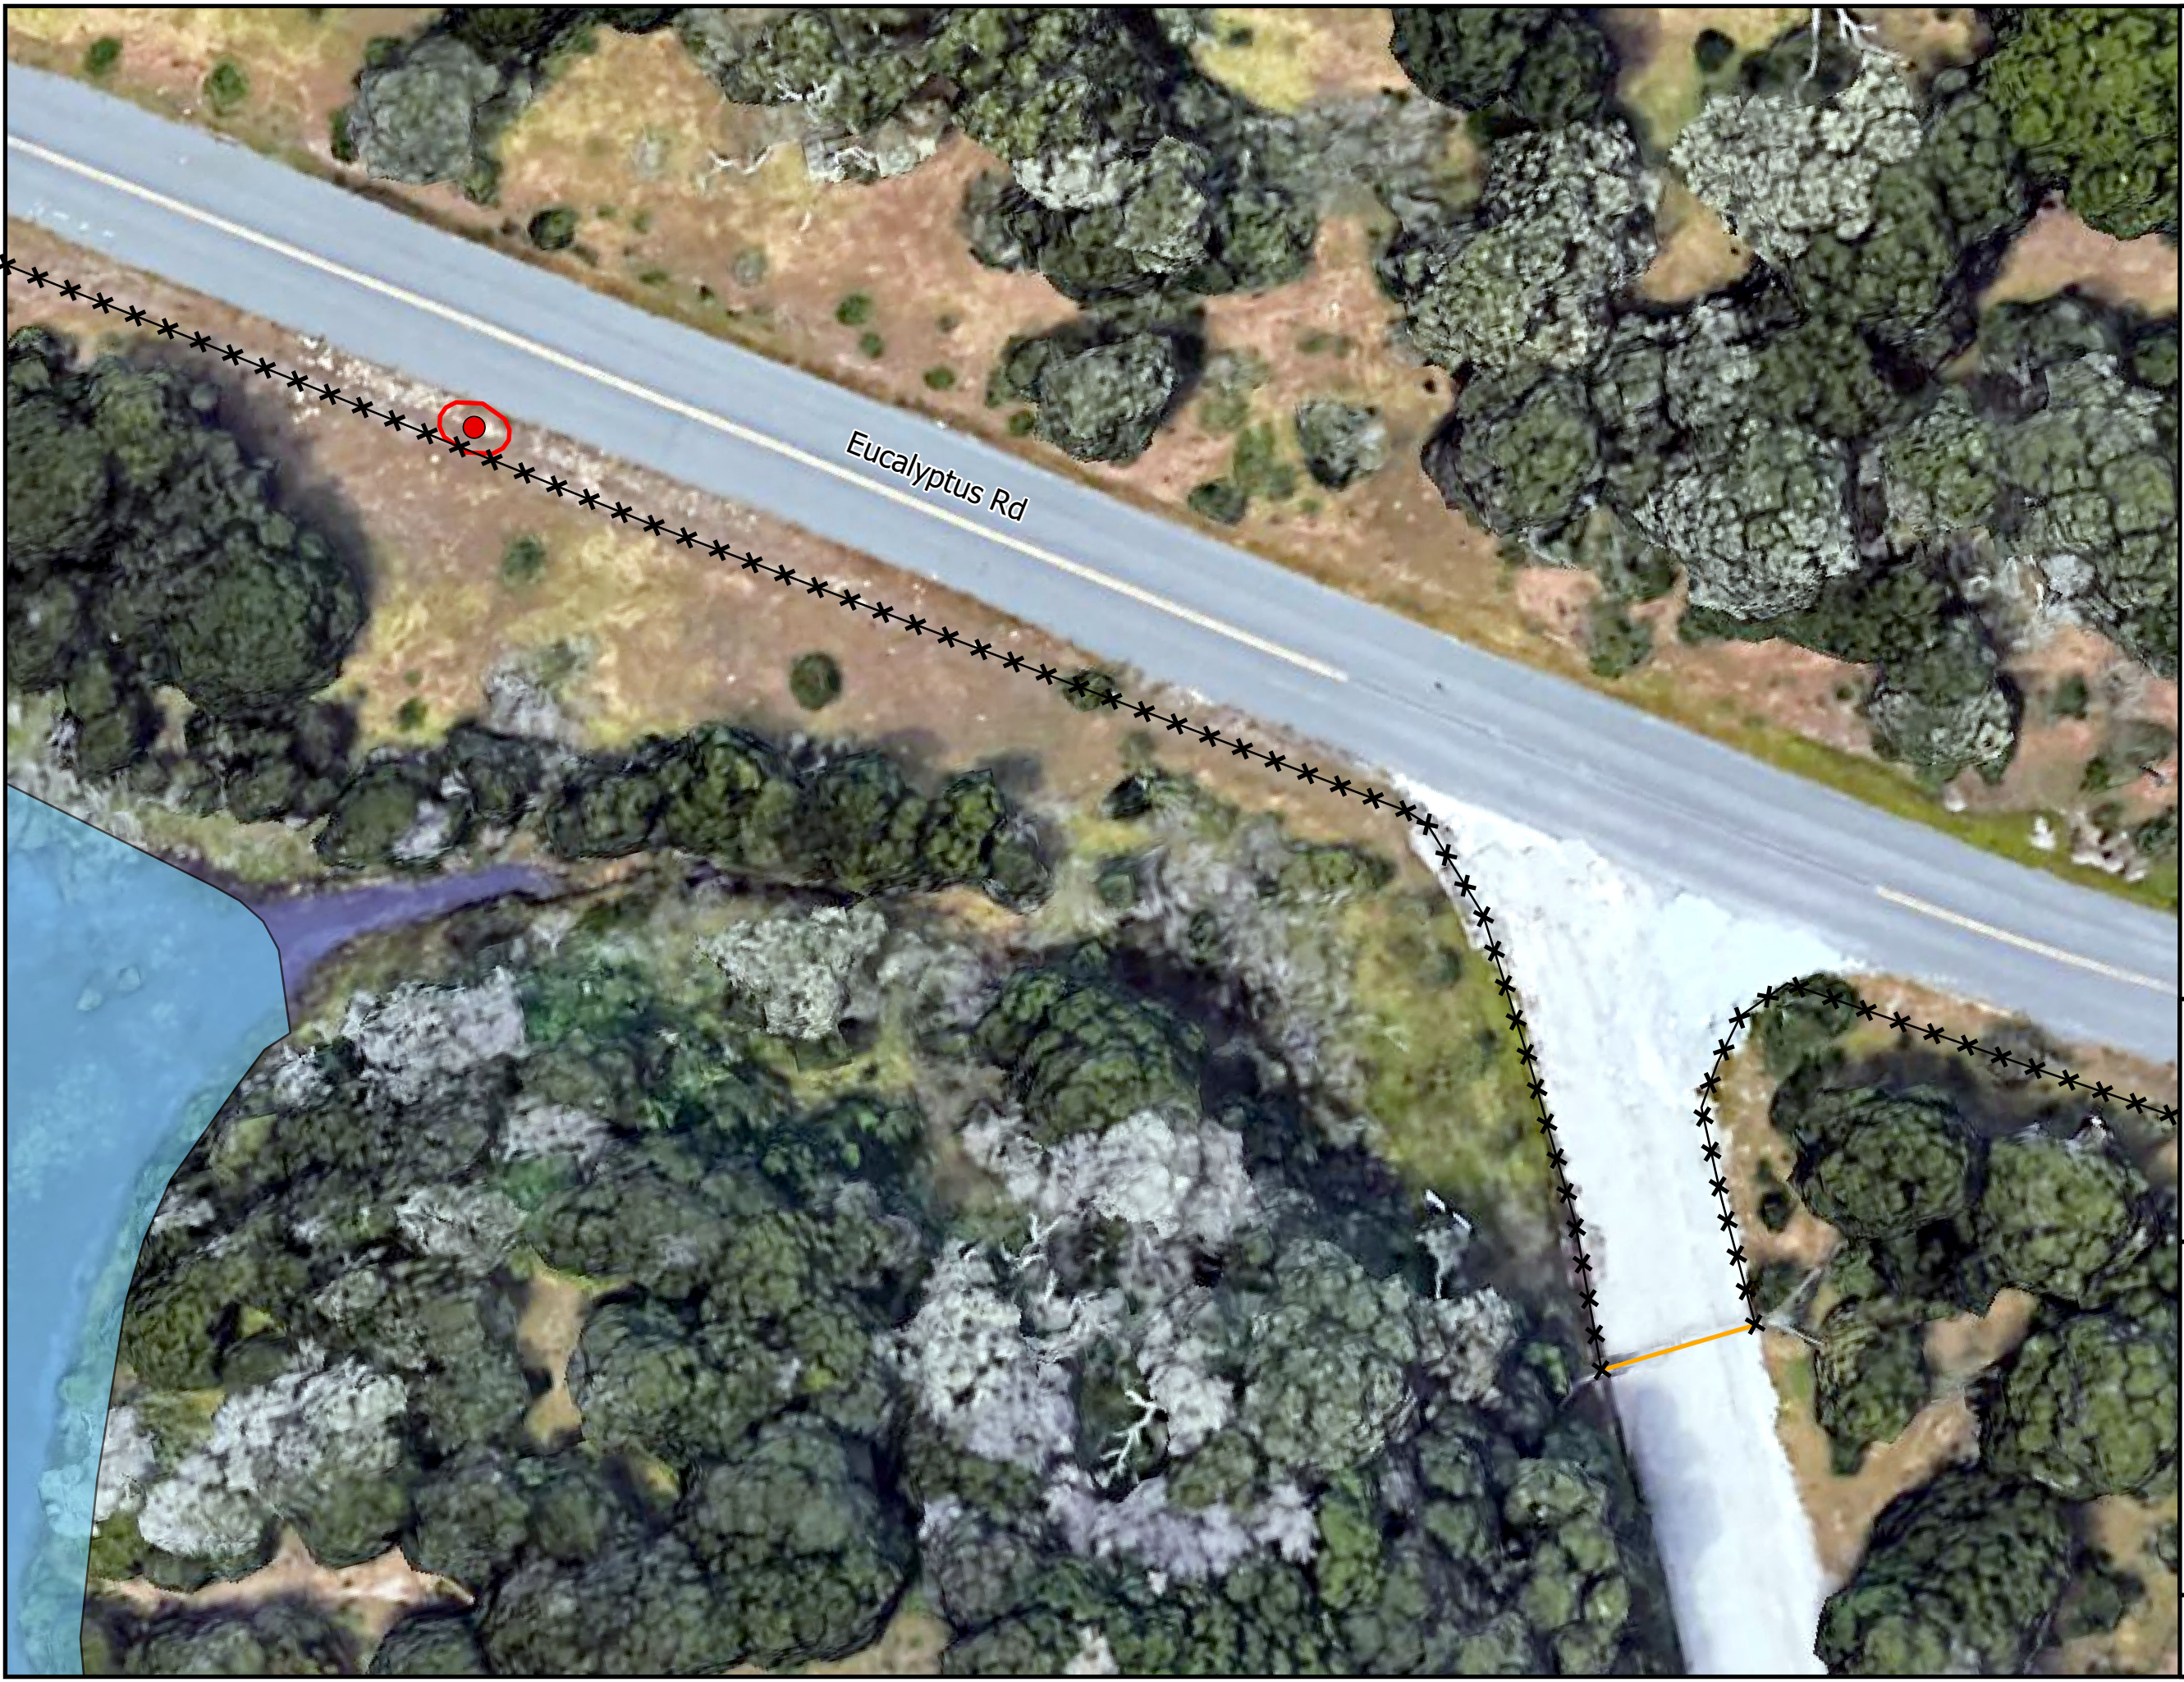
**Location Map
Gasoline Spill**

Figure 1 presents the regional setting and general location of the incident.
Figure 2 shows the location of the incident and excavation extent.
Figure 3 is a schematic of the sample collection locations.

- ✕ ✕ ✕ Impact Area Fence
- Impossible Canyon North Gate aka MOUT Gate
- ▭ Vernal Pond 11 (Dry at time of accident)
- ▭ Excavation Pit (8x10 ft)
- Car Accident

The USACE contracted with CKG Environmental to remove the remainder of the petroleum contaminated soil. CKG Environmental subcontracted Vanquish Environmental & Engineering to excavate the remaining contaminated soil and restore the site to original condition before the incident. On September 16, 2019, Vanquish excavated approximately 14 cubic yards of soil to a depth of 3 feet in the original 8-foot by 10-foot elliptical footprint of the hand excavation performed on May 14, 2019. During excavation an Industrial Scientific 5 gas meter was used to evaluate organic vapors. Readings were taken from freshly excavated soil immediately upon removal from the excavation. The results of the gas meter were nominal and not indicative of gross residual contamination.

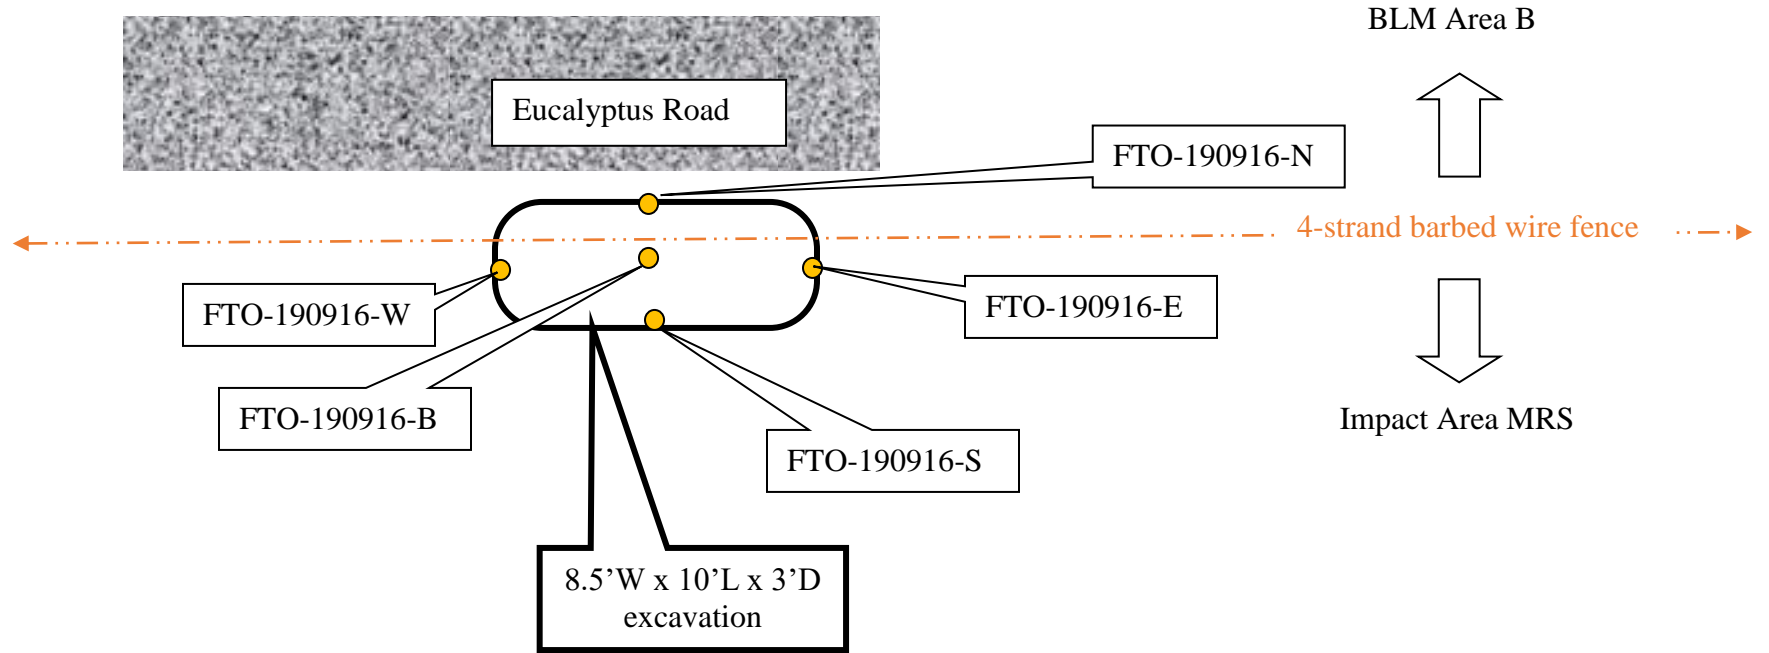
Figure 3
Schematic Diagram of Soil Samples
not to scale

Six soil samples were collected which included, a sample from the base of the final excavation, four samples from the excavation sidewalls and a four-point composite sample from the excavated soil in the roll-off bin (Figure 3). Soil samples were collected by using six Encore™ capsules at each sample location. The samples were sent to McCampbell Analytical, Inc. for analysis. The soils were sampled for TPH-GRO (EPA Method 8260B) and BETX (EPA Method 8015B). A laboratory blank and LCS/LCSD were also evaluated by the lab. Data validation was completed by the USACE chemist, Kyle Bayliff.

Table 1 lists the results of the soil samples. Three samples yielded contaminants of concern above the reporting limits for TPH-GRO (FTO 190916-S, FRO 190916-B and FTO 190916-C1,2,3,4) and total Xylenes (FTO 190916-S, FRO 190916-W and FTO 190916-C1,2,3,4). All samples were below California Environmental Screening Levels – Tier 1 (CA ESL - Tier 1).
