Report
Investigation of Munitions and
Explosives of Concern (MEC) Incident
Discarded Military Munitions (DMM)
Grenade, Hand, Smoke, White
Phosphorous, M15

November 9, 2009

Report
Investigation of Munitions and Explosives of Concern (MEC) Incident
Discarded Military Munitions (DMM) Grenade, Hand, Smoke, White Phosphorous, M15
August 29, 2009

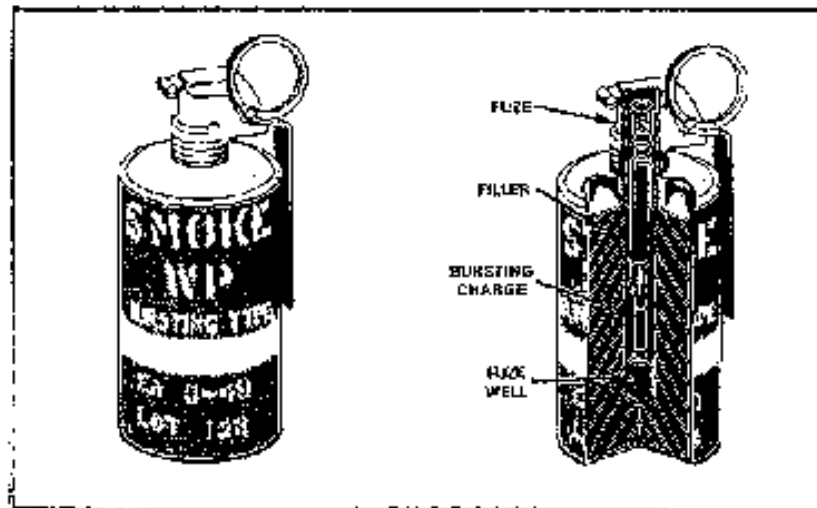
The M15 White Phosphorous grenade is a bursting type grenade used for signaling, screening, and incendiary purposes.

M15 WP smoke hand grenade.
