Subject: **Future East Garrison Munitions Response Area (Grenade Range) - Erosion Inspection on December 3, 2012**

FORA ESCA Remediation Program Team

Subject: **Future East Garrison Munitions Response Area (Grenade Range) - Erosion Inspection on December 27, 2012**

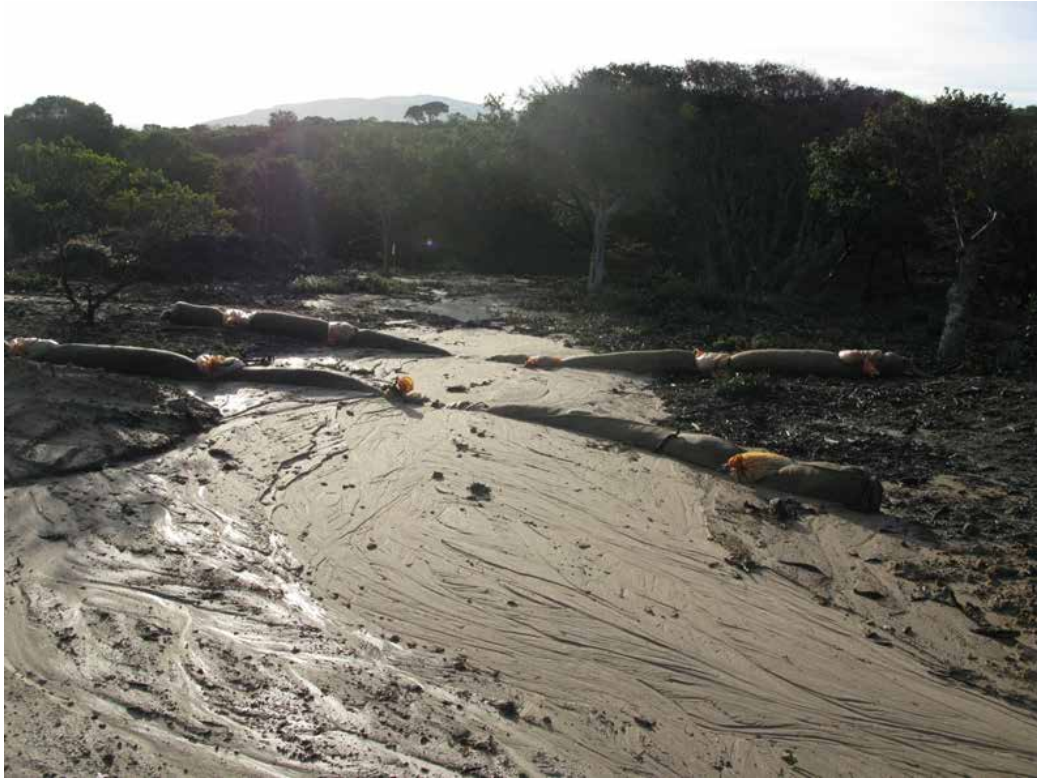
Photo #1

In the ‘grenade range’ in FEG, sediment laden water left the work area in two locations over the top of installed BMPs (See Map A DYM 2012 12 03). Sediment laden water went over two straw wattles installed on the south end of the work area. The sediment traveled approximately 50 feet into vegetation (Photo 1 and 2). The sediment was observed to be up to 4 inches in depth in vegetated areas. The wattles were pulled out of the sediment and placed on top of the sediment. In addition grading was completed so that less run-off would be directed to this location. One additional straw wattle was also installed at this location (Photos# 3).

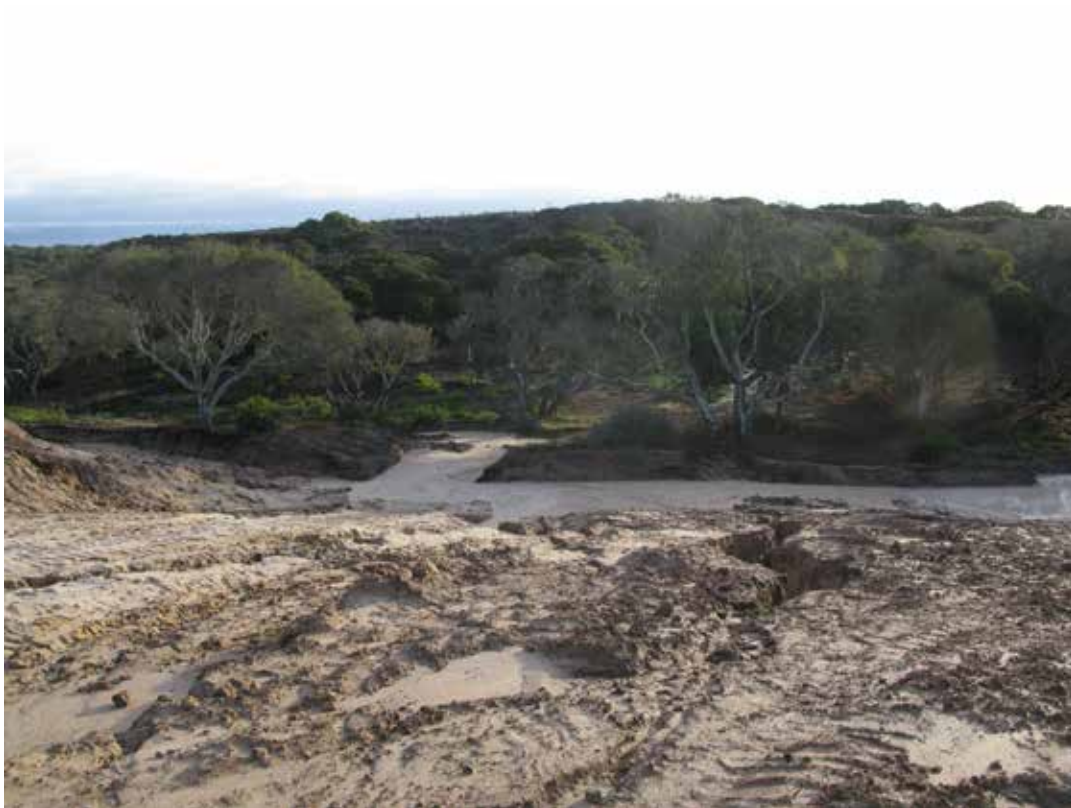
Photo #4

The top soil and subsoil have been removed in the eastern end of in the site during remediation work. The soil has been stockpiled in the west side of the grenade range. By removing the soil layers a temporary “catch basin” was created in the eastern end of the site. However, due to the large amount of rain fall received, sediment laden water flowed over the top of this area at the lowest point (Photo 4). Sediment laden water travelled several hundred feet down a dirt road to the east north east of the grenade range (Photo # 5-6). Weston Solutions employees installed four straw wattles with stakes and sand bags at this location on December 4, 2012 to try to resolve this issue (Photo #7).

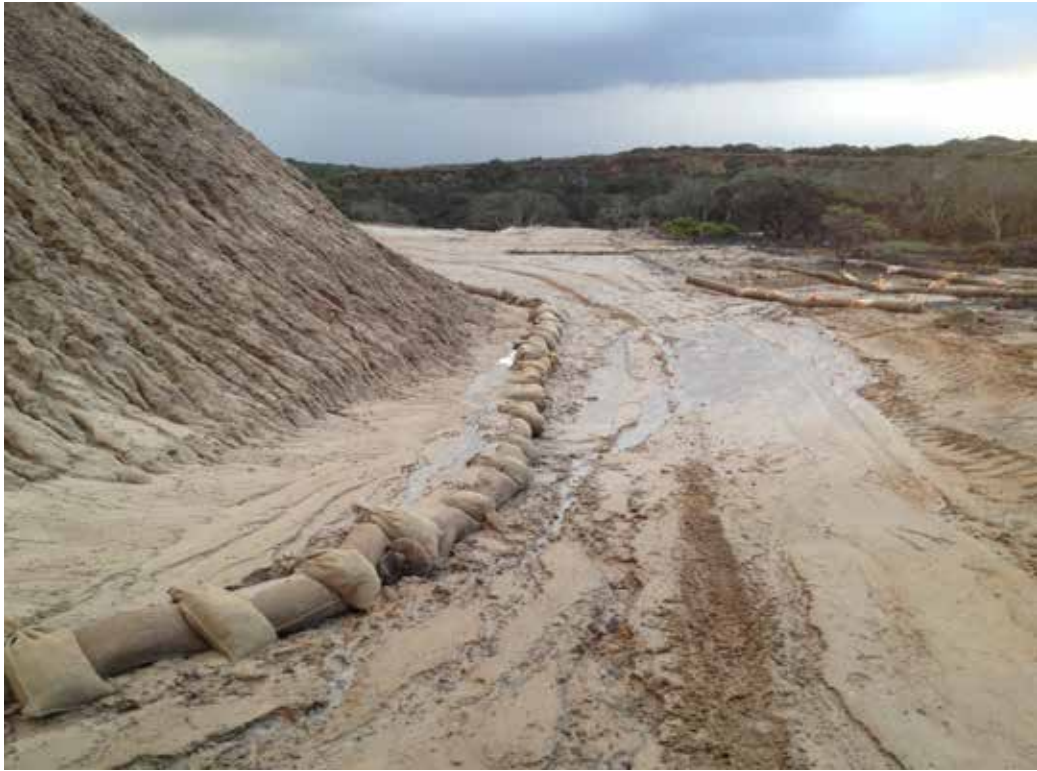
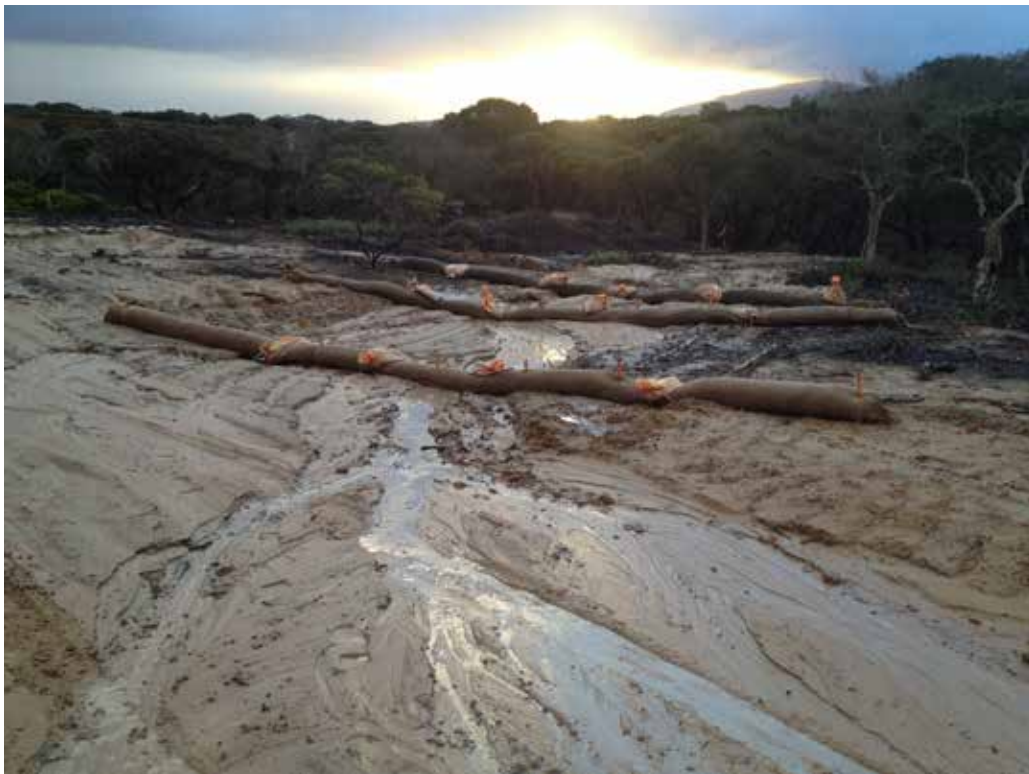
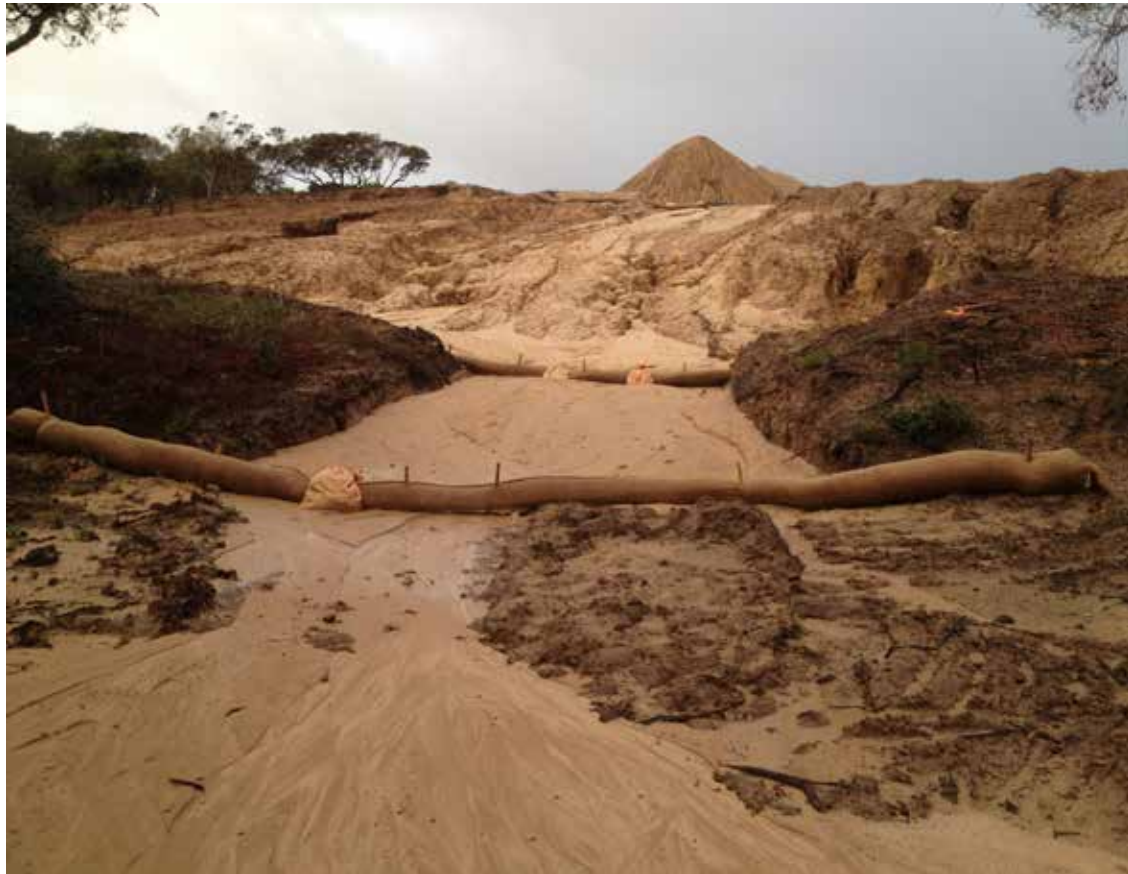
Below are photographs from 26-Dec-12 /27-Dec-12

On December 26, 2012, Tessa Chapman and Mike Filbin observed that some of recommendations did not hold the soil sediments as there were torrential rains over the weekend. Doug Fischer, Kristie Reimer, and Mary Carroll were advised of the site condition and approved that additional sandbags were needed Mike Filbin and his crew corrected wattles to help prevent more soil sediments deposit away from the site to the best of their ability. Note: Site extremely saturated.

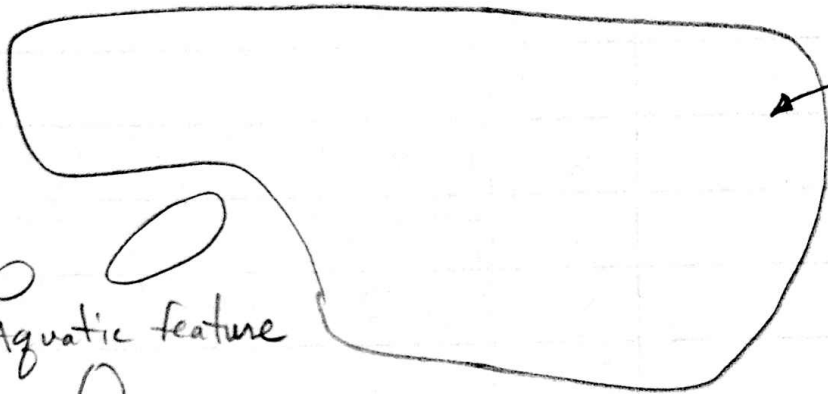
Aquatic feature

steep area w/  
new wattles  
and water bars

Wattles have been  
overtopped and have  
minimal function.
