**Independent Third-Party Quality Assurance Work
Summary Report for
Munitions and Explosives of Concern Activities at
Interim Action Ranges Munitions Response Area
Former Fort Ord Facility, Monterey, California**

August 2014

ERRG implemented quality assurance (QA) efforts in support of the design study for the Interim Action Range (IAR) Munitions Response Area (MRA) Range 44 and 47 Special Case Areas (SCA) and Central Area Non-Complete Areas (NCA) in compliance with the QASP to satisfy regulatory agency concerns. It is recognized that a MEC removal action may not successfully acquire and recover all MEC therefore the regulatory agencies have expressed concern regarding the residual risk that remains after MEC removals have taken place, particularly in areas that are slated as planned for community development with borderland that will interface habitat reserve (with administrative controls). This report is intended to document ERRG's efforts in providing the ESCA MEC Remediation Program with Third-Party Quality Assurance oversight, as required by the regulatory agencies, in addition to the Quality Control provided by Weston during their field work.

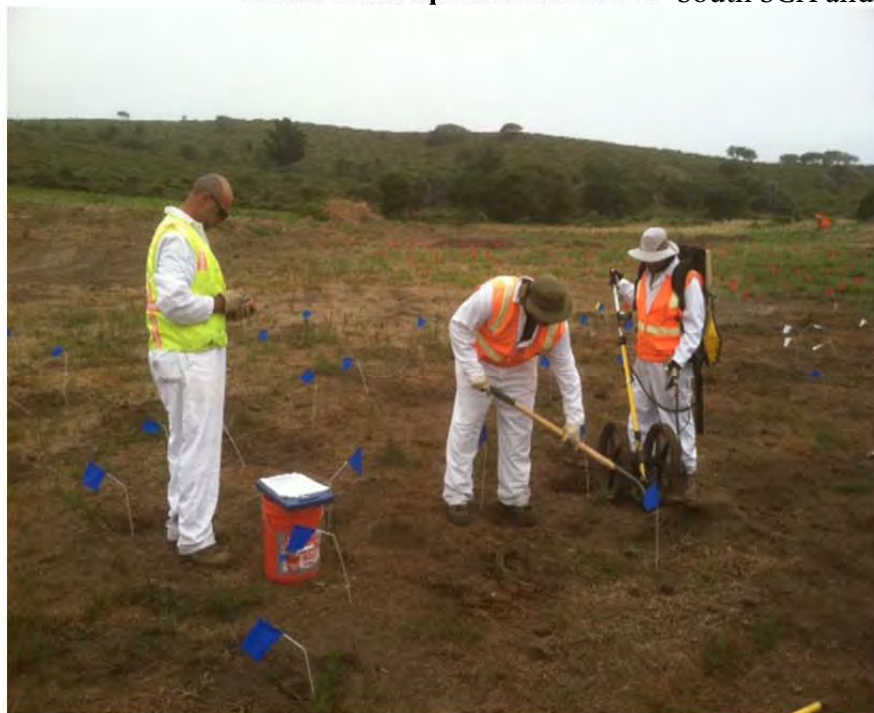
Picture 2: Mag & Dig Operations in RQA Level 2, MRS-1, Parcel E24

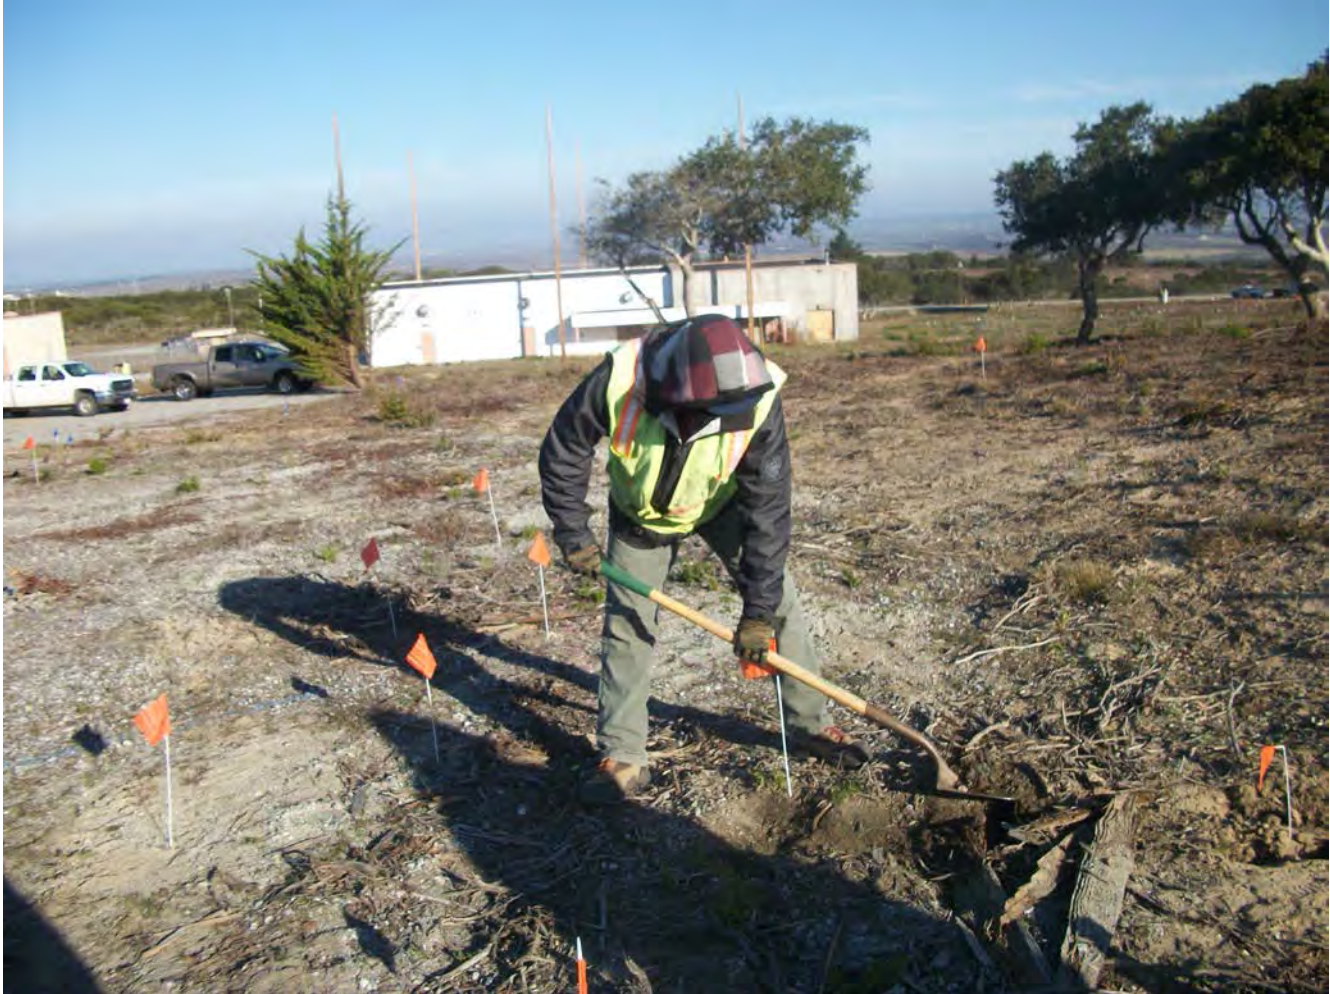
Picture 2: Anomaly excavation

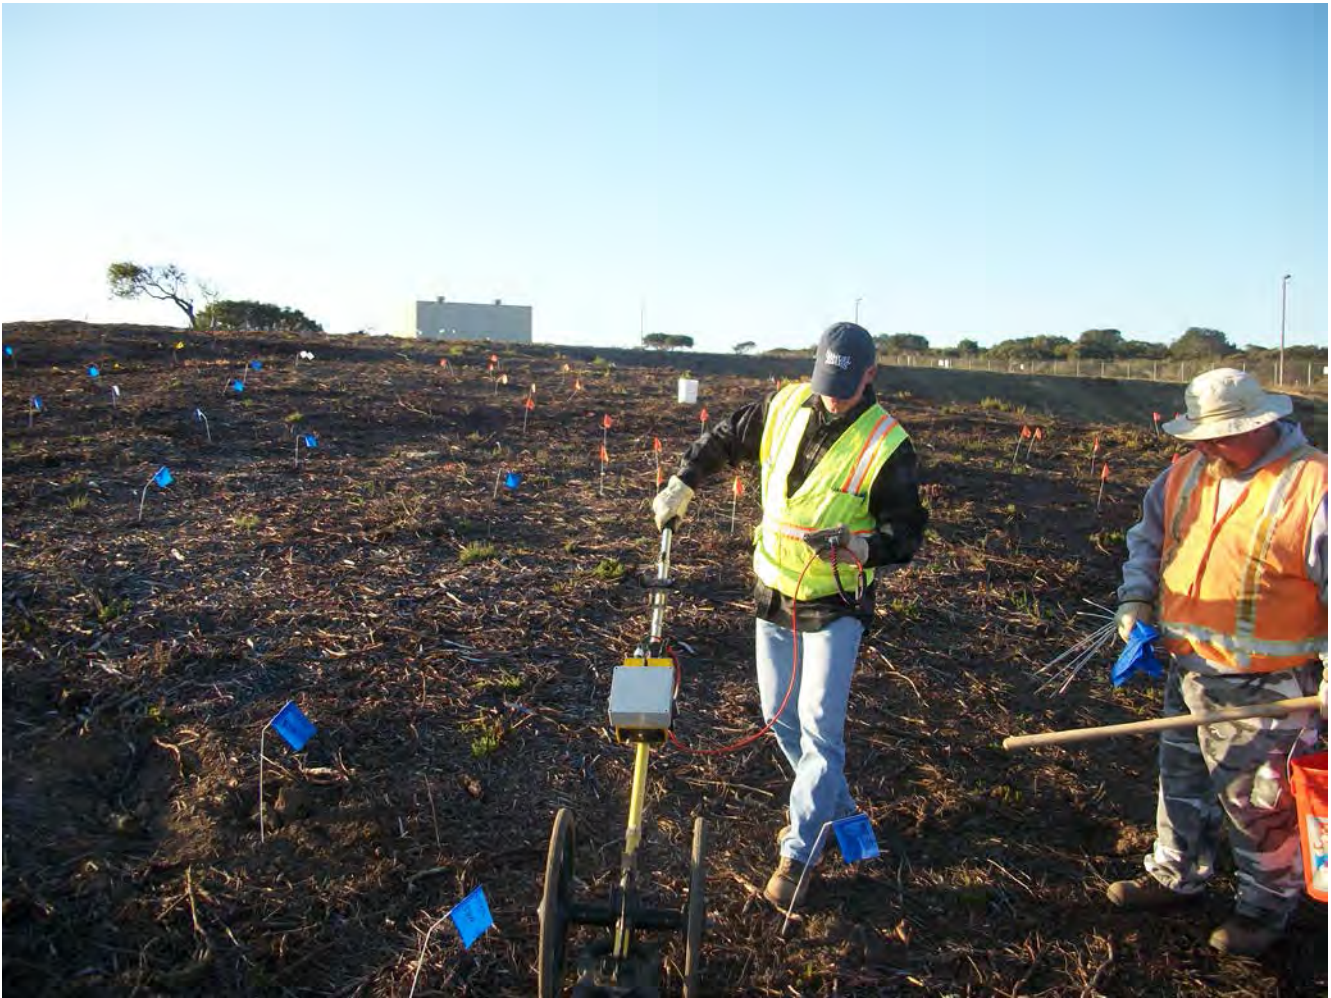
Picture 3: UXOQC performing QC anomaly inspections

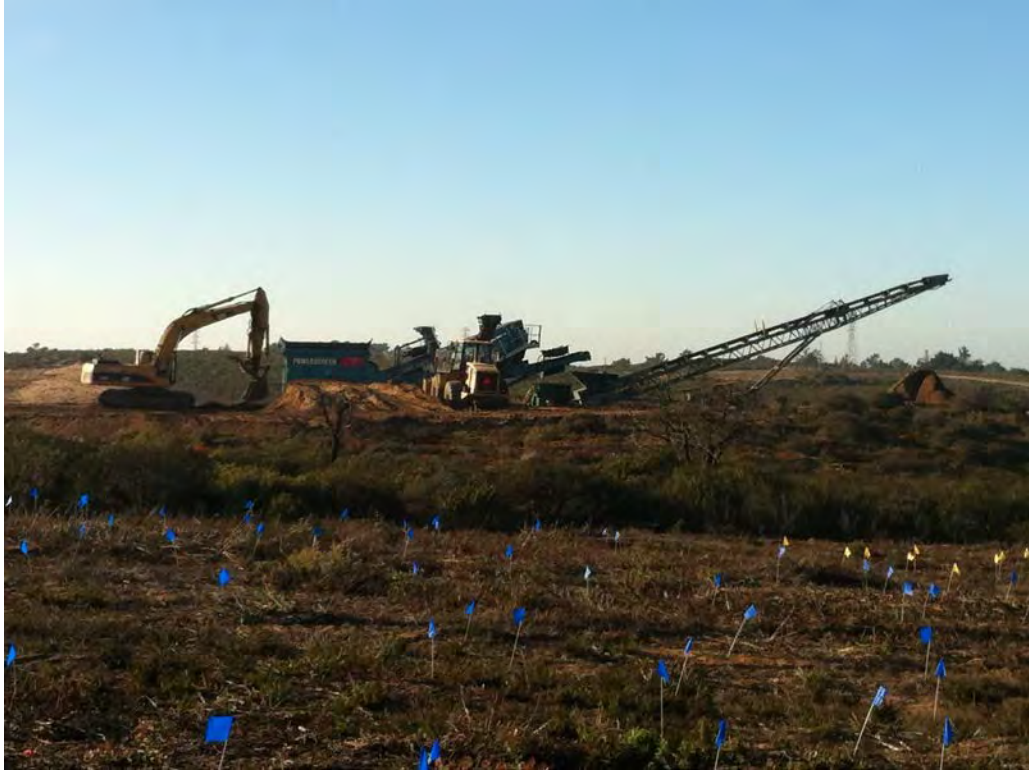
Picture 1: Sift operations at Range 47 IAR

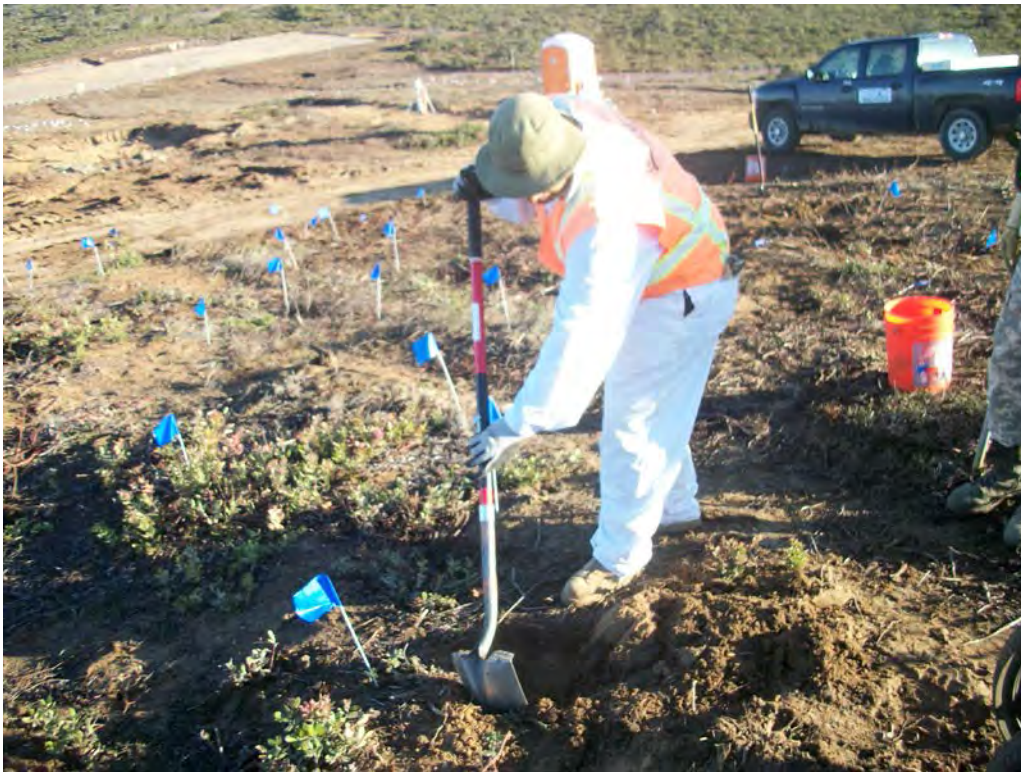
Picture 3: Anomaly excavation IAR R44 North SCA

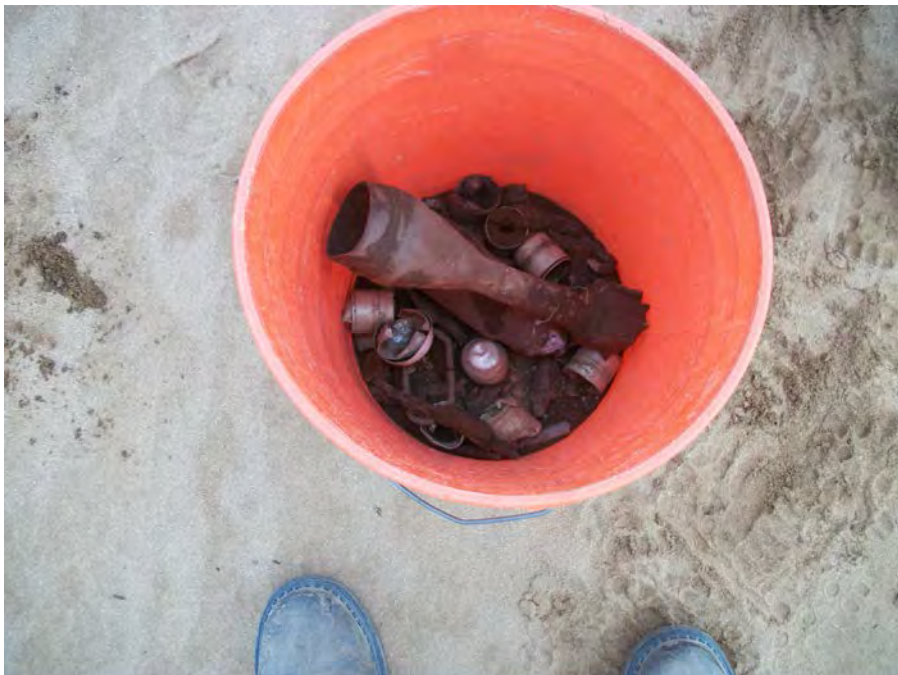
Picture 4: Munitions Debris located, 40mm grenade and 81mm mortar components IAR Rg 47

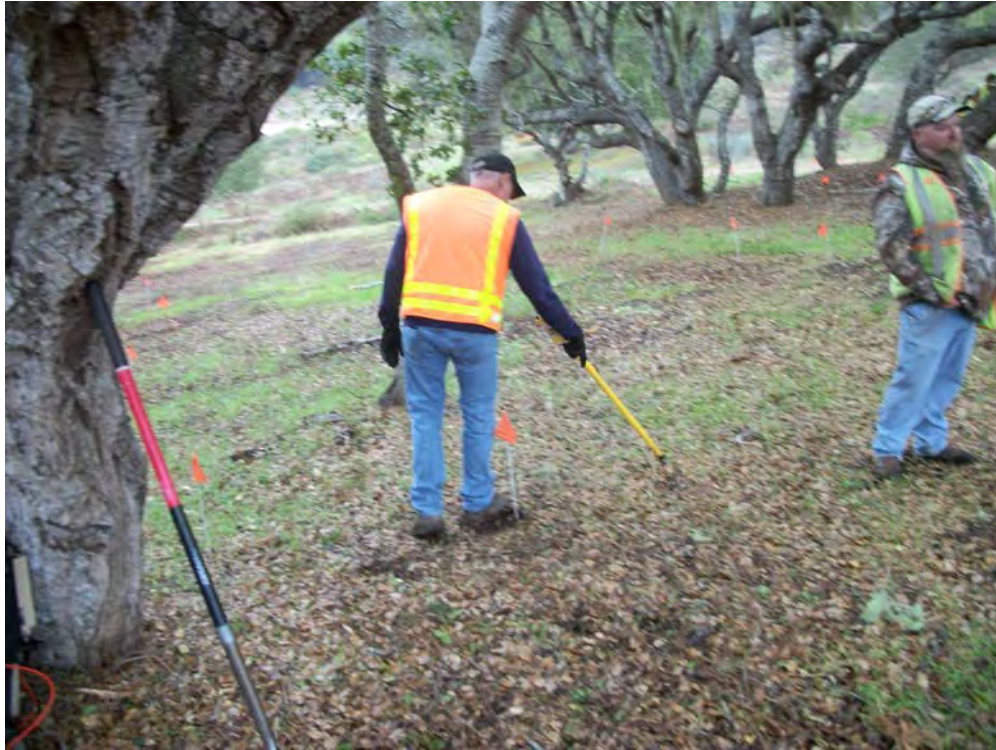
Picture 3: UXO Technician pinpointing with a Schonstedt detector IAR Range 47 SCA

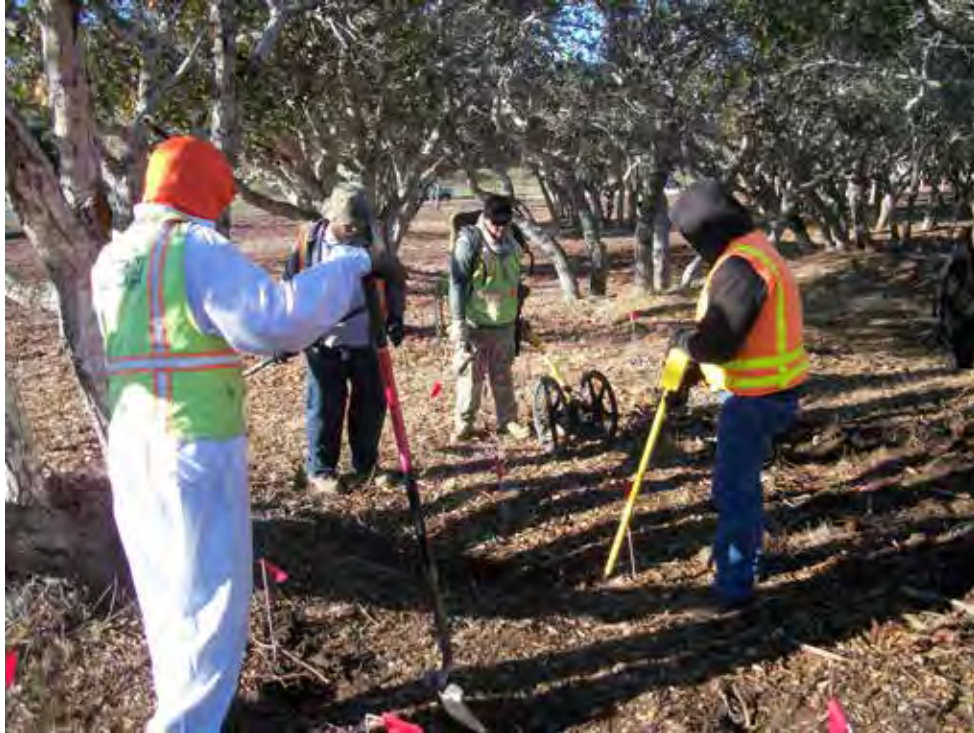
Picture 1: Personnel performing all procedures; anomaly acquisition, pinpointing, and excavation IAR Range 47 SCA

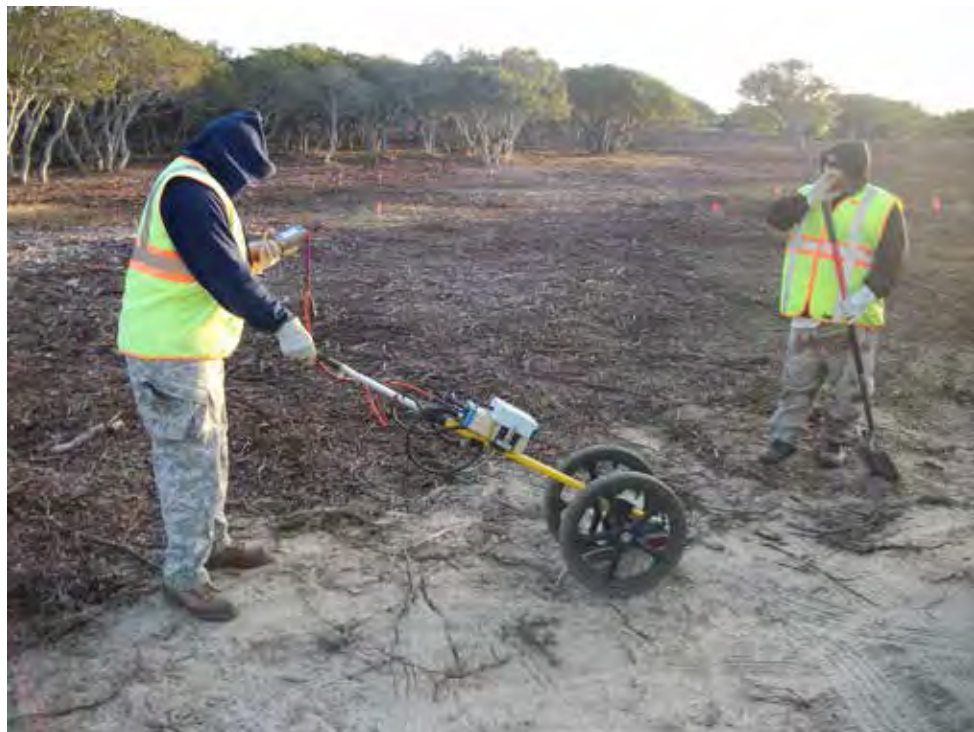
Picture 2: Personnel performing anomaly acquisition and pinpointing IAR Range 47SCA

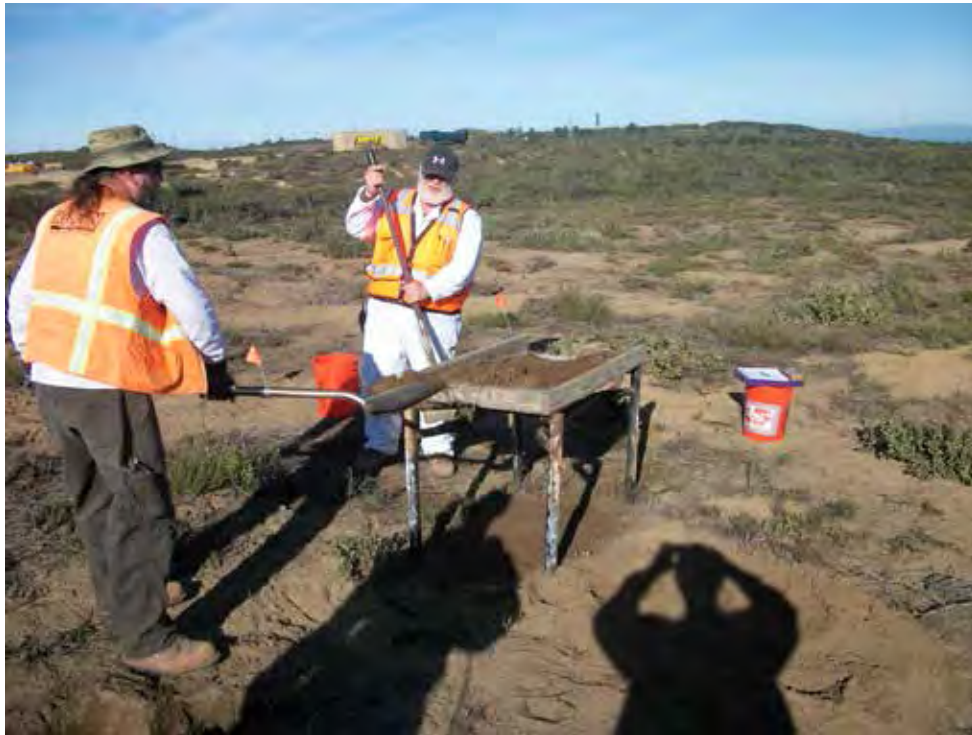
Picture 3: Sift table used on soils with concentrated small anomalies IAR Range 47SCA
