4.3 SOILS, GEOLOGY, TOPOGRAPHY, AND SEISMICITY

4.3.1 Soil and Geologic Ecosystem Relationships

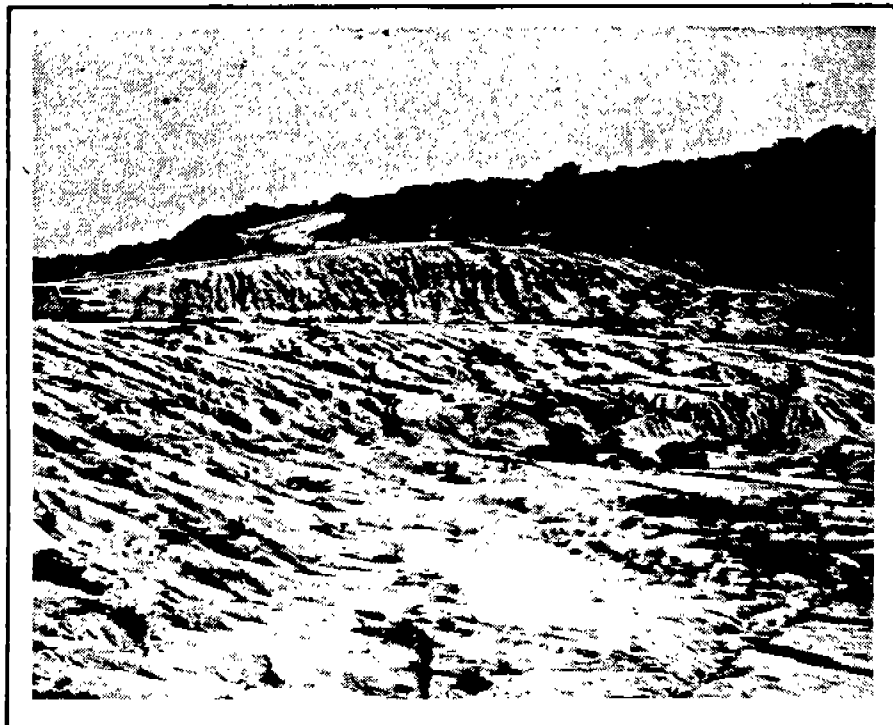
Erosion on cutbank and downslope of a roadway,
Aromas formation on Fort Ord.

Erosion on the Aromas formation is exacerbated by disturbance, such as roadcuts. Figure 4.3-4 shows eroded areas on the cutbank and downslope of a roadway. Problems in drainage were also encountered in the construction of the new ammunition supply point. A ditch for an electric line pipe conduit formed a gully breakout where it was excavated below the sandstone layer, and a drainage structure conveying runoff partly downslope from the ridgetop facility induced erosion in spite of riprapping.
