# **Final 5<sup>th</sup> Five-Year Review Report for Fort Ord Superfund Site Monterey County, California**

September 2022

**U.S. Army Corps of Engineers  
Sacramento District  
1325 J St.  
Sacramento, CA 95822**

**U.S. Department of the Army  
Fort Ord Base Realignment and Closure  
Building 4463 Gigling Road  
Ord Military Community, CA 93955**

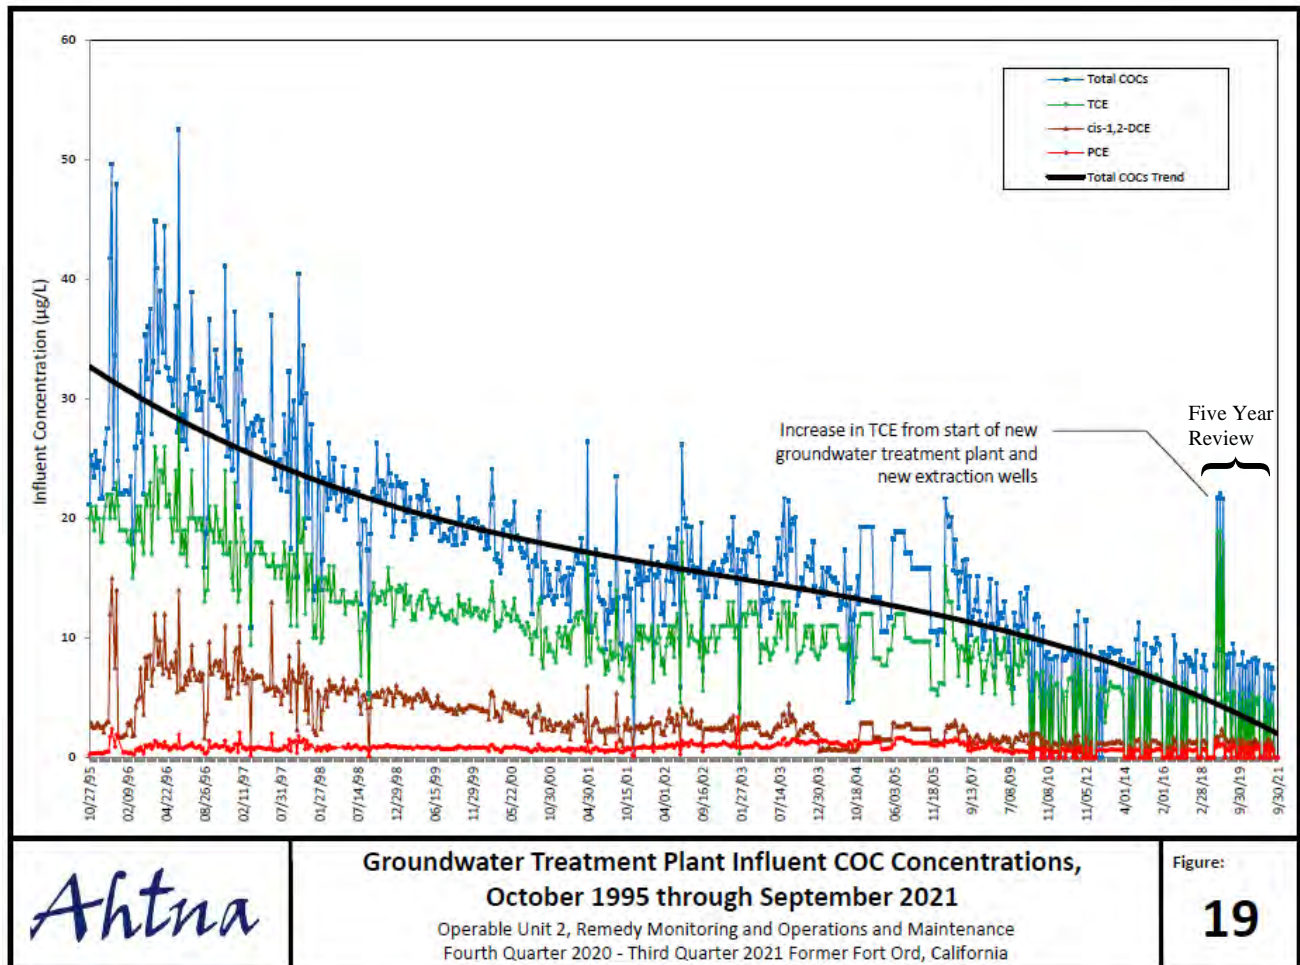
The following chart shows the groundwater treatment system influent COC concentrations from system start up to September 2021. All major COC concentrations are trending down since system start-up including through this Five-Year Review period. A spike in TCE concentrations is visible from the start-up of the new GWTP and wells, indicating better capture with the new infrastructure.

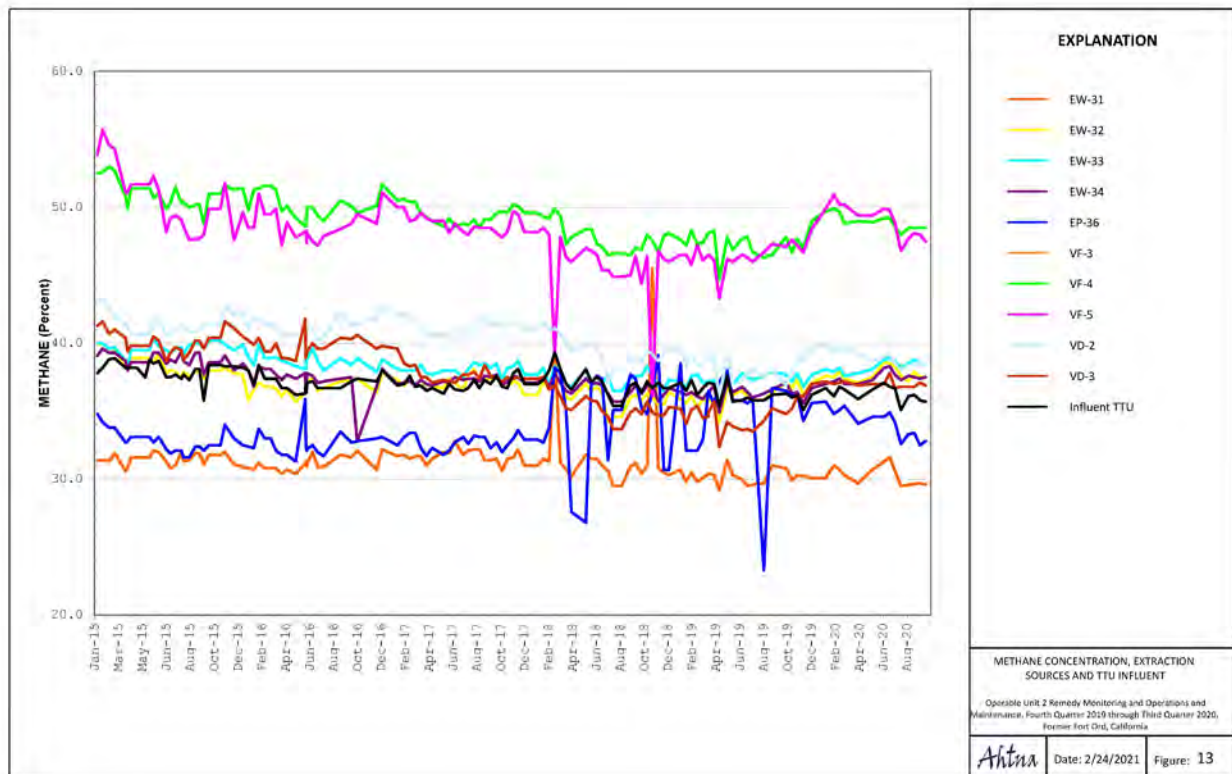
The time series plot below shows methane concentrations starting in January 2015 and gives some indication that there is a reduction in landfill methane generation based on the trend line (Ahtna, 2021b)

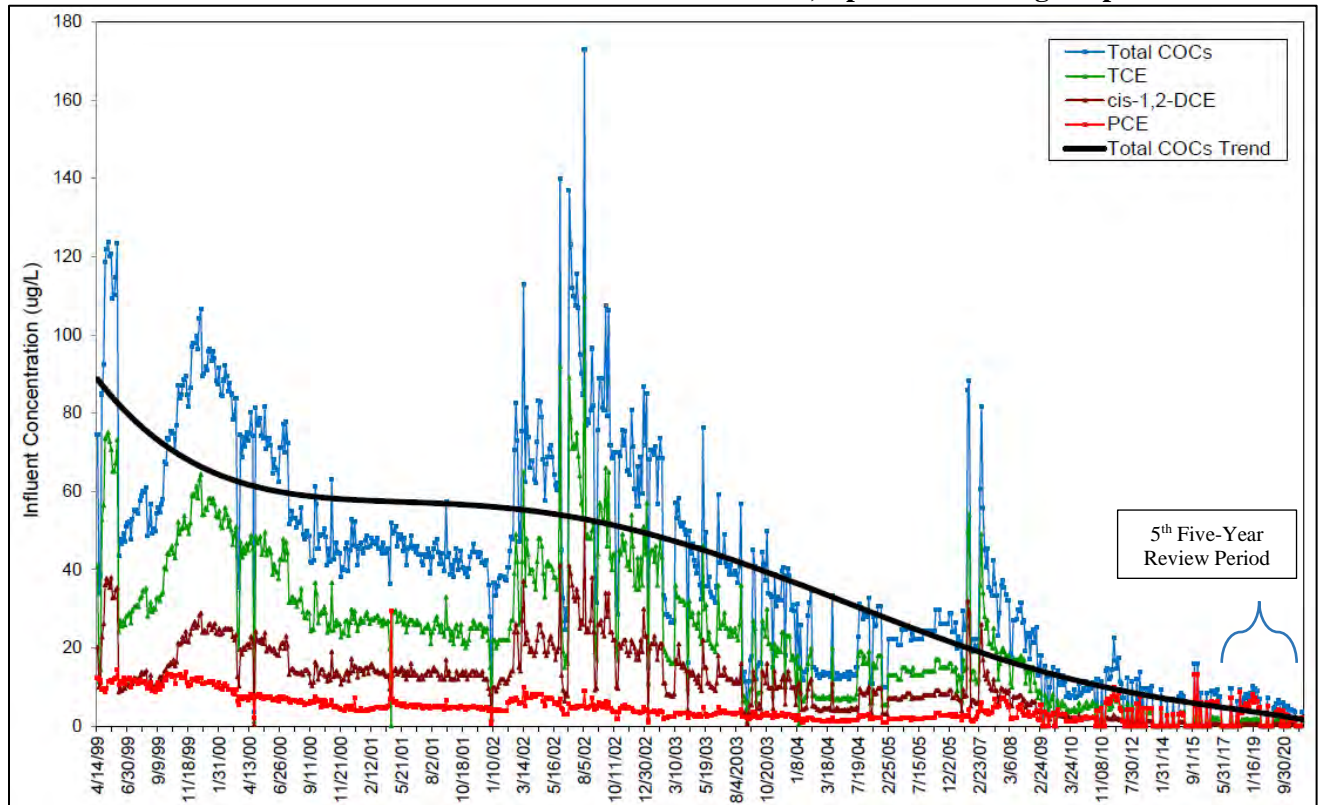
### Groundwater Treatment Plant Influent COC Concentrations, April 1999 through September 2021

During the Five-Year Review reporting period, the GWTP operated continuously in the automatic control mode utilizing two GAC treatment vessels and an air stripper until a GAC change-out on April 18, 2017. It was agreed that operation of the Sites 2/12 GWTP with one GAC vessel and air stripper would be acceptable for treatment. Since that change, the GWTP operated continuously in the automatic control mode utilizing one GAC treatment vessel and the air stripper (Ahtna, 2021g). The capacity of the Sites 2 and 12 GWTP with the GAC vessels and air stripper in series (225 gpm) is the practical maximum flow rate that allows for adequate residence time in the air stripper (Ahtna, 2021v). The two Site 2 injection wells (IW-02-01-180 and IW-02-02-180) have limited capacity and receive an insignificant amount of treated water. The total volume of treated groundwater for the reporting period was approximately 314.6 million gallons. The average flow rate approximating the reporting period for this Five-Year Review is 120 gpm. The reported average monthly flow rate varies depending on flow rates for individual wells and downtime events at the GWTP or the extraction wells. Cumulative treated groundwater flow since startup on April 13, 1999 through September 2021 is estimated at 2.224 billion gallons.

The data shows a decline in COC mass from groundwater since the start of the system and through this Five-Year Review reporting period (most recent data set Third Quarter, 2021). The following table shows the volume of treated water from Site 12 extraction wells, average flow rates, mass removal for the Third Quarter 2017 through the Third Quarter 2021 period, as well as the total mass removal (April 1999 to September 2021). The data show an estimated 17.2 pounds of COCs were removed in a period approximating the reporting period for this Five-Year Review.

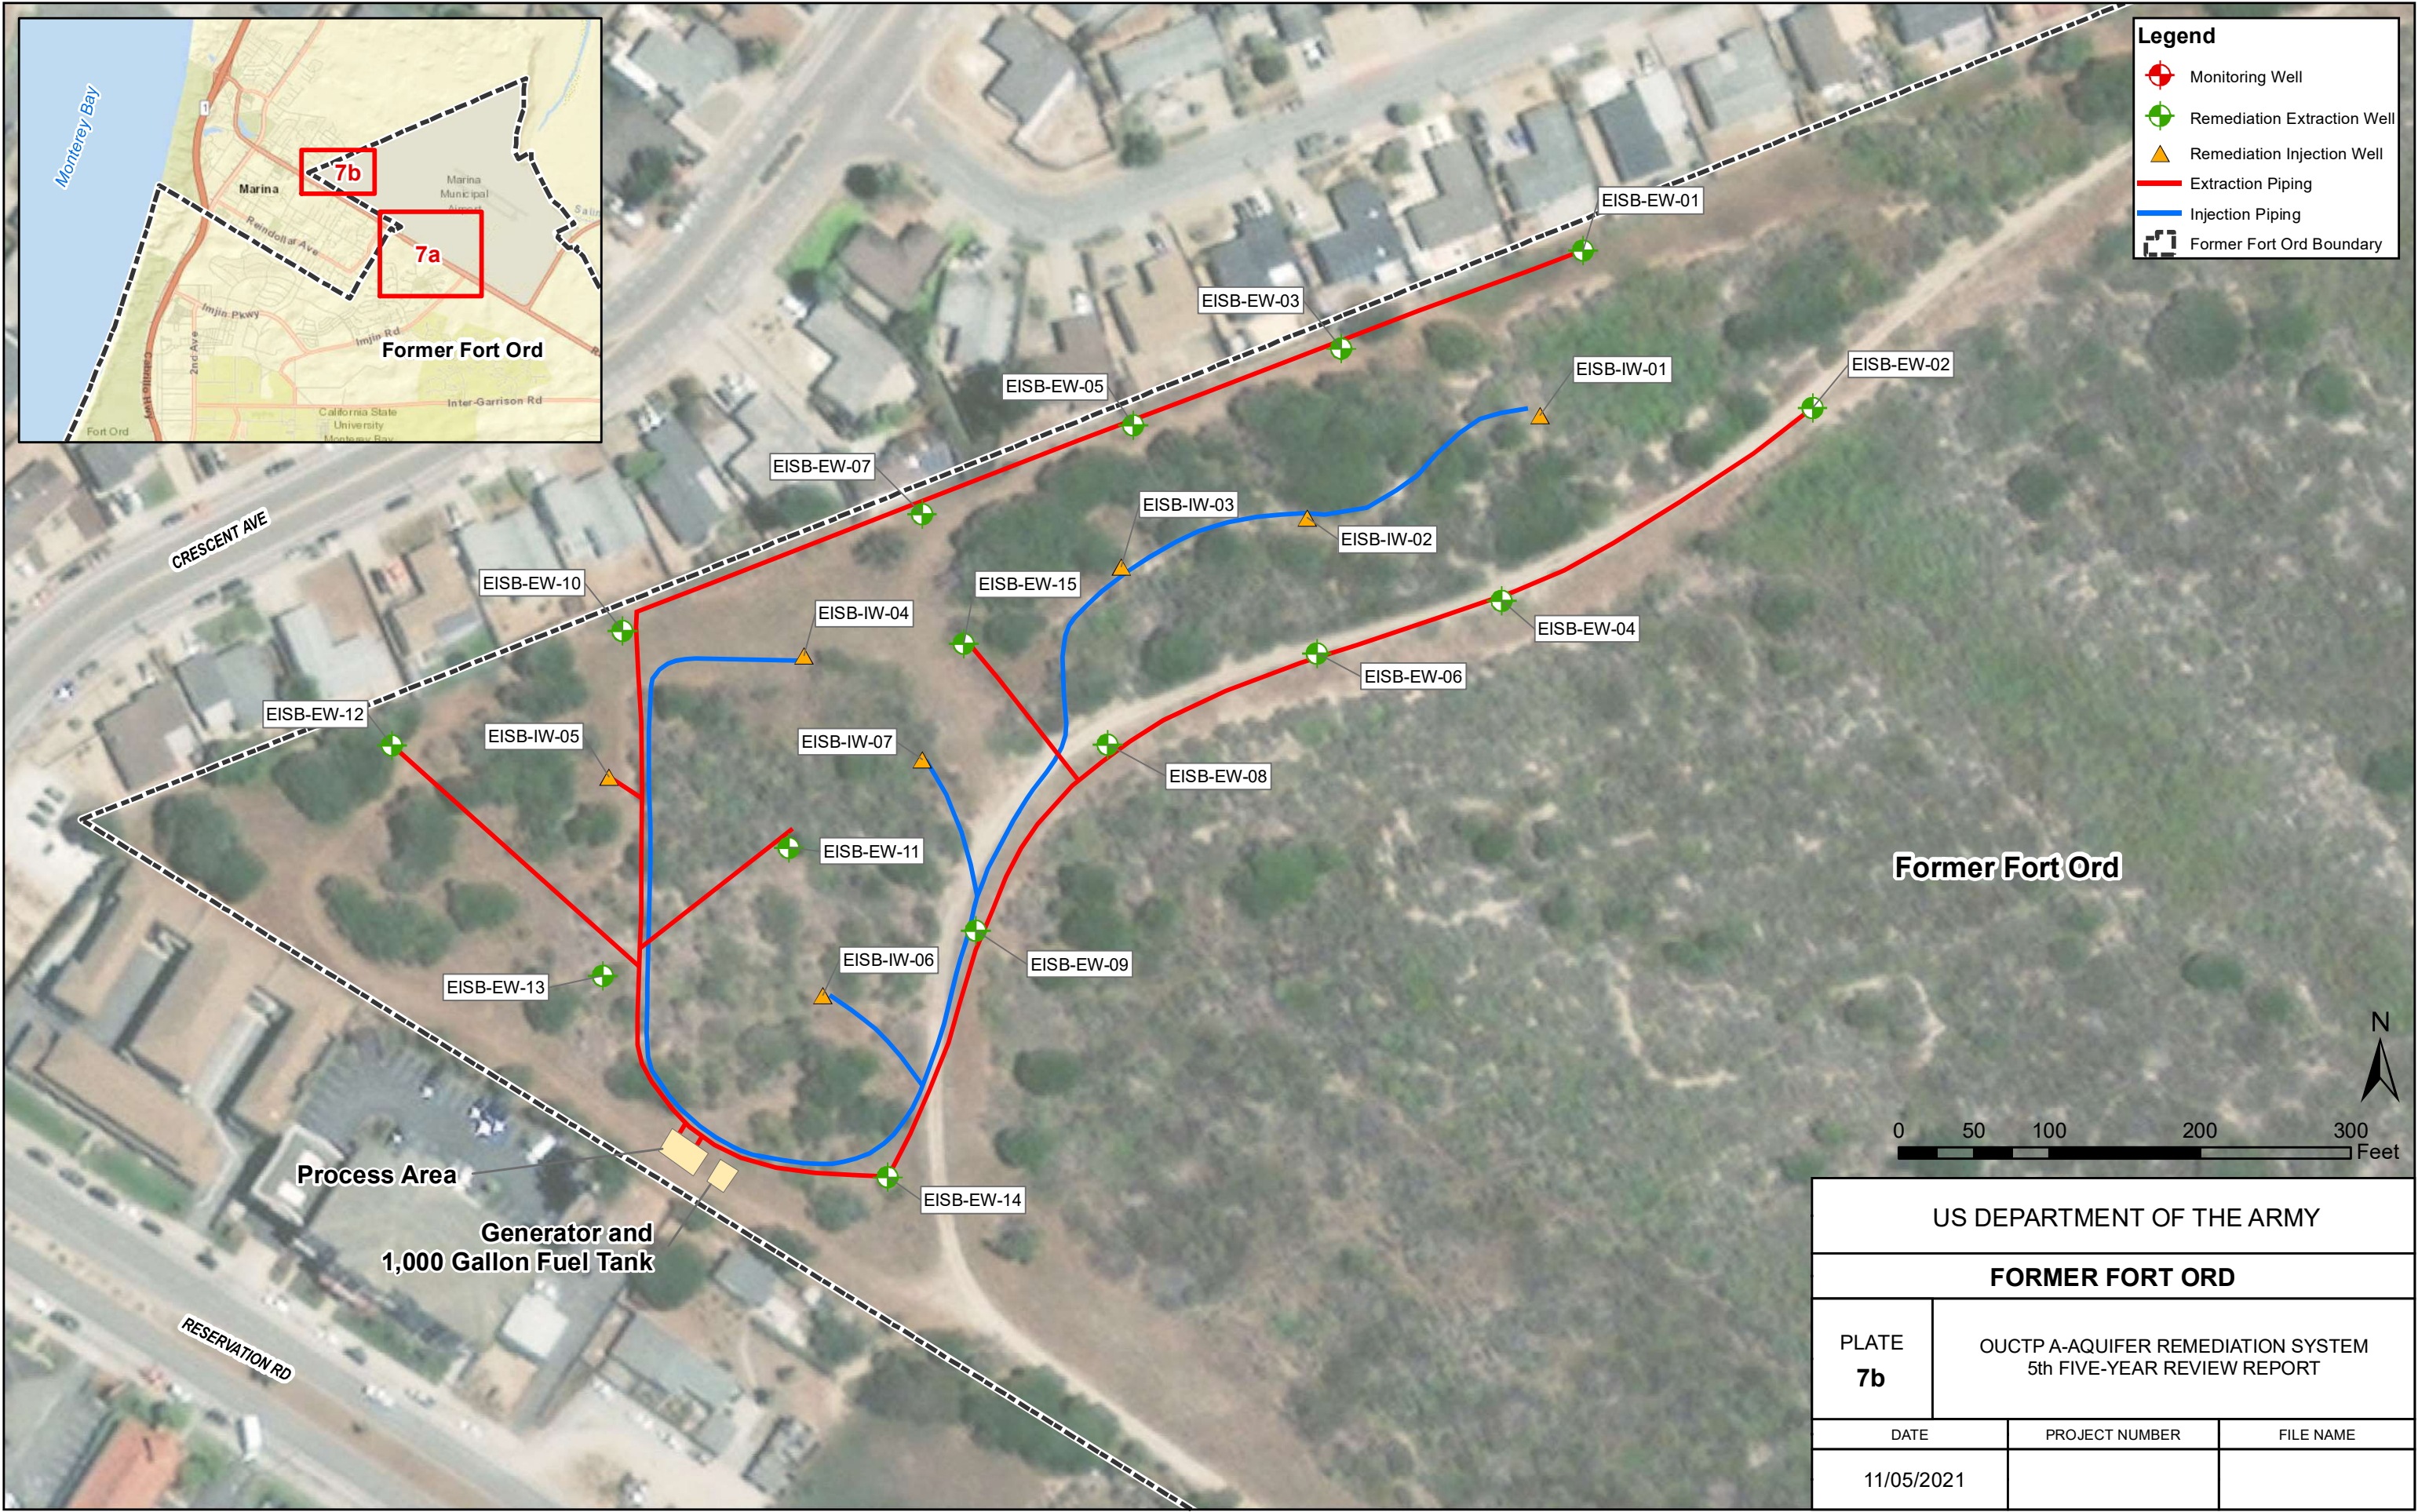
US DEPARTMENT OF THE ARMY		
FORMER FORT ORD		
PLATE 7b	OUCTP A-AQUIFER REMEDIATION SYSTEM 5th FIVE-YEAR REVIEW REPORT	
DATE	PROJECT NUMBER	FILE NAME
11/05/2021

The A-Aquifer remedial action, based on the results of the EISB Study, focused the EISB treatment on two treatment areas within the OUCTP. These treatment areas included the upper plume (source area) and the middle plume (high concentration area). Three separate deployments within the source area (Treatment Area 1) treated residual contaminants introduced into the groundwater prior to the source removal. Two separate deployments within the middle-plume (Treatment Area 2) treated the area that historically exhibited the highest CT concentrations between 2009 and 2011. The treatment areas are shown on Plates 7a and 7b. A total of six deployments of EISB (Pilot Study, Deployment Areas 1A, 1B, 1C, 2A, and 2B) were conducted within the source and the middle plume areas (Ahtna, 2012a). In January 2016, it was determined the A-Aquifer CT Plume had migrated further to the east of the groundwater divide and north into the FONR than previously defined. Therefore, an additional EISB Deployment Area 3A was implemented in September 2016 and completed substrate injections and recirculation in August 2017. More information about Deployment Area 3A can be found in Section 10.3.2.

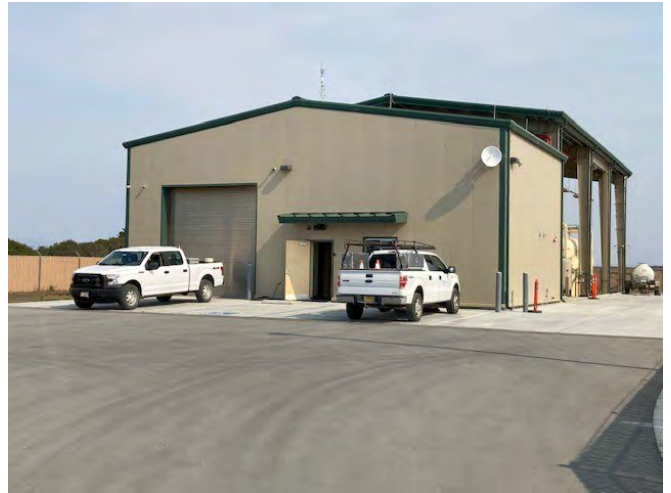
**Description:** New OU2 GWTP from outside, offices and storage in front, treatment vessels in rear under cover

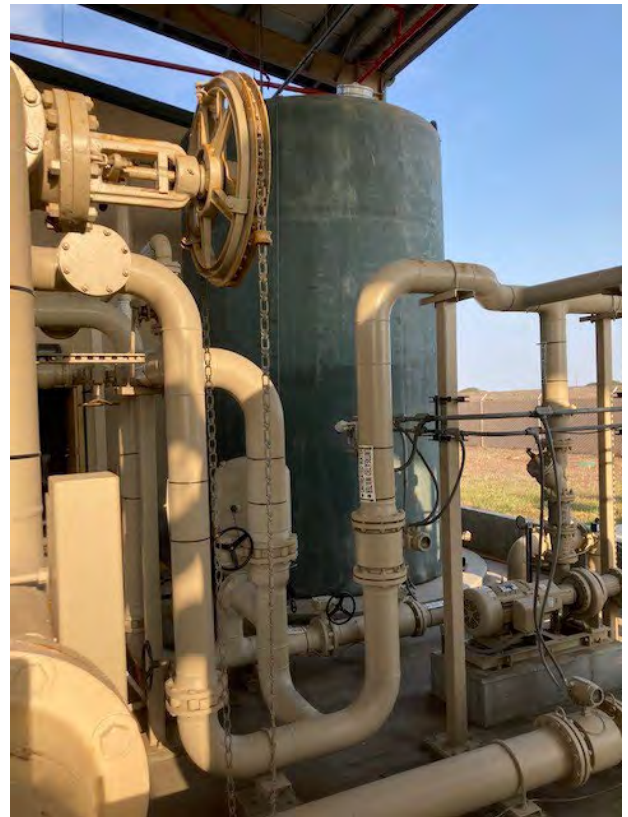
**Description:** OU2 GWTP Backwash Tank

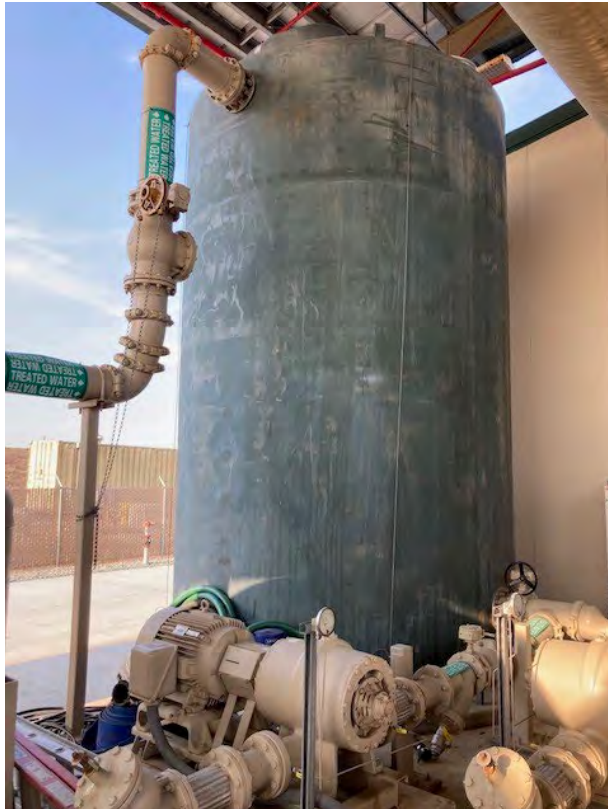
**Description:** OU2 GWTP  
Effluent Tank

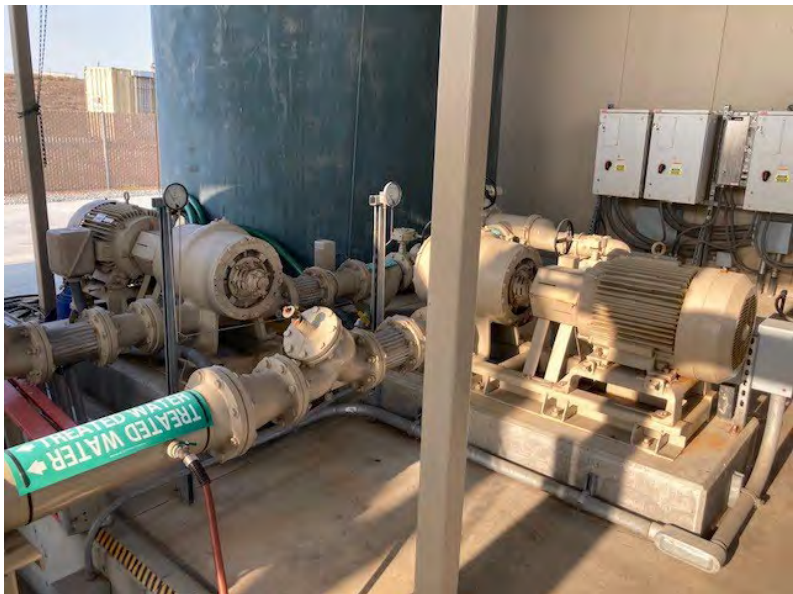
**Description:** OU2 GWTP  
Effluent pumps

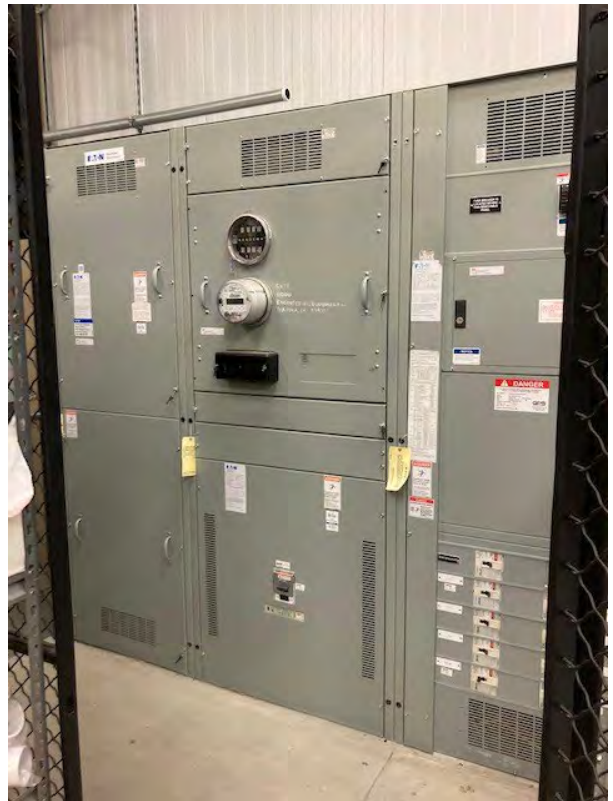
**Description:** OU2 GWTP Electrical Panel

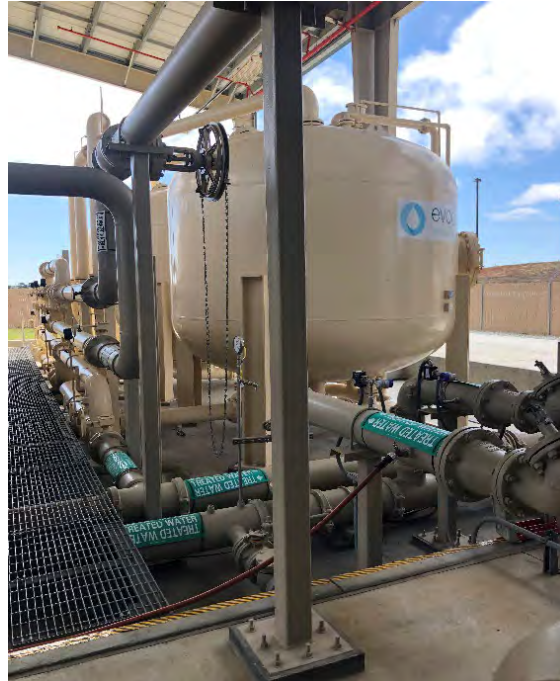
**Photograph No. 7**

**Description:** OU2 GWTP GAC vessels in series looking east. Not pictured are 3 more GAC vessels in series north of the pictured system.

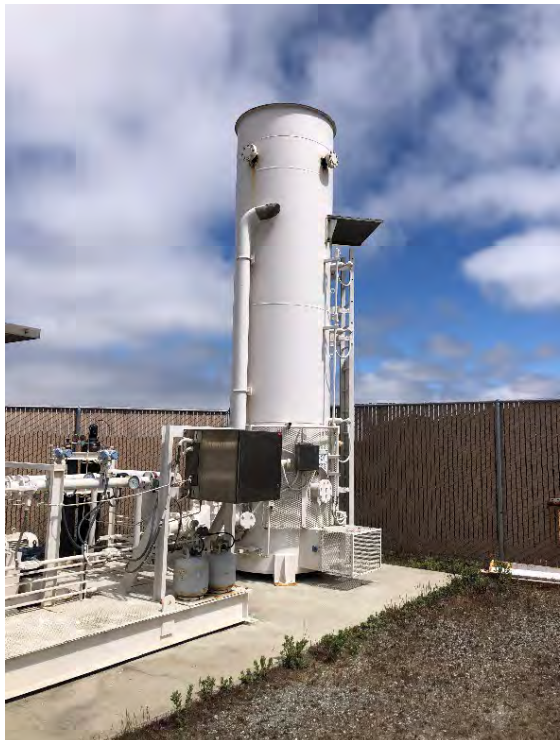
**Photograph No. 8**

**Description:** Landfill gas extraction and treatment system TTU, looking north inside from the TTU compound.

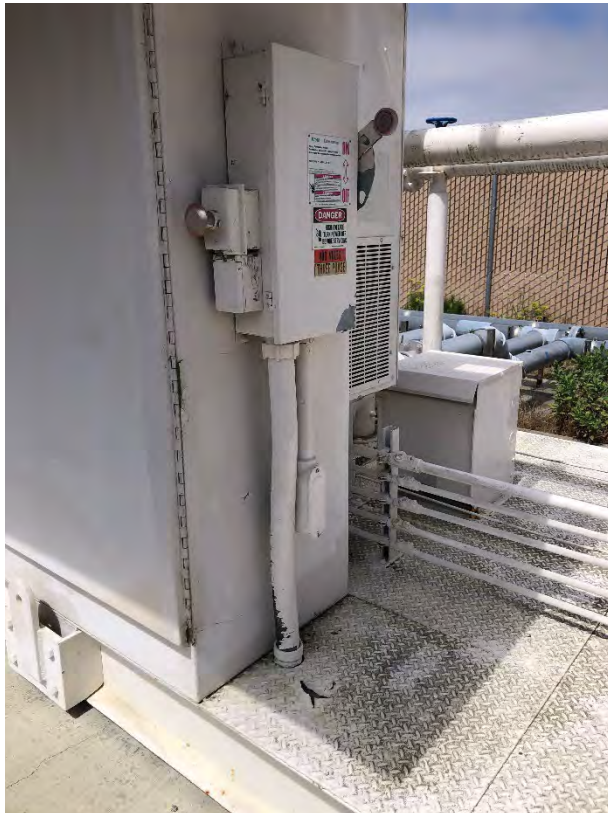
**Description:** Landfill gas extraction and treatment system TTU control panel.

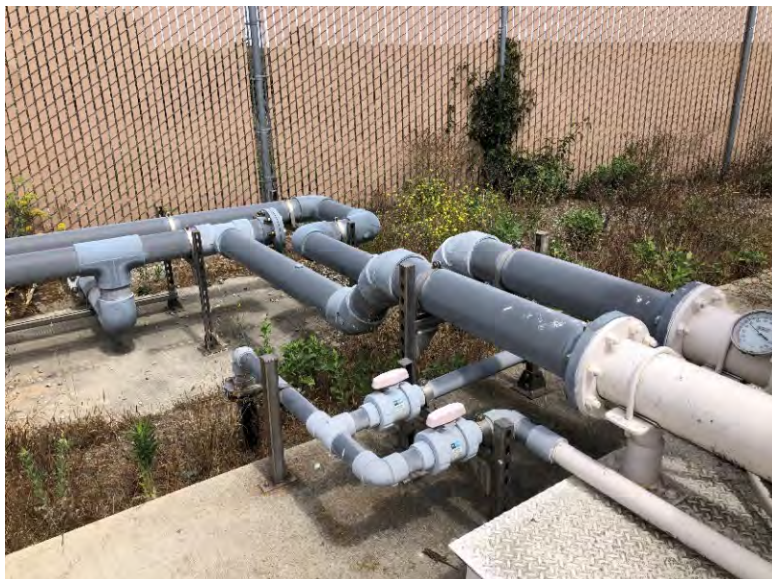
**Description:** Landfill gas extraction treatment system TTU influent manifold valves.

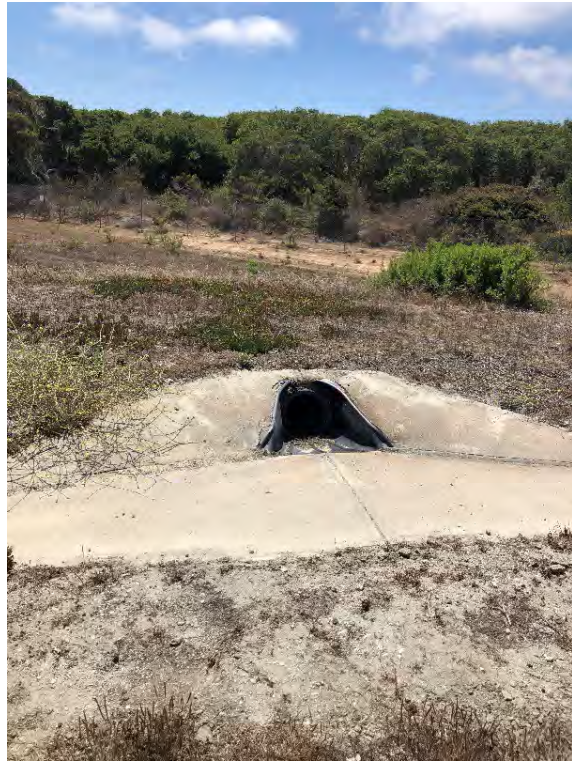
**Photograph No. 11**

**Description:** Landfill's surface drainage feature looking east.

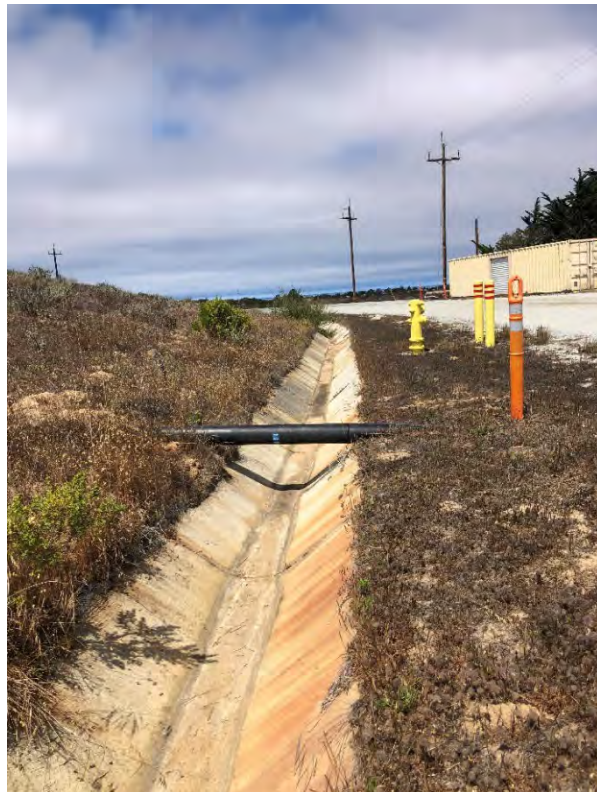
**Photograph No. 12**

**Description:** Landfill surface drainage feature and landfill cell vegetative cover on left side of photo.

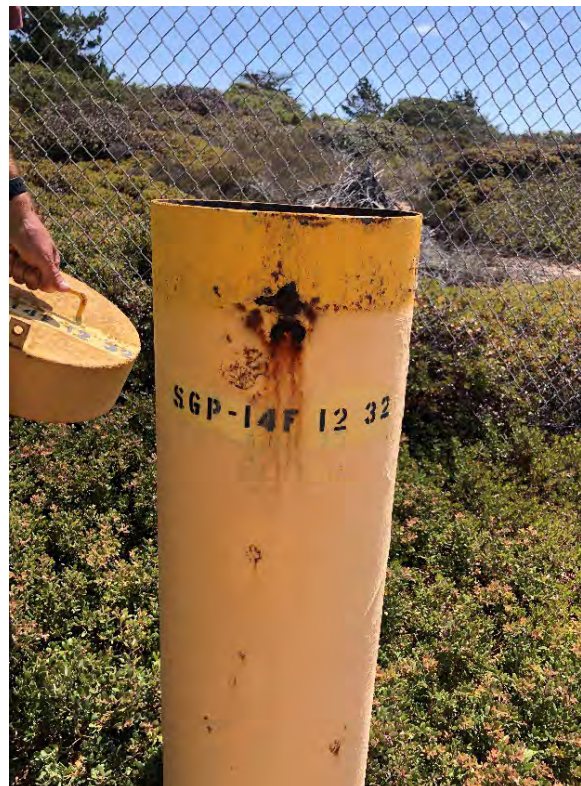
**Description:** Landfill gas monitoring probe on east side of Area F.

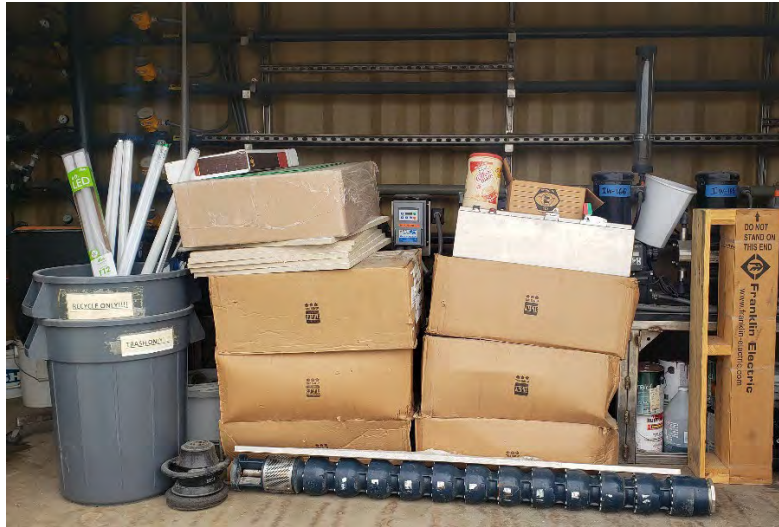
**Description:** Storage container for the processing system container and wellhead equipment from the Deployment Area 3A located at the OU2 GWTP. Storage container is normally closed and locked.

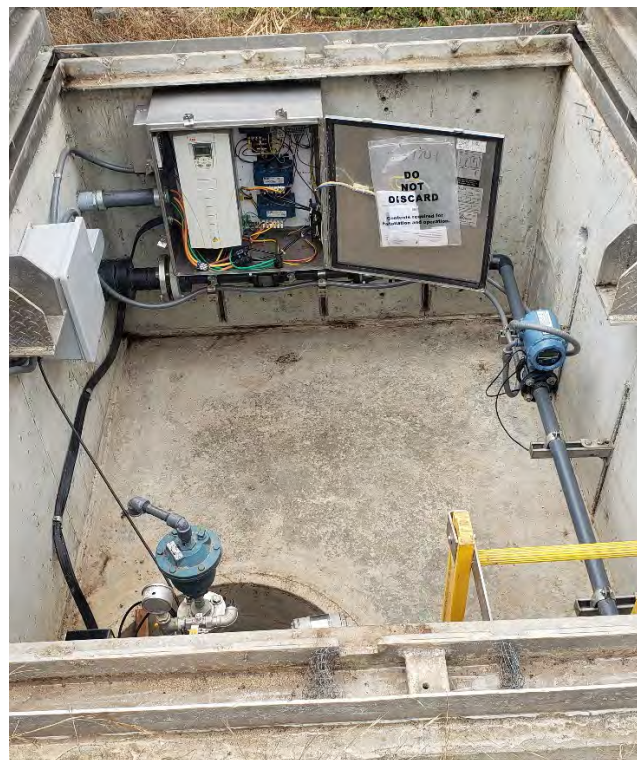
**Description:** Upper-180 Foot Aquifer Extraction well EW-OU2-09-180 well vault. Area is gated and well vault is normally closed and locked.

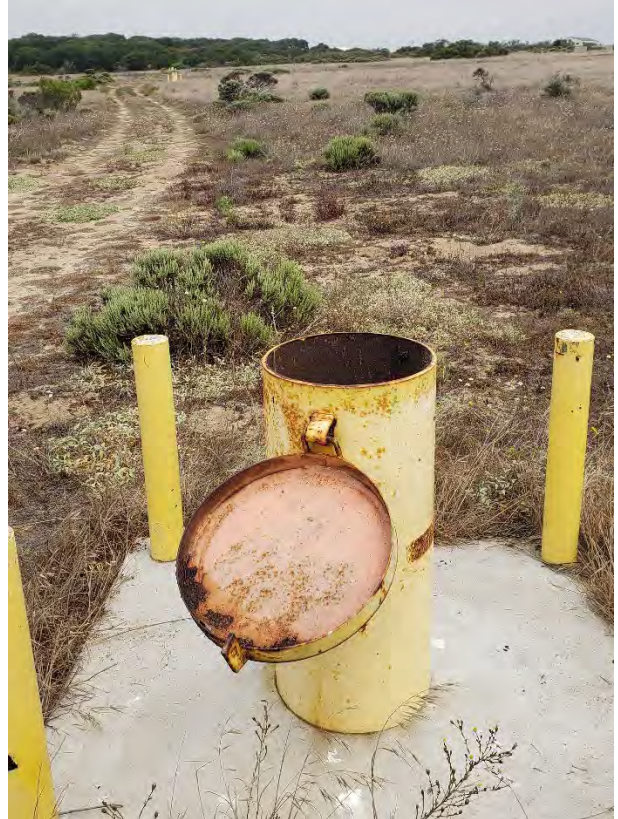
**Description:** A-Aquifer  
Extraction Well EW-BW-162-  
A with EW-BW-160-A and  
EW-BW-161-A in the  
background, facing south. Well  
is typically locked.

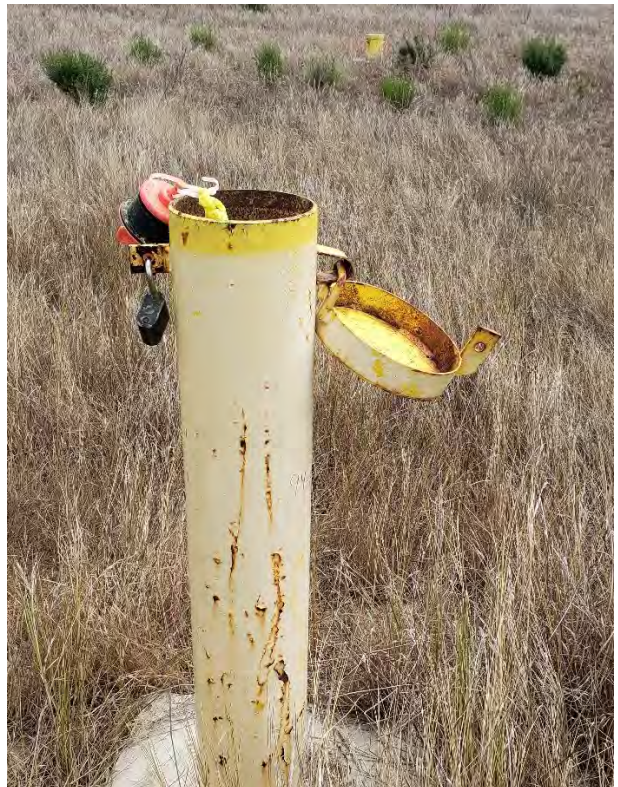
**Description:** A- Aquifer  
Monitoring well MW-BW-94-  
AR with MW-BW-94-A in the  
background, facing east. Well is  
typically locked.

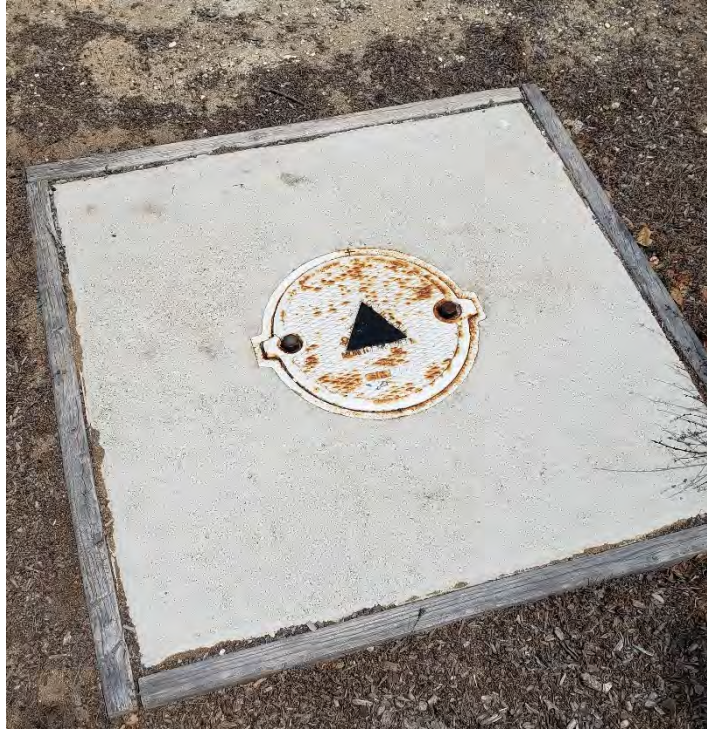
**Photograph No. 5**

**Description:** Lower 180-Foot  
Aquifer monitoring well MW-  
BW-59-180.

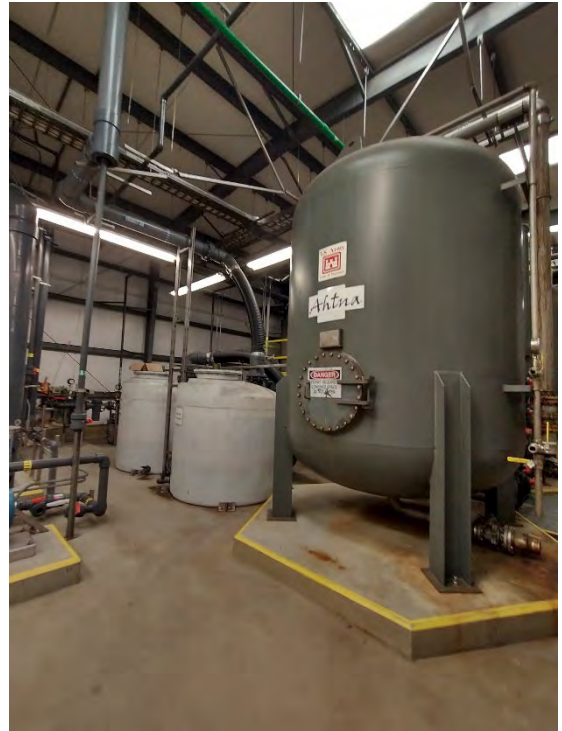
**Description:** GAC vessel (gray tank) on the right. Two white tanks of potassium permanganate on the left for the air stripping system in the Groundwater Treatment Facility.

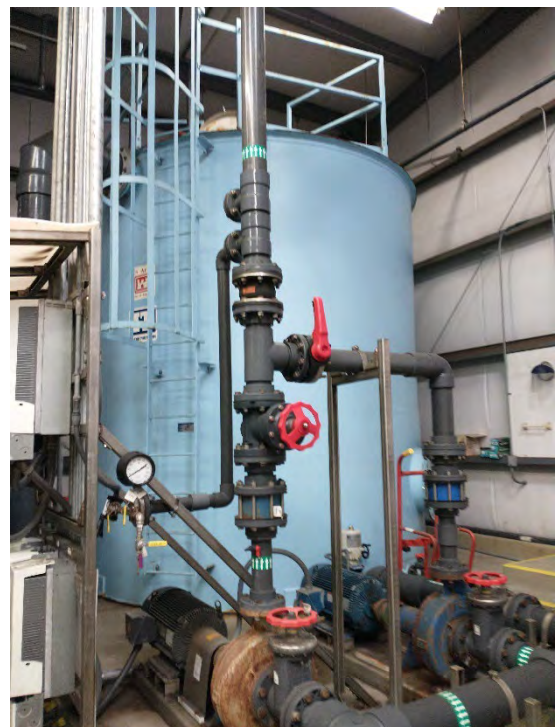
## **Photograph No. 2**

**Description:** Effluent tank in the Groundwater Treatment Facility.

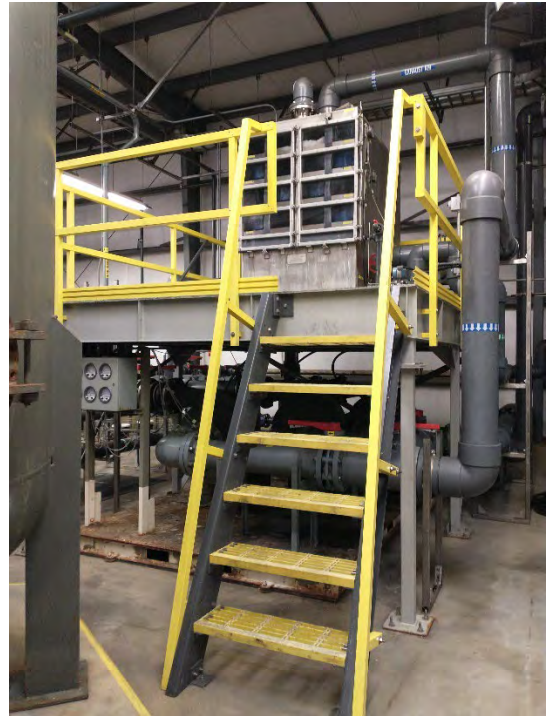
**Photograph No. 3**

**Description:** Air stripper on top of stairs in Groundwater Treatment Facility.

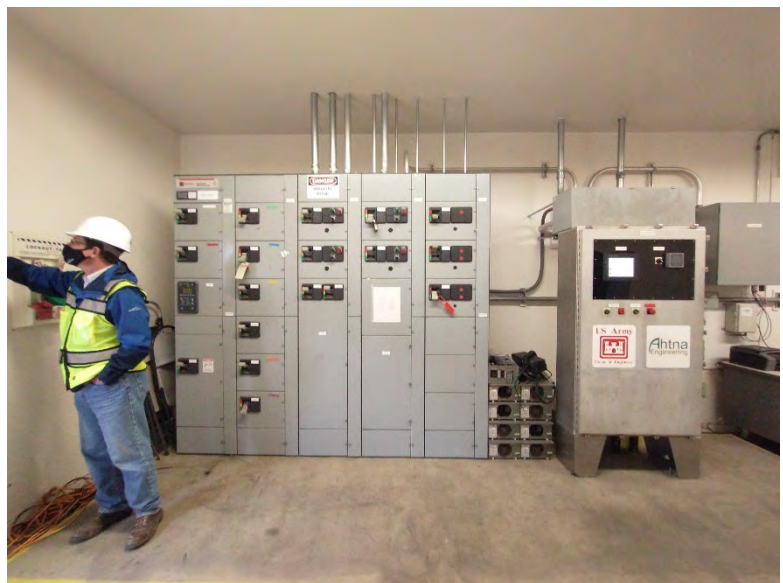
**Photograph No. 4**

**Description:** Inside control room at Groundwater Treatment Facility.

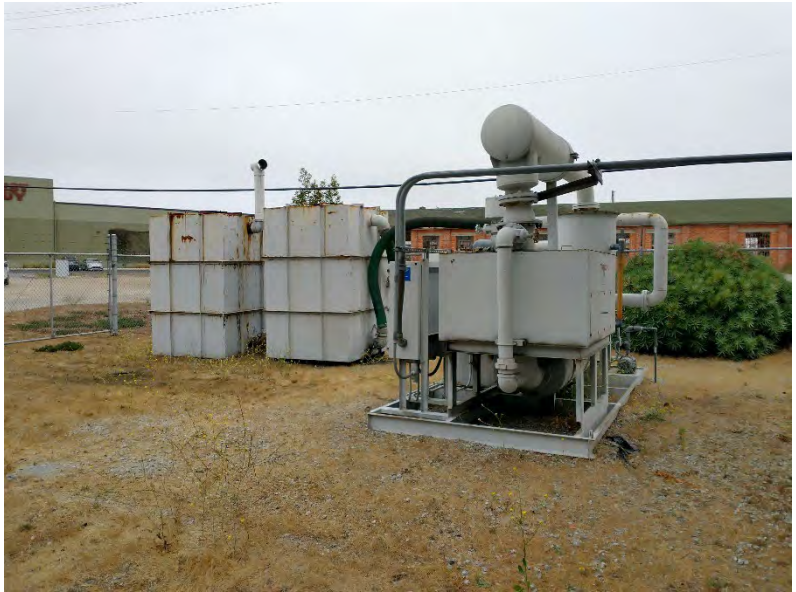
**Description:** Offline SVE system.

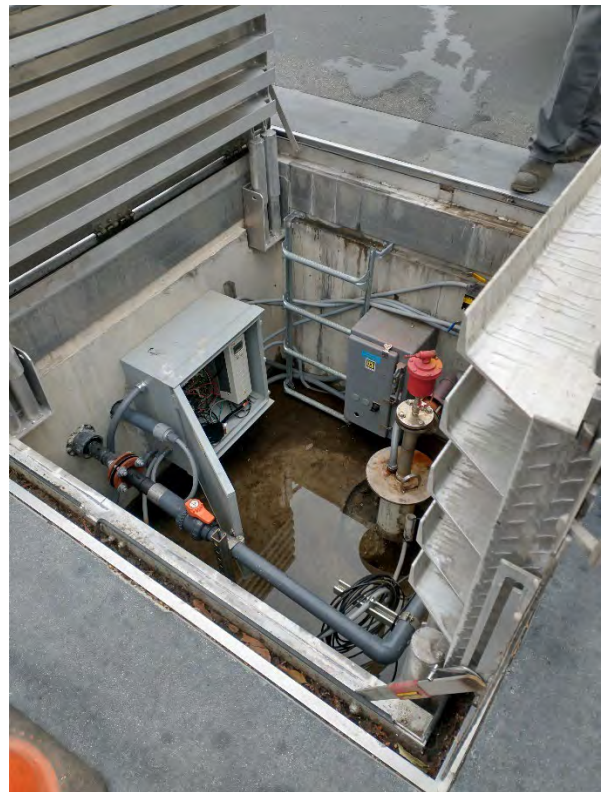
**Description:** Inside vault for EW-12-08-180U.

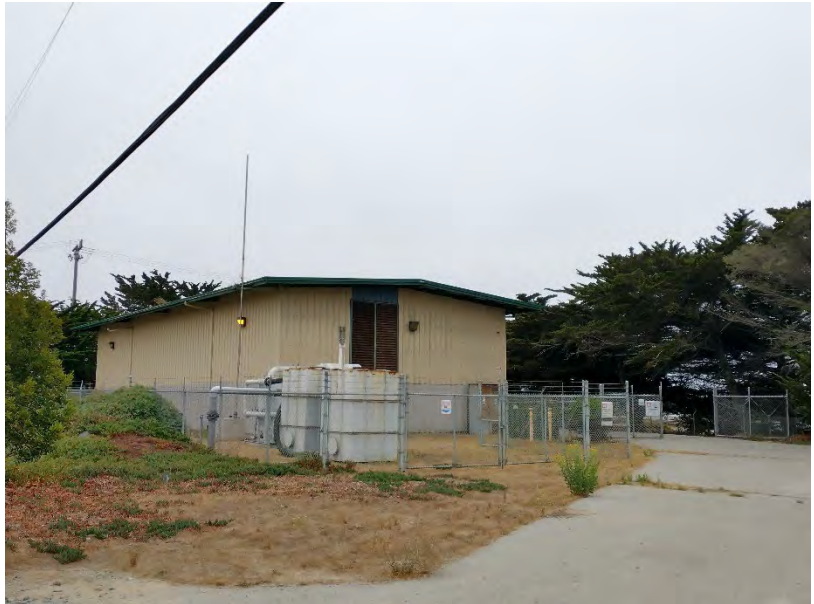
**Photograph No. 8**

**Description:** Outside Groundwater Treatment Facility. Fence normally closed and locked.

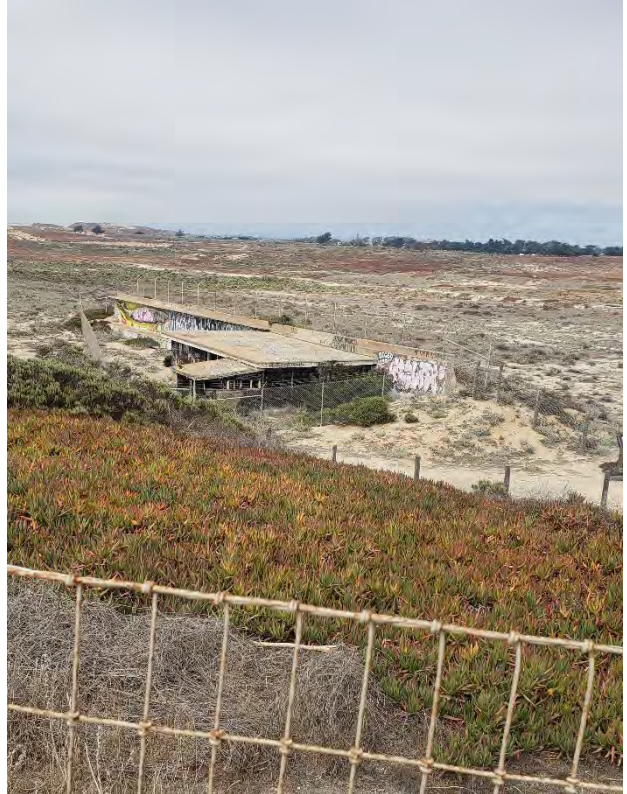
**Description:** Fencing around a  
Former firing ranges facility with  
new (within the last 4 years) graffiti,  
facing east

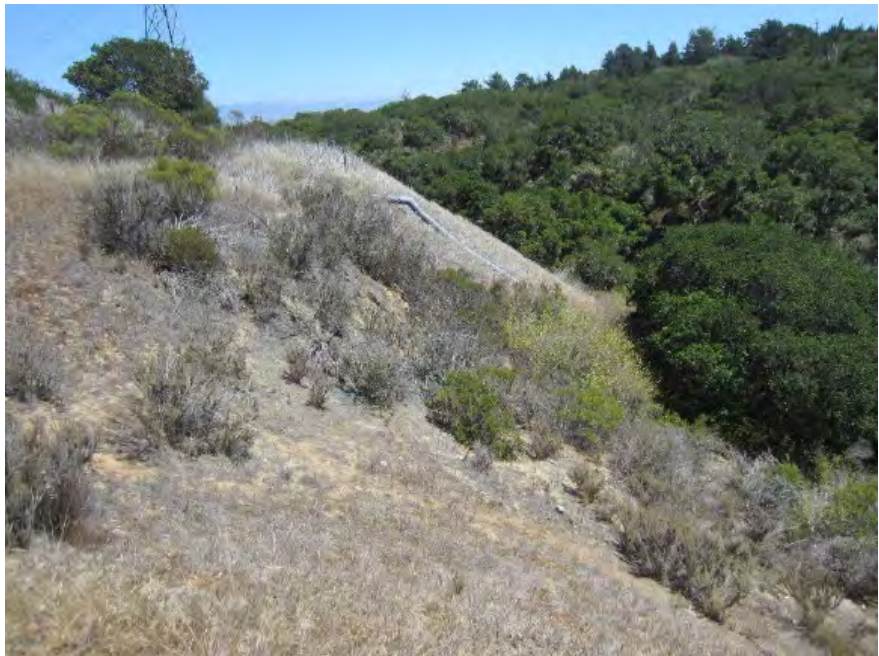
**Description:**  
Looking southeast.  
Site 31 excavated  
slope in foreground,  
vegetation growth  
evident. Drainage  
pipe on slope in  
background.

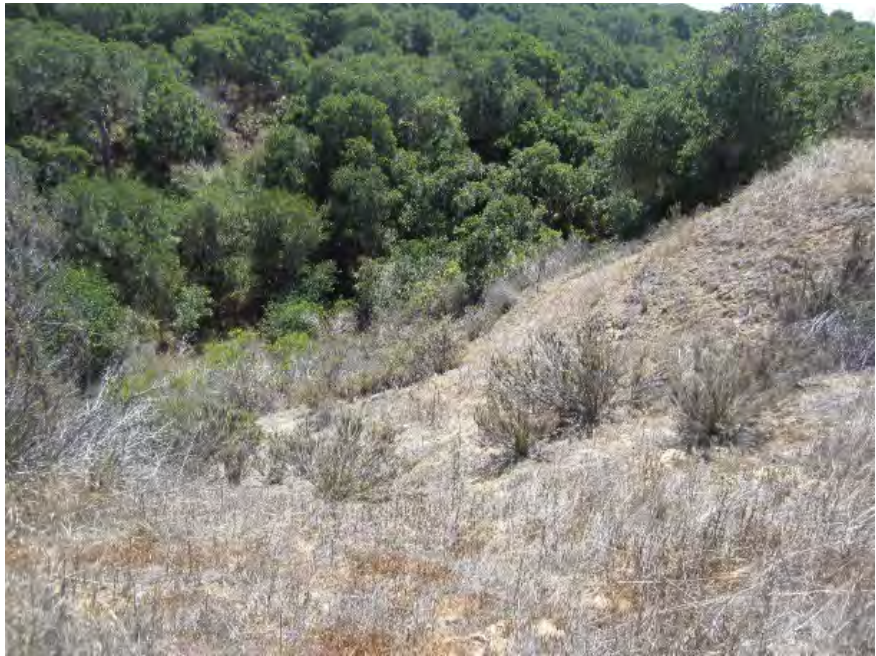
**Description:**  
Facing downslope  
looking at  
vegetation growth  
on excavated slope.

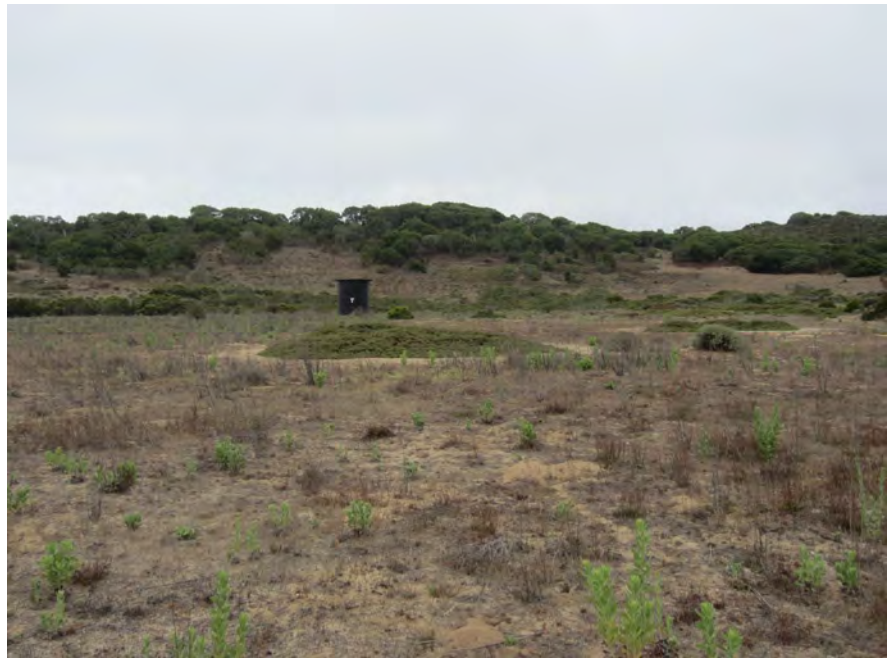
**Photograph No. 2**

**Description:**  
Habitat restoration  
after remedial  
activities at HA-38.

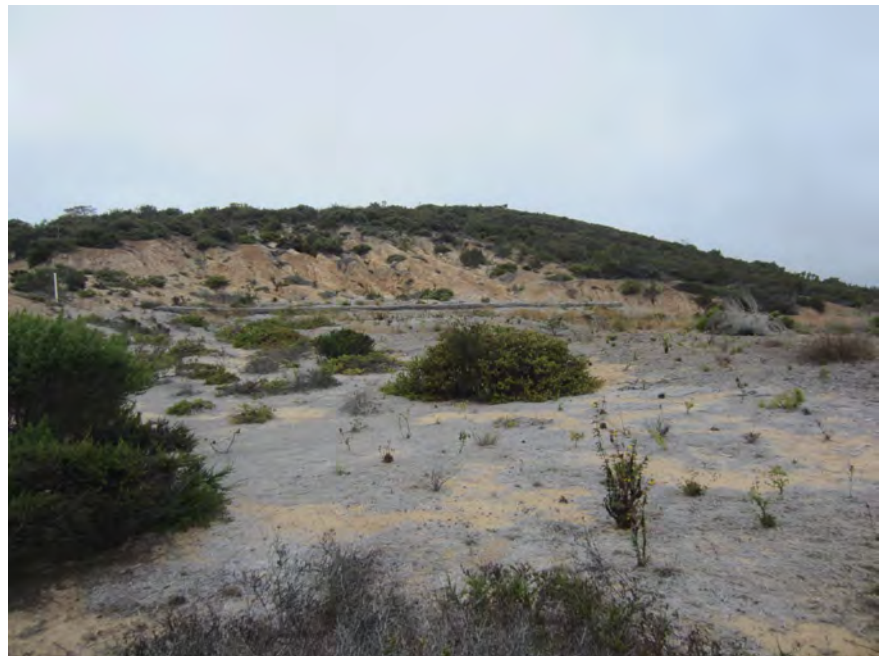
**Photograph No. 3**

**Description:** Habitat  
restoration after remedial  
activities at HA-37.
