# **Final 5<sup>th</sup> Five-Year Review Report for Fort Ord Superfund Site Monterey County, California**

September 2022

**U.S. Army Corps of Engineers  
Sacramento District  
1325 J St.  
Sacramento, CA 95822**

**U.S. Department of the Army  
Fort Ord Base Realignment and Closure  
Building 4463 Gigling Road  
Ord Military Community, CA 93955**

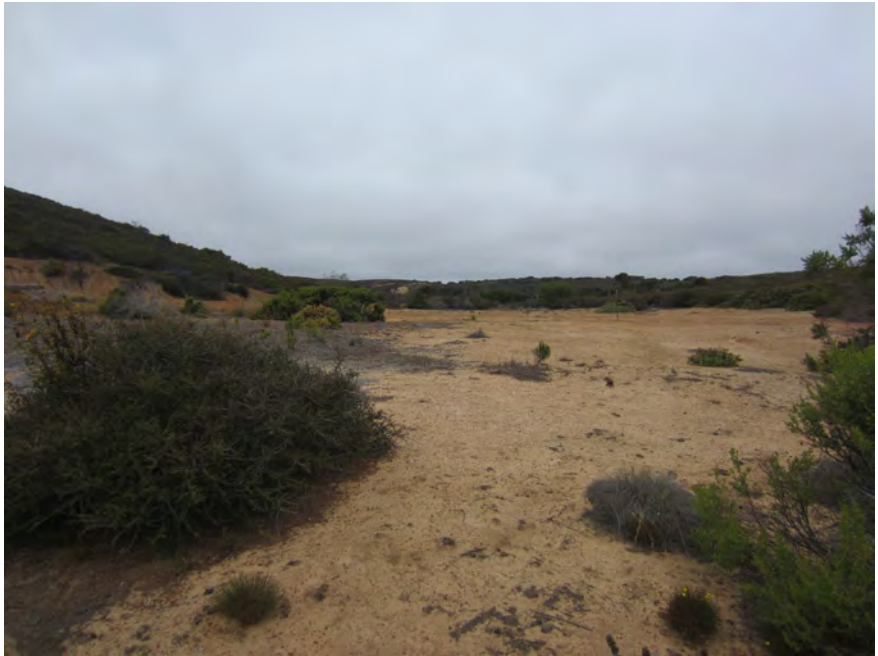
**Photograph No. 4**

**Description:**  
Habitat restoration  
after remedial  
activities at HA-37.

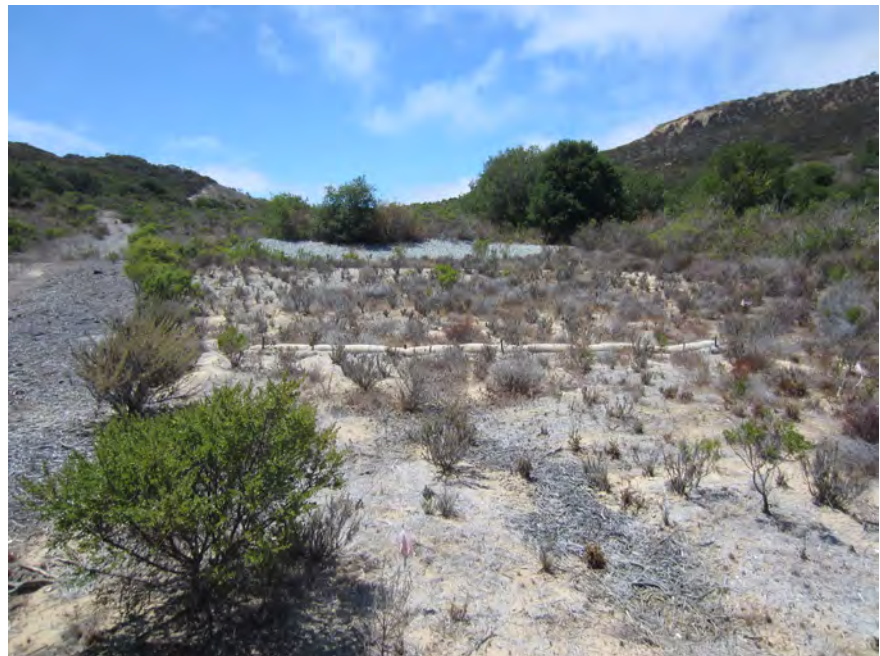
**Description:** Habitat  
restoration after remedial  
activities at HA-34. BMPs  
(rip rap, wattles) evident.

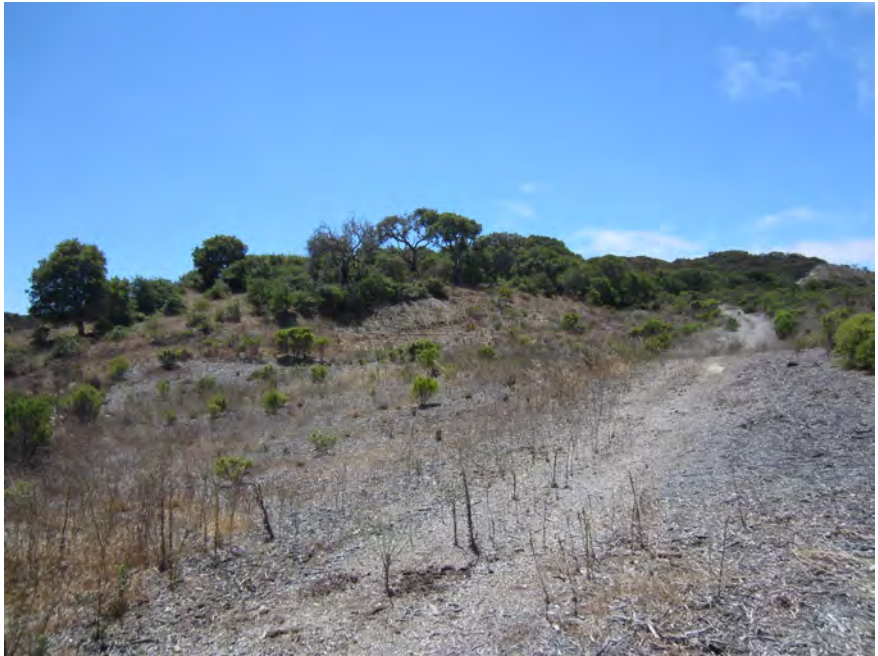
**Photograph No. 8**

**Description:**  
Habitat restoration  
after remedial  
activities at HA-34.  
Access road  
running through  
HA.

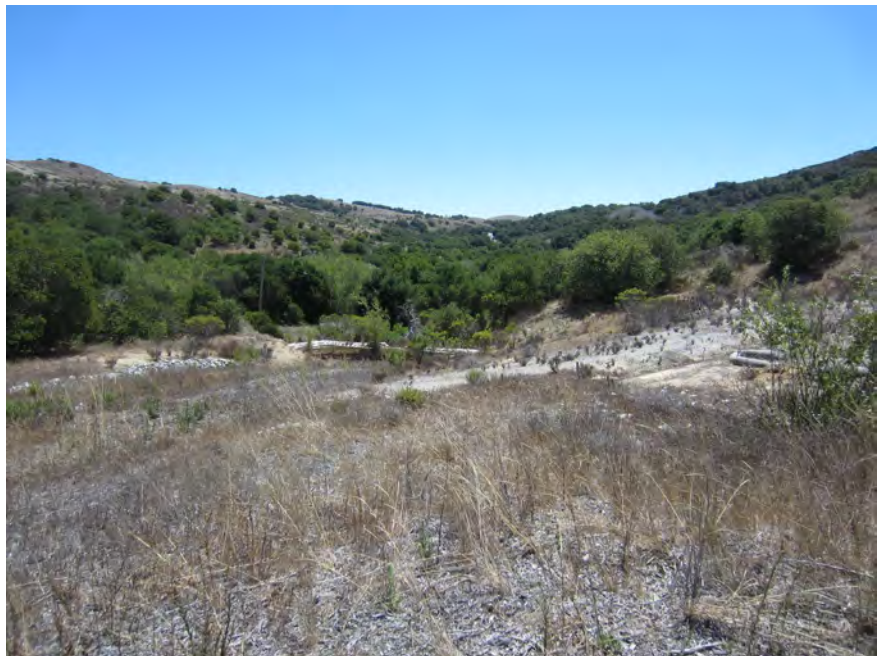
**Description:** Habitat  
restoration after remedial  
activities at HA-34. BMPs  
(rip rap, wattles) evident.

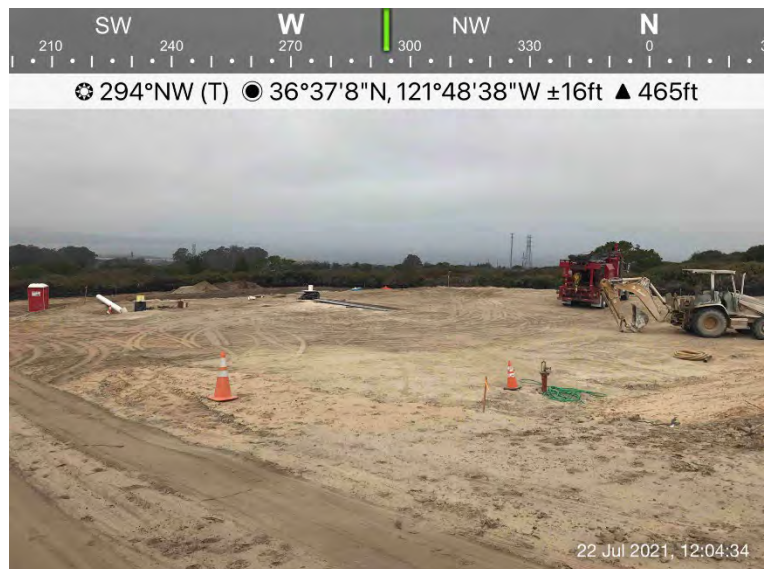
## **Photograph No. 2**

**Description:** View facing west from Blue Line Road. Construction activities associated with the Pure Water Monterey Groundwater Replenishment project.

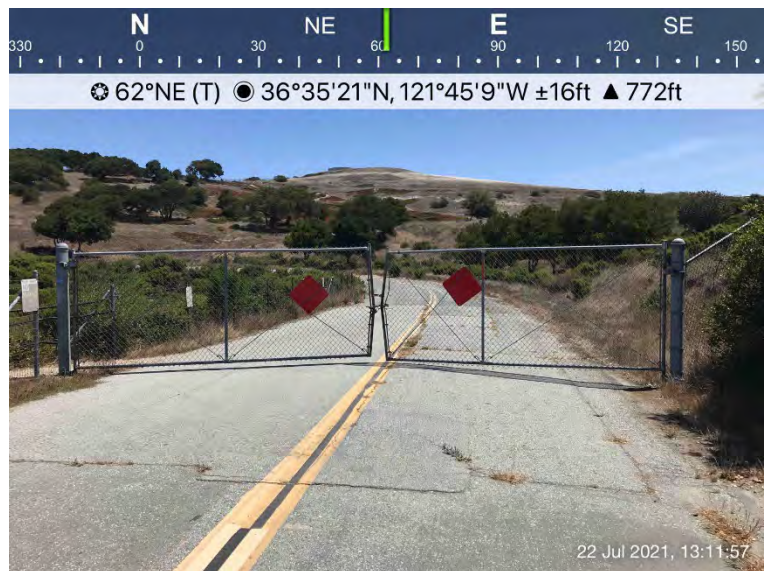
**Site:** ESCA Group 3 Laguna Seca Parking  
MRA

**Description:** Locked gate at entrance to  
Laguna Seca Raceway from Barloy  
Canyon Road. Four-strand barbed wire  
fence and warning signange along Impact  
Area MRA perimeter are located on the far  
side of the gate.

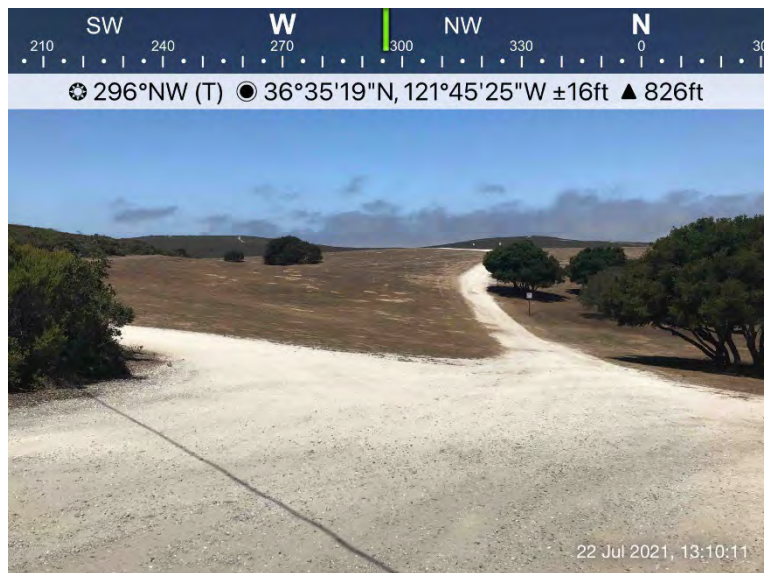
### Photograph No. 3

**Site:** ESCA Group 3 Laguna Seca Parking MRA

**Description:** View looking northwest over the Laguna Seca overflow parking lot.

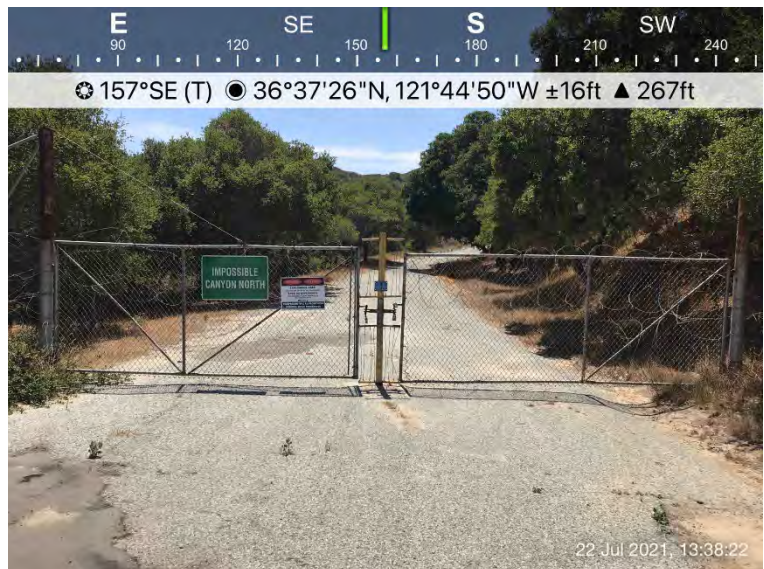
### Photograph No. 4

**Site:** ESCA Group 3 MOUT Site MRA

**Description:** Locked gate with concertina wire and warning sign at entrance to Impossible Canyon on northern boundary of Impact MRA. This section of road leads to the MOUT Site MRA.

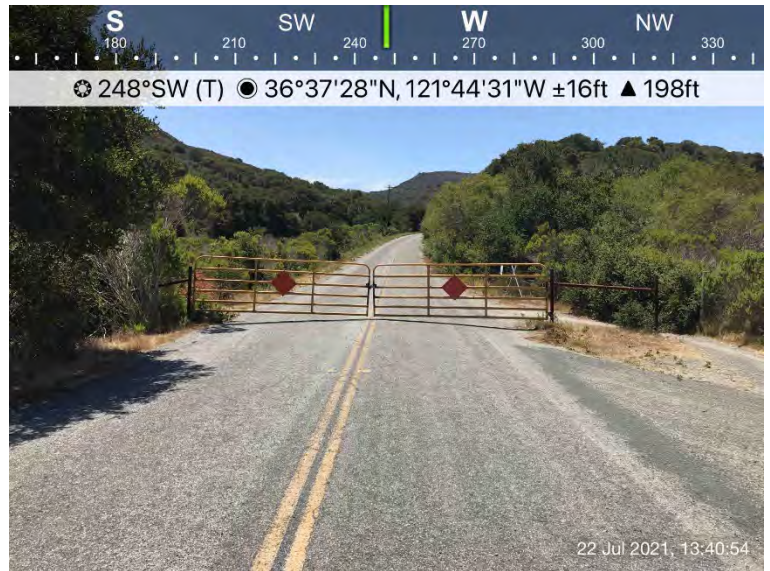
**Photograph No. 5**

**Site:** ESCA Group 3 MOUT Site MRA

**Description:** View facing southwest at intersection of Barloy Canyon Road with Eucalyptus Road. Locked gate at northern boundary of the roadway portion of the MOUT Site MRA. This portion of roadway leads to the northern boundary of Laguna Seca Parking MRA.

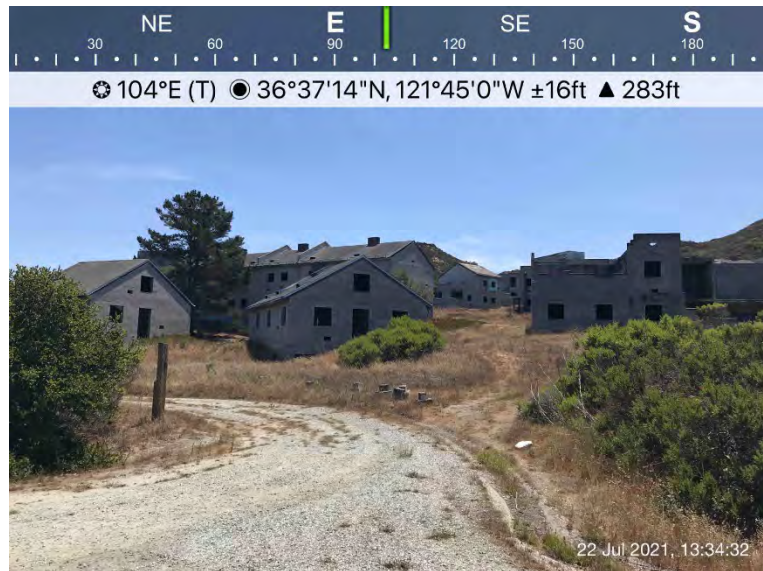
**Photograph No. 7**

**Site:** ESCA Group 3 MOUT Site MRA

**Description:** View facing east from access road. MOUT Site structures.

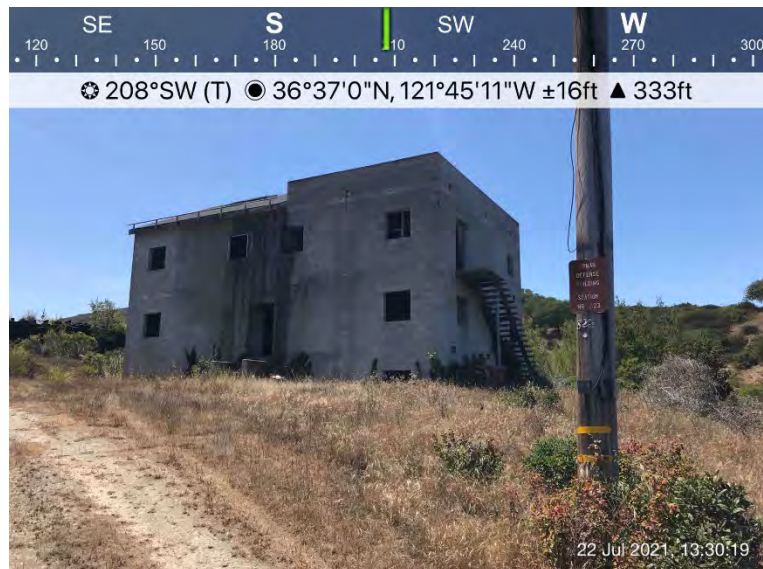
**Photograph No. 8**

**Site:** ESCA Group 3 MOUT Site MRA

**Description:** View facing southwest from access road. MOUT Site structure.

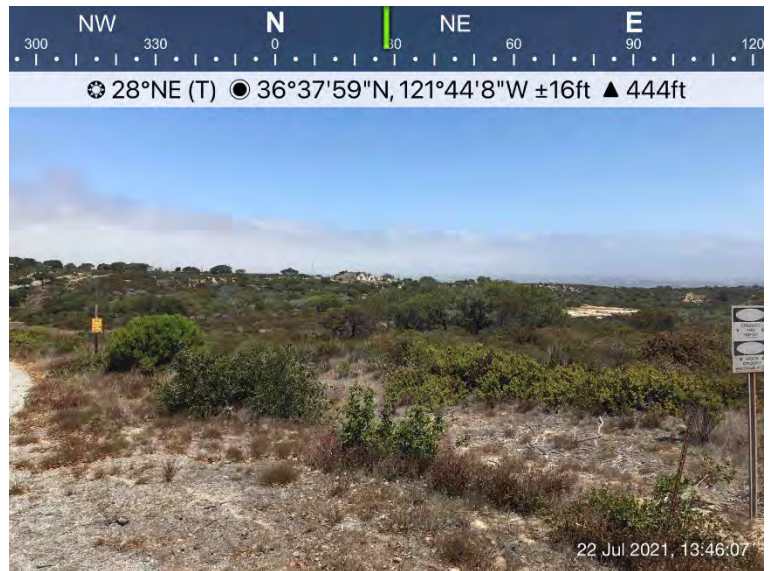
**Site:** ESCA Group 4 Future East Garrison MRA

**Description:** View of the Future East Garrison MRA looking northeast from the southern boundary of the MRA along Barloy Canyon Road. “Danger: Explosives Area” sign in Parcel E11b.7.1.1.

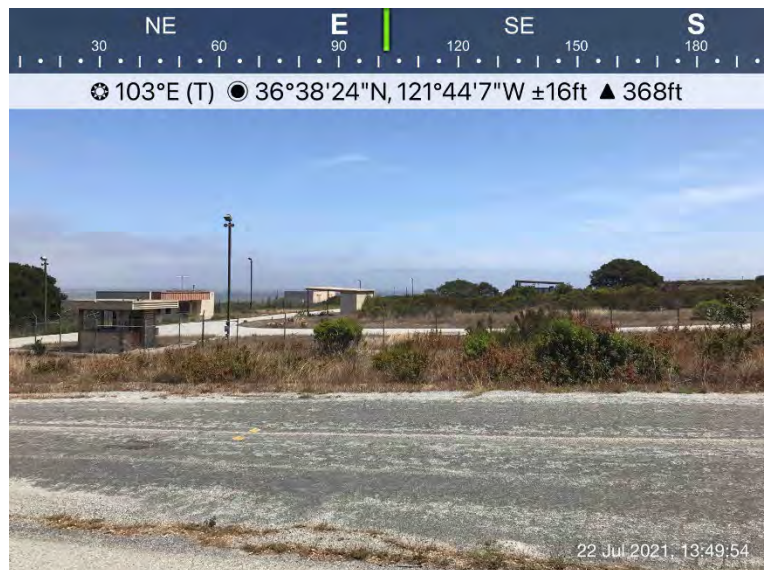
## Photograph No. 2

**Site:** ESCA Group 4 Future East Garrison MRA

**Description:** View facing east from Barloy Canyon Road. Future East Garrison MRA structures.

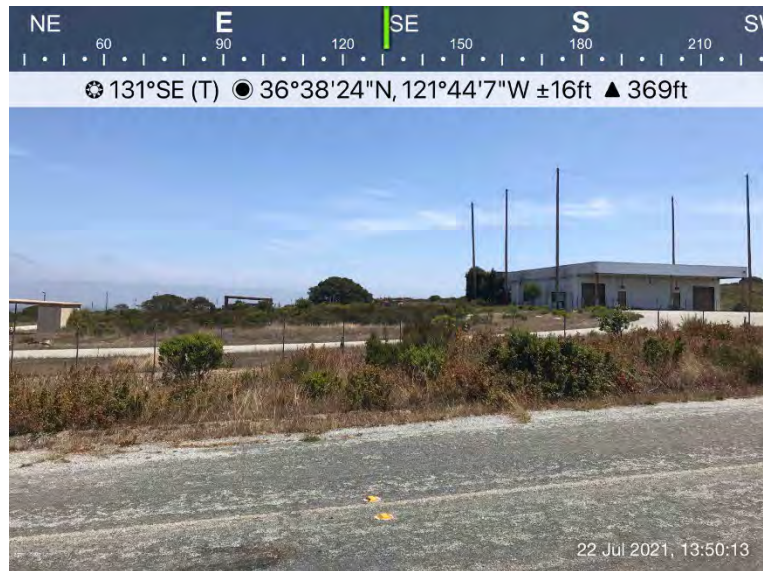
**Photograph No. 3**

**Site:** ESCA Group 4 Future East Garrison MRA

**Description:** View facing southeast from Barloy Canyon Road. Future East Garrison MRA structures.

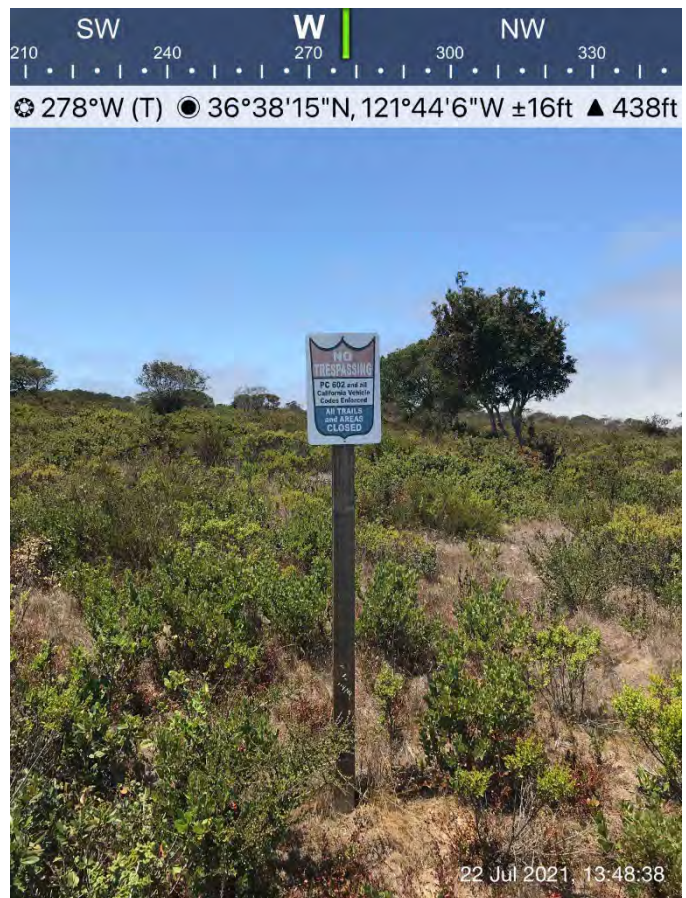
**Photograph No. 4**

**Site:** ESCA Group 4 Future East Garrison MRA

**Description:** View facing west from Barloy Canyon Road. “No Trespassing” sign in Parcel E11b.6.1.

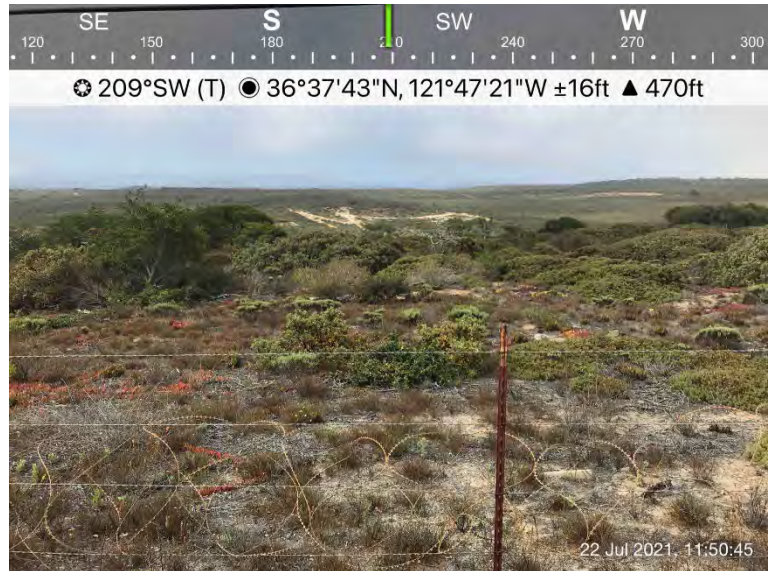
**Description:** Representative open space site conditions at the Interim Action Ranges MRA with typical four-strand barbed and concertina wire fence perimeter.

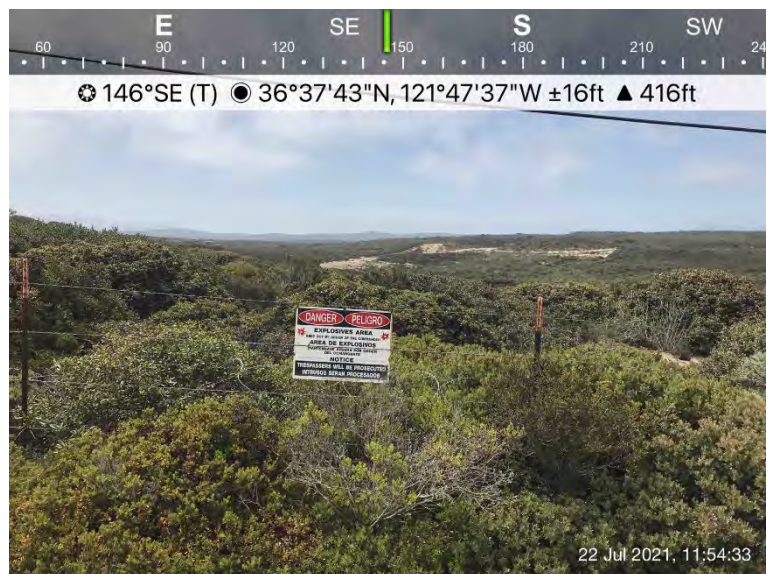
**Description:** Representative open space site conditions at the Interim Action Ranges MRA with typical fence along the perimeter boundary with warning sign, four-strand barbed wire, and concertina wire.

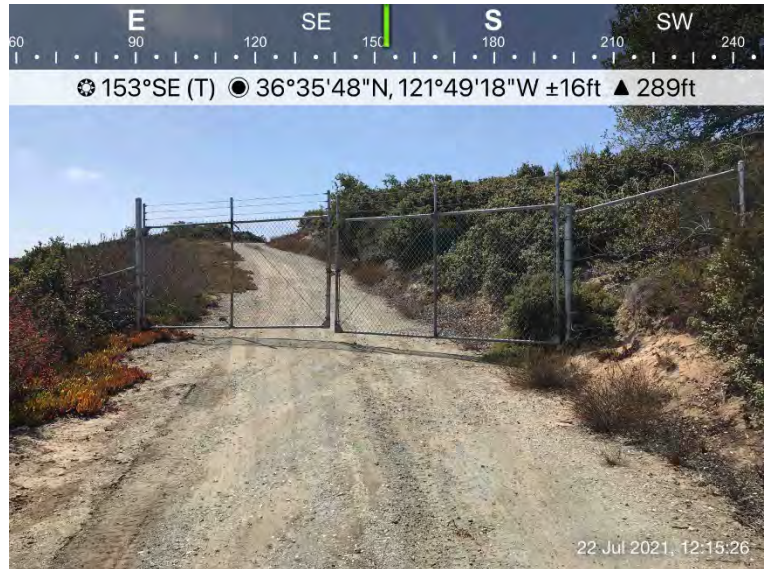
**Site:** Track 2 Del Rey Oaks MRA

**Description:** Locked gate leading to Track 2 Del Rey Oaks MRA along the Blue Line Road from Seaside MRA.

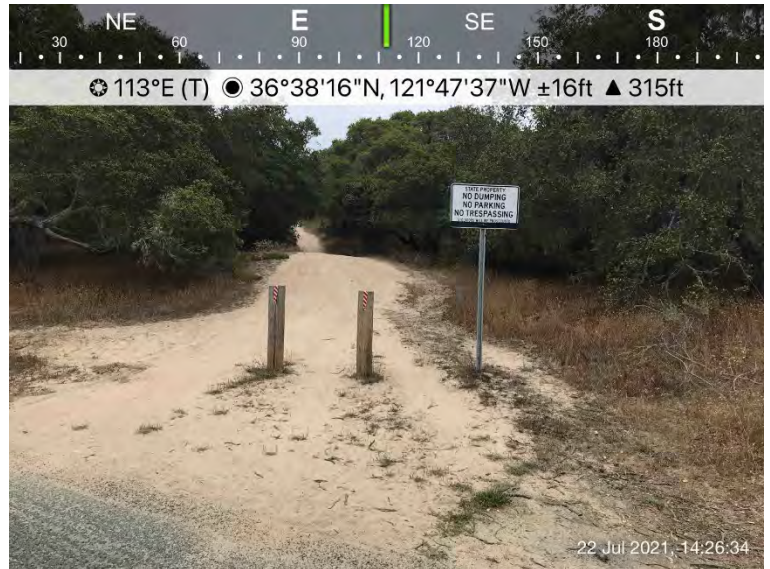
**Site:** Track 2 Parker Flats MRA

**Description:** Trail entrance where the CCCVC illegal BMX track was located. Barricades with No Dumping, No Parking, and No Trespassing sign located on northern boundary of the MRA

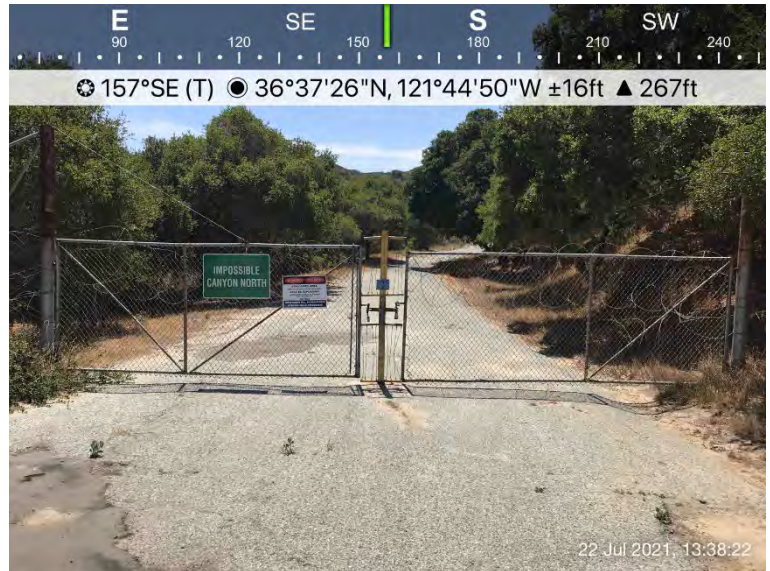
**Site:** Impact Area MRA

**Description:** Impossible Canyon North gated access point with signage located along the Impact Area MRA perimeter boundary.

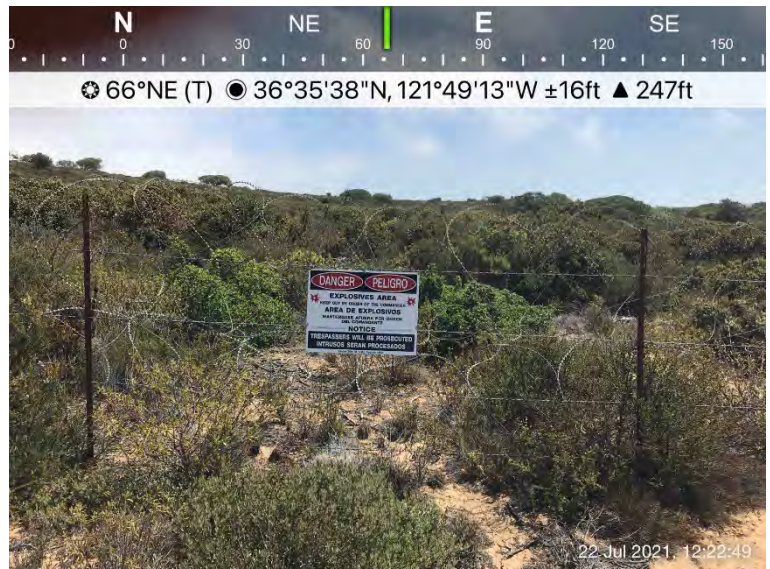
## Photograph No. 2

**Site:** Impact Area MRA

**Description:** Typical fence along the Impact Area MRA perimeter boundary with warning sign, barbed wire, and concertina wire.

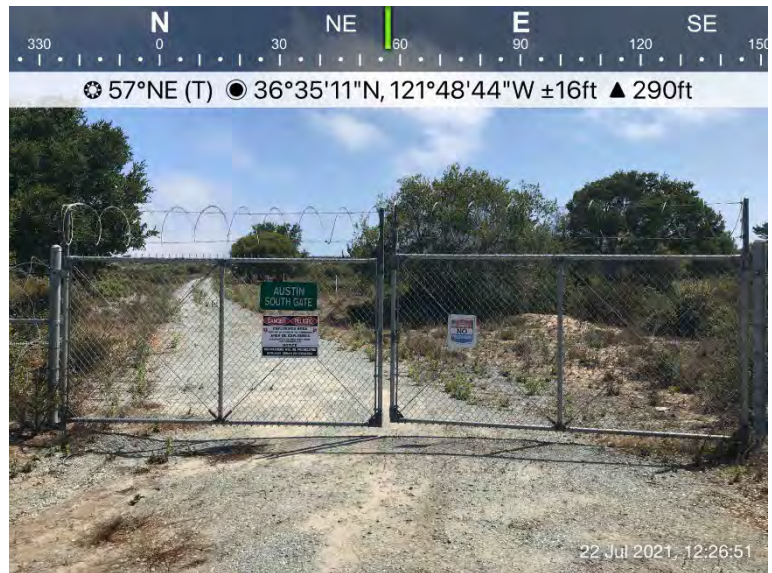
**Photograph No. 3**

**Site:** Impact Area MRA

**Description:** Austin South gated access point with signage located along the Impact Area MRA perimeter boundary.
