FORA ESCA REMEDIATION PROGRAM

Appendix A. 2013 Habitat Restoration Implementation and Monitoring Report Interim Action Ranges Munitons Response Area

Former Fort Ord
Monterey County, California

March 28, 2014

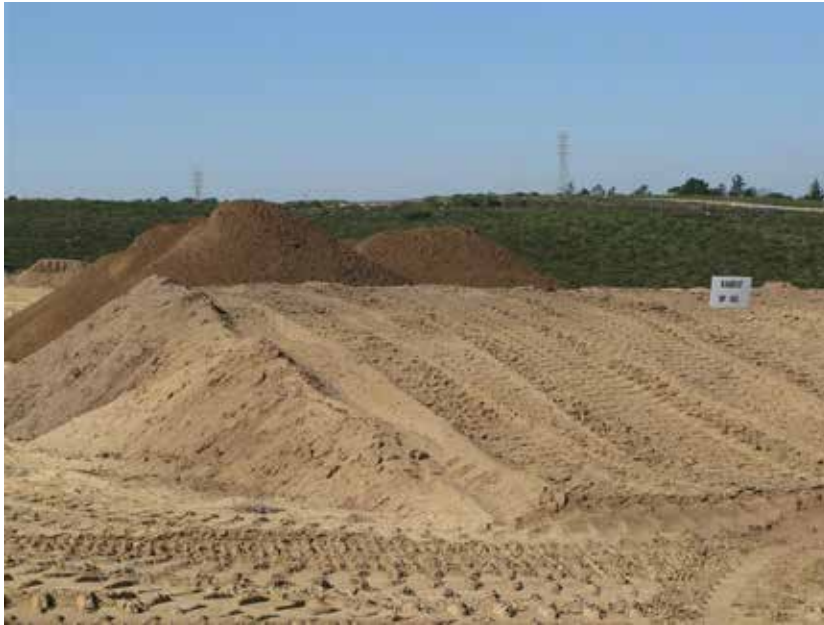
Photograph 1 – Interim Action Ranges MRA Development Parcel.
Stockpiled topsoil from Range 47 prior to backfilling. 28 October 2012

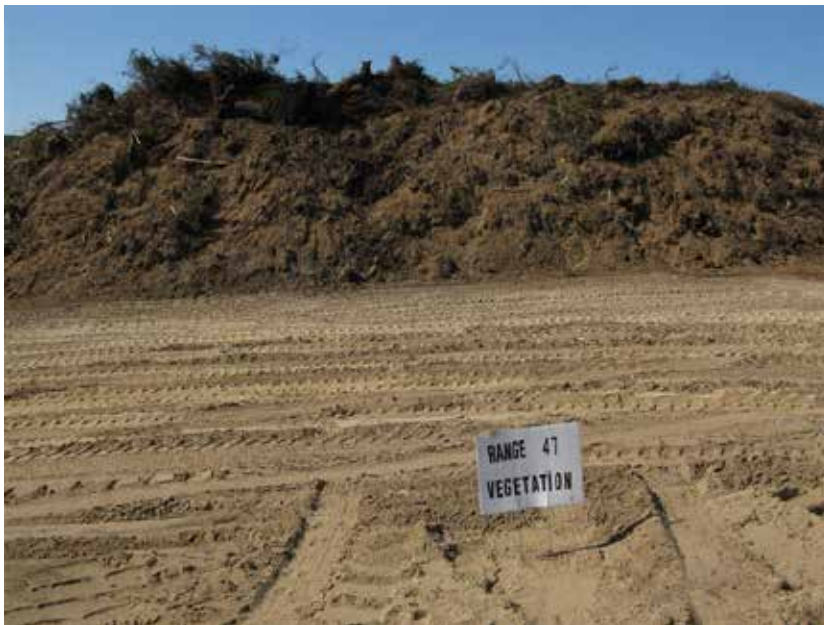
Photograph 2 – Interim Action Ranges MRA Development Parcel.
Stockpiled vegetation from Range 47 prior to being chipped. 28 October 2012

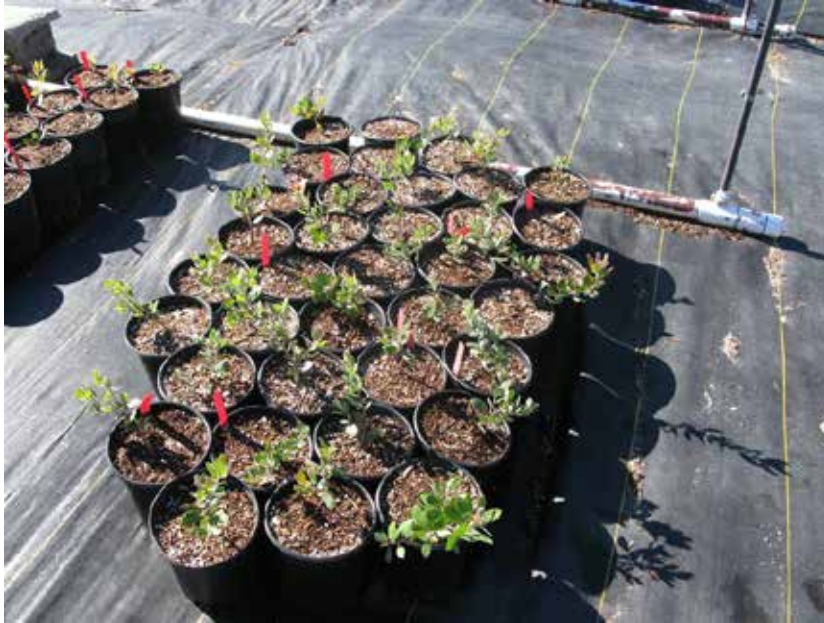
Photograph 3 – Interim Action Ranges MRA Central Coast Wilds Nursery, Santa Cruz, CA.
Shaggy-barked manzanita container plants grown from cuttings. 29 October 2012

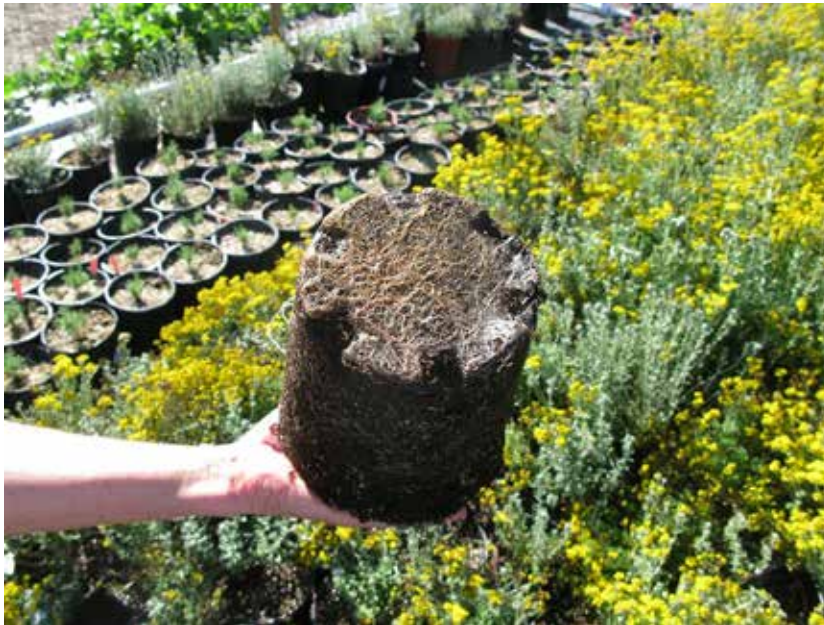
Photograph 4 – Interim Action Ranges MRA Central Coast Wilds Nursery, Santa Cruz, CA.
Roots of golden yarrow container plants grown from seed. 29 October 2012

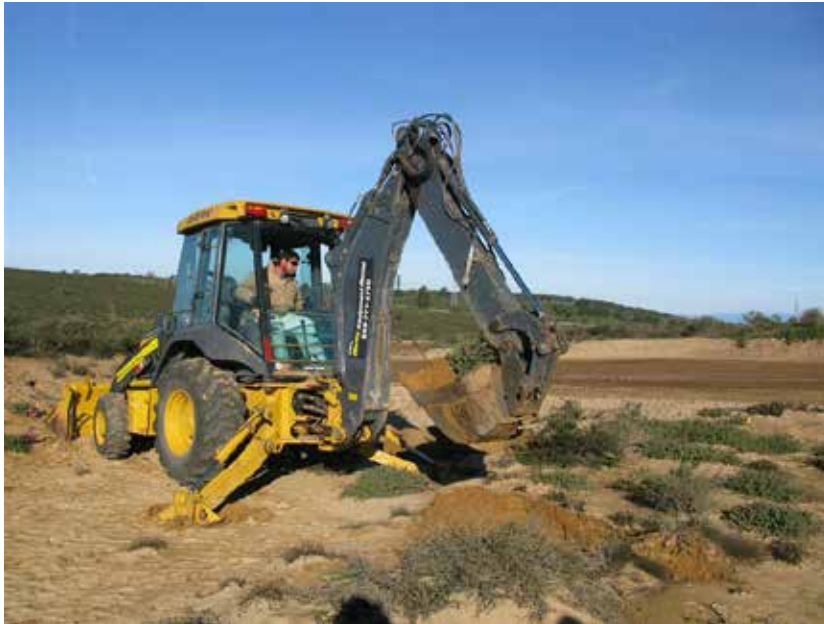
Photograph 5 – Interim Action Ranges MRA Development Parcel.
Shaggy-barked manzanita transplanting trials. 20 December 2012

Prior to salvaging, over 150 shaggy-barked manzanitas were flagged in accessible parts of the IAR MRA development parcel. Once an area was cleared for potential MEC, flagged shaggy-barked manzanitas were dug out with a backhoe and placed in five-gallon (18.9 l) buckets filled with water and one capful of plant vitamin supplement (Superthrive[®]). The bucket was then covered with moist burlap. Plants were held in buckets for no longer than 20 minutes.

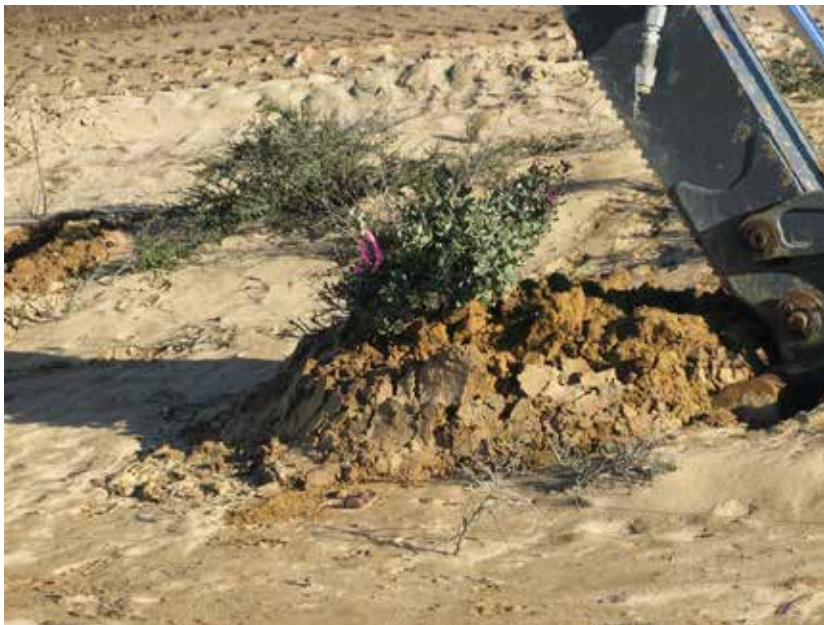
Photograph 6 – Interim Action Ranges MRA Development Parcel.
Shaggy-barked manzanita transplanting trials. 20 December 2012

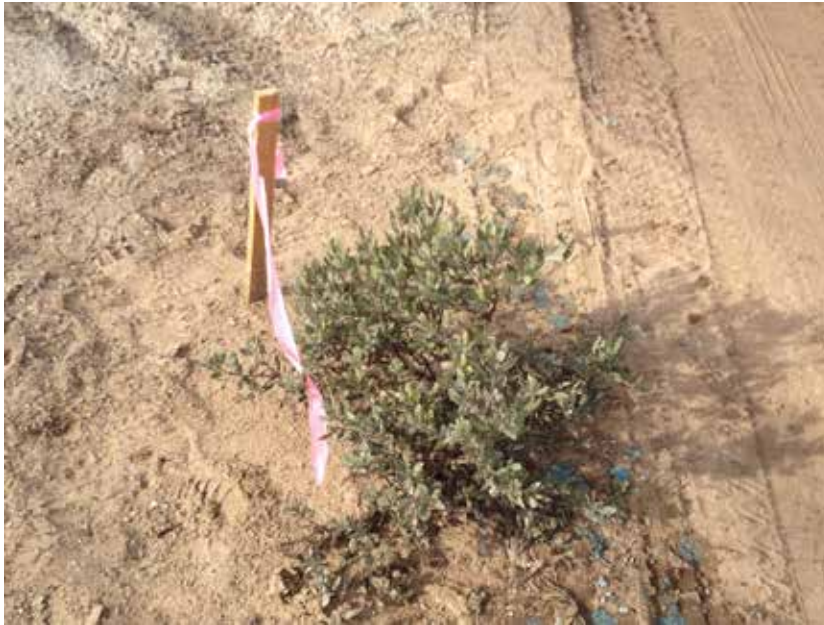
Photograph 7 – Interim Action Ranges MRA Range 47 Restoration Area.
Salvaged and transplanted shaggy-barked manzanita. 22 January 2013

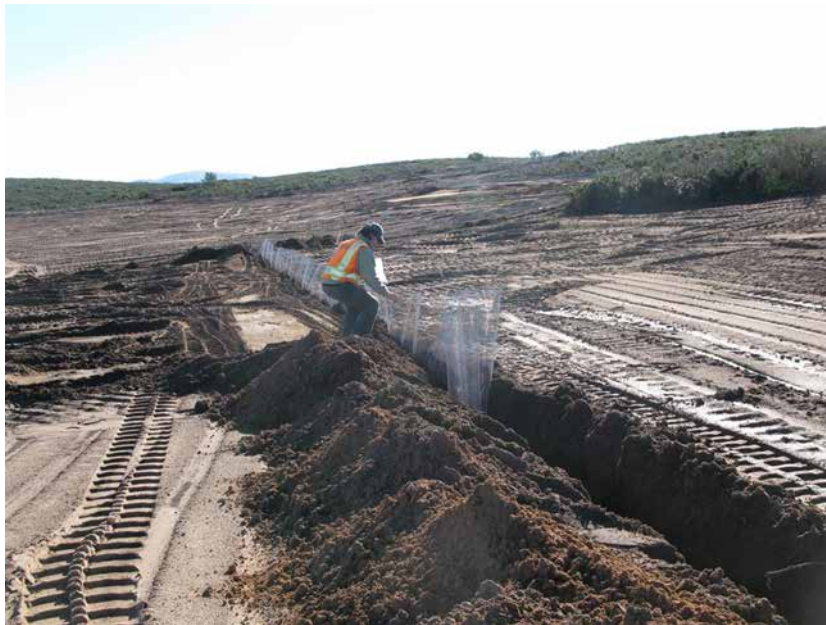
Photograph 8 – Interim Action Ranges MRA Range 47 Restoration Area.
Below-ground fence installation to exclude burrowing animals. 7 January 2013

Animal deterrent system maintenance has been ongoing since the fencing system was completed in January 2013. ESCA RP biologists routinely inspect the system for potential damage from animal entry. Evidence (bite marks on the deer fencing and scat) of black-tailed jackrabbits (*Lepus californicus*) and desert cottontails (*Sylvilagus audubonii*) entering the site have been observed including gaps in the fencing. Gaps in the fencing are repaired and additional hardware cloth or galvanized metal fencing is added, as needed.

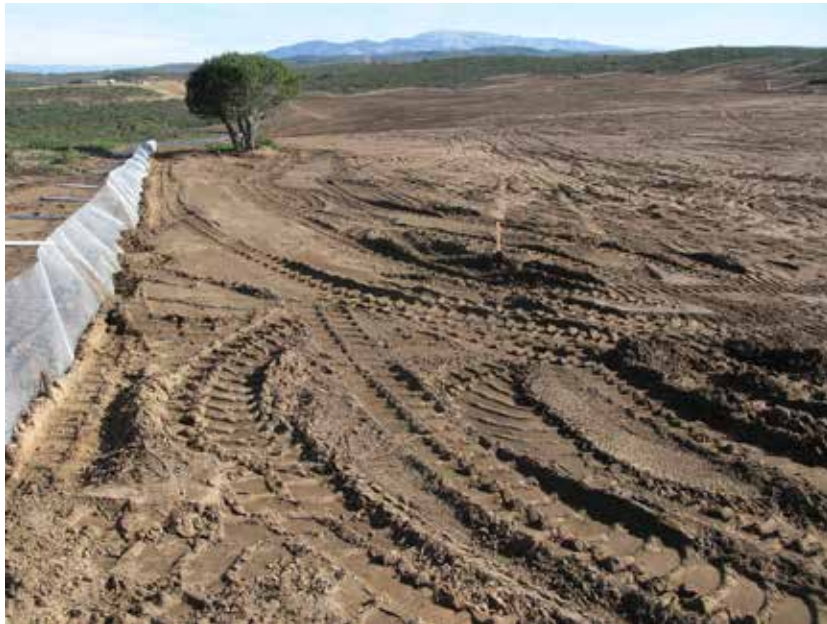
Photograph 9 – Interim Action Ranges MRA Range 47 Restoration Area.
Restoration area during fence installation, looking east. 7 January 2013

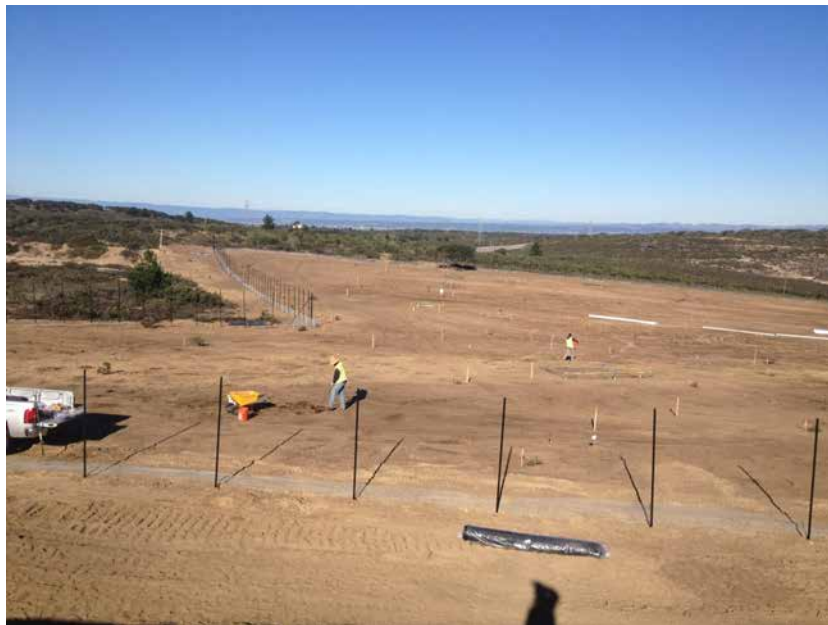
Photograph 10 – Interim Action Ranges MRA Range 47 Restoration Area.
Fence installation, looking north. 14 January 2013

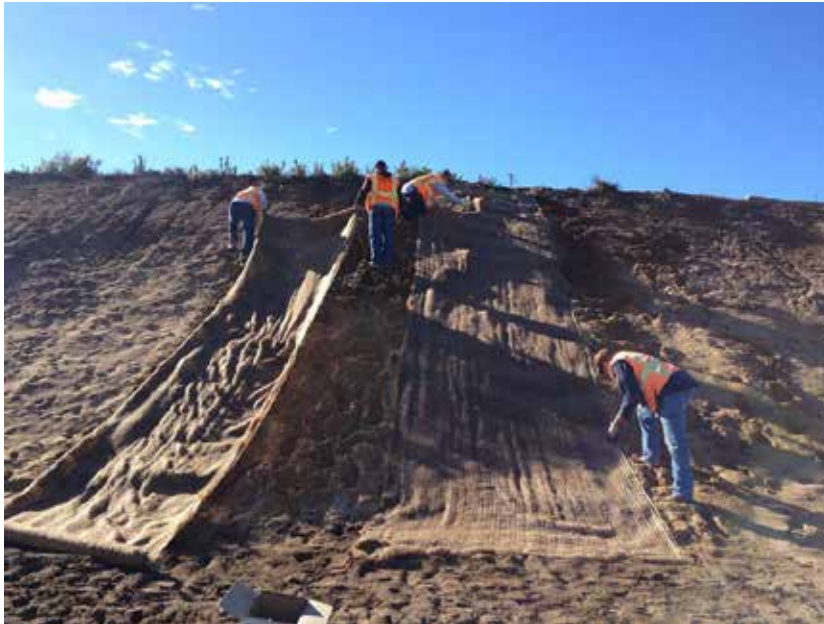
Photograph 11 – Interim Action Ranges MRA Range 47 Restoration Area.
Erosion control blanket installation on escarpment. 3 January 2013

In order to address potential erosion on the escarpment in the Range 47 Restoration Area, a 100% biodegradable coconut fiber erosion control blanket (American Excelsior BioNet[®] 8-foot x 112.5-foot Straw Coco Blanket) was installed and secured with 100% biodegradable stakes (4-inch GreenStakes[®]).

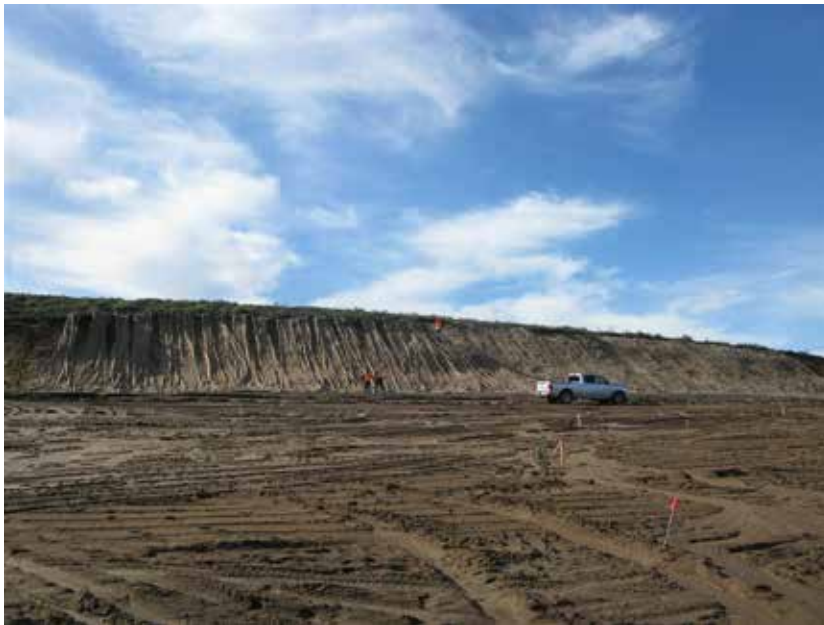
Photograph 12 – Interim Action Ranges MRA Range 47 Restoration Area.
Erosion control blanket installation on escarpment. 7 January 2013

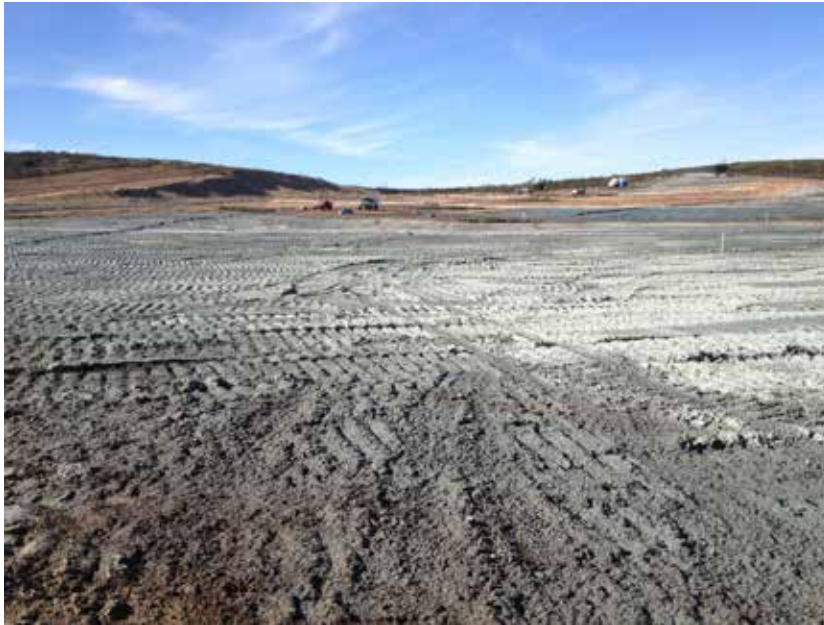
Photograph 13 – Interim Action Ranges MRA Range 47 Restoration Area
Gray hydromulch application on soil surface for erosion control. 18 January 2013

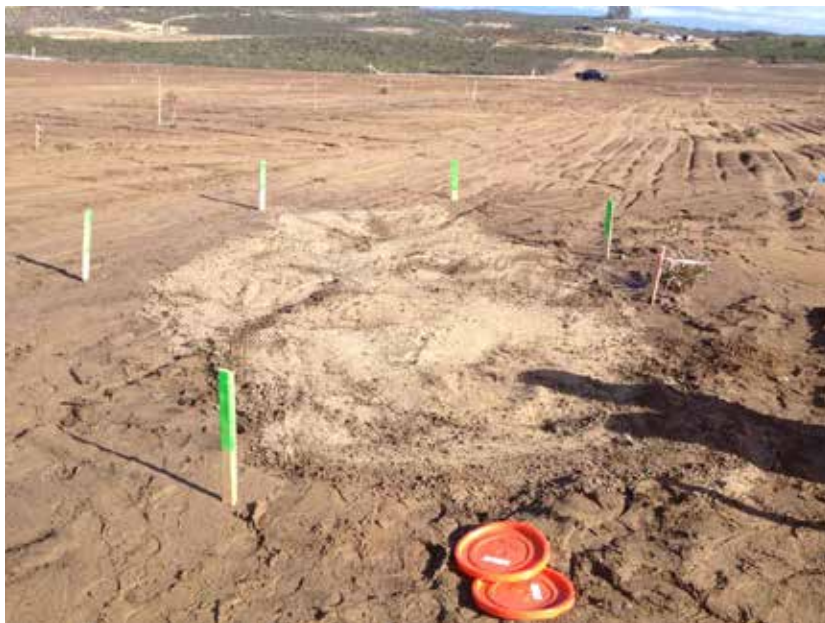
Photograph 14 – Interim Action Ranges MRA Range 47 Restoration Area.
HMP annual species seeding polygon. 10 January 2013

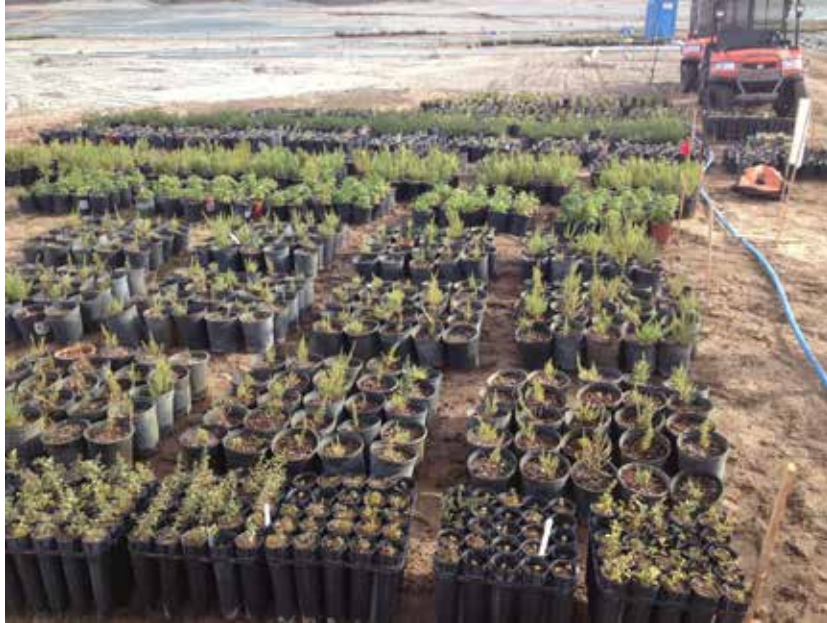
Photograph 15 – Interim Action Ranges MRA Range 47 Restoration Area.
Container plant staging area. 22 January 2013

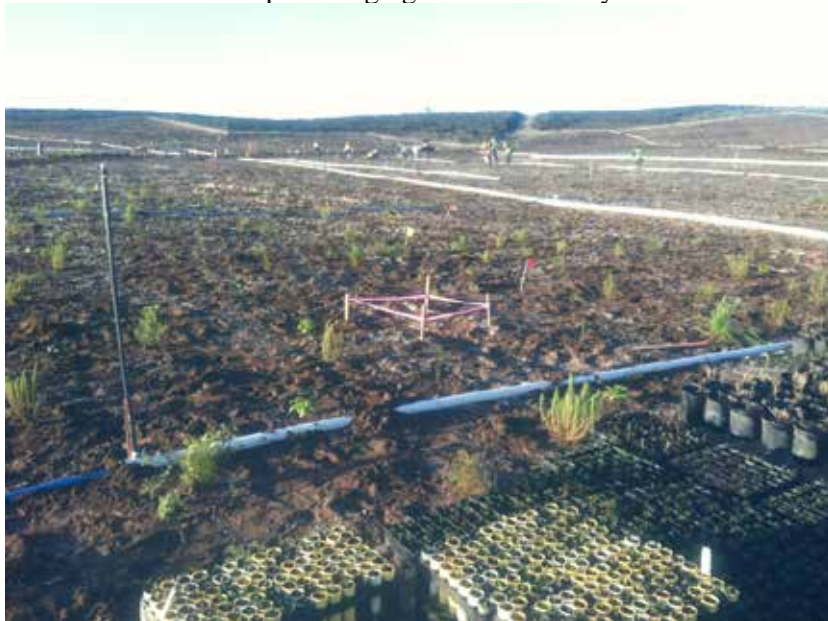
Photograph 16 – Interim Action Ranges MRA Range 47 Restoration Area.
Planting crews working in restoration area. 6 February 2013

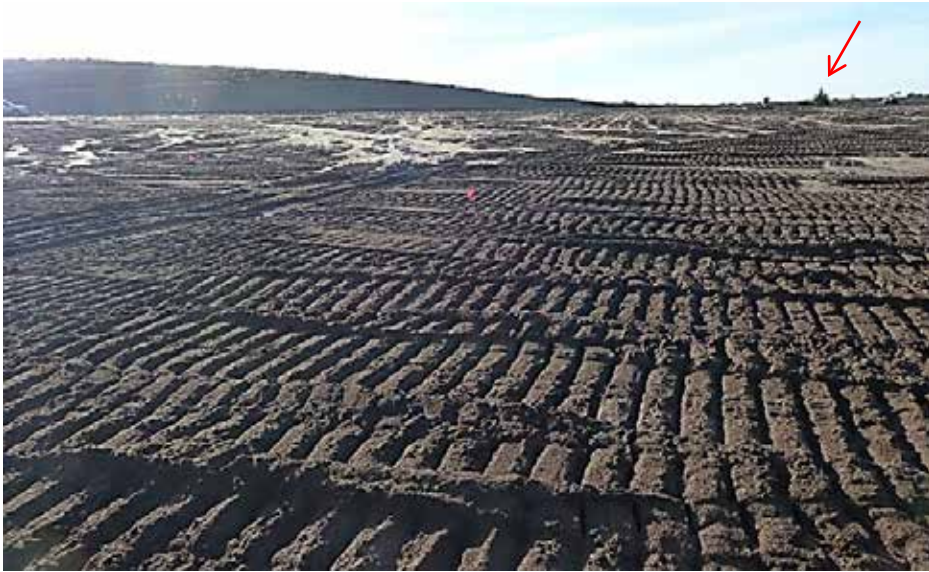
Photograph 17 – Interim Action Ranges MRA Range 47 Restoration Area.
Restoration area prior to planting. 8 January 2013

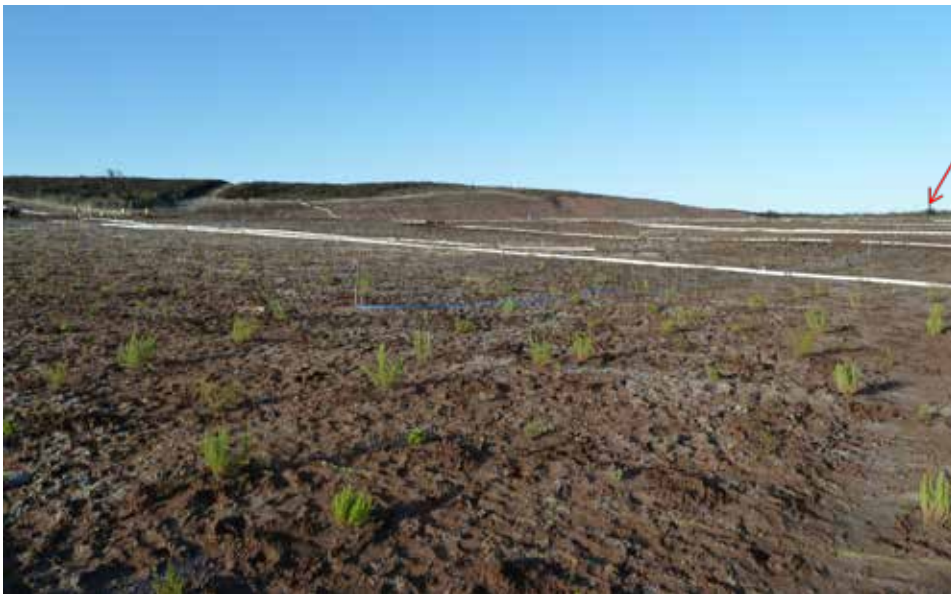
Photograph 18 – Interim Action Ranges MRA Range 47 Restoration Area.
Newly planted restoration area. 6 February 2013

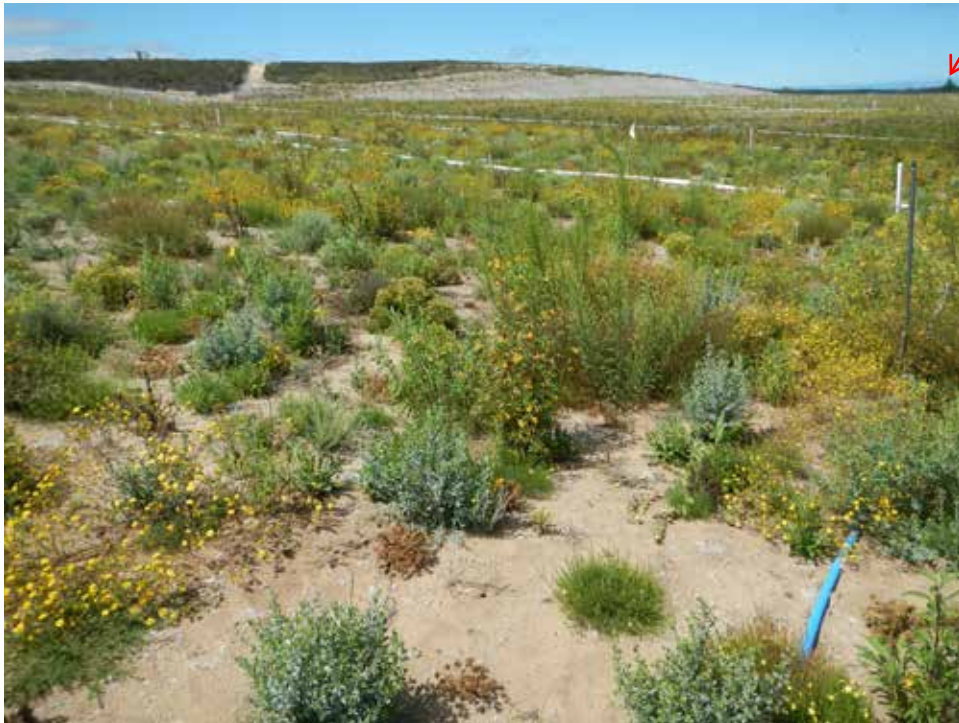
Photograph 20 – Interim Action Ranges MRA Range 47 Restoration Area.
Restoration area. 21 August 2013

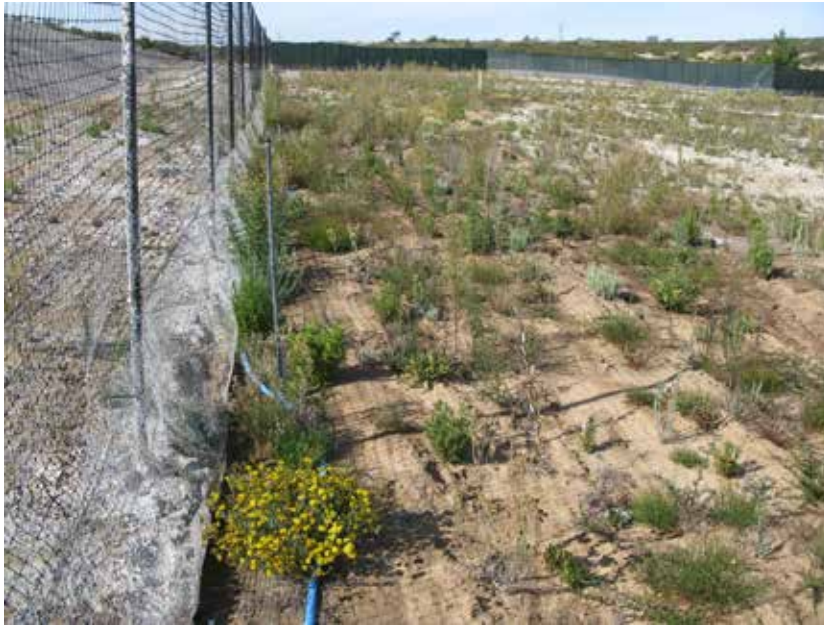
Photograph 21 – Interim Action Ranges MRA Range 47 Restoration Area.
Subarea A photo-monitoring point PPT6A, looking west. 6 November 2013

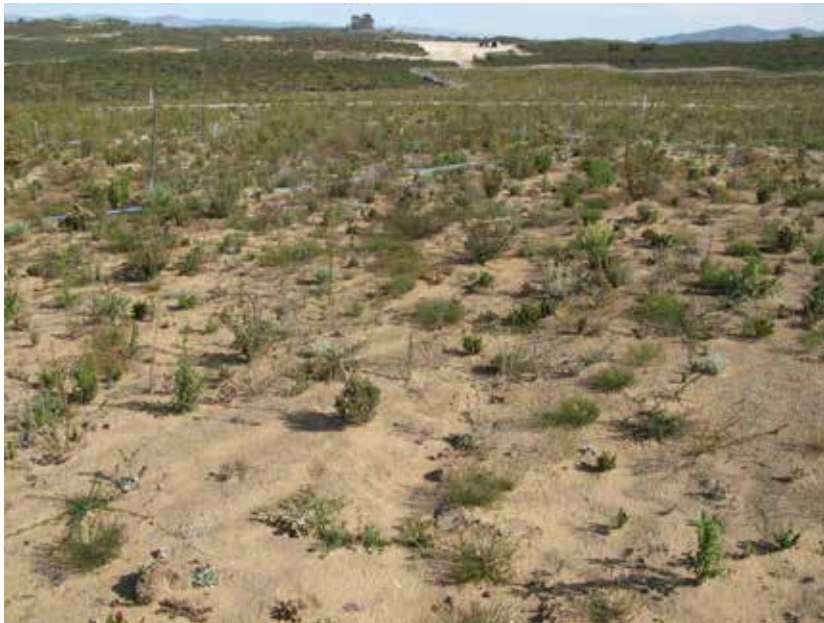
Photograph 22 – Interim Action Ranges MRA Range 47 Restoration Area.
Subarea B photo-monitoring point 12A, looking east. 6 November 2013

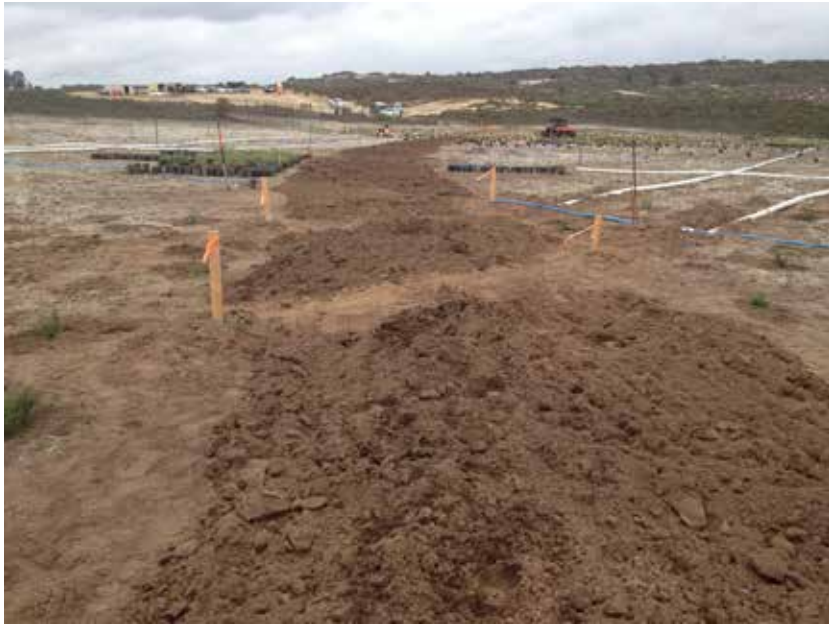
Photograph 23 – Interim Action Ranges MRA Range 47 Restoration Area.
Temporary restoration area road after soil ‘ripping,’ looking east. 5 February 2013

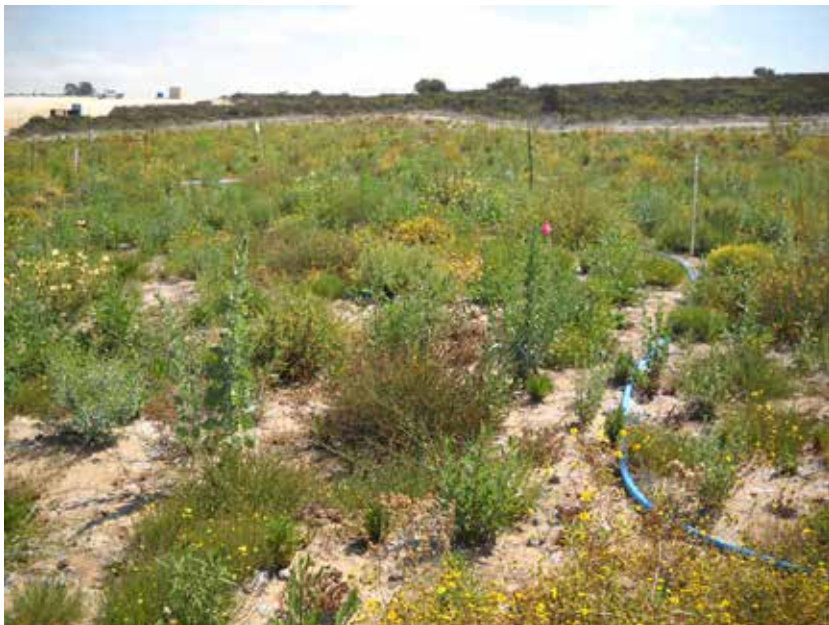
Photograph 24 – Interim Action Ranges MRA Range 47 Restoration Area.
Few signs of temporary road remain in restoration area by late summer, looking east. 10 September 2013

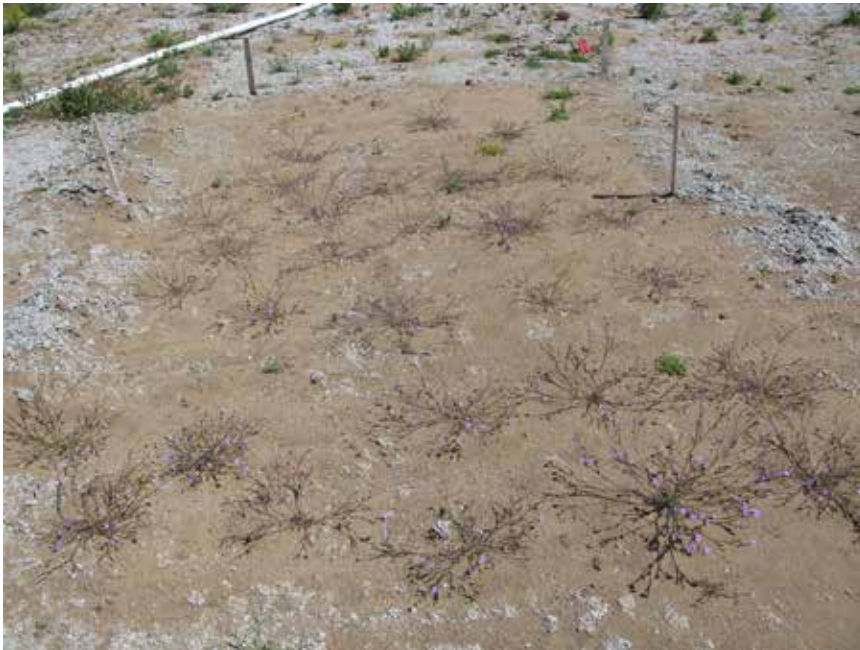
Photograph 25 – Interim Action Ranges MRA Range 47 Restoration Area.
Monterey gilia container planting polygon. 31 May 2013

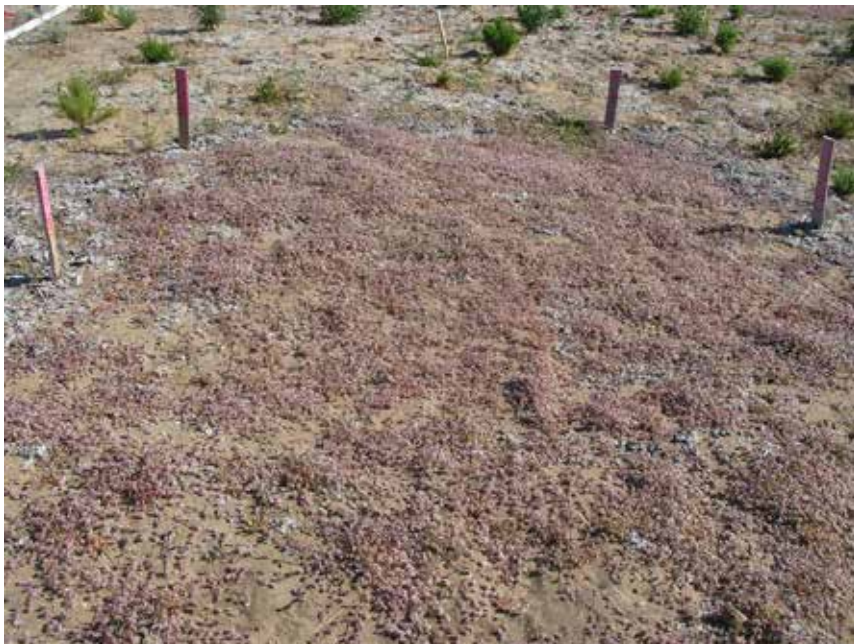
Photograph 26 – Interim Action Ranges MRA Range 47 Restoration Area.
Monterey spineflower seeding polygon. 31 May 2013

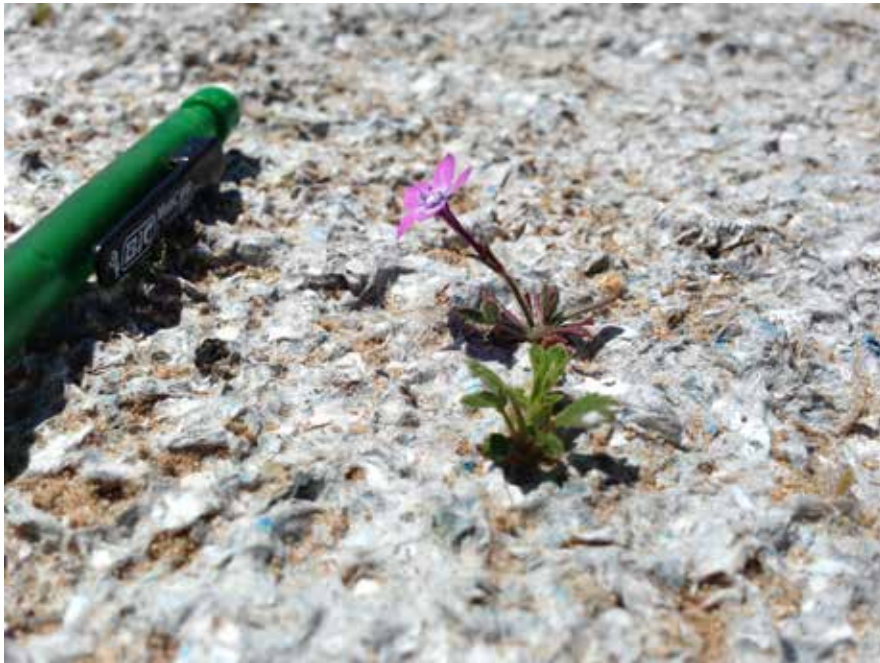
Photograph 27 – Interim Action Ranges MRA Range 47 Restoration Area.
Monterey gilia growing from soil seedbank through hydromulch. 29 April 2013

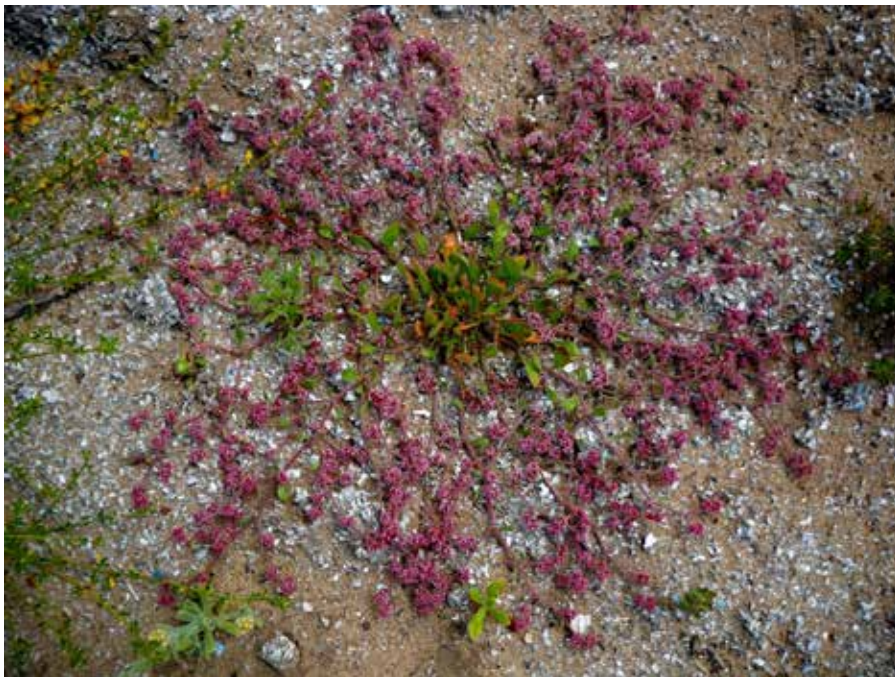
Photograph 28 – Interim Action Ranges MRA Range 47 Restoration Area.
Monterey spineflower growing from soil seedbank. 24 June 2013

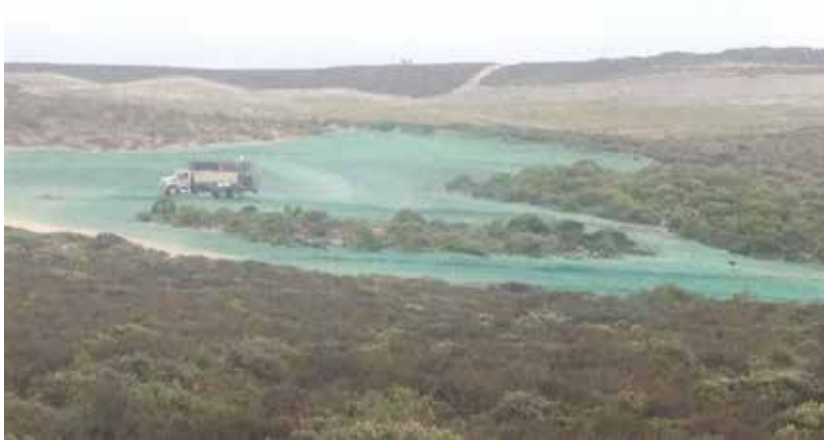
Photograph 29 – Interim Action Ranges MRA Development Parcel.
Hydromulching for control of wind erosion, looking south-southwest. 11 July 2013

Following the rainy season, as soils dried out, wind erosion was noted in bare-soil areas of the development parcel adjacent to the Range 47 Restoration Area. During high wind events, surface soils were eroded and transported eastward. Wind erosion was controlled by application of hydromulch to all bare-soil areas in the development parcel (approximately 11.5 acres [4.7 ha]) between 08 and 12 July 2013. The hydromulch mixture consisted of 2,000 pounds (907 kg) per acre of wood fiber matrix and 5 gallons (19 l) per acre of EarthGuard® tackifier. No seed was added to the hydromulch mixture. Since the

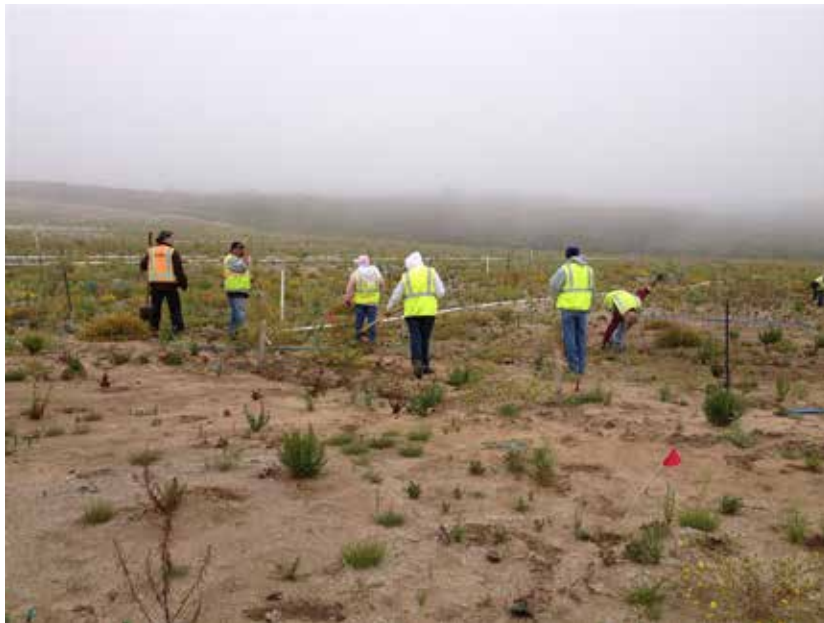
Photograph 30 – Interim Action Ranges MRA Range 47 Restoration Area.
Maintenance weeding in Subarea B, looking northwest. 19 July 2013

As required by the HRP, weed abatement has been performed by the ESCA RP Team on a continuous basis since the start of implementation (ESCA RP Team 2013b). All weeds were initially removed from the Range 47 Restoration Area during soil excavation. Shortly after soil replacement, germinating weeds were observed in the Range 47 Restoration Area, so weed abatement activities commenced early in the first-year monitoring period.

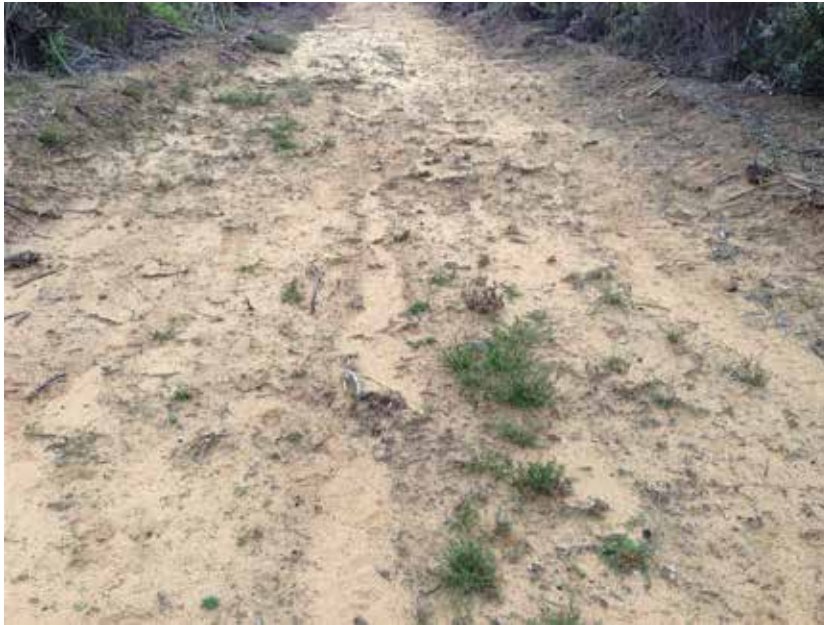
Photograph 31 – Interim Action Ranges MRA South Range 47.
Growth after small-scale excavation. 4 March 2013

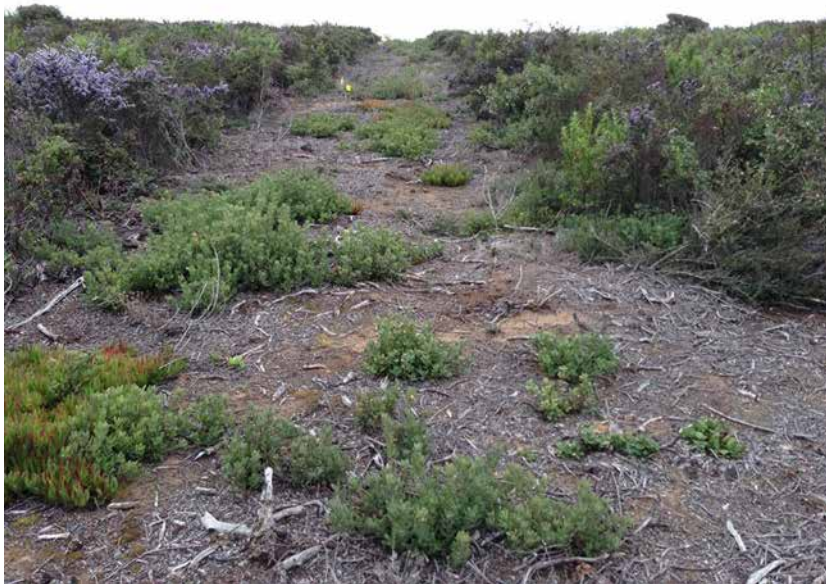
Photograph 32 – Interim Action Ranges MRA North Range 44.
Vegetation regrowth along 10-foot-wide transects subject to vegetation cutting. 21 May 2013

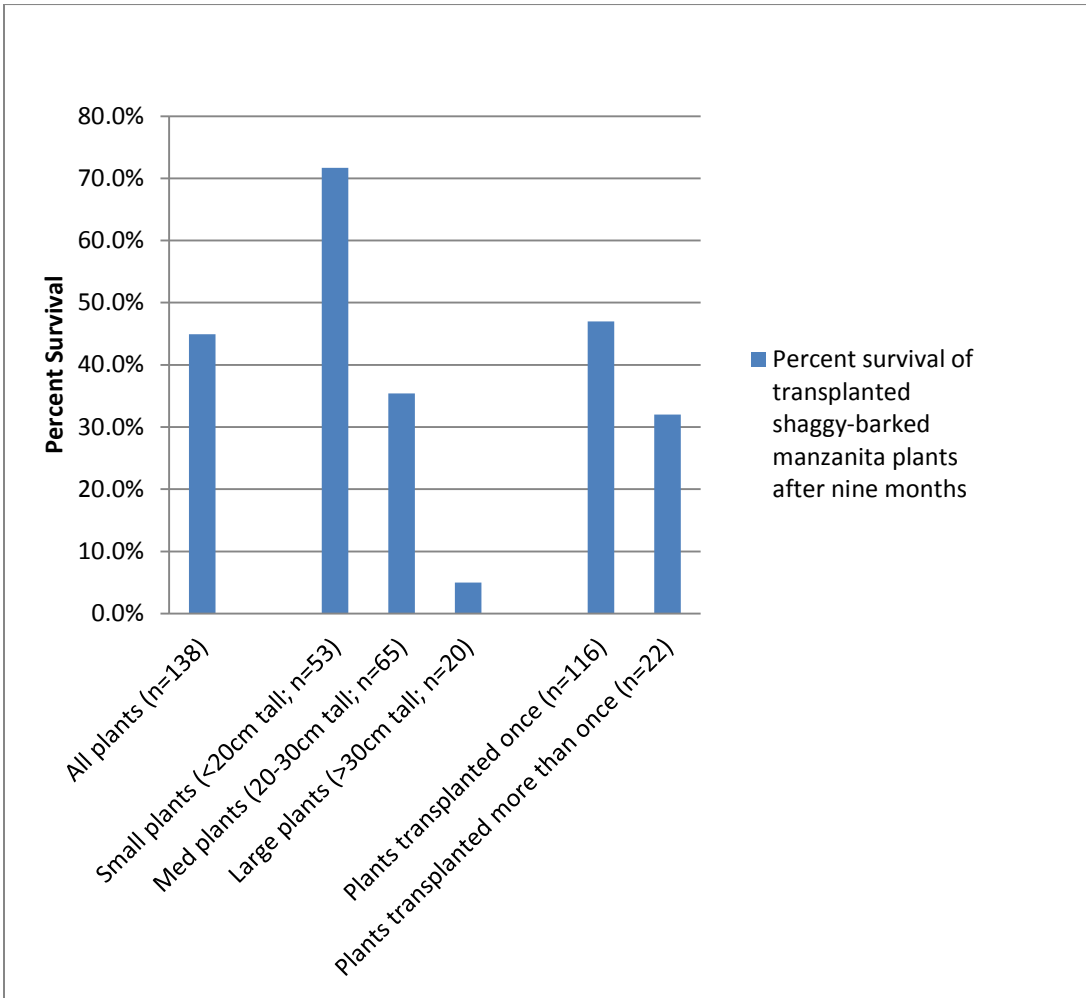
Figure A11
Percent Survival of Salvaged Shaggy-barked Manzanitas in Interim Action Ranges MRA Range 47 SCA Subarea B
