FIELD VARIANCE FORM

DATE: 11-AUG-11 **PROJECT NAME:** Interim Action Ranges (IAR) Munitions Response Area (MRA) **PROJECT LOCATION:** Interim Action Ranges
APPLICABLE DOCUMENT / SECTION: Final Phase II Interim Action Work Plan, Interim Action Ranges Munitions Response Area, Former Fort Ord, dated May 24, 2011
SUBJECT: Design Study Enhancement for Range 47 Special Case Area – Berm

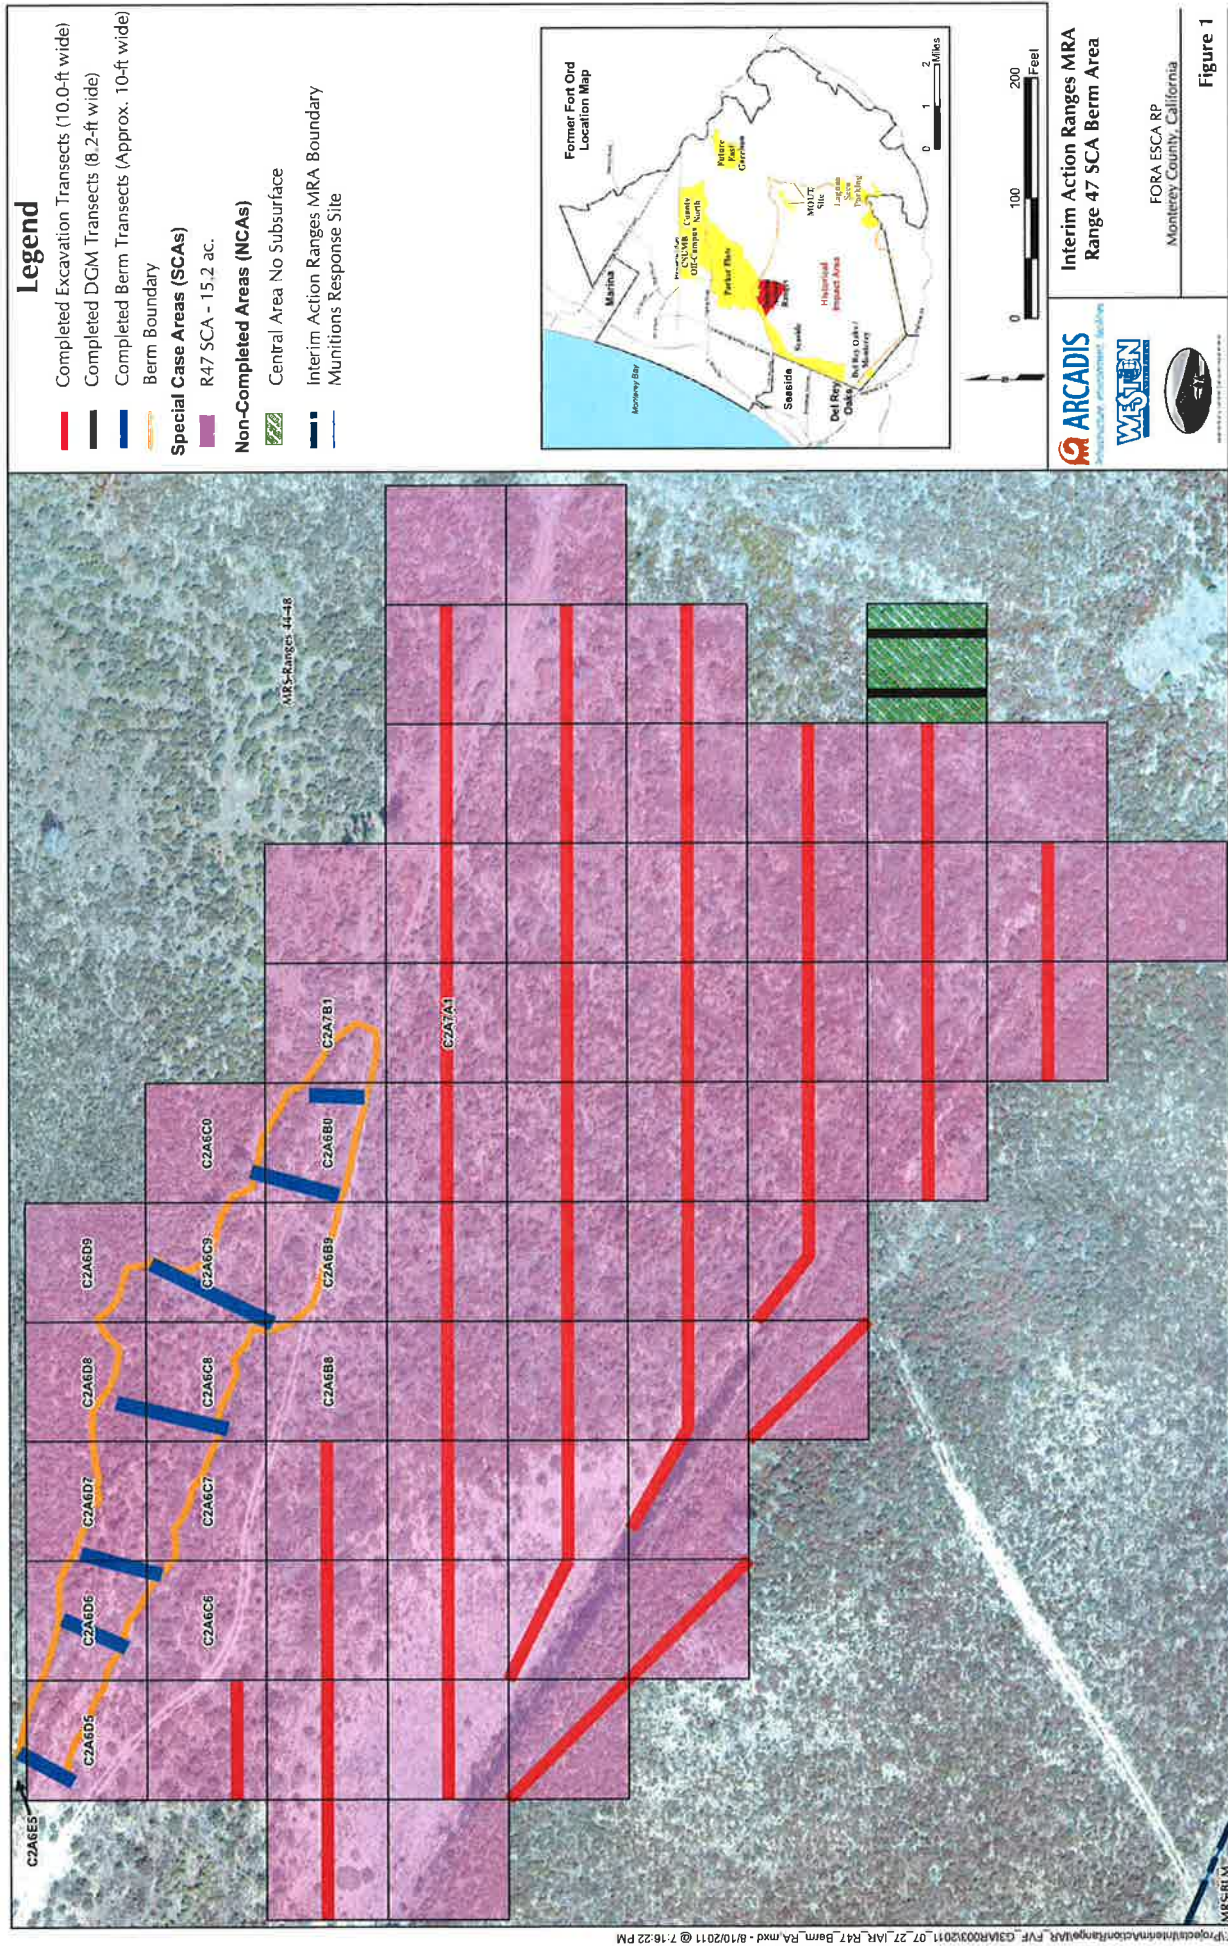
Figure 1 – Interim Action Ranges MRA Range 47 SCA Berm Area

The Design Study that includes Range 47 (R47) Special Case Area (SCA) (Figure 1) began June 13, 2011, and transect and berm investigations were conducted in accordance with the Final Phase II Interim Action Work Plan for the Interim Action Ranges Munitions Response Area (IAR MRA). Figure 1 provides the location of the berm and investigation transects. Forty millimeter (40mm) high explosive (HE) munitions debris (MD) and 40mm HE unexploded ordnance (UXO), which are sensitively fuzed munitions, have been found during the Design Study in R47 SCA.

The recommended approach includes vegetation removal, excavation and sifting of the berm material, which covers approximately 1.2 acres of R47 SCA (approximately 7,500 cubic yards of soil), and conduct a digital geophysical survey and target investigation of the original ground surface. The approximately 1.2-acre area includes portions of sixteen 100-foot-by-100-foot grids (C2A6D5, C2A6D6, C2A6D7, C2A6D8, C2A6D9, C2A6C6, C2A6C7, C2A6C8, C2A6C9, C2A6C0, C2A6B8, C2A6B9, C2A6B0, C2A7B1, C2A6E5, and C2A7A1; Figure 1).
