Final
Record of Decision
No Action Regarding
Ordnance-Related Investigation
Former Fort Ord, California

June 19, 2002

United States Department of the Army
HQ, U.S. Army Garrison (Fort Ord)
Fort Ord, California 93941

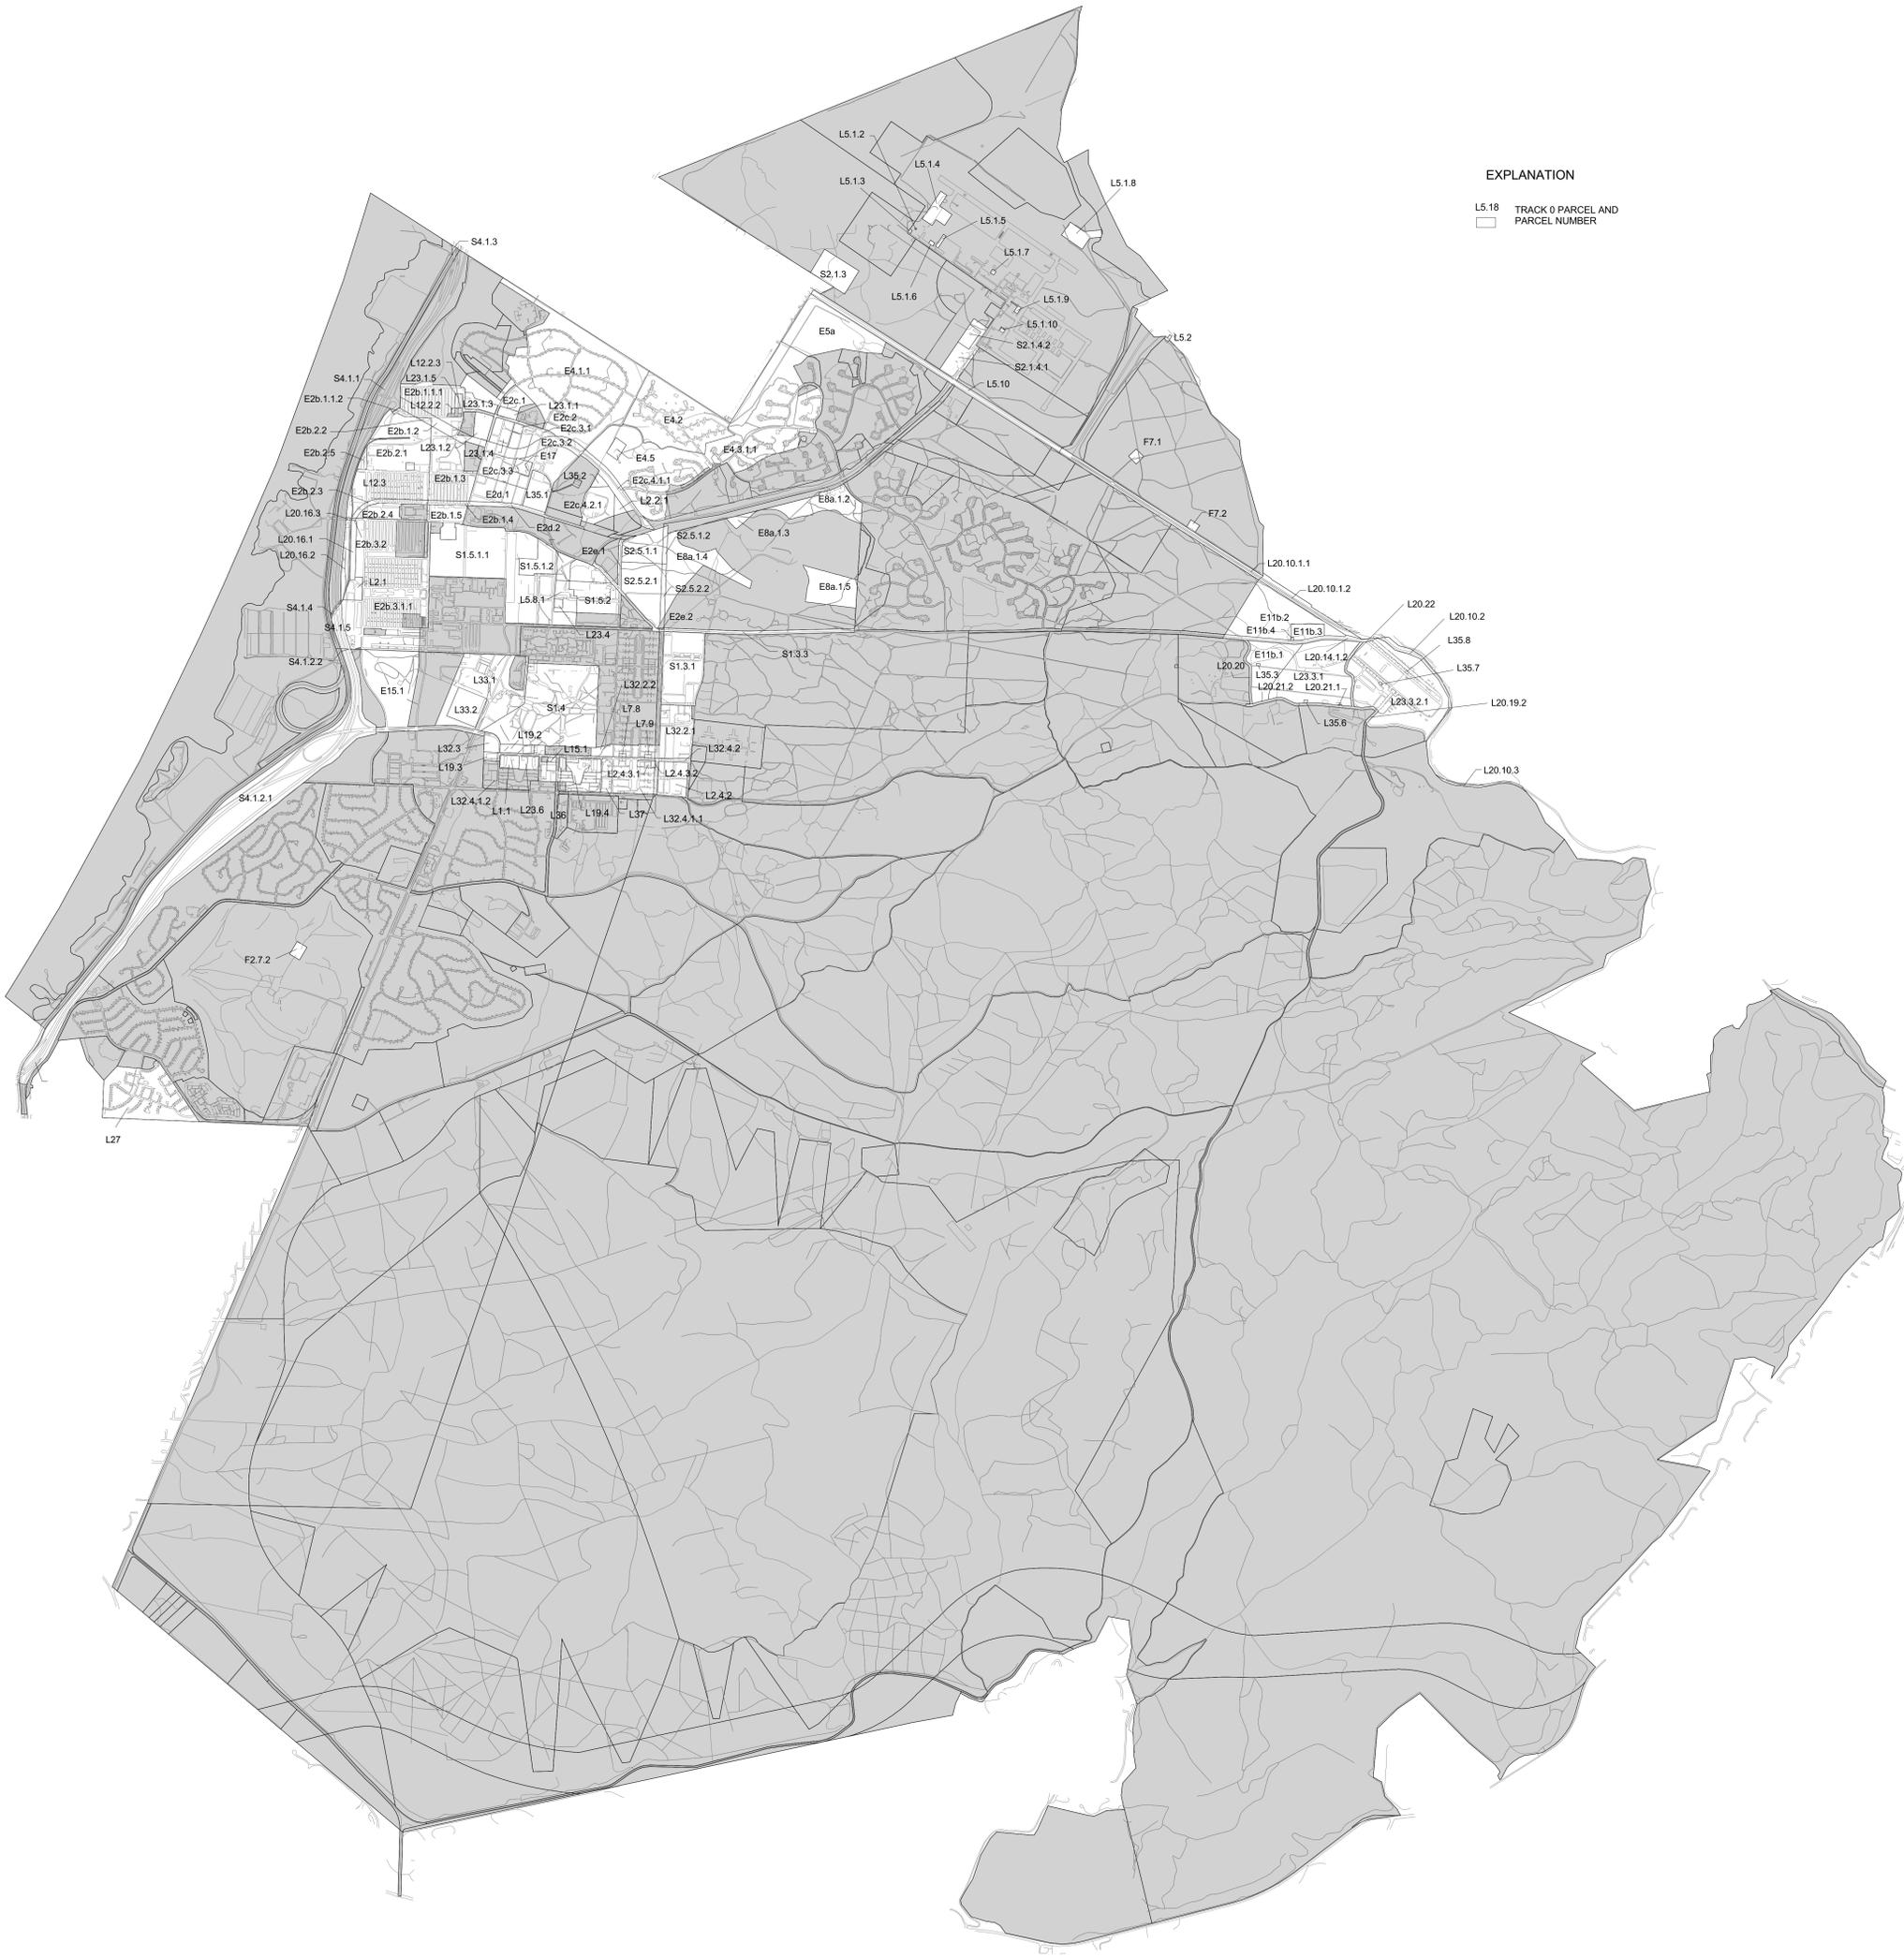
Track 0 areas pose no known current or potential risk to human health or the environment from previous OE-related activities. The locations and descriptions of the areas proposed for No Action are shown on Plate 2 and are listed on Table 1.

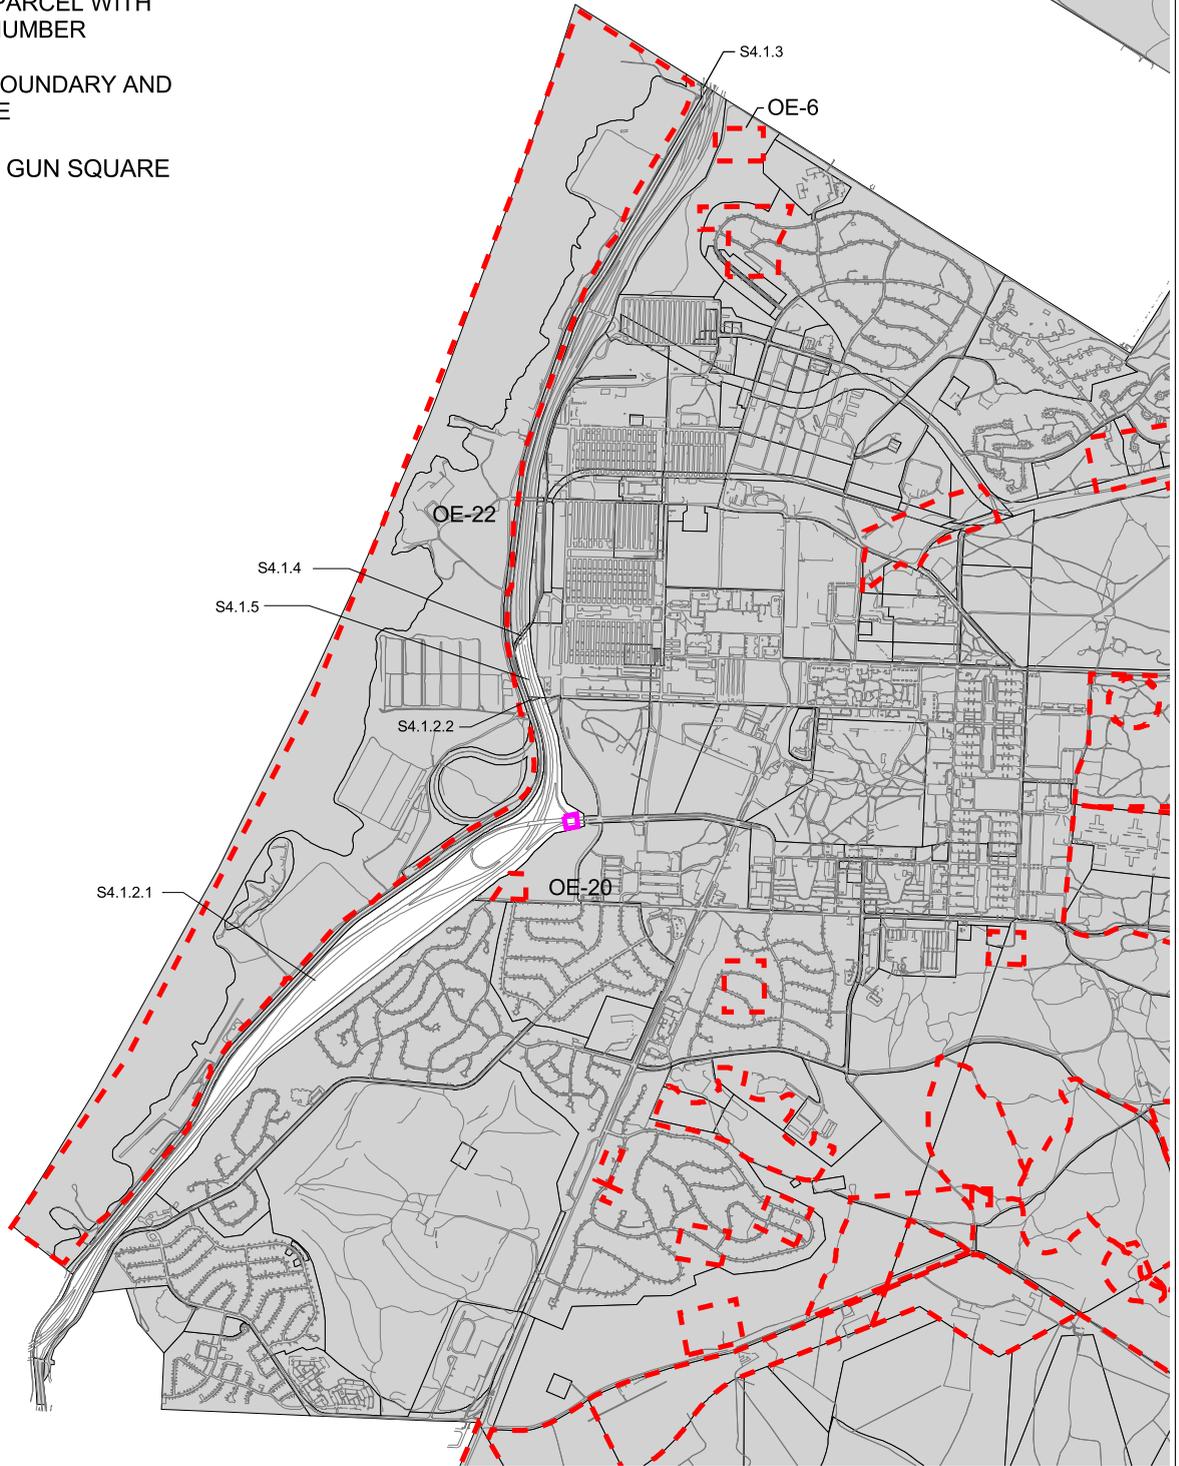
- S4.1.3 TRACK 0 PARCEL WITH PARCEL NUMBER
- OE-22 OE SITE BOUNDARY AND SITE NAME
- MACHINE GUN SQUARE

Site OE-22, the Beach Ranges, were small arms ranges located along the former Fort Ord beachfront. Firing at the ranges was toward the west away from the Track 0 parcels. Sampling of Site OE-22 was preformed in 1993-1994. Numerous live small arms and several OE scrap items (fins from a 60mm mortar, an inert training grenade, expended smoke grenade and grenade fuze and a 40mm cartridge case) were found (*HFAI, 1994*). Additional sampling

One former training area, a machine gun square, overlaps a portion of Parcel S4.1.2.1 near the former Fort Ord main entrance. No evidence has been found that would support the use of OE at the machine gun squares (*HLA, 2000*). The machine gun squares were located within developed areas of former Fort Ord, adjacent to main roads, military housing, and other military facilities.

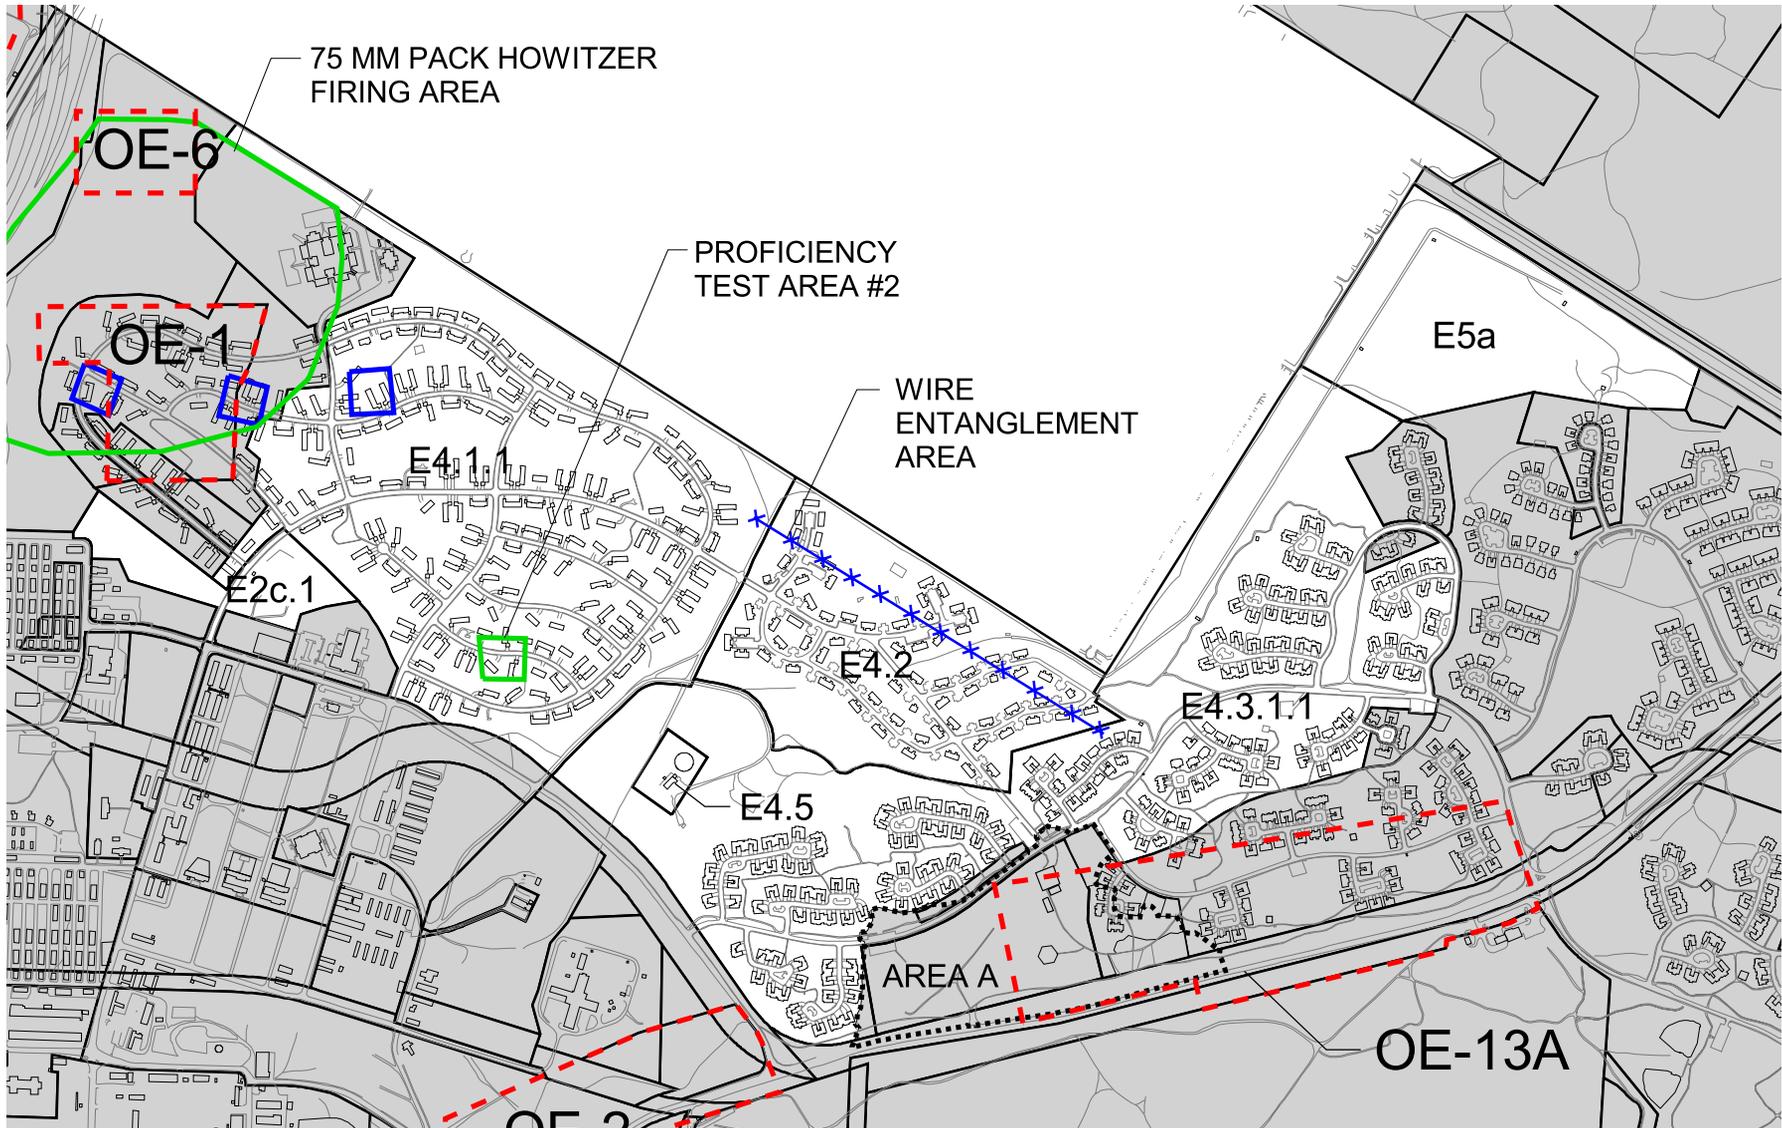
PLATE
5

- L5.6.1 TRACK 0 PARCEL WITH PARCEL NUMBER
- OE-13A OE SITE BOUNDARY AND SITE NAME
- EXTENT OF EXCAVATED AND GRADED LANDFILL AREA (AREA A)
- MORTAR SQUARE

The boundary of Site OE-13A as identified in the ASR is partially within the current Abrams Park housing area and partially overlies a former landfill (Area A). The earliest housing construction within Abrams Park was completed in 1978 and involved the removal of up to 25 feet of soil and landfill material from various areas (*USACE, 2000*). Construction and grading is evident on 1978 aerial photographs. No evidence of OE was found outside of Area A during construction of Abrams Park (*HLA, 2000*).

As discussed above, Area A was used as a sanitary landfill in the 1960s. Excavation of landfill material within Area A was conducted in 1996 through 1998 as part of the relocation of that portion of the OU 2 landfill. The excavation included the entire limits of Area A, including the overlapping portion of Site OE-13A. During the excavation numerous OE scrap items were found. The items were either removed or destroyed in place (*IT, 1999c*), however no live OE was found. All landfill disposal areas, including land within the OE footprint, have been excavated. The excavated areas have been backfilled and re-graded. Although OE items were found within landfill materials excavated from Area A, the items were related to disposal within these parcels and were not associated with ordnance use at Site OE-13A.

A mortar square was located within Parcel E4.1.1. The mortar square was identified on training facilities maps from the 1950s and 1960s. No evidence has been found that would support the use of live ordnance at the mortar squares (HLA, 2000).

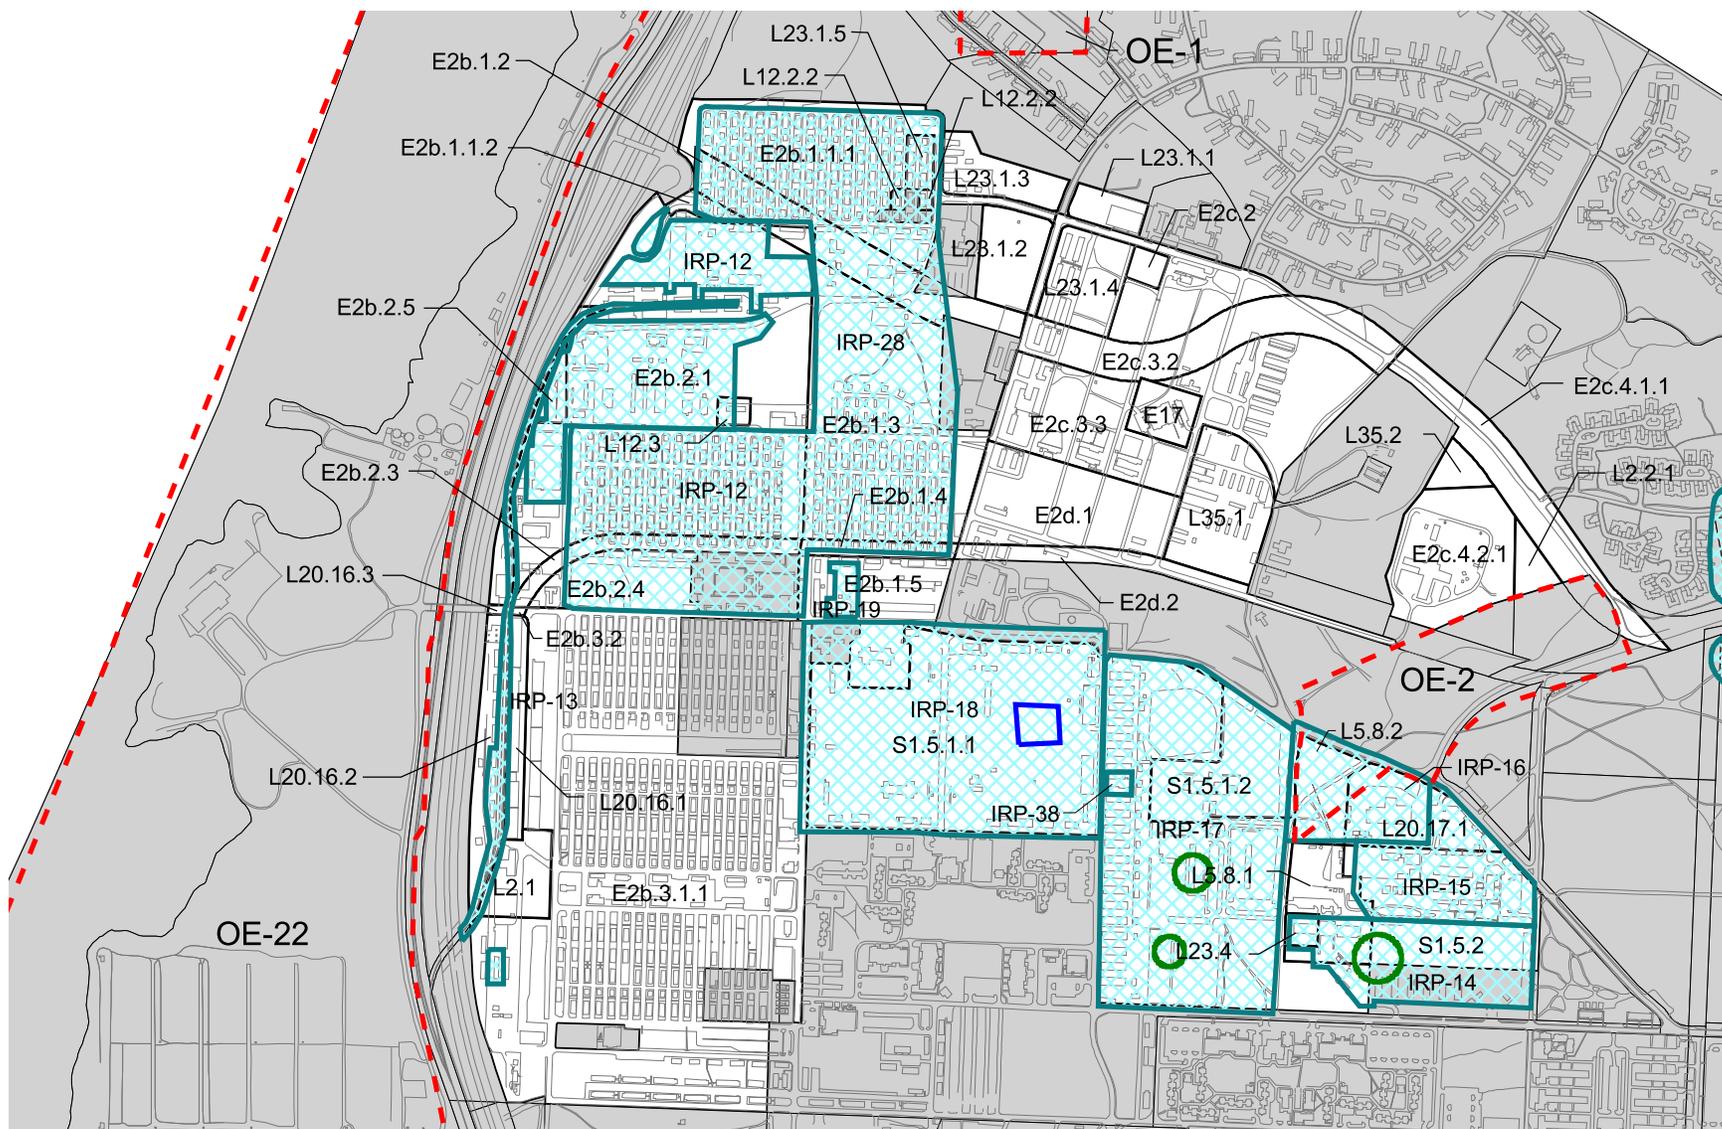
10

- L23.1.4 TRACK 0 PARCEL WITH PARCEL NUMBER
- OE-2 OE SITE BOUNDARY AND SITE NAME
- EXCAVATED LANDFILL AREAS
- RIFLE INSTRUCTION CIRCLE
- MORTAR SQUARE
- IRP SITE

One potential OE site is adjacent to these parcels. Site OE-2, Pete’s Pond is located adjacent to Parcels S1.5.1.1, S1.5.1.2, and L5.8.1 and a portion of Site OE-2 overlies Parcel L5.8.2 (Plate 10). Site OE-2 was identified as a chemical training area and a landmine warfare training area (USAEDH, 1997b). Site OE-2 was sampled for OE in 1994 and two inert OE scrap items were found (HFAI, 1994). A portion of Site OE-2 overlaps IRP Site 16 (Parcel L5.8.2) and is adjacent to IRP Site 17 (Parcel S1.5.1.2). During the investigation and remediation of IRP Sites 16 and 17, 468 2.36-inch inert practice rockets were removed from burial pits located in former landfill areas within Parcels L5.8.2 and S1.5.1.2 (IT, 2000) (Plate 10). Landfill areas within Parcels S1.5.1.2 and L5.8.2 were fully excavated in 1997. This area is considered a Special Case Track 0 area. Although ordnance was found on Parcels S1.5.1.2 and L5.8.2, the items were buried in disposal pits within these parcels and were not associated with ordnance use in these areas. The land within the OE footprint has been excavated, backfilled and re-graded. Any ordnance that might not have been located through excavation would most likely have been found during the re-grading process. Site OE-2 will undergo additional evaluation in the OE RI/FS.

- The landfill areas within Parcels S1.5.1.2, L5.8.2 and L20.17.1 that were found to contain buried inert rockets were fully excavated. Additionally, the remaining non-landfill areas of Parcels L5.8.2 and L20.17.1 that lie within the Site OE-2 boundary were completely re-graded

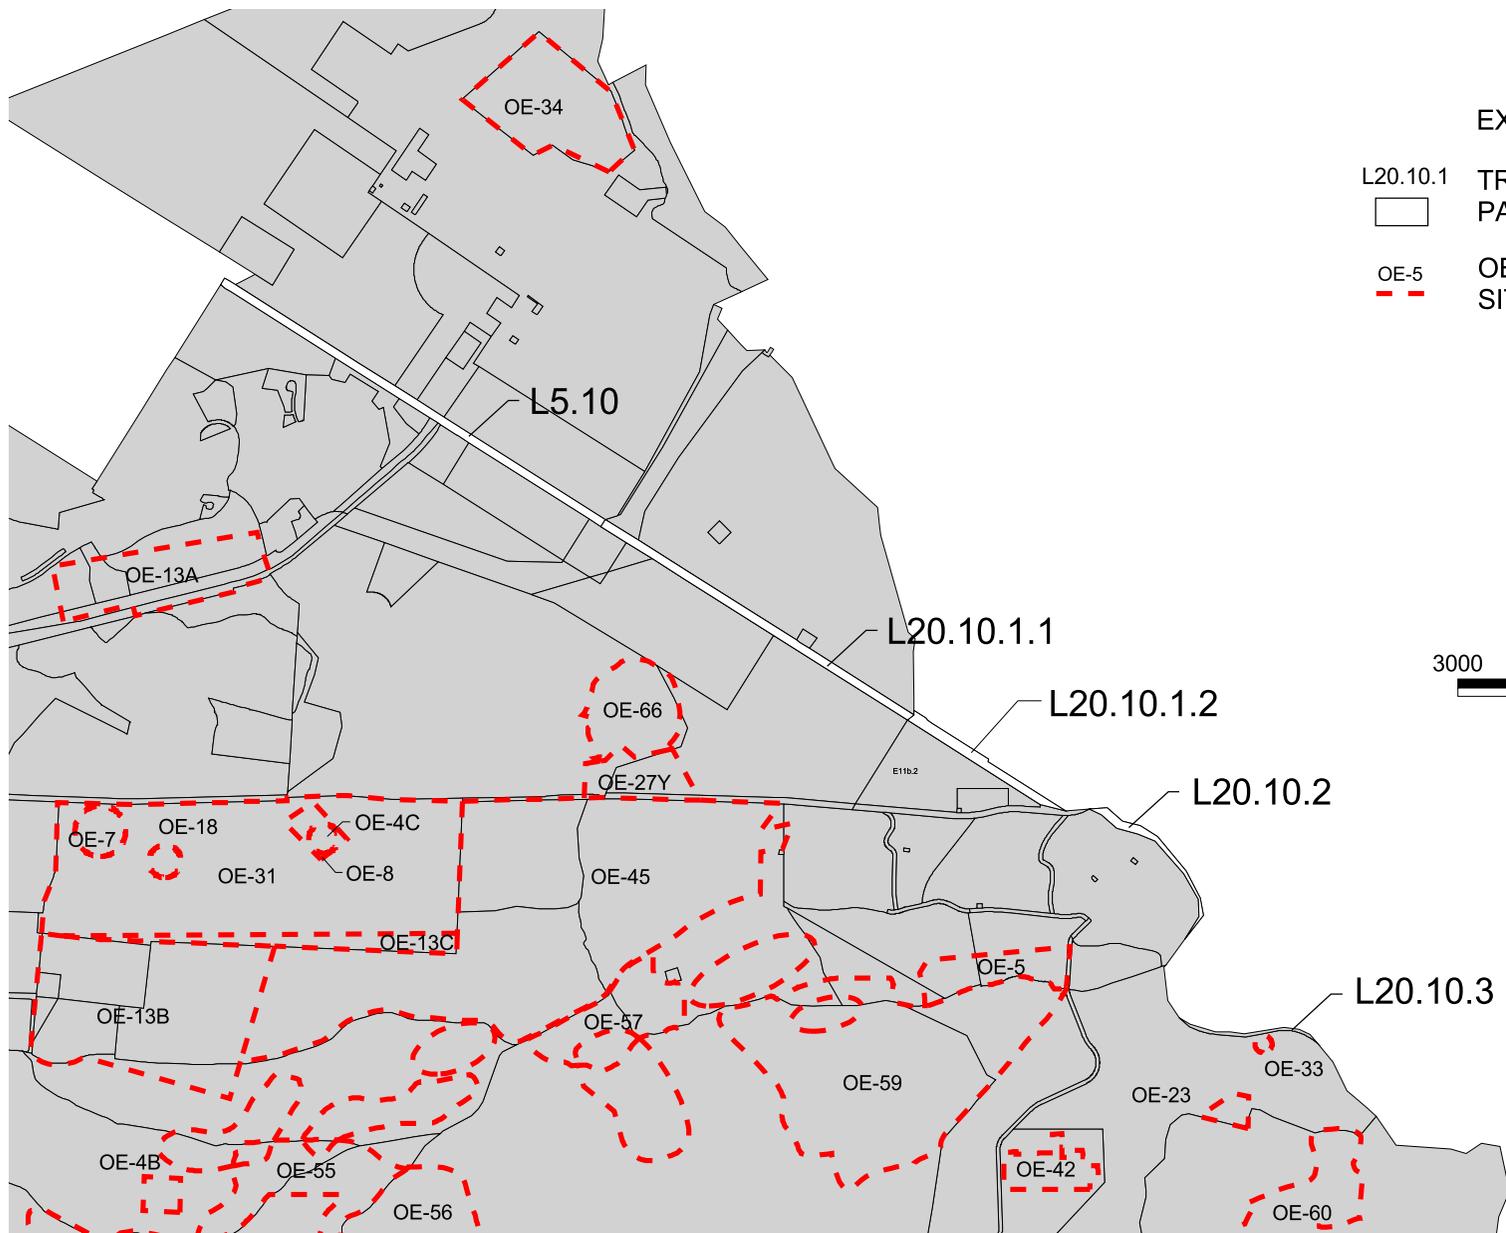
11

- L20.10.1 TRACK 0 PARCEL WITH PARCEL NUMBER
- OE-5 OE SITE BOUNDARY AND SITE NAME

The only training involving the use of weapons in the immediate area occurred within nearby small arms ranges located on adjacent parcels. Firing at the small arms ranges was toward the south away from the East Garrison (*Army, 1940b*). The northern boundary of Site OE-5 is located to the south of the East Garrison area. Site OE-5, south of East Garrison, was established as the result of the finding of a scrap 3.5” rocket motor in the branches of an oak tree in the area (*USAEDH, 1997b*). No known range for rocket firing was located in this area. An ordnance removal contractor sampled this site and did not find evidence of ordnance use (*HFAI, 1994*). As shown on Plate 9, undeveloped land separates the northern boundary of Site OE-5 and Track 0 Parcels L20.20, L20.21.1, L20.21.2, L23.3.1, L23.3.2.1, L35.6 and E11b.1. Site OE-5 will undergo additional evaluation in the OE RI/FS.
