**Independent Third-Party Quality Assurance Work
Summary Report for
Munitions and Explosives of Concern Activities at
Interim Action Ranges Munitions Response Area
Former Fort Ord Facility, Monterey, California**

August 2014

ERRG implemented quality assurance (QA) efforts in support of the design study for the Interim Action Range (IAR) Munitions Response Area (MRA) Range 44 and 47 Special Case Areas (SCA) and Central Area Non-Complete Areas (NCA) in compliance with the QASP to satisfy regulatory agency concerns. It is recognized that a MEC removal action may not successfully acquire and recover all MEC therefore the regulatory agencies have expressed concern regarding the residual risk that remains after MEC removals have taken place, particularly in areas that are slated as planned for community development with borderland that will interface habitat reserve (with administrative controls). This report is intended to document ERRG's efforts in providing the ESCA MEC Remediation Program with Third-Party Quality Assurance oversight, as required by the regulatory agencies, in addition to the Quality Control provided by Weston during their field work.

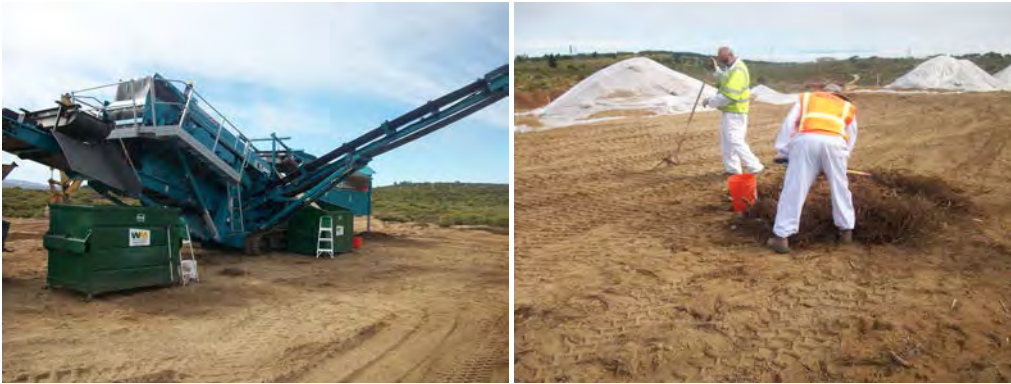
Pictures 1&2: Sifting Operations in the Interim Action Range

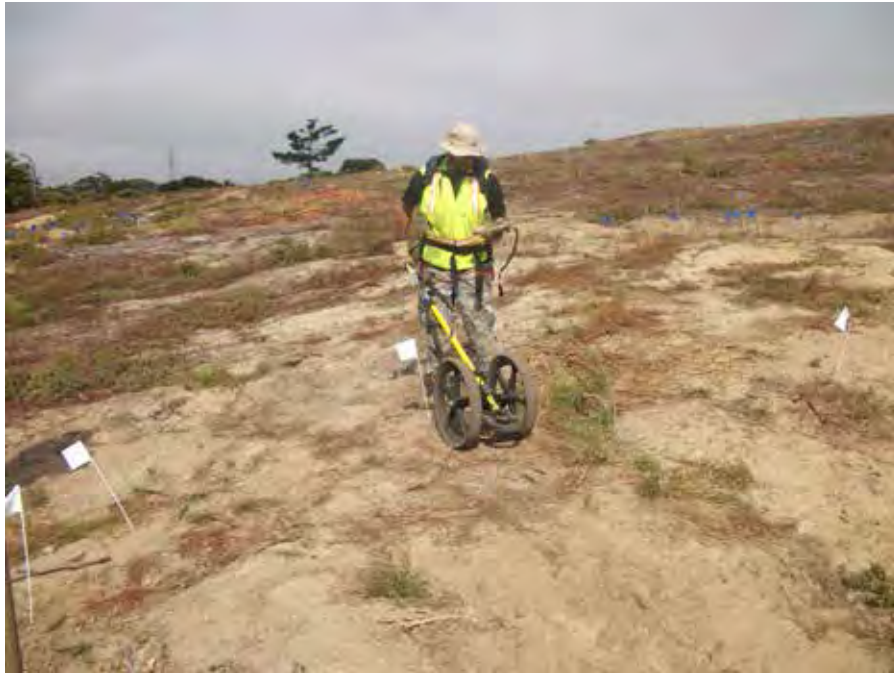
Picture 1: Employment of EM 61 HH for Target Investigation in Grid B1B8F5

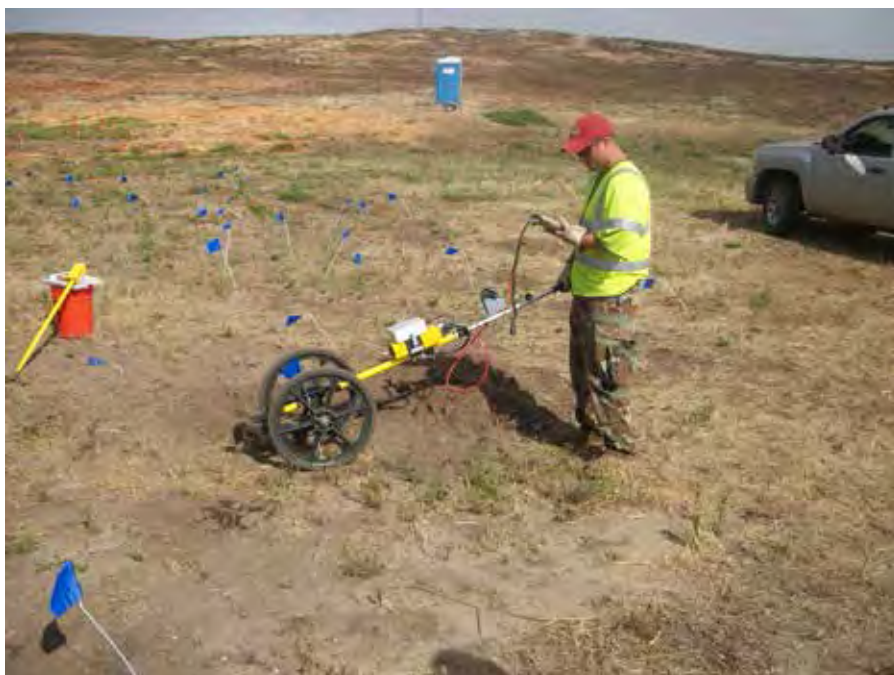
Picture 2: Employment of EM 61 HH for Mag & Dig Operations in Grid B1B8F7

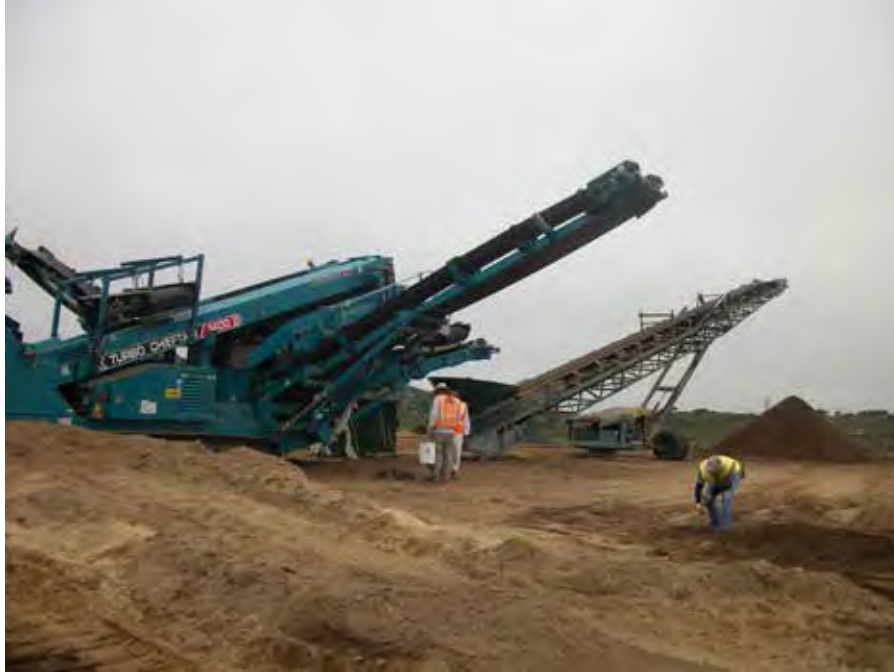
Picture 1: Sifting Operations IAR R47 SCA

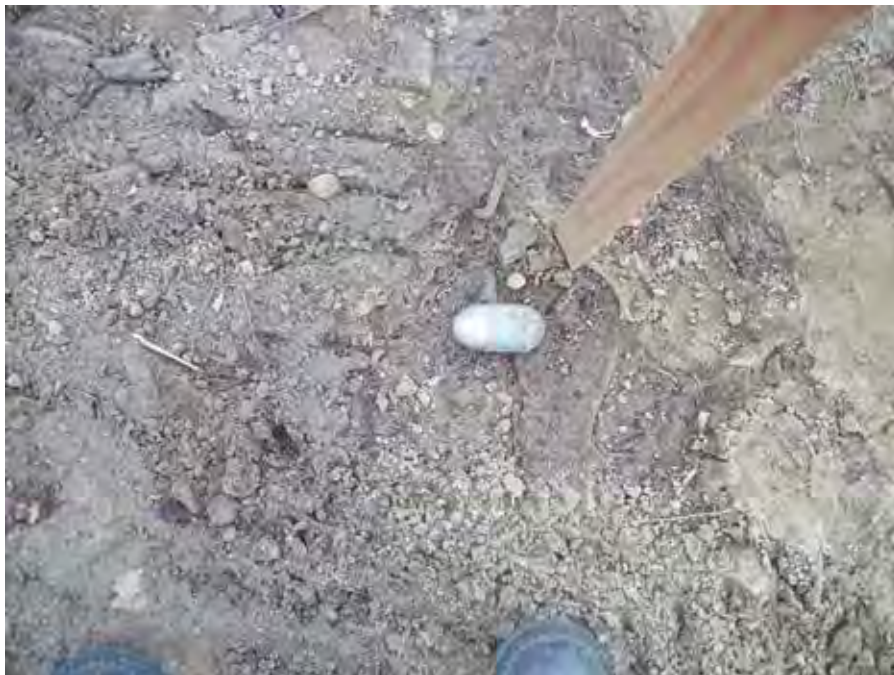
Picture 2: 40 MM, M407A1 found during Sifting Operations

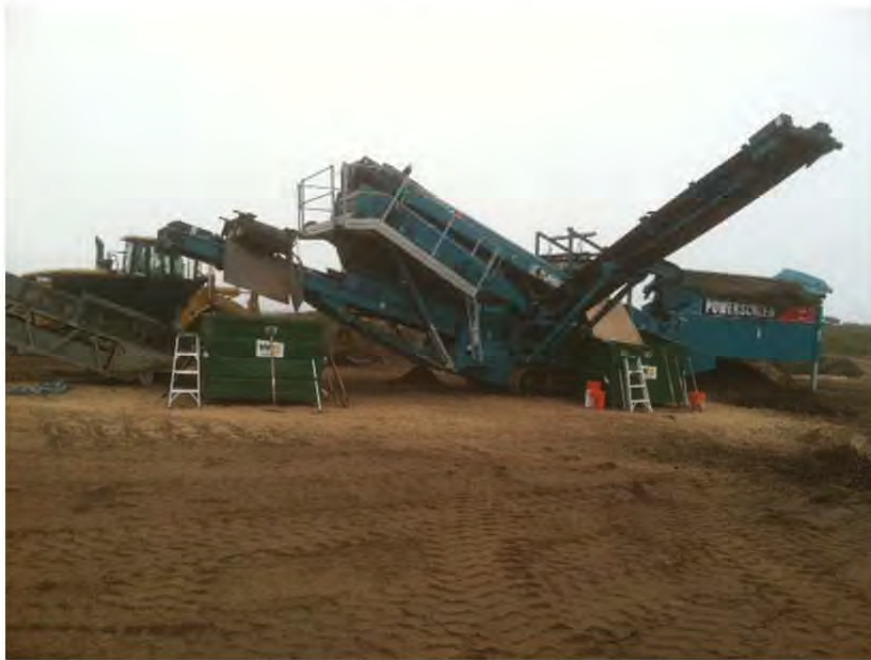
Picture 1: Sift Operations in IAR 44 South SCA and Central Aea NCA

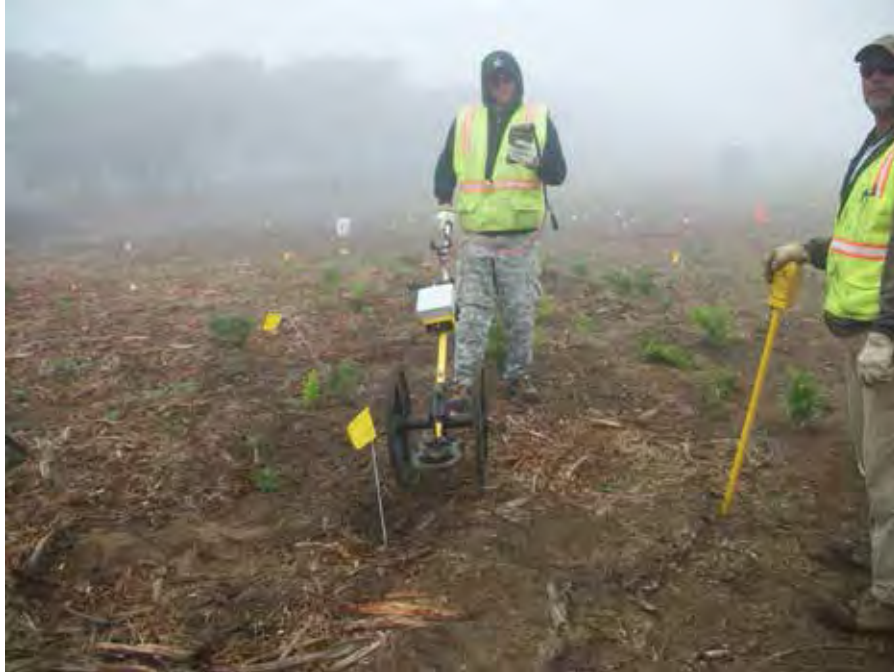
Picture 1: Anomaly being located

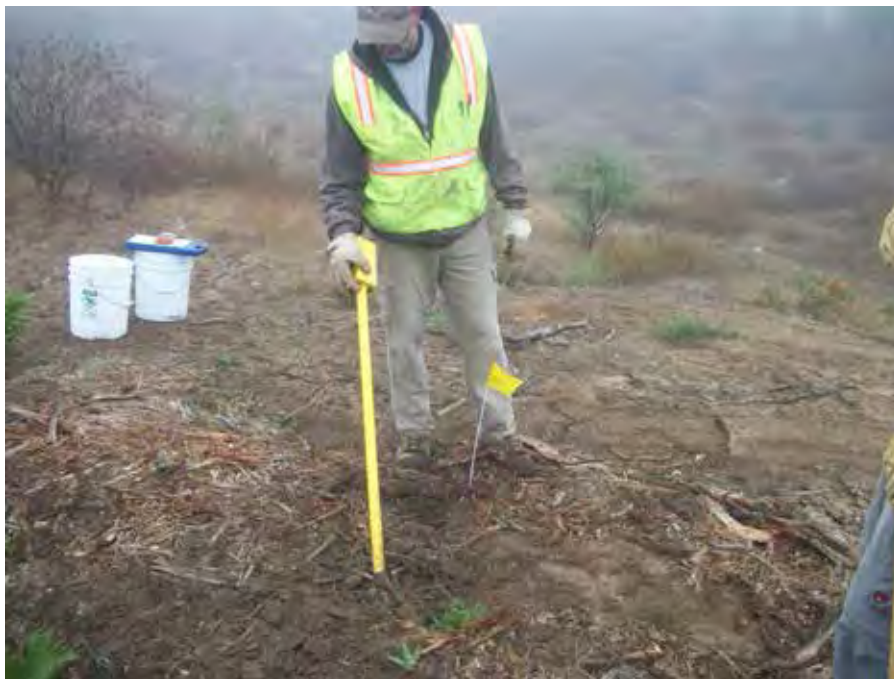
Picture 2: Pin pointing of anomaly

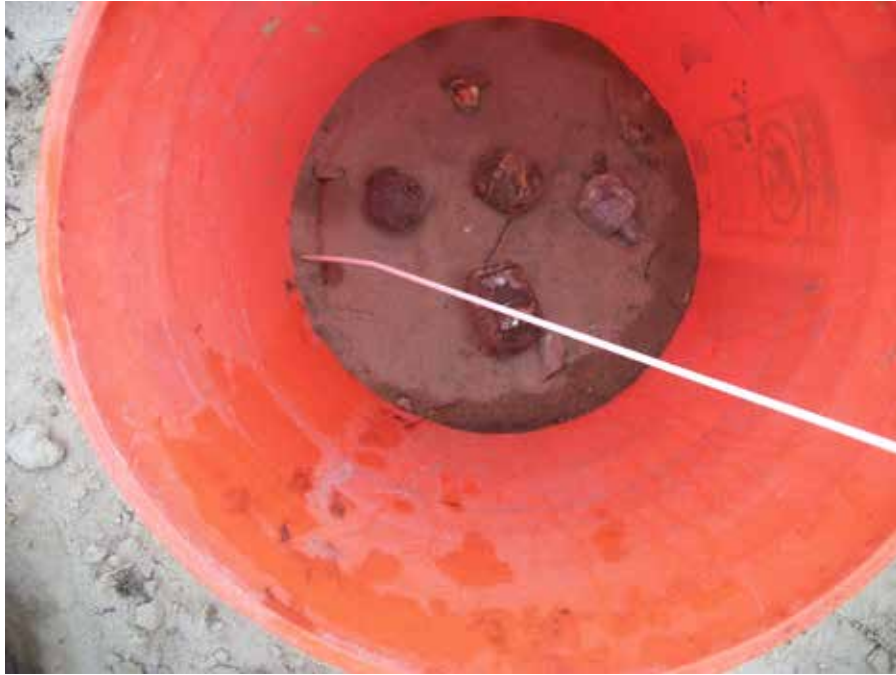
Picture 3: MEC items found during R47 SCA Berm sifting operations

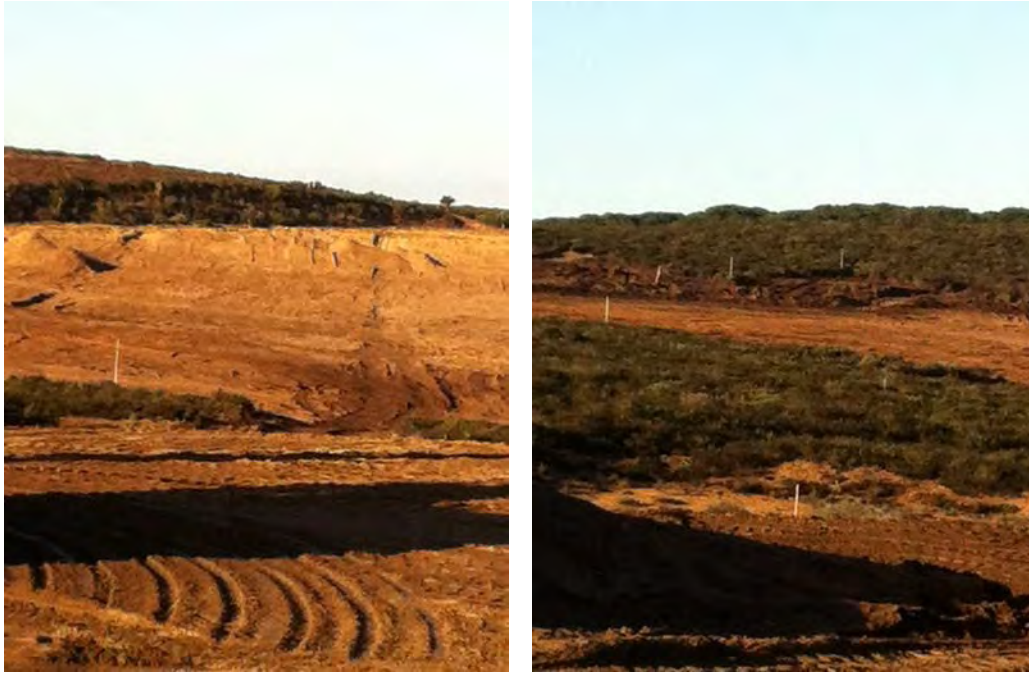
Picture 1&2: IAR R 47 SCASift Area

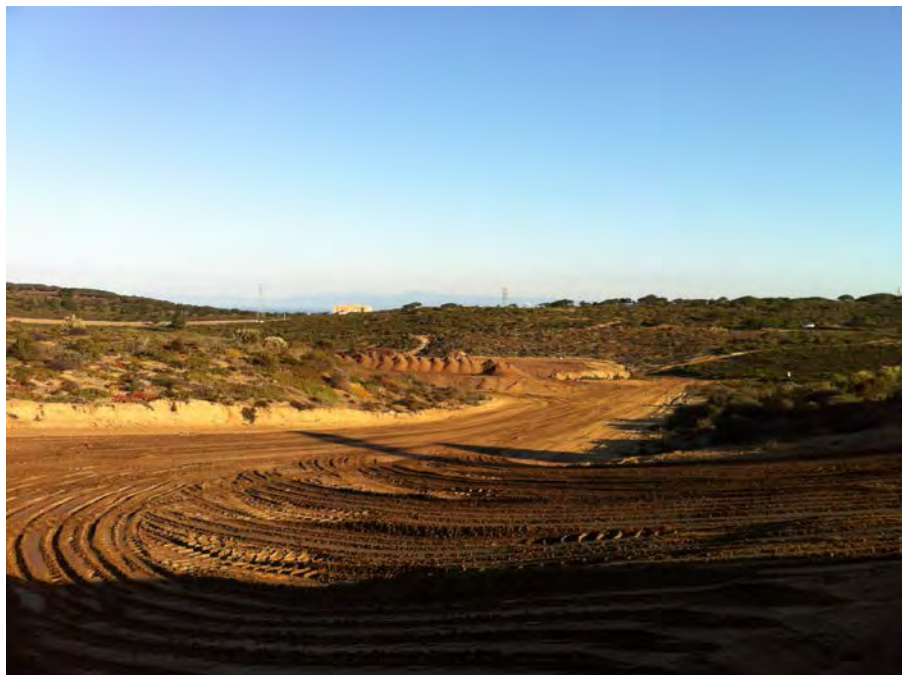
Picture 3: IAR MRA Sift Area fines piles

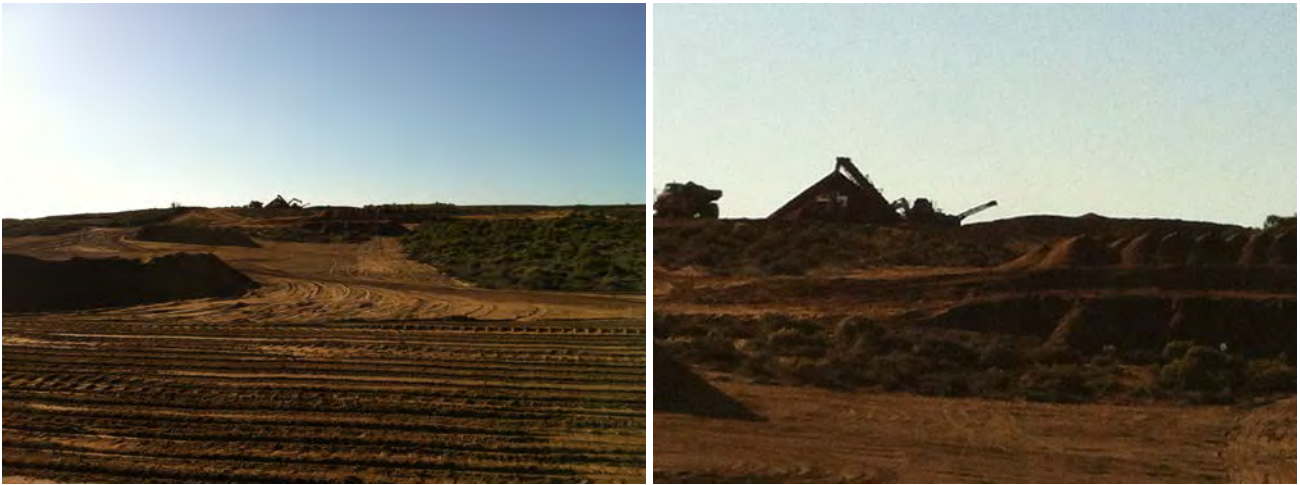
Picture 4&5: Sifter set up in IAR MRA

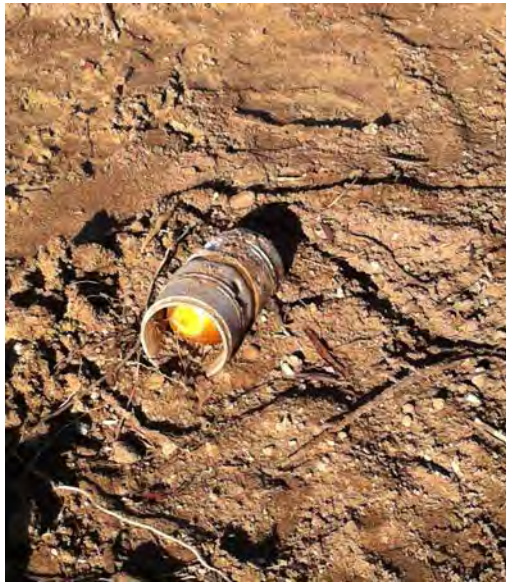
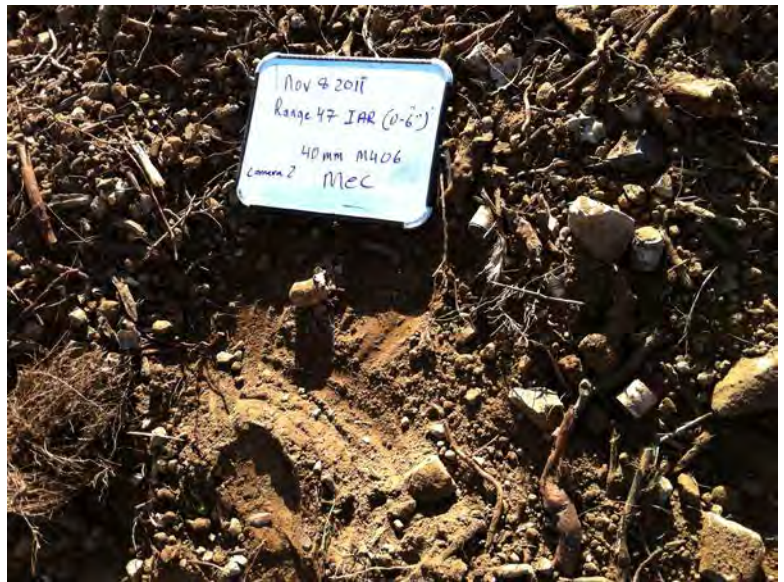
Picture 6&7: 1 M406 and 1 M407A1 40mm projectiles discovered during sift operations

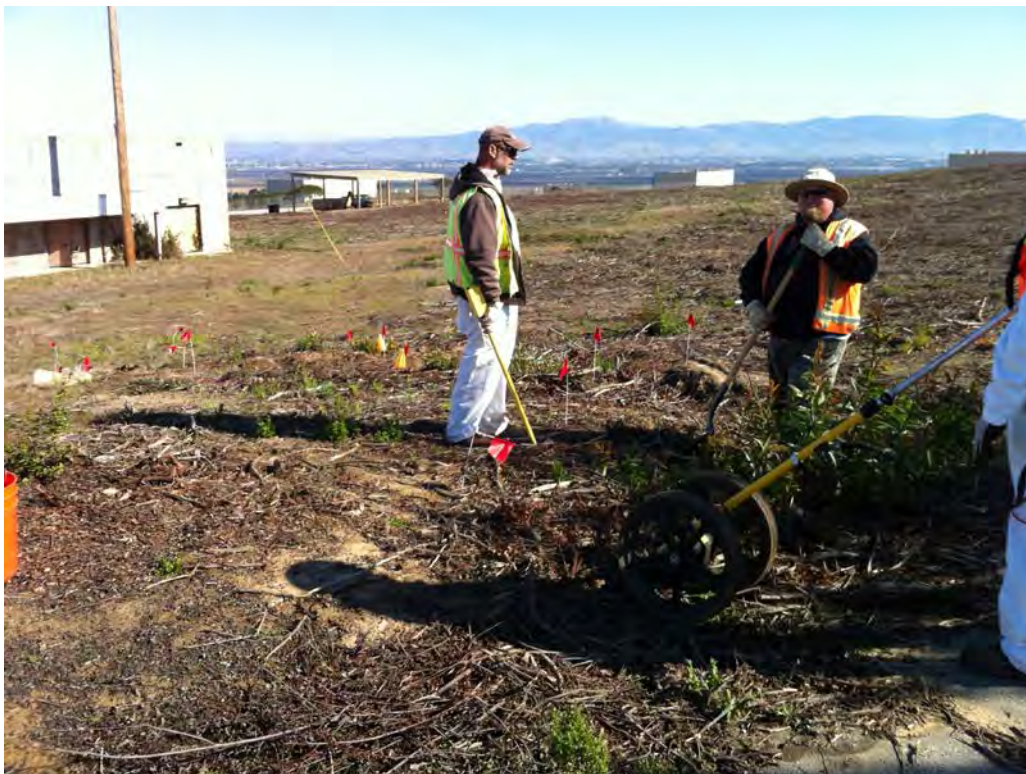
Picture 9: Anomaly investigation in Future East Garrison MRA 42, Parcel E11b.8

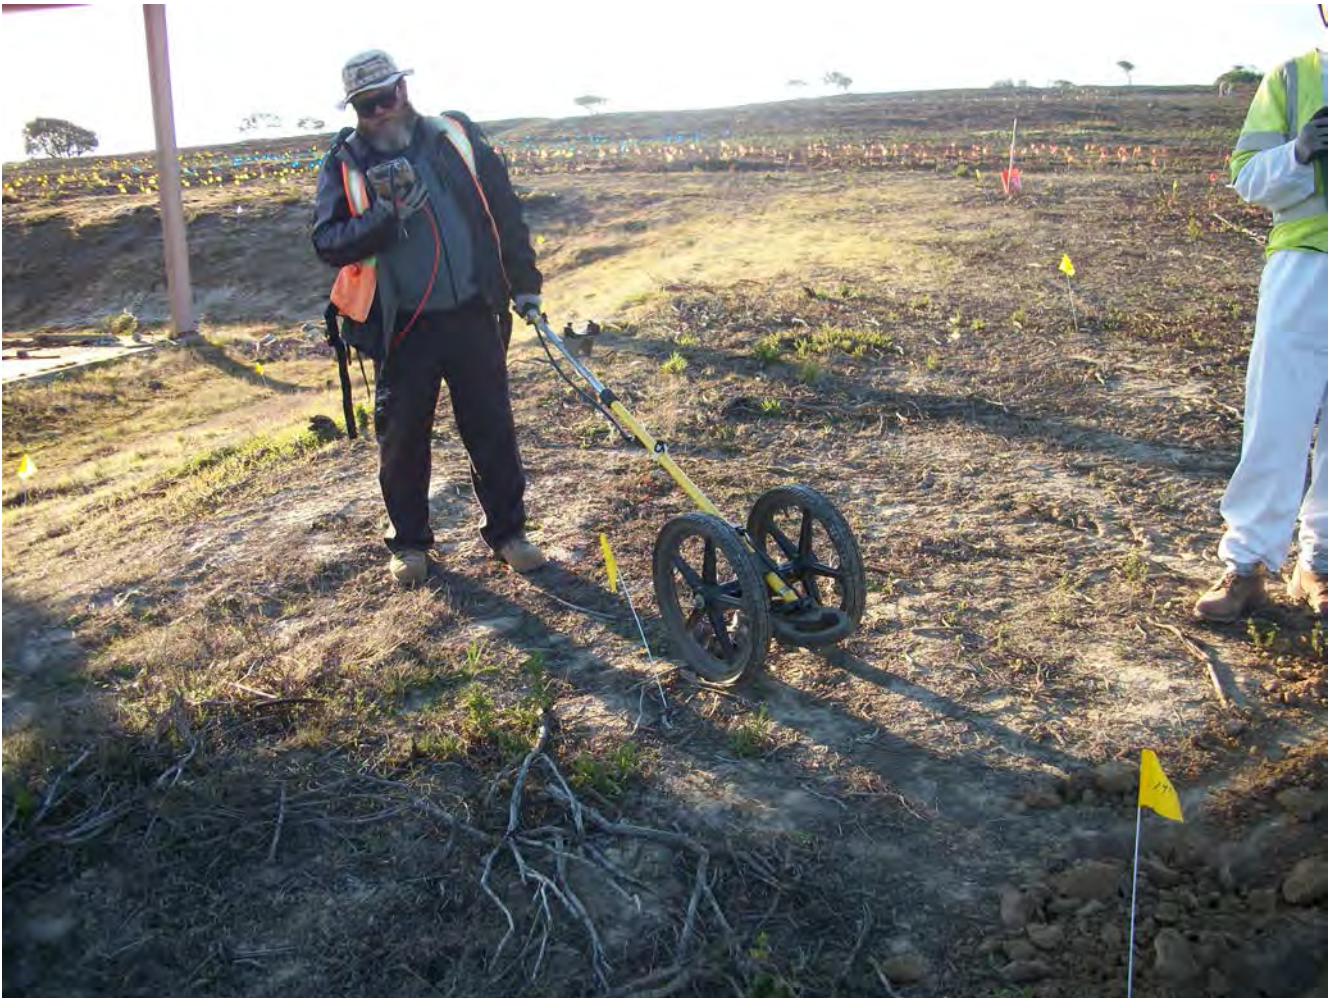
Picture 1: Anomaly locating utilizing the EM 61

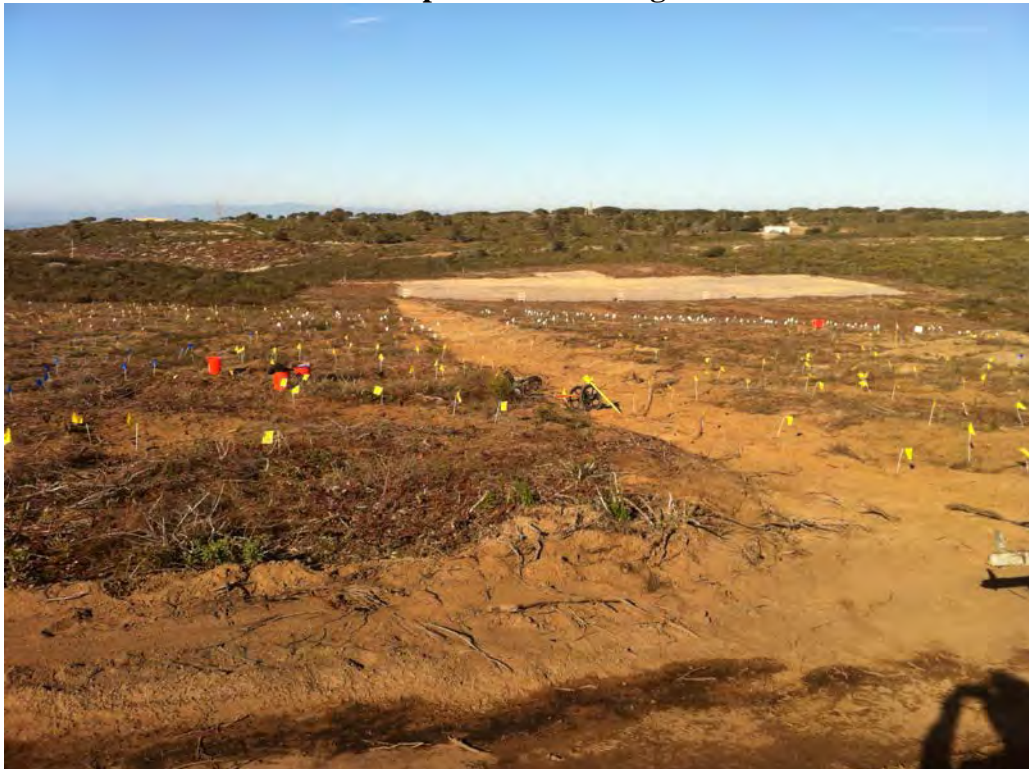
Picture 2: Anomaly reacquired at Range 44 North SCA IAR

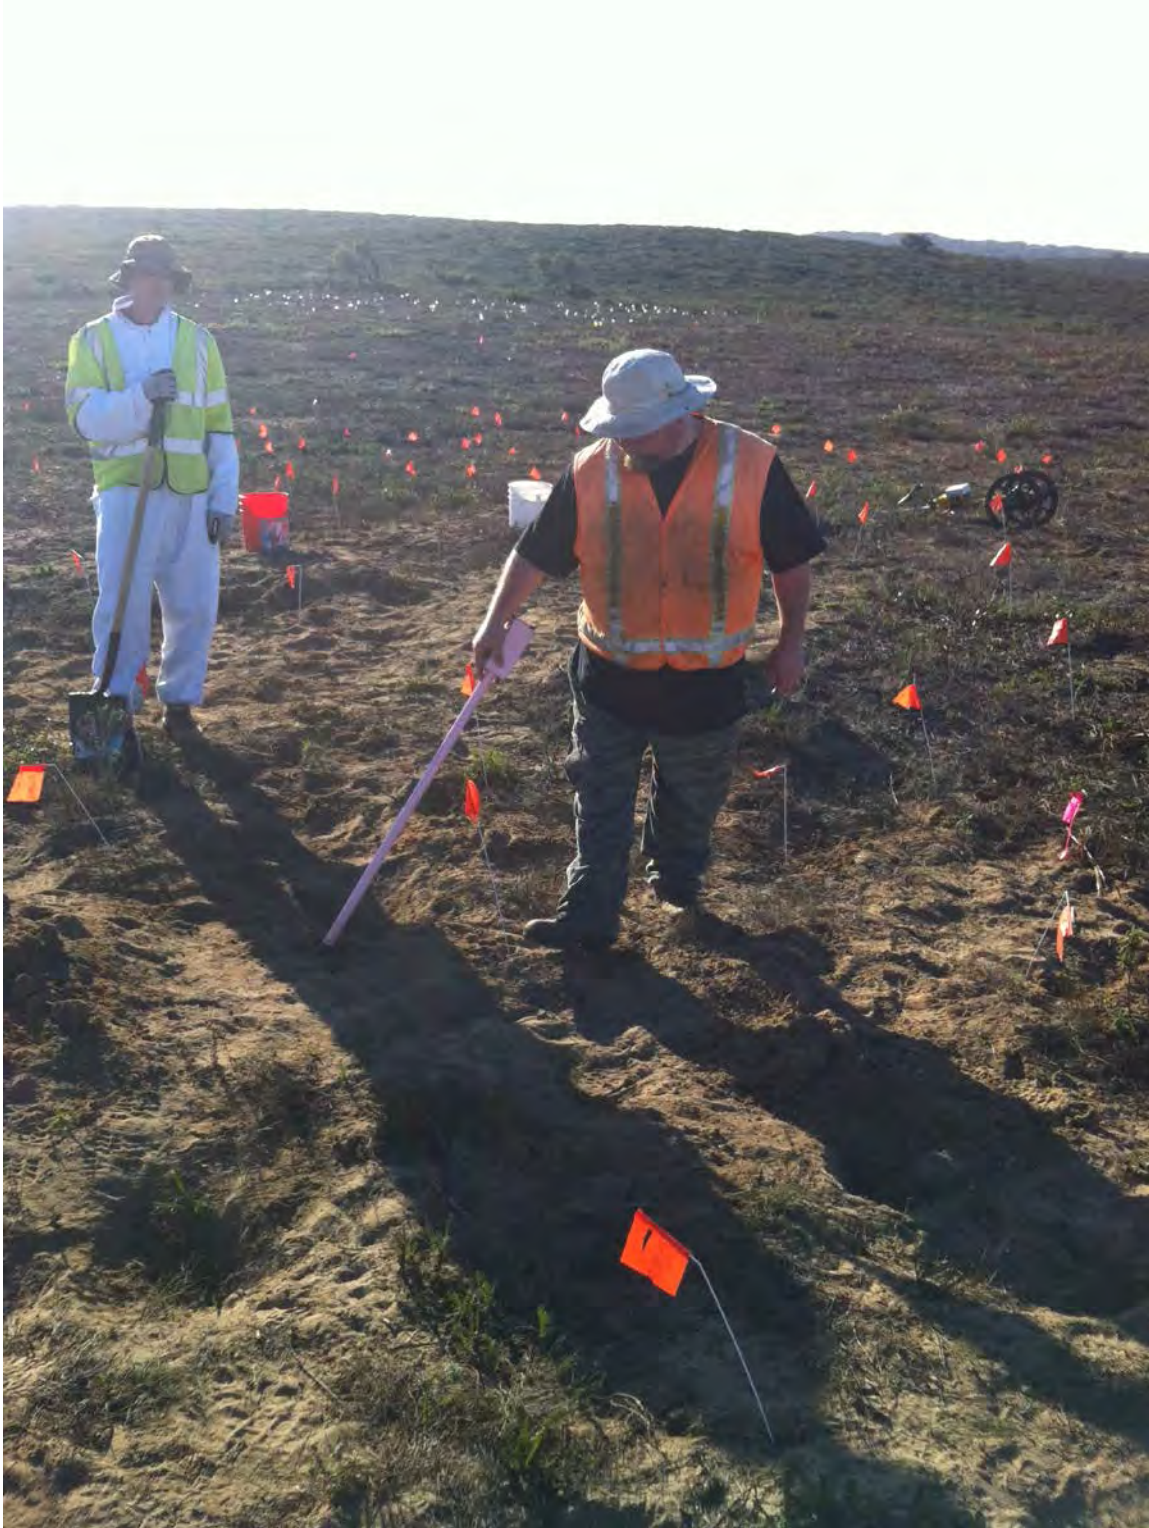
Picture 3: Pinpointing an anomaly utilizing a Shconstedt

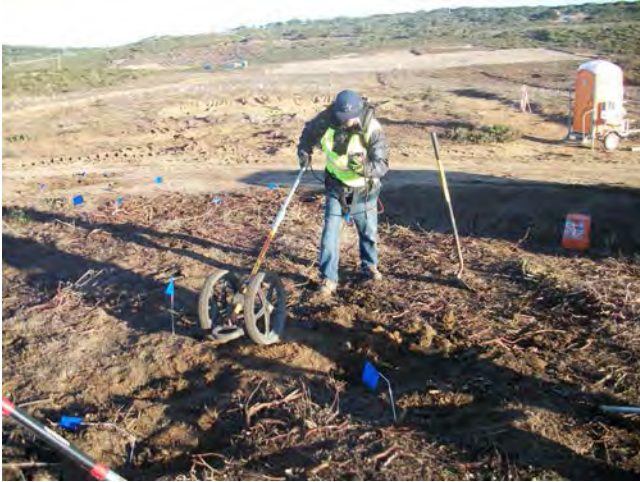
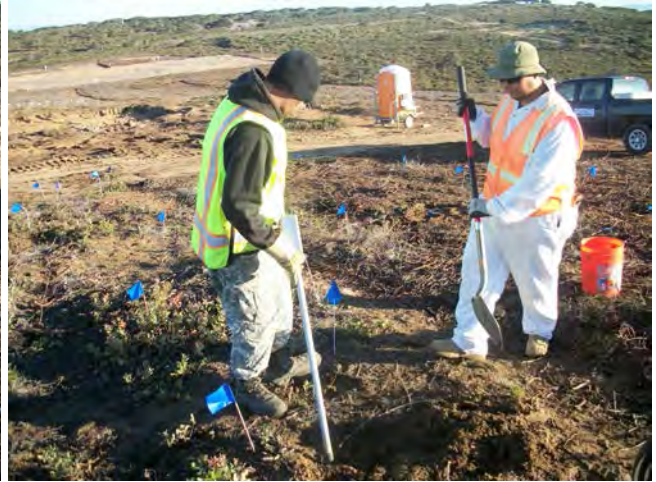
Picture 1&2: Anomaly locating with the EM 61 and pinpointing utilizing Schonstedt IAR R 44 North SCA

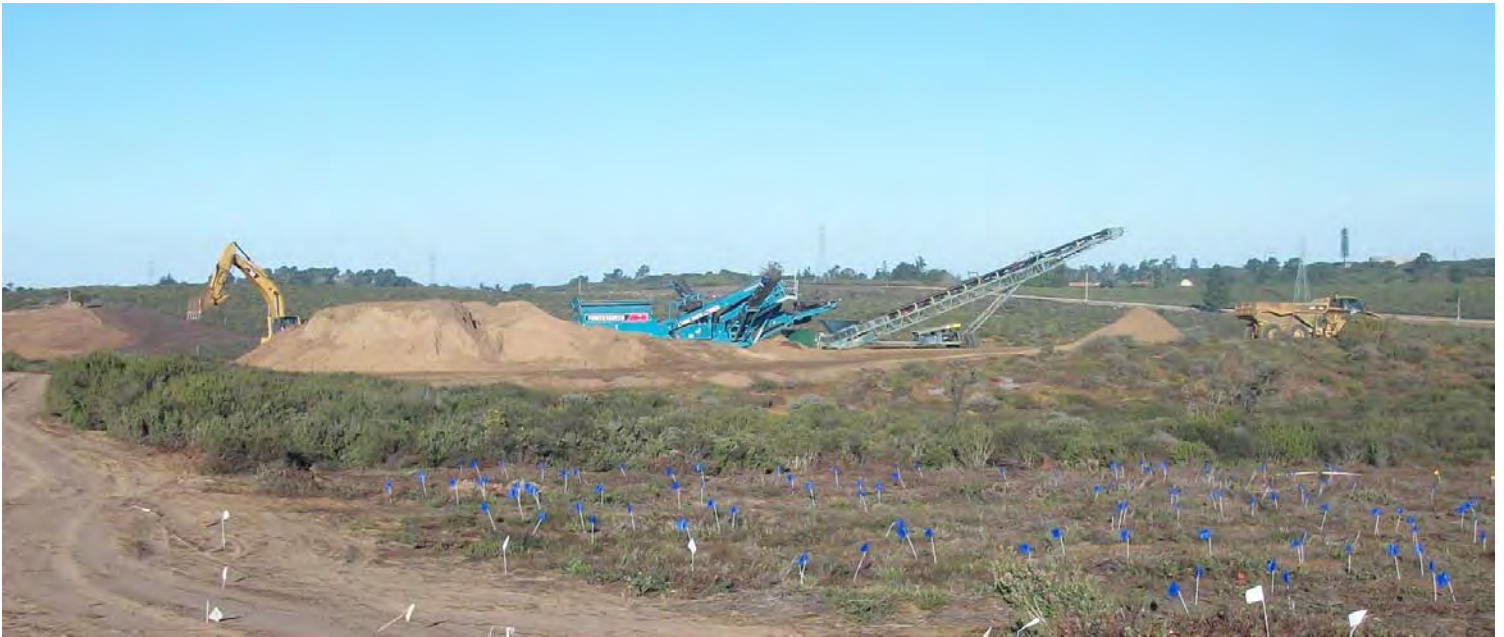
Picture 5: Sifter Operations in IAR 47 SCA

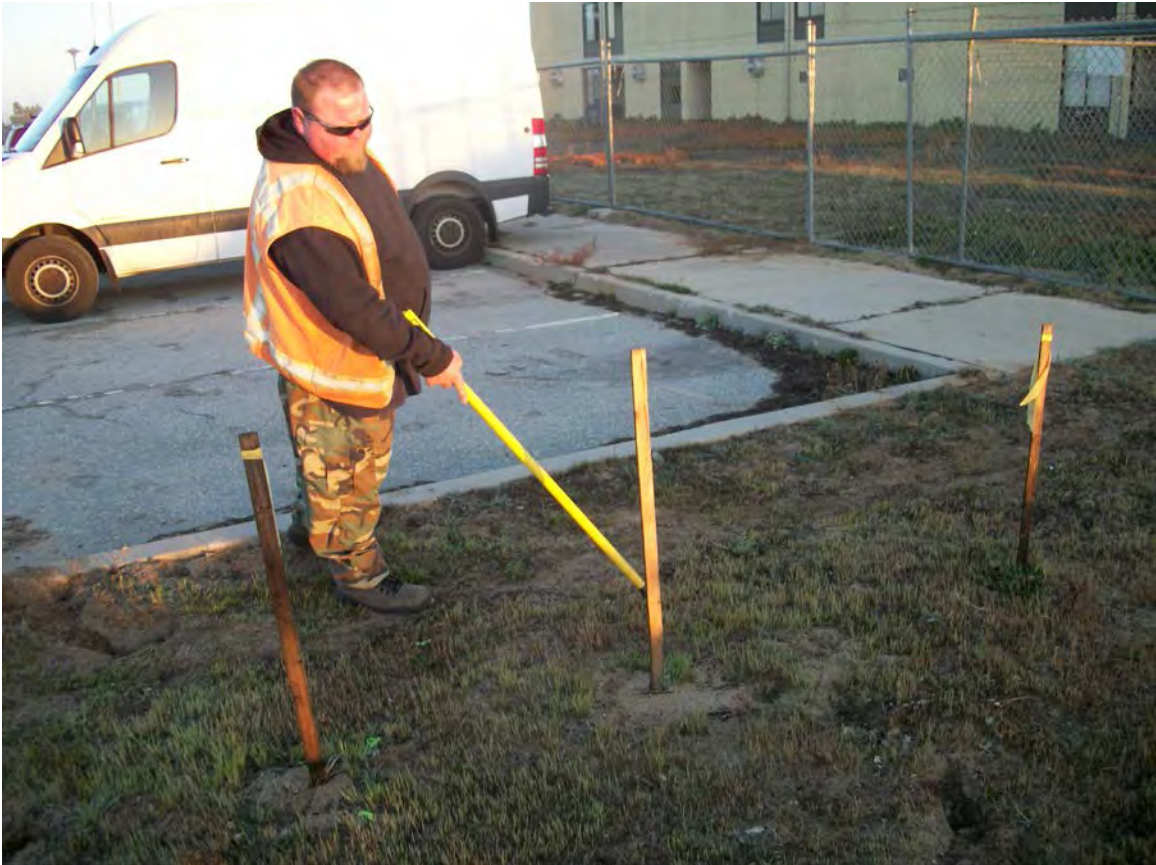
Picture 1: Shconstedt function check prior to operations

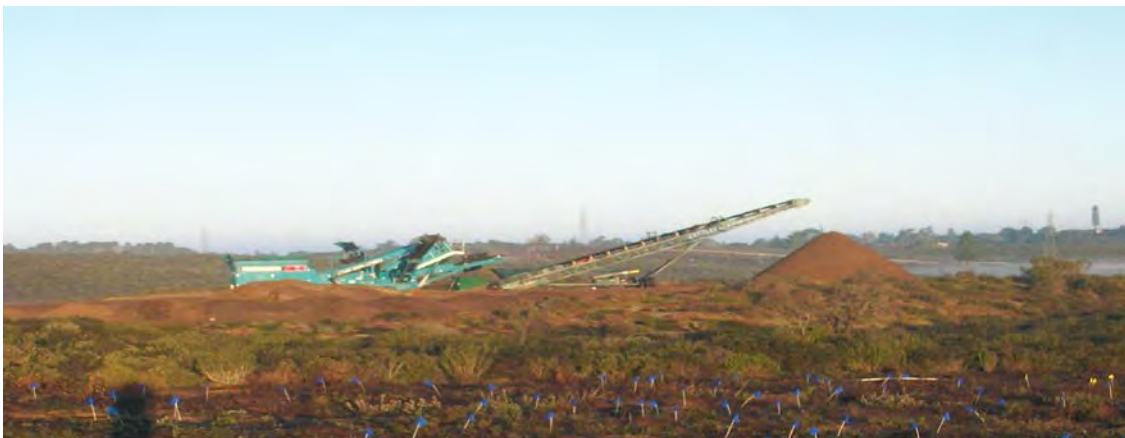
Picture 2: Range 47 SCA Sift operations viewed from safe distance

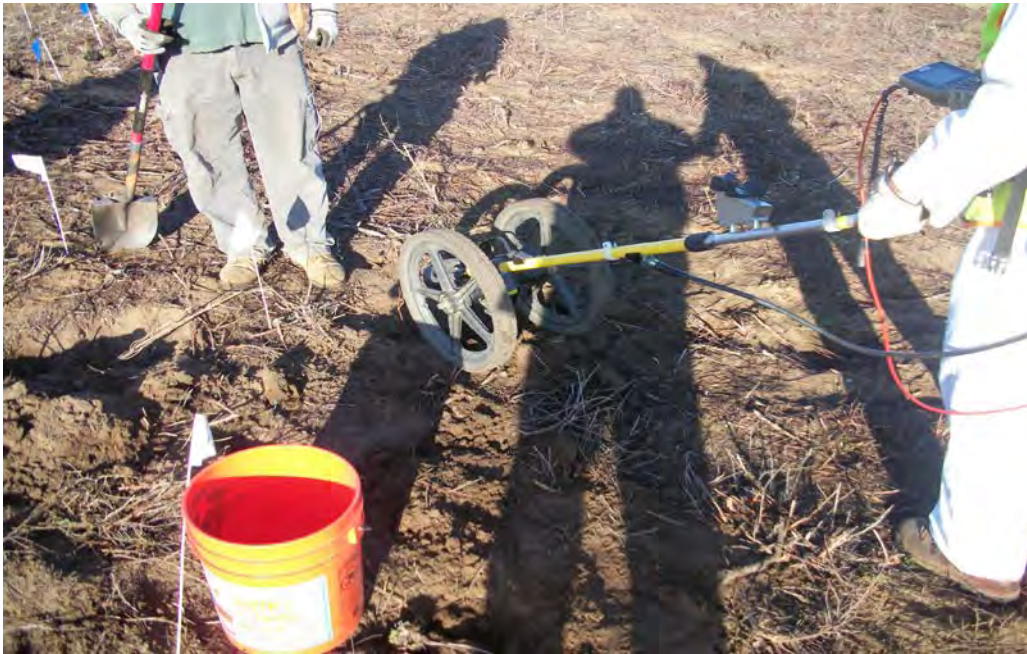
Picture 3: Anomaly locating utilizing the EM61

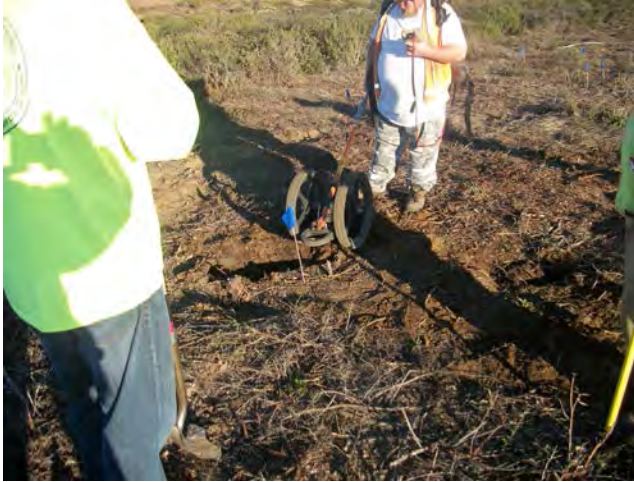
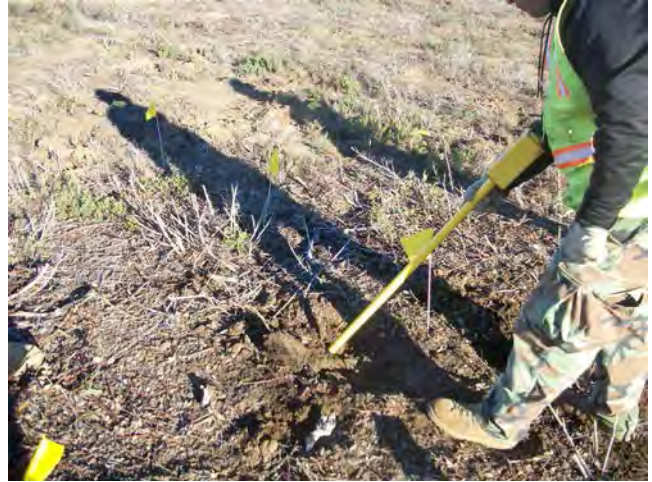
Pics 1&2 anomaly investigations using an EM 61 and a Schonstedt

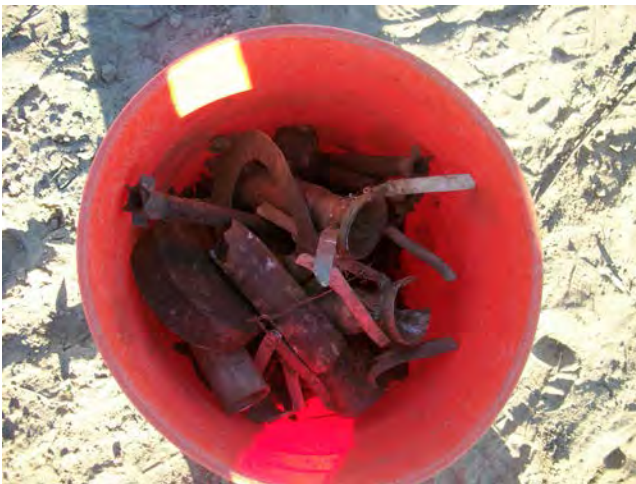
Pic 3: MD recovered in Grids

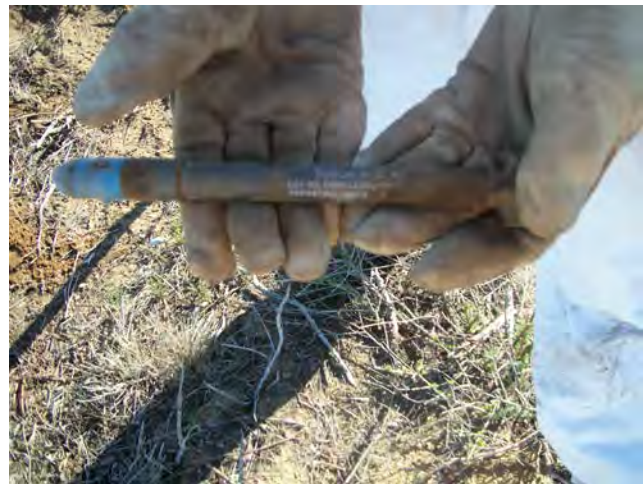
Pic 4: MEC Item M73 Sub Cal Rockets

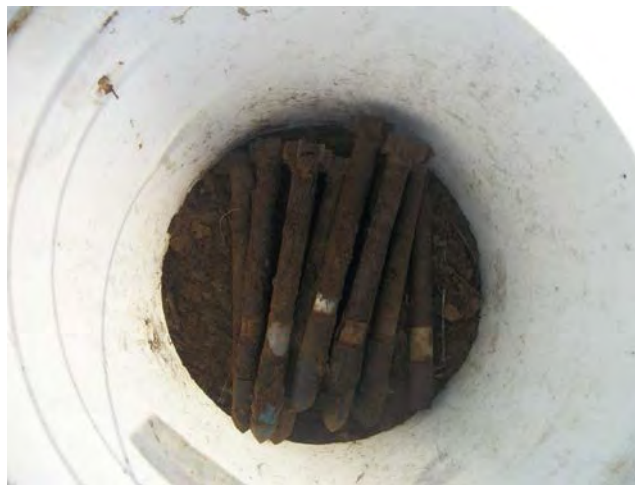
Pic 5: Consolidated MEC Items

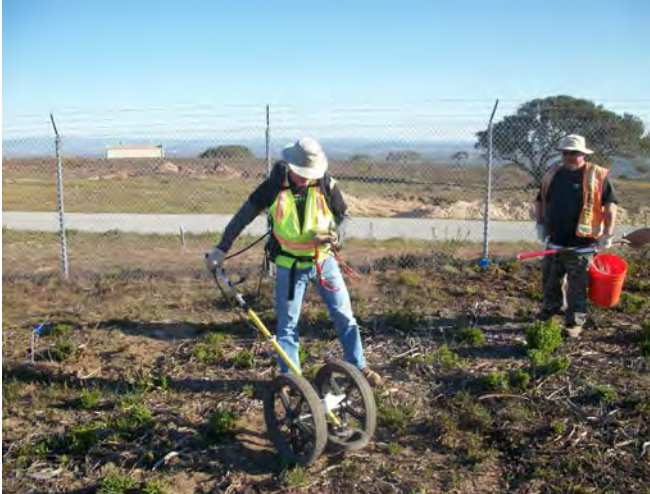
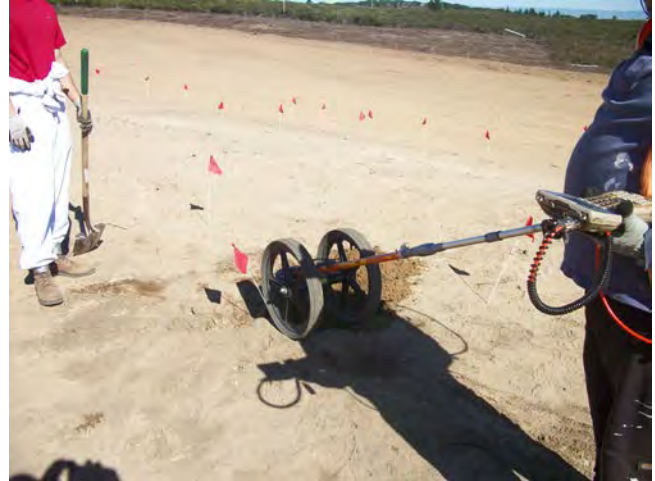
Pics 1&2 anomaly investigations using an EM 61

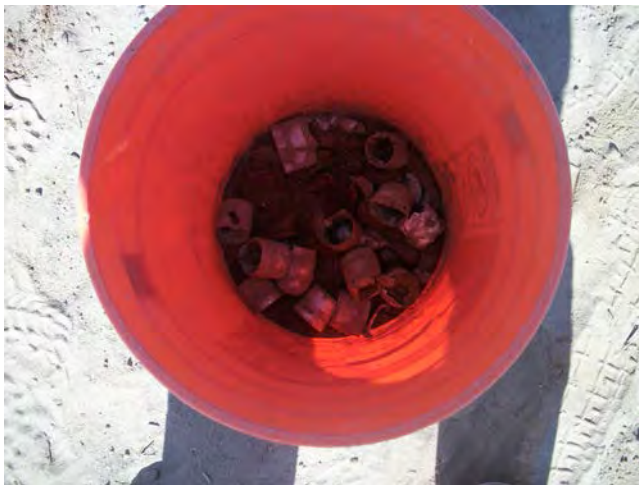
Pic 3: MD recovered in Grids

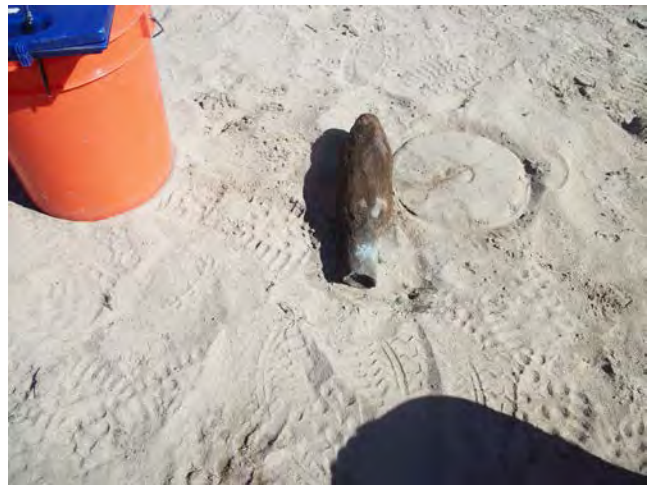
Pic 4: MD, partial M29, 3.5 inch rocket

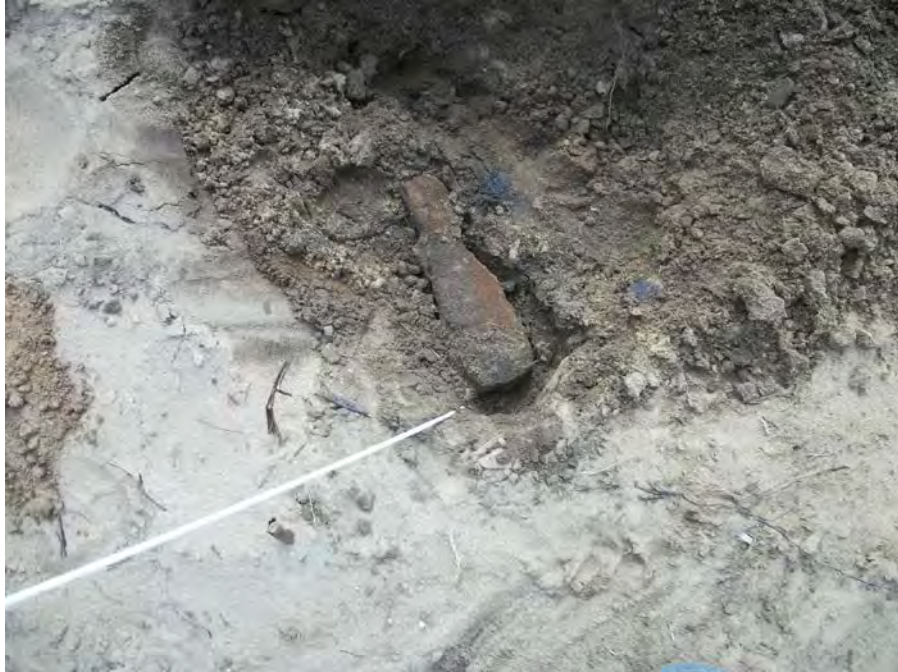
Picture 3: M49 Mortar, 60 MM IAR Rg 47

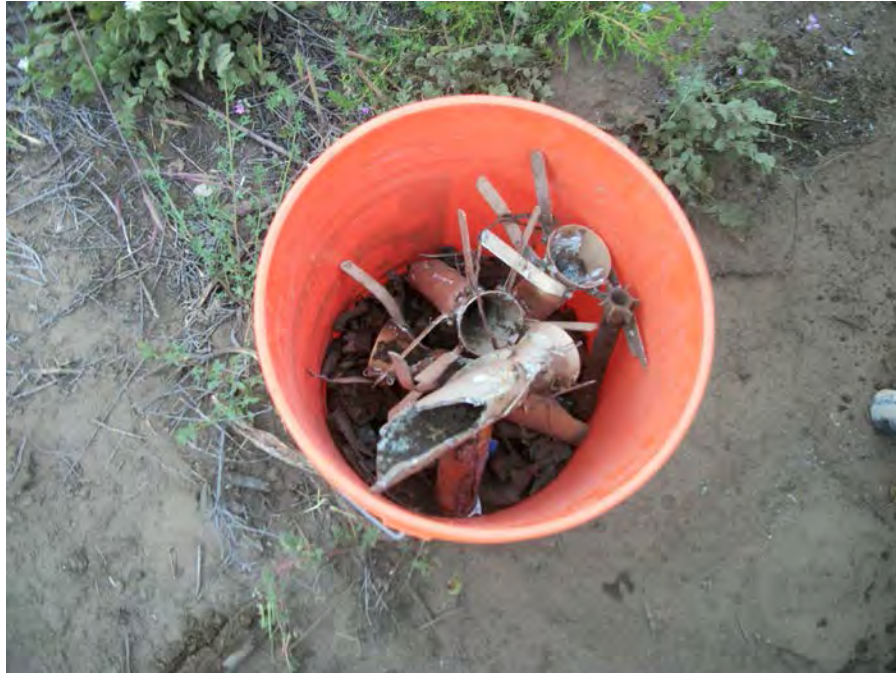
Pic 3: Munitions debris recovered

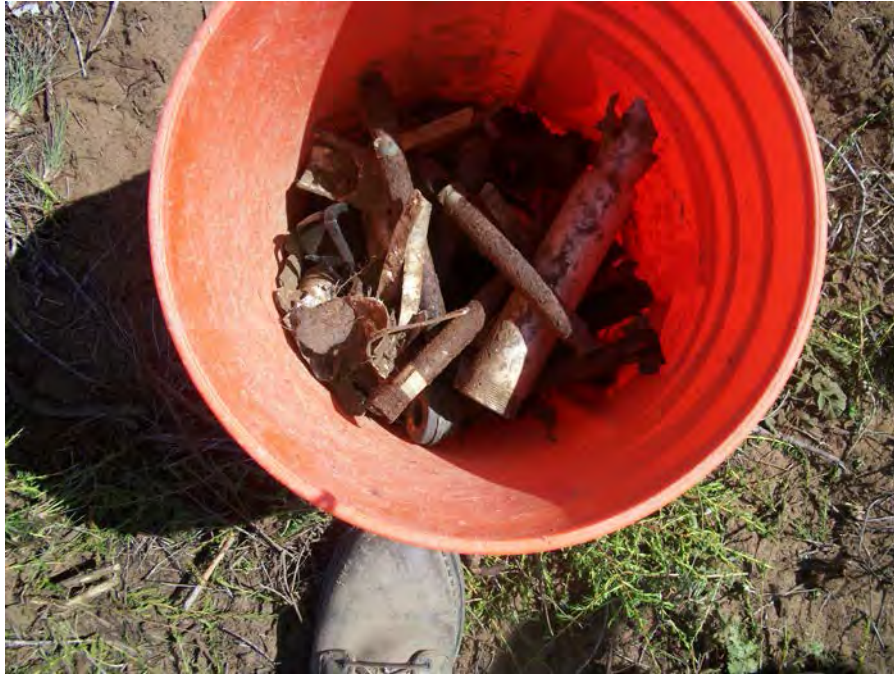
Pic 3: Munitions debris recovered

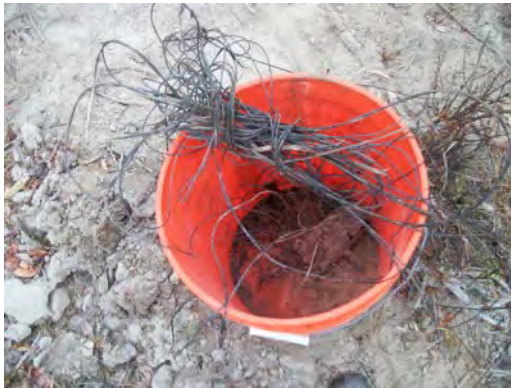
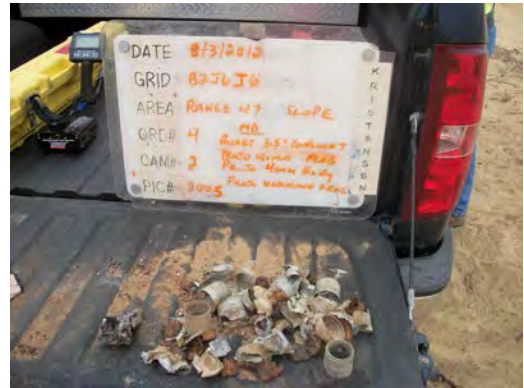
Pic 4 & 5: Orange bucket with non-munitions scrap, tailgate with MD

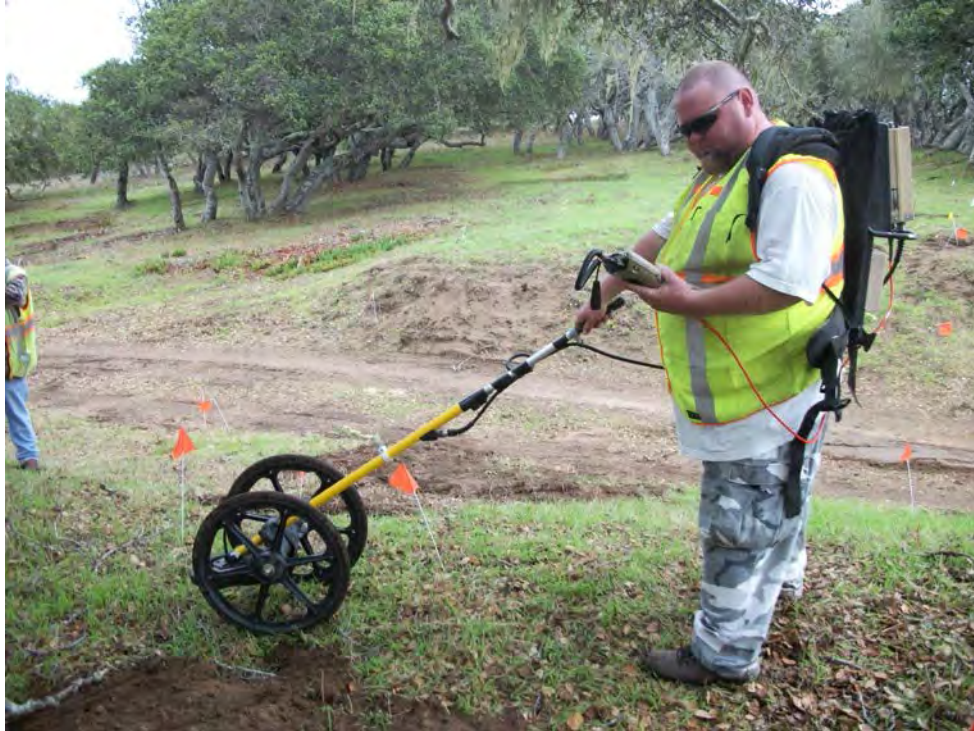
Picture 1: Weston Personnel performing anomaly acquisition at flag IAR Range 47 SCA
