**Independent Third-Party Quality Assurance Work
Summary Report for
Munitions and Explosives of Concern Activities at
Interim Action Ranges Munitions Response Area
Former Fort Ord Facility, Monterey, California**

August 2014

ERRG implemented quality assurance (QA) efforts in support of the design study for the Interim Action Range (IAR) Munitions Response Area (MRA) Range 44 and 47 Special Case Areas (SCA) and Central Area Non-Complete Areas (NCA) in compliance with the QASP to satisfy regulatory agency concerns. It is recognized that a MEC removal action may not successfully acquire and recover all MEC therefore the regulatory agencies have expressed concern regarding the residual risk that remains after MEC removals have taken place, particularly in areas that are slated as planned for community development with borderland that will interface habitat reserve (with administrative controls). This report is intended to document ERRG's efforts in providing the ESCA MEC Remediation Program with Third-Party Quality Assurance oversight, as required by the regulatory agencies, in addition to the Quality Control provided by Weston during their field work.

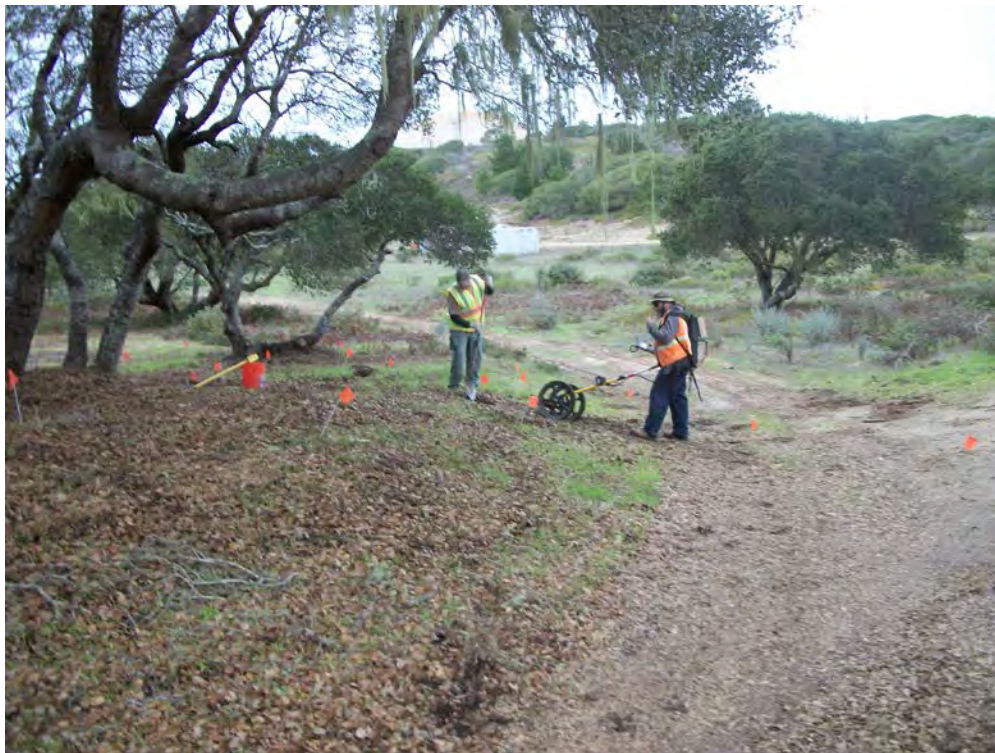
Picture 2: Team performing intrusive investigation on anomalies IAR Range 47 SCA

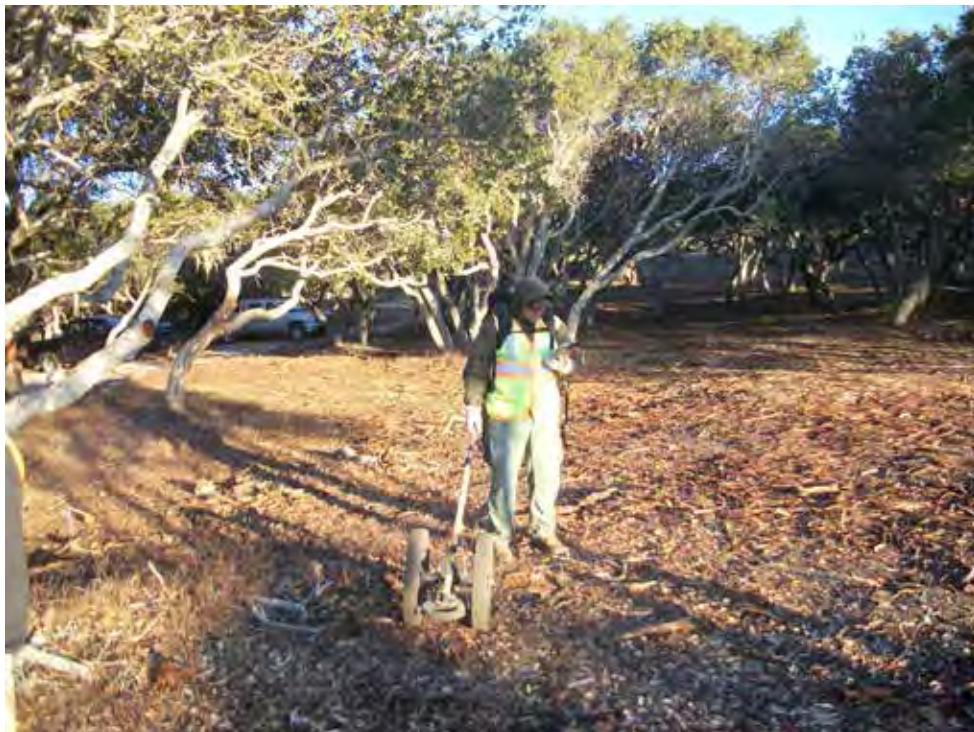
Picture 2: EM 61 utilized for anomaly acquisition IAR Range 47 SCA

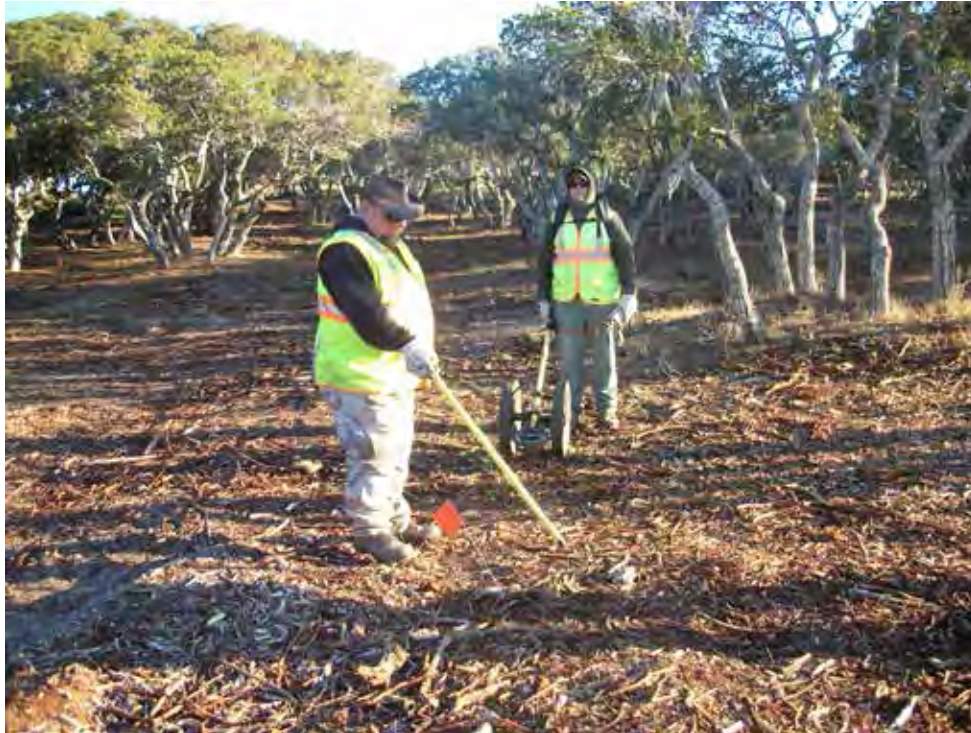
Picture 3: UXO Technician pinpointing with Schonstedt detector IAR Range 47SCA

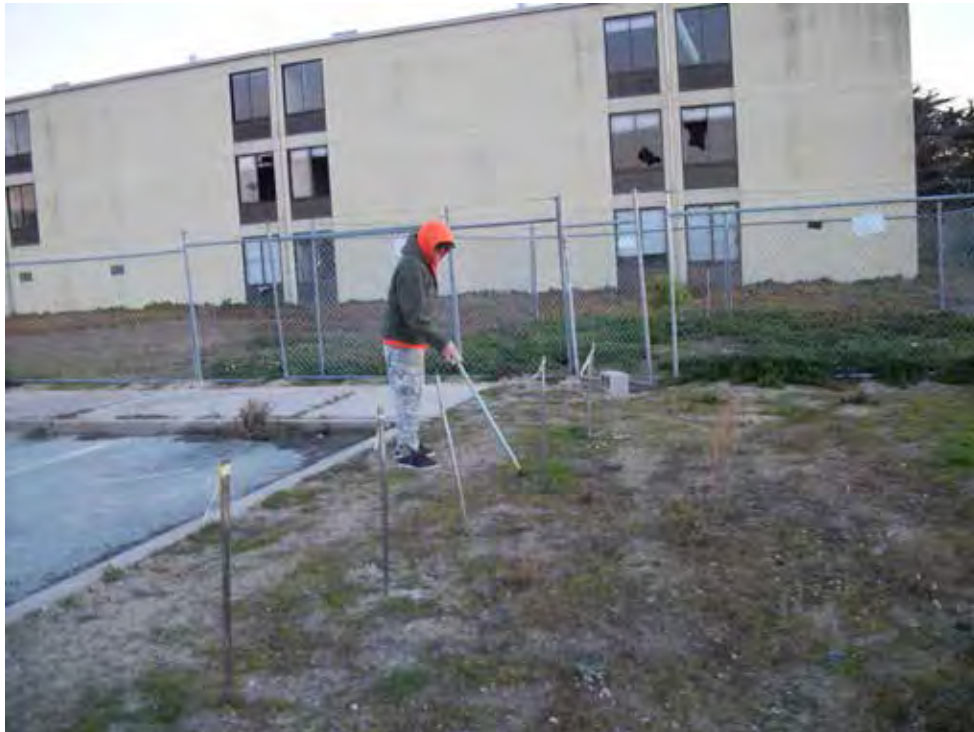
Picture 1: Personnel performing detector function testing

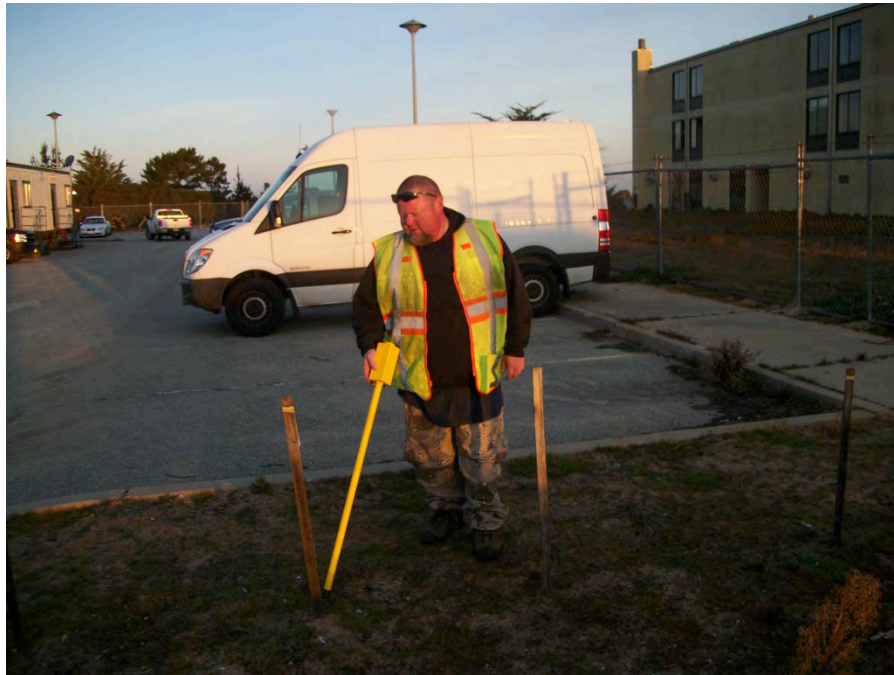
Picture 1: Personnel performing detector function testing

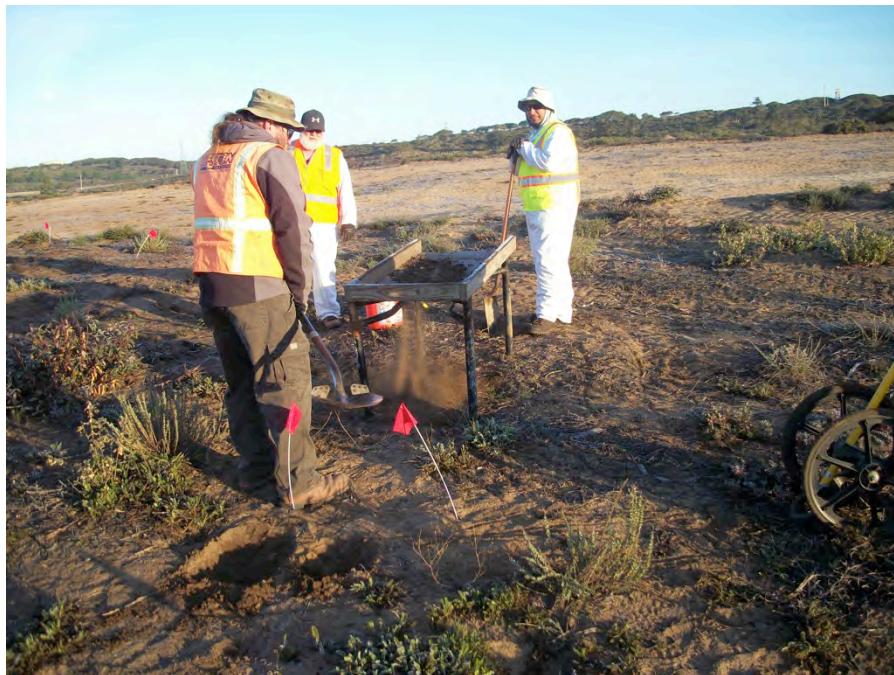
Picture 2: UXO Personnel performing anomaly investigations IAR

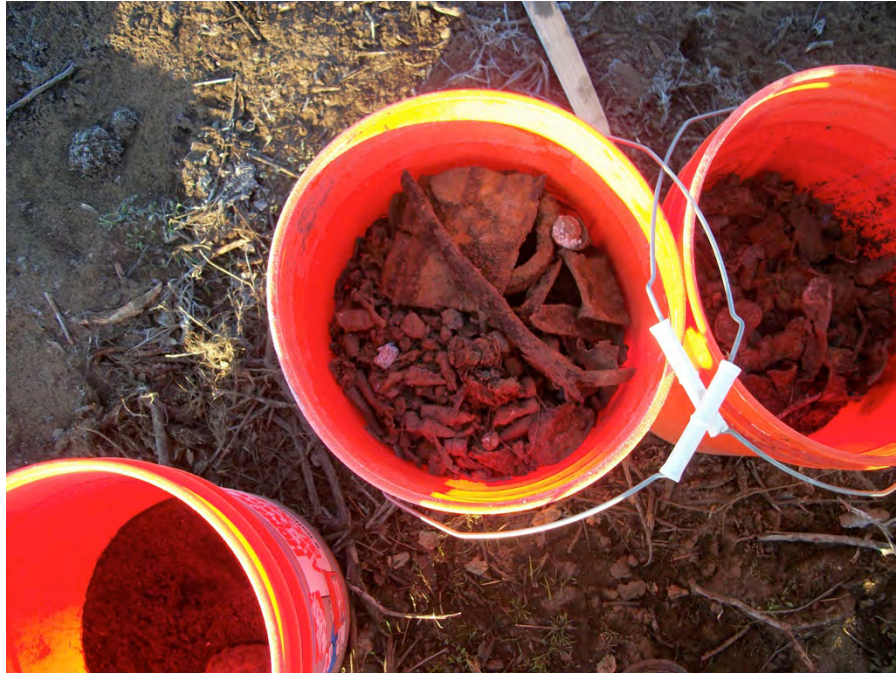
5. Munitions Related Debris found in grid: Expended M72 components.
 6. MEC found in grid: One (1) MK2 grenade, two (2) .22 caliber M73
 7. QA Seeds during visit: None

Picture 3: MD recovered by the team

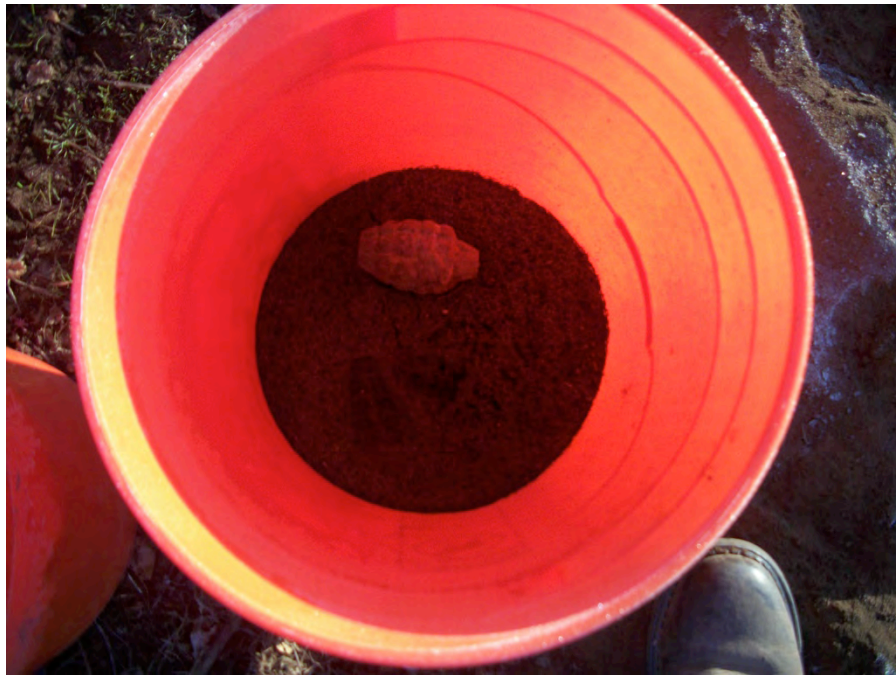
Picture 4: MK2 grenade recovered by the team

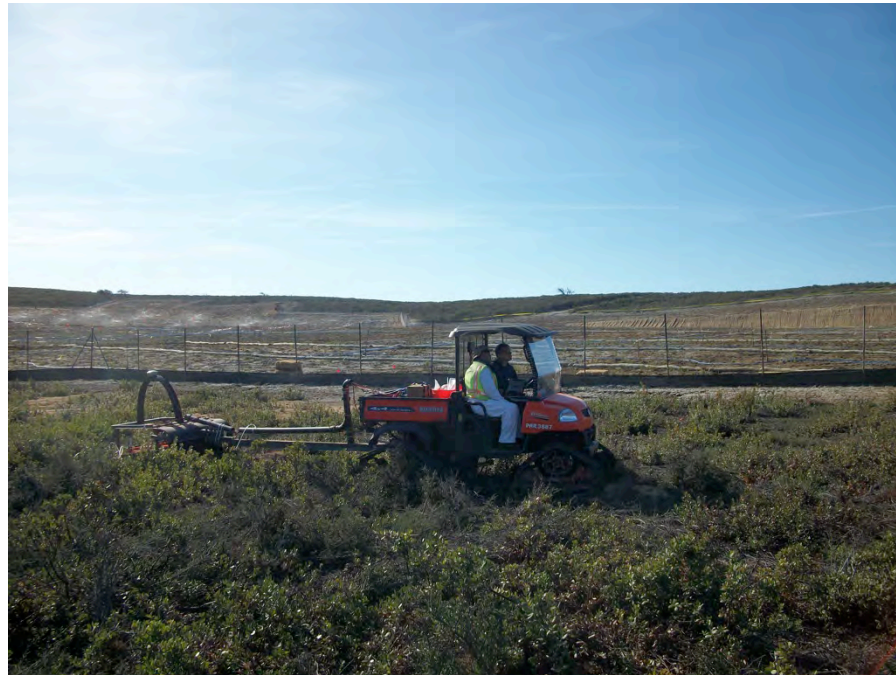
- QA observed Weston DGM Team performing towed array QA data collection in IAR MRA Range 47 SCA
 1. DGM equipment QC checks performed at the IVS before and after operations

2. Observed DGM performed within boundaries of the required areas
 3. Safe work practices observed

Picture 5: DGM operations performed in IAR MRA Range 47
